ENGINEERING FEATURES
OF THE
SAN FERNANDO EARTHQUAKE OF FEBRUARY 9, 1971

Paul C. Jennings, Editor

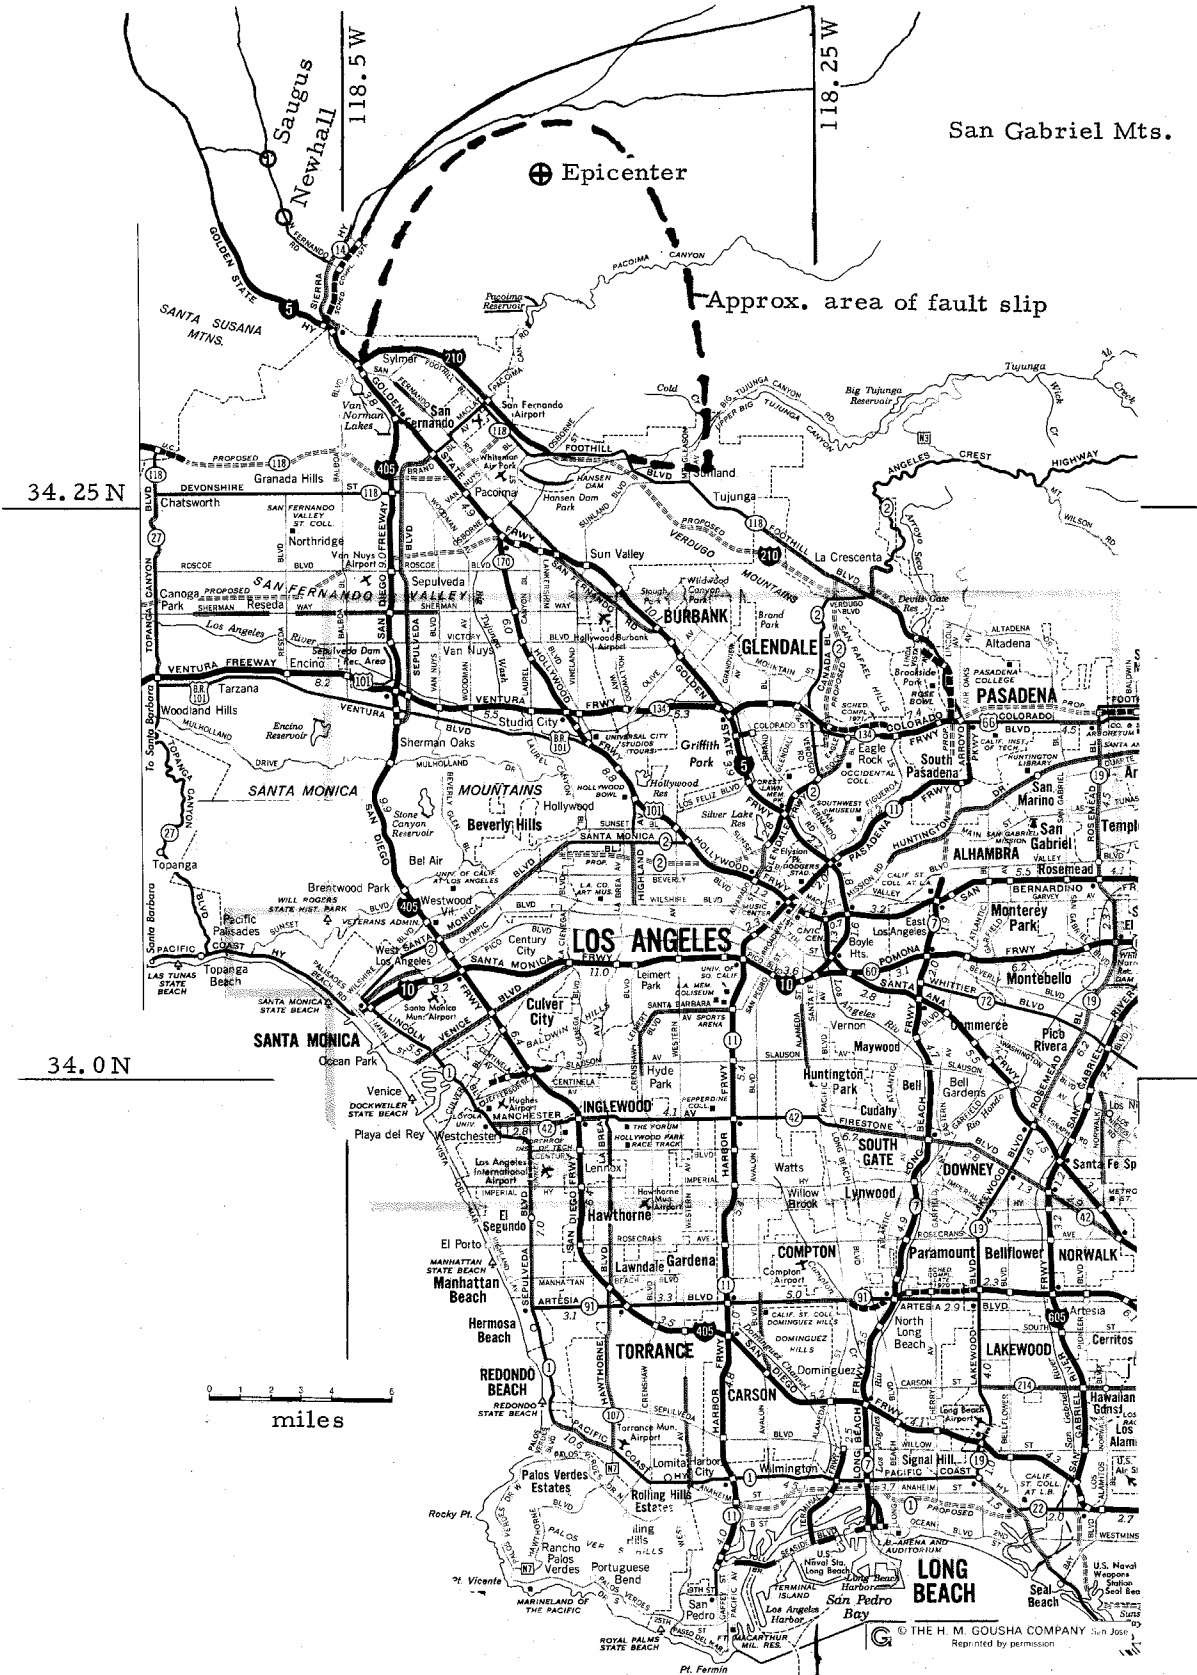
Figure 1.1 Map of western Los Angeles.

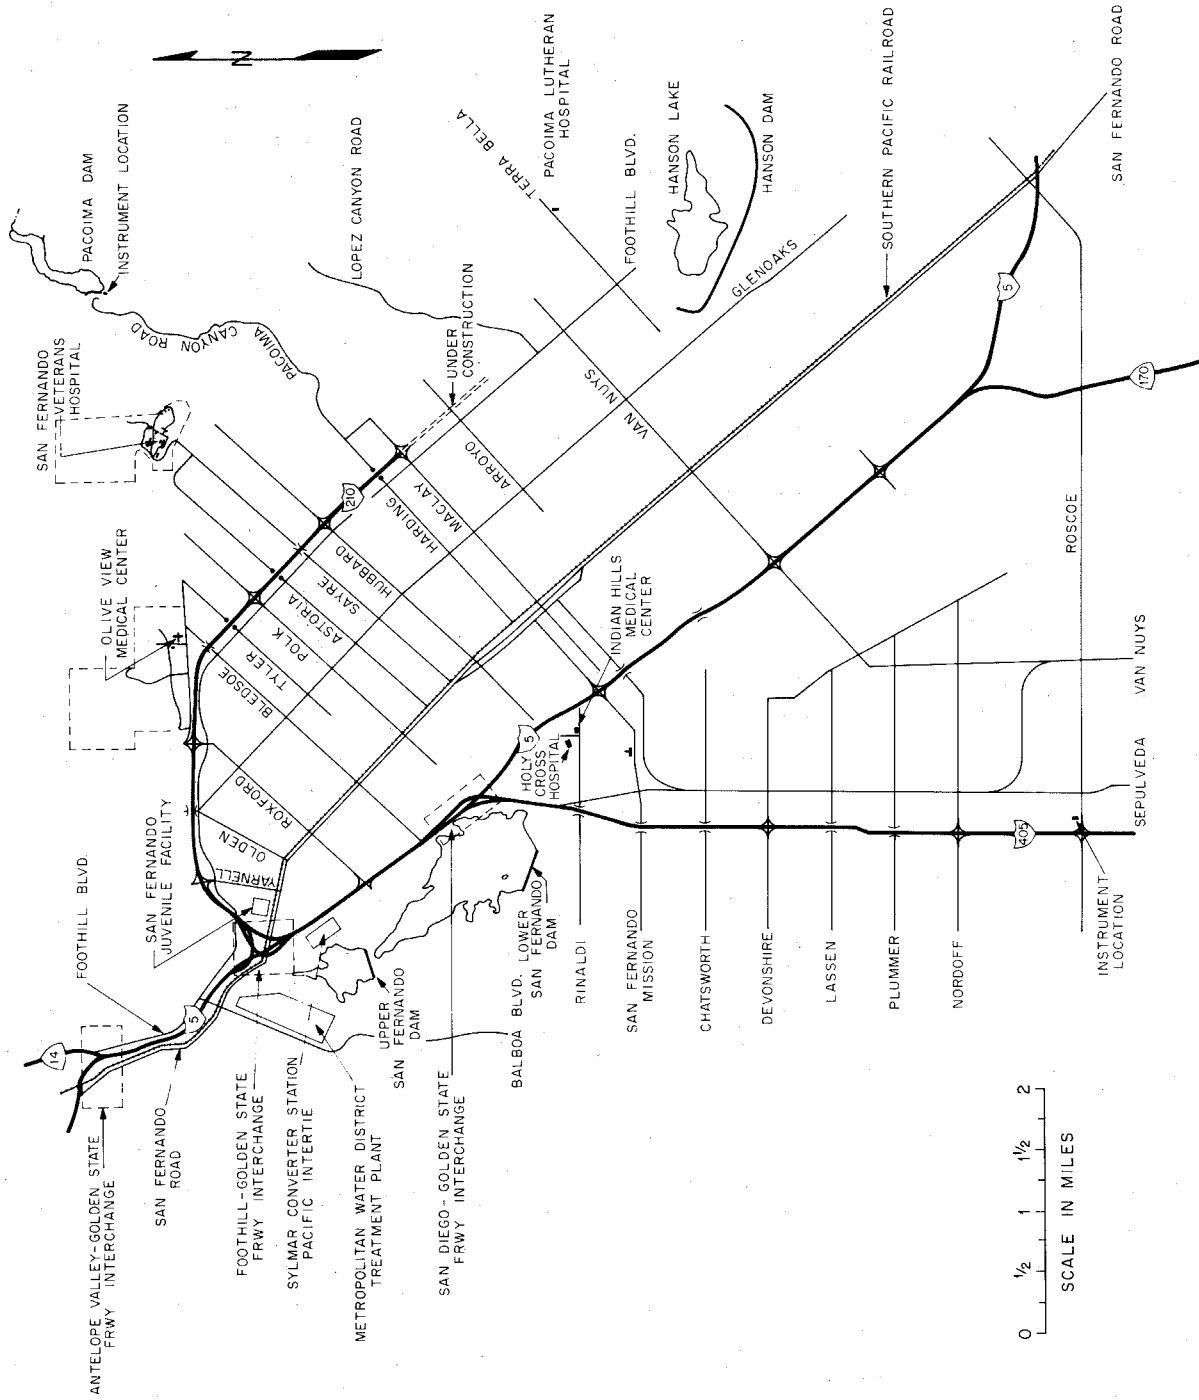
Figure 1.2 Plan of northern San Fernando Valley showing main points of interest and major streets.

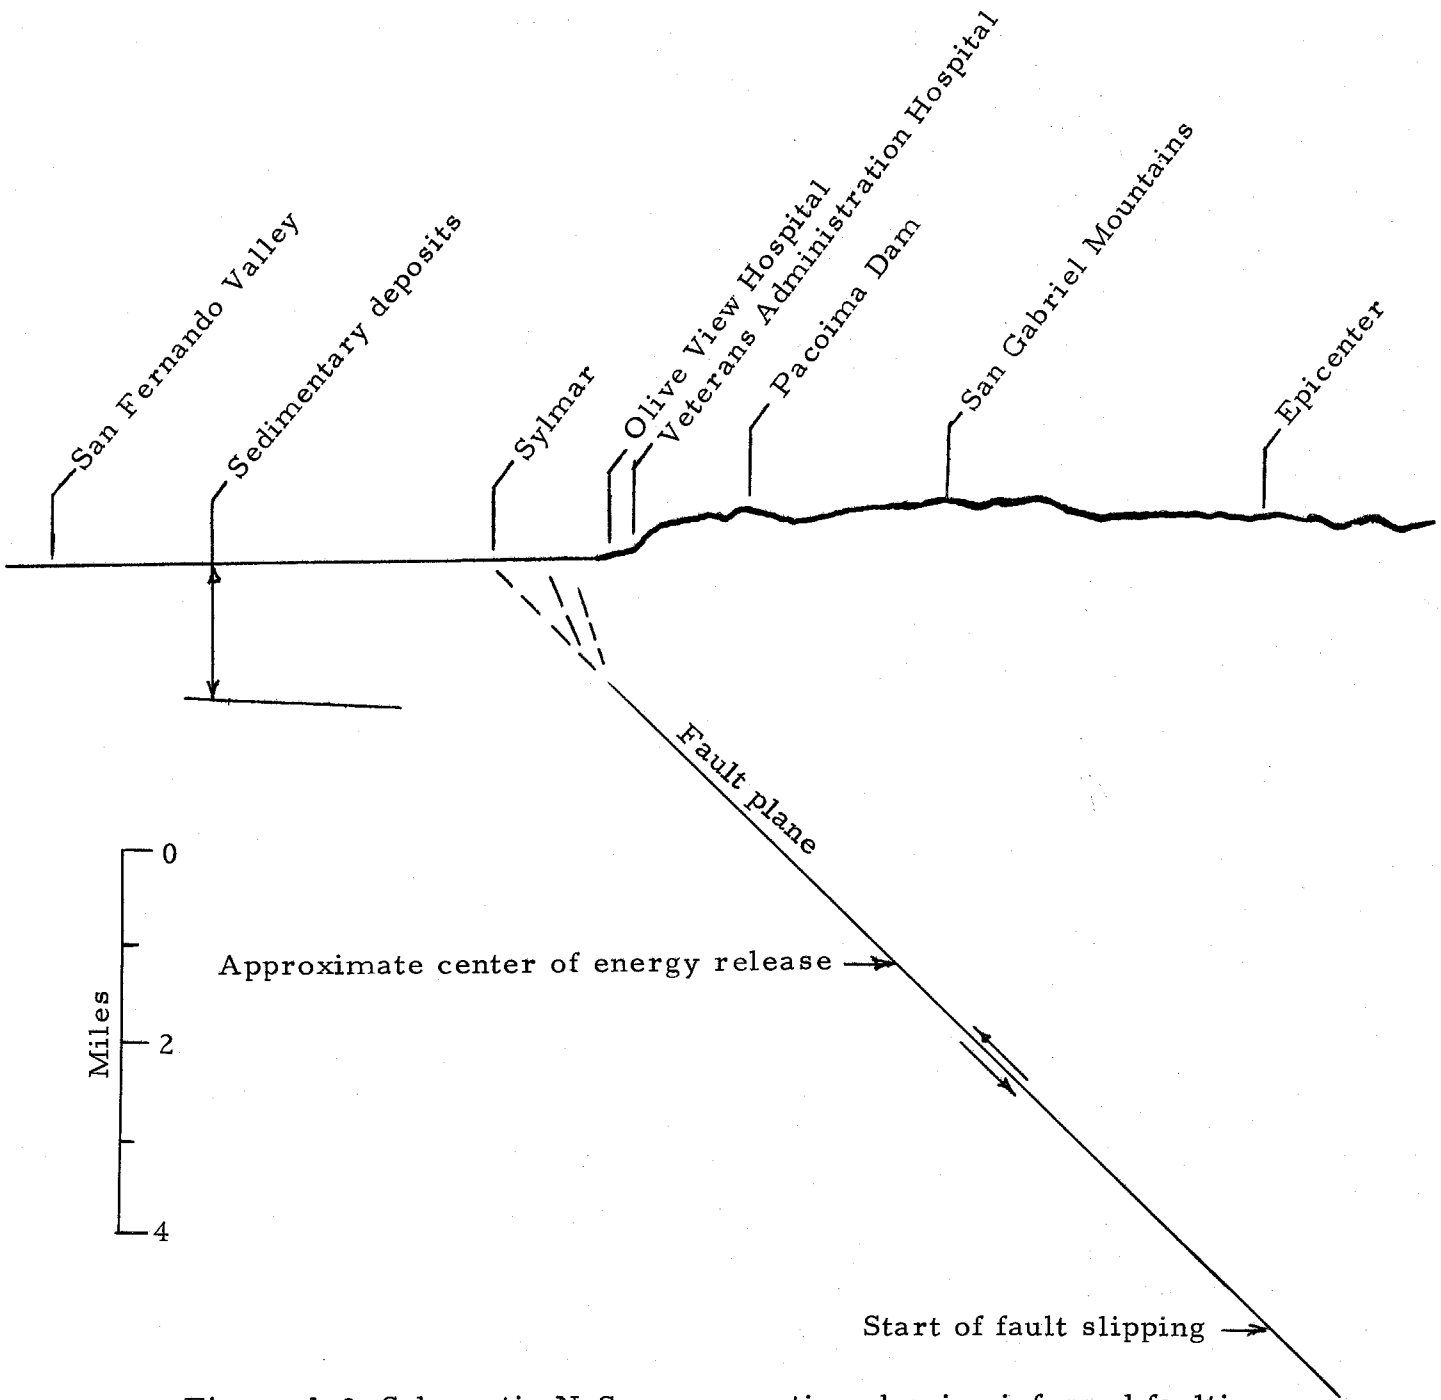
Figure 1.3 Schematic N-S cross-section showing inferred faulting.

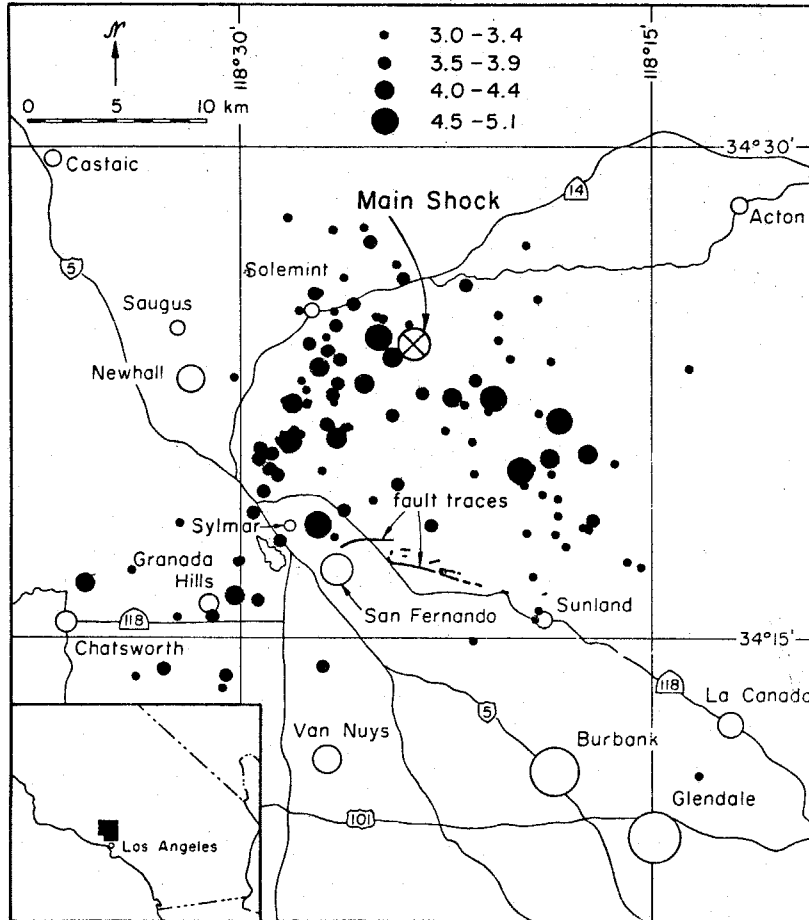
Figure 1.4 The San Fernando Earthquake of February 9, 1971. The map shows the epicenter of the magnitude 6.6 main shock and of representative aftershocks (magnitudes greater than 3) through March 1, 1971. (Report on the San Fernando Earthquake of 9 February 1971, Seismological Laboratory, California Institute of Technology).

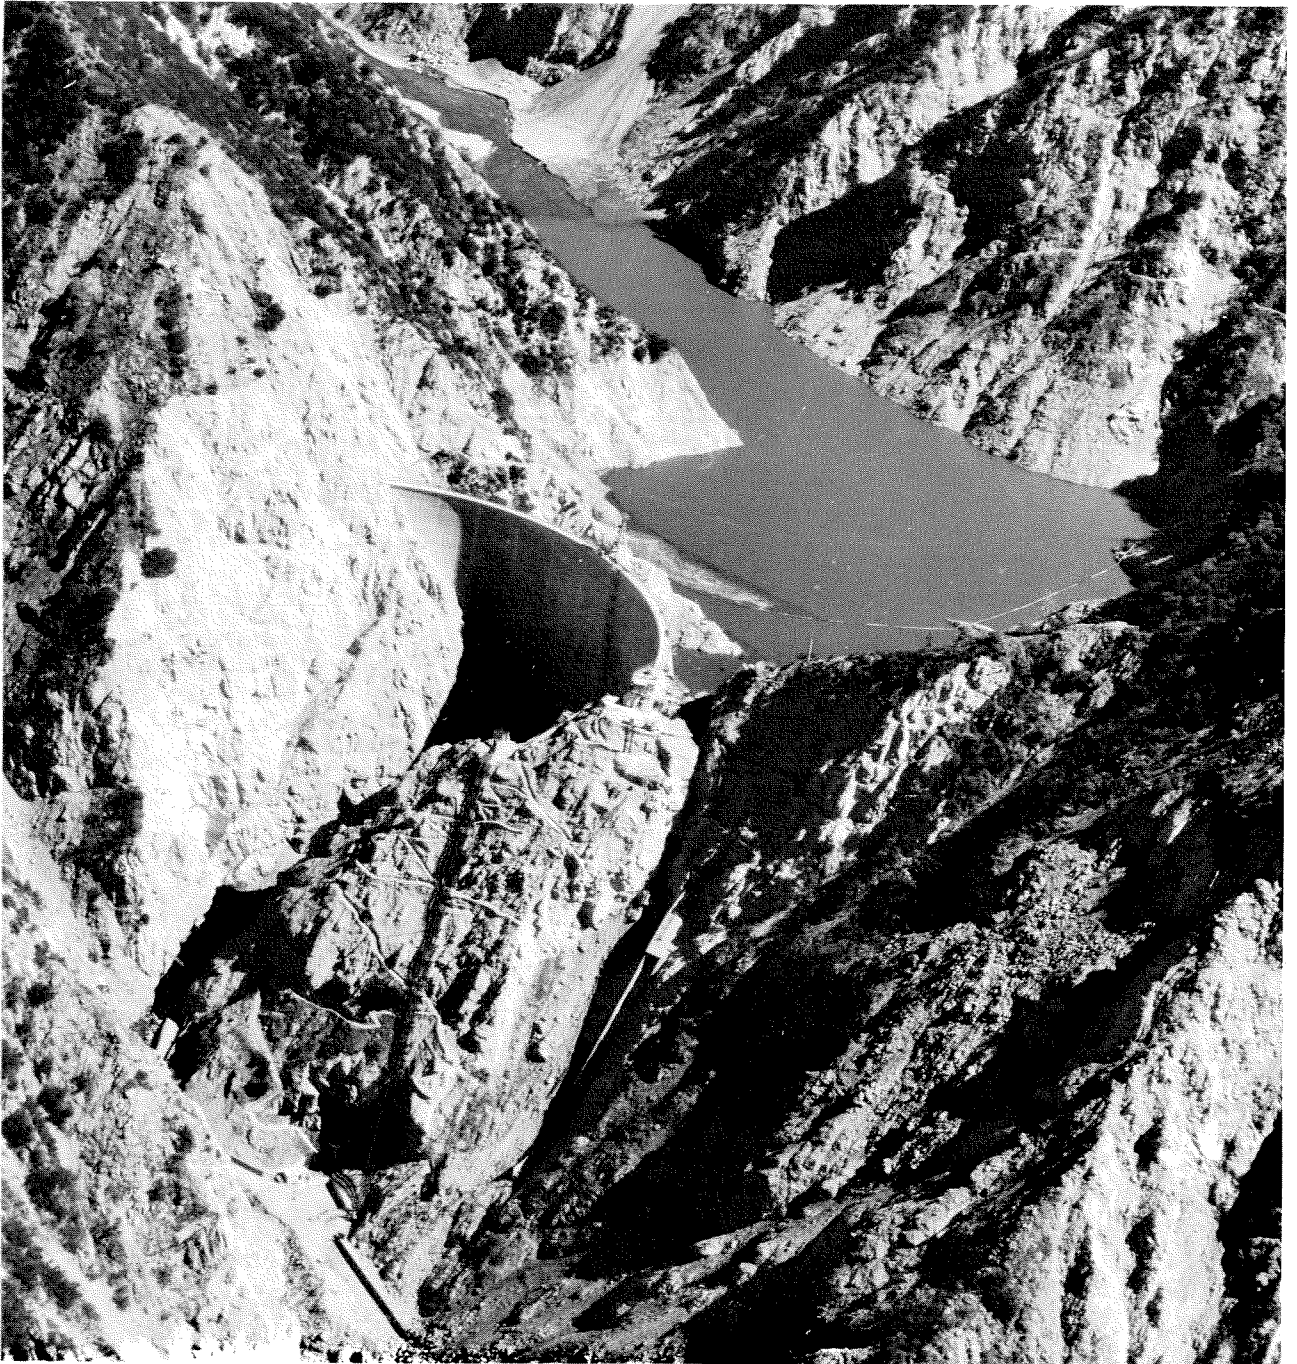
Figure 1.13 Near view of Pacoima Dam looking northeast. The small white accelerometer house is to the left of and adjacent to the larger white water tank on top of the ridge to the right and above the near abutment. This 372 ft high concrete arch dam was constructed in 1928. The dam was not damaged by the earthquake. Another view of the dam is shown in the paper by Hudson and Trifunac.

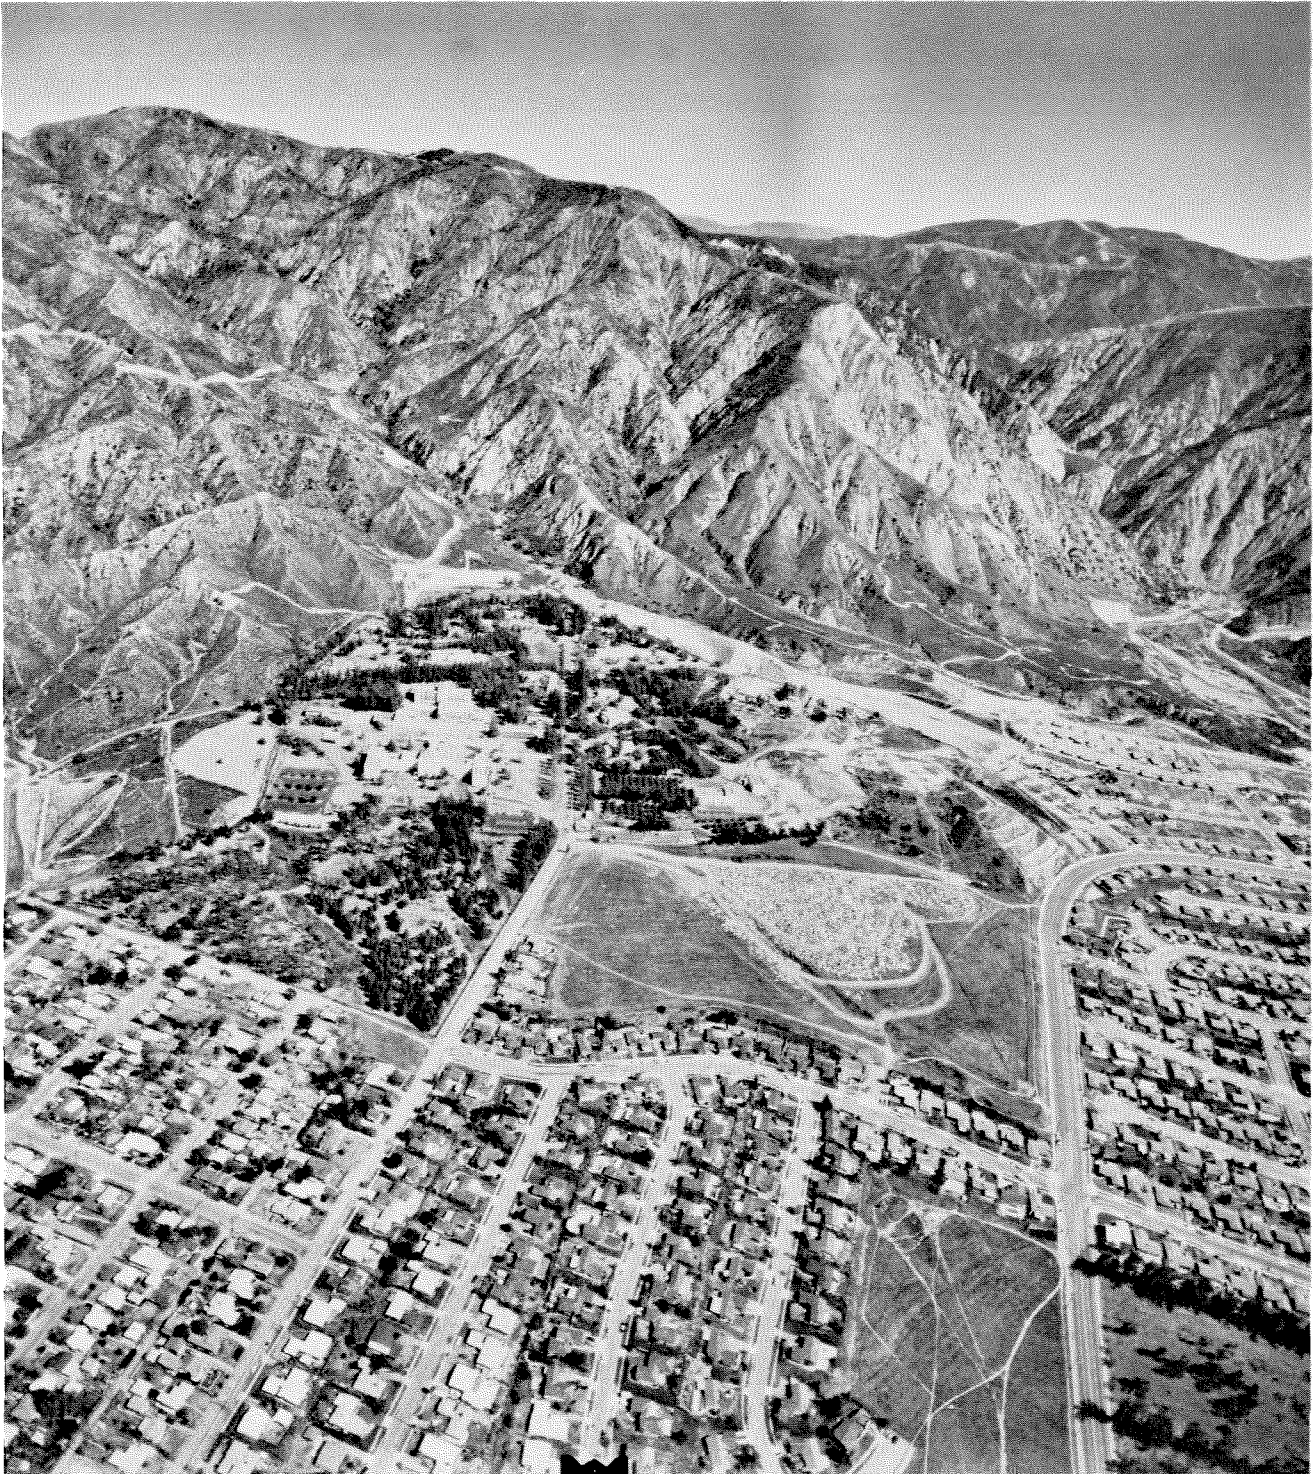
Figure 1.14 View of Veteran's Administration site looking northeast. Hubbard Avenue is on the right and Sayre Street is on the left running into the hospital grounds. In the field between Sayre Street and Hubbard Avenue, the heart-shaped area is formed by the pieces of the collapsed building which were trucked here as the remains of the building were carefully picked up piece by piece during the search for survivors. Pacoima Dam is visible in the background.

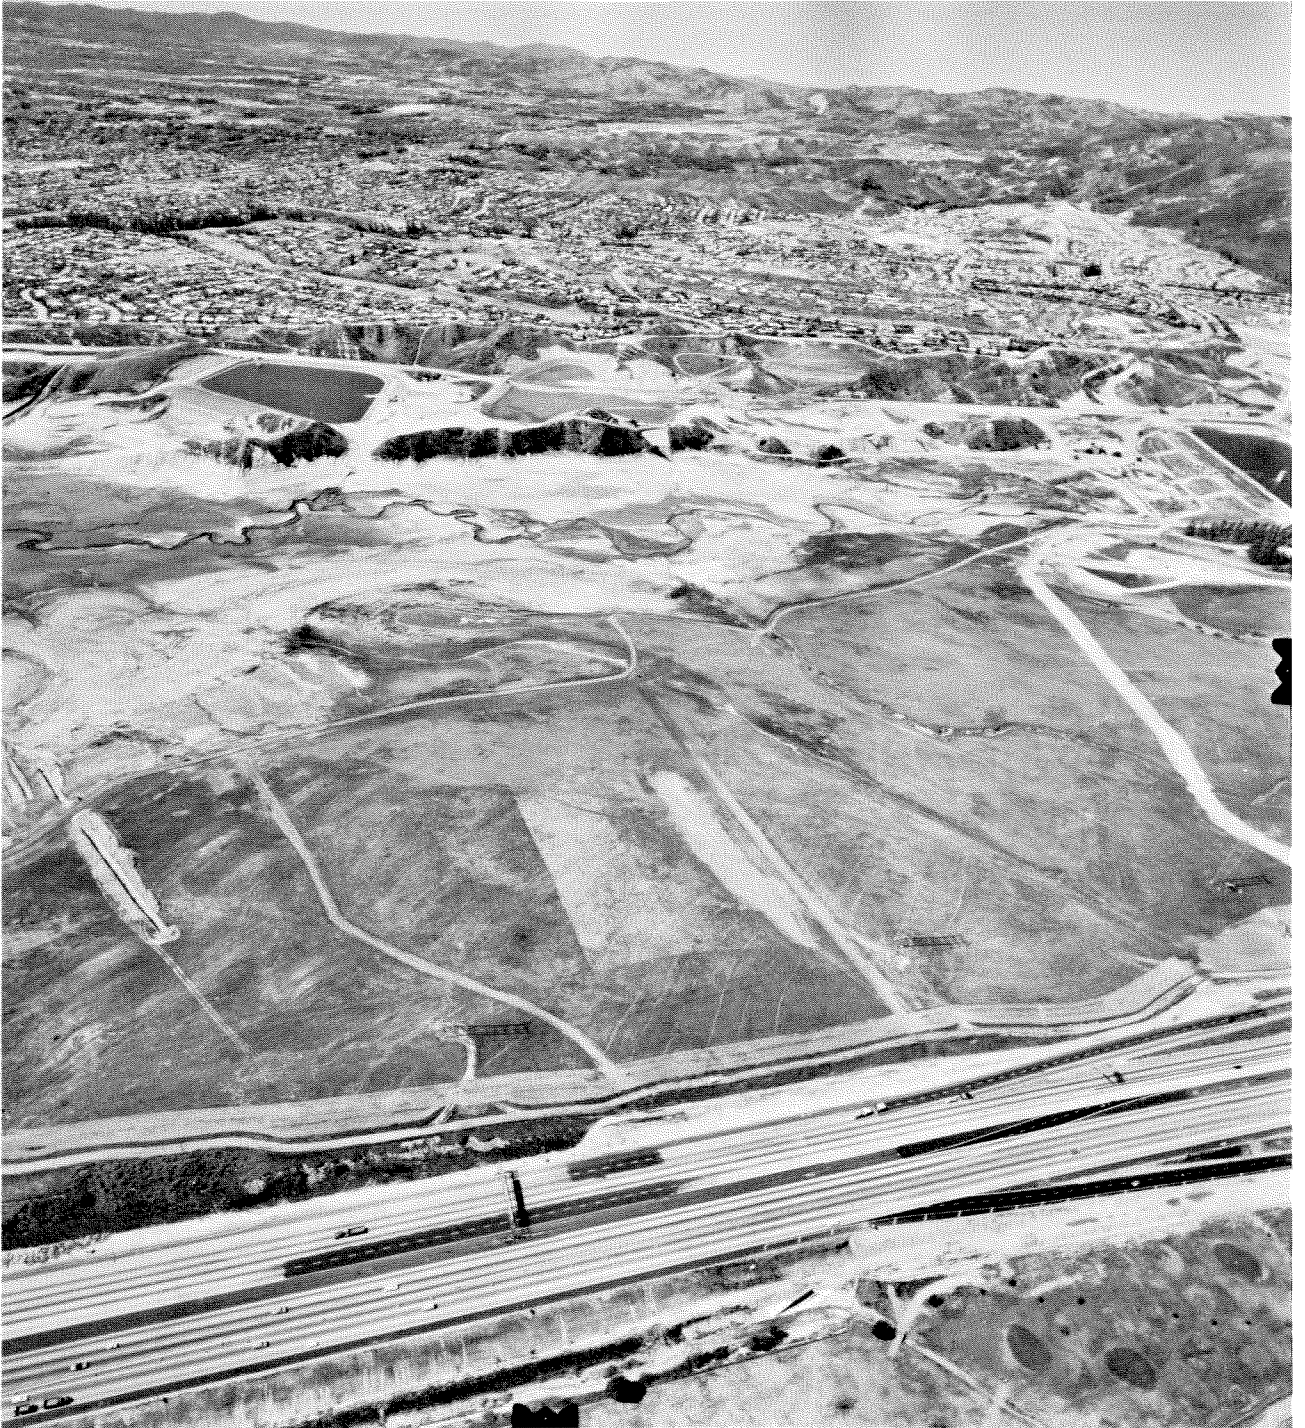
Figure 1.19 Looking southwest over the northern end of upper Van Norman Reservoir. In the left background is the new by-pass reservoir and earth dam which was not damaged by the earthquake. The upper Van Norman Dam and a portion of the reservoir is seen in the upper right of the photo. This dam started to fail downstream during the earthquake and the crest moved 5 ft.

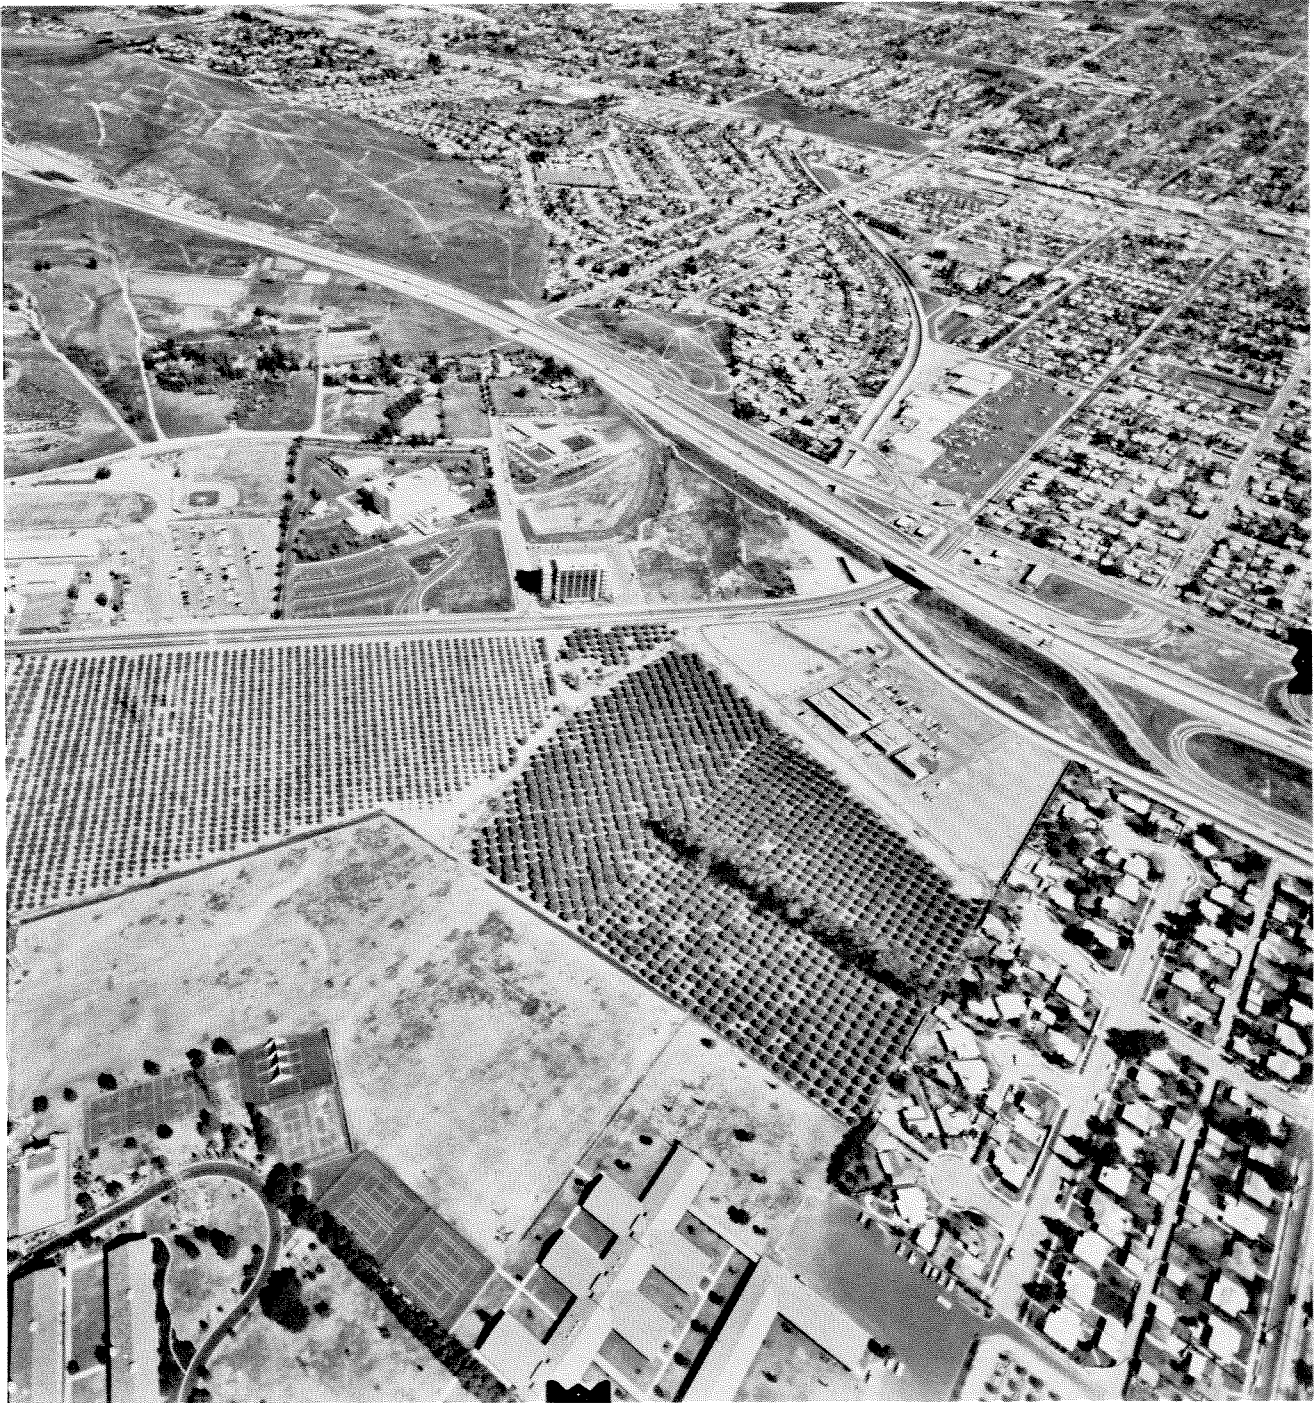
Figure 1.20 In the center of the photograph Rinaldi Avenue passes under Golden State Freeway. The damaged Indian Hills Medical Center Building faces on Rinaldi, and just beyond and to the left is the Holy Cross Hospital building, also damaged. Lower Van Norman Reservoir is just outside of the upper left of the photograph.

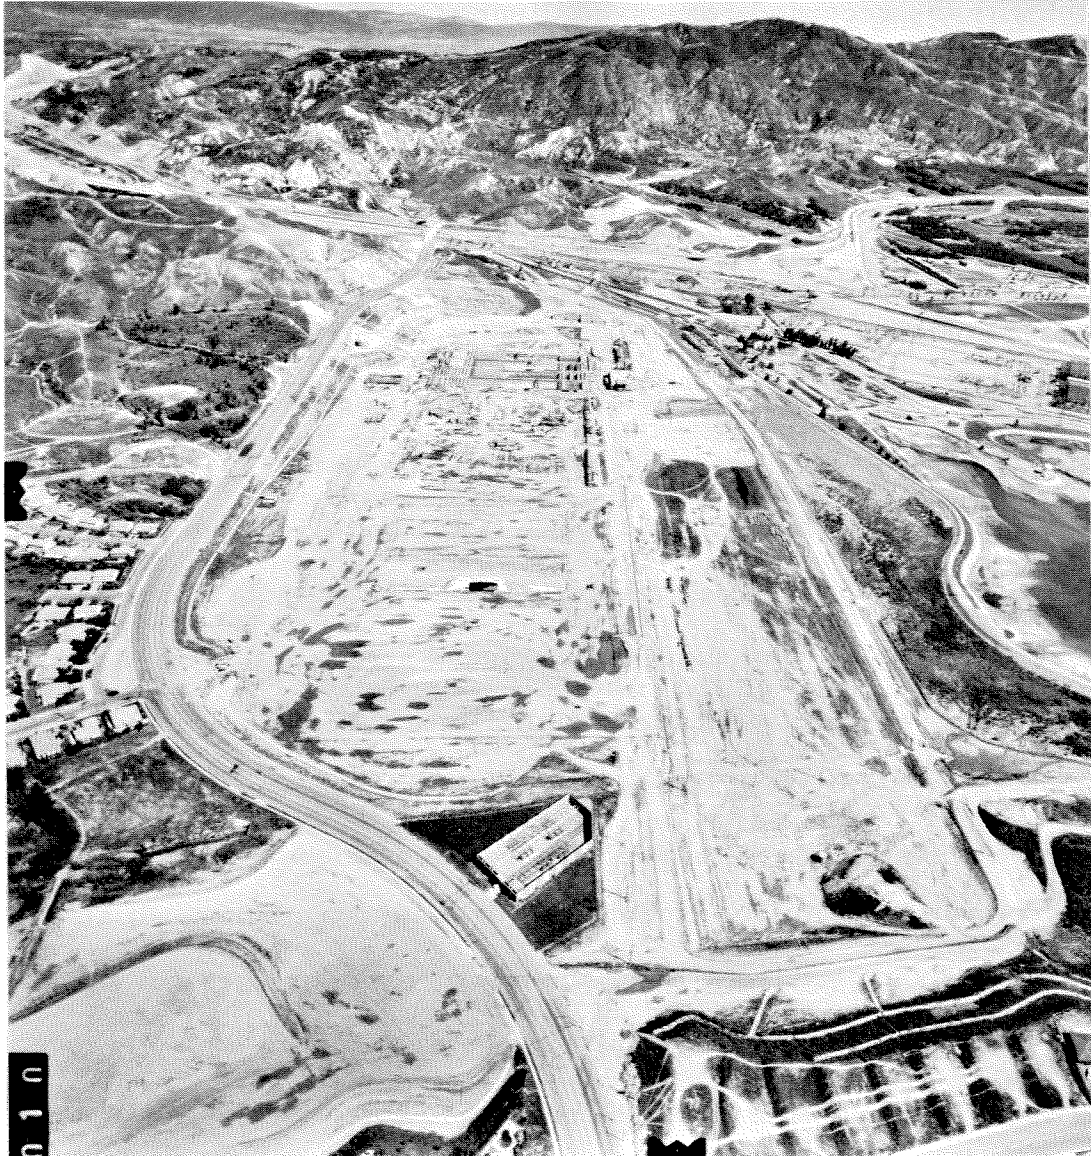
Figure 1.21 Aerial view looking N 27° W across Metropolitan Water District Balboa Water Treatment Plant site. The settling basins are in the background and the rectangular outline of the underground reservoir can be seen just this side of the contractor's work area. The small dark rectangle is a portion of the south edge of the reservoir not yet covered. Balboa Blvd. is on the left-hand side of the site, upper Van Norman Reservoir is on the right-hand side, and the Pacific Intertie Converter Station and the San Fernando Juvenile Facility are just beyond. The old San Fernando Electric Power Plant is in the small white building between the Intertie and the settling basins. In the center foreground is the Balboa Blvd. electrical switching station of the Los Angeles Department of Water and Power where cantilevered concrete walls were damaged by the earthquake.

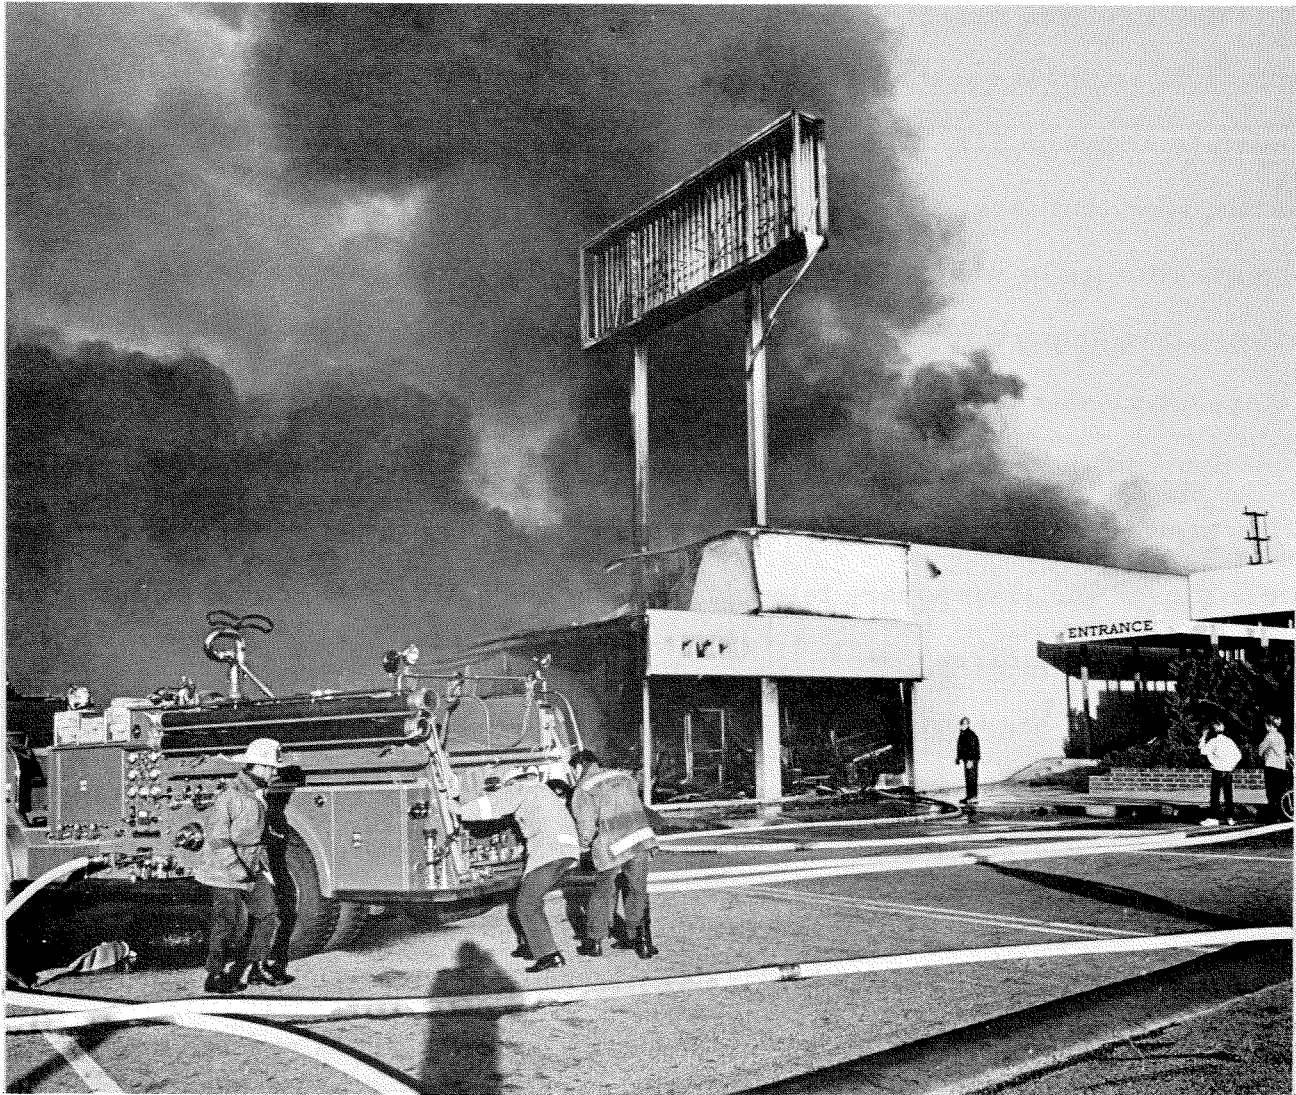
1.22 A fire in San Fernando Valley, after the earthquake. Fire damage in the Valley was small despite the fact that some regions were without water supply.

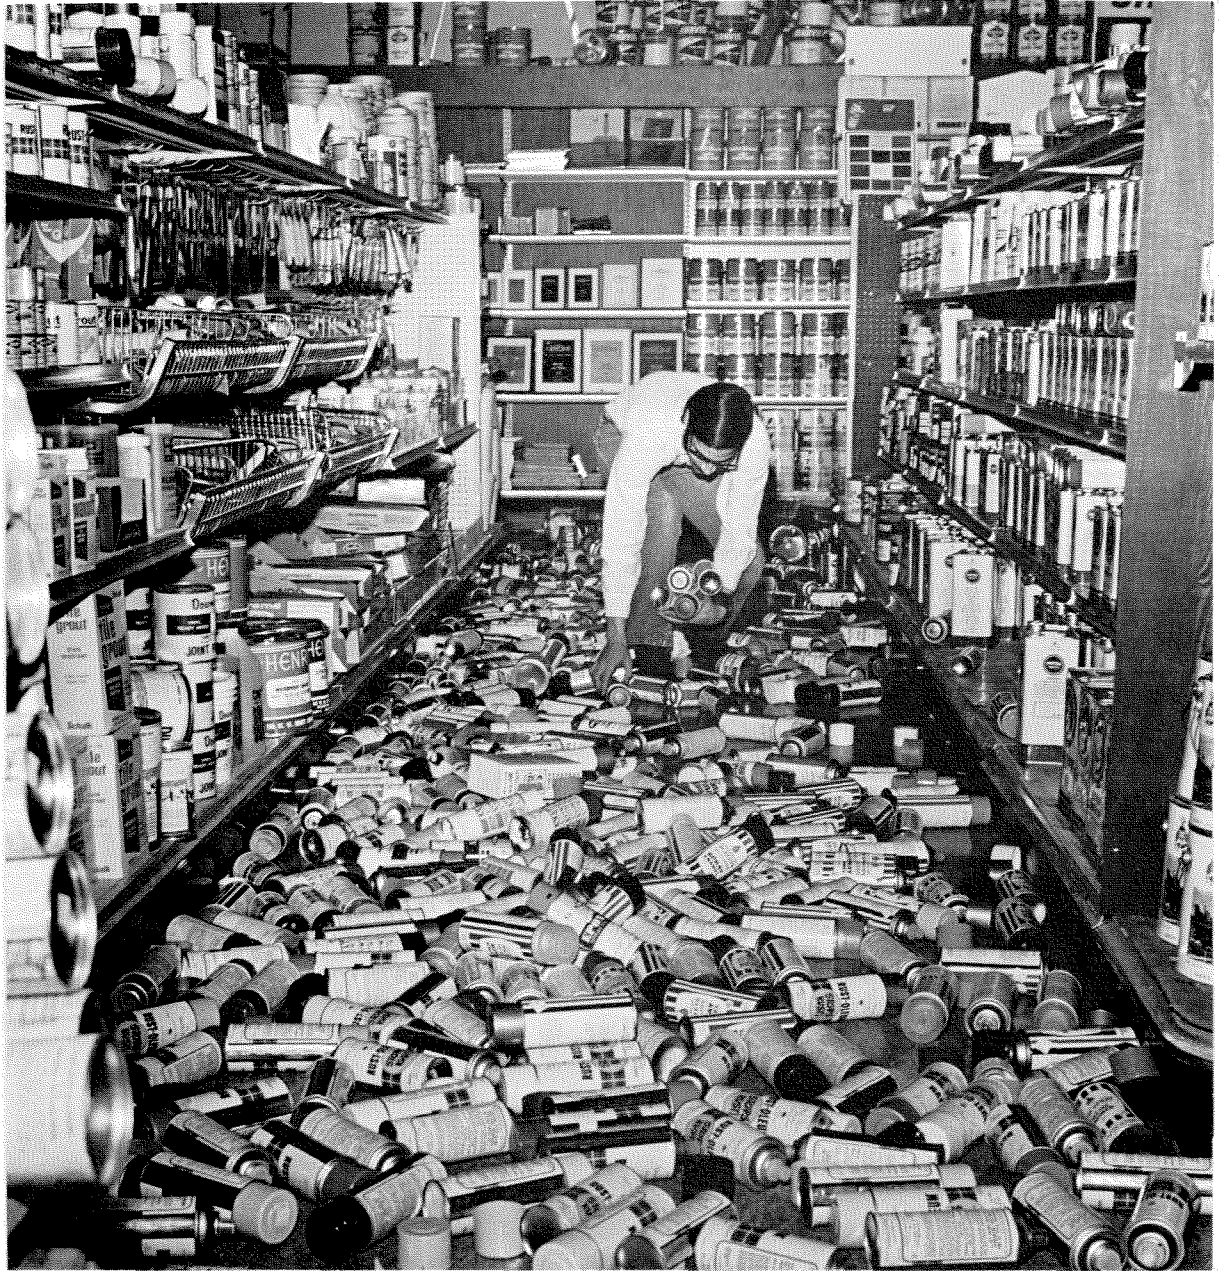
Figure 1.23 Many stores in the area had their stocks thrown to the floor. In some cases this resulted in considerable damage. Libraries as distant as Pasadena had the books strewn about and bookcases collapsed.

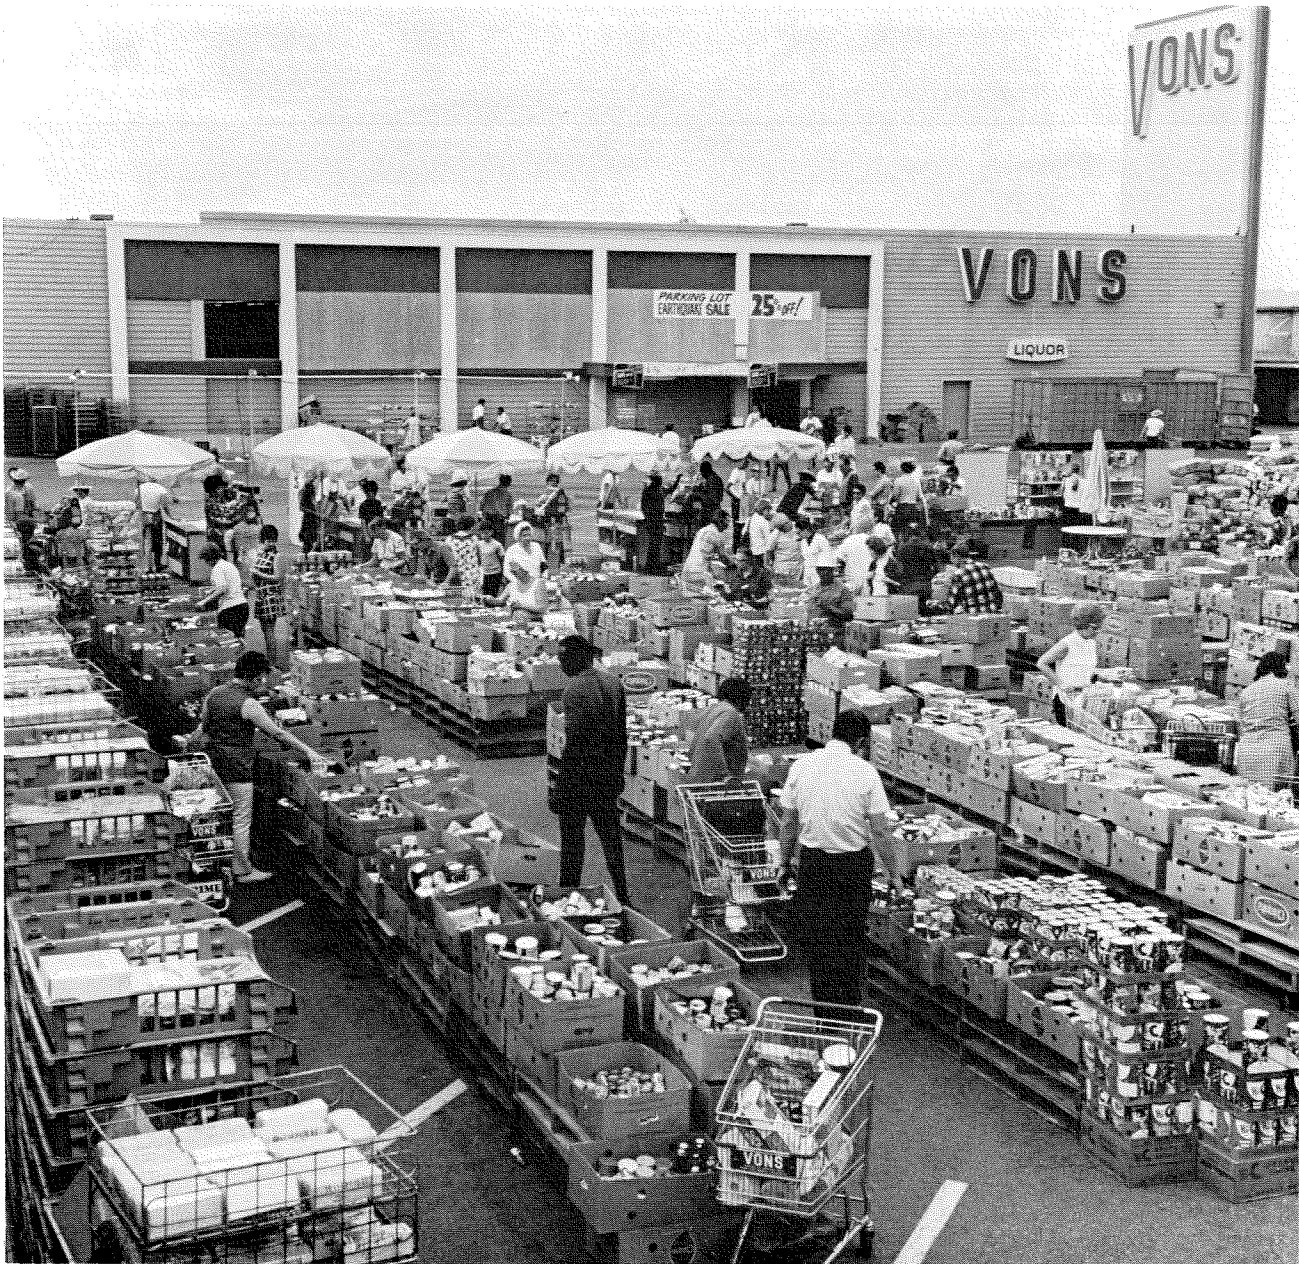
Figure 1.24 Parking lot sale at Von's Market on Foothill Blvd. after the earthquake.

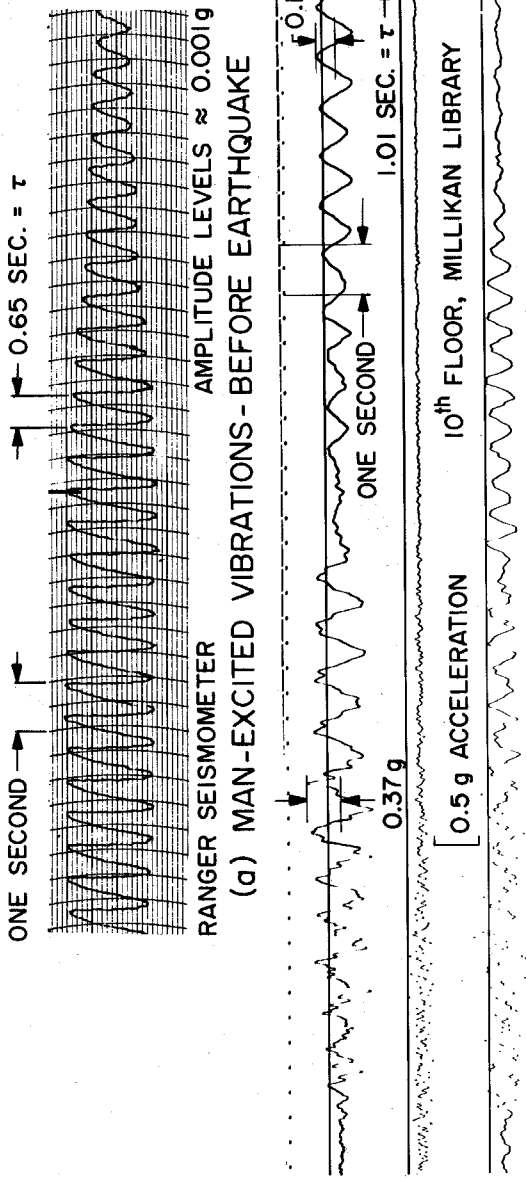
RFT-250 ACCELEROGRAPH

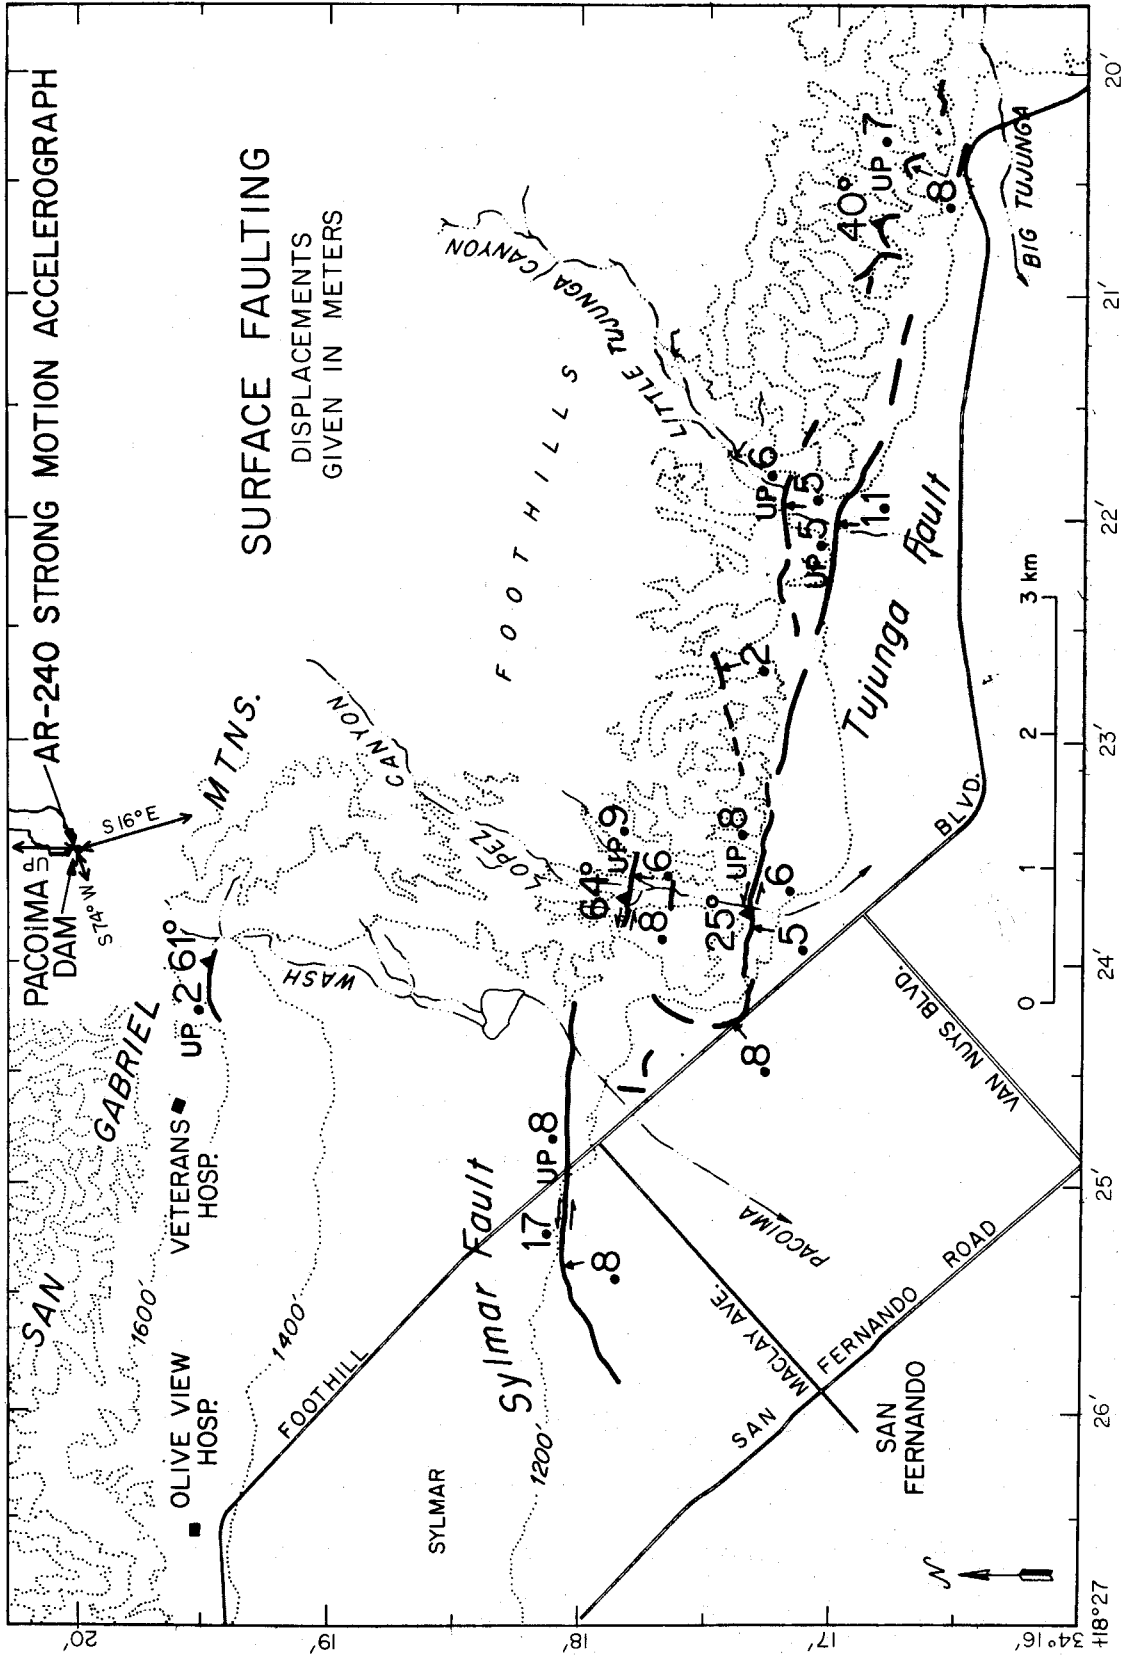
Figure 2.6 Surface faulting in the Sylmar-San Fernando-Tujunga area (reproduced by permission from the Division of Geological and Planetary Sciences, California Institute of Technology, and Kamb et al, 1971), and its relation to the recorded strong ground motion at the Pacoima Dam.
