ENGINEERING FEATURES
OF THE
SAN FERNANDO EARTHQUAKE OF FEBRUARY 9, 1971

Paul C. Jennings, Editor

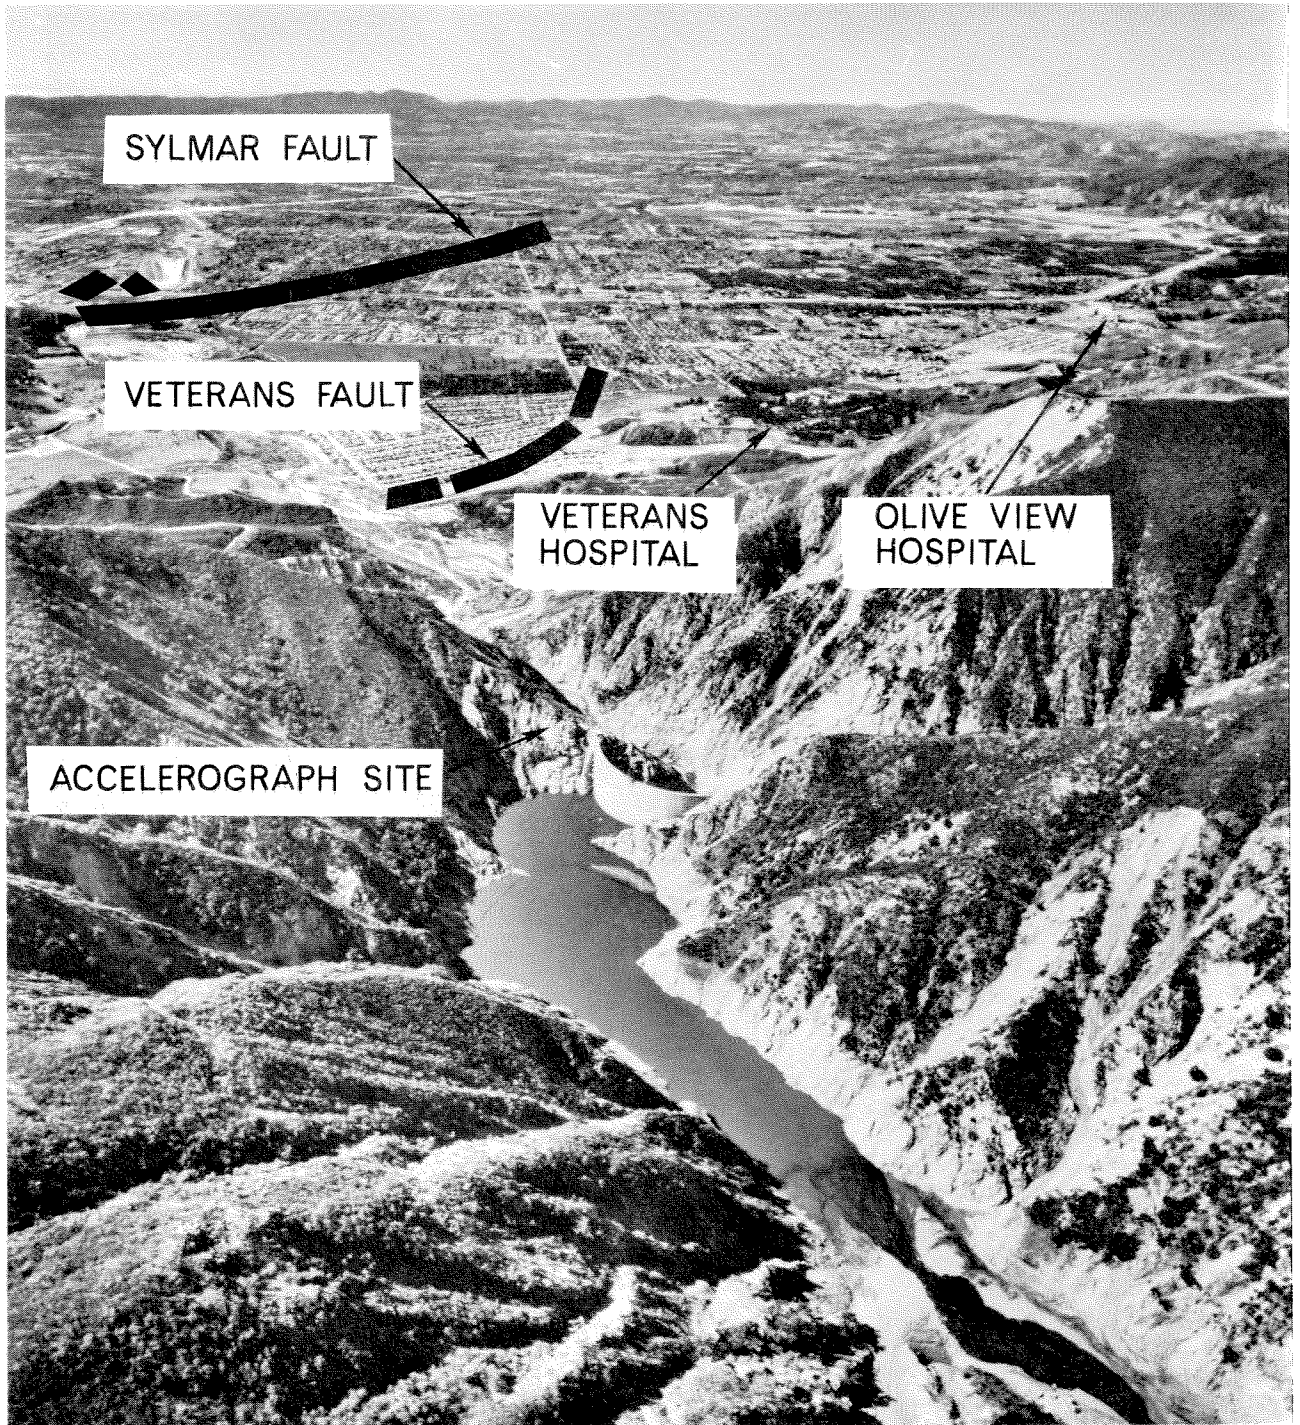
Figure 2.8 Oblique aerial view looking southwest over the Pacoima Dam site.

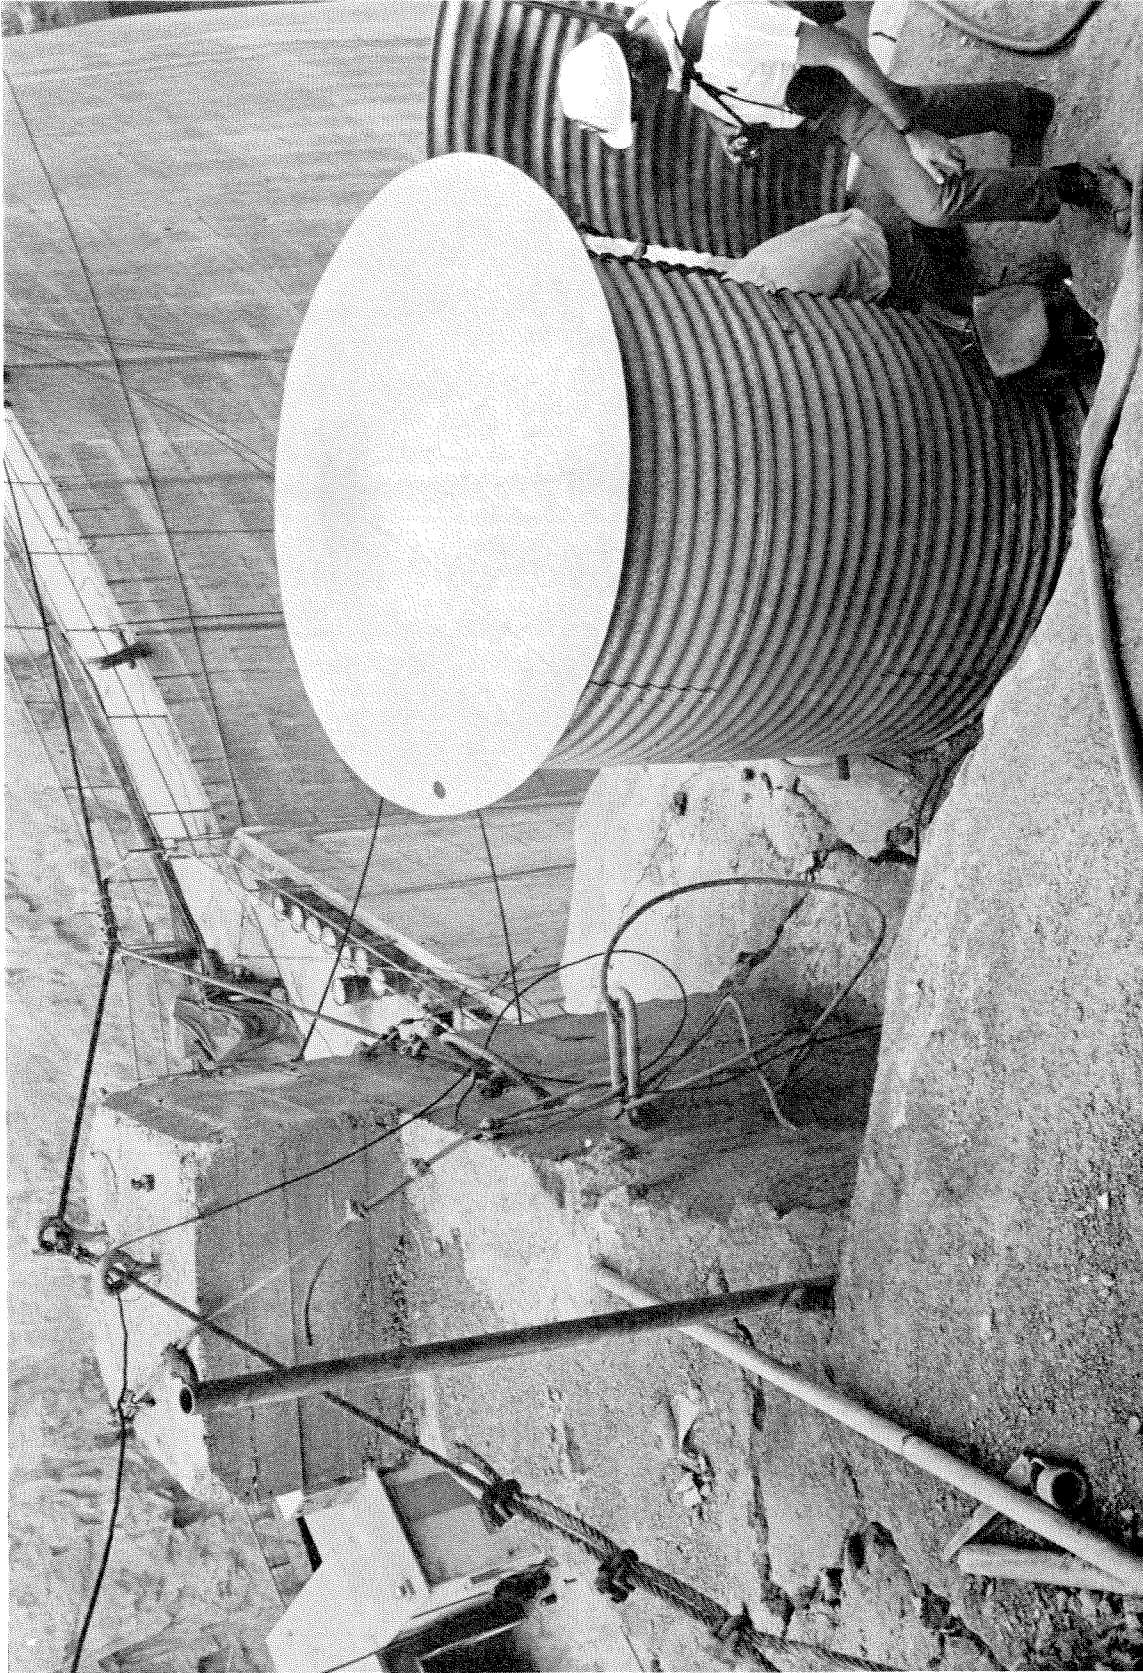
Figure 2.11 View of the dam and the instrument site.

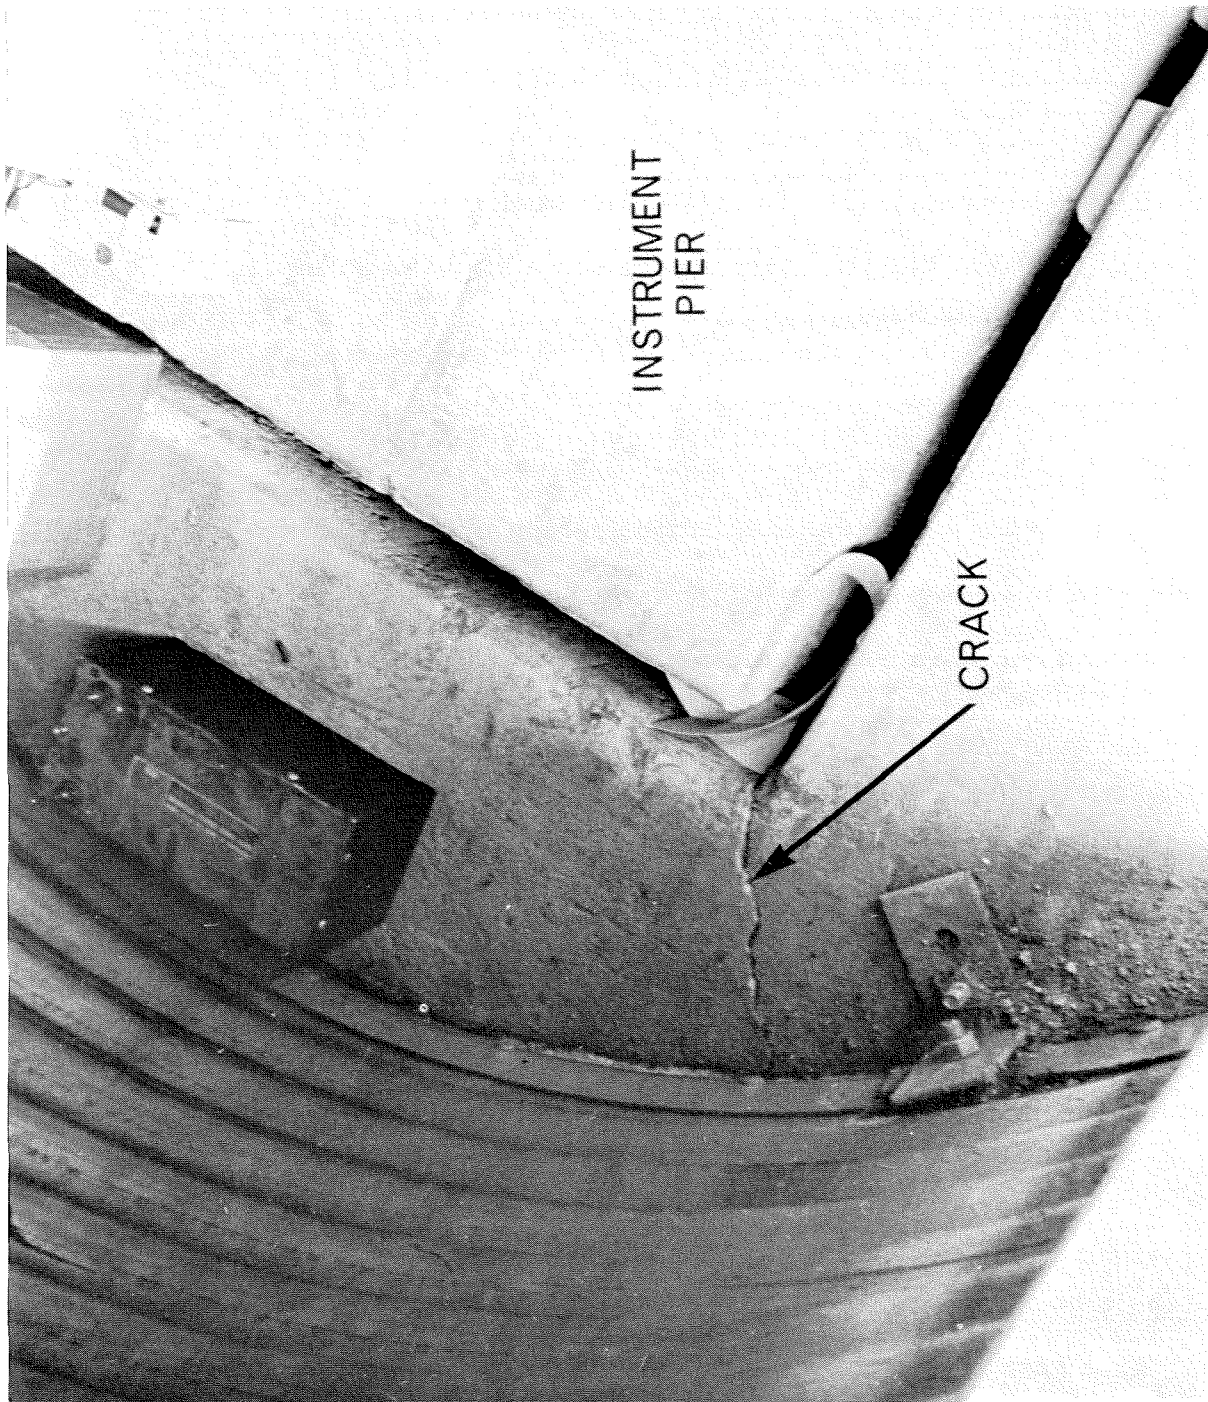
Figure 2.12 Cracks in the foundation of the instrument house.

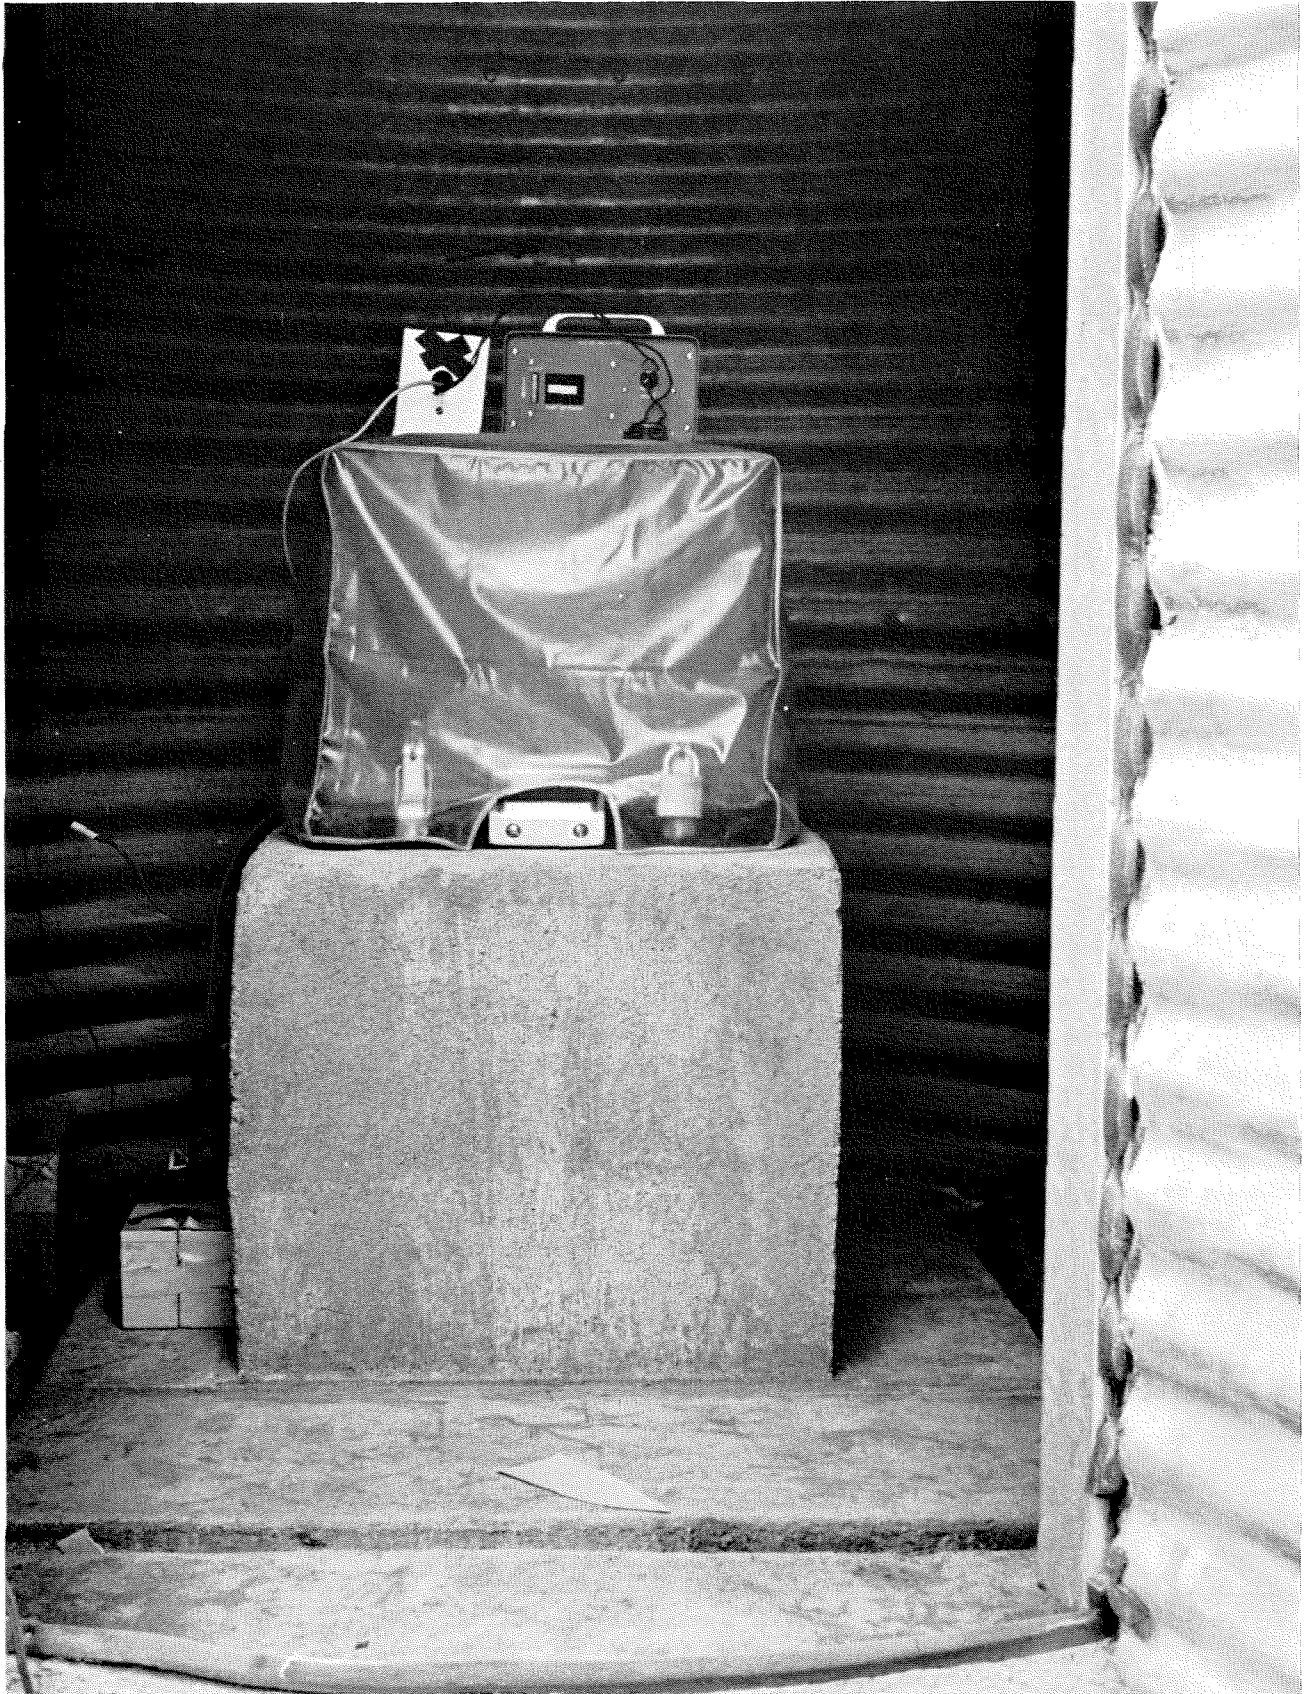
Figure 2.13 AR-240 accelerograph after the earthquake.

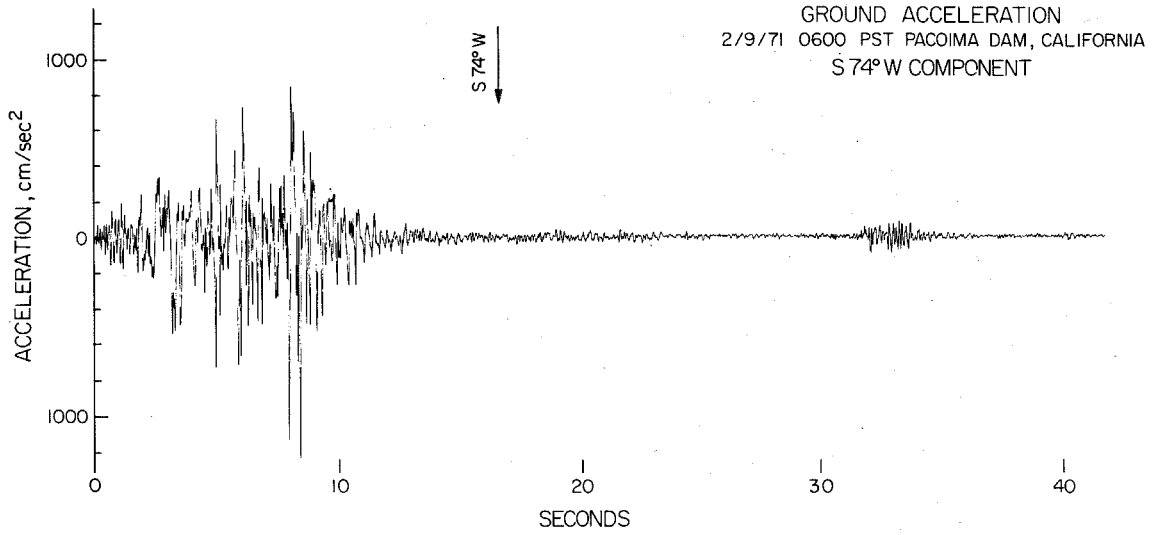
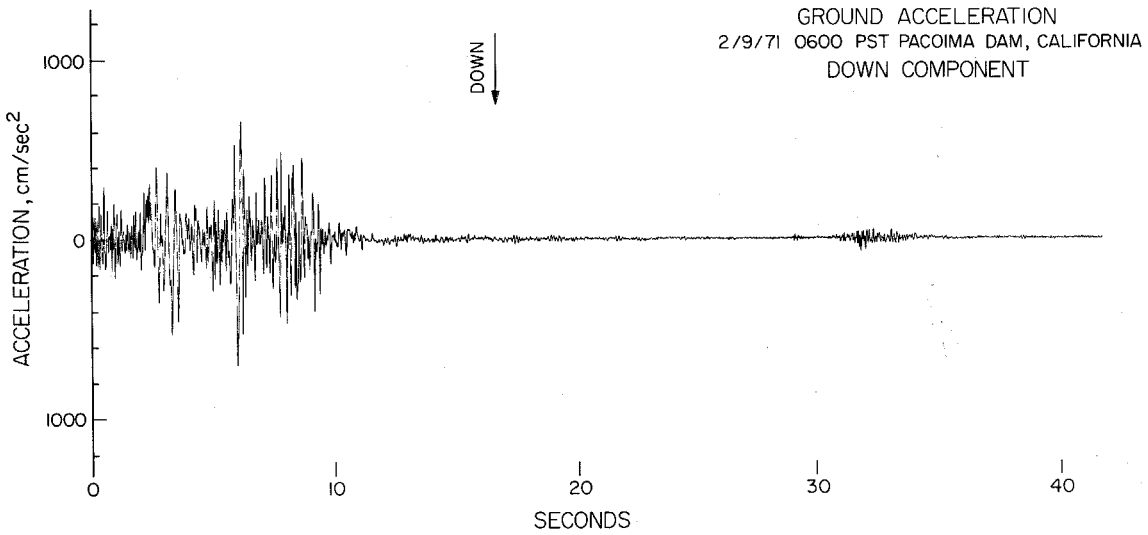
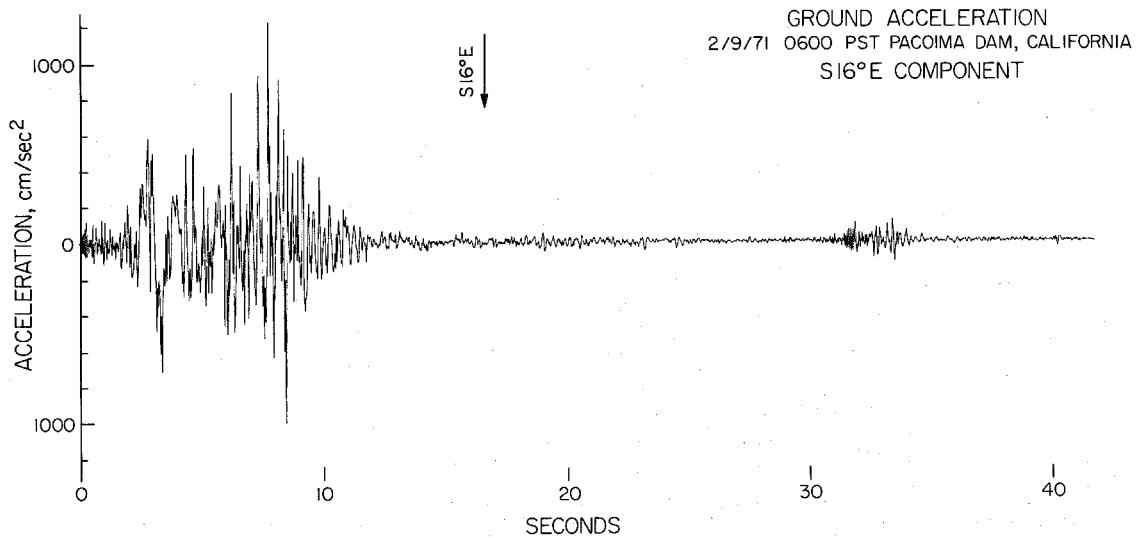
Figure 2.15 Plot of digitized accelerograms recorded at the Pacoima Dam.

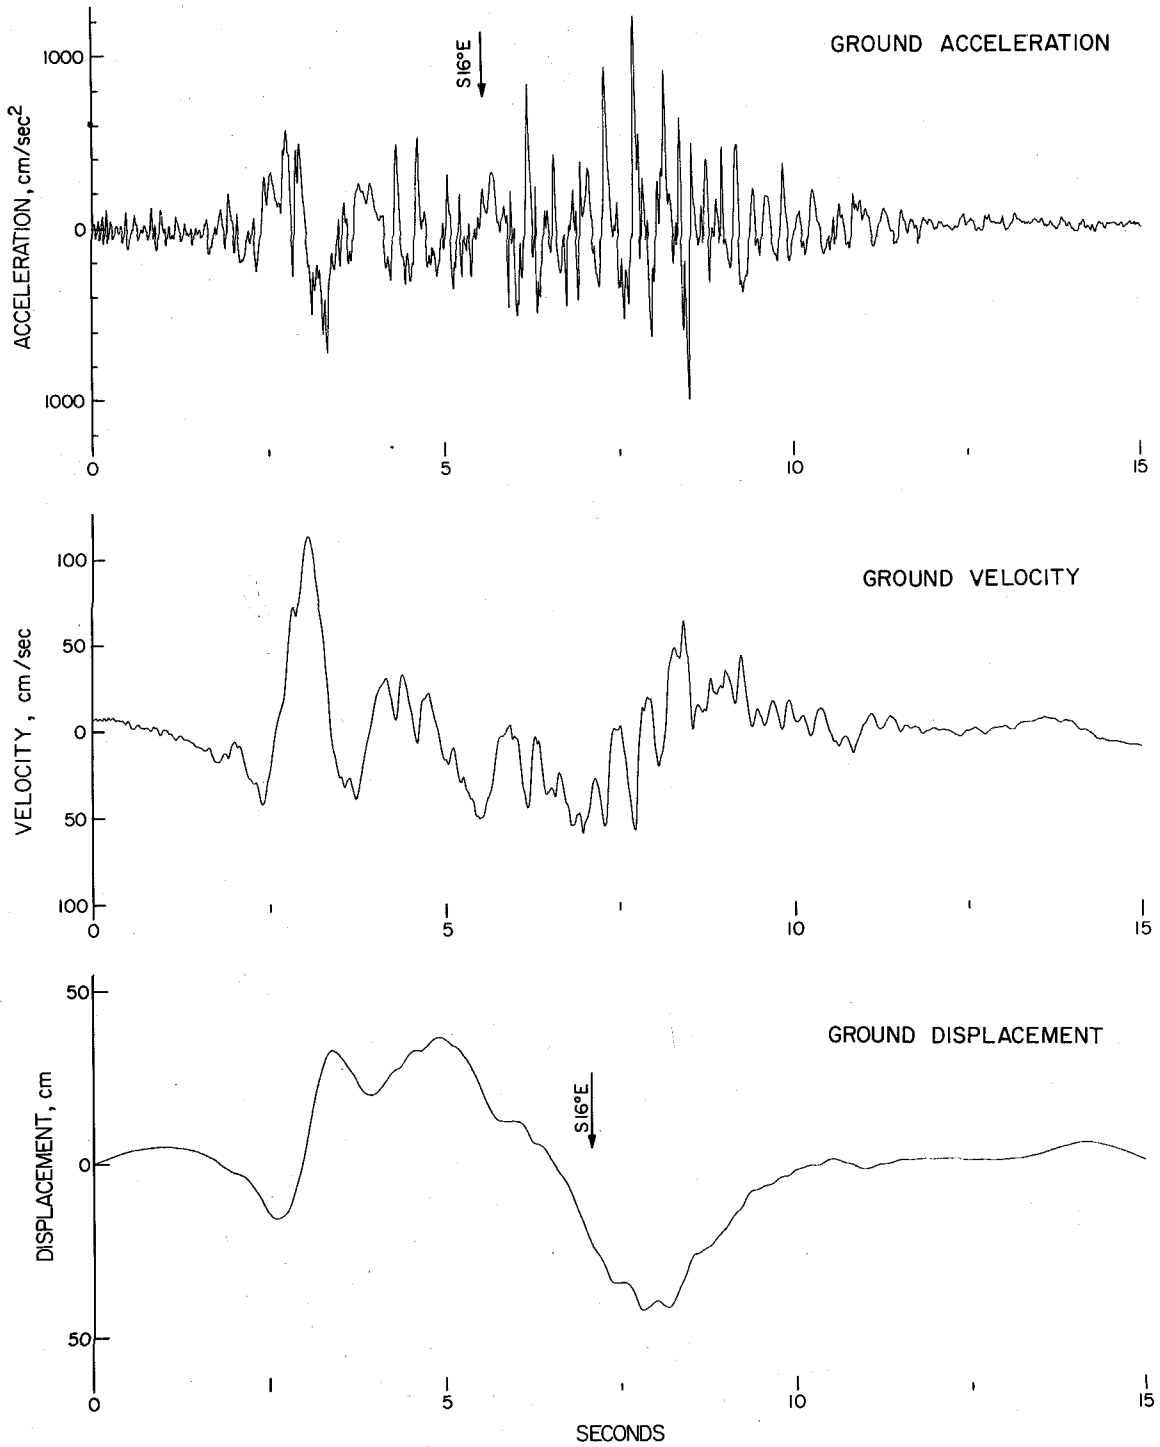
Figure 2.18. S 16° E motion, Pacoima Dam.

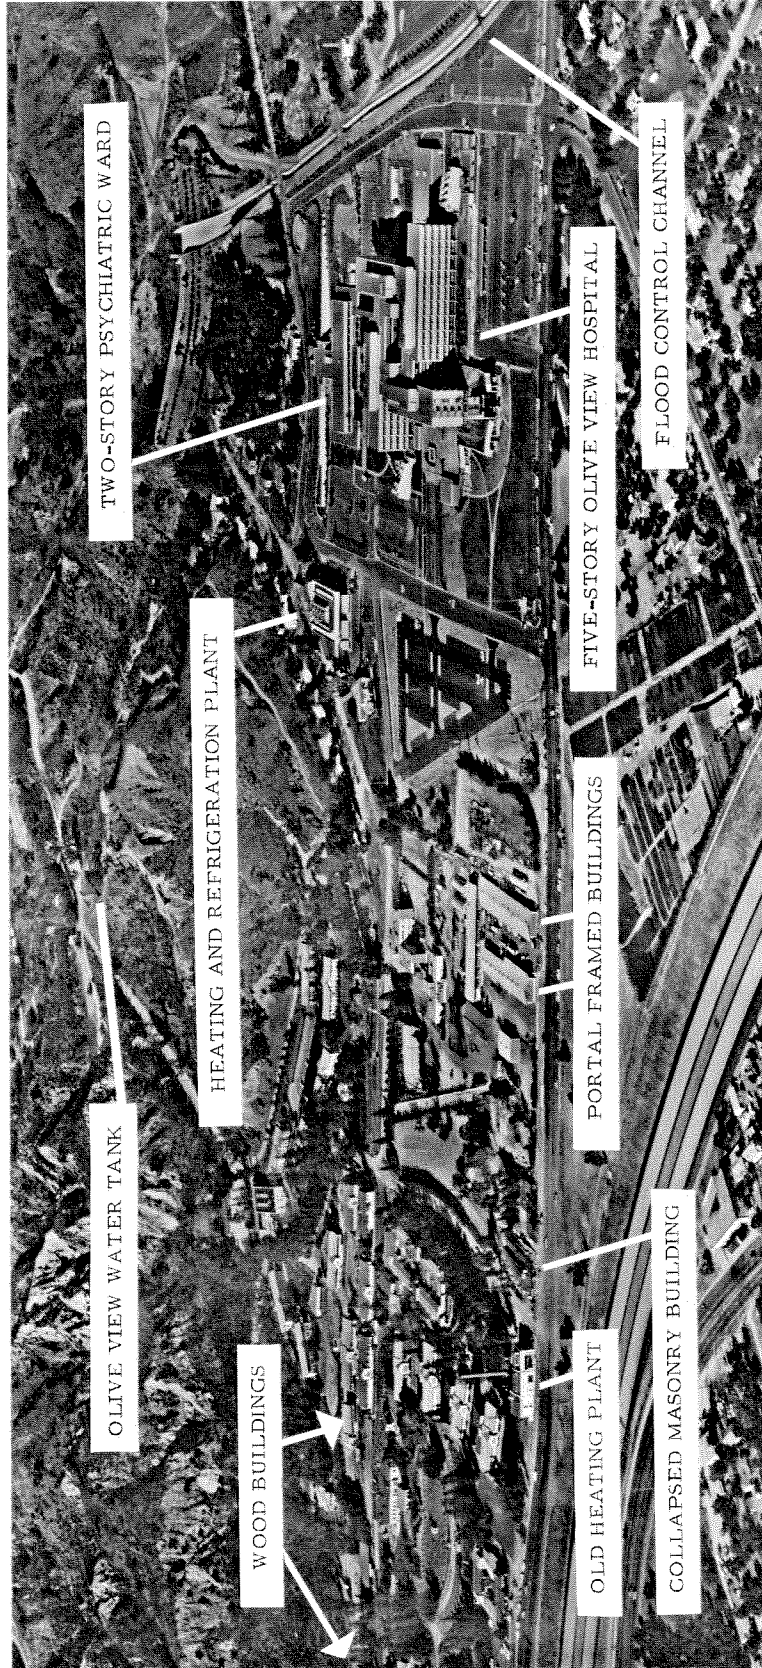
Figure 3. 1 Olive View Hospital site, looking north.

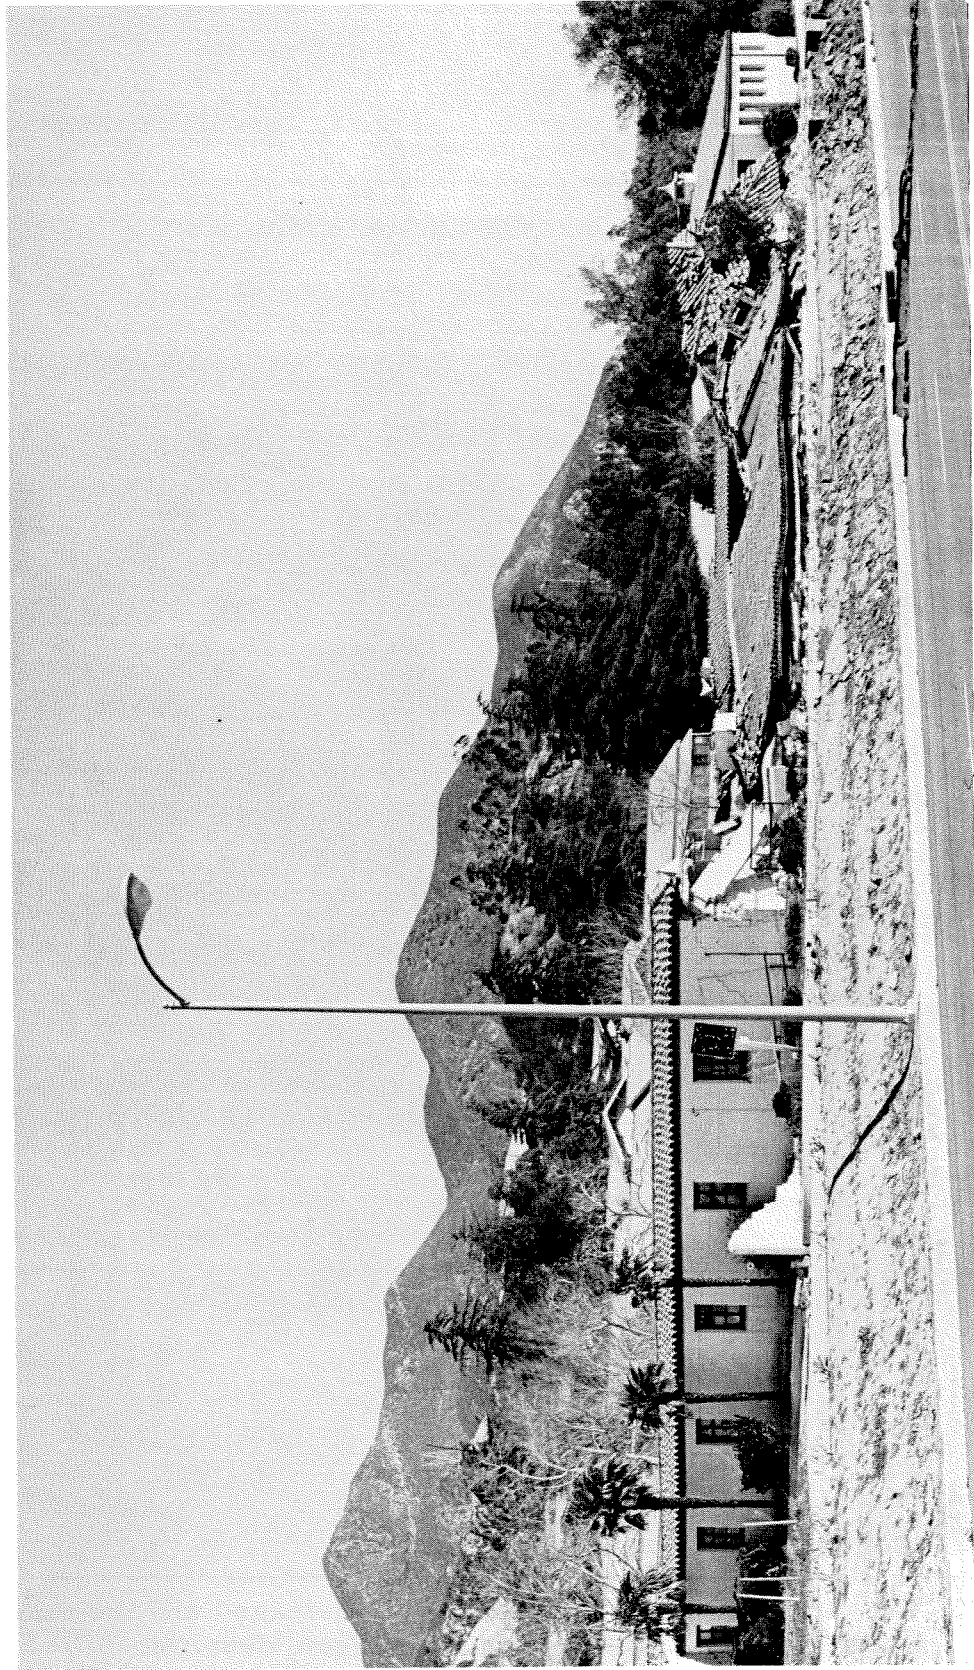
Figure 3.2 Single-story unreinforced brick building at the Olive View Hospital constructed prior to 1933, the year lateral load requirements were first placed in the building code. Ralph Samuels photo.

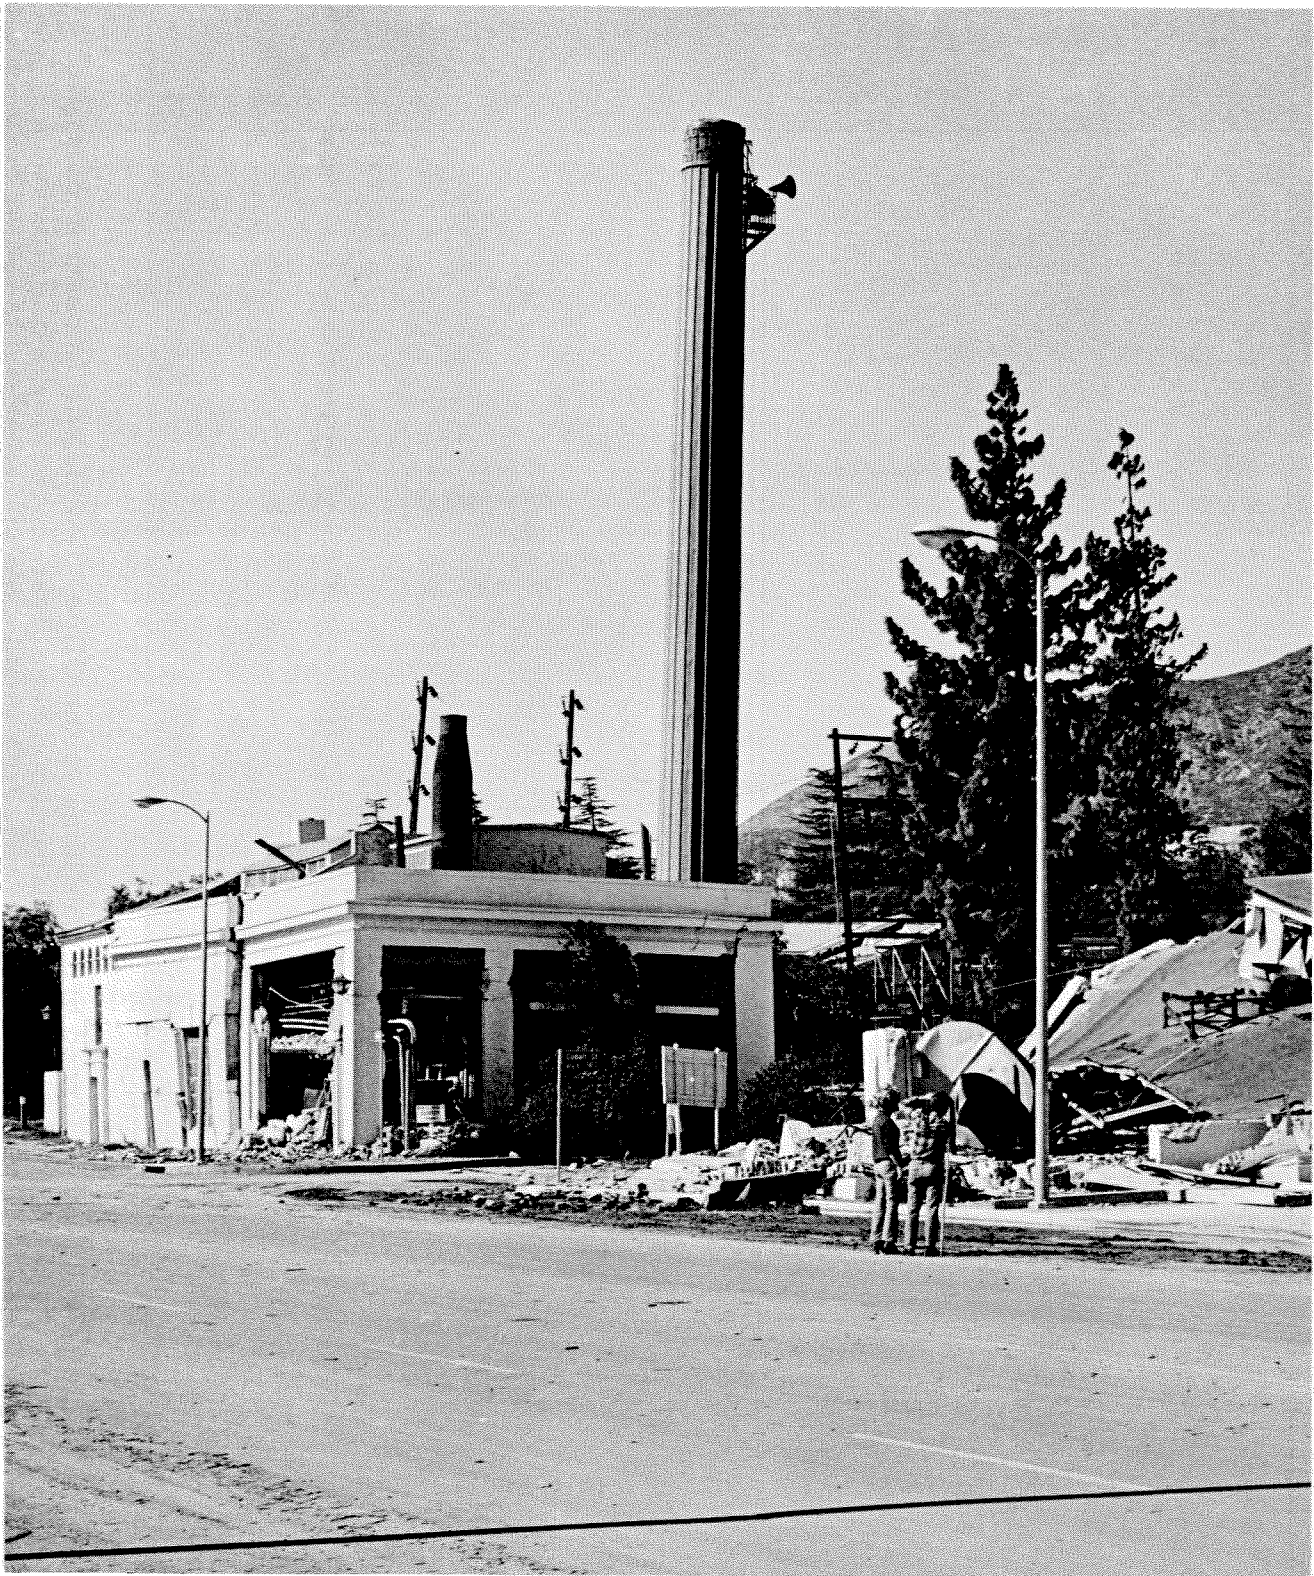
Figure 3.3 The old heating plant was severely damaged and the masonry building to the right collapsed at the Olive View Hospital. The concrete stack, which is leaning slightly, was removed shortly after the quake. Ralph Samuels photo.

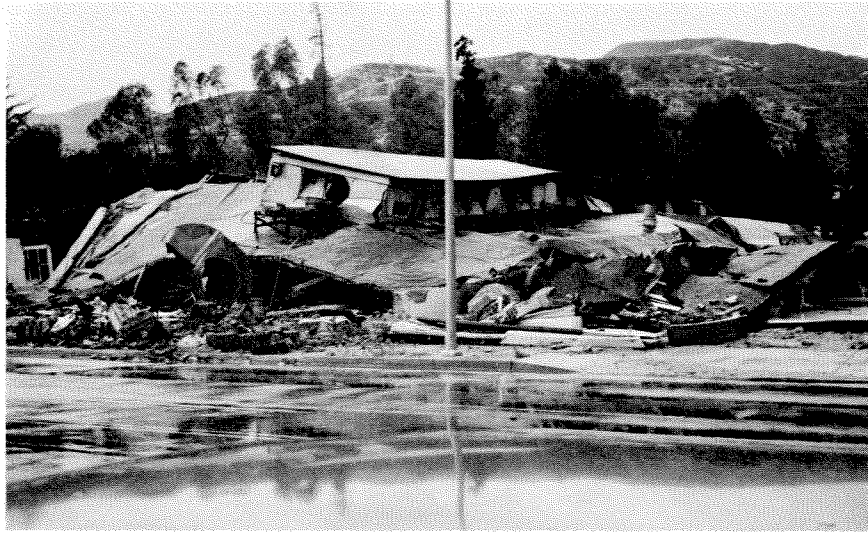
Figure 3.4 This old masonry building at Olive View Hospital, adjacent to the heating plant of the previous figure, was not designed to withstand earthquake loadings.

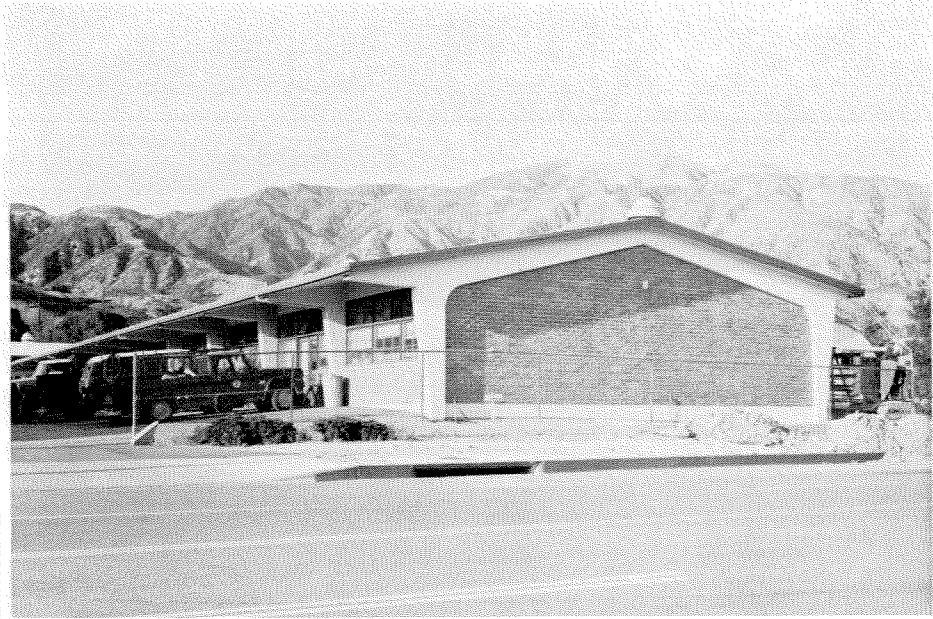
Figure 3.6 Reinforced concrete portal framed building with no visible damage. Olive View Hospital.

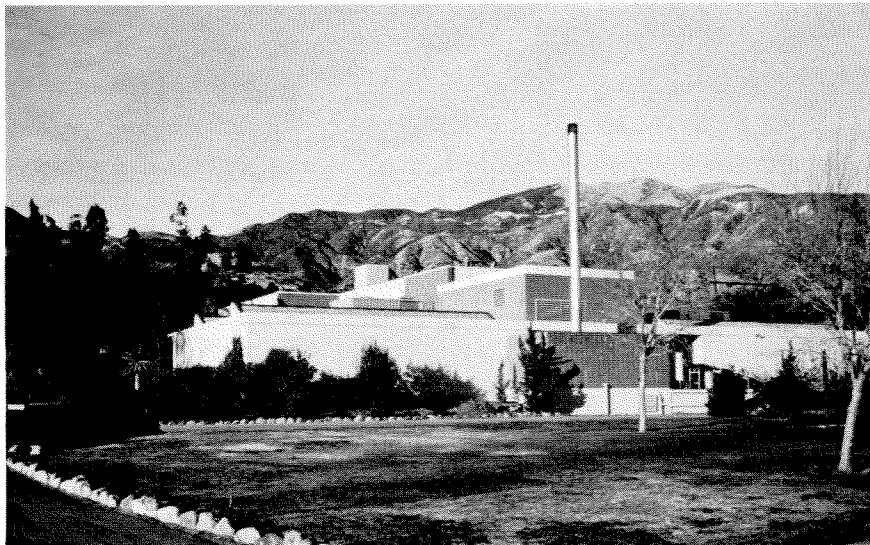
Figure 3.7 New laboratory building at Olive View Hospital received only minor damage.

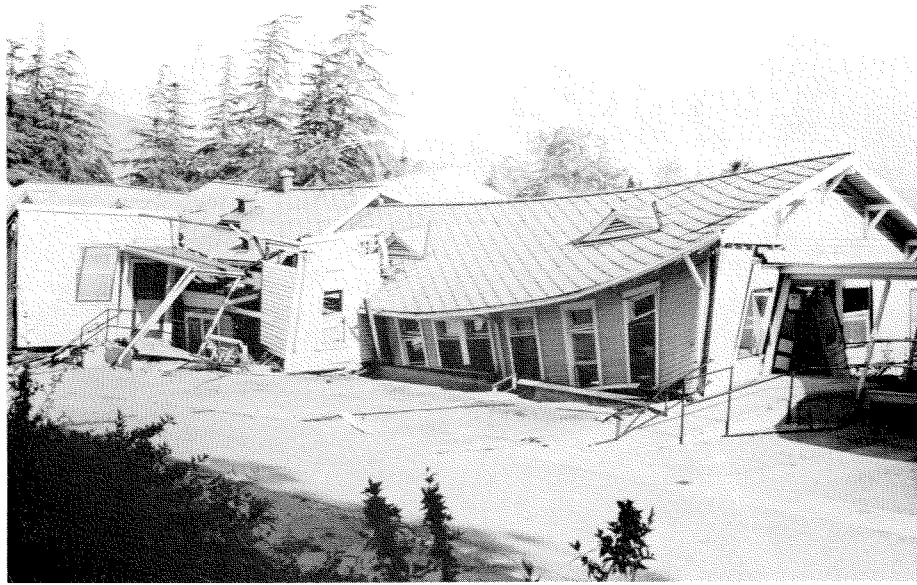
Figure 3.8 One of the more severely damaged old wooden buildings at the Olive View Hospital.

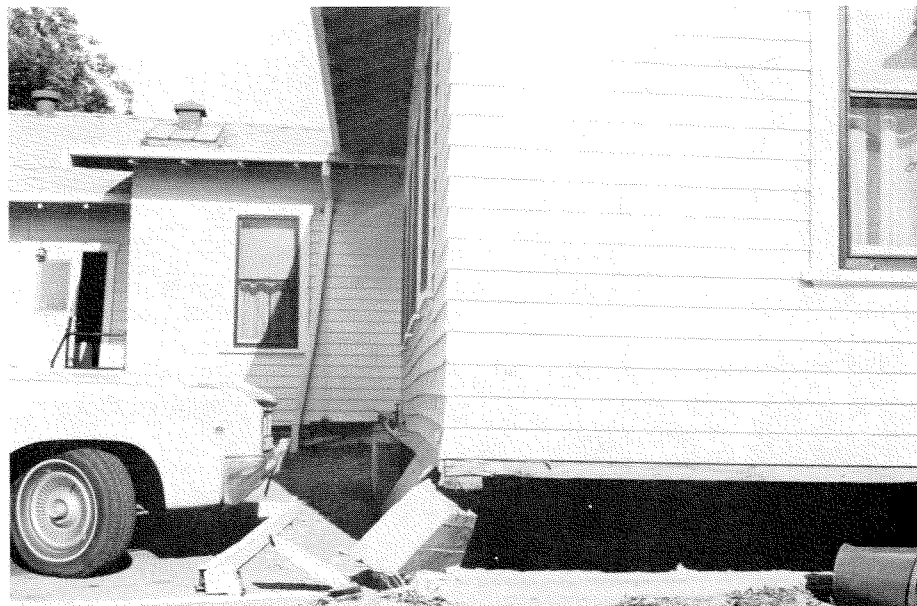
Figure 3.9 Old wooden building moved to the right and nearly fell from its concrete support props, Olive View Hospital.

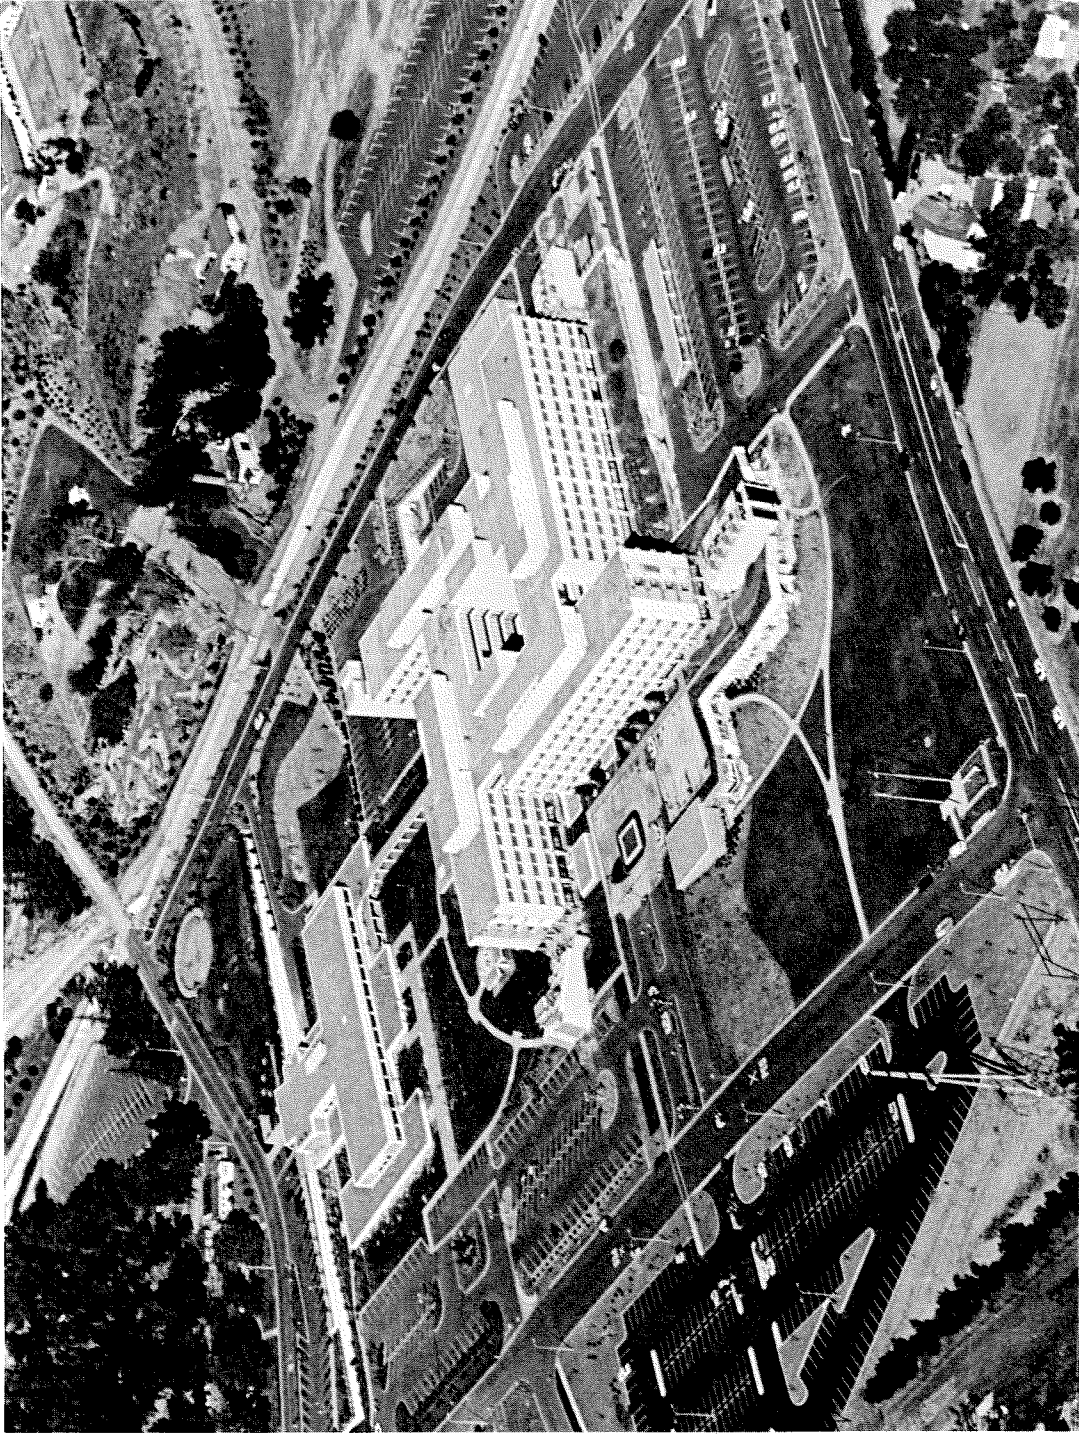
Figure 3.10 Aerial view of the Olive View Hospital, looking north. The collapsed two-story Psychiatric Day Care Center is in the upper left. Ralph Samuels photo.

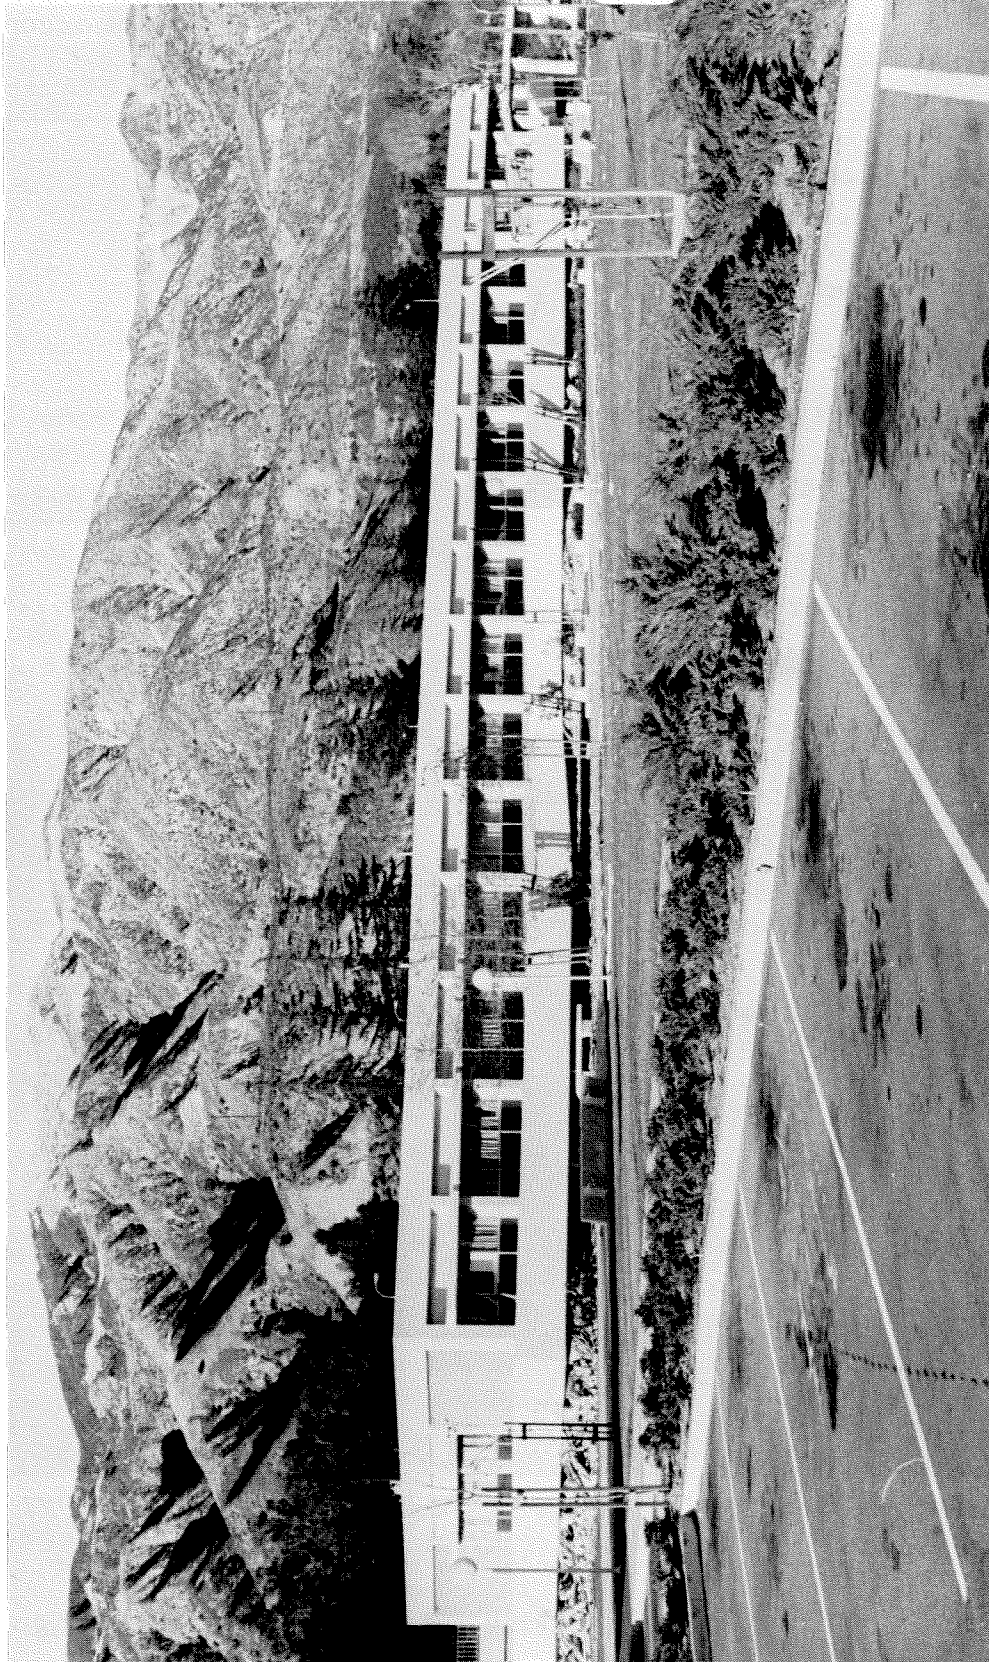
Figure 3.11 Two-story Psychiatric Day Care Center just north of the main building at Olive View Hospital collapsed towards the south.

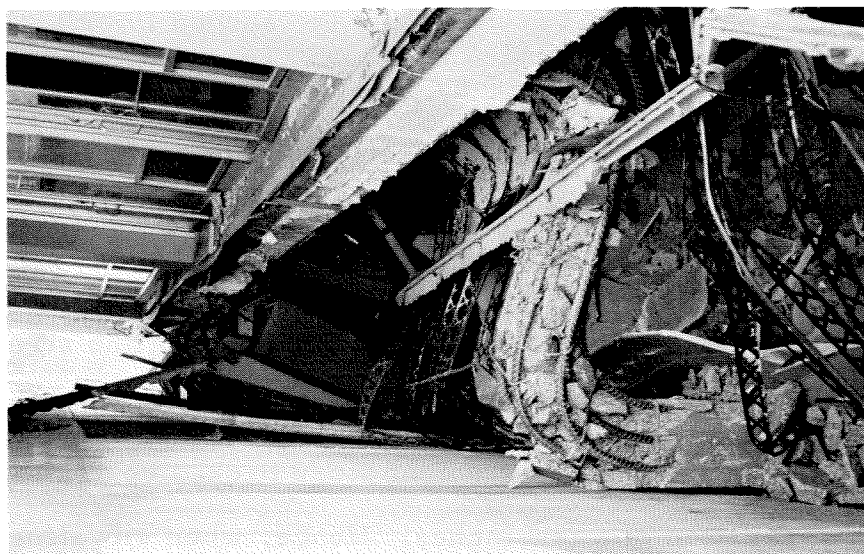
Figure 3.12 North entrance of the Psychiatric Day Care Center, Olive View Hospital. The second story fell down and to the south.

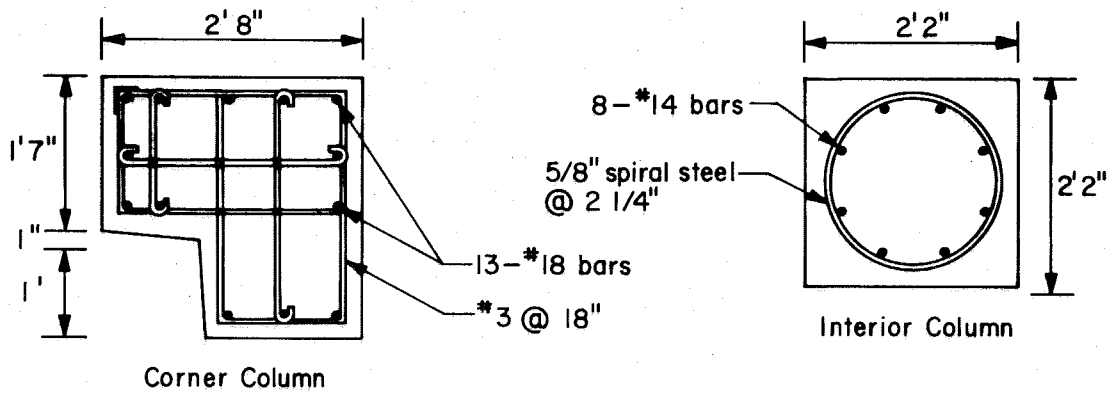
Typical First Floor Column Details
