ENGINEERING FEATURES
OF THE
SAN FERNANDO EARTHQUAKE OF FEBRUARY 9, 1971

Paul C. Jennings, Editor

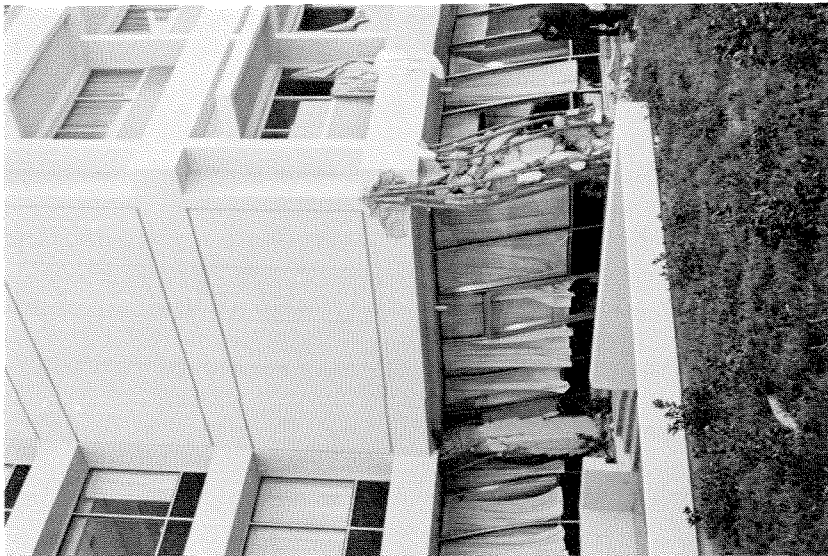
Figure 3.21 Shear wall at the north end of the southwest wing, Olive View Hospital.

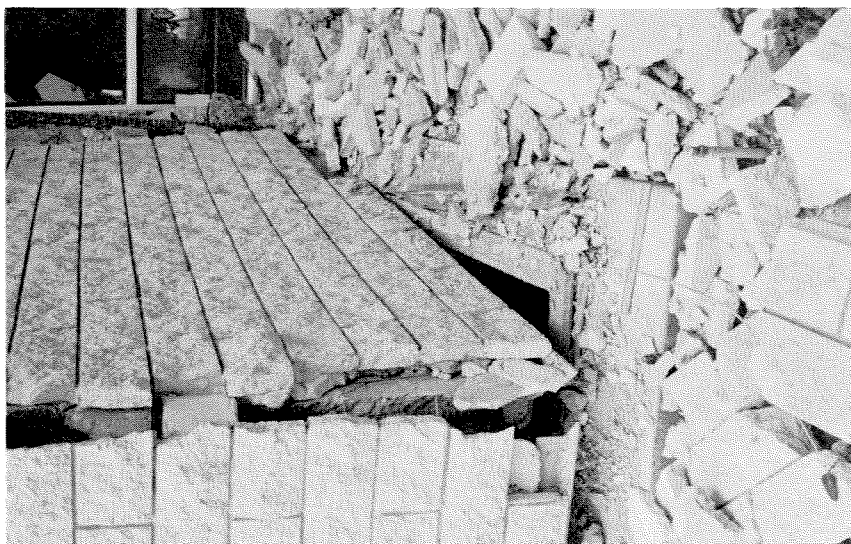
Figure 3.23 Exterior wall of elevator shaft moved about 16 inches to the north at the separation joint.

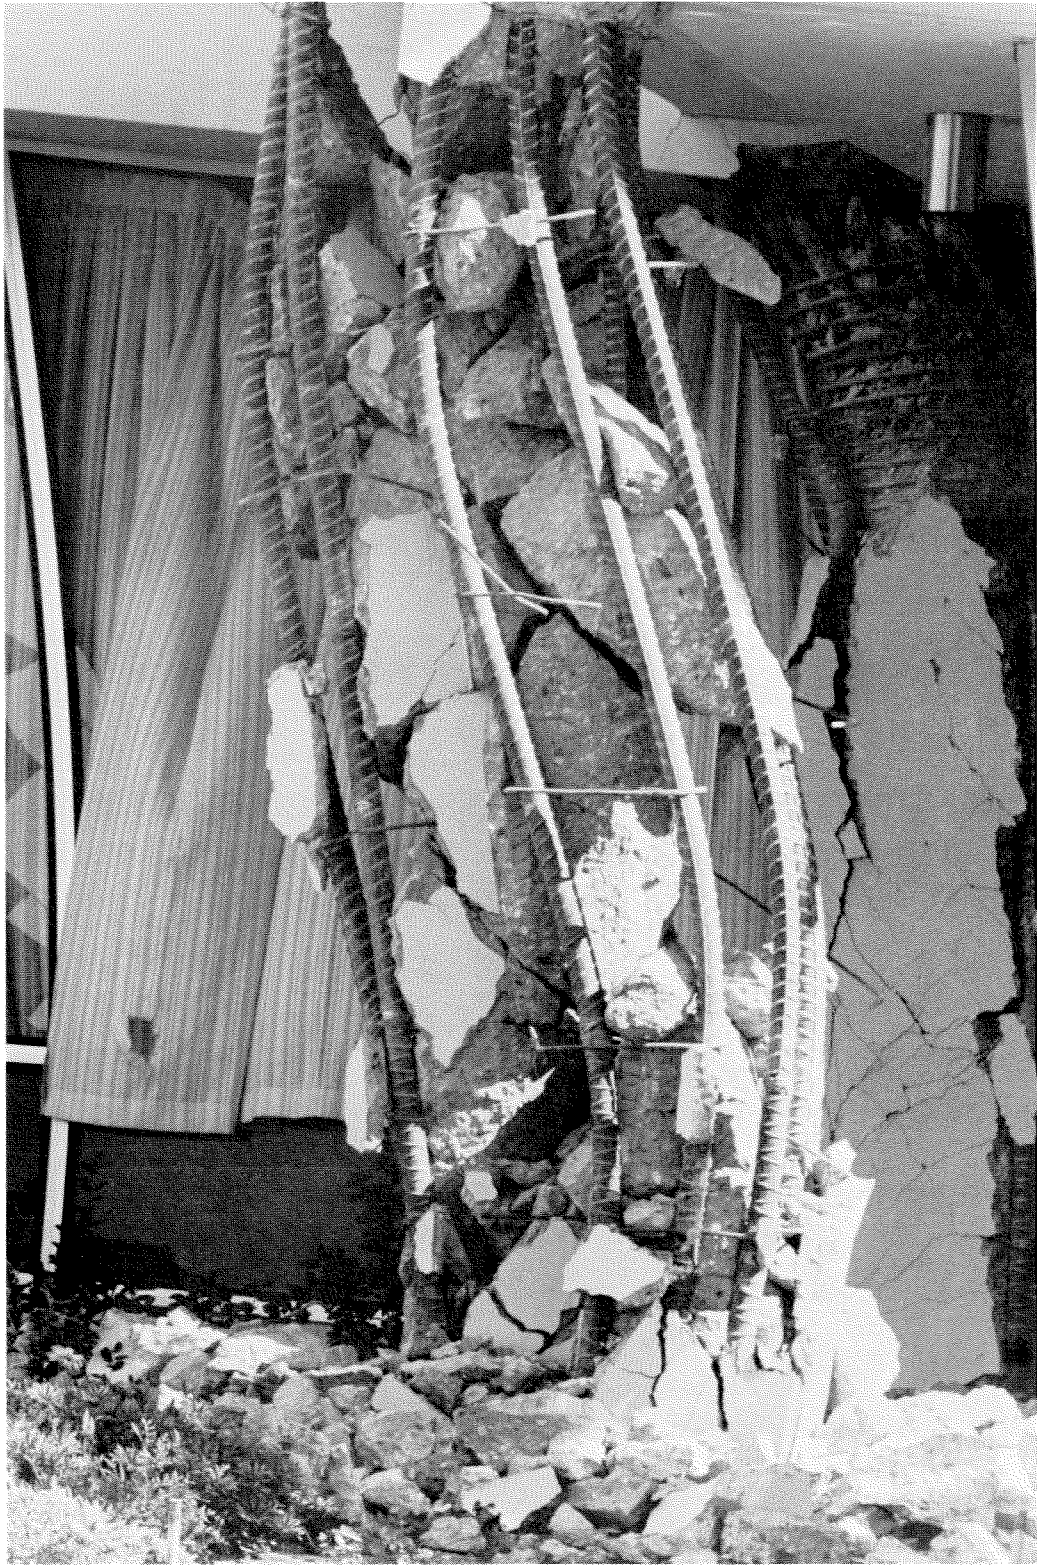
Figure 3.24 Shattered L-shaped corner column, Olive View Hospital.
The ties are No. 3's at 18 in on centers.

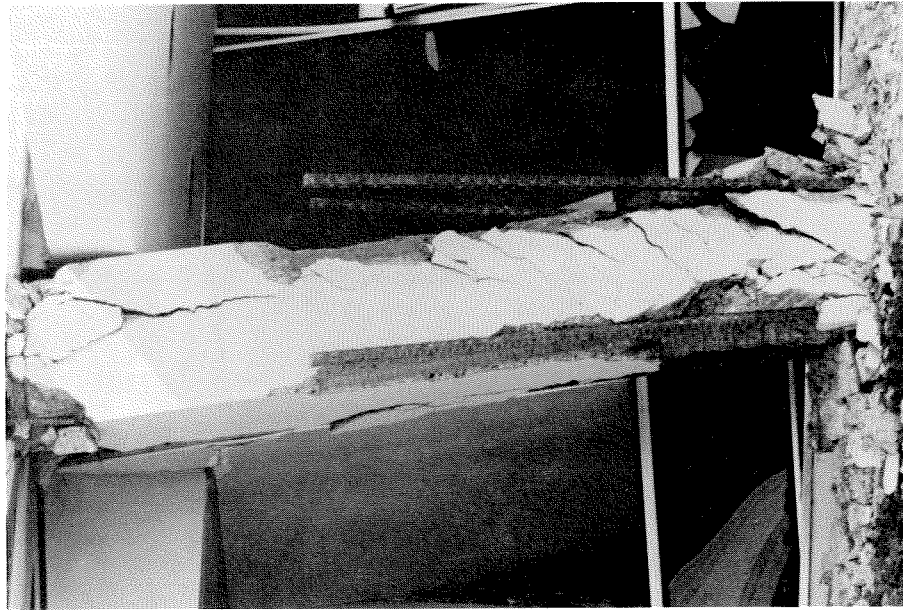
Figure 3.25 Spirally reinforced column at the Olive View Hospital. The untied reinforcing steel outside the core of columns spalled away on most of the columns of this type.

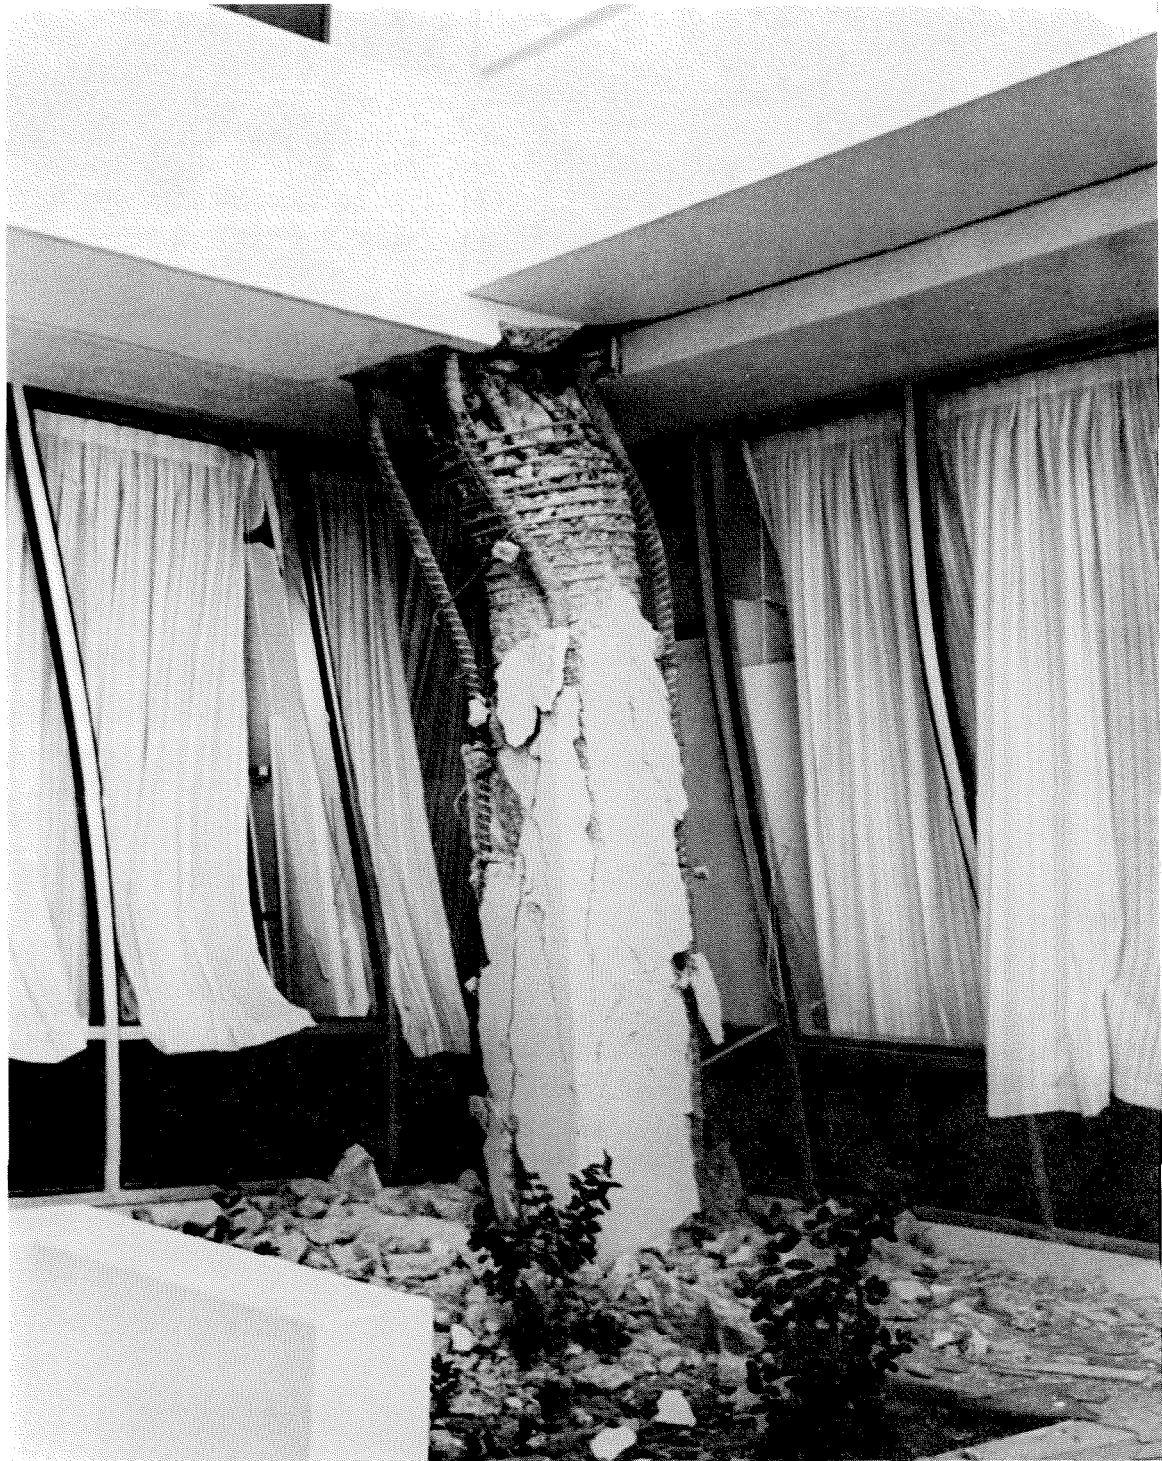
Figure 3.27 Damaged column at Olive View Hospital. This square concrete column had a circular, spirally wound core, and had four large bars outside the core at the corners. Those with tied outside bars performed somewhat better than those without ties shown in Figure 3.25.

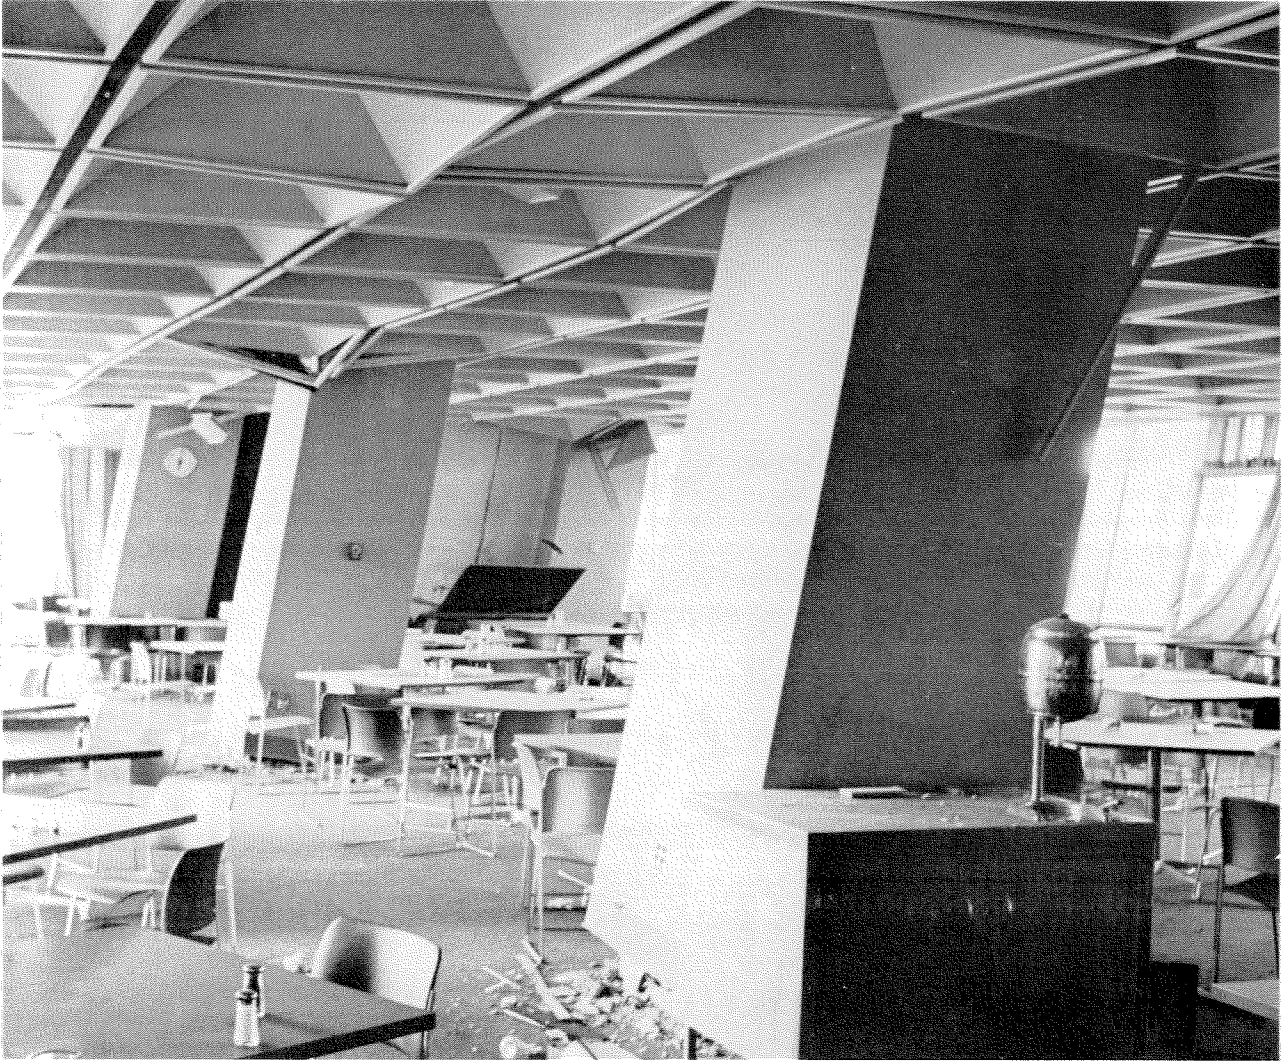
Figure 3.28 Cafeteria in Olive View Hospital.

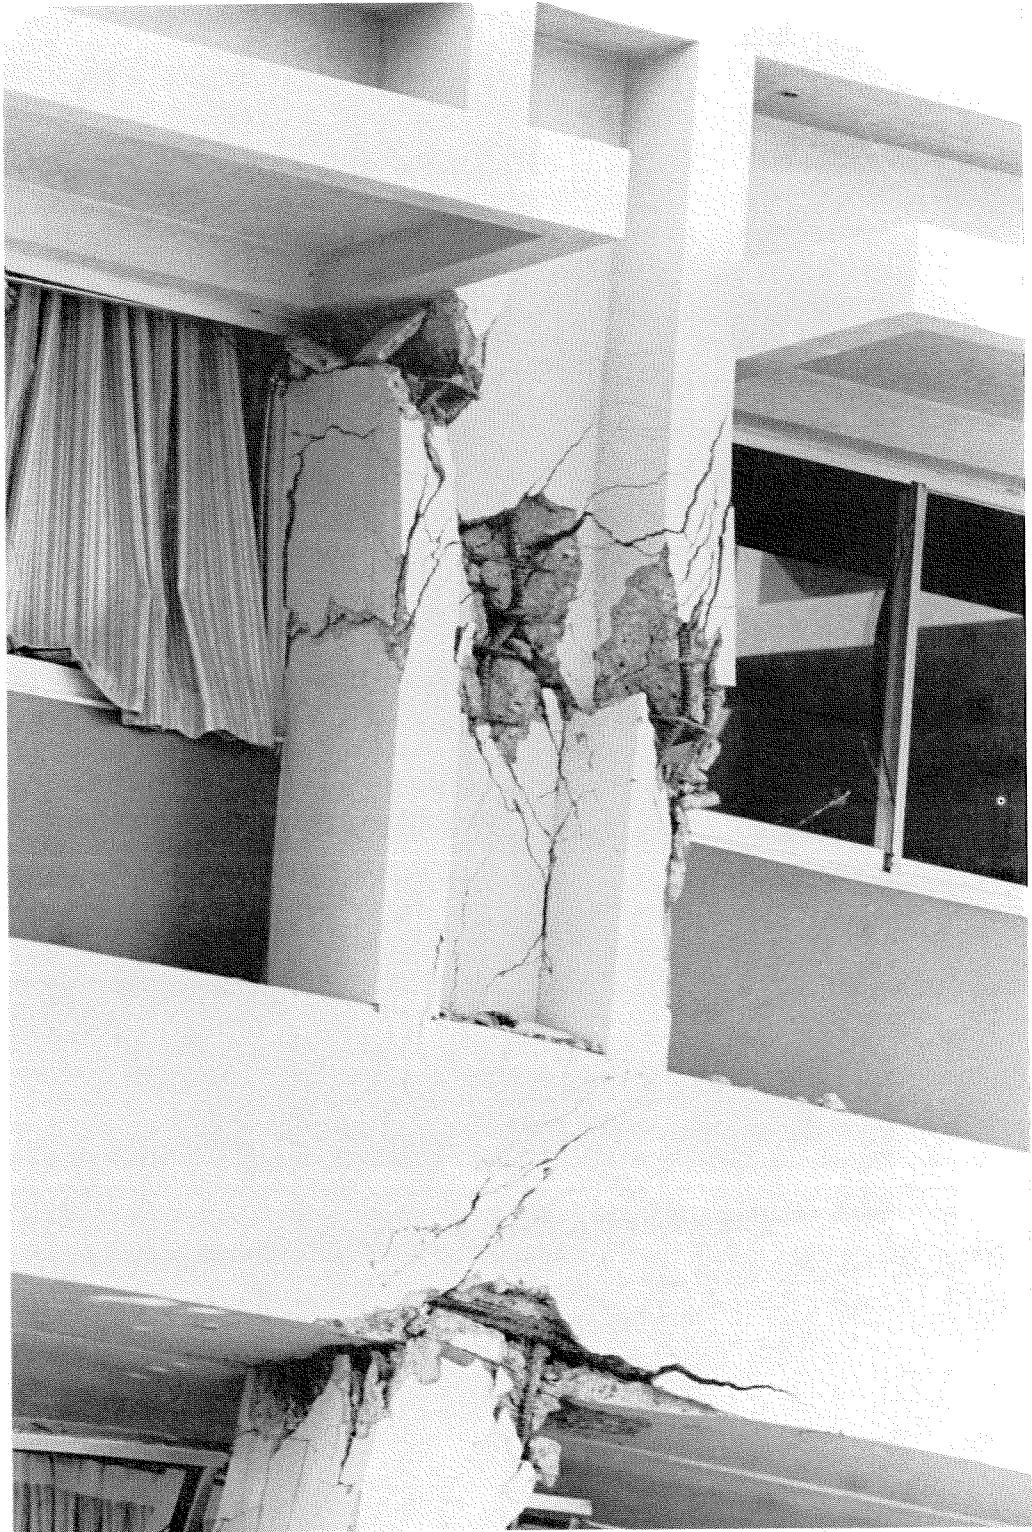
Figure 3.29 Shear failure in a second story column of the west wing, Olive View Hospital.

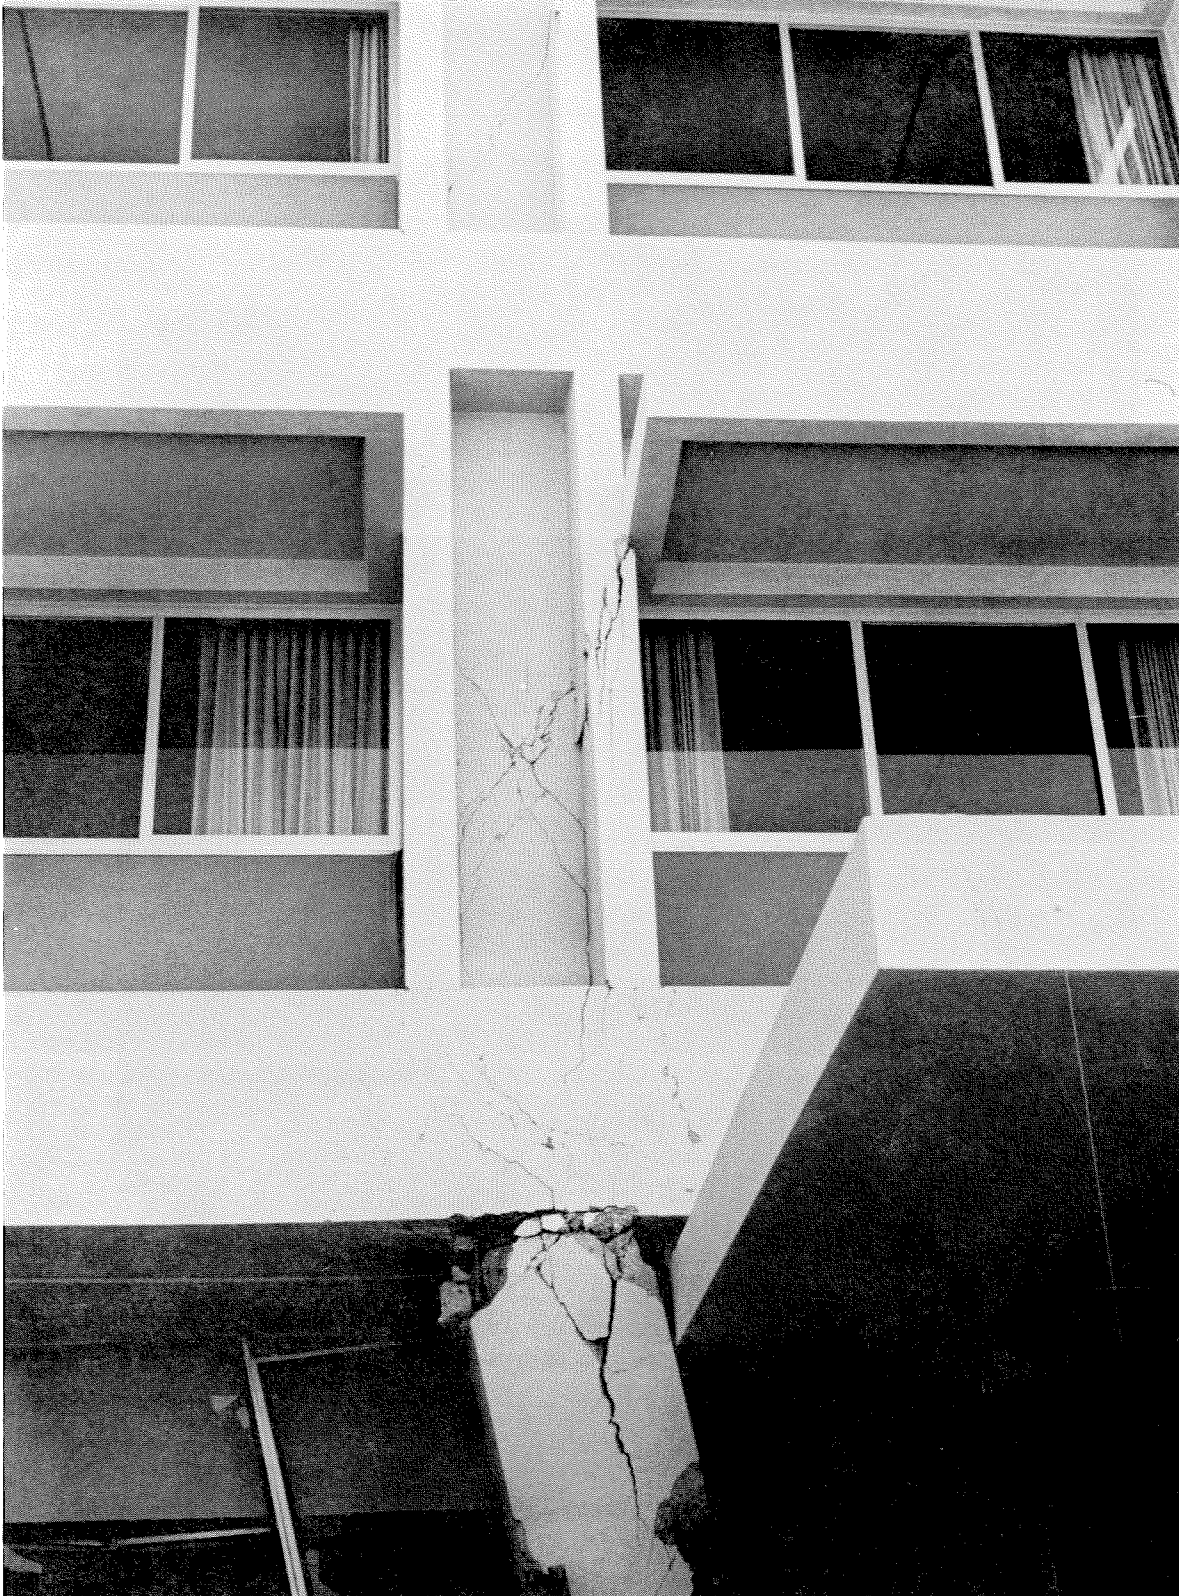
Figure 3.30 Above main entrance of Olive View Hospital. View showing cracks in second and third story of west wall of south wing.

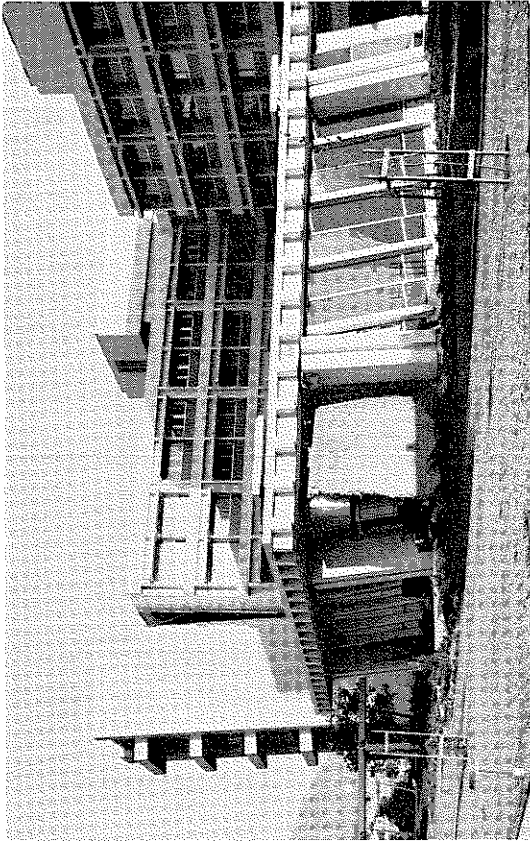
Figure 3. 32 Damaged assembly hall at Olive View Hospital. Failure occurred at the column-roof connection.

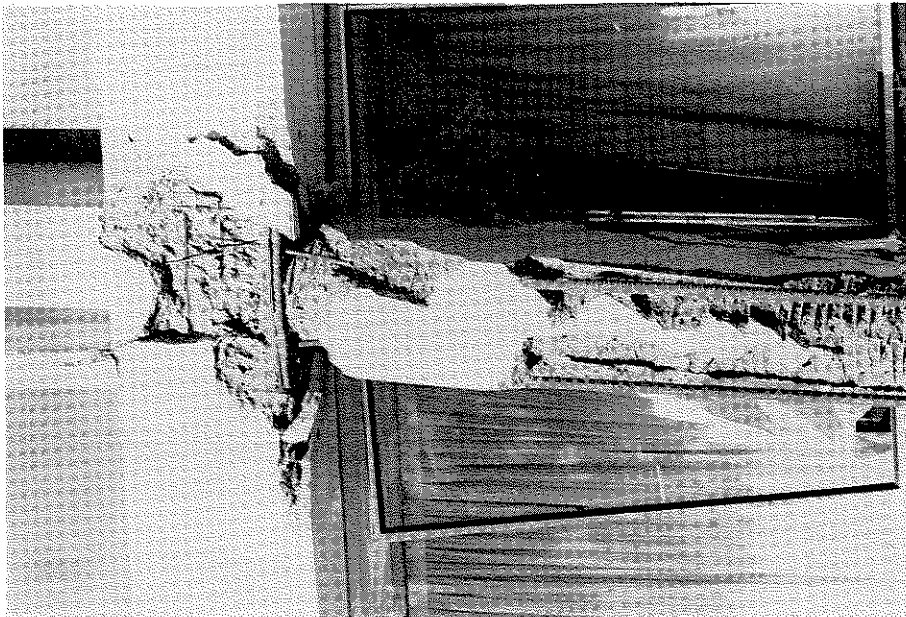
Figure 3. 31 Connection damage between second floor beam and spiral column, Olive View Hospital

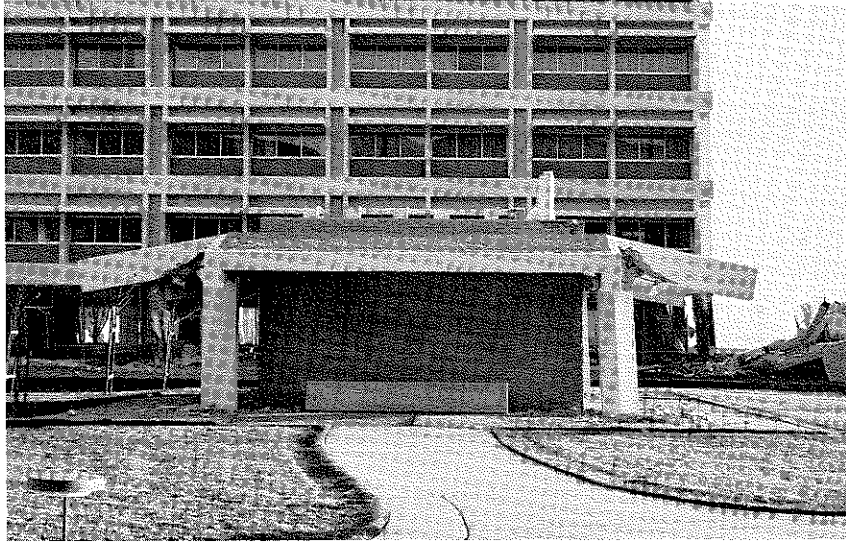
Figure 3.33 Exhaust pavilion to the north of the main building of the Olive View Hospital. The overhangs were originally horizontal. The cantilevered canopy was supported on four columns and is independent of the exhaust structure.

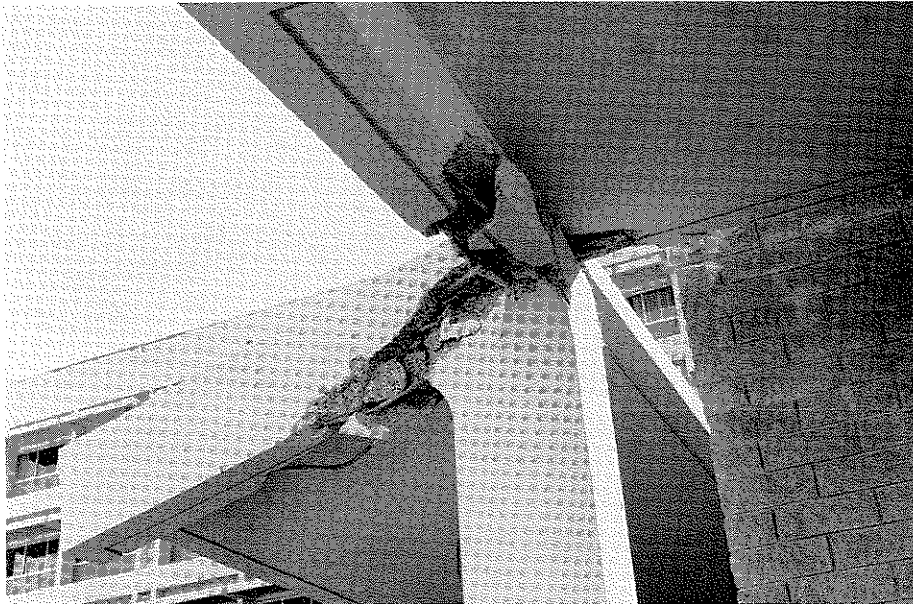
Figure 3.34 Beam and connection failure in the free-standing canopy of the exhaust pavilion, Olive View Hospital. The failure pattern suggests torsional failure of the beams from lateral motion of the structure. Note the scars on the brick facing of the separate, interior structure.

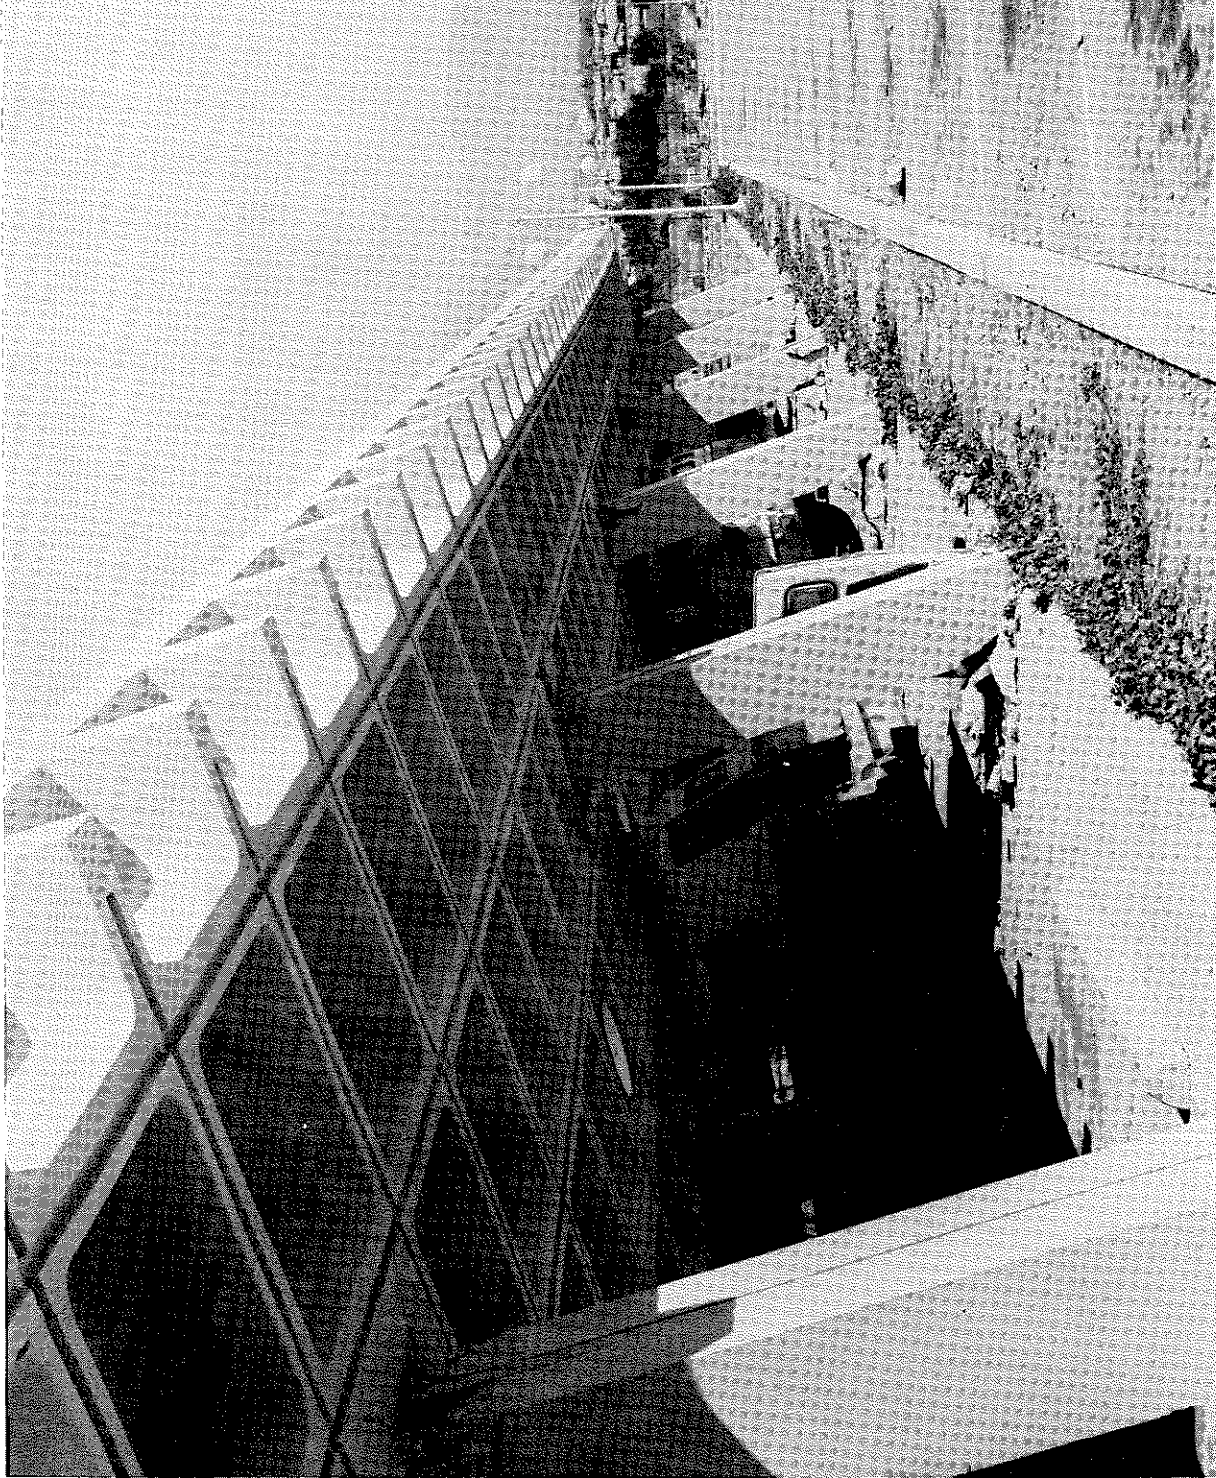
Figure 3. 35 Concrete canopy collapsed onto ambulances at Olive View Hospital, just south of main building. The columns were originally vertical.

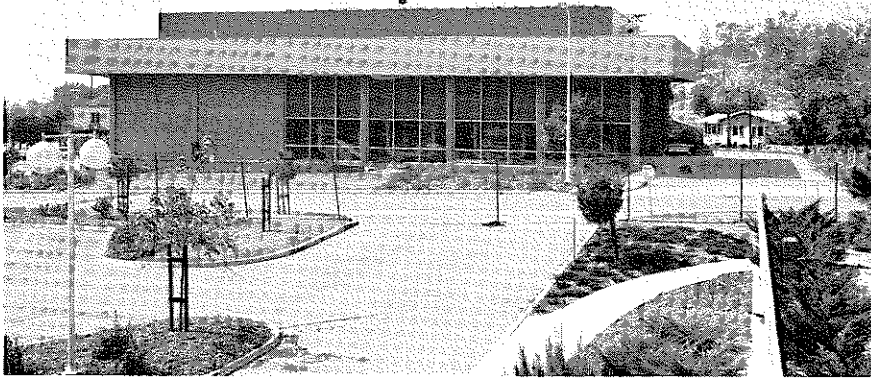
Figure 3.36 East wall of central heating and refrigeration plant, 150 yards northwest of the main buildings of Olive View Hospital.

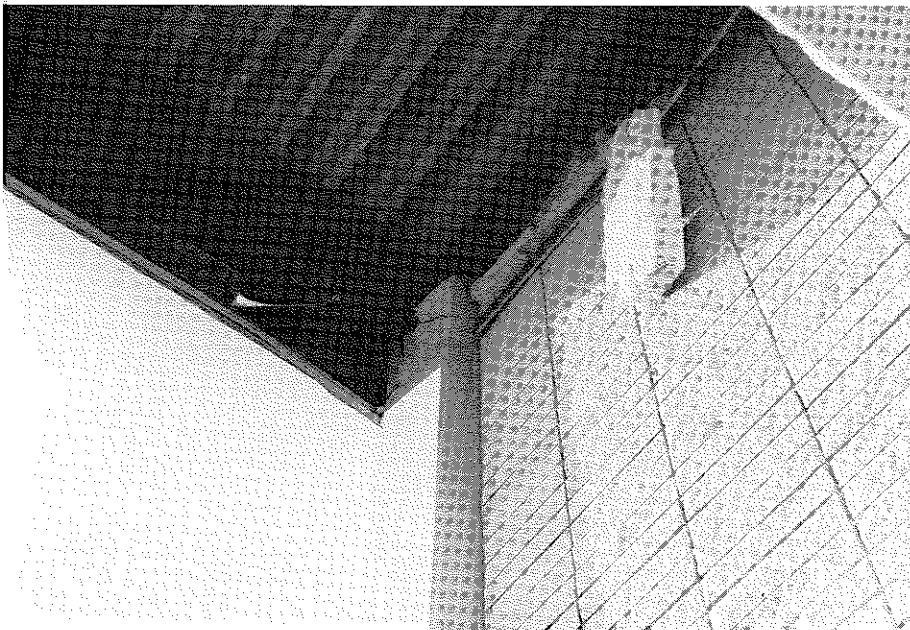
Figure 3.37 Damage at the connection between the reinforced columns and the steel beams, central heating and refrigeration plant, Olive View Hospital.

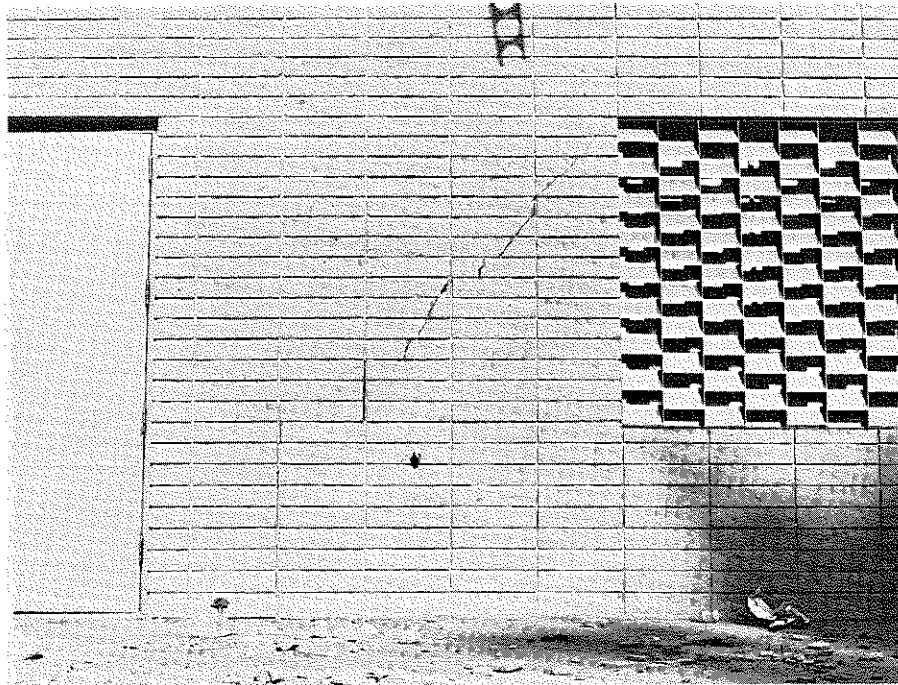
Figure 3.38 Crack in west wall of power plant building at Olive View Hospital. A similar crack, though smaller, occurred in the east wall.

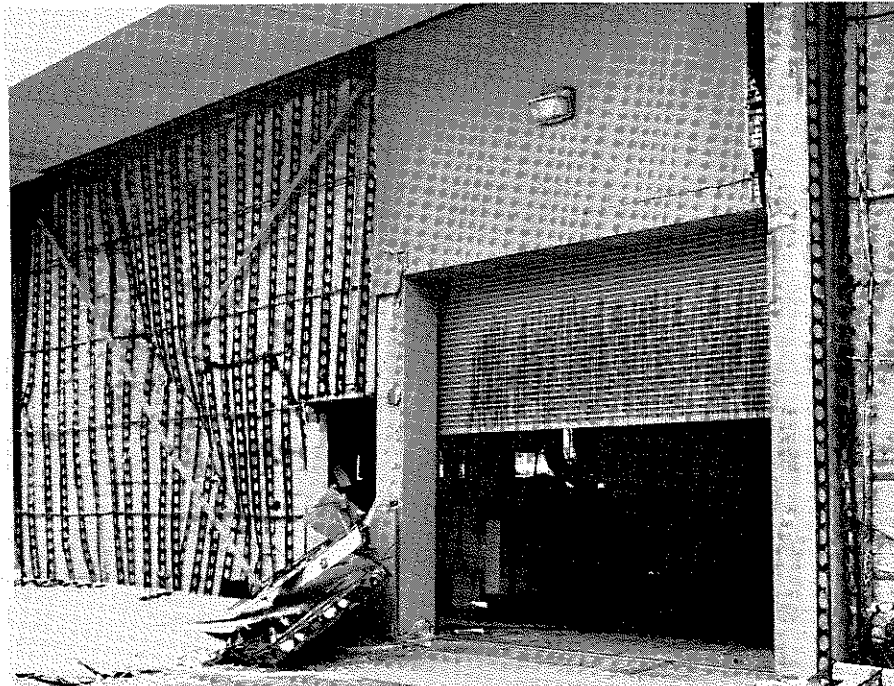
Figure 3.39 The two outside bays of the north wall of the power plant building at Olive View Hospital had steel strap crossbracing ($1/2'' \times 4''$). One strap failed at the weld and its companion had almost failed. The two straps in the west panel were badly deformed.

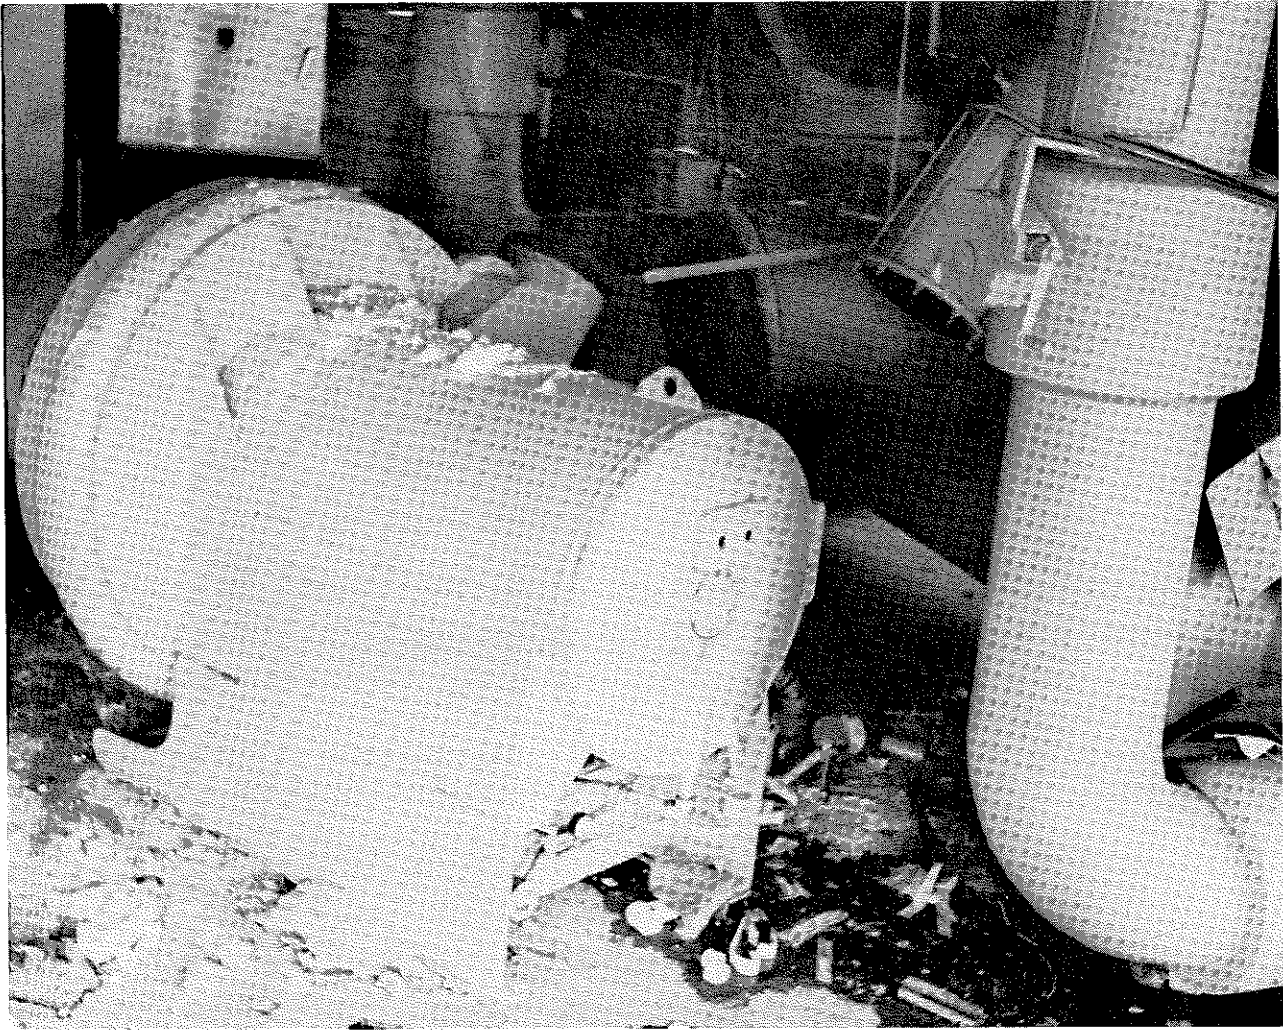
Figure 3.40 Equipment that was not bolted to the floor in the Olive View Central Heating and Refrigeration Plant moved about.

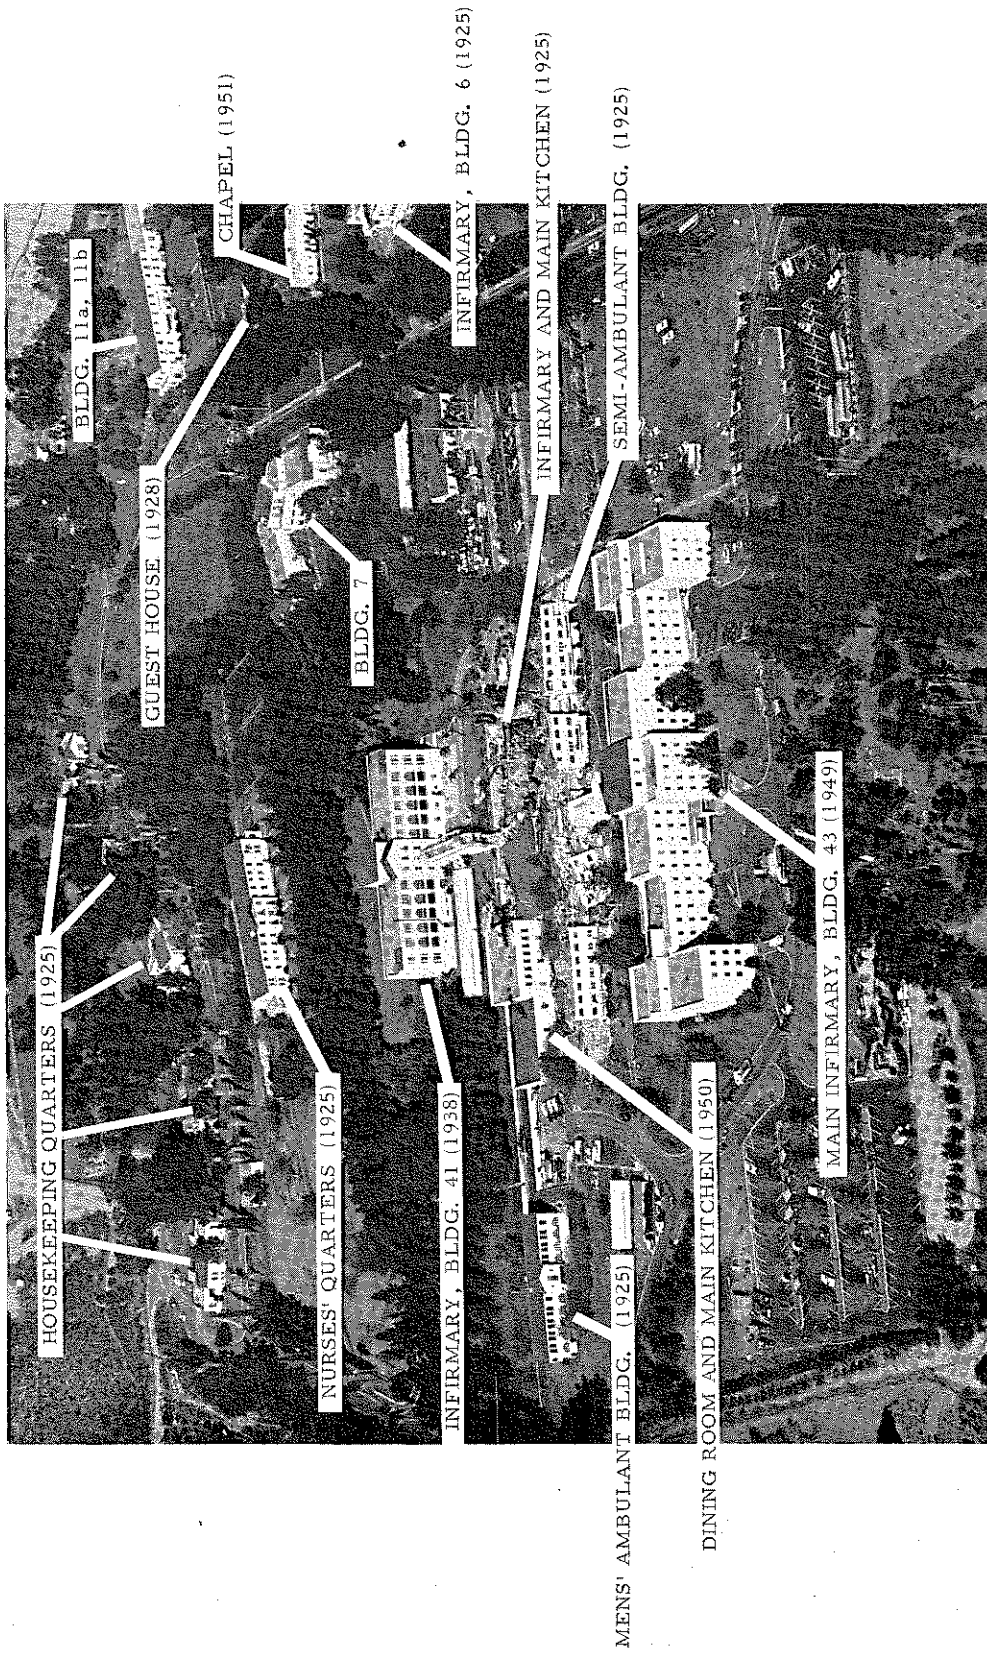
Figure 3. 41 Aerial view, looking northeast, of the San Fernando Veterans Hospital taken the day of the earthquake. Ralph Samuels photo.

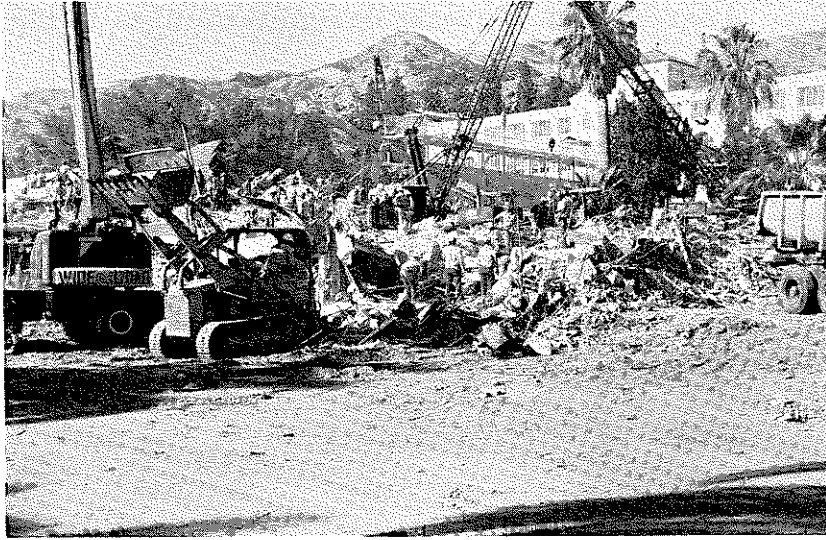
Figure 3.42 Rescue operations at the Veterans Hospital, looking north.

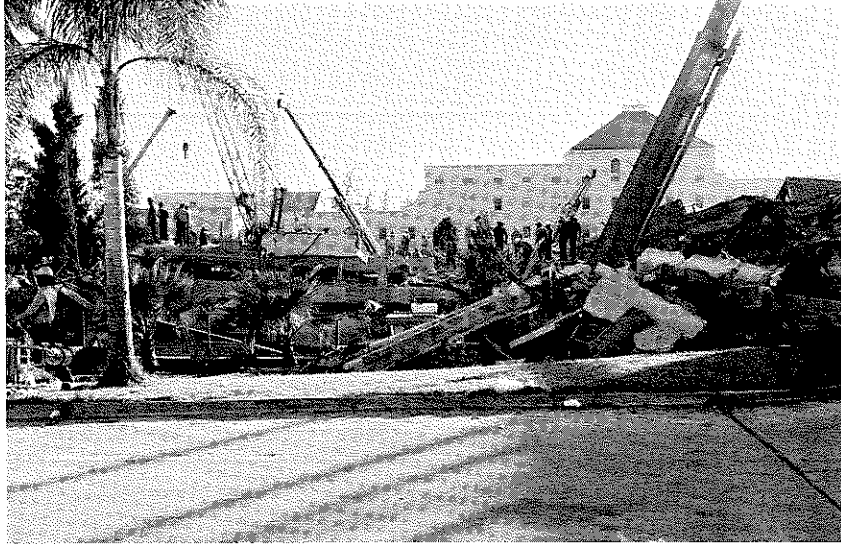
Figure 3.44 Collapsed building at the Veterans Administration Hospital. Building in background was not damaged significantly.

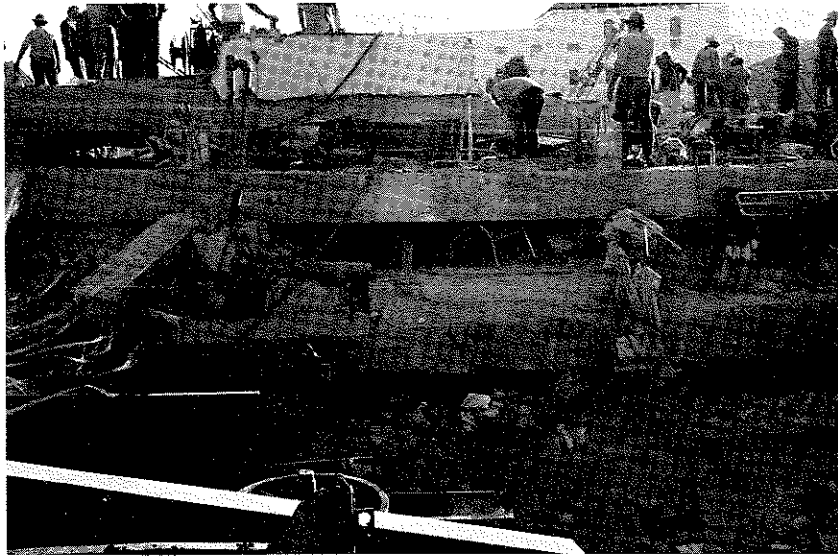
Figure 3.45 Details of collapsed structure, Veterans Hospital. Building in background was not damaged significantly.

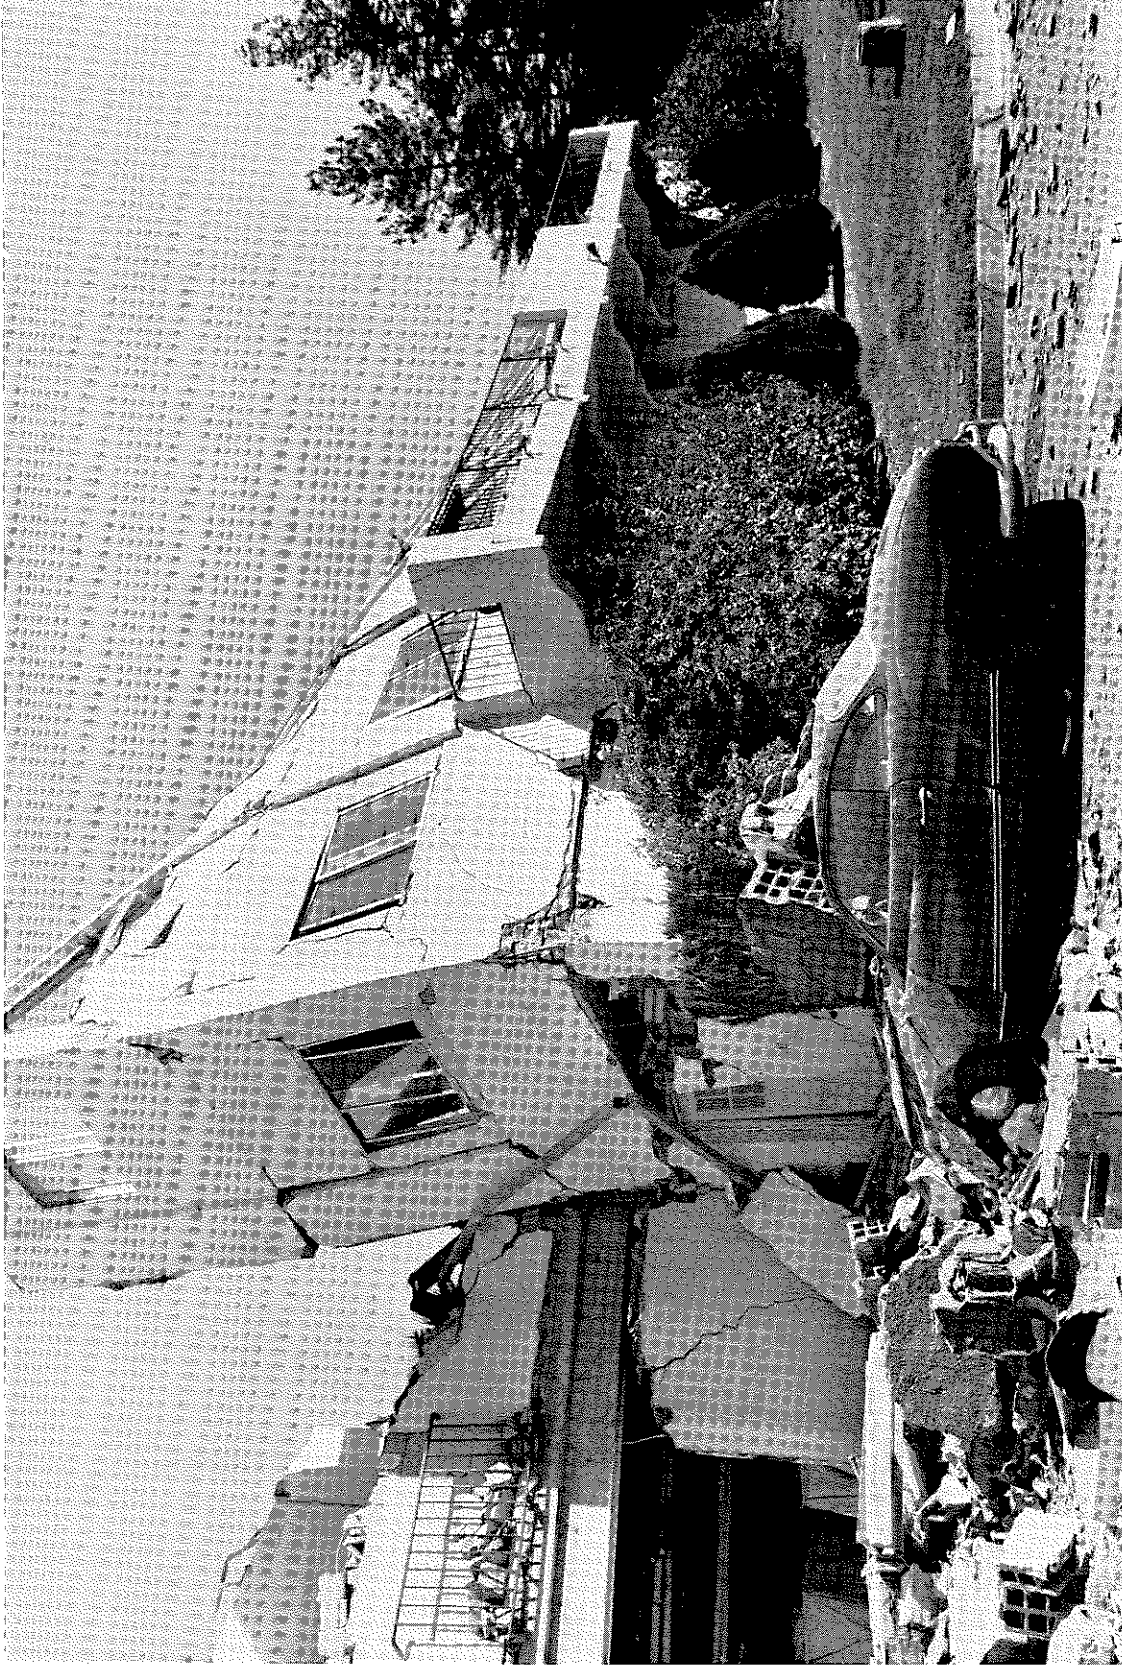
Figure 3.46 The collapsed Semi-Ambulent Building at the San Fernando Veterans Hospital. View is looking to the northeast shortly after the earthquake. L.A. Times photo.
