ENGINEERING FEATURES
OF THE
SAN FERNANDO EARTHQUAKE OF FEBRUARY 9, 1971

Paul C. Jennings, Editor

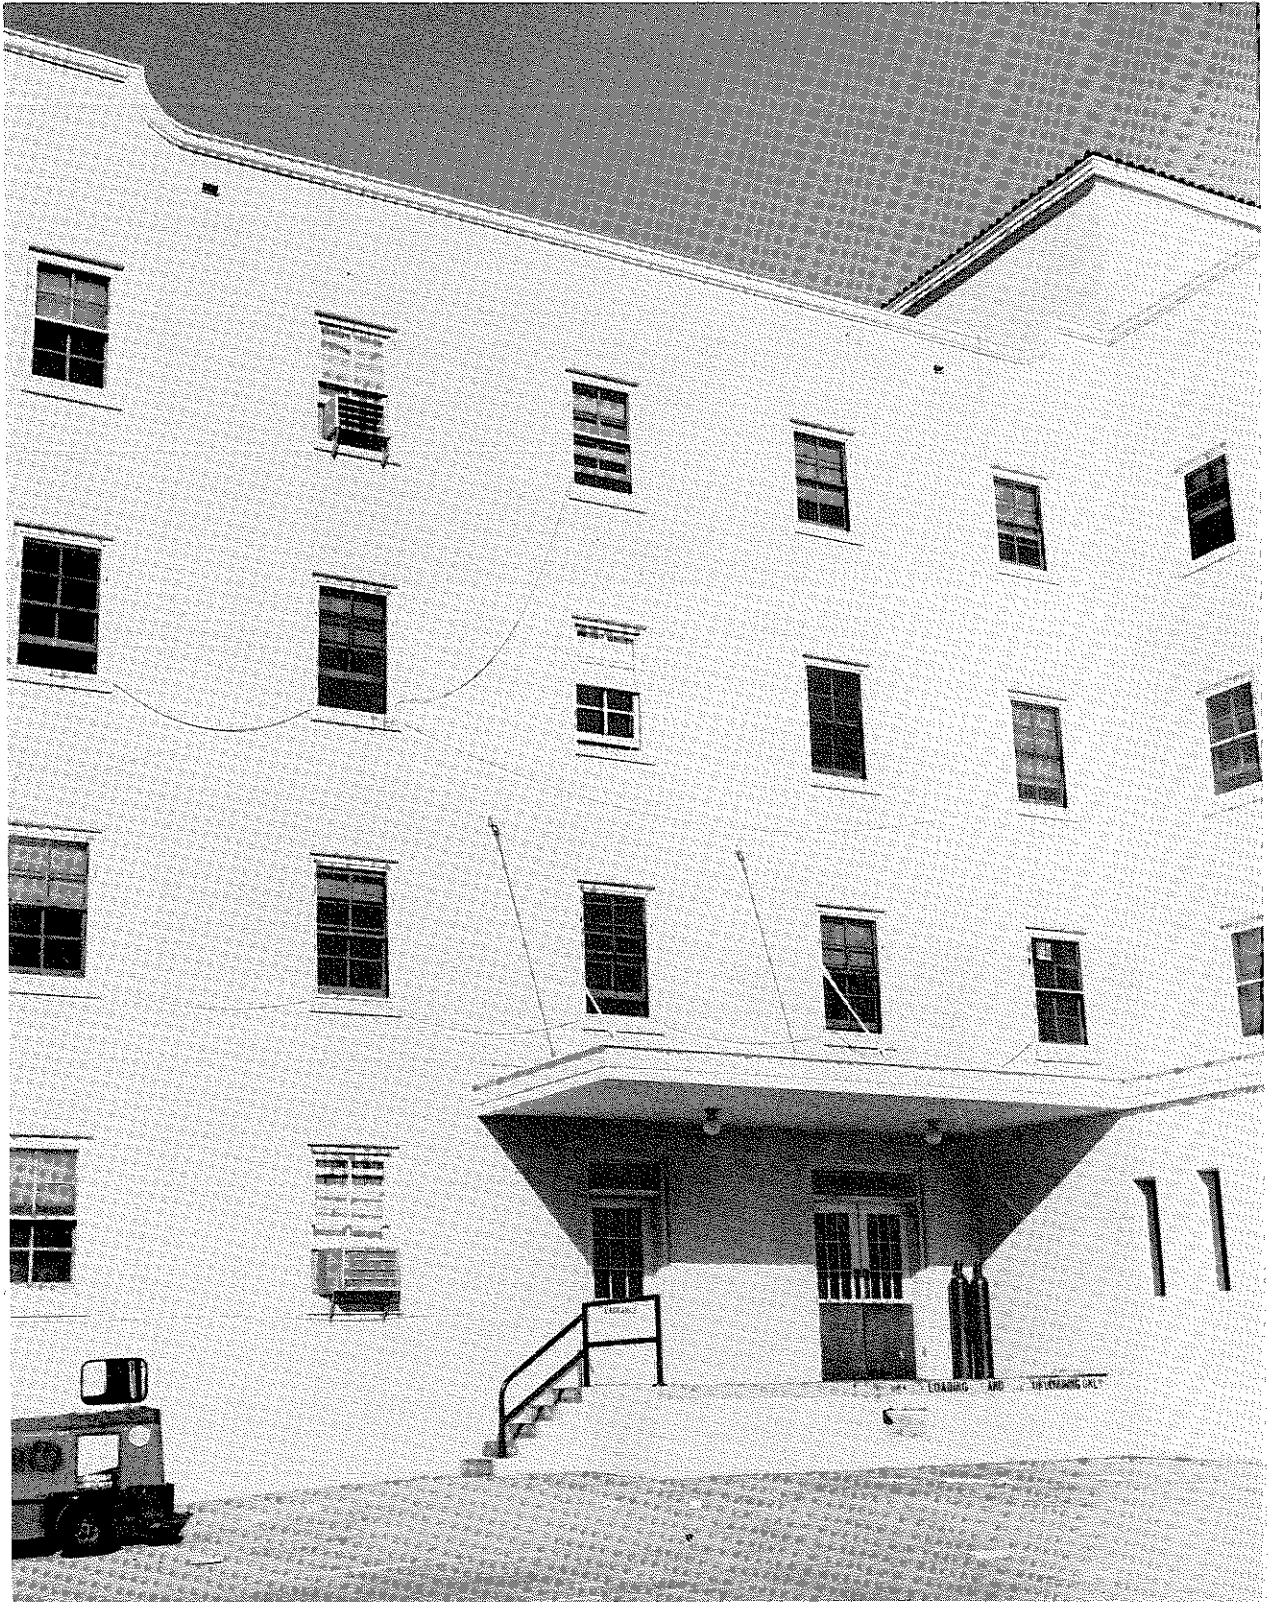
Figure 3.47 The Main Infirmary Building, a concrete frame and shear-wall building at the Veterans Administration Hospital, was not seriously damaged. The building was constructed in 1949, after earthquake provisions were a part of the building code.

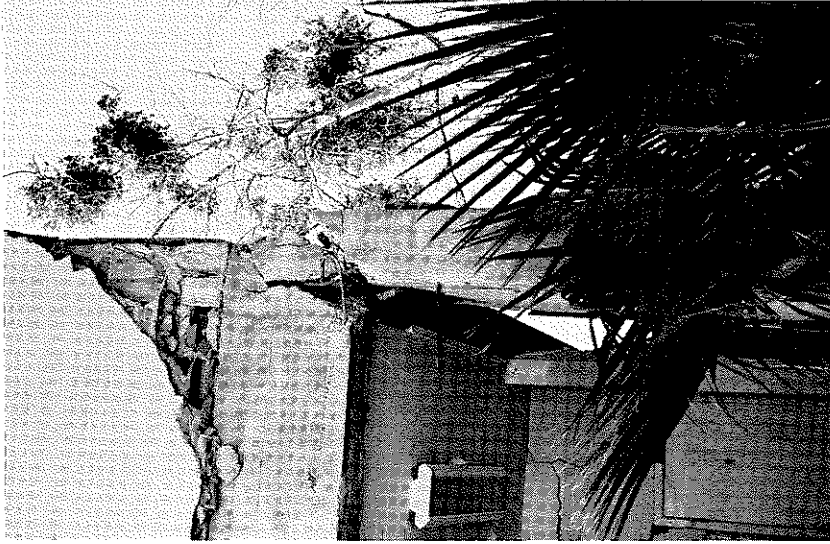
Figure 3.49 Eastern corner of the Men's Ambulant Building, Veterans Hospital, showing column damage.

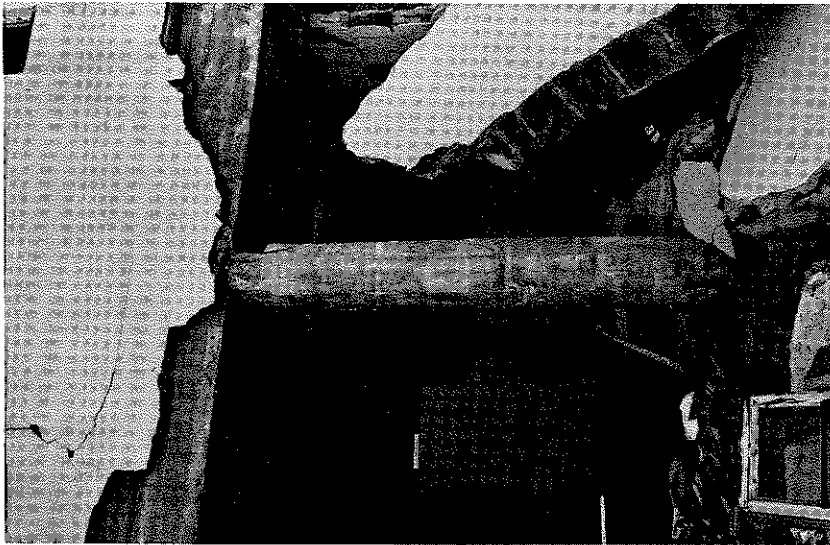
Figure 3.48 Damage to southeast end of the Mens' Ambulant Building; typical old construction. Note column-to-beam connections and portion of collapsed tile filler-wall. Veterans Hospital.

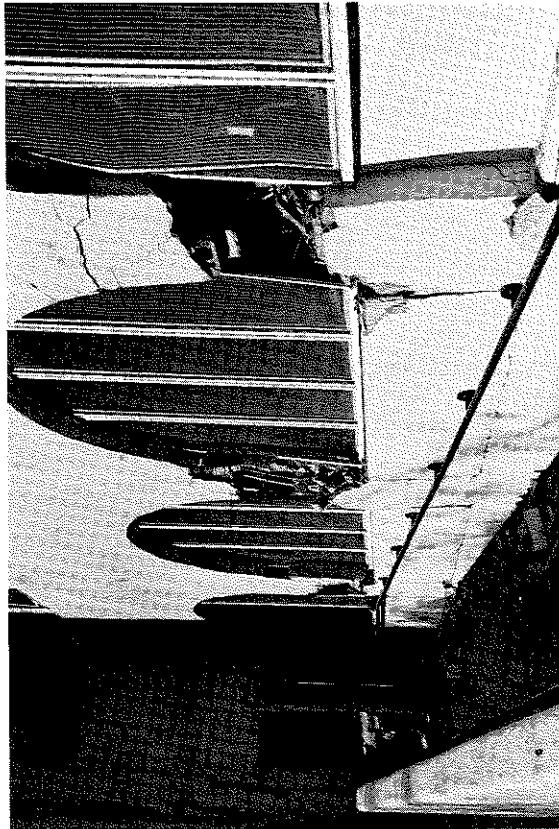
Figure 3.50 Shear failure in columns in southwest side of Men's Ambulant Building, Veterans Hospital.

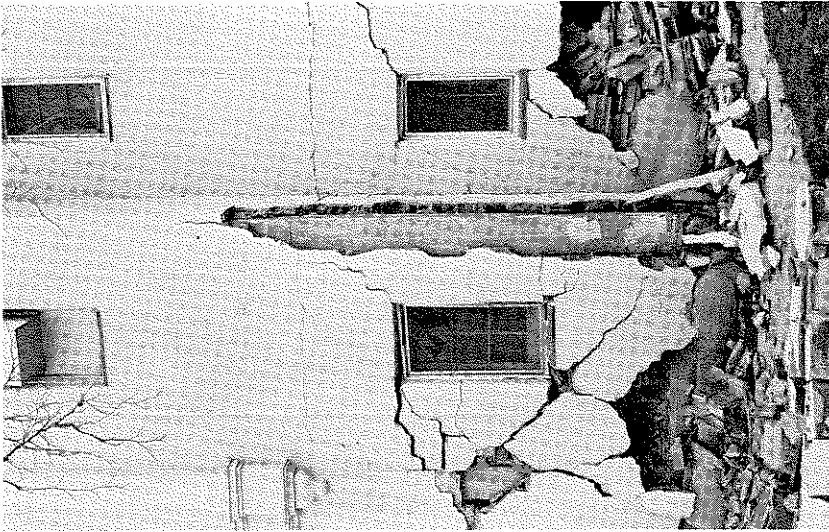
Figure 3.51 Northeast side of Men's Ambulant Building, Veterans Hospital. Note base of column.

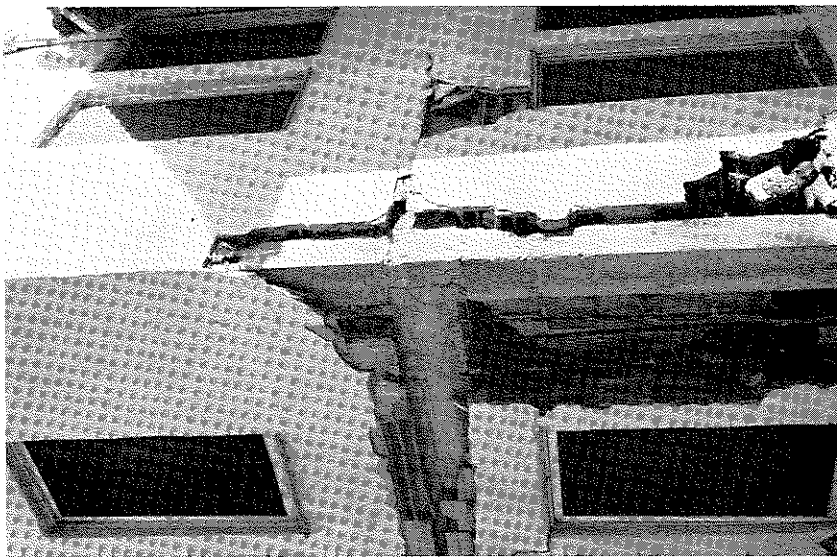
Figure 3. 53 Beam-to-column connection, Infirmary Building (Bldg. 5), Veterans Hospital.

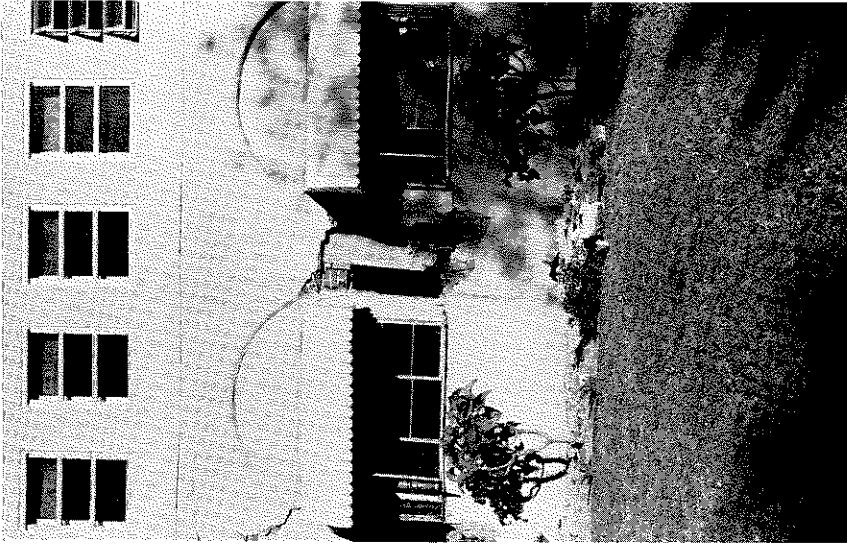
Figure 3.55 Shear failure of column, Infirmary Building (Bldg. 6), Veterans Hospital.

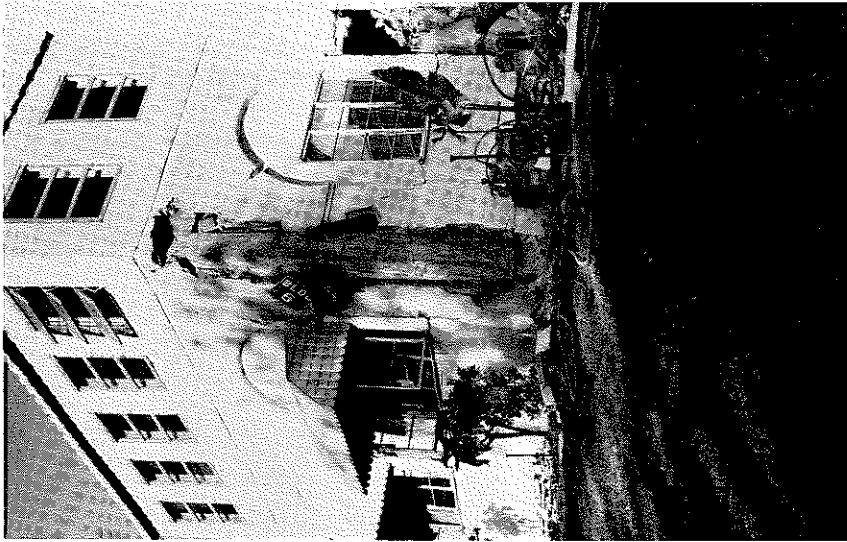
Figure 3.54 Failure of column at base, Infirmary Building (Bldg. 6), Veterans Hospital.

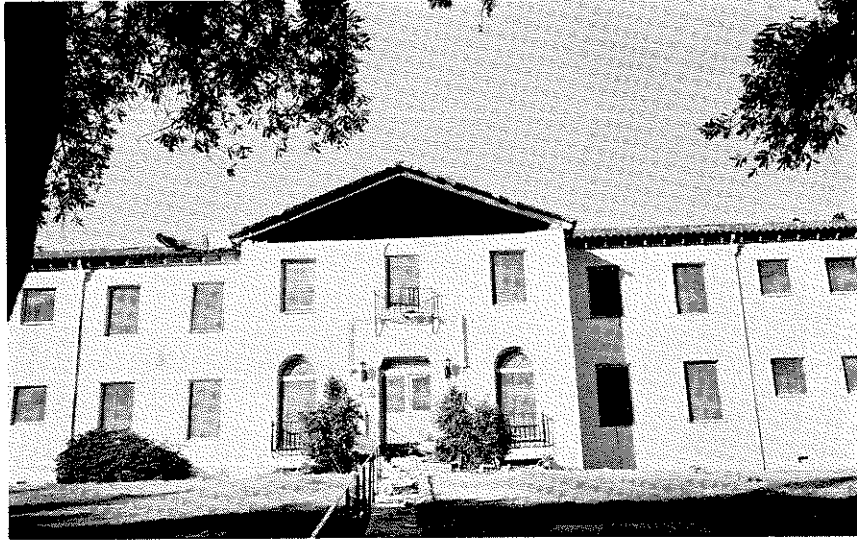
Figure 3.56 Nurses' Quarters (Bldg. 12) at the Veterans Hospital, as seen from the southwest. The gable wall fell in front of the entrance.

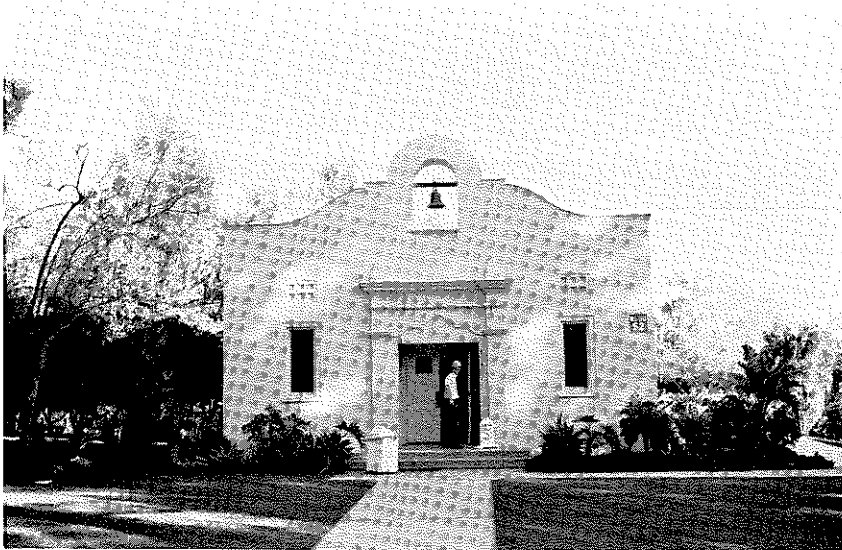
Figure 3.59 The chapel at the Veterans Hospital, built in 1951, suffered no apparent structural damage.

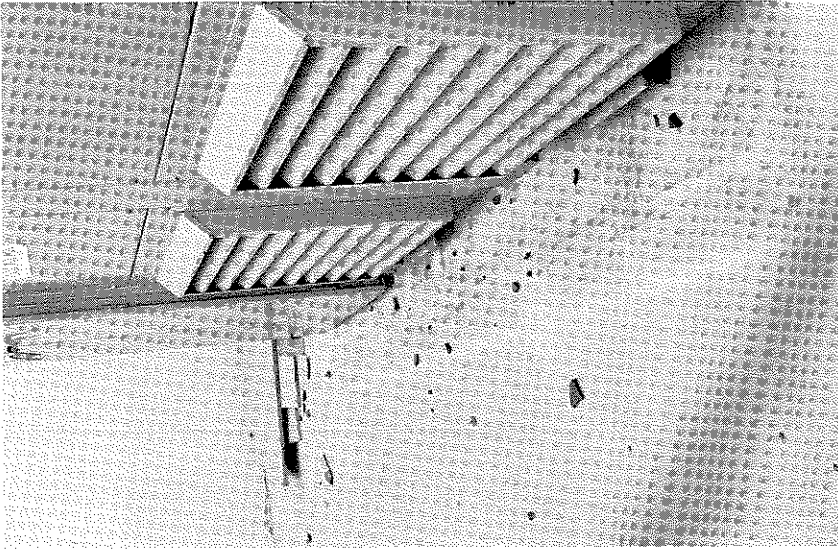
Figure 3.61 Electrical equipment was displaced several inches by earthquake motions, Veterans Hospital.

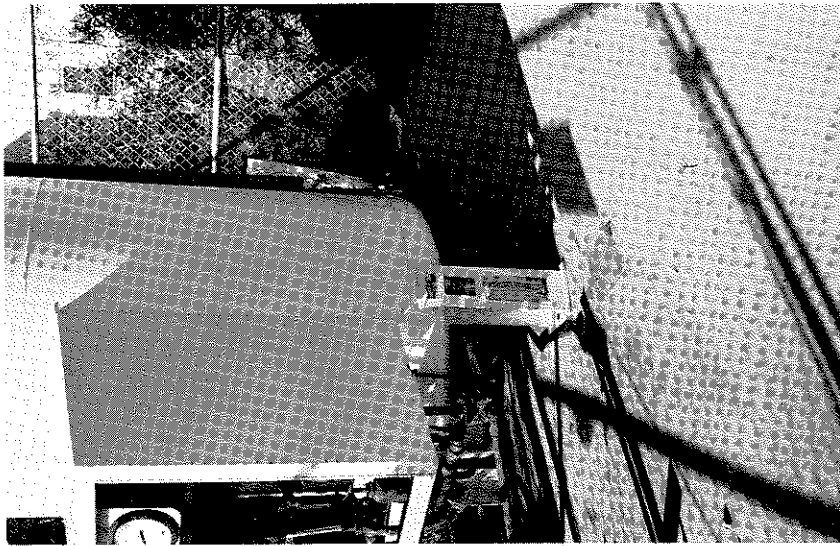
Figure 3.60 Marks on foundation show movement of storage tank, Veterans Hospital.

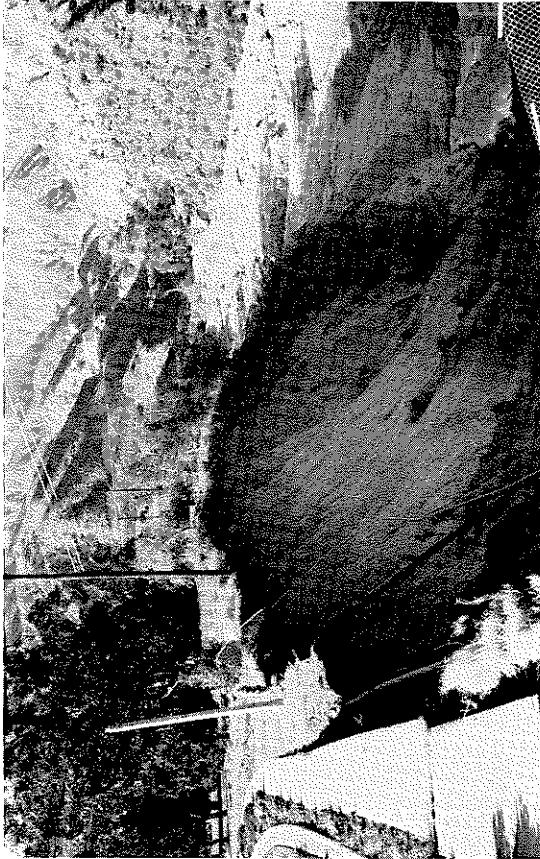
Figure 3.62 Landslide at eastern edge of site, Veterans Hospital.

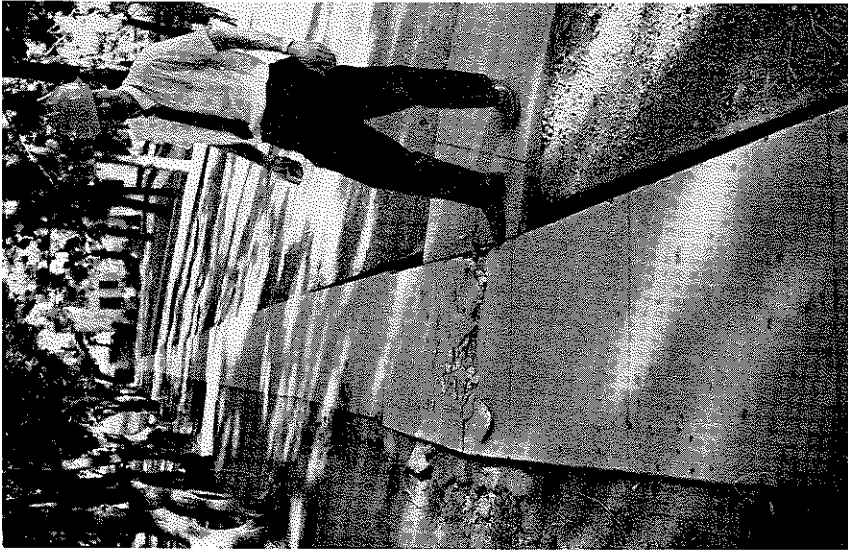
Figure 3.63 Sidewalk failure from ground movements near Infirmary Building (Bldg. 41), Veterans Hospital.

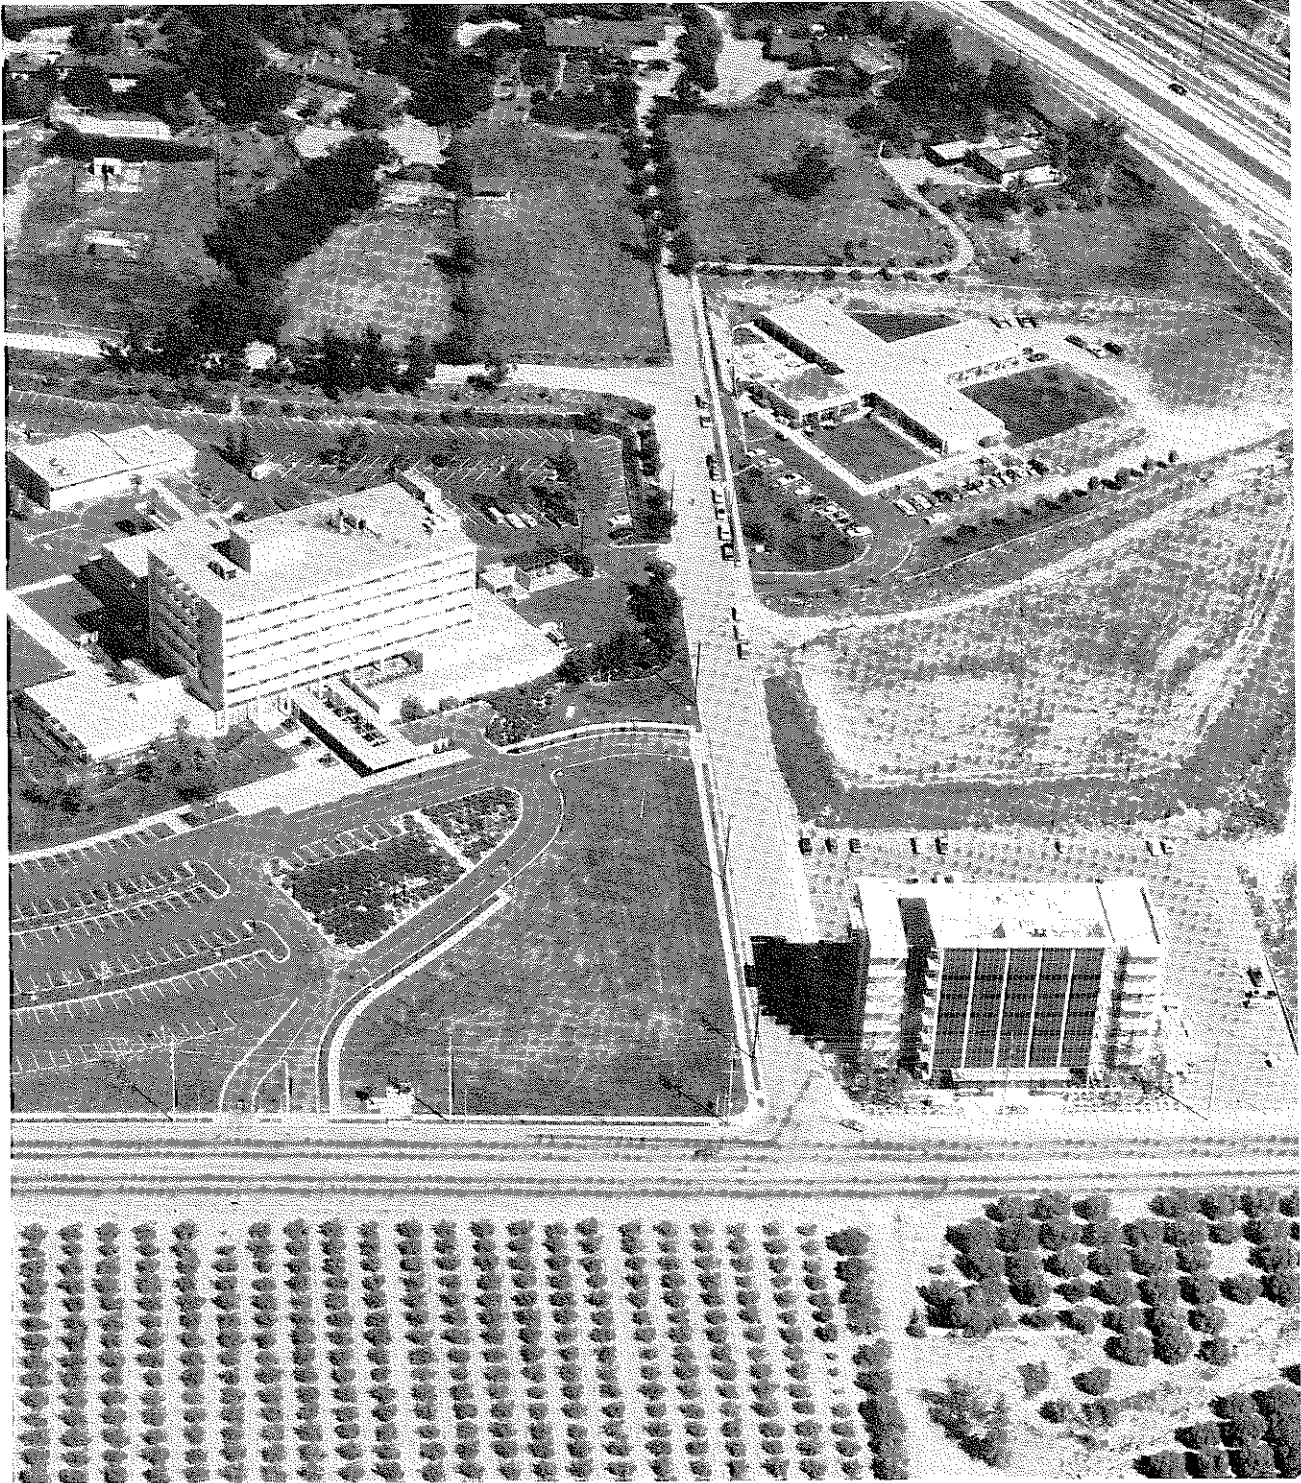
Figure 3.64 Aerial view looking north across Rinaldi Street. Pictured are Indian Hills Medical Center (lower right), Holy Cross Hospital (left), and Holy Cross Continuing Care Facility (upper right).

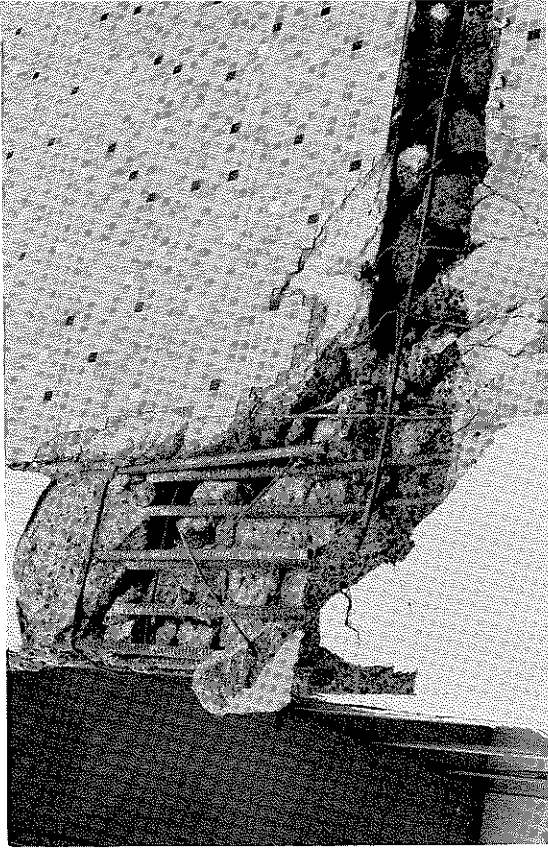
Figure 3.68 Closeup view of the end wall fracture at the fourth floor construction joint. The distorted vertical reinforcing steel in the wall indicates large movements have taken place. The vertical reinforcing steel in the corner column is lapped at the fourth floor level, and a reduced number of bars are continued above this level.

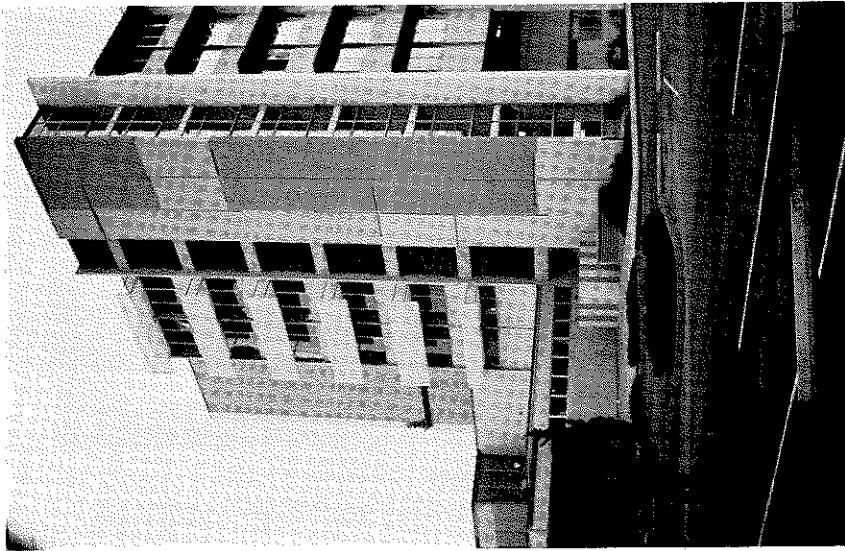
Figure 3.67 Holy Cross Hospital showing fractured end wall at the fourth floor construction joint.

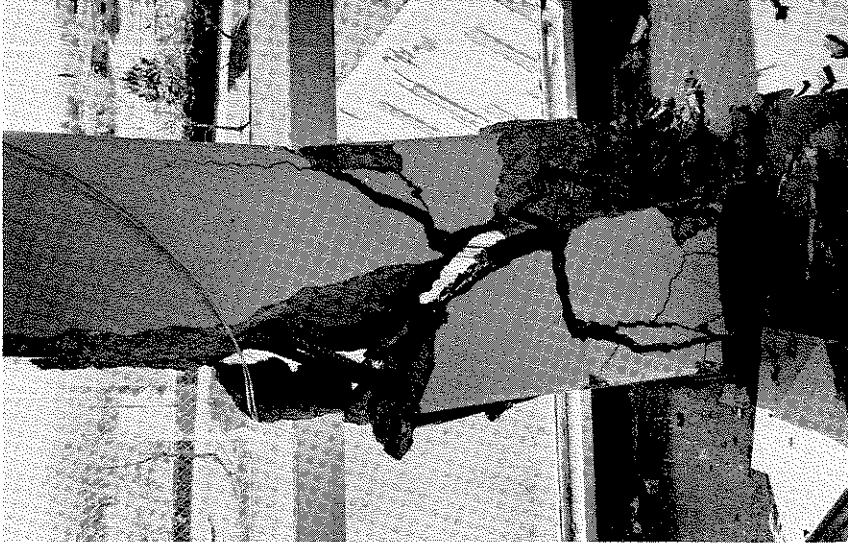
Figure 3.70 The third floor column between the end walls shown in Figure 3.69 was destroyed. Holy Cross Hospital.

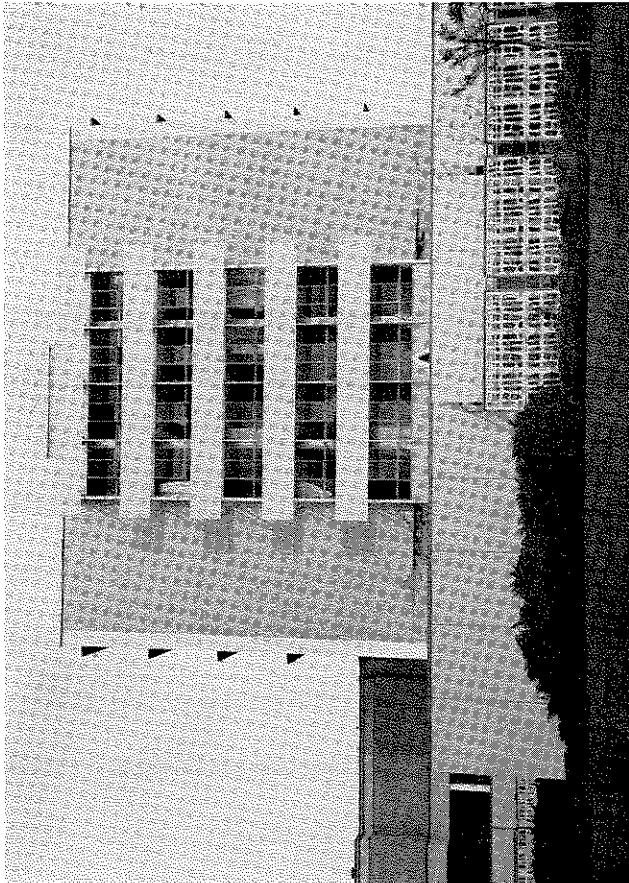
Figure 3.69 End walls at Holy Cross Hospital showing breaks at the third floor construction joints. Opposite view from Figure 3.67.

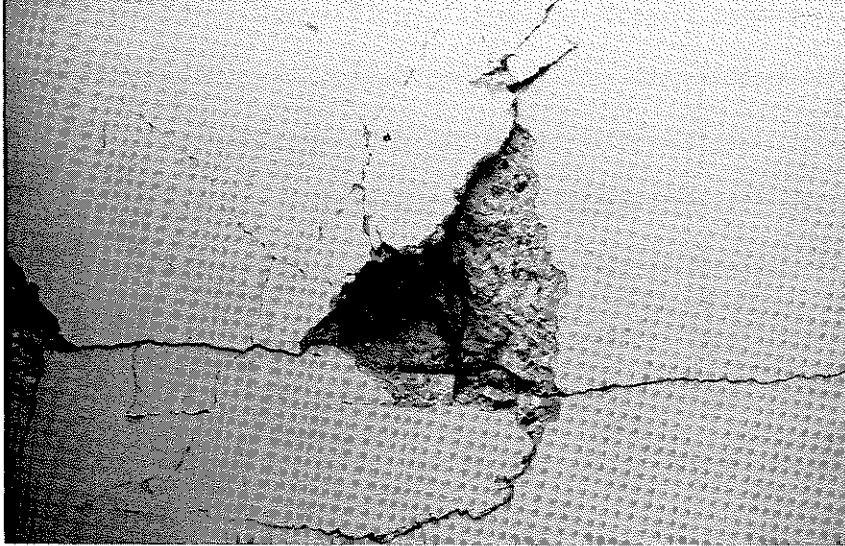
Figure 3.71 Most of the interior concrete walls in the first, second, and third stories of Holy Cross Hospital were cracked. At some points, where concrete spalled, the reinforcing steel was visible.

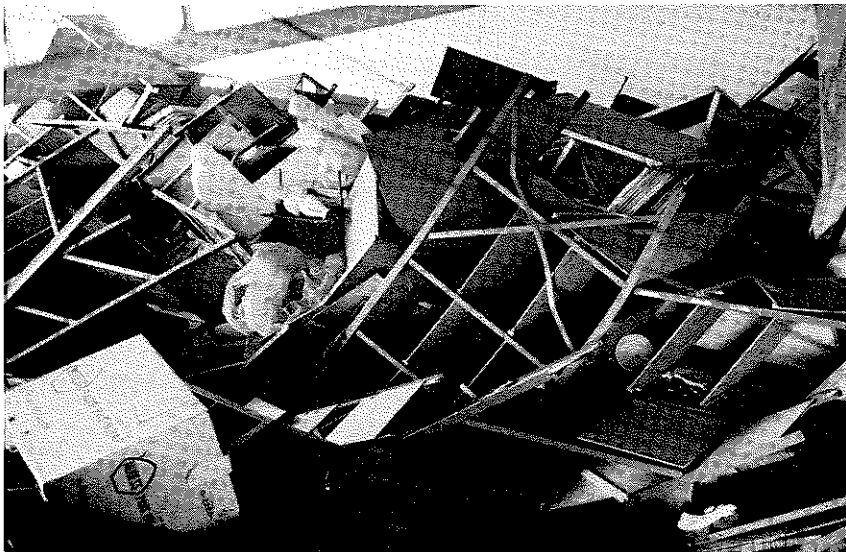
Figure 3.72 The storage shelves on the seventh floor of the Holy Cross Hospital were not properly secured. Potential hazards of this type can be avoided.

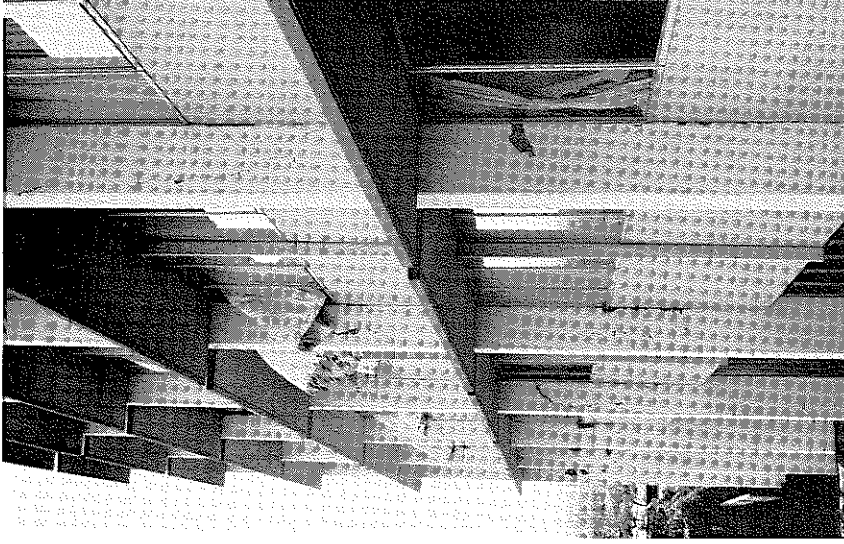
Figure 3.74 Exterior columns of Holy Cross Hospital with meandering cracks at points away from the floor connections.

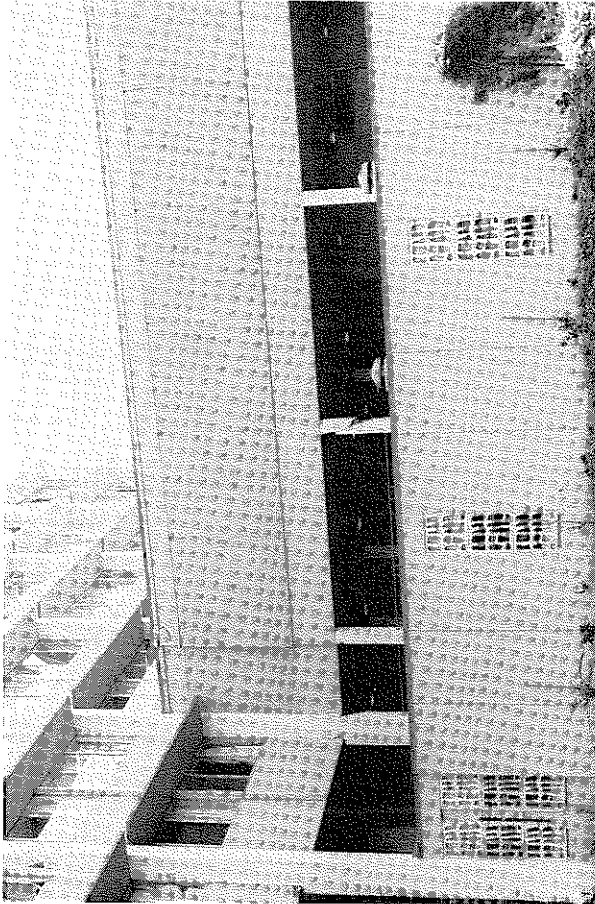
Figure 3.73 Three-story corridor annex to the Holy Cross Hospital. Column damage is present in both the annex and the hospital building.

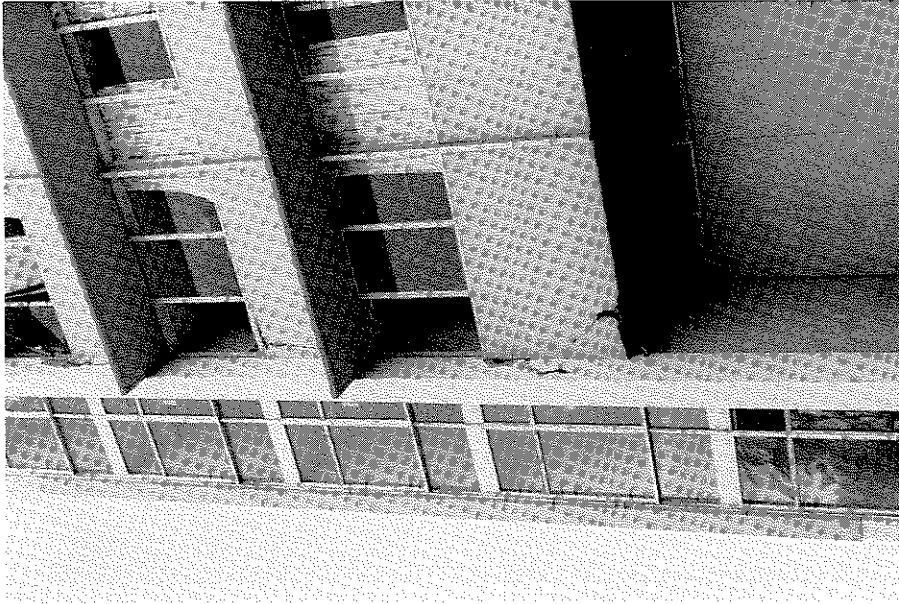
Figure 3.76 Fractured spandrel beams on the north side, Holy Cross Hospital.

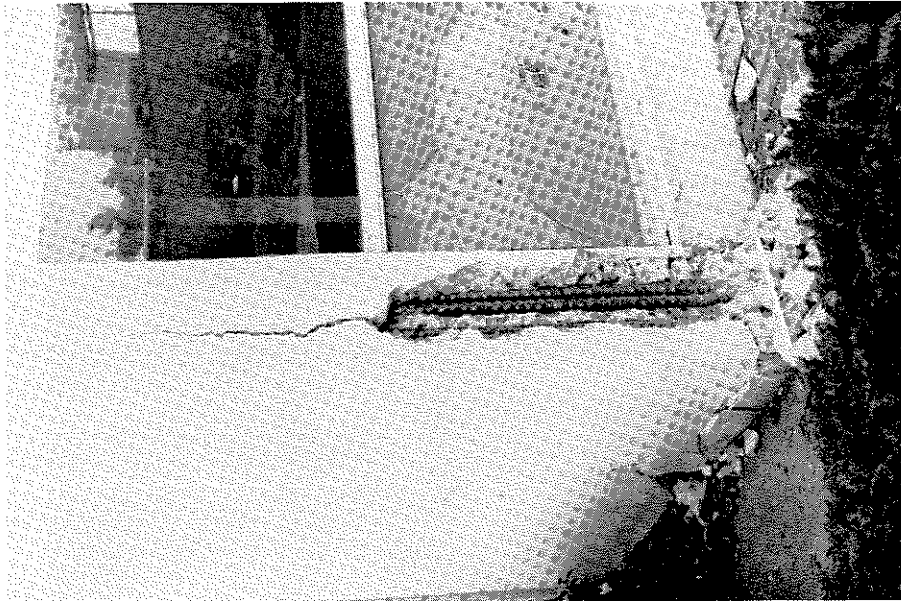
Figure 3.75 Fractured shear wall, Holy Cross Hospital.

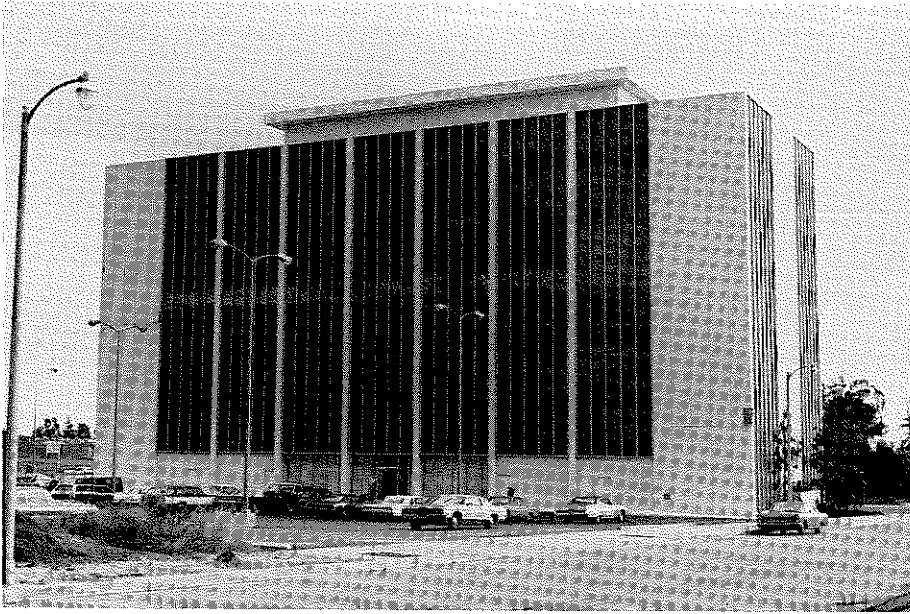
Figure 3.77 North elevation of the Indian Hills Medical Center as seen the day after the earthquake.

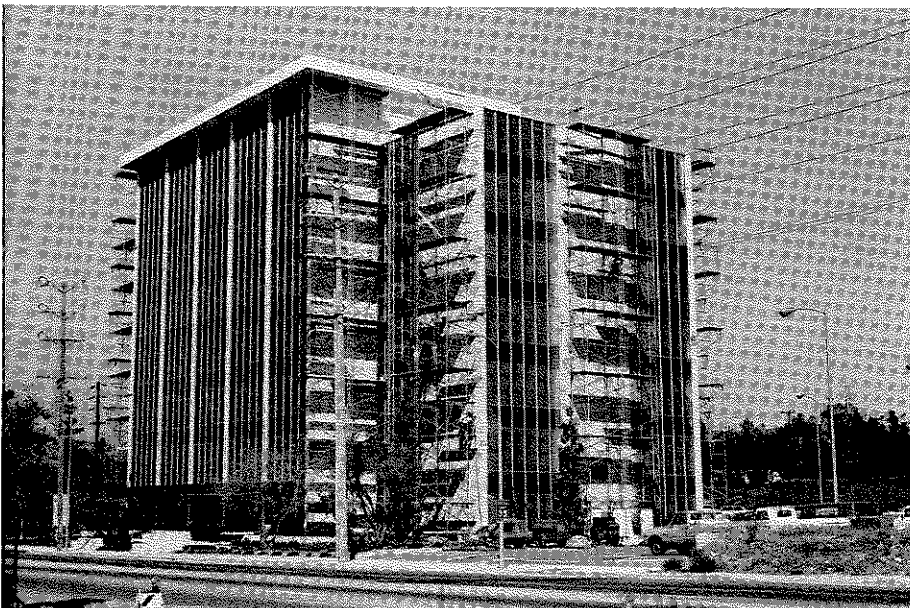
Figure 3.78 Southeast corner of the Indian Hills Medical Center. Repair operations six weeks after the earthquake.

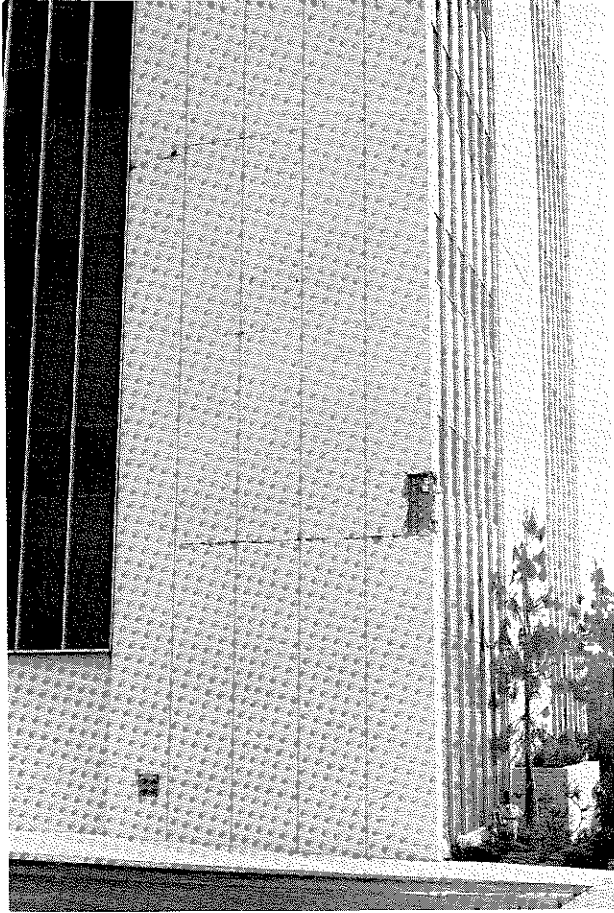
Figure 3.80 Cracking and spalling on western wall, north elevation of Indian Hills Medical Center.

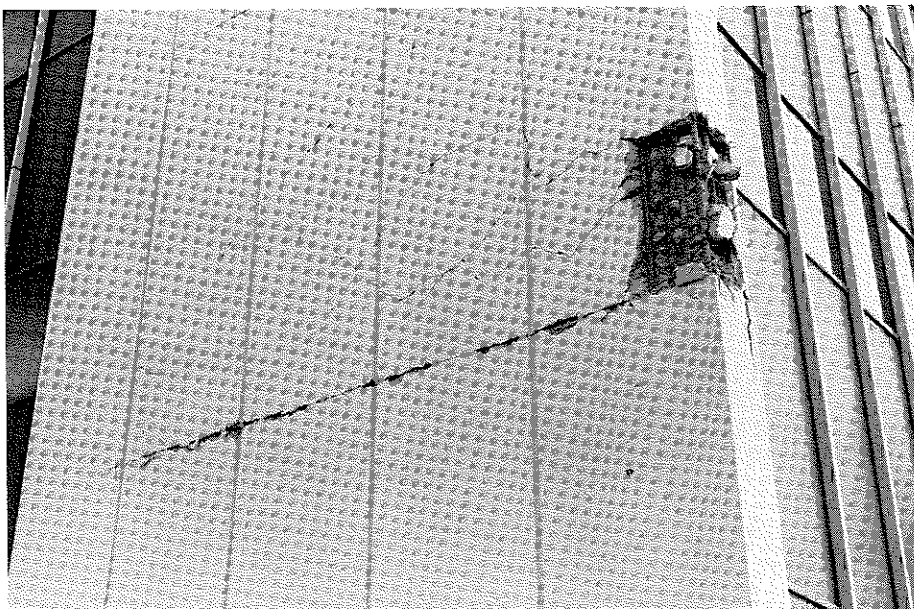
Figure 3.81 Closer view of spalled area shown in Figure 3.80. Indian Hills Medical Center.

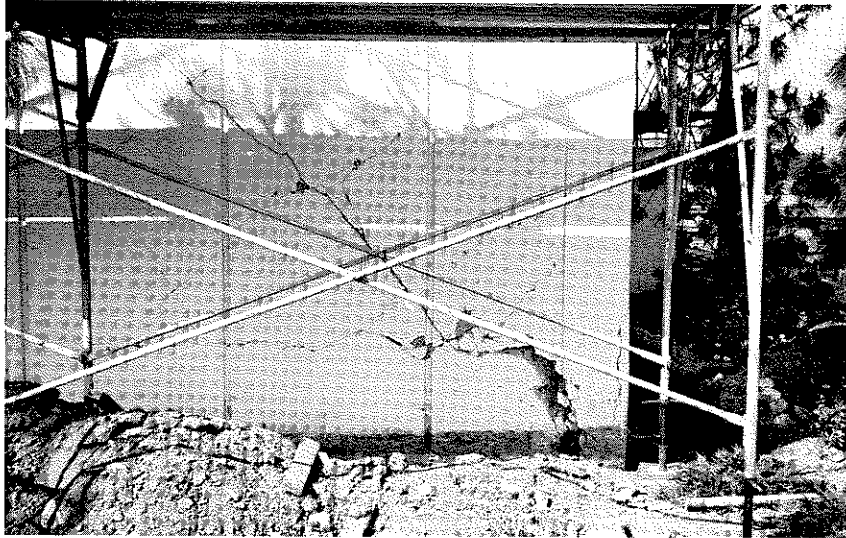
Figure 3.82 Cracking and spalling at the base of the eastern wall, south elevation of Indian Hills Medical Center.

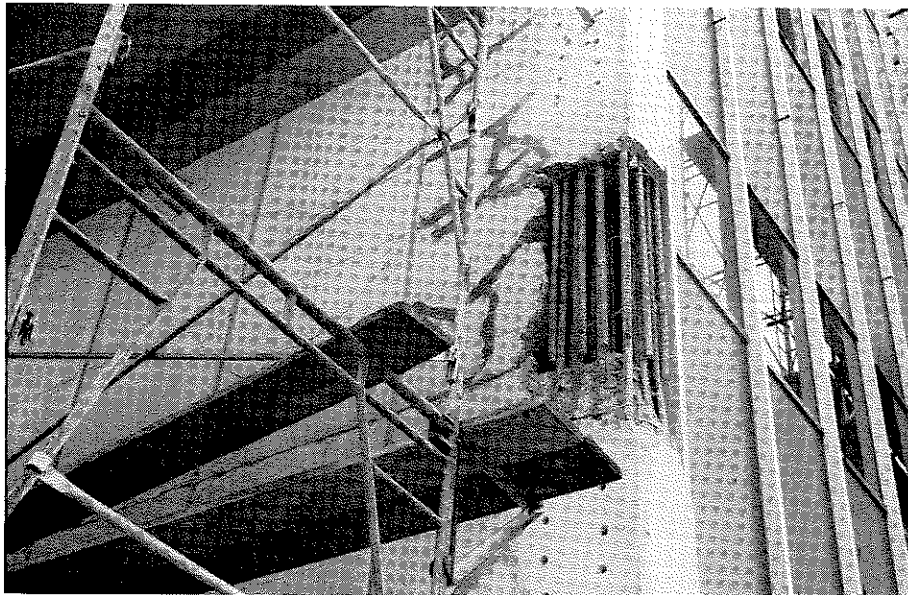
Figure 3.83 Vertical wall reinforcement exposed during repair operations. Same view as shown in Figure 3.81. Indian Hills Medical Center.

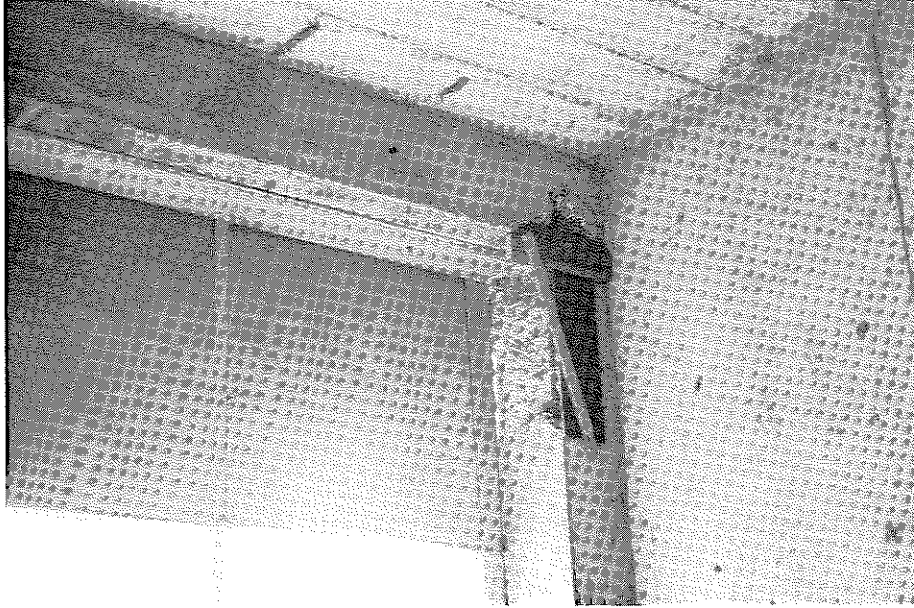
Figure 3.84 Spalling at connection between lightweight concrete beam and normal concrete column at the fourth story, Indian Hills Medical Center.

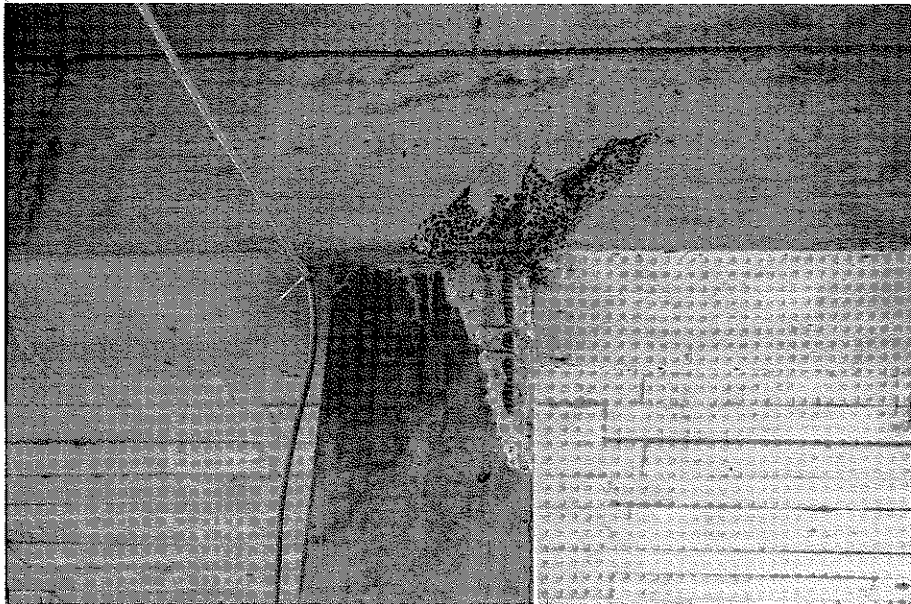
Figure 3.85 Spalling at beam-wall connection at the fifth story, Indian Hills Medical Center.

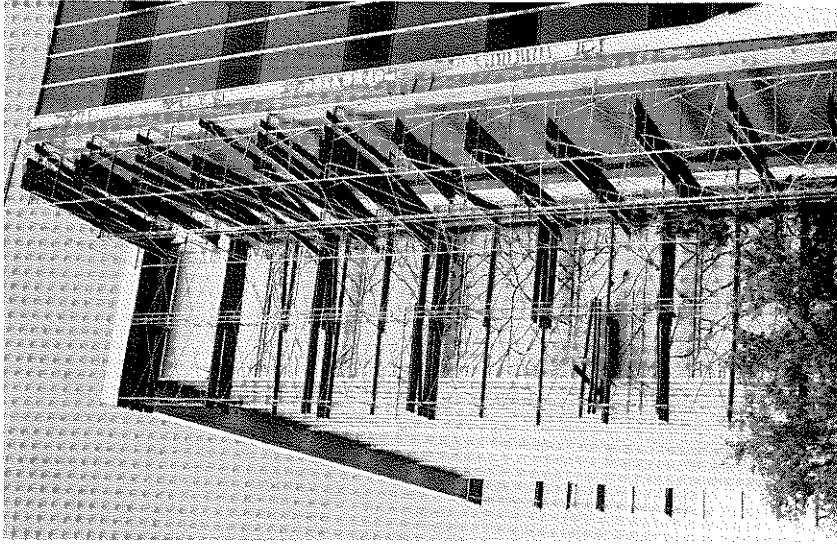
Figure 3.87 Exterior shear wall being repaired with epoxy. The epoxy makes the cracks visible and shows how badly cracked the walls were. Indian Hills Medical Center.

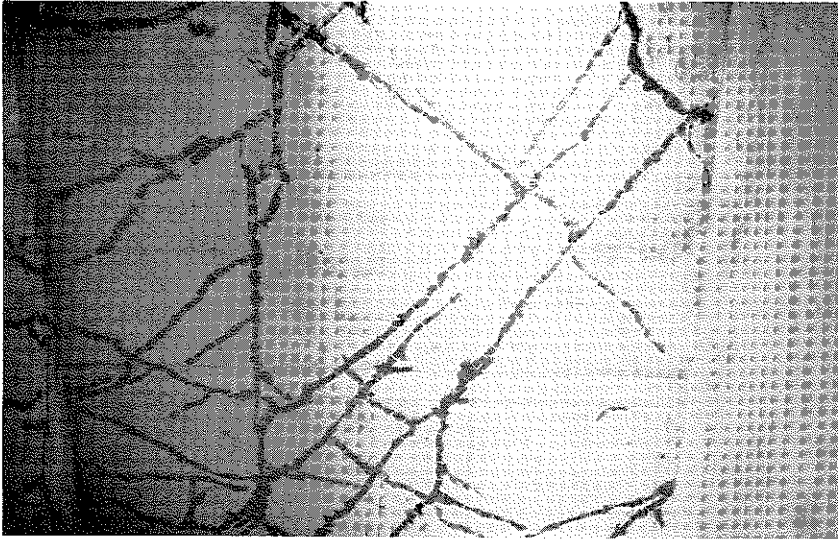
Figure 3.86 Interior view of shear wall with cracks made visible by the epoxy. Indian Hills Medical Center.
