ENGINEERING FEATURES
OF THE
SAN FERNANDO EARTHQUAKE OF FEBRUARY 9, 1971

Paul C. Jennings, Editor

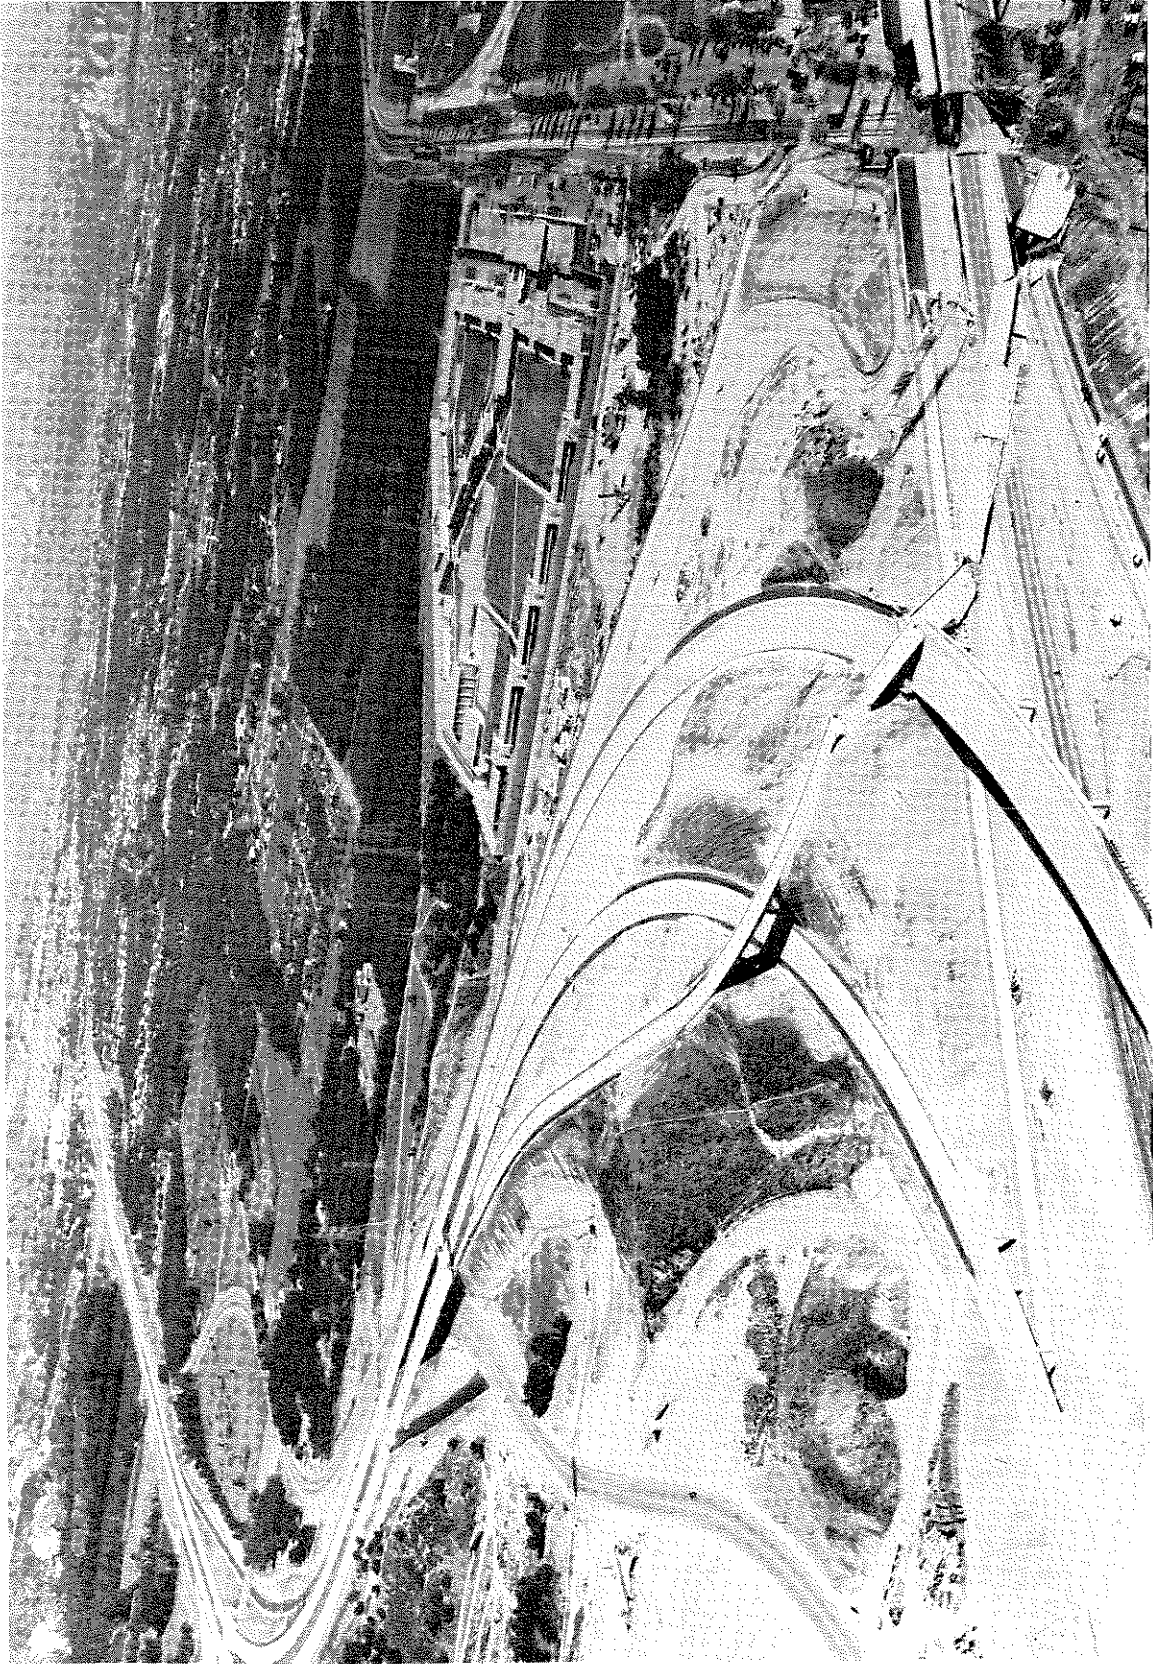
Figure 3. 88 View looking east over the San Fernando Juvenile Facility and the Golden State-Foothill freeway interchange. Olive View Hospital is in the left background.

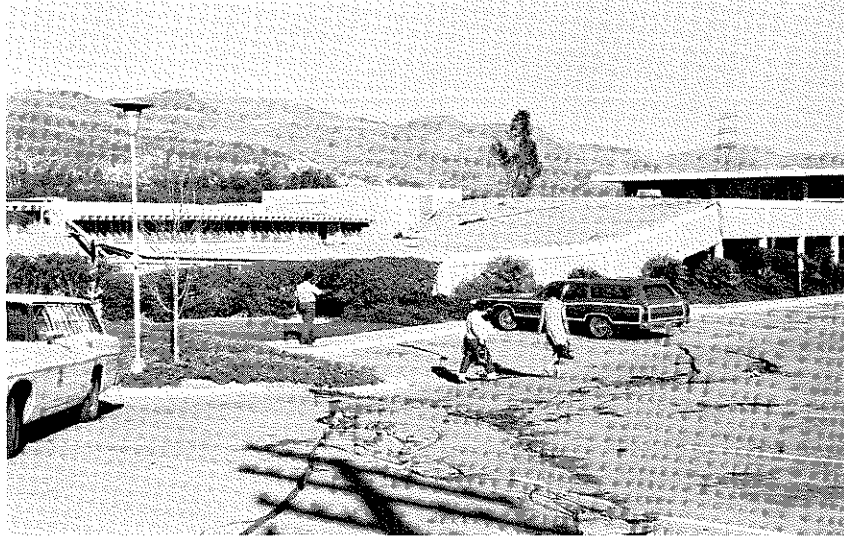
Figure 3.90 View of cracking and change in elevation of asphalt parking area; collapsed wing of concrete frame Administration Building in the background. San Fernando Juvenile Facility.

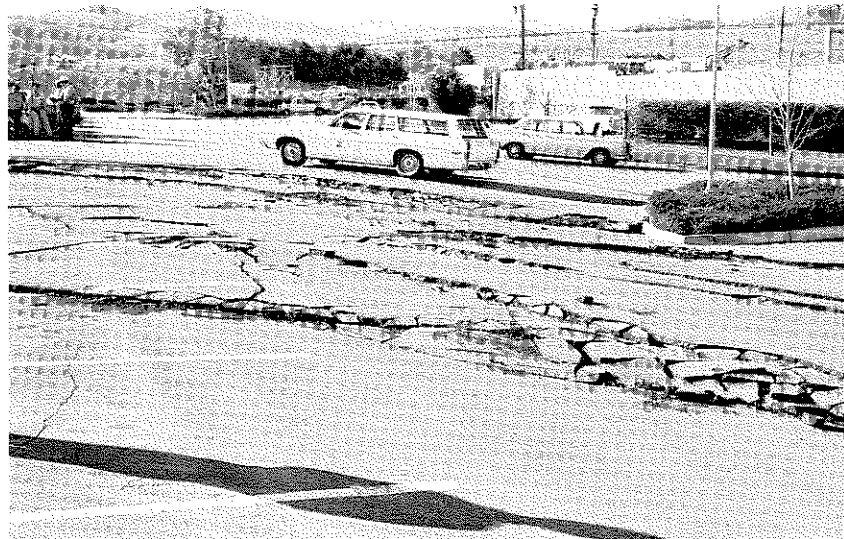
Figure 3.91 Evidences of ground movement in central parking area of the San Fernando Juvenile Facility.

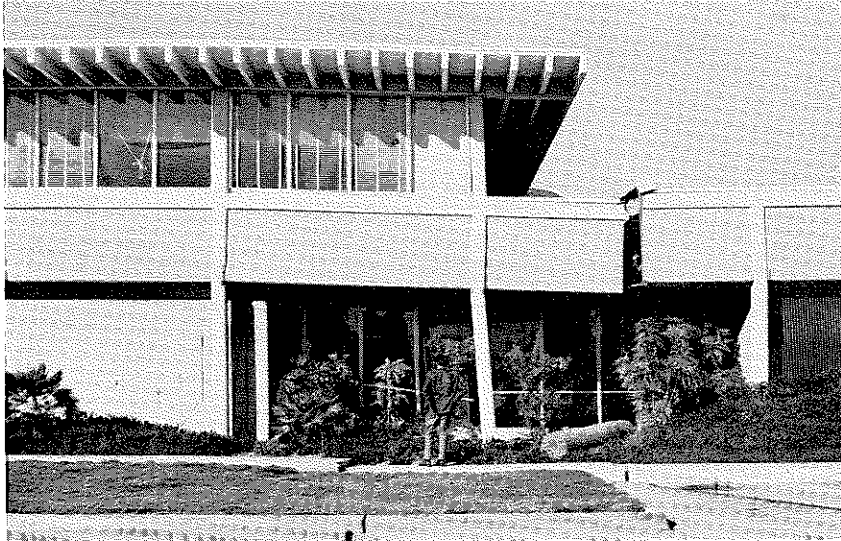
Figure 3.92 View showing ground displacements, reinforced concrete column failure, and opening of separation joint. San Fernando Juvenile Facility.

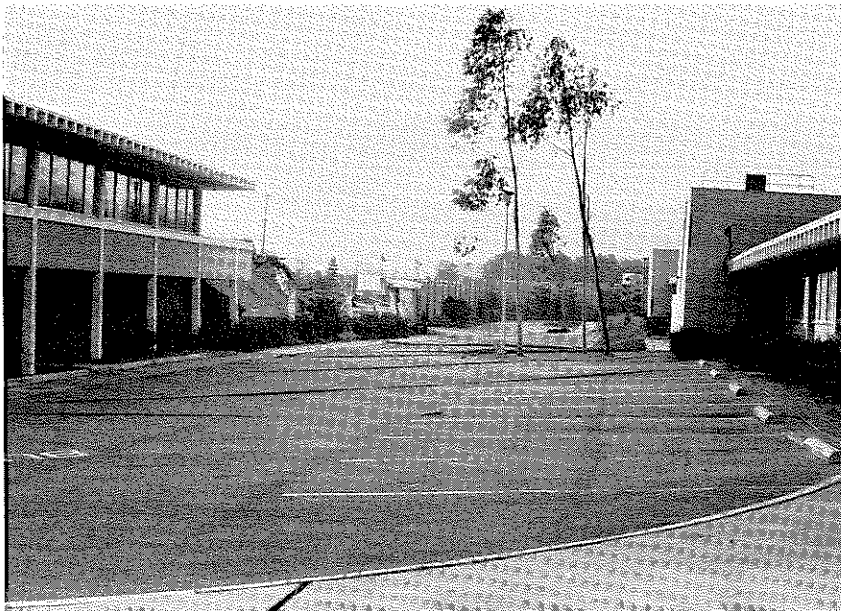
Figure 3.93 Interior courtyard looking west past collapsed wing of main building. Numerous cracks are visible in the asphalt parking area. San Fernando Juvenile Facility.

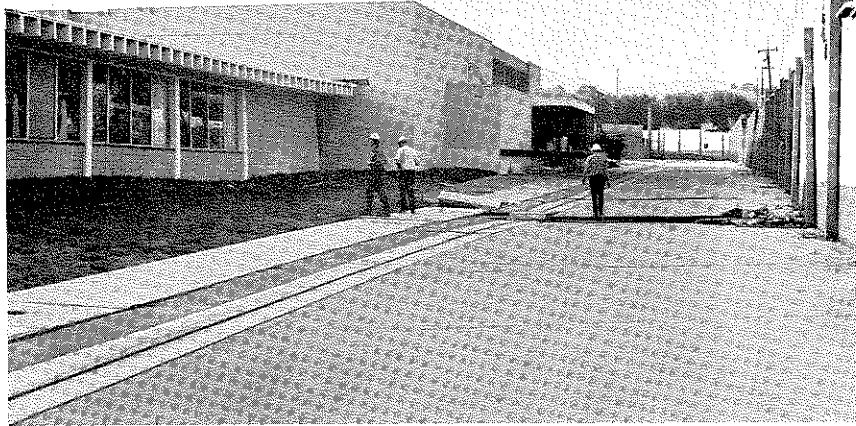
Figure 3.94 Ground displacement and structural damage near northern boundary of San Fernando Juvenile Facility.

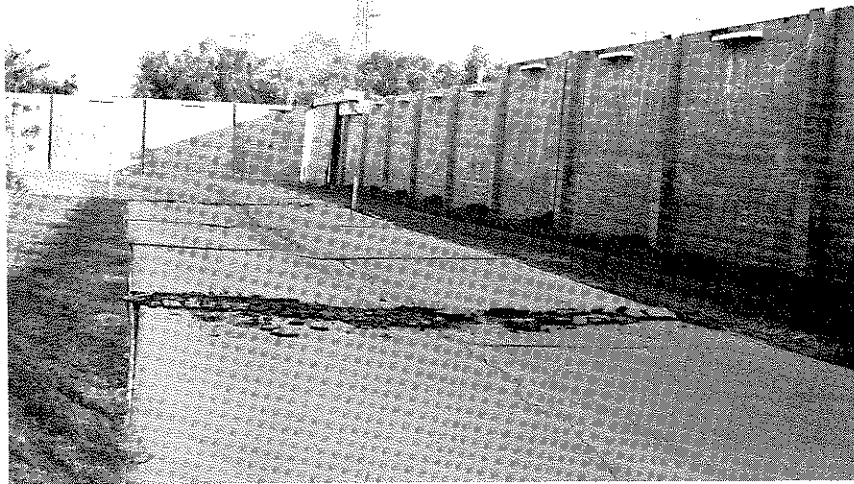
Figure 3.95 Ground displacement near northeast corner of San Fernando Juvenile Facility. The walls are concrete block construction.

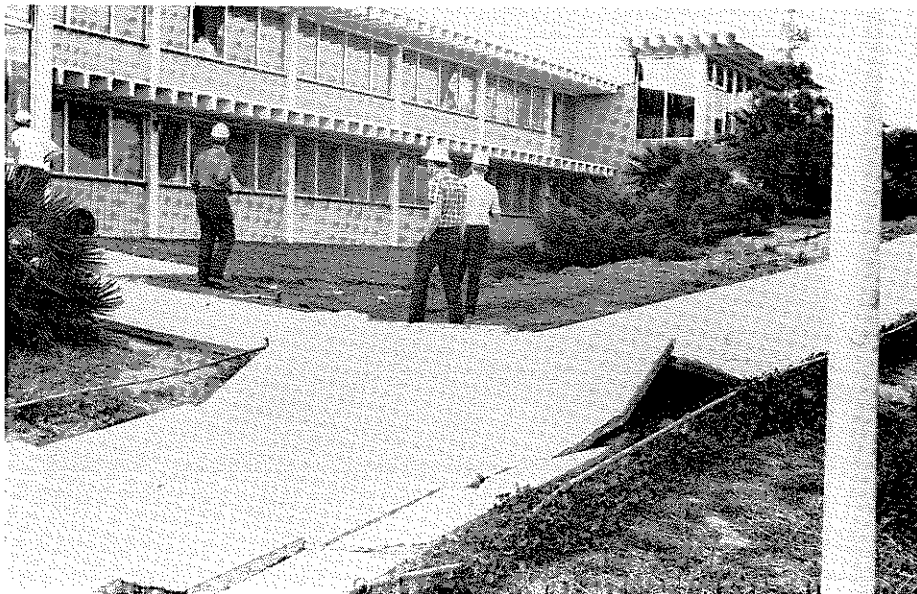
Figure 3. 97 Buckled sidewalk at San Fernando Juvenile Facility.

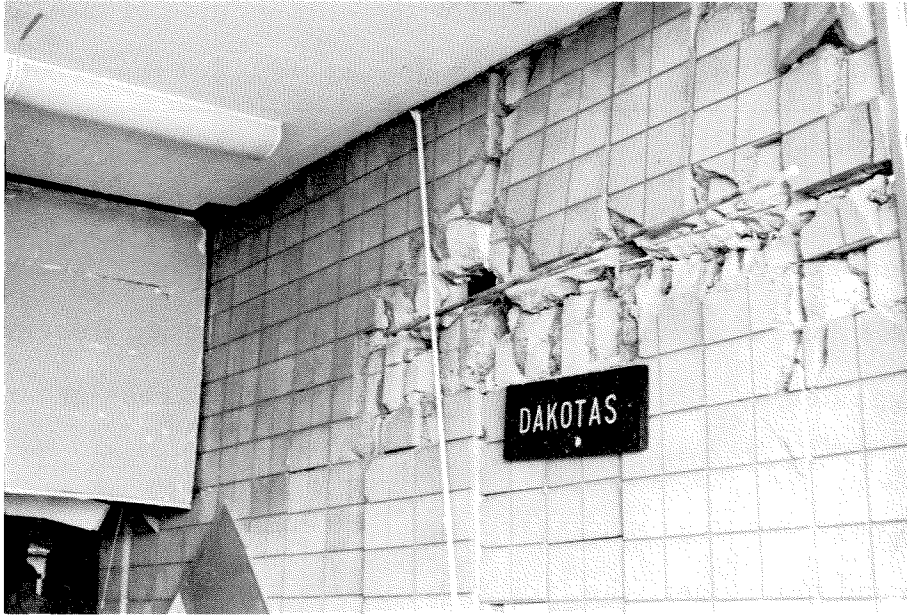
Figure 3.98 Damage to reinforced concrete block wall at the San Fernando Juvenile Facility. See also Figure 3.99.

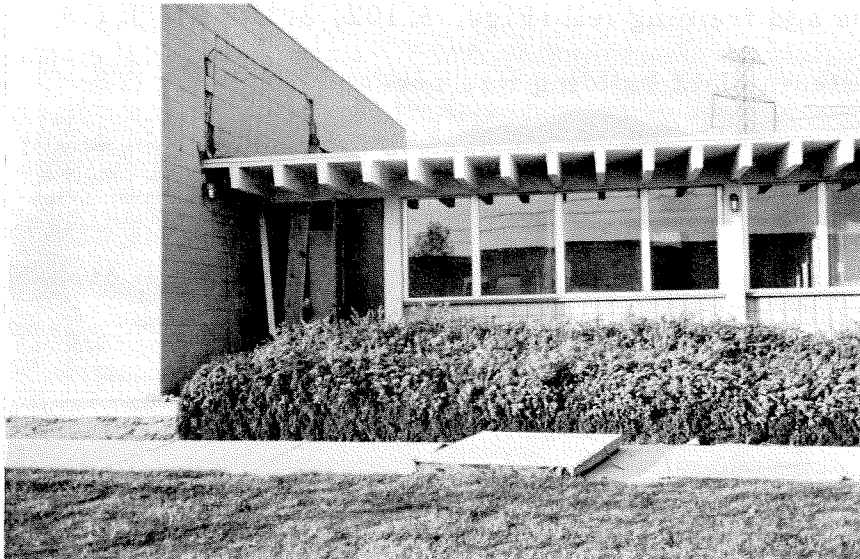
Figure 3.99 Damage to concrete block wall caused by pounding of adjacent roof. San Fernando Juvenile Facility.

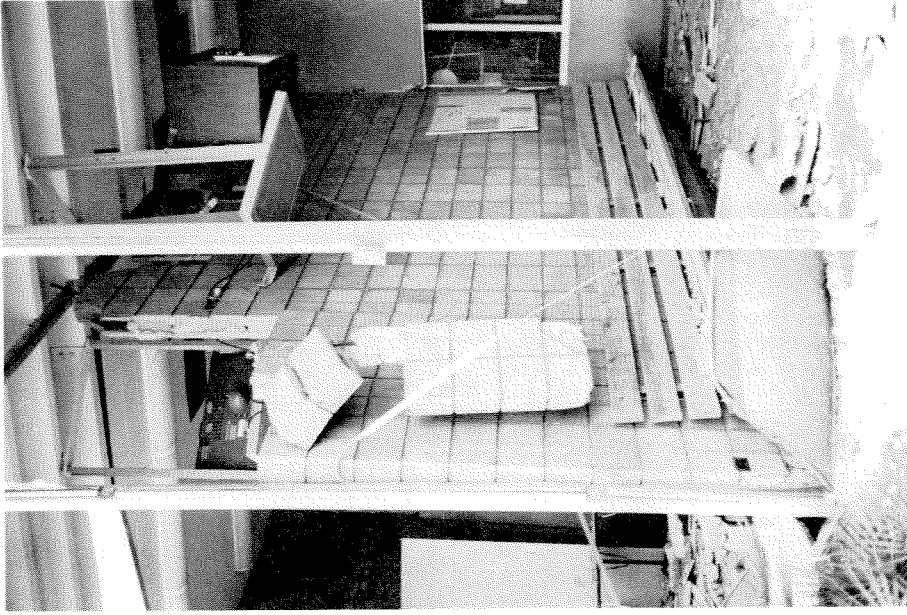
Figure 3.101 Damage to concrete-block wall. San Fernando Juvenile Facility.

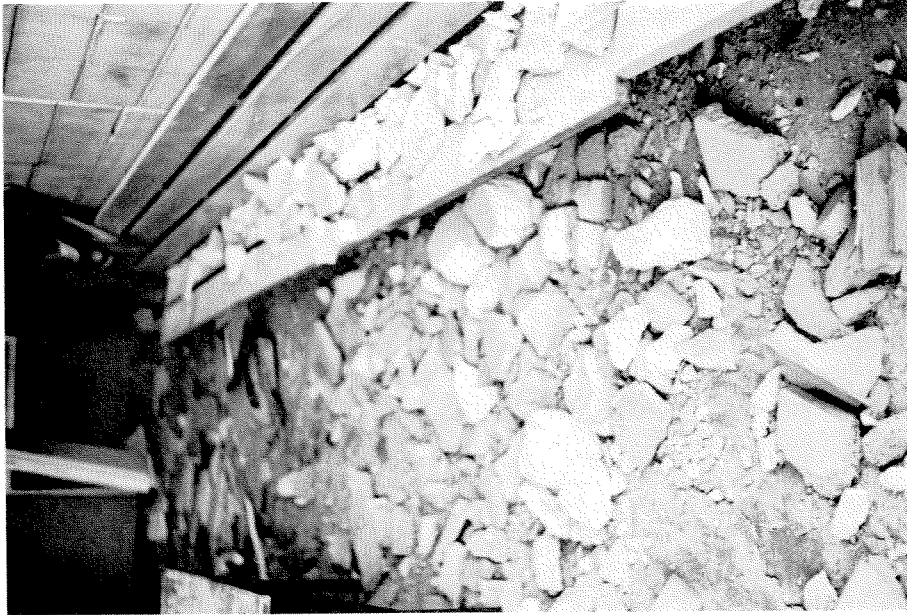
Figure 3.100 Fallen debris from concrete-block wall. San Fernando Juvenile Facility.

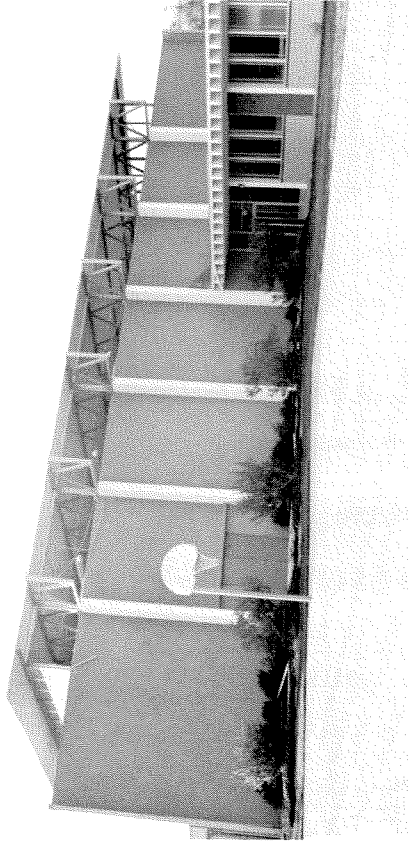
Figure 3.103 Gymnasium building. Cross-bracing rods between trusses were broken and safety glass window panes were shattered. (See preceding photo). San Fernando Juvenile Facility.

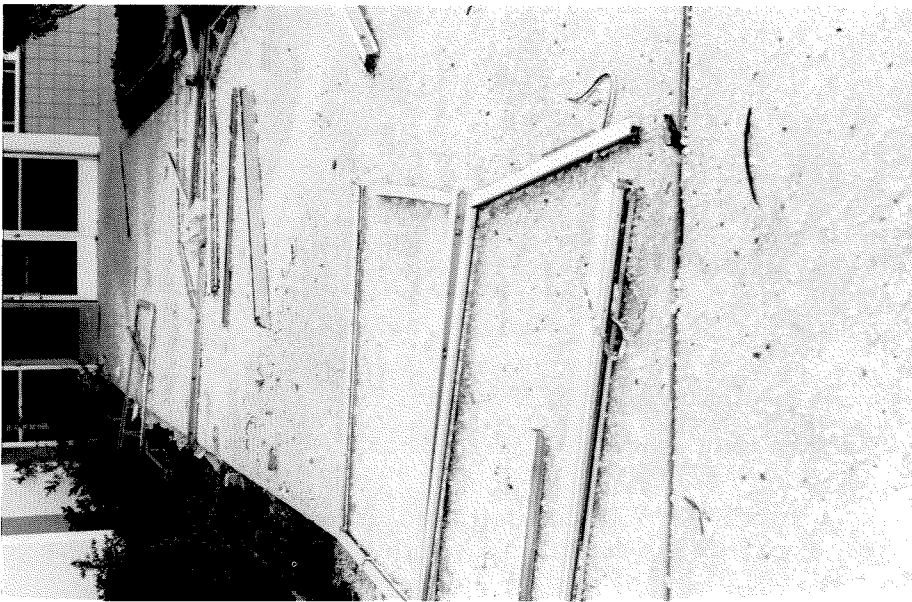
Figure 3.102 Window frames and shattered safety glass from gymnasium skylight (see following photograph). San Fernando Juvenile Facility.

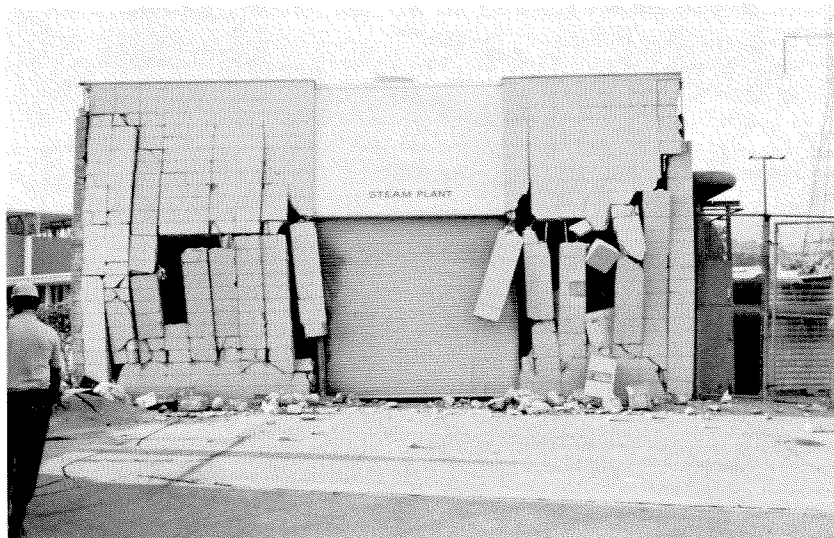
Figure 3.105 Walls of steam plant building at San Fernando Juvenile Facility were shattered.

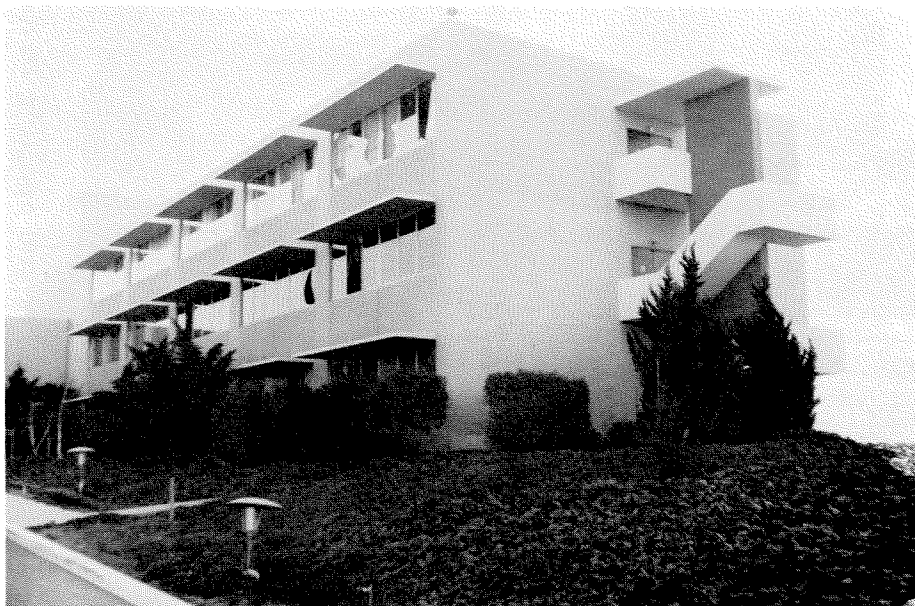
Figure 3.106 Three-story wing. Pacoima Lutheran Hospital, looking east.

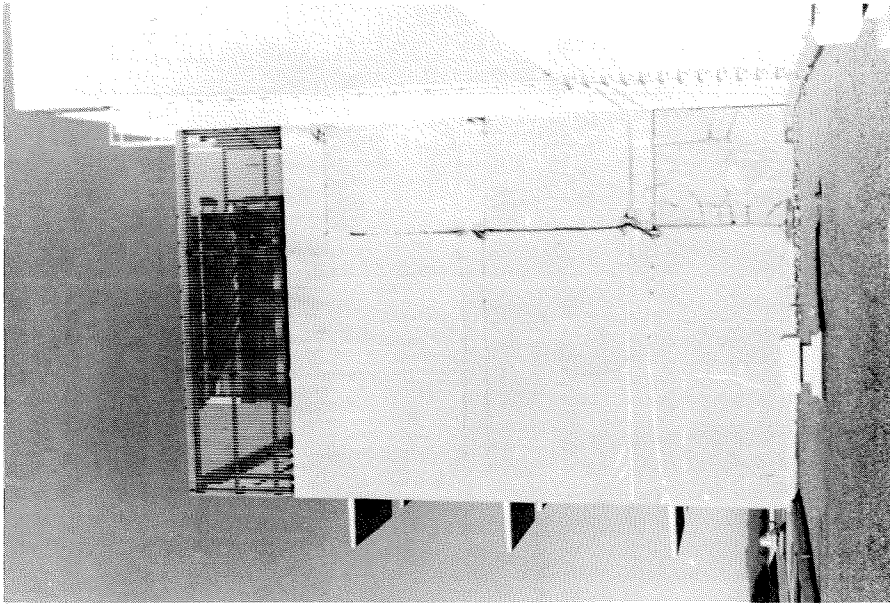
Figure 3.109 Cracking and spalling in the east shear wall of the three-story wing, Pacoima Lutheran Hospital.

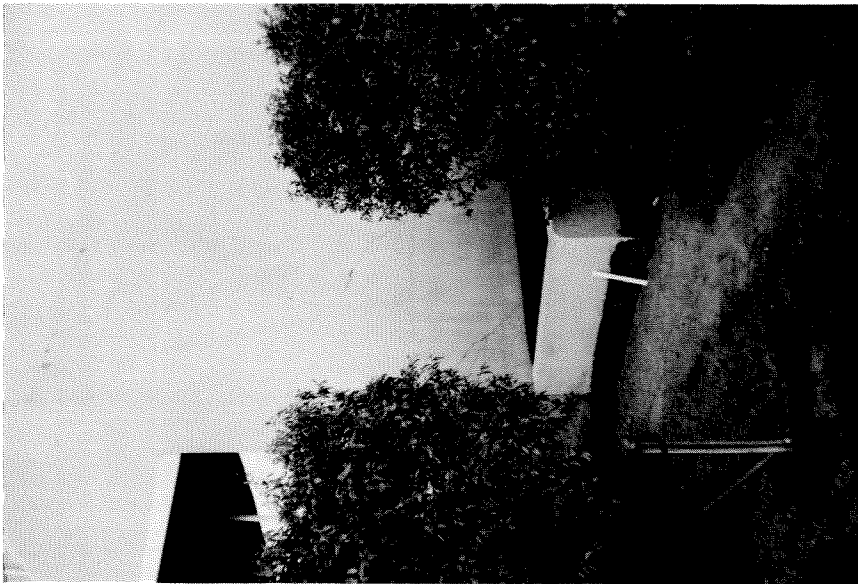
Figure 3.108 Cracking in west shear wall and settlement of backfill. Three-story wing of the Pacoima Lutheran Hospital.

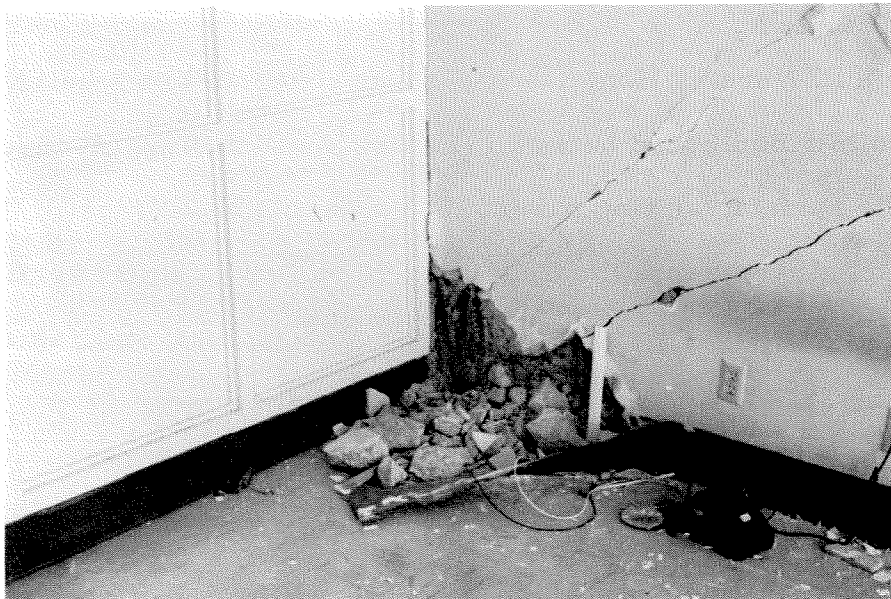
Figure 3.110 Interior view of the eastern shear wall of the three-story wing, Pacoima Lutheran Hospital.

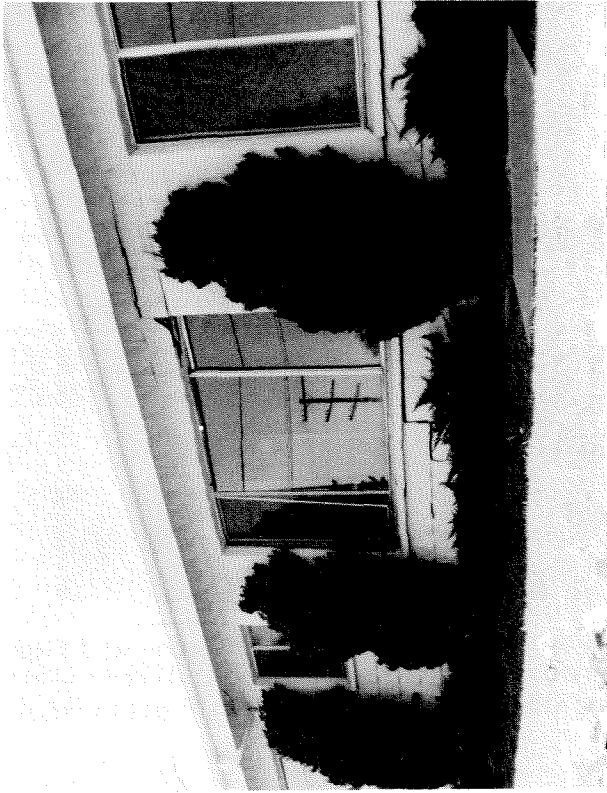
Figure 3.113 Structural damage to block walls, Foothill Nursing Home.

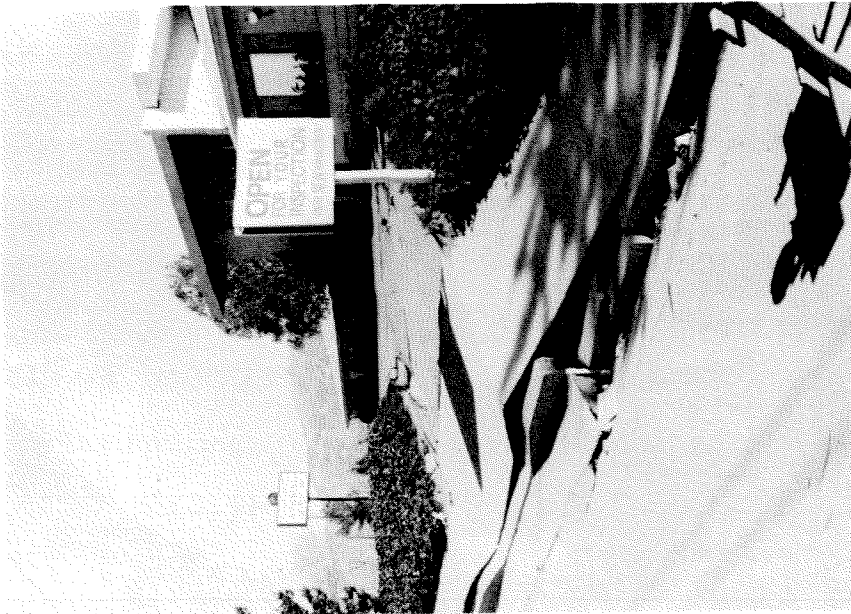
Figure 3.112 Ground displacements caused by faulting, Foothill Nursing Home.

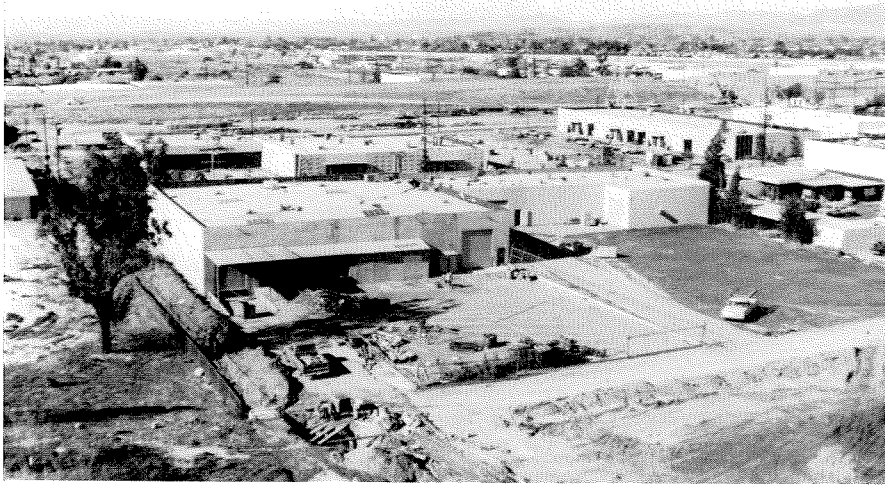
Figure 3.114 San Fernando Industrial Park. Omneco and Cosmic Plastic Buildings in the foreground. Permanent ground displacements have forced these buildings together causing serious structural damage.

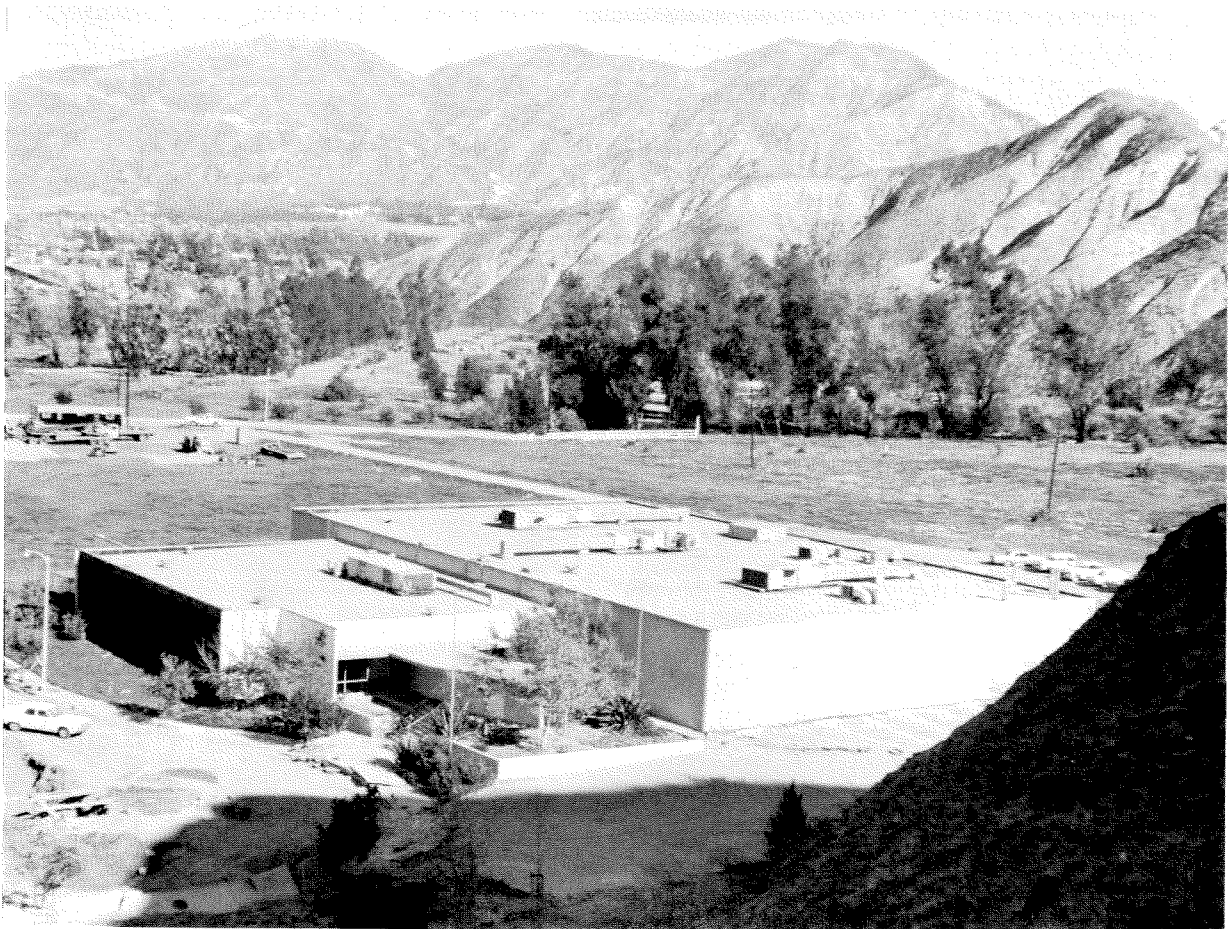
Figure 3.115 Permanent ground displacements show in the sidewalk and parking lot. Donaldson Building.

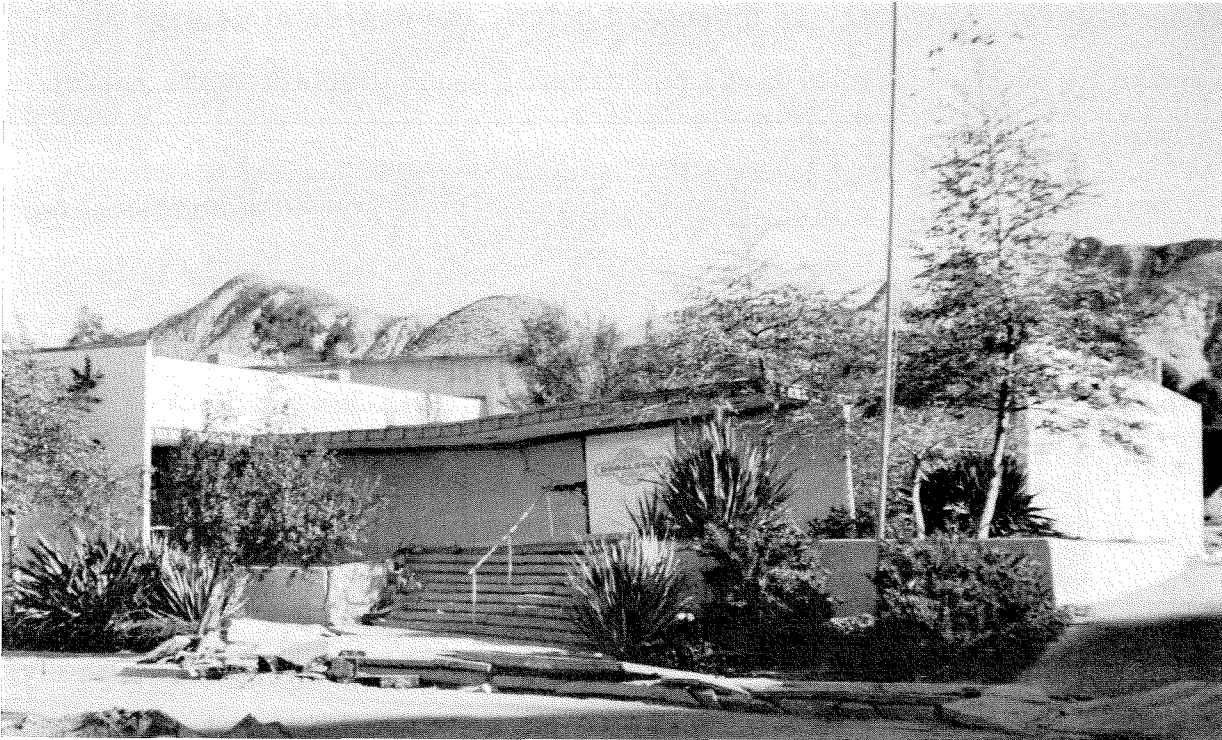
Figure 3.116 Structural damage resulting from permanent ground displacements. Donaldson Building.

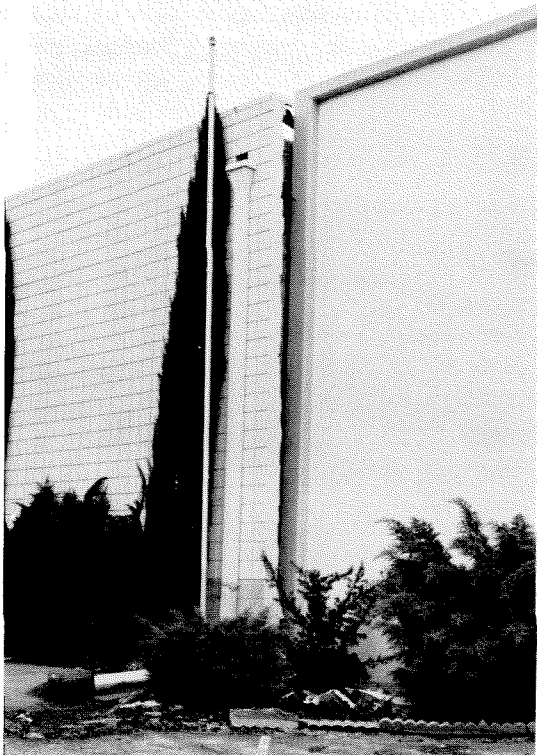
Figure 3.117 Permanent ground displacements caused a collision between the Omneco and Cosmic Plastics buildings.

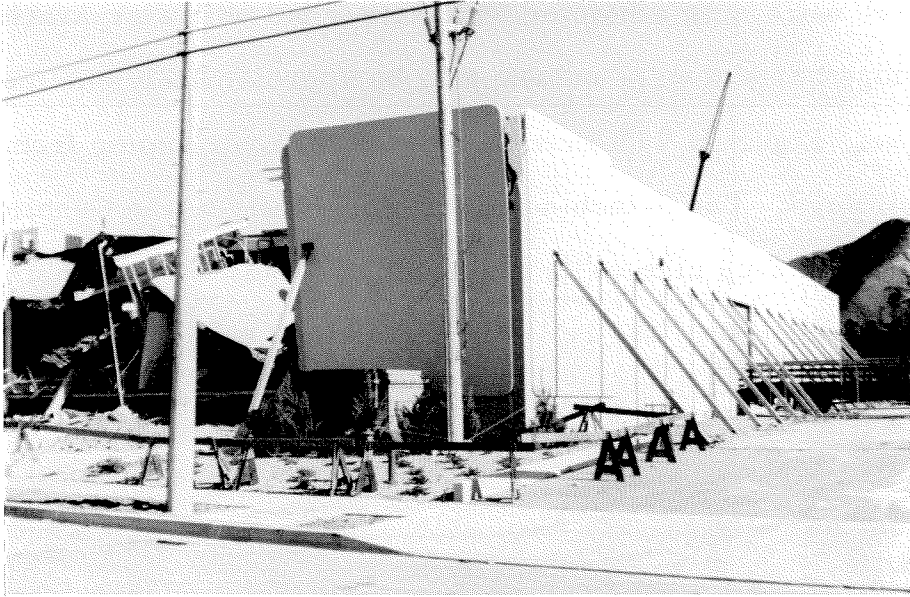
Figure 3.118 Collapsed section of tilt-up wall. Vector Electronics Building.

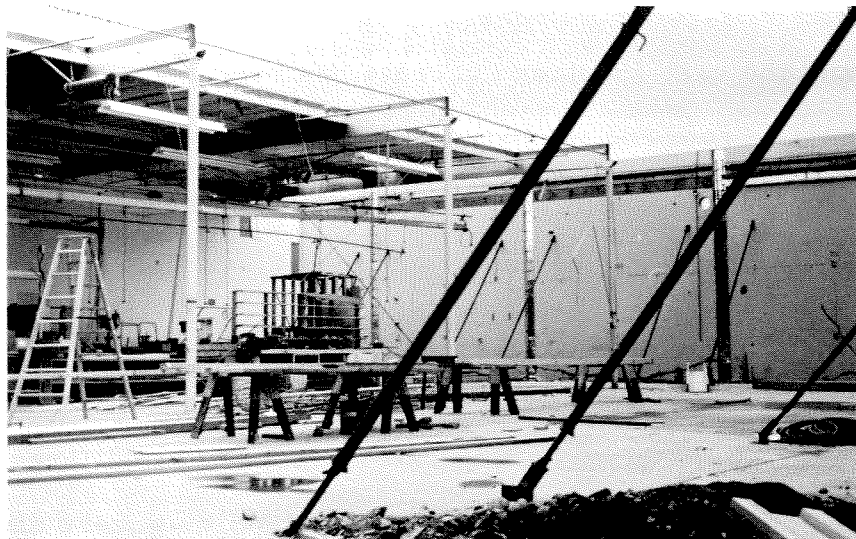
Figure 3.122 An interior view of the Vector Electronics Building. Part of the roof has been removed to carry out repairs.

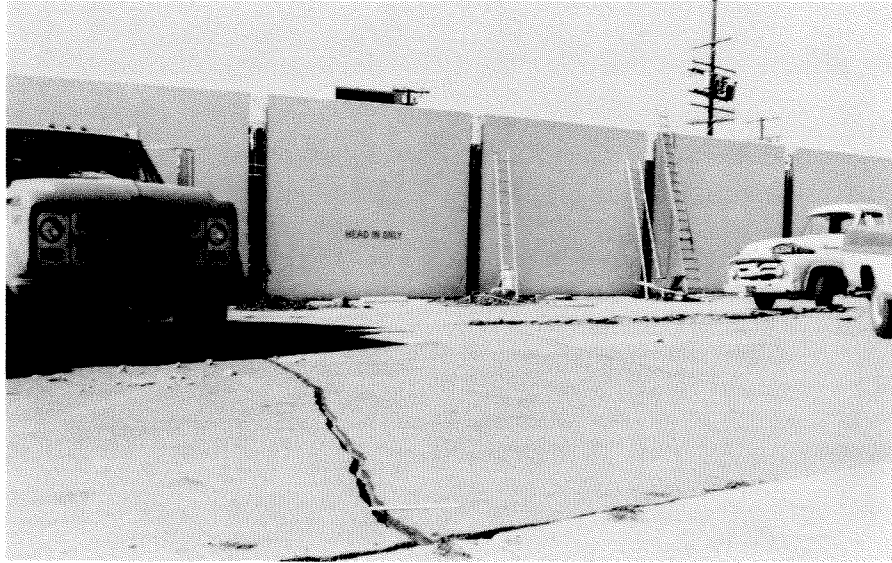
Figure 3.123 Repair work on tilt-up slab wall, two weeks after the earthquake. Adrian's Building.

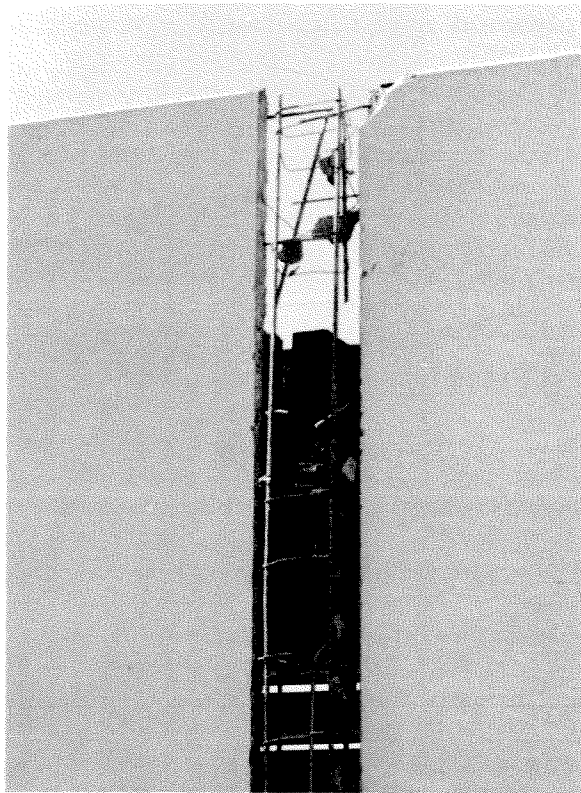
Figure 3.124 Wall and beam connection details. Adrian's Building.

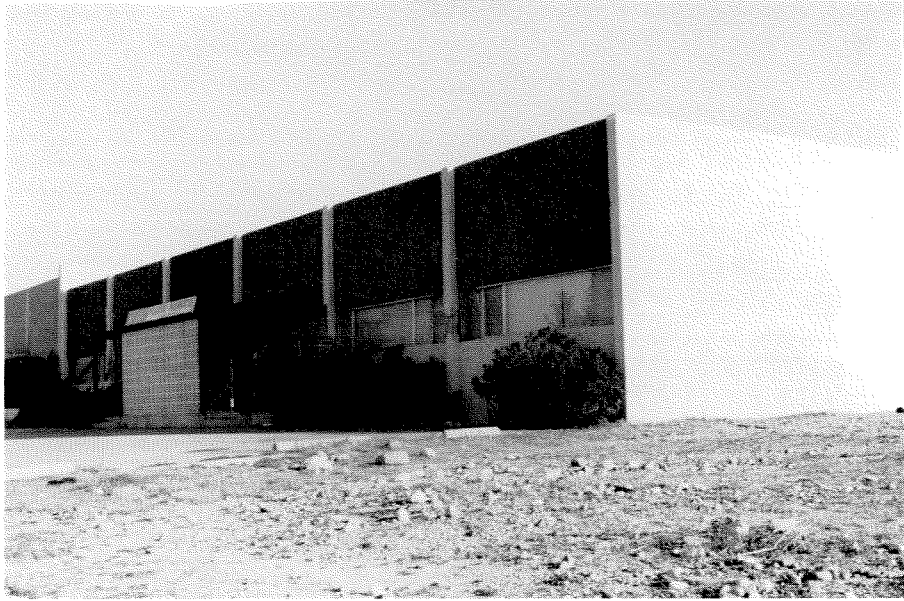
Figure 3.125 Front elevation (southwest wall) of the Gibraltar Building.

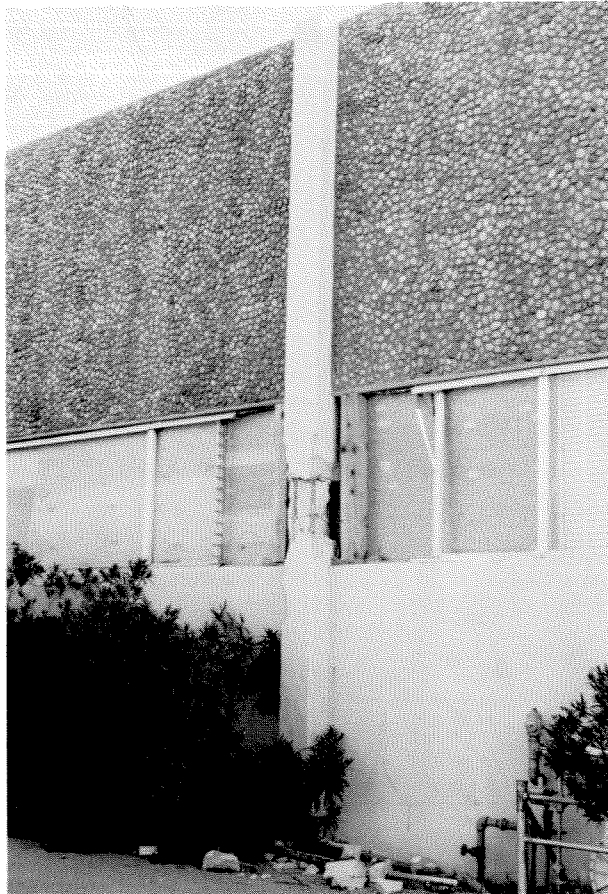
Figure 3.126
Failure of 12-in
x 12 in column,
Gibraltar Plastic
Products Building.

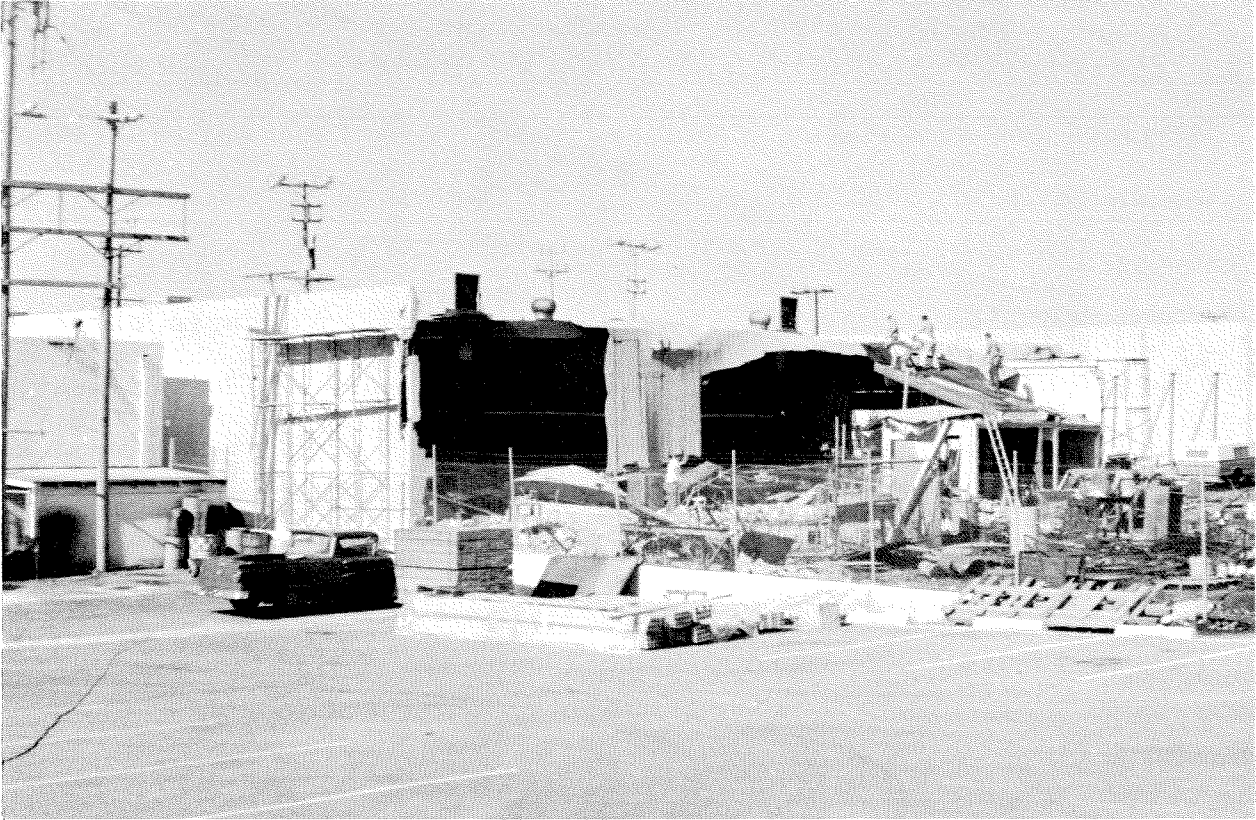
Figure 3.127 Collapse of concrete block wall (northeast wall).
M & L Machine and Stamping Company Building.

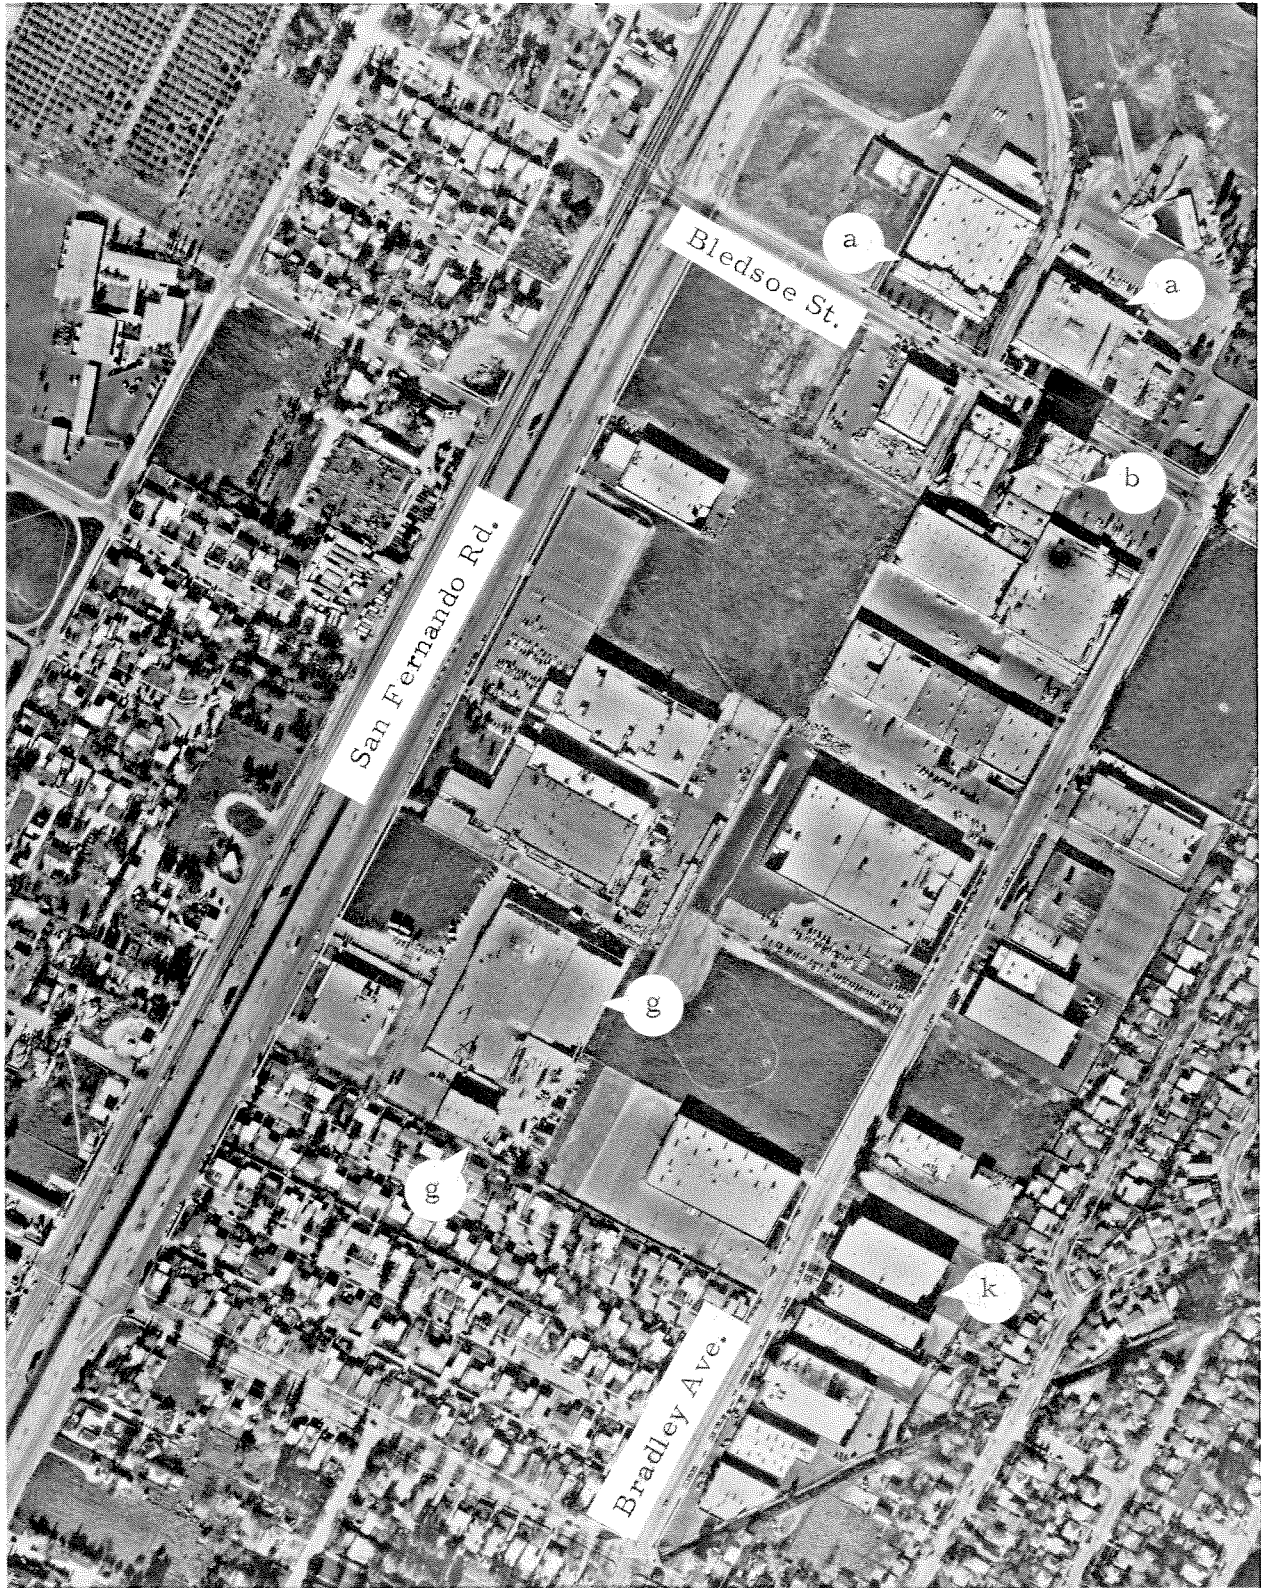
Figure 3.129 Roof collapses on tilt-up factory buildings. The identification letters refer to the list of buildings given in the text.

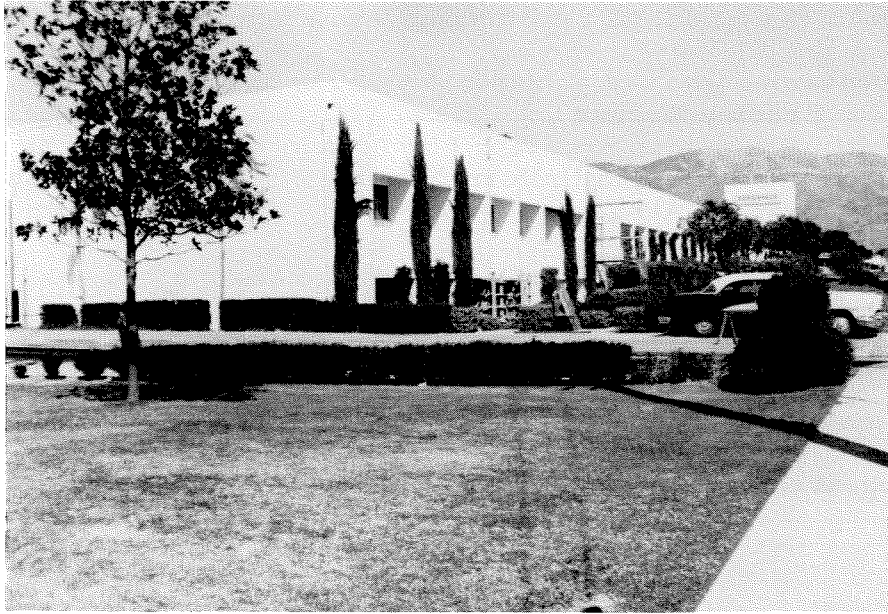
Figure 3.130 International Telephone and Telegraph eastern building, Aerospace Division, Bledsoe Street.

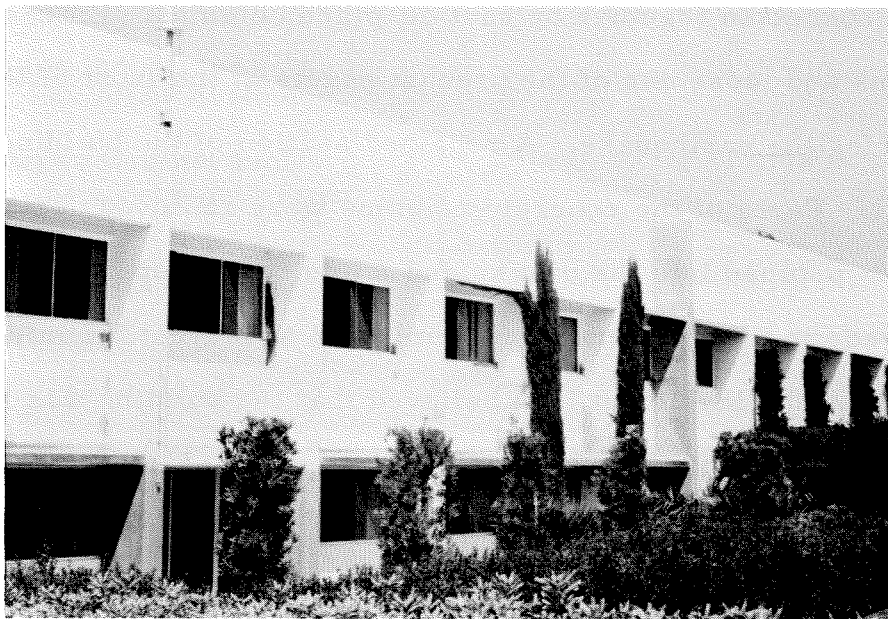
Figure 3.131 Repaired section of building shown in Figure 3.130. Sections of the columns have been recast and cracks filled with epoxy.
