ENGINEERING FEATURES
OF THE
SAN FERNANDO EARTHQUAKE OF FEBRUARY 9, 1971

Paul C. Jennings, Editor

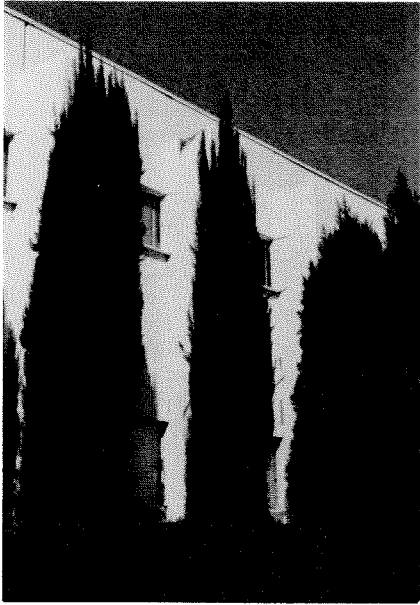
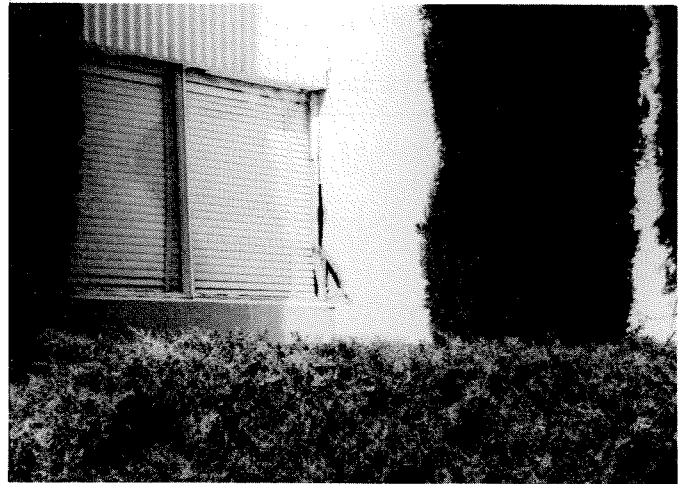
Nethercutt Museum: The Nethercutt 4-story building is located alongside a group of single-story tilt-up buildings owned by the same firm on Bledsoe Street. The tilt-up walls in one of the single-story buildings adjoining the 4-story structure received damage which probably resulted from pounding between the two structures. The other single-story buildings appeared undamaged but the 4-story structure, which was under construction at the time of the earthquake, received a moderate amount of structural damage. A view of the structure, which is to be used as a private antique car museum, is shown in Fig. 3.134. The exterior structure consists of 8-in thick normal

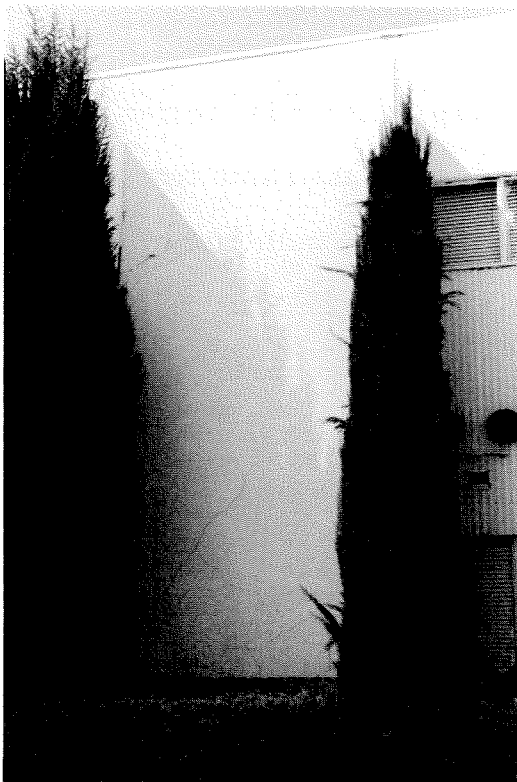
Figure 3.133 Cracked wall, front face of International Telephone and Telegraph western building, Bledsoe Street.

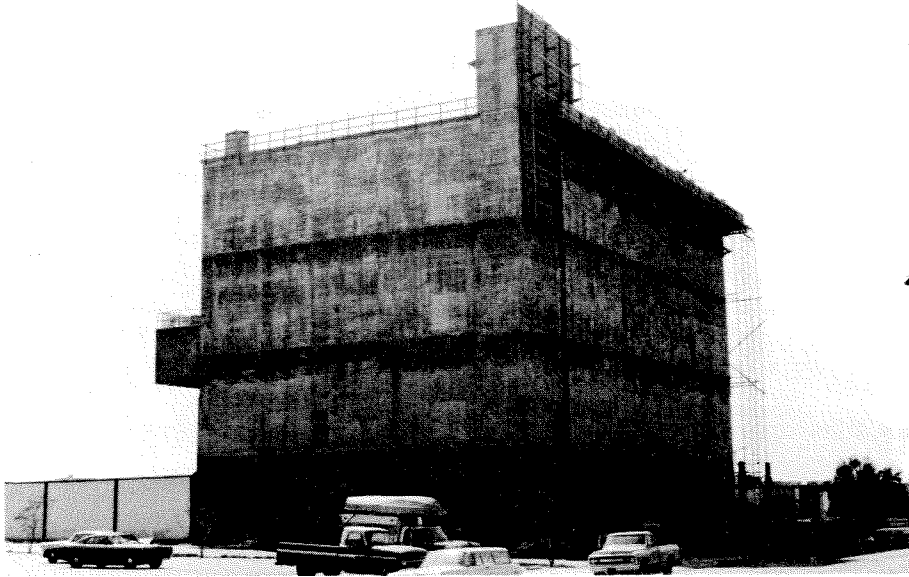
Figure 3.134 Nethercutt Museum, Bledsoe Street.

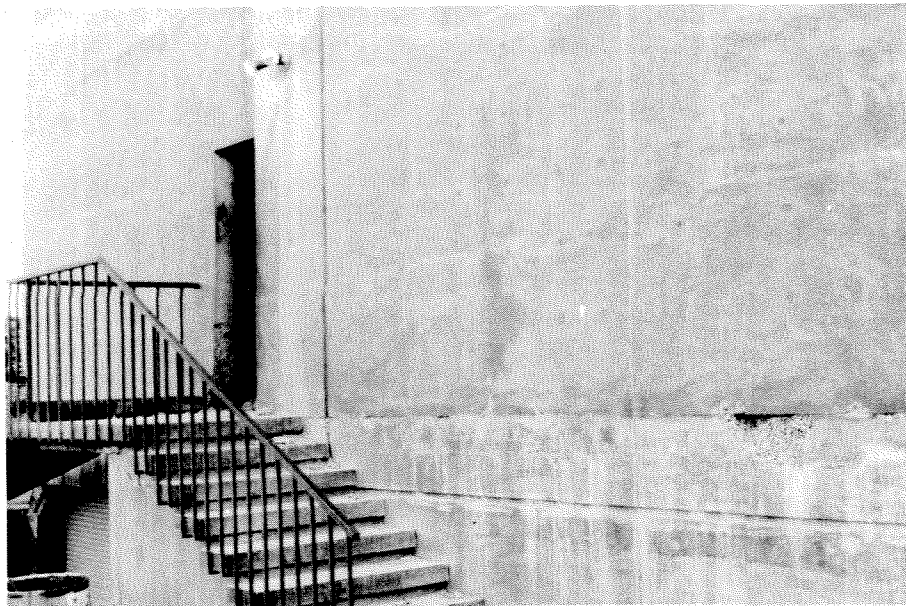
Figure 3.135 Cracking and spalling on the construction joint above the first floor slab. Lightweight concrete was used for the slab and beam construction. Nethercutt Museum.

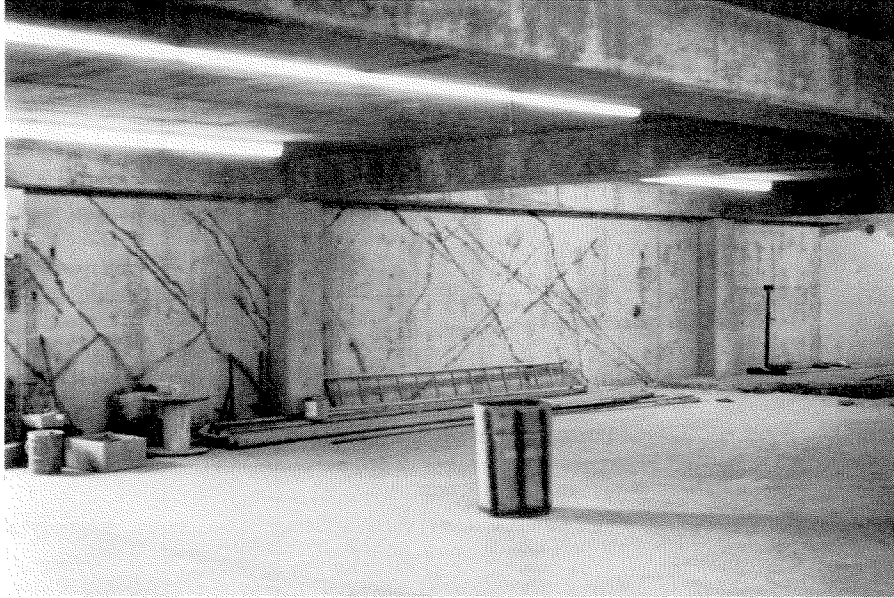
Figure 3.136 Repaired crack in a basement wall.
Nethercutt Museum.

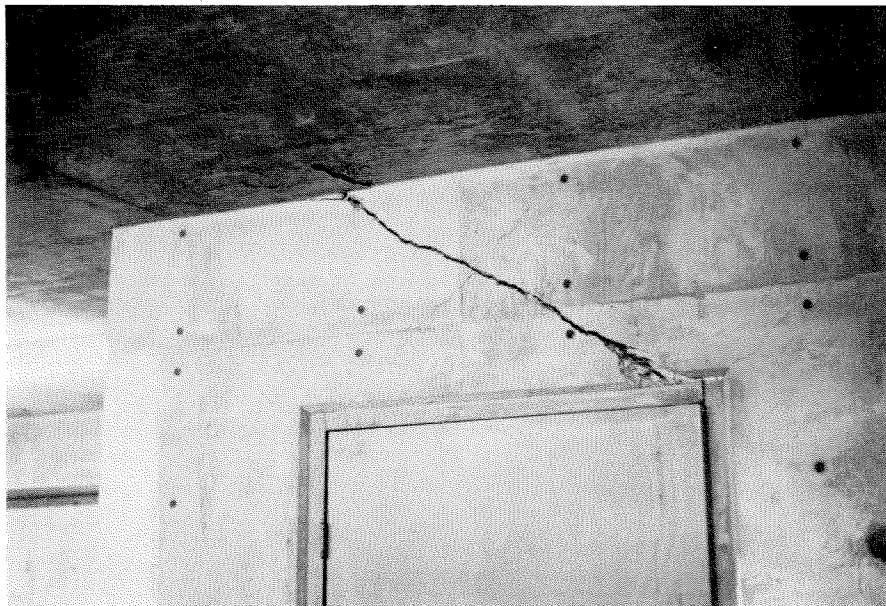
Figure 3.137 Wide cracks over door in basement.
Nethercutt Museum.

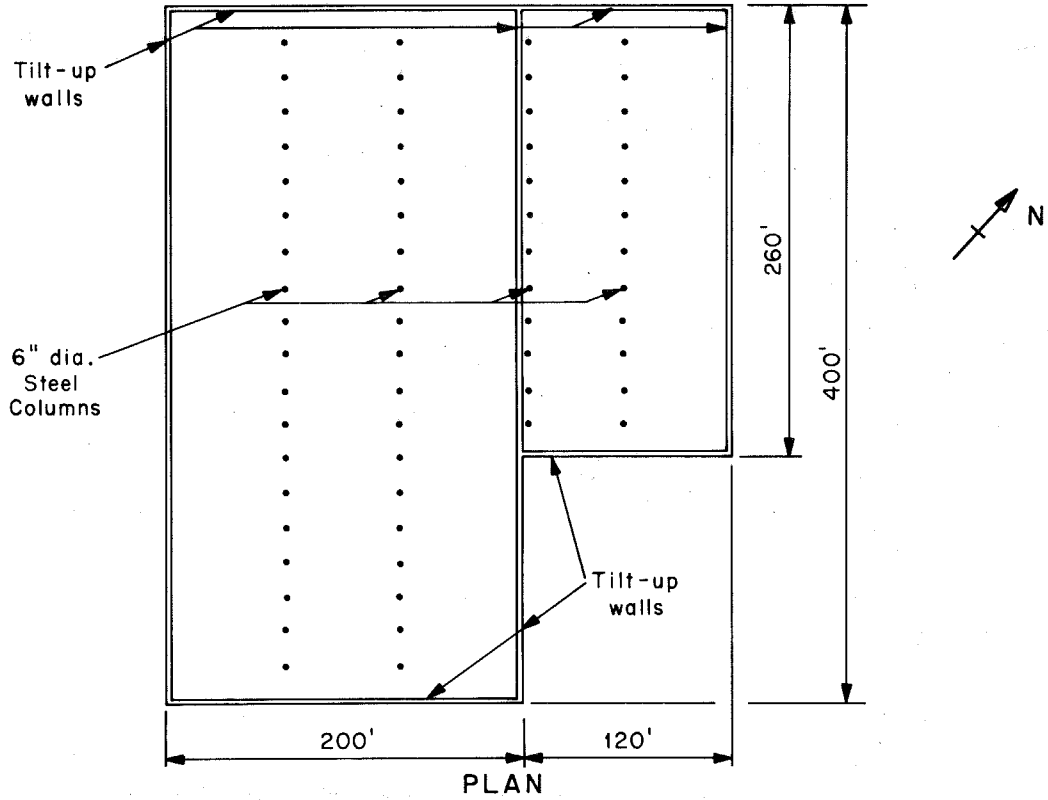
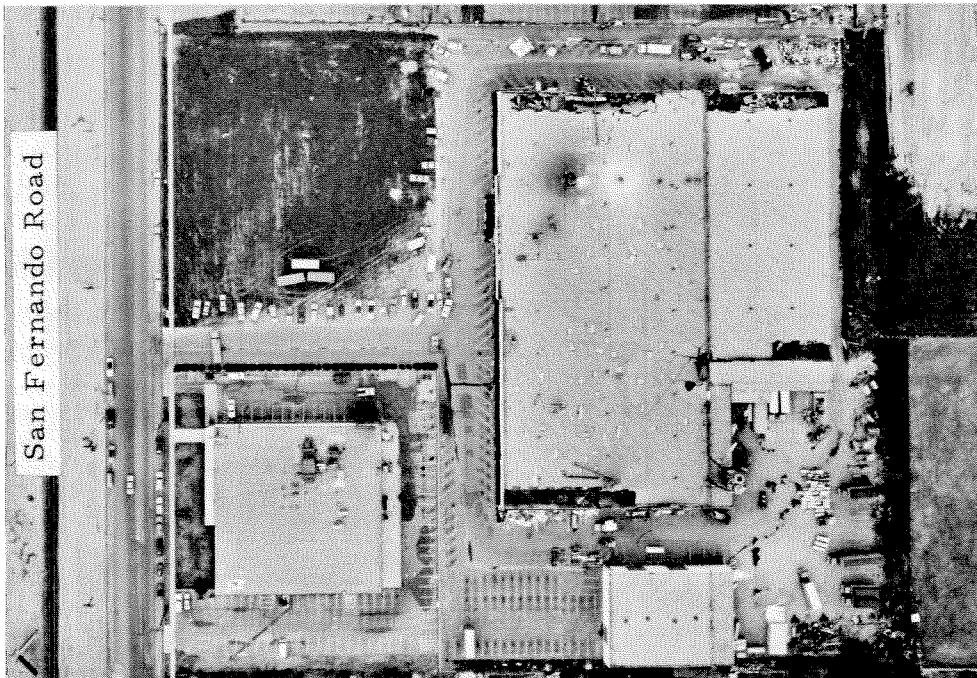
Figure 3.138 Plan dimension and aerial view of roof collapse of Sawyer Cabinet, Inc. Aerial view taken three days after earthquake.

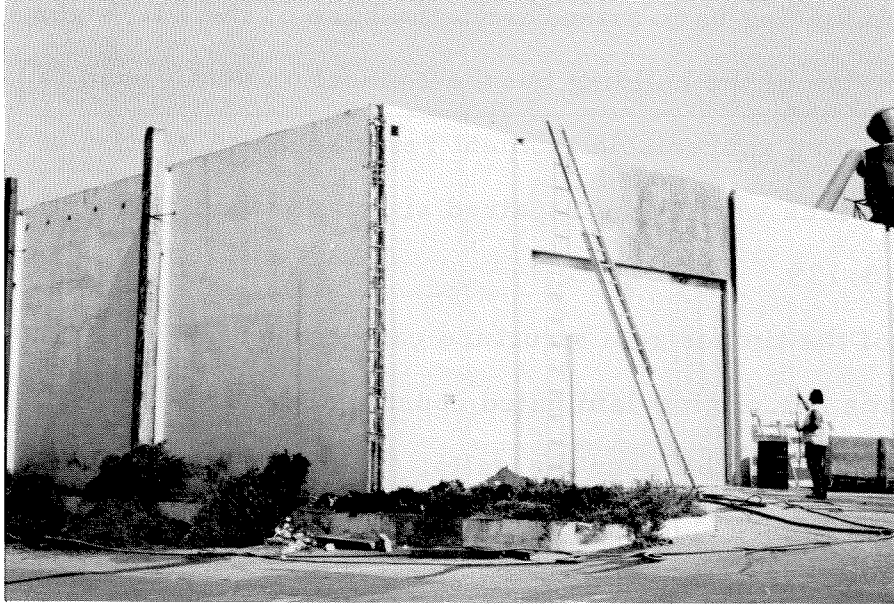
Figure 3.139 Repair of cracked tilt-up walls. A sand-blasting operation prior to application of gunite. Sawyer Cabinet Inc. building.

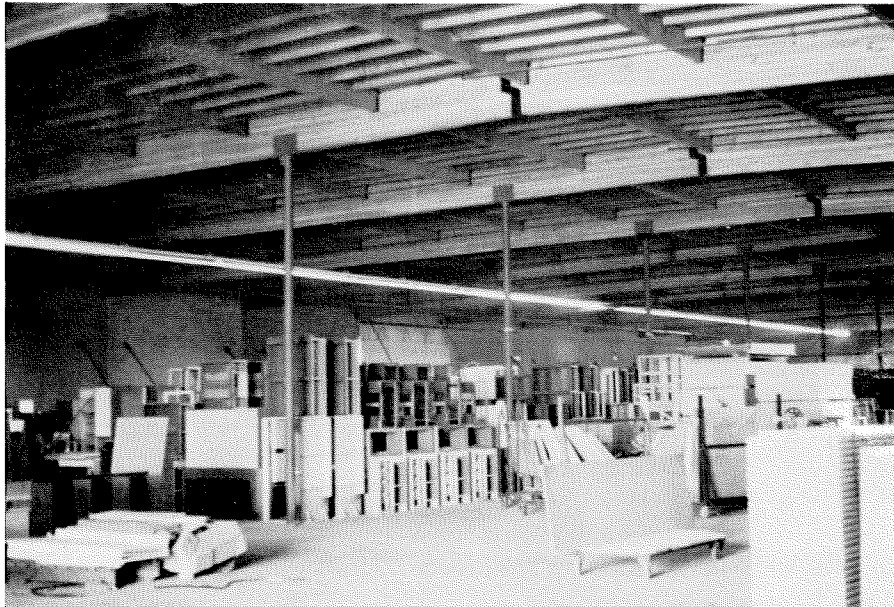
Figure 3.140 Interior view showing the roof structure and 6 in diameter steel supports. Sawyer Cabinet Inc. Building.

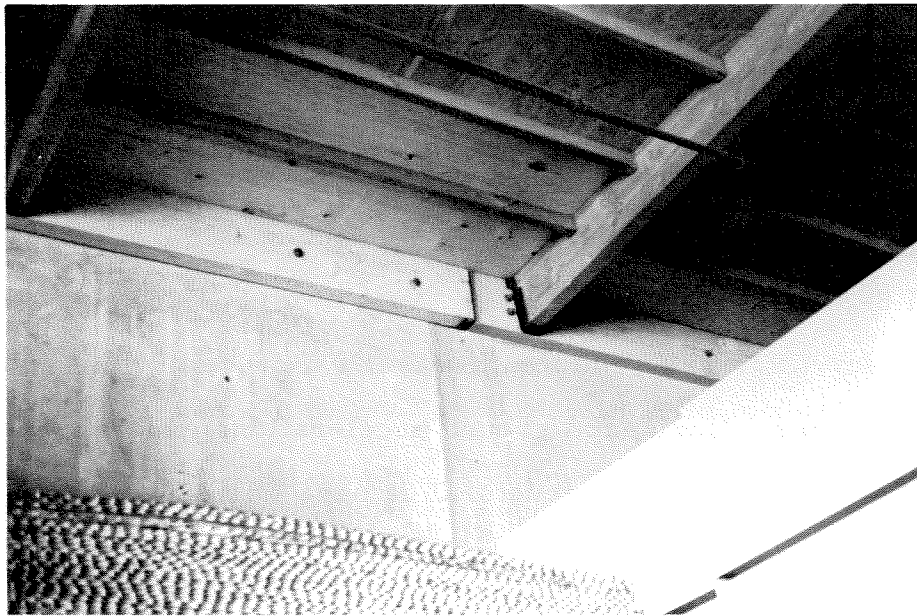
Figure 3.142 Detail of roof purlin connection to tilt-up walls. The steel connector is nailed to the timber ledger and the 11 in x 3-1/2 in purlin. Sawyer Cabinet Inc. building.

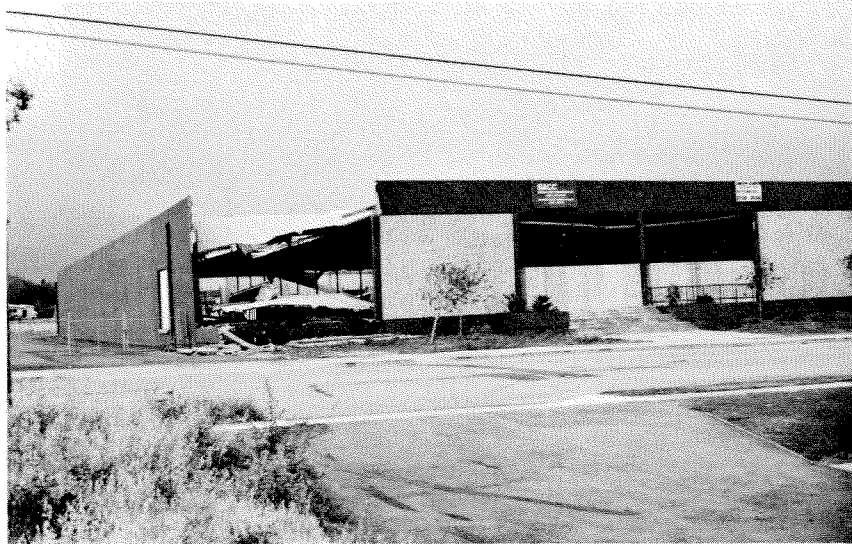
Figure 3.143 Collapse of a corner section in a new building at 12880 Bradley Avenue. The roof-to-wall connections failed at both the front and rear walls.

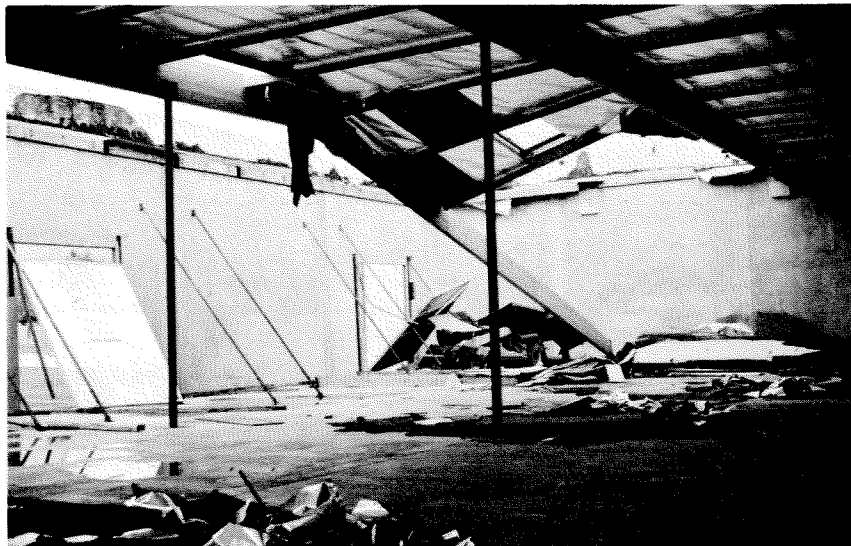
Figure 3.144 Collapse of a section of roof at the rear wall of the building shown in Figure 3.143. Laminated timber roof beams are supported at midspan by 6 in diameter steel columns.

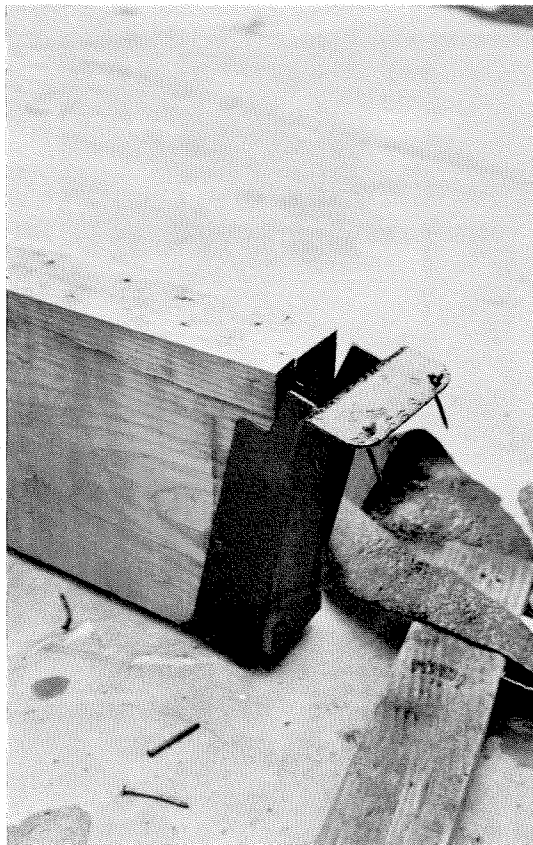
Figure 3.146 Steel connector used to fasten the 11 in x 3-1/2" purlin to the main beams and to the timber ledger on the walls. 12880 Bradley Ave.

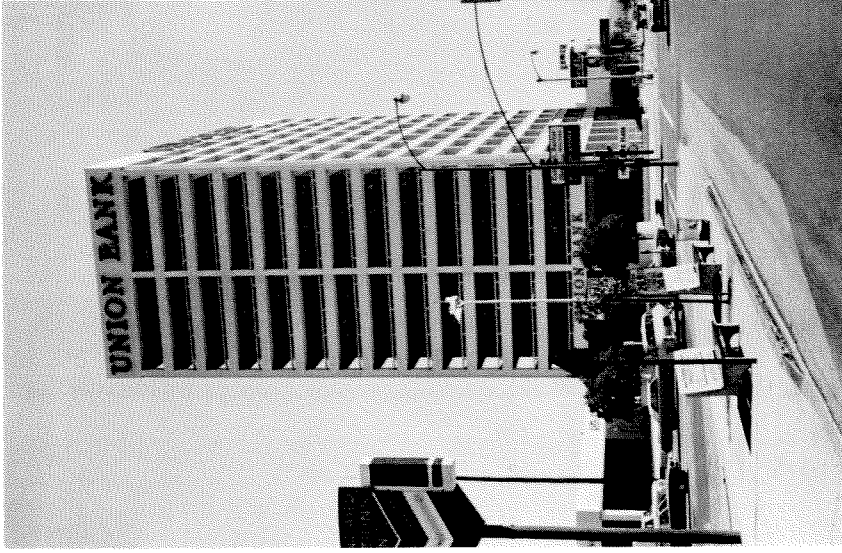
Figure 3.148 Thirteen-story reinforced concrete frame, Union Bank Building, 15233 Ventura Boulevard, Sherman Oaks.

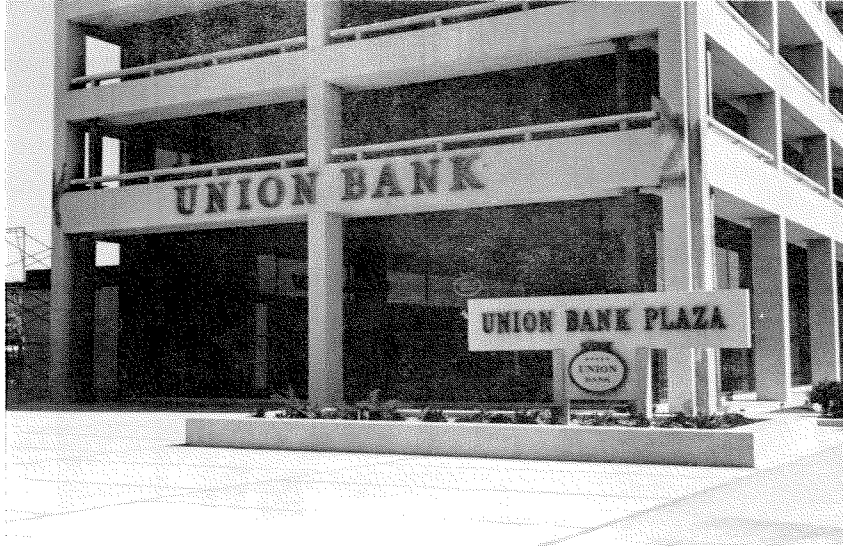
Figure 3.149 The cracks in the reinforced concrete frame were filled with epoxy, Union Bank building, Sherman Oaks.

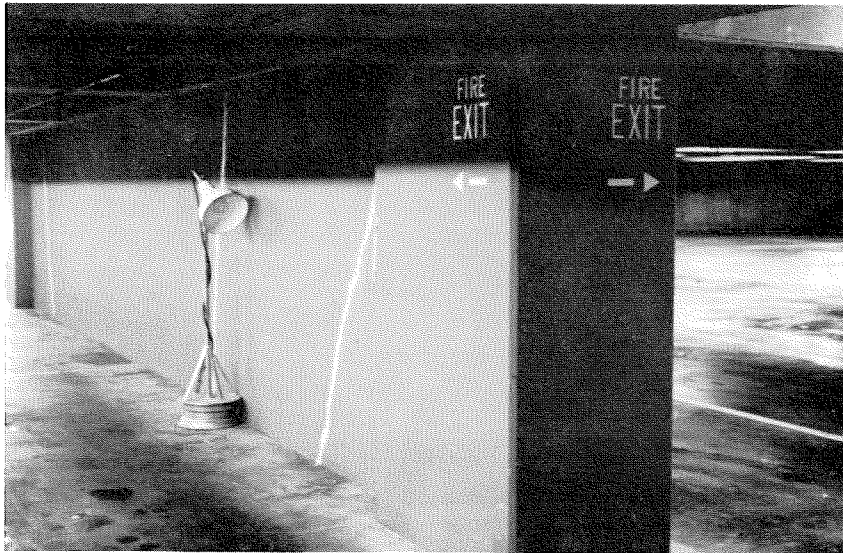
Figure 3.150 A light colored epoxy was used to fill cracks in this sub-basement interior wall aligned with the short dimension of the Union Bank building, Sherman Oaks.

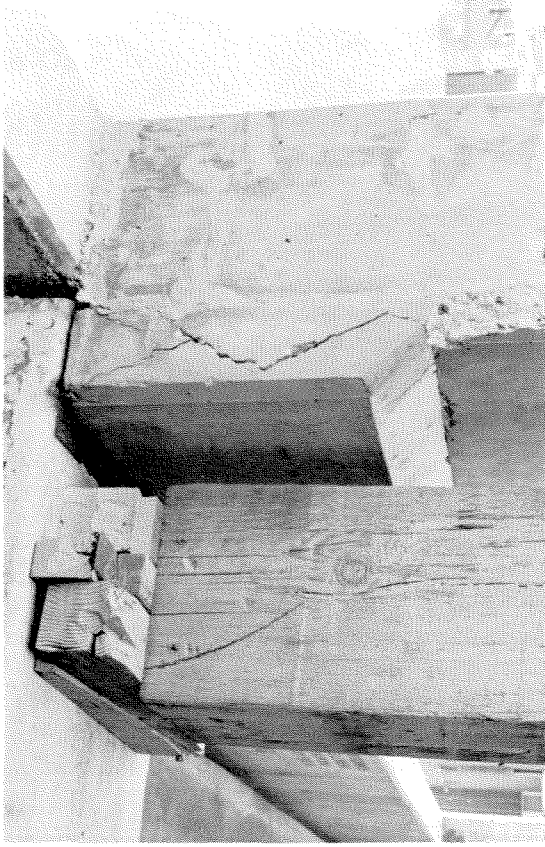
Figure 3. 152 The cracks in the exterior column of the Union Bank parking structure were probably caused by horizontal movements of the overhead beam.

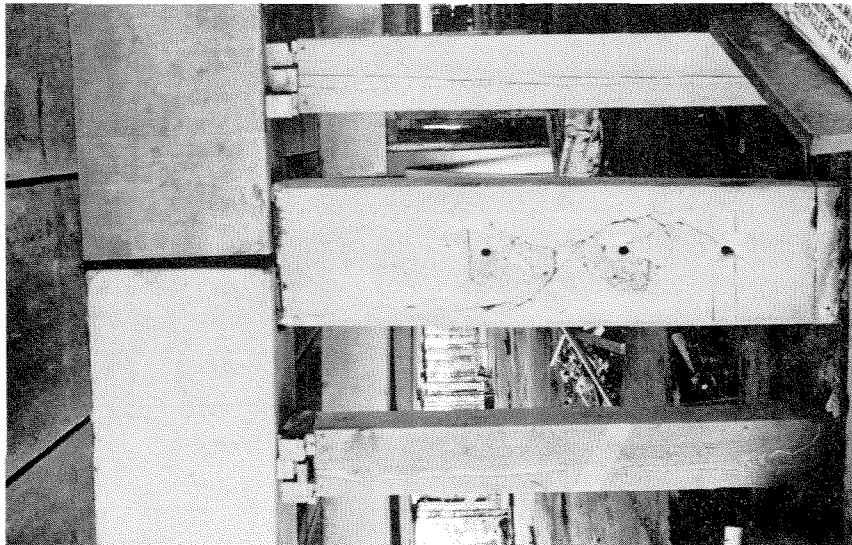
Figure 3. 151 Cracked column and displaced beams in the parking structure adjacent to the Union Bank, Sherman Oaks.

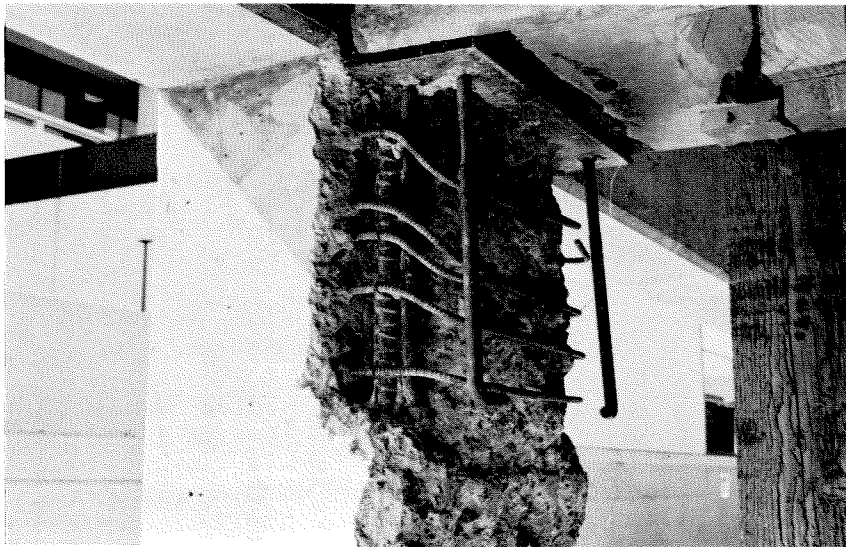
Figure 3.153 Concrete removed from the exterior column of the Union Bank parking structure to reveal the reinforcing steel.

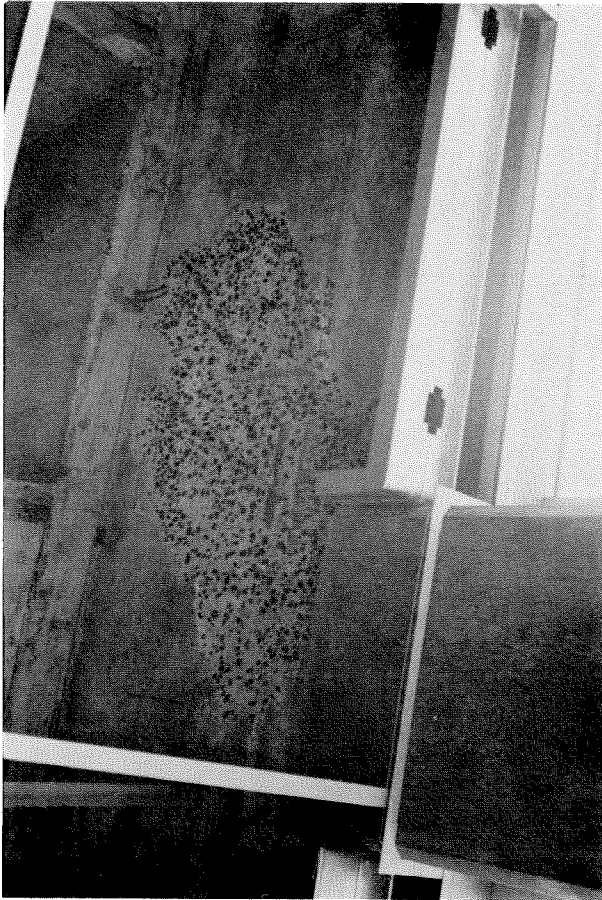
Figure 3. 156 The concrete cracked and spalled in the region of the beam-column connection with no visible damage to the reinforcing steel, fourth floor level, Bank of California.

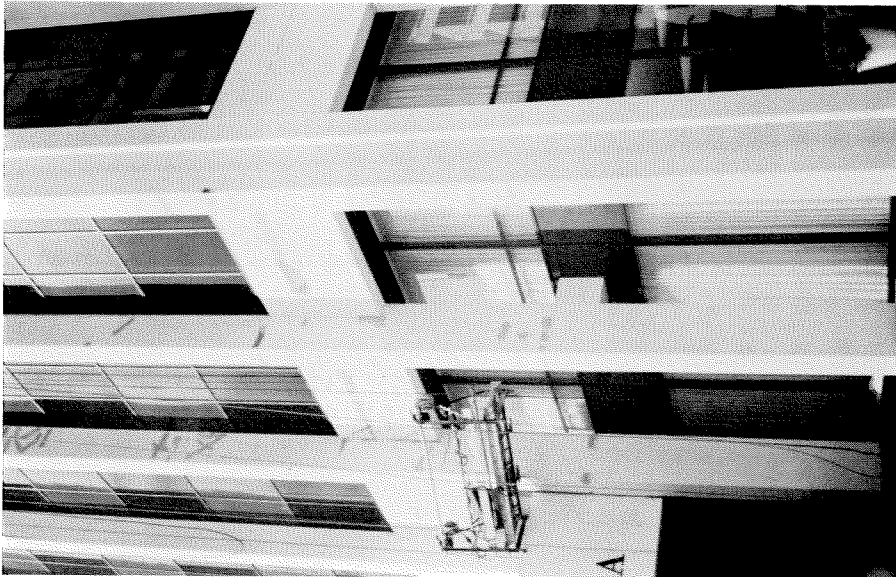
Figure 3. 155 Epoxy was used to repair cracks in the exterior frame of the Bank of California.

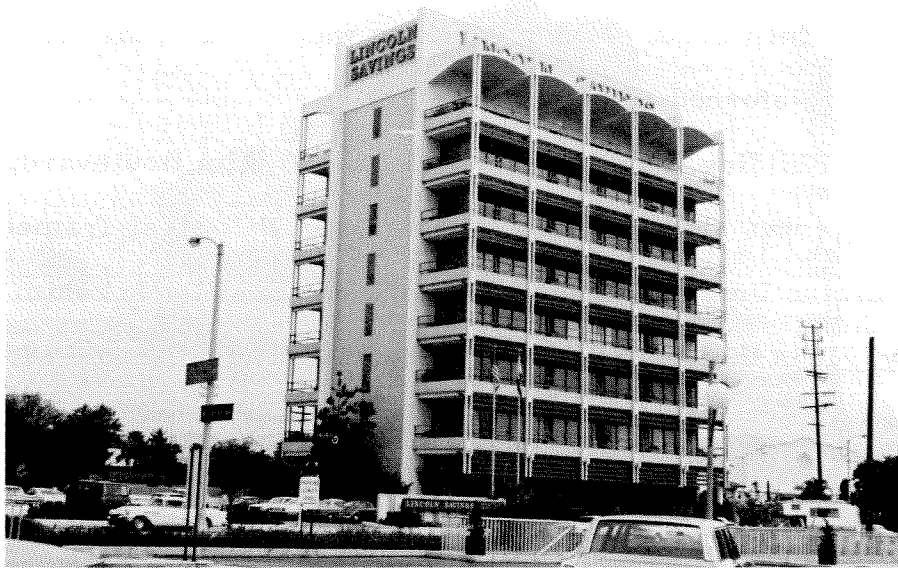
Figure 3.157 Eight-story Lincoln Savings building, 13701 Riverside Drive, Sherman Oaks.

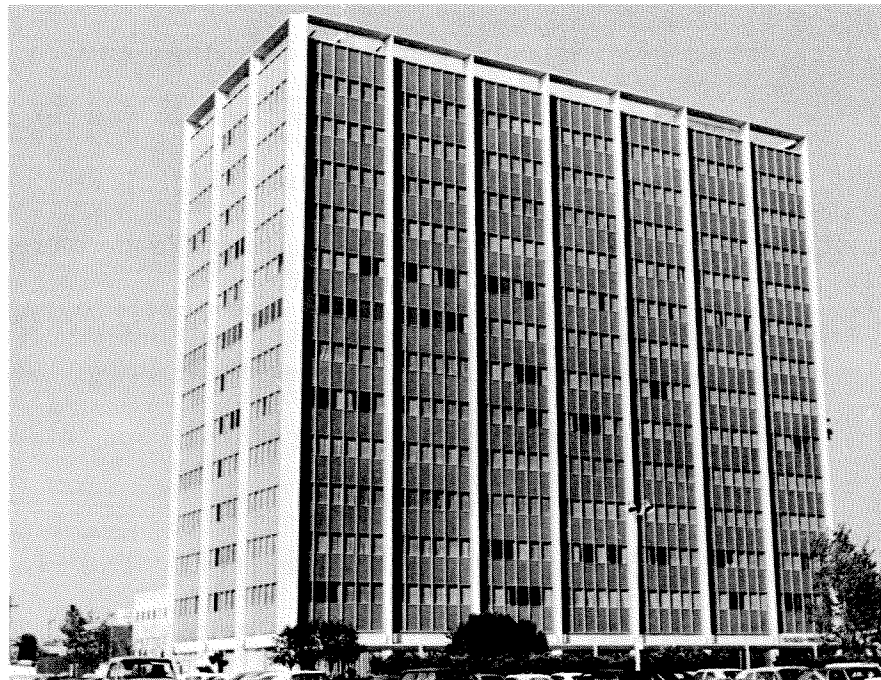
Figure 3.158 Panorama Towers building on Van Nuys Blvd. in Van Nuys. Example of a multi-story building in the southern San Fernando Valley.

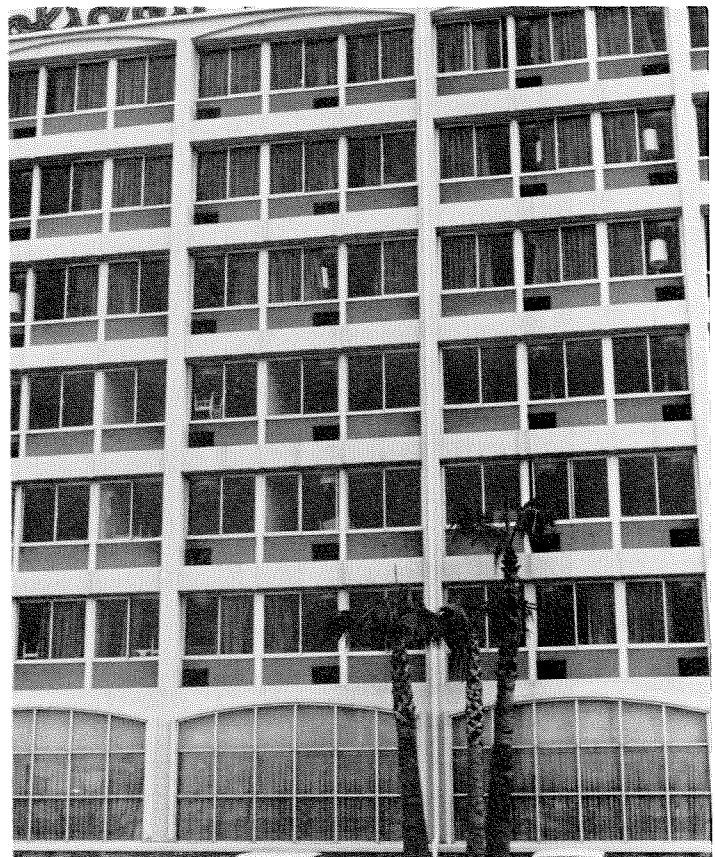
Figure 3.160 North elevation of building on March 21st. The second, third and fourth floors suffered severe non-structural damage estimated to be approximately \$250,000. An aftershock seven weeks after the main earthquake damaged the repairs that had already been made.

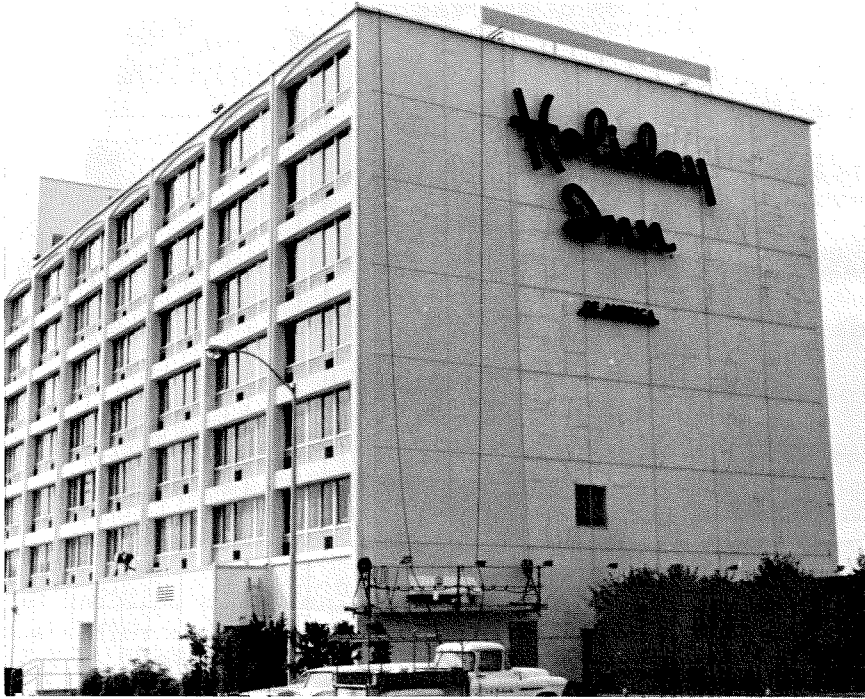
Figure 3.161 West elevation of Holiday Inn.

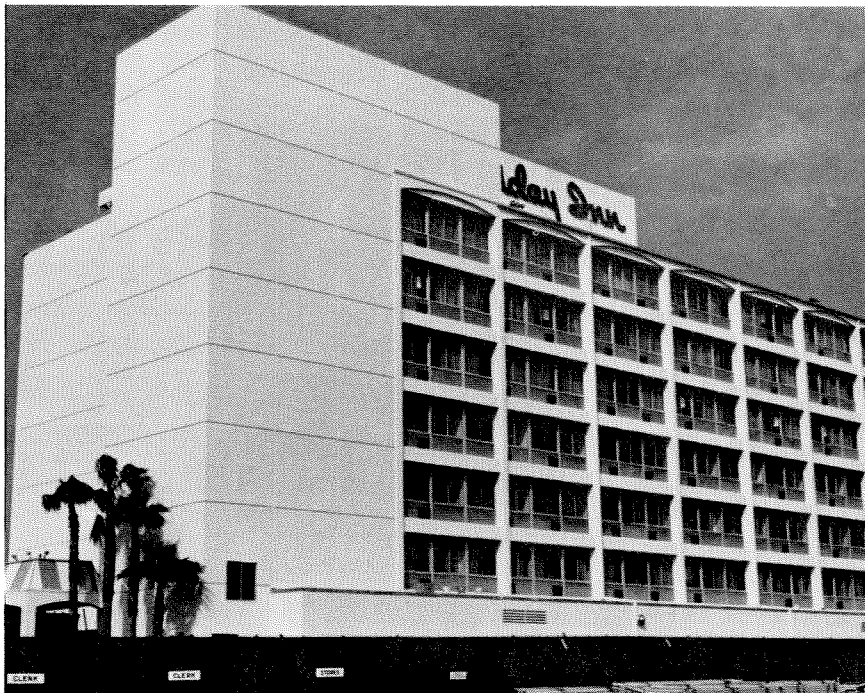
Figure 3.162 South elevation of Holiday Inn. The concrete frame underwent some cracking which indicated strains beyond the yield point.

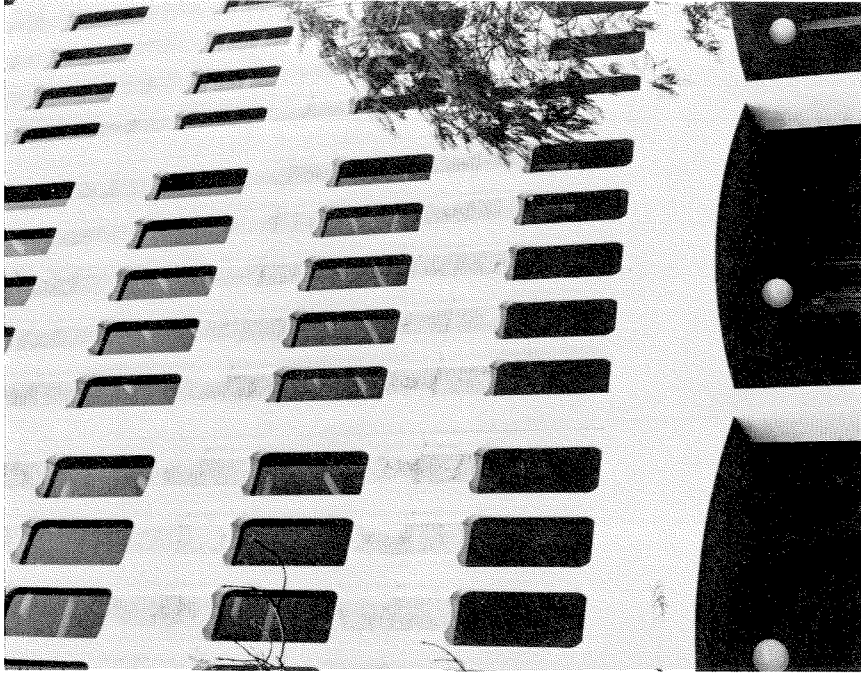
Figure 3.164 Each precast concrete panel extends from column to column, and from floor to floor. The concrete walls of the elevator shaft form the resisting elements for horizontal forces in the east-west elevation.

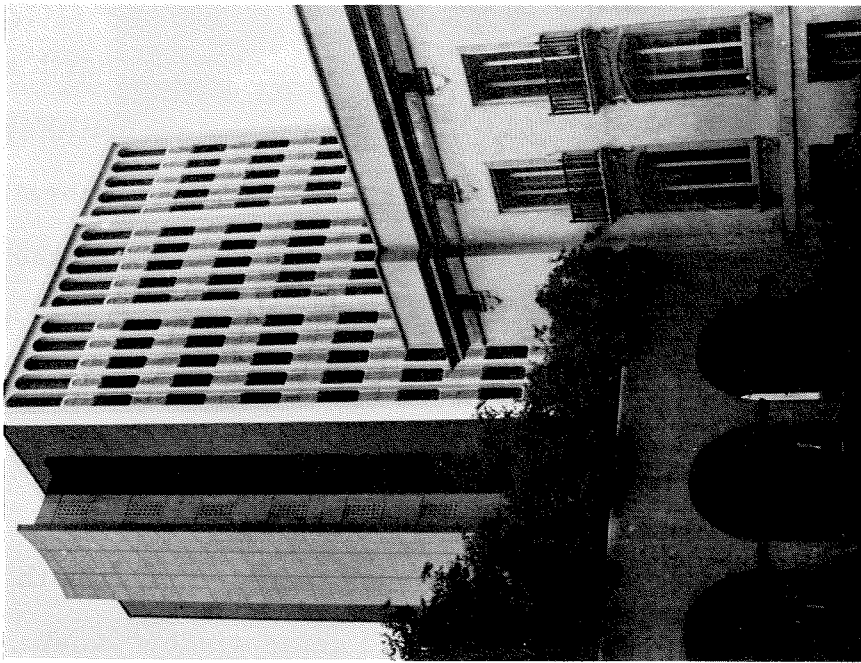
Figure 3.163 North elevation of the Millikan Library building on the Caltech campus, a 9-story, plus enclosed roof, concrete shear-wall structure. The north and south faces of the building have precast concrete panels bolted to the floor beams.

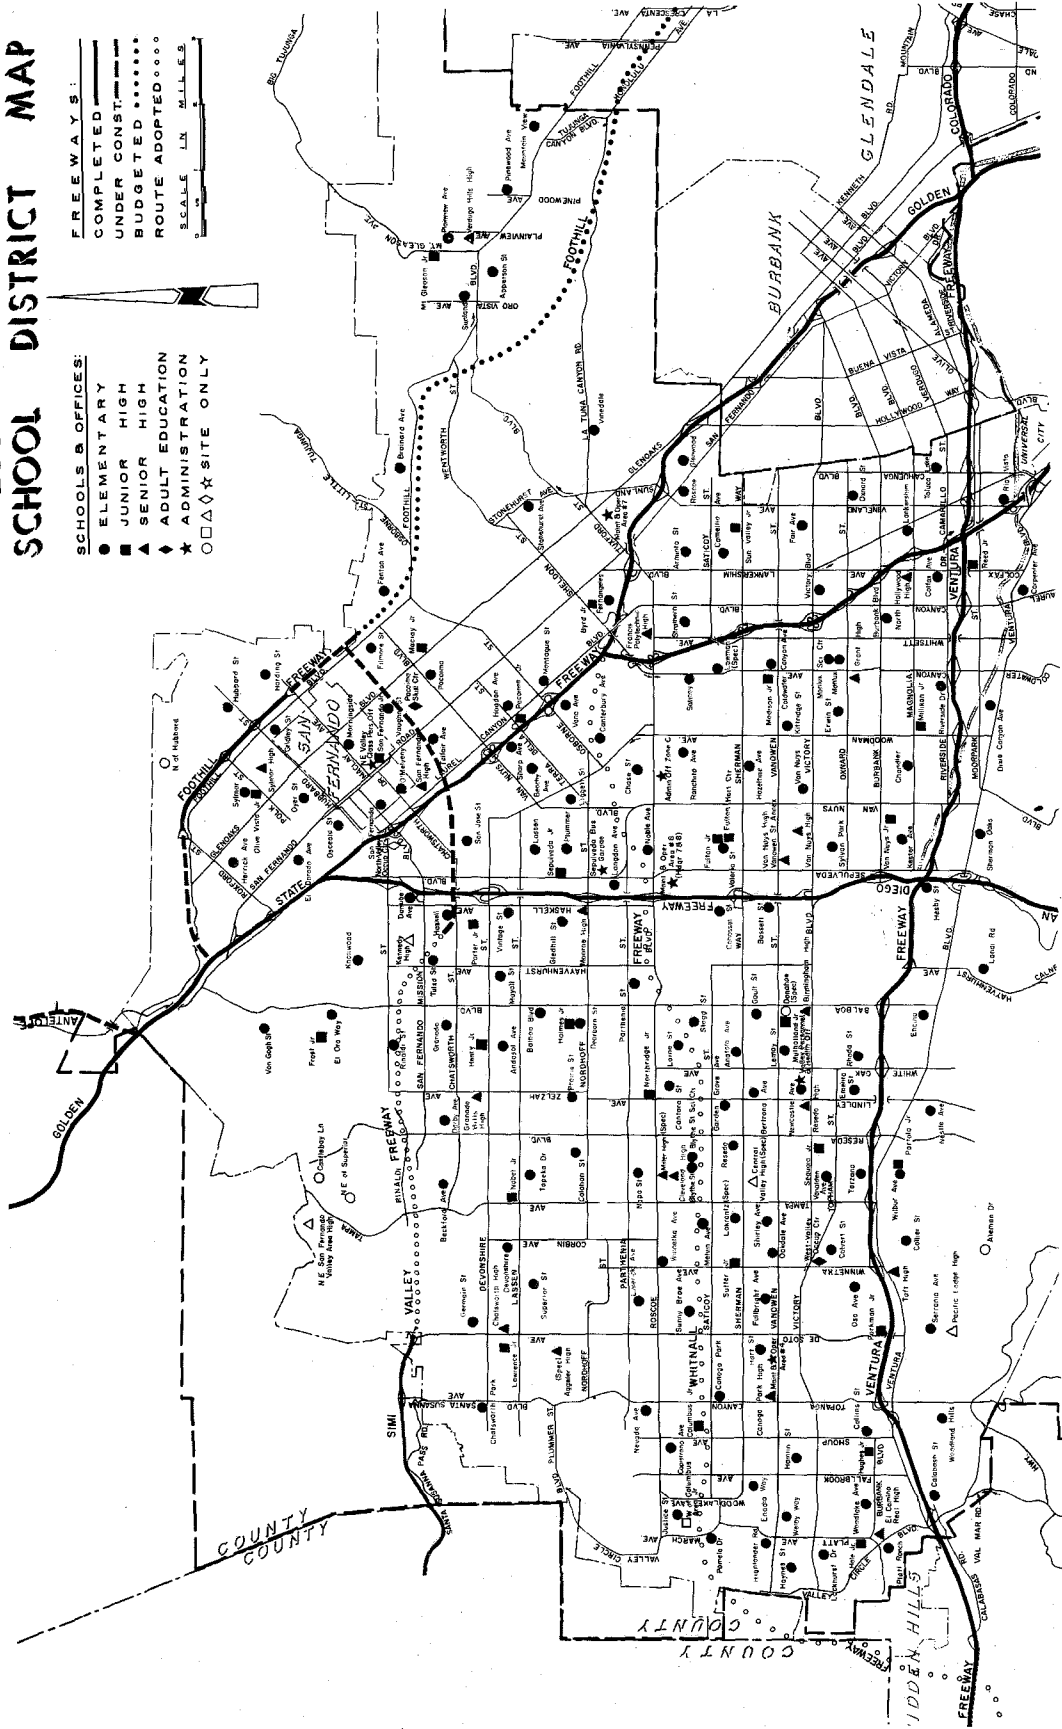
Figure 3.165 Location of schools in San Fernando Valley. Several of the school buildings in Sylmar were damaged by permanent differential foundation displacements but this damage would not have been hazardous to occupants.

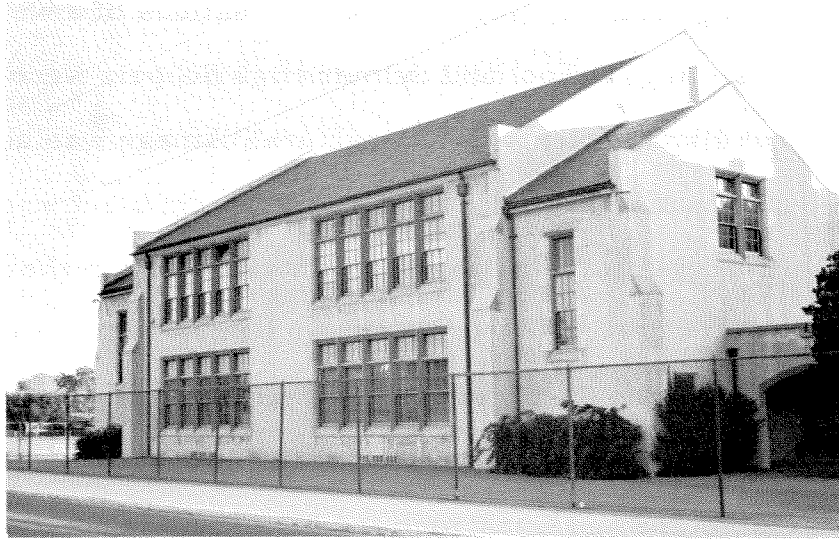
Figure 3.166 Morningside School at Maclay and Fifth Streets in San Fernando city. This well-constructed 1928 brick wall structure was severely cracked. It had brick corridor walls and crosswalls, concrete corridor slabs, and wood roof and floors. The gable walls had been anchored to the roof framing in recent years.

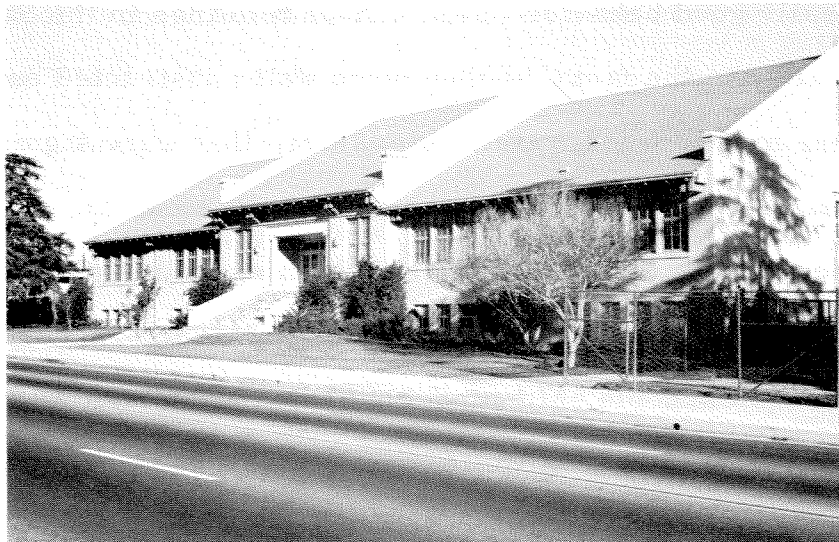
Figure 3.167 Morningside School at Maclay and Fifth Streets in San Fernando city. This 1915 building had been strengthened recently to make it satisfy the requirements of the building code for earthquake resistant design.

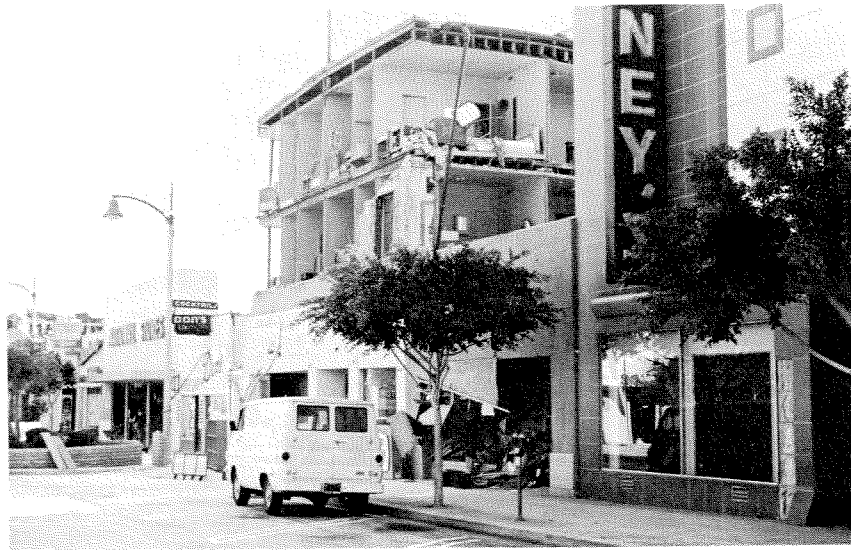
Figure 3.172 This building was hazardous not only to its occupants but also to the occupants of adjacent buildings and to passersby on the street.

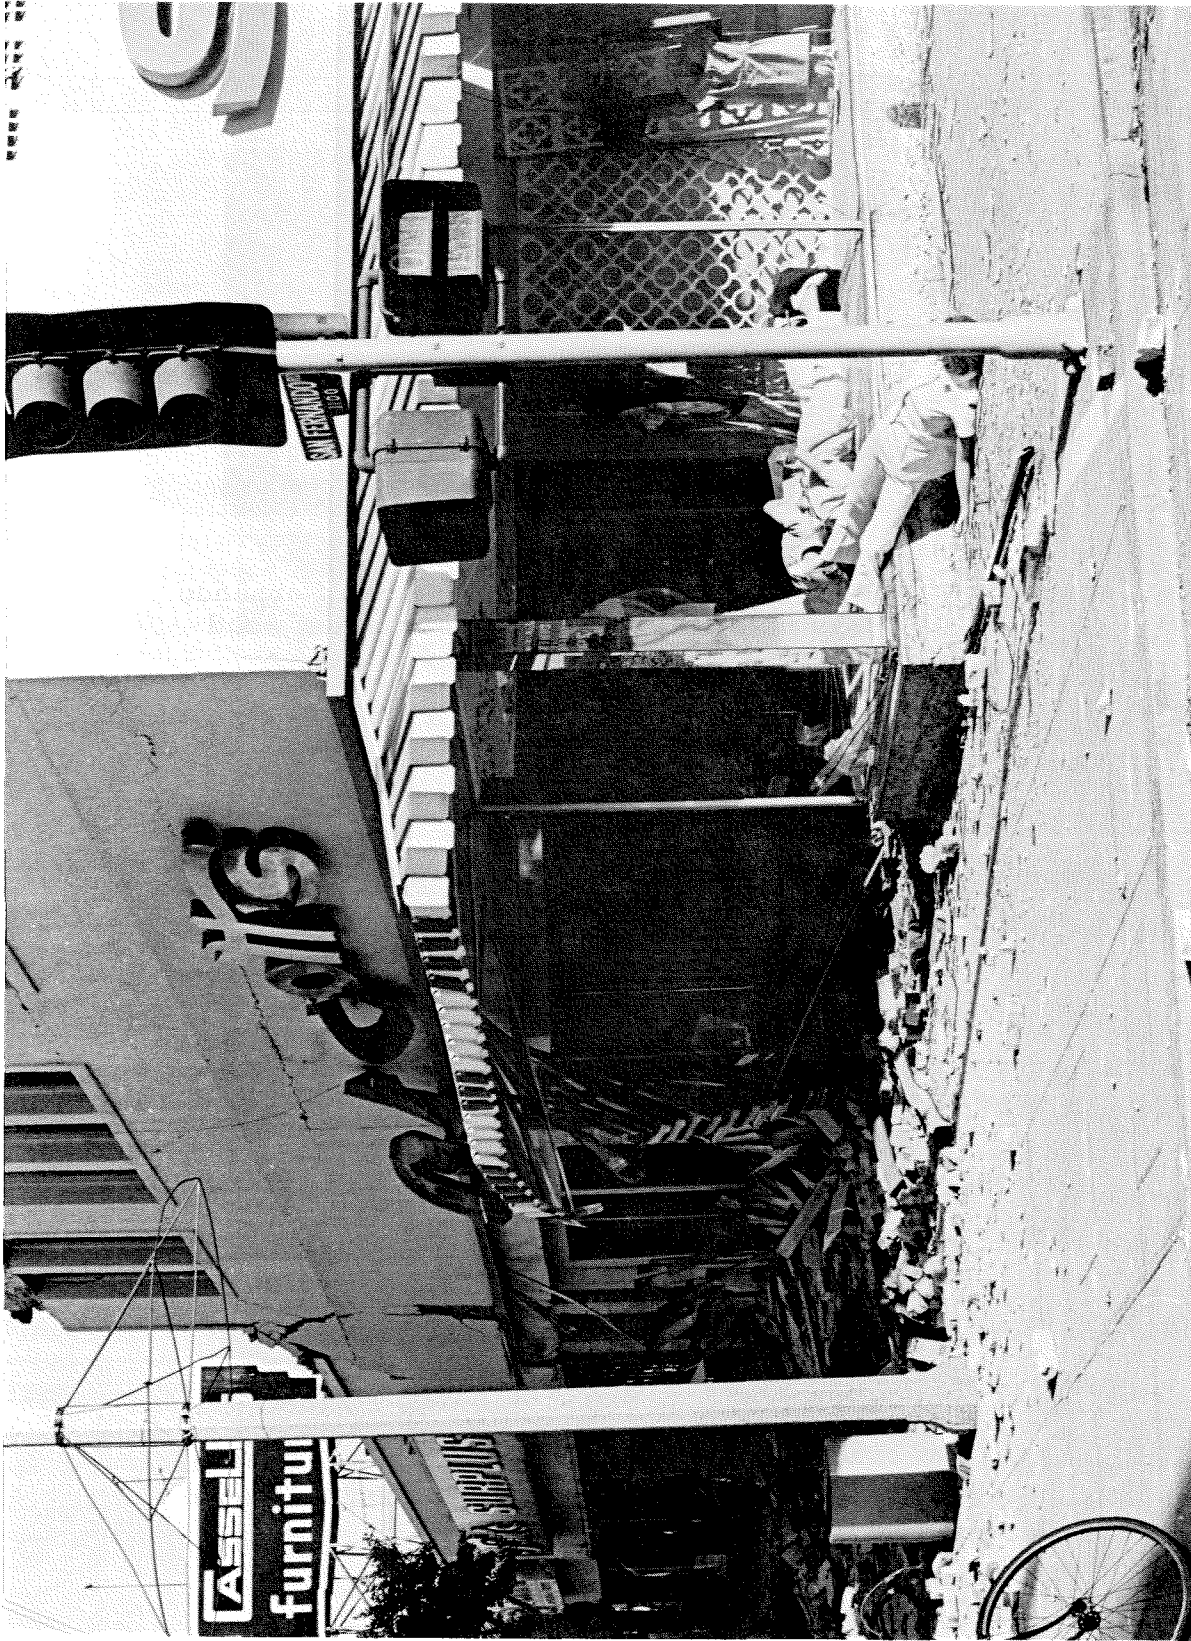
Figure 3.173 This old building in San Fernando city was badly damaged by the earthquake. Bricks from the upper walls have fallen onto the sidewalk. Ralph Samuels photo.

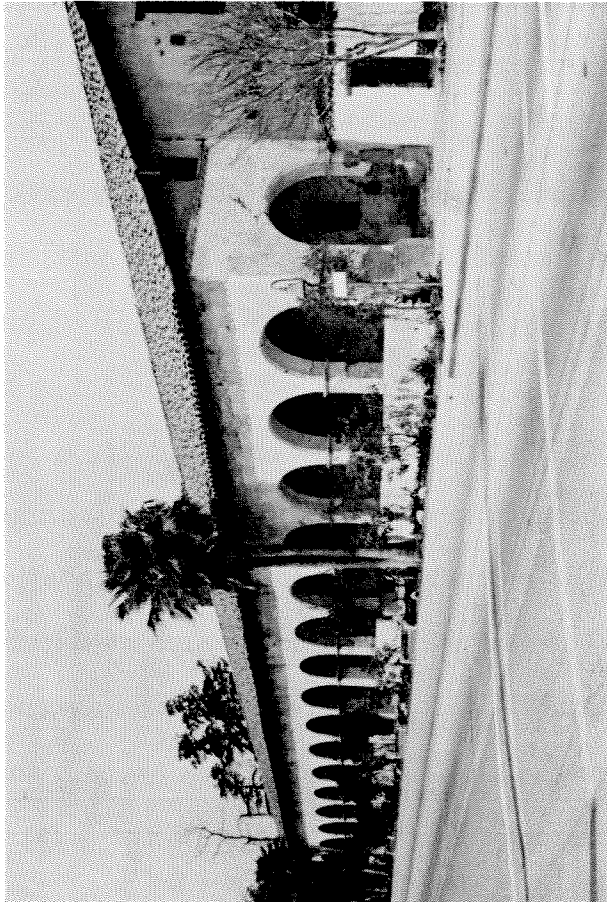
Figure 3.174 Old San Fernando Mission located just south of Holy Cross Hospital and Indian Hills Medical Center, and three miles north of Holiday Inn. The mission building was first constructed around 1800 and has been rebuilt and repaired since then. Its walls are adobe brick (unburnt clay). There was sufficient cracking of the walls for the city to declare it unsafe for occupancy.
