ENGINEERING FEATURES
OF THE
SAN FERNANDO EARTHQUAKE OF FEBRUARY 9, 1971

Paul C. Jennings, Editor

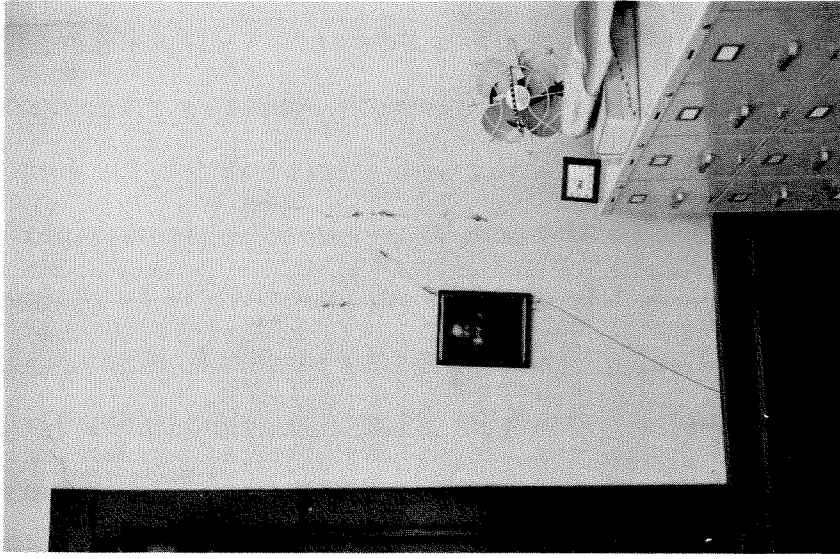
Figure 3.175 Hollow tile filler walls were cracked in old buildings as far away as Pasadena. Throop Hall, California Institute of Technology.

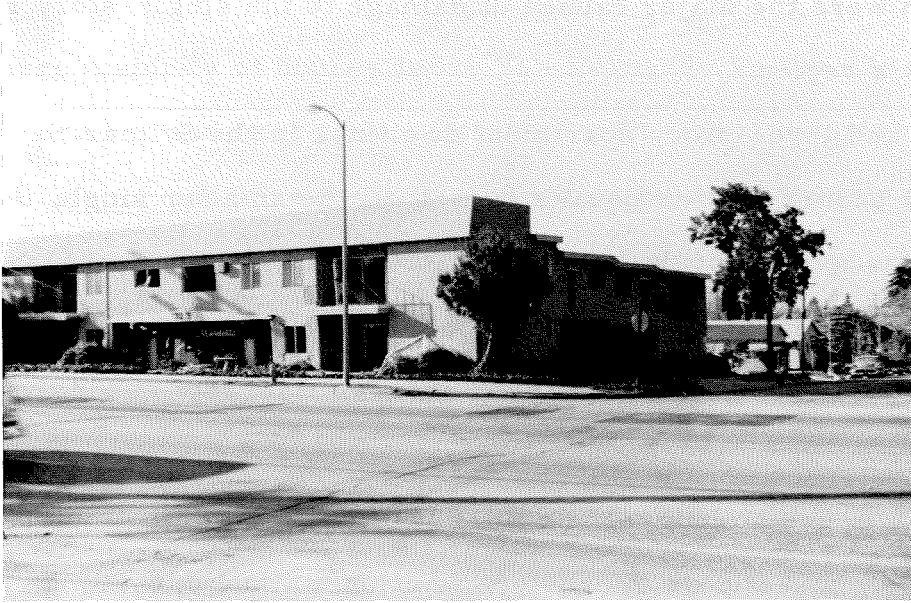
Figure 3.176 Mardette Apartment Buildings. Northwest building. Foothill Boulevard, San Fernando.

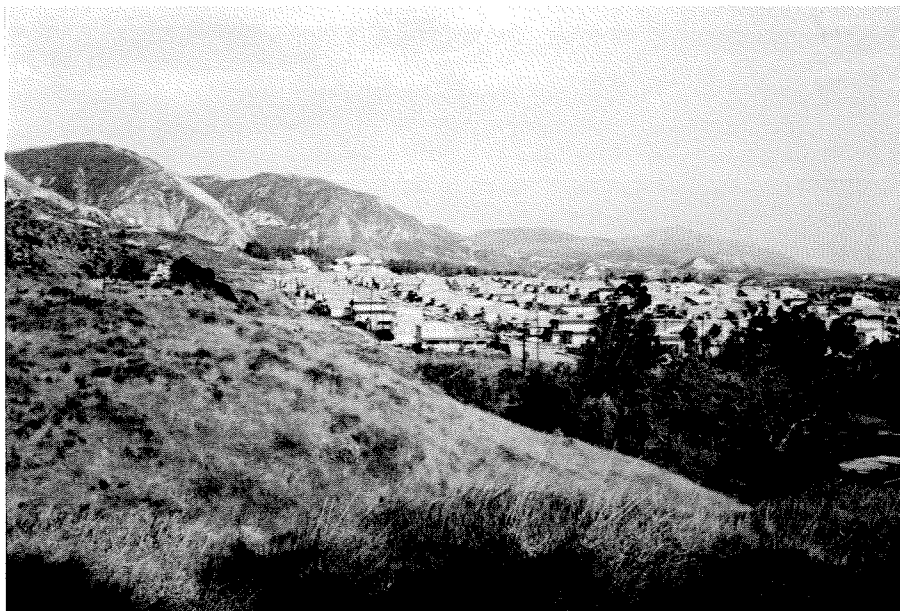
Figure 3.181 Looking east toward the Veterans Administration Hospital at the northern few blocks of Sylmar (Almetz and Aldergrove Streets) where extensive residential damage occurred.

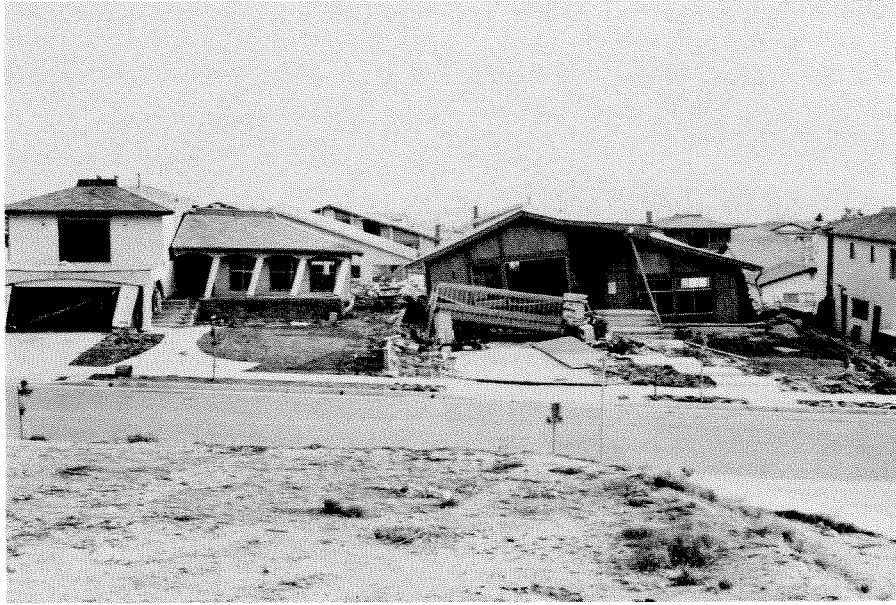
Figure 3.182 Two of the most severely damaged split-level houses on Almetz Street.

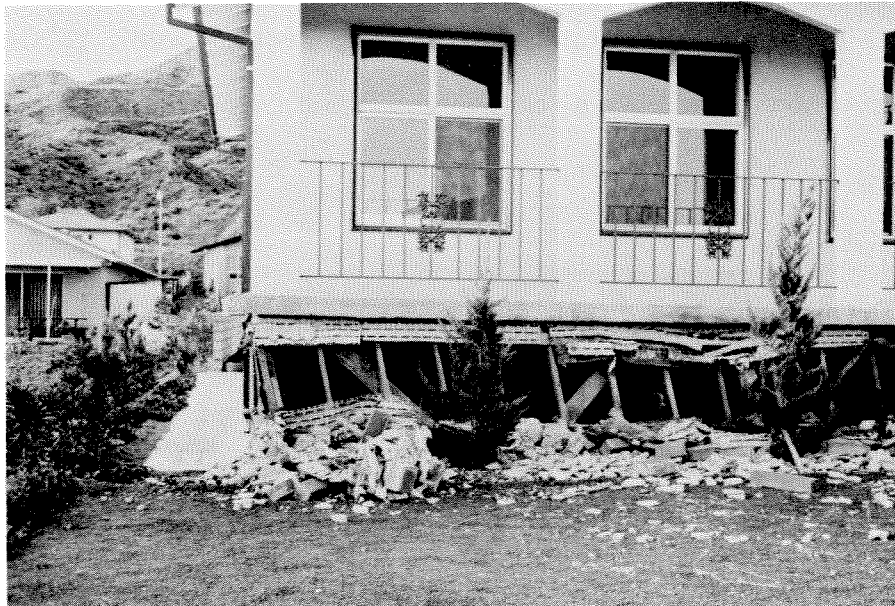
Figure 3.183 A house on Aldergrove Street that shows horizontal movement on its wood supports.

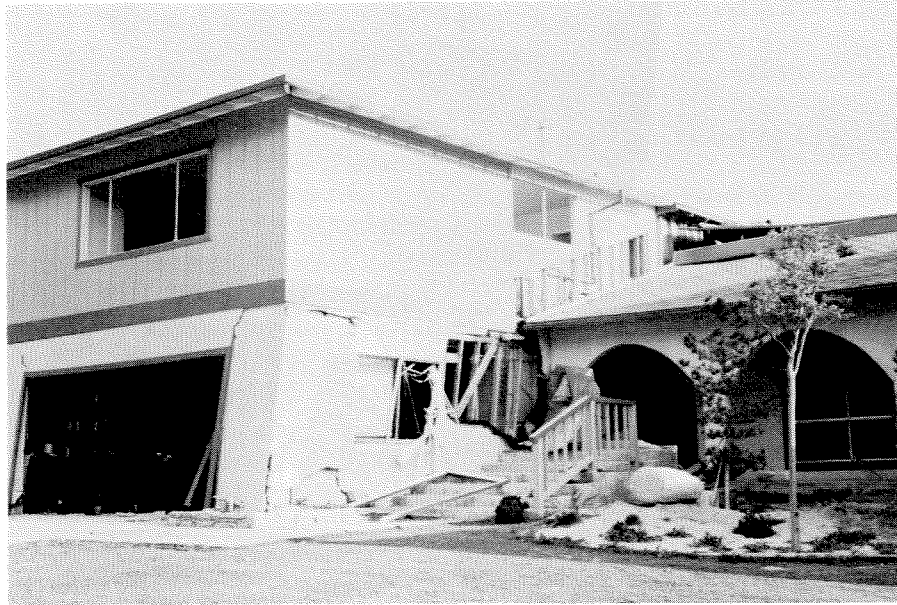
Figure 3.184 A split-level house on Almetz Street; the living quarters fell from the underlying supports.

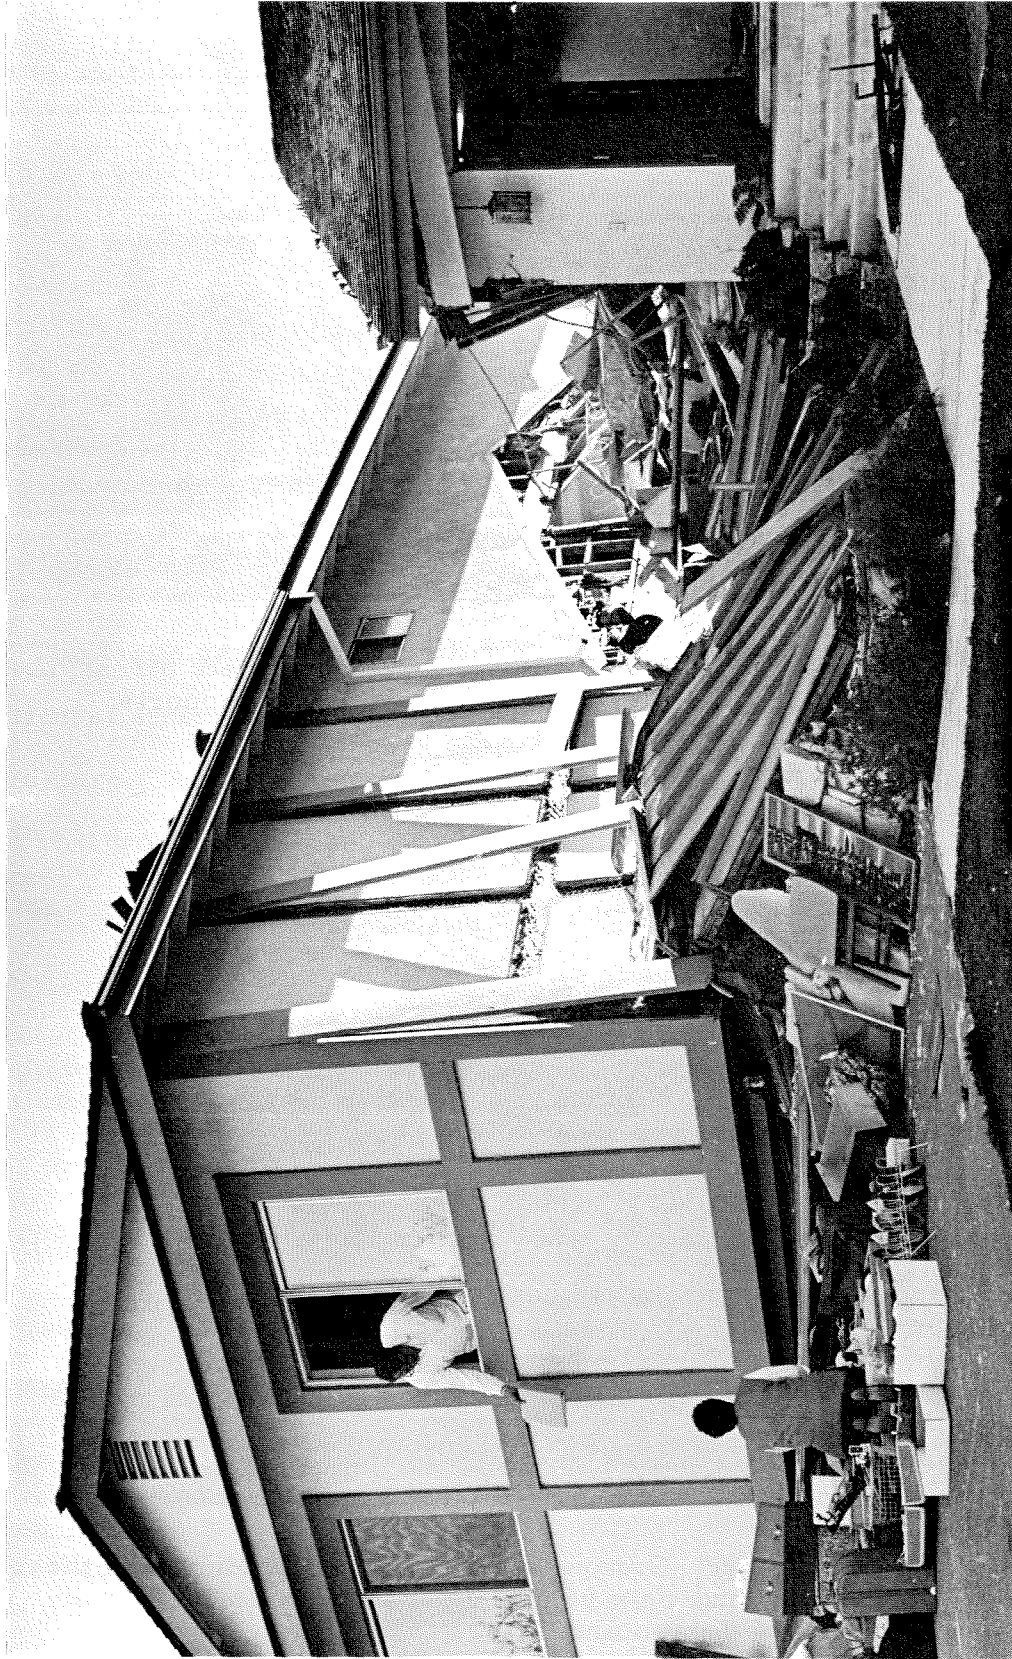
Figure 3.186 Garage walls that supported an overhead bedroom collapsed in this split-level home on Fenton Avenue between Polk and Tyler. Ralph Samuels photo.

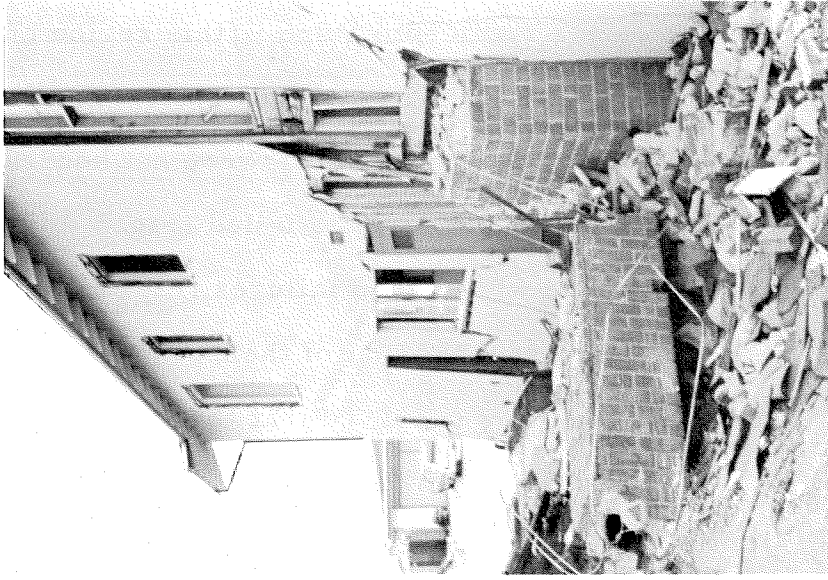
Figure 3. 188 Typical chimney with four half inch vertical reinforcing bars, structurally independent of the adjacent house, Aldergrove Street.

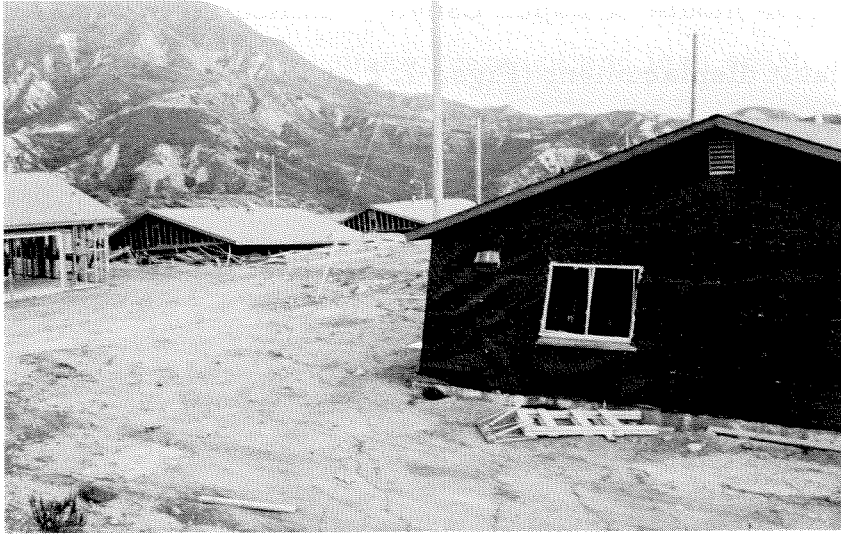
Figure 3.189 Heavily damaged and collapsed residential houses under construction, east of Veterans Administration Hospital.

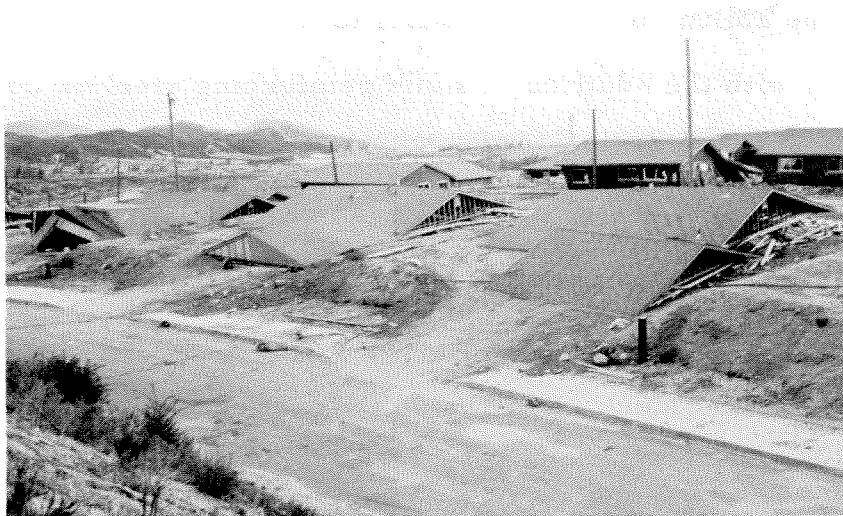
Figure 3.190 Heavily damaged and collapsed residential houses under construction, east of Veterans Administration Hospital.

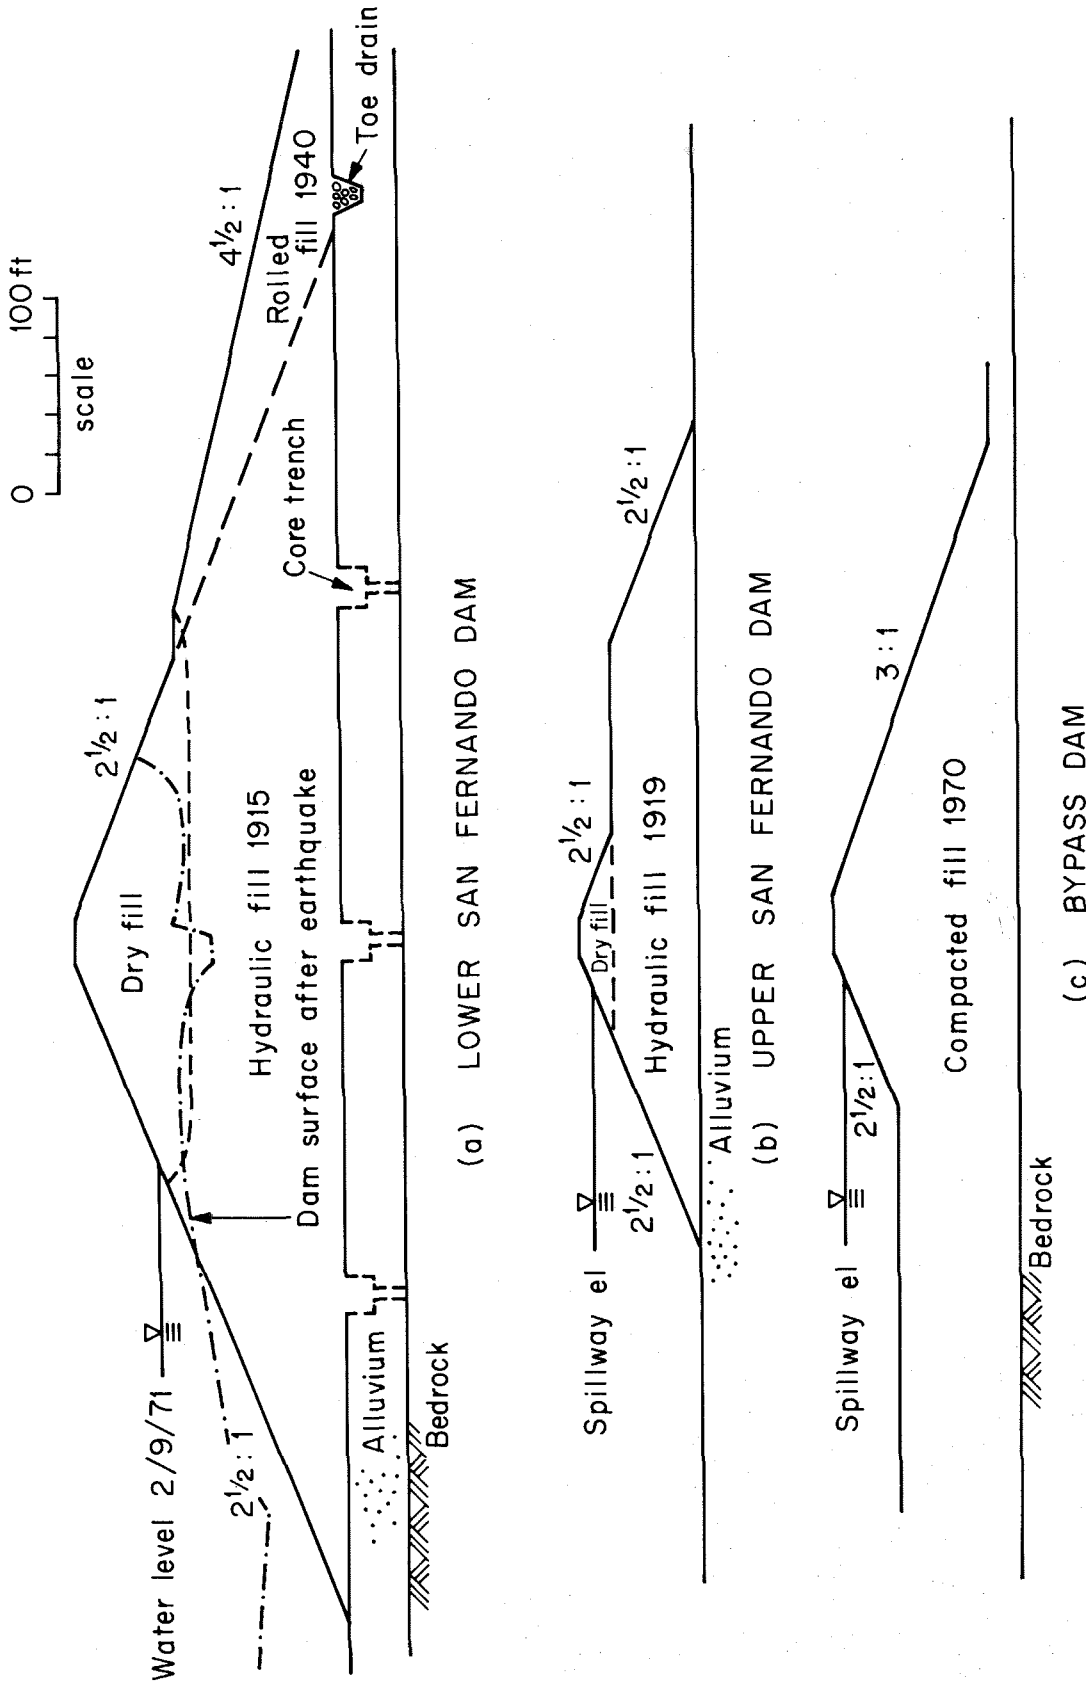
TYPICAL PROFILES OF SAN FERNANDO DAMS

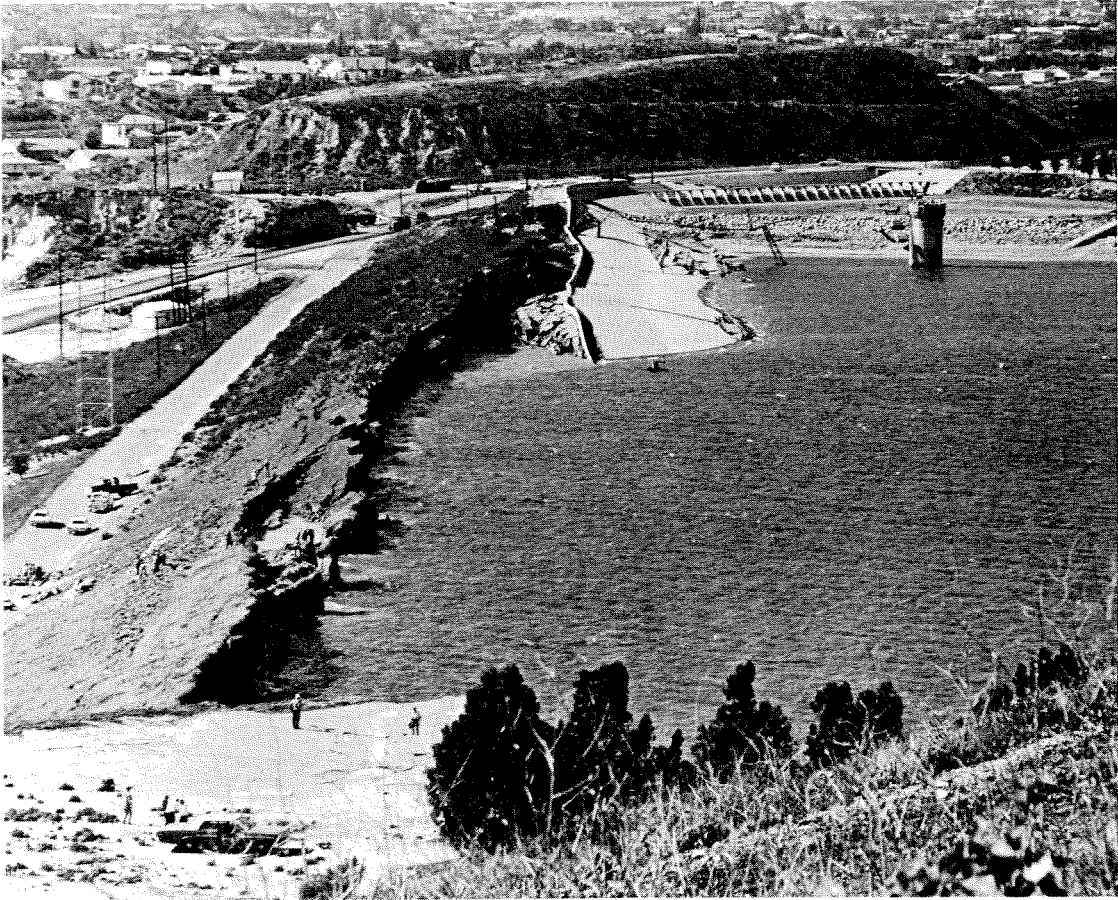
Figure 4.2 Oblique view of lower San Fernando Dam, 9 February 1971, looking west. The upstream face of the dam had a concrete slab facing to prevent erosion of the dam surface.

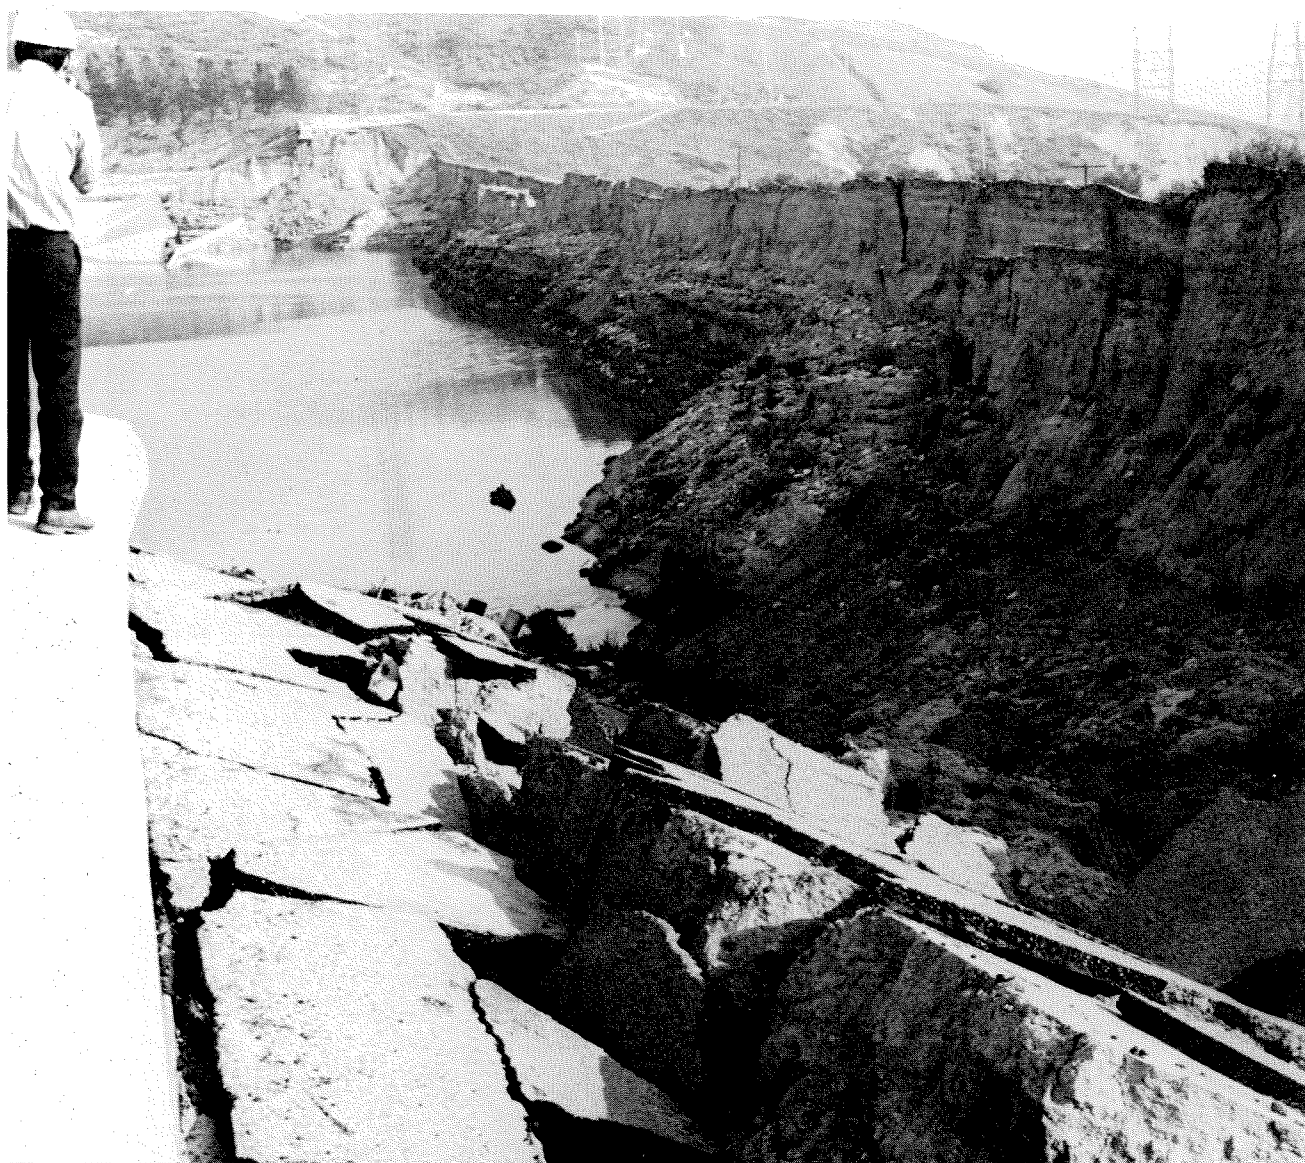
Figure 4.3 Ground view of crest of lower San Fernando Dam, 21 February 1971, looking east.

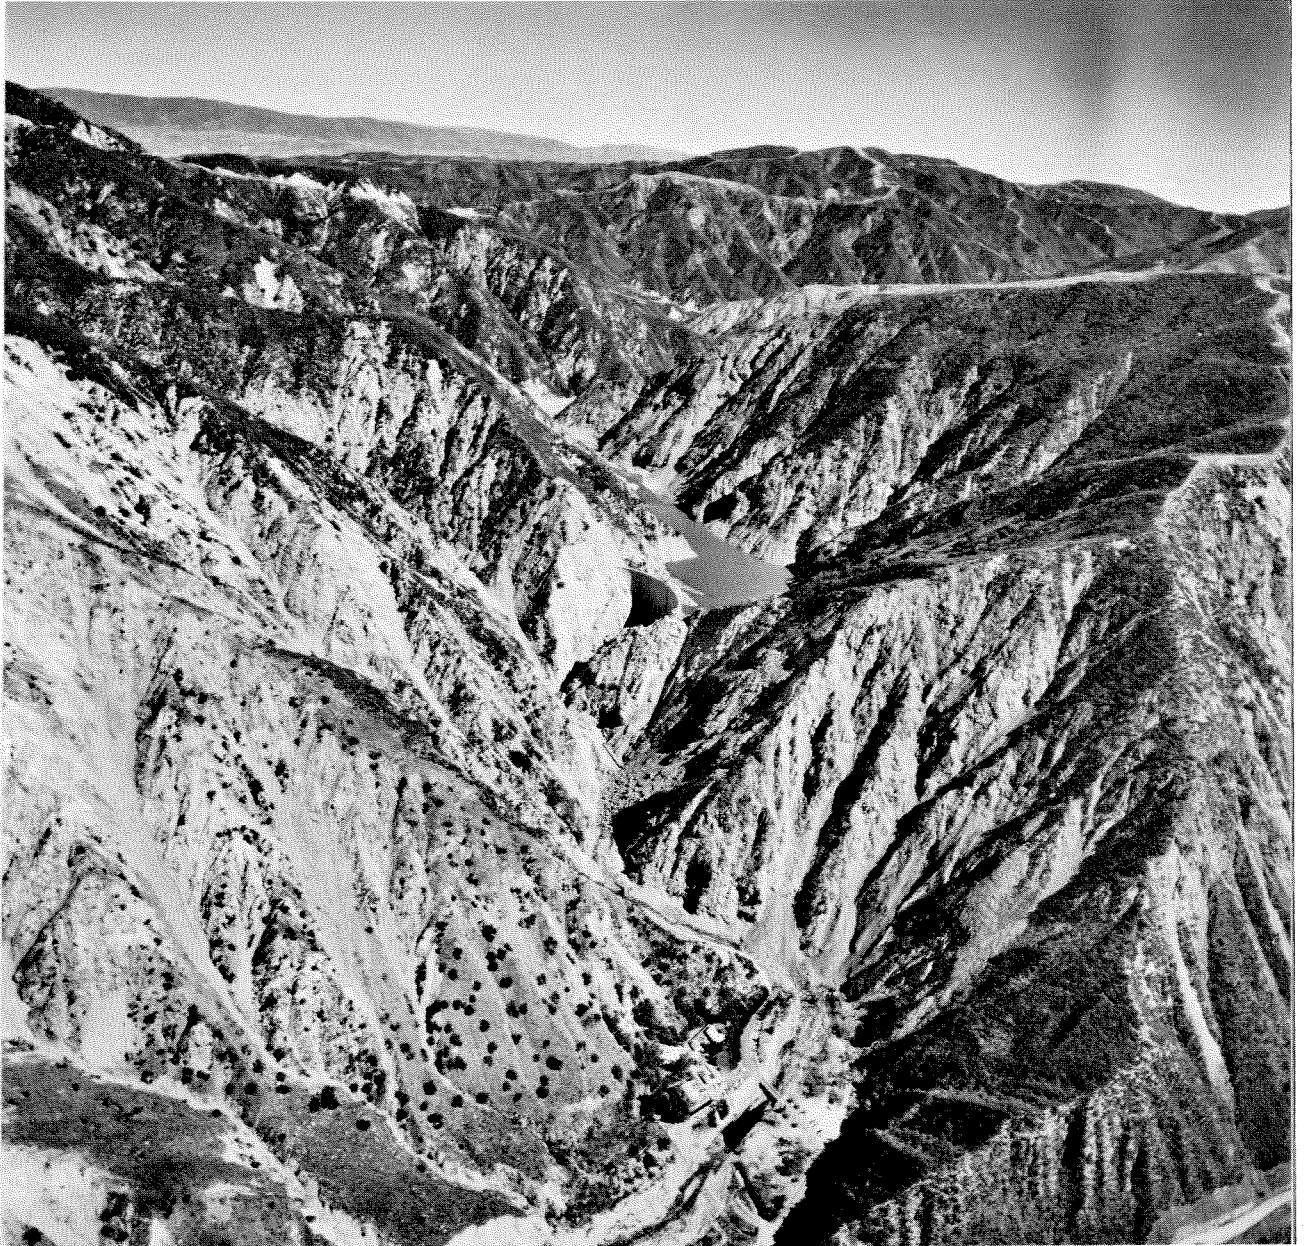
Figure 4.7 Oblique aerial photograph of 15 March 1971, showing numerous rockfalls in Pacoima Canyon.

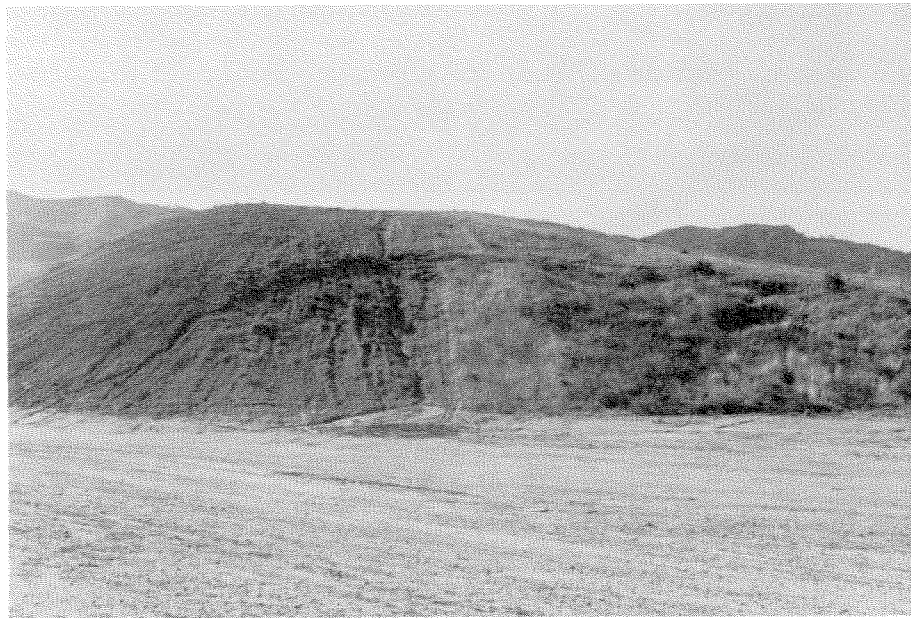
Figure 4.10 Incipient slope failure adjacent to Interchange of Foothill and Golden State freeways, 11 February 1971.

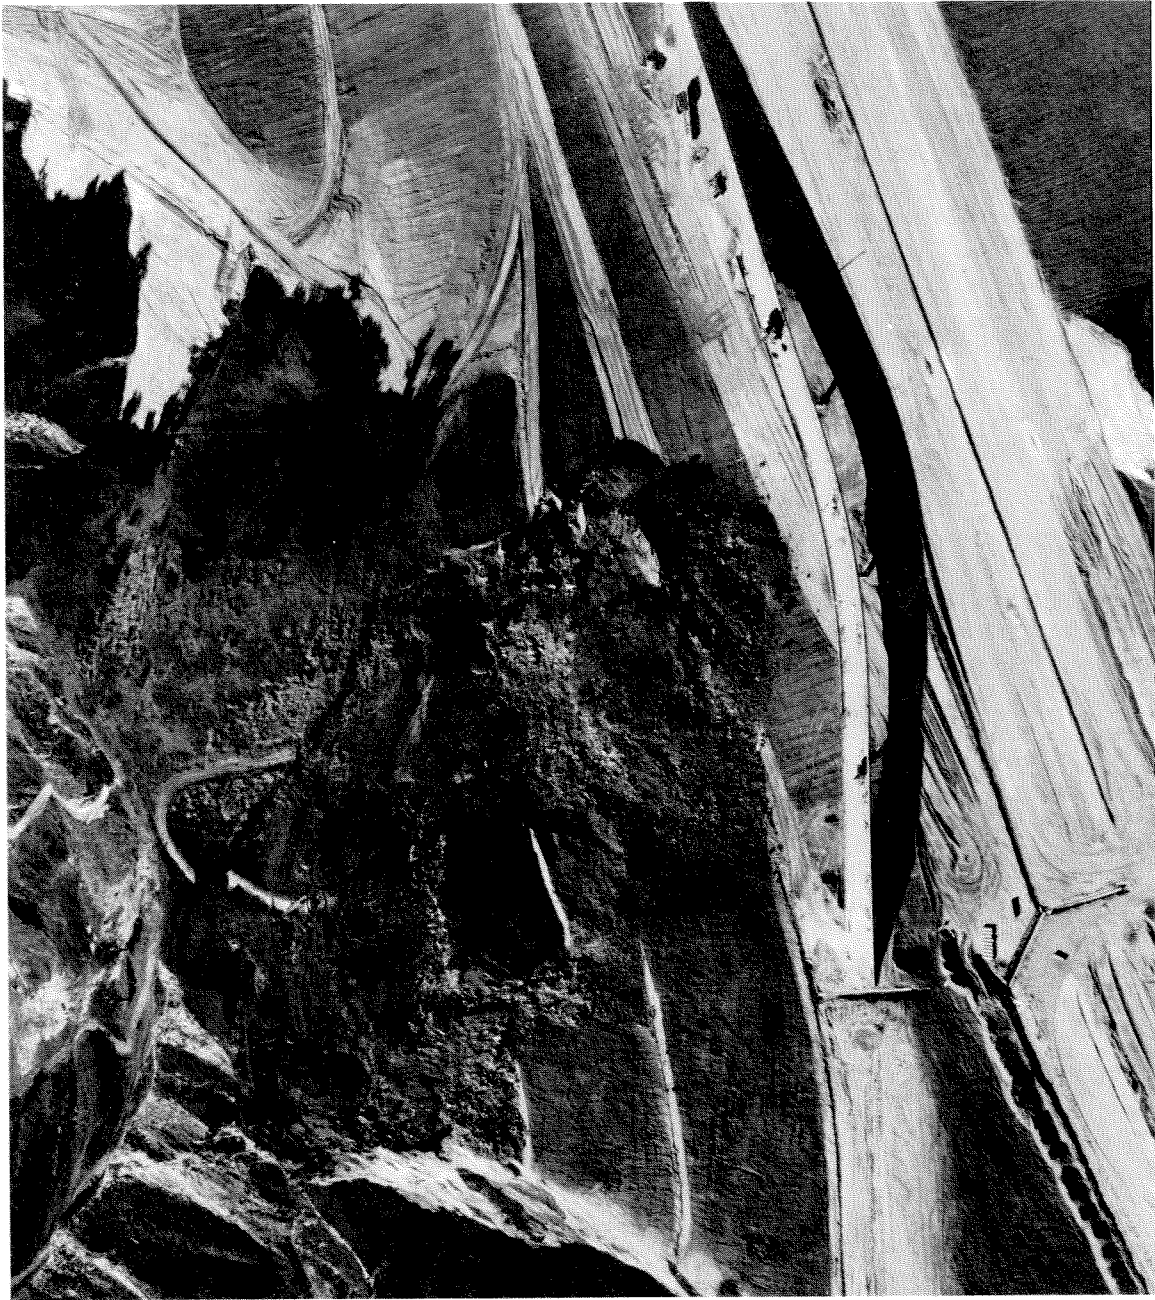
Figure 4.11 Slope failure on the west side of the Golden State freeway (Interstate 5), near the interchange with the Foothill freeway.

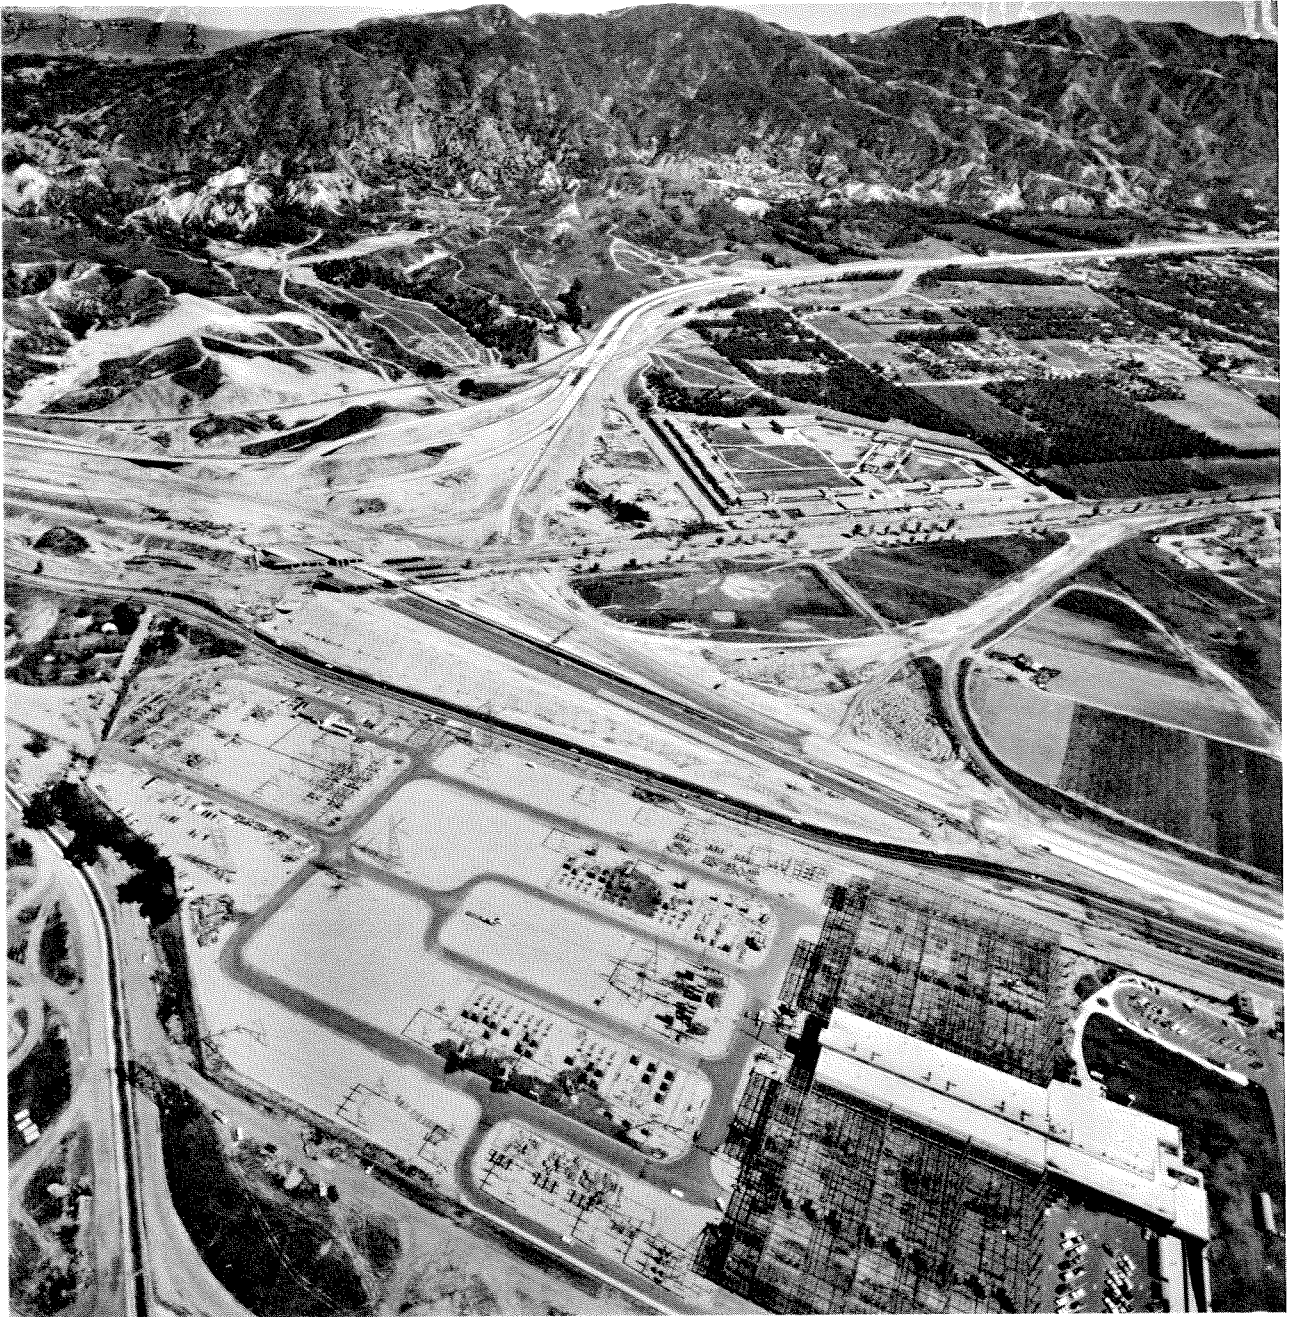
Figure 4. 12 Aerial photograph of ground displacement extending from Juvenile Facility to Sylmar Converter Station.

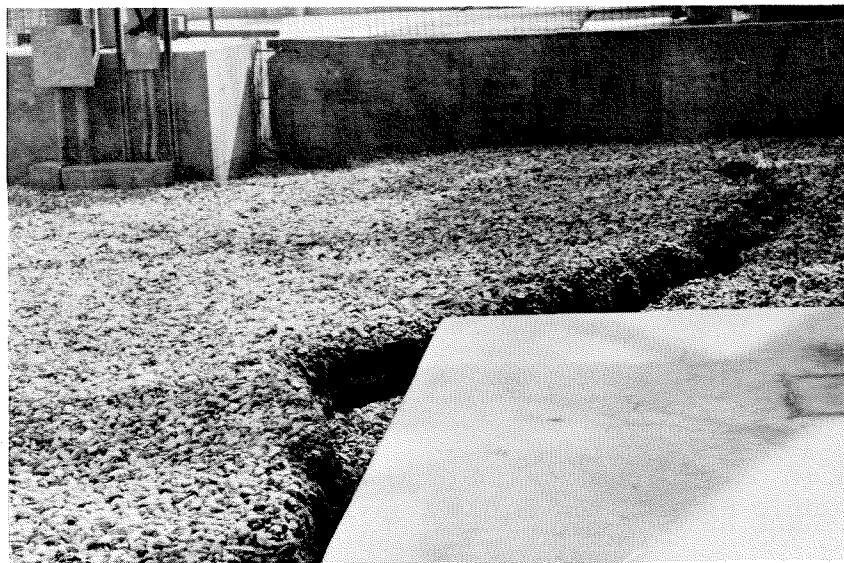
Figure 4.14 Horizontal displacements inside Sylmar Converter Station evident in ground crack and in separation of wall from column footing in background.

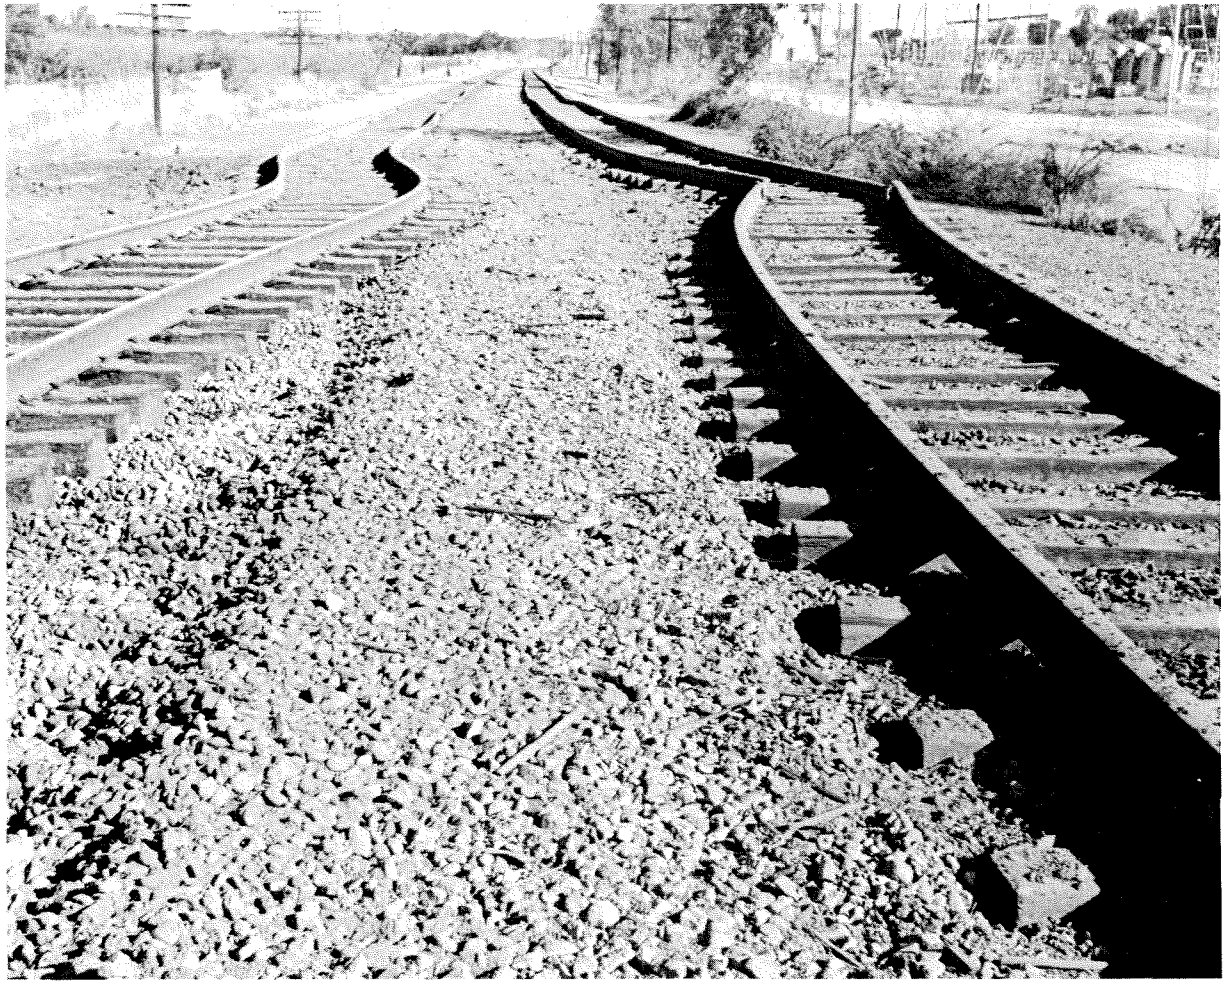
Figure 4. 15 The Southern Pacific Railroad tracks just south of the San Fernando Juvenile Facility at the east end show evidence of substantial ground movement.

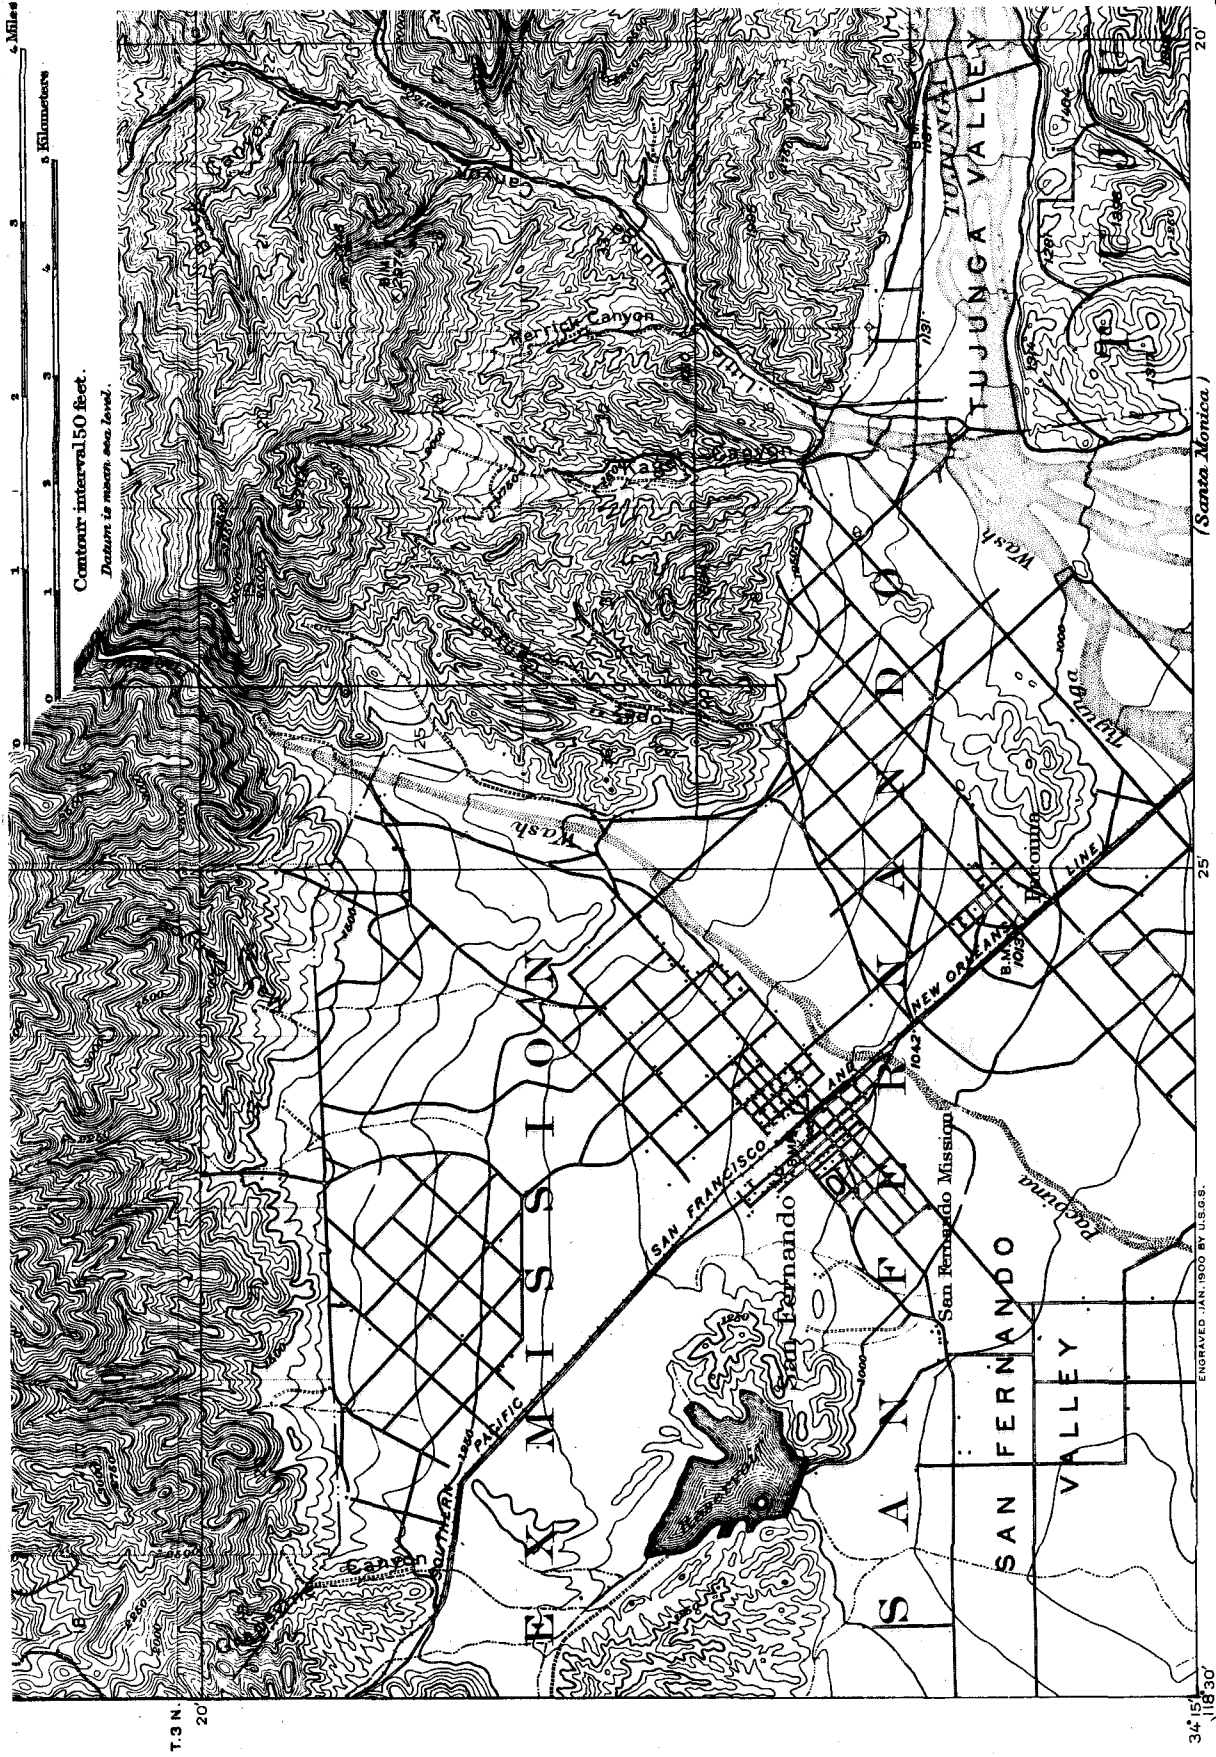
Figure 4. 16a USGS topographic map of the San Fernando area, edition of 1900; reprinted 1929.

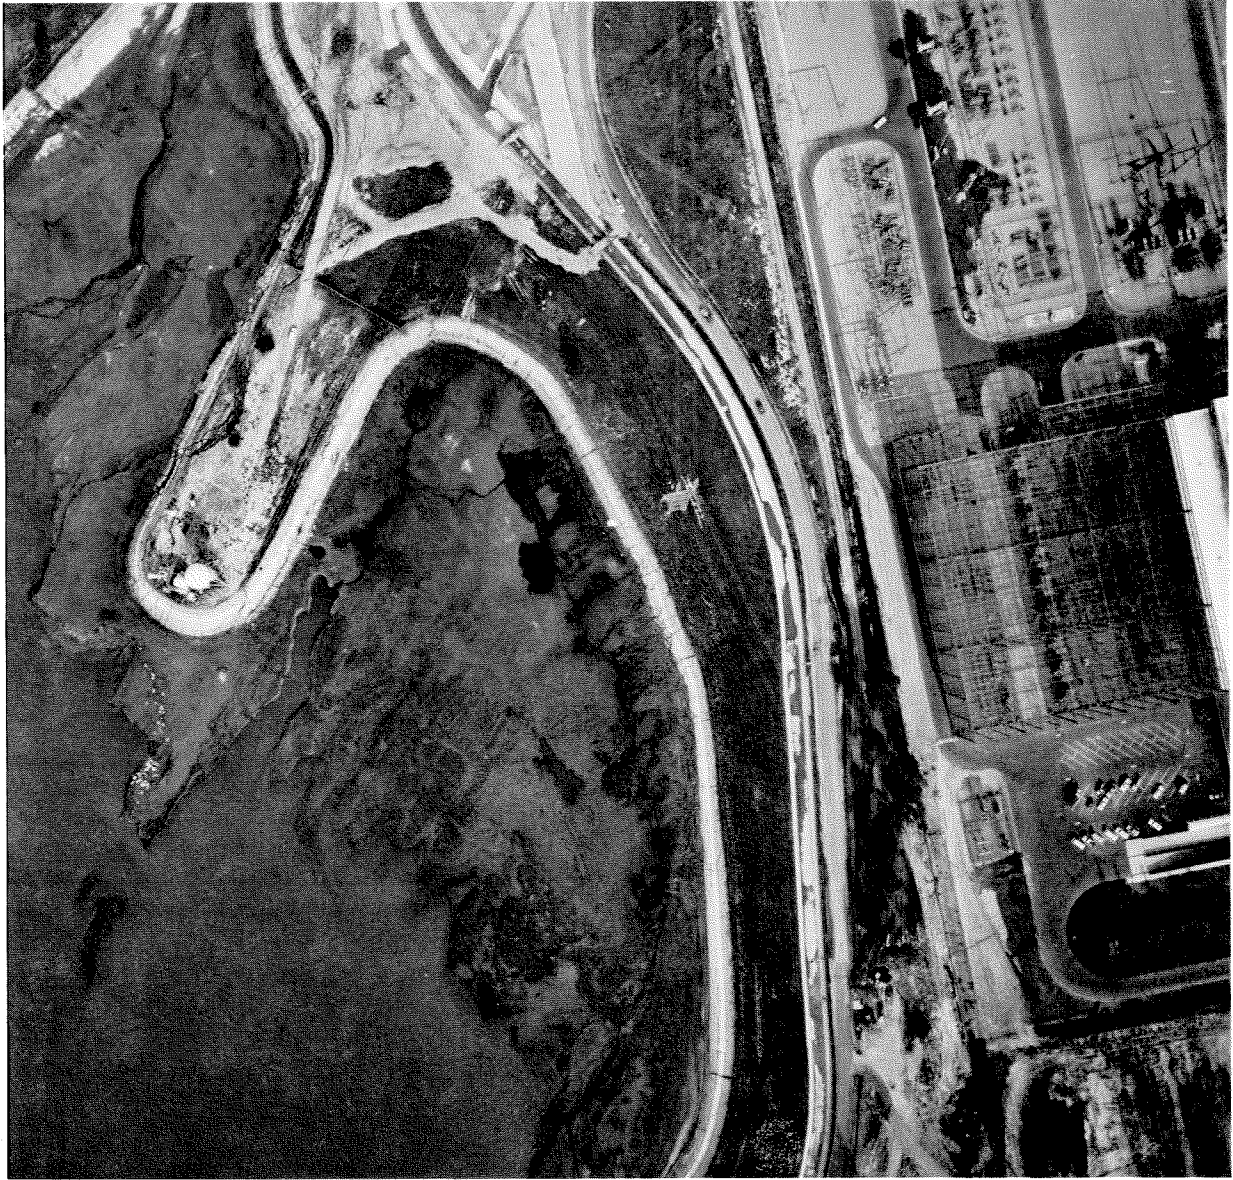
Figure 4.19 Aerial photograph of upper Van Norman Lake showing zones in which sand boils are encountered.

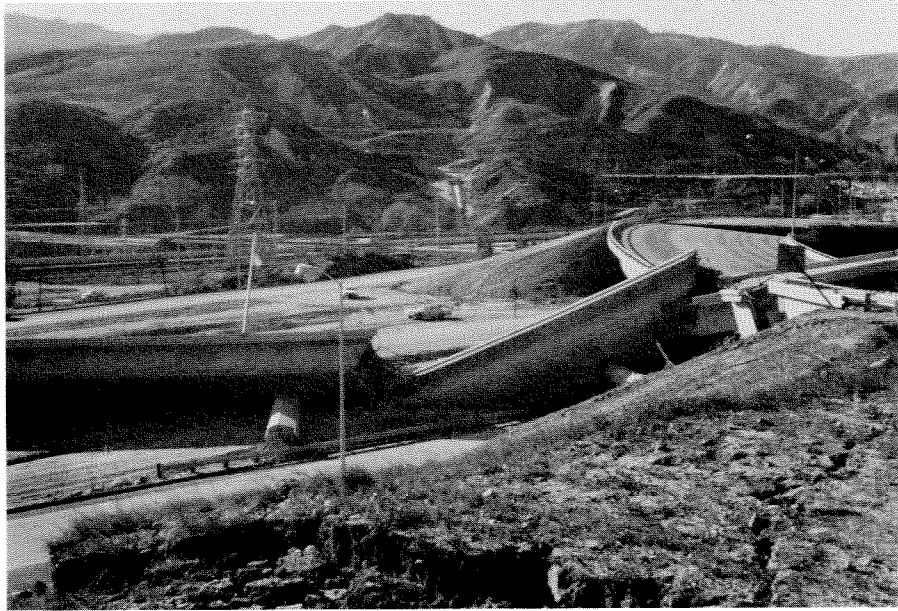
Figure 4.20 Overturned freeway overpass at intersection of Foothill and Golden State freeways. Overpass column reinforcing has pulled out of foundation. Partial slope failure seen in embankment fill in foreground.

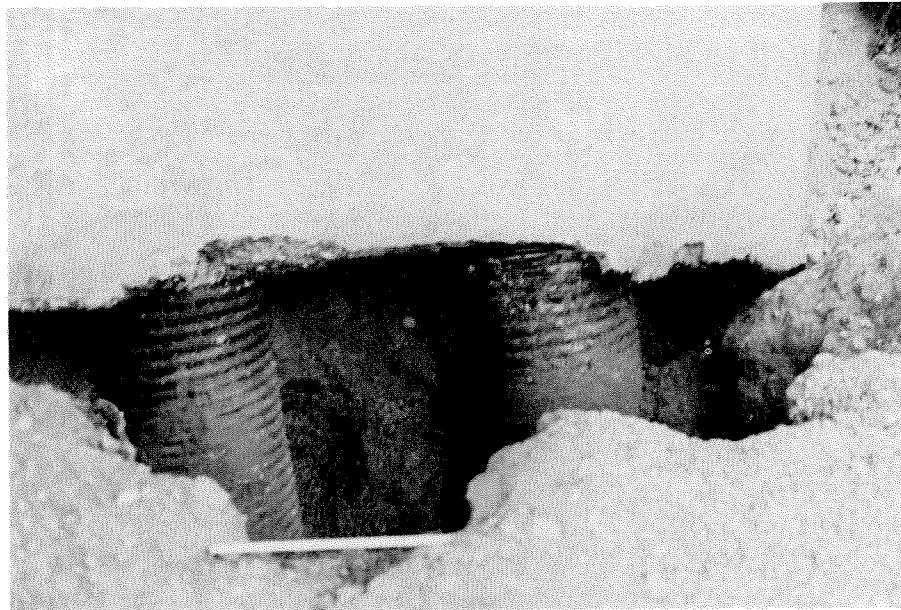
Figure 4.21 Lateral movement of Roxford Street bridge on abutments has failed tops of piles. (Foothill freeway).
