ENGINEERING FEATURES
OF THE
SAN FERNANDO EARTHQUAKE OF FEBRUARY 9, 1971

Paul C. Jennings, Editor

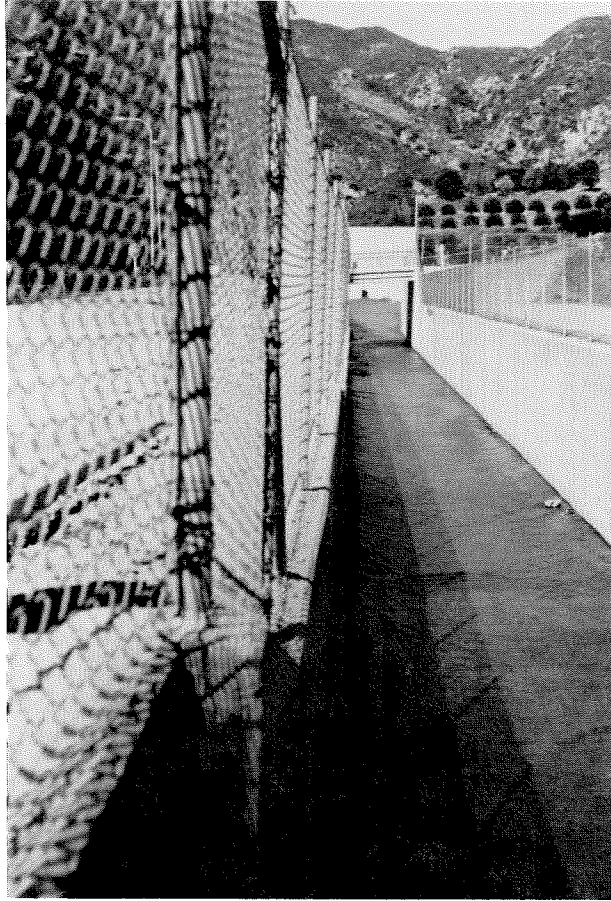
Figure 4.22 Motion of retaining wall of flood control channel towards channel. Joint in foreground has displaced about 4 inches; joint in middle distance about 2 inches. Near Olive View Hospital.

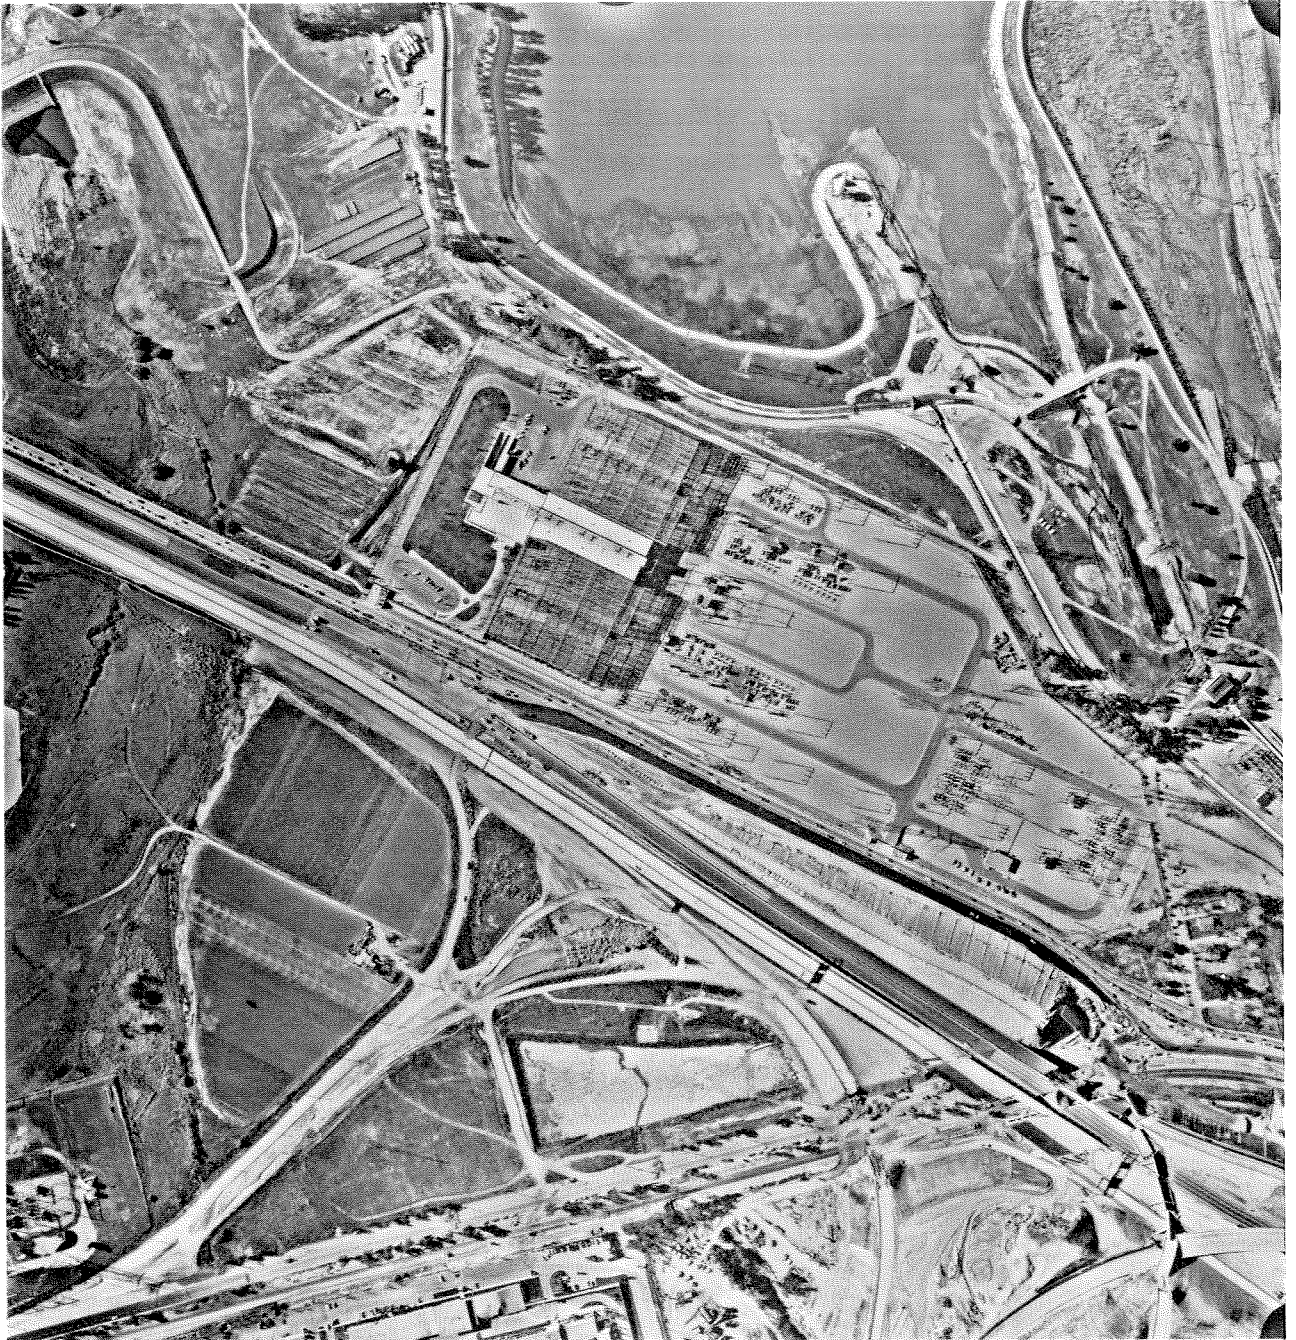
Figure 5.1 Aerial photo showing Sylmar Converter Station (near center of photo), Sylmar Switching Station (right center of photo), a portion of the Foothill-Golden State freeway interchange (lower right corner), Juvenile Facility (just visible at lower edge of photo), Olive Switching Station (lower left corner) and a portion of the upper Van Norman Reservoir (upper edge of photo). The center line of the photograph from bottom to top points in a south by southwesterly direction.

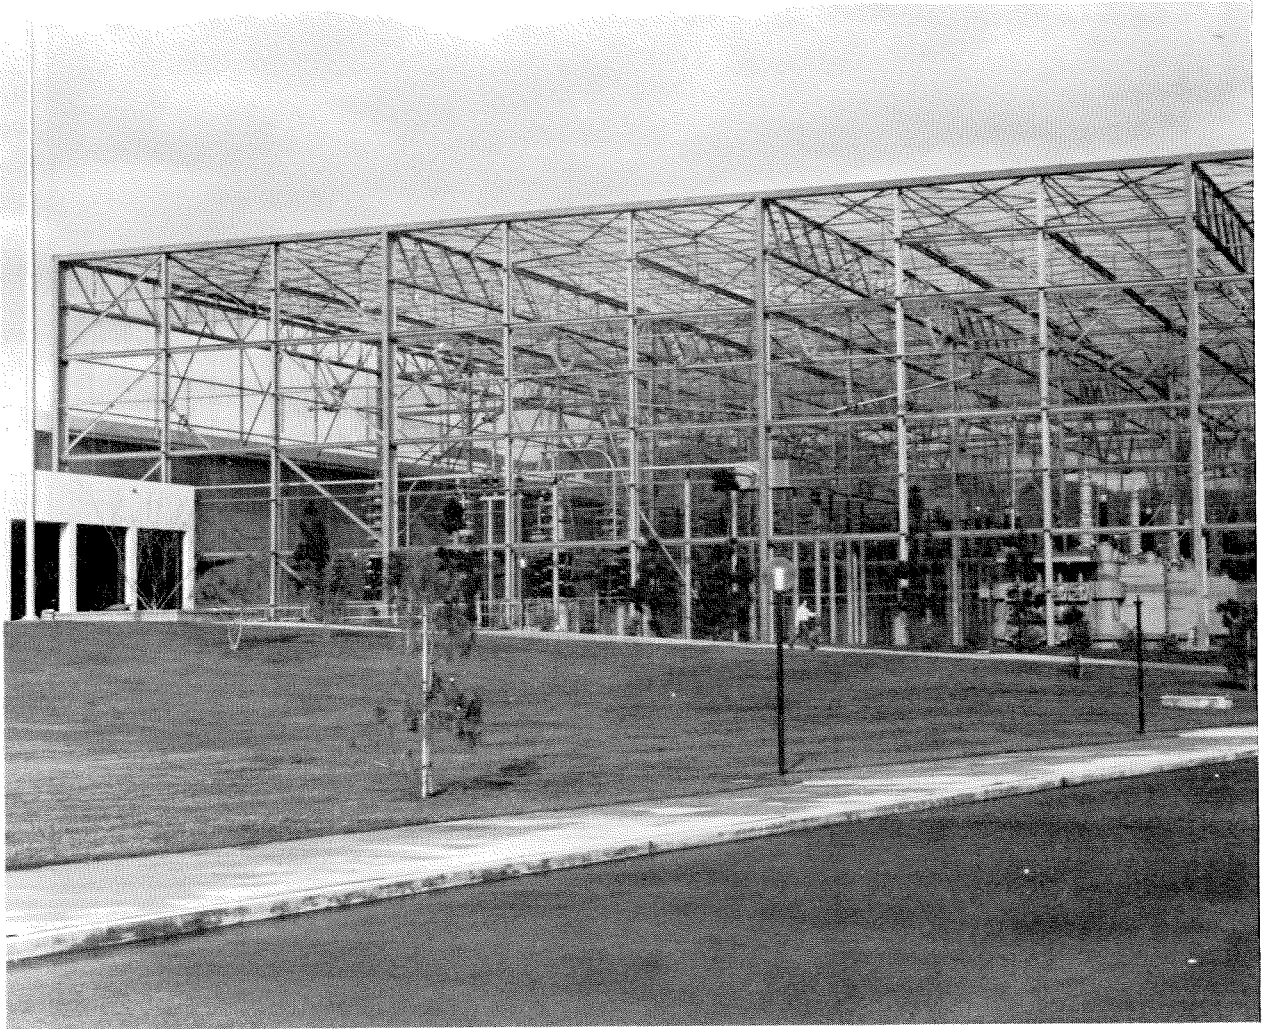
Figure 5. 3 "Birdcage" on east side of Sylmar Converter Station. The crossbracing of the cage was damaged and some of the equipment suspended from the roof of the cage was damaged.

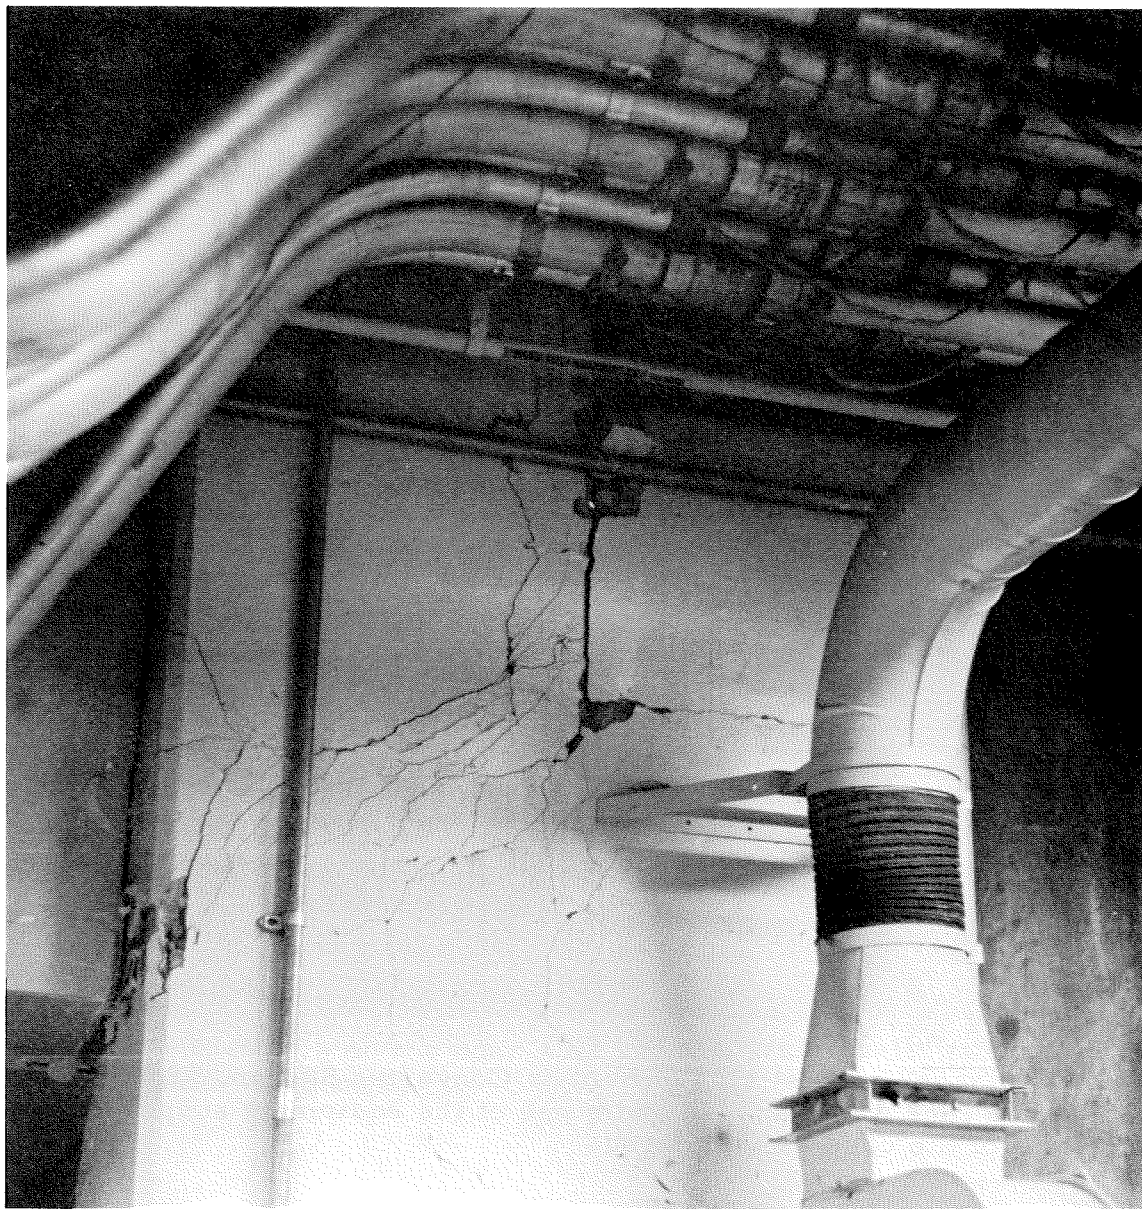
Figure 5.4 Basement support column at juncture of service section and the valve section, Sylmar Converter Station. The two sections of the building tended to move independently, fracturing the common support column.

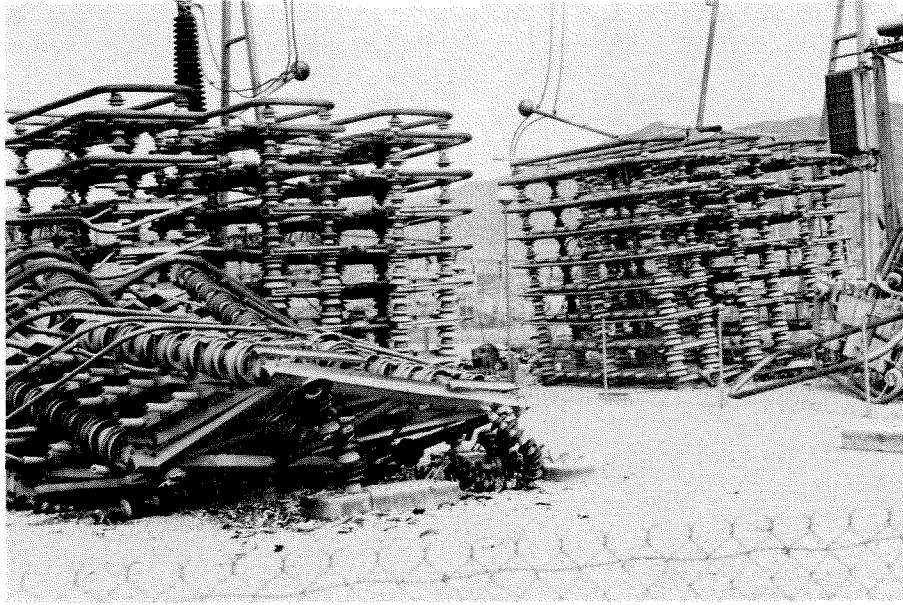
Figure 5. 15 Damaged capacitor stacks in yard north of service and equipment building, Sylmar Converter Station

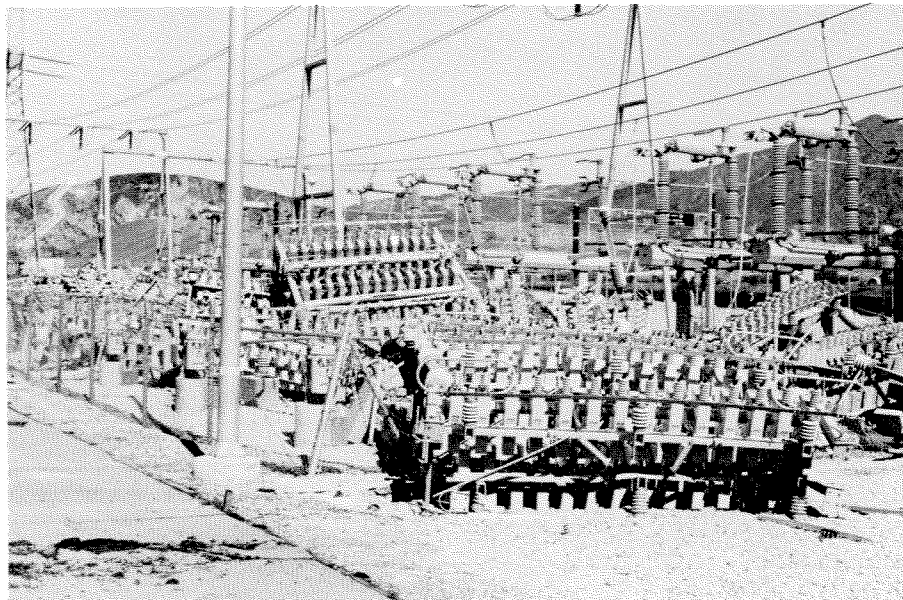
Figure 5. 16 Damaged capacitor stacks in yard north of service and equipment building, Sylmar Converter Station.

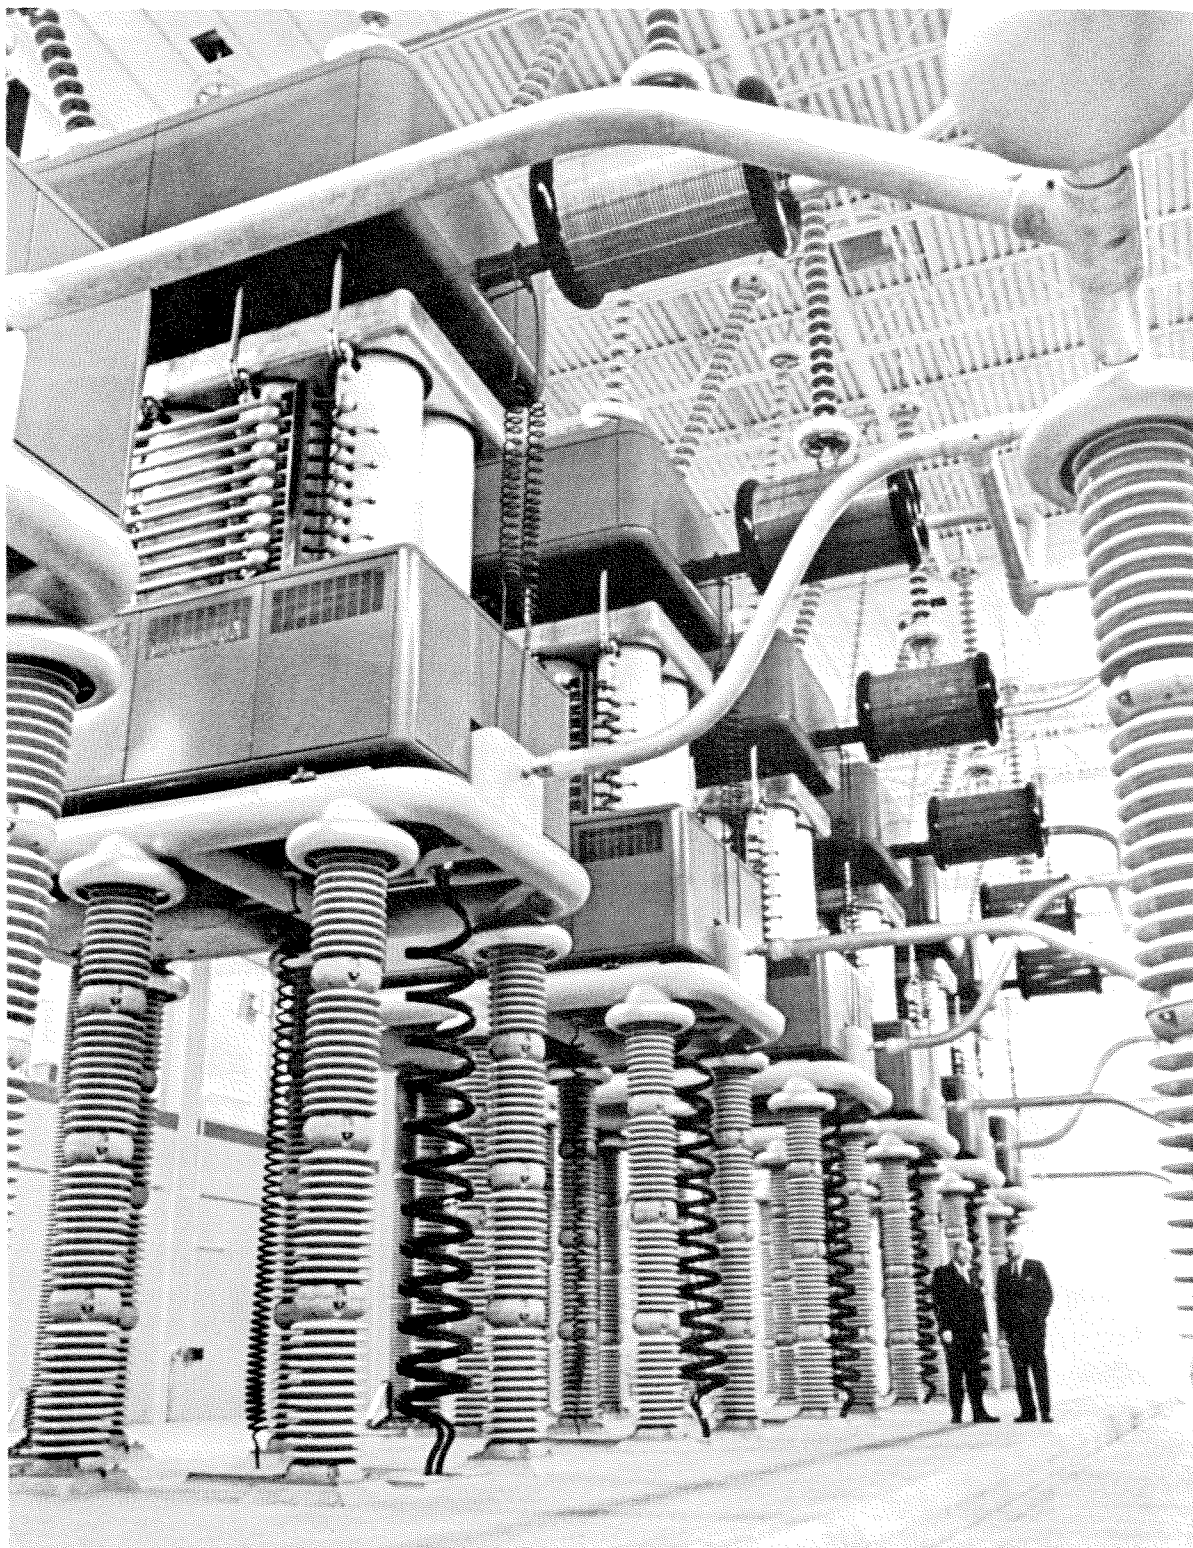
Figure 5.7 View of a portion of the "valve hall" of the Sylmar Converter Station before the earthquake.

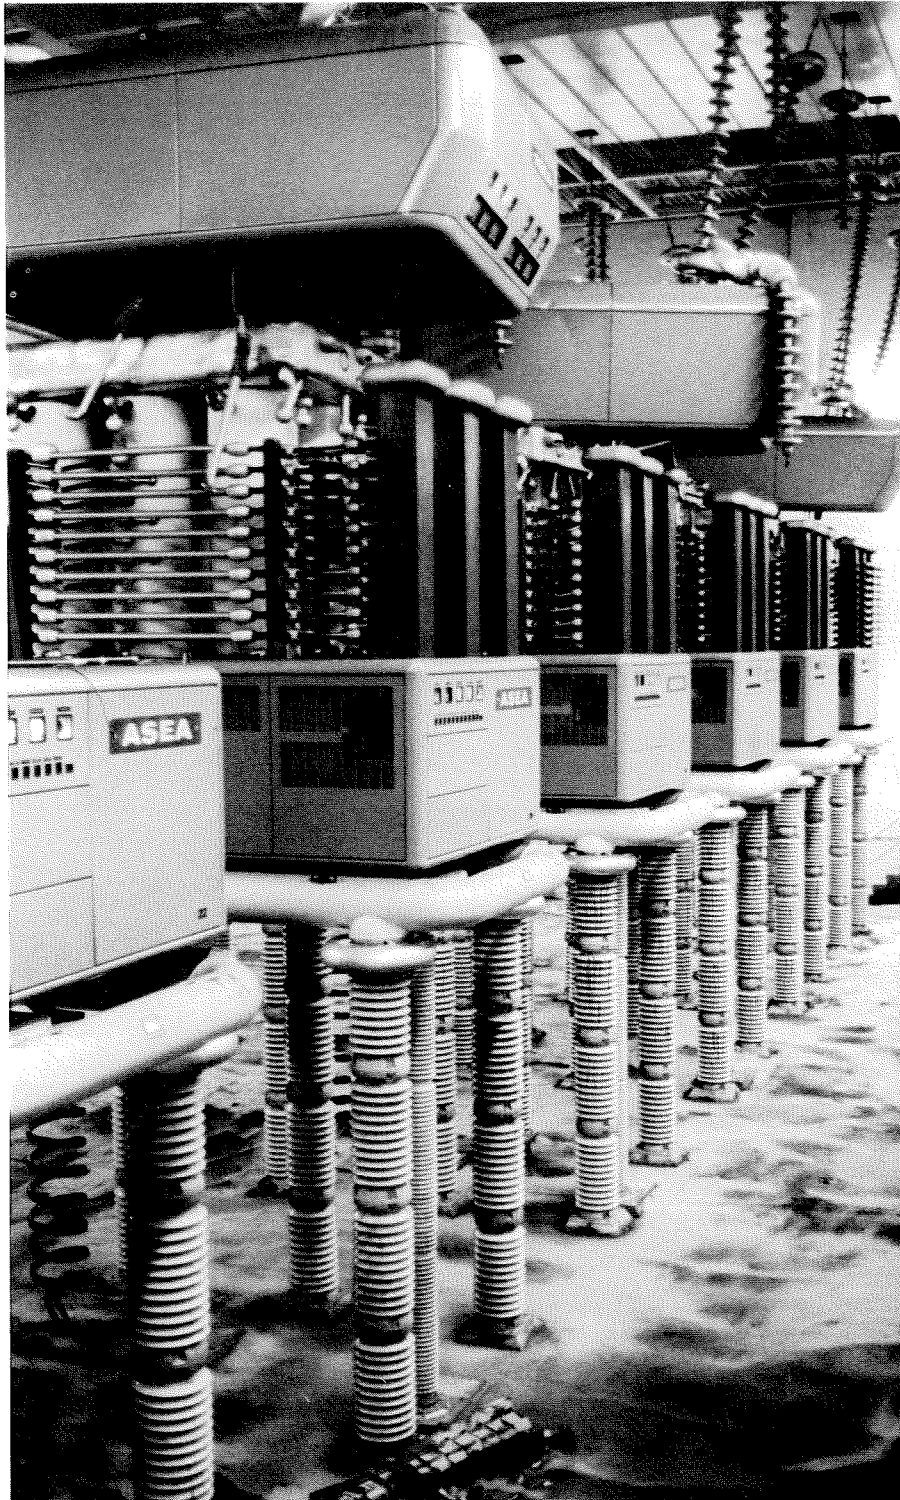
Figure 5.8 View of the "valve hall" of the Sylmar Converter Station after the earthquake. Porcelain supports were not damaged by the ground motion.

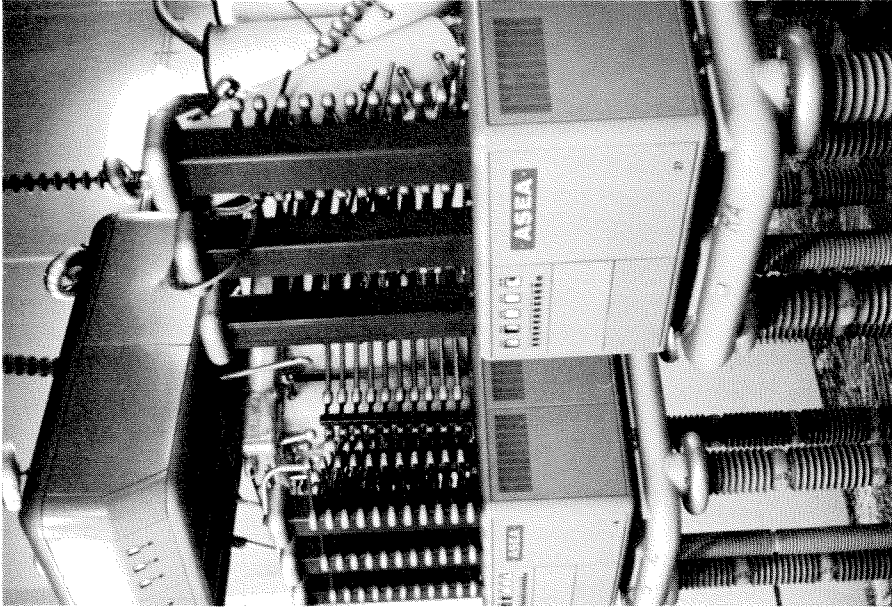
Figure 5.10 Valve assembly and current divider, Sylmar Converter Station. Note damage to anodes caused by current divider in near unit.

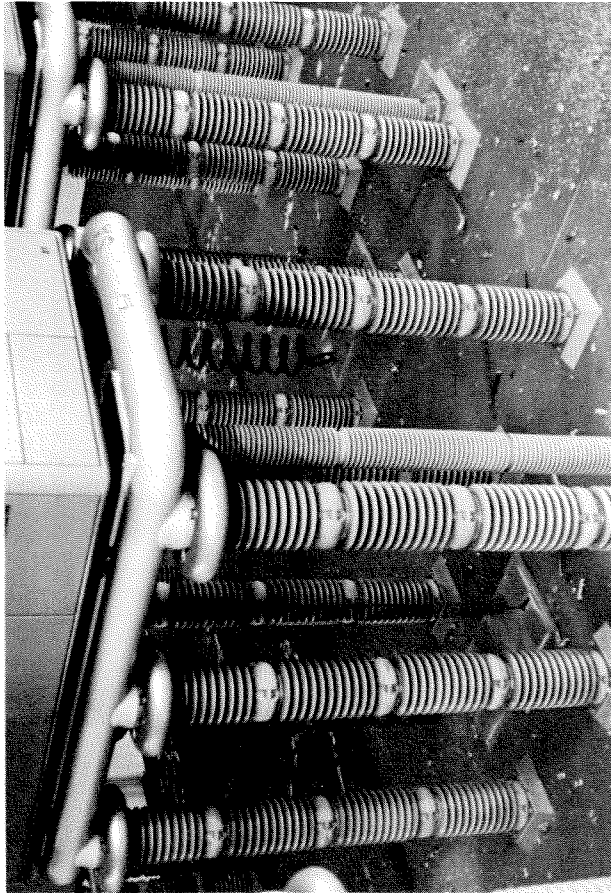
Figure 5.9 Support structure for valve assembly, Sylmar Converter Station.

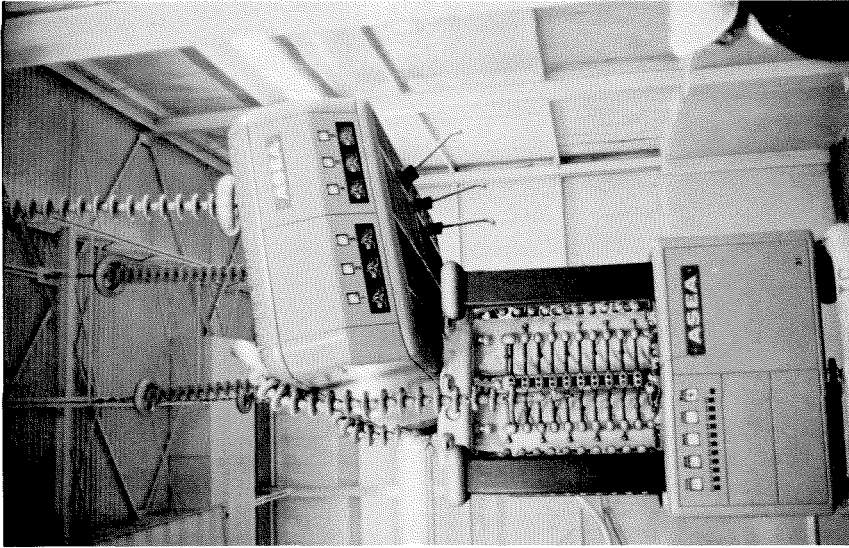
Figure 5.12 View of valve assembly, showing failure of current divider suspension, Sylmar Converter Station.

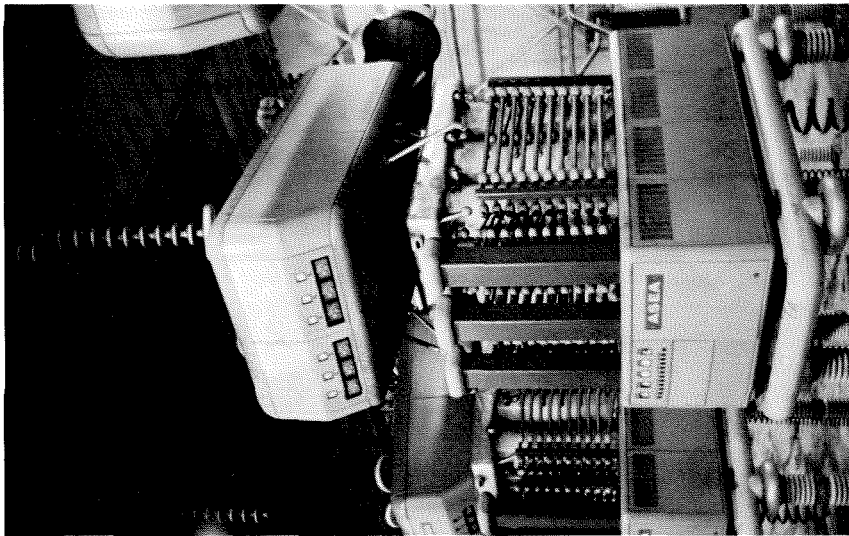
Figure 5.11 View of valve assembly, showing failure of current divider suspension, Sylmar Converter Station.

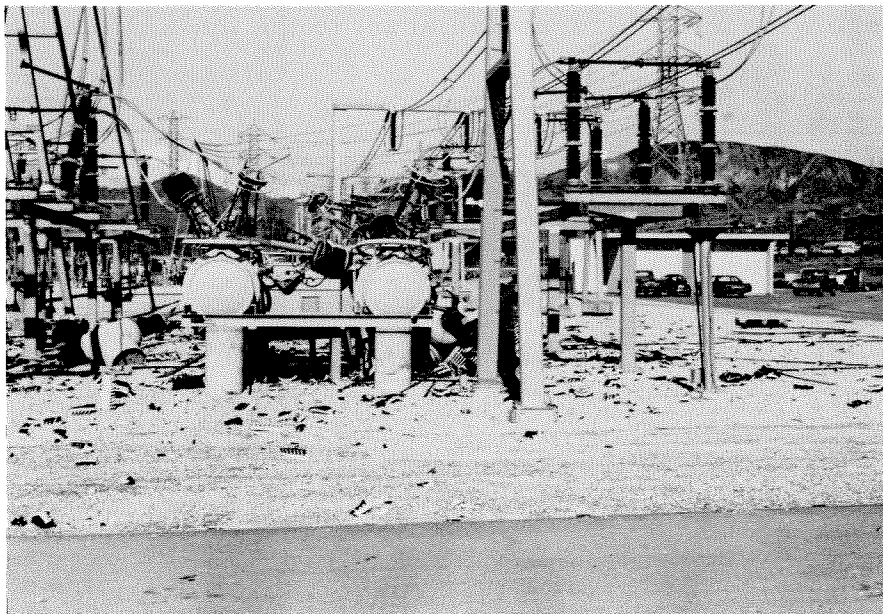
Figure 5.13 Air-blast circuit breakers, Sylmar Switching Station.

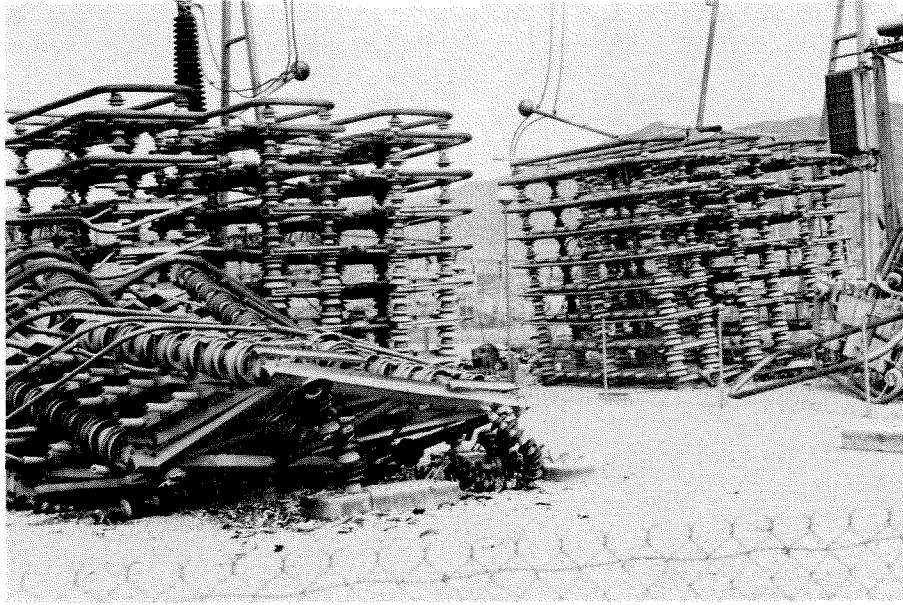
Figure 5. 15 Damaged capacitor stacks in yard north of service and equipment building, Sylmar Converter Station

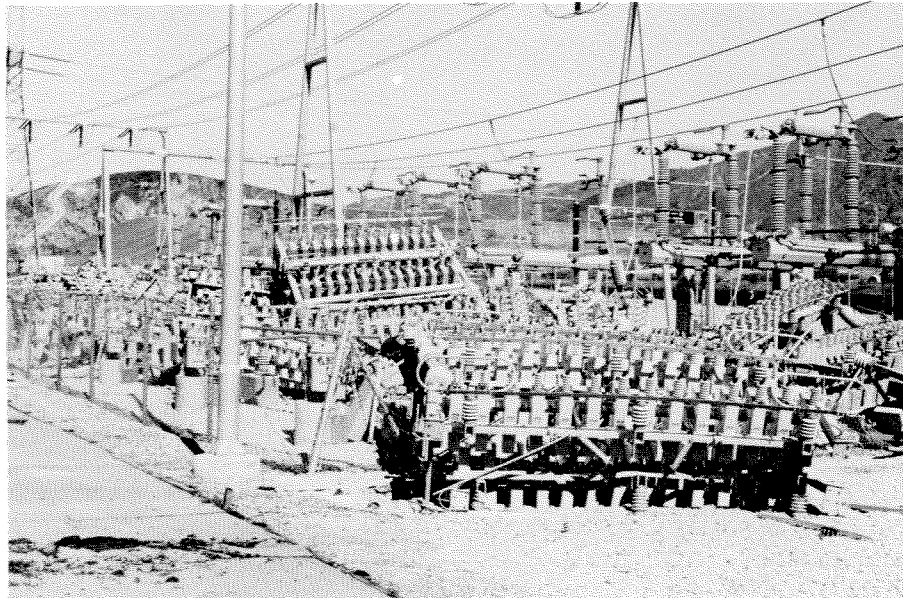
Figure 5. 16 Damaged capacitor stacks in yard north of service and equipment building, Sylmar Converter Station.

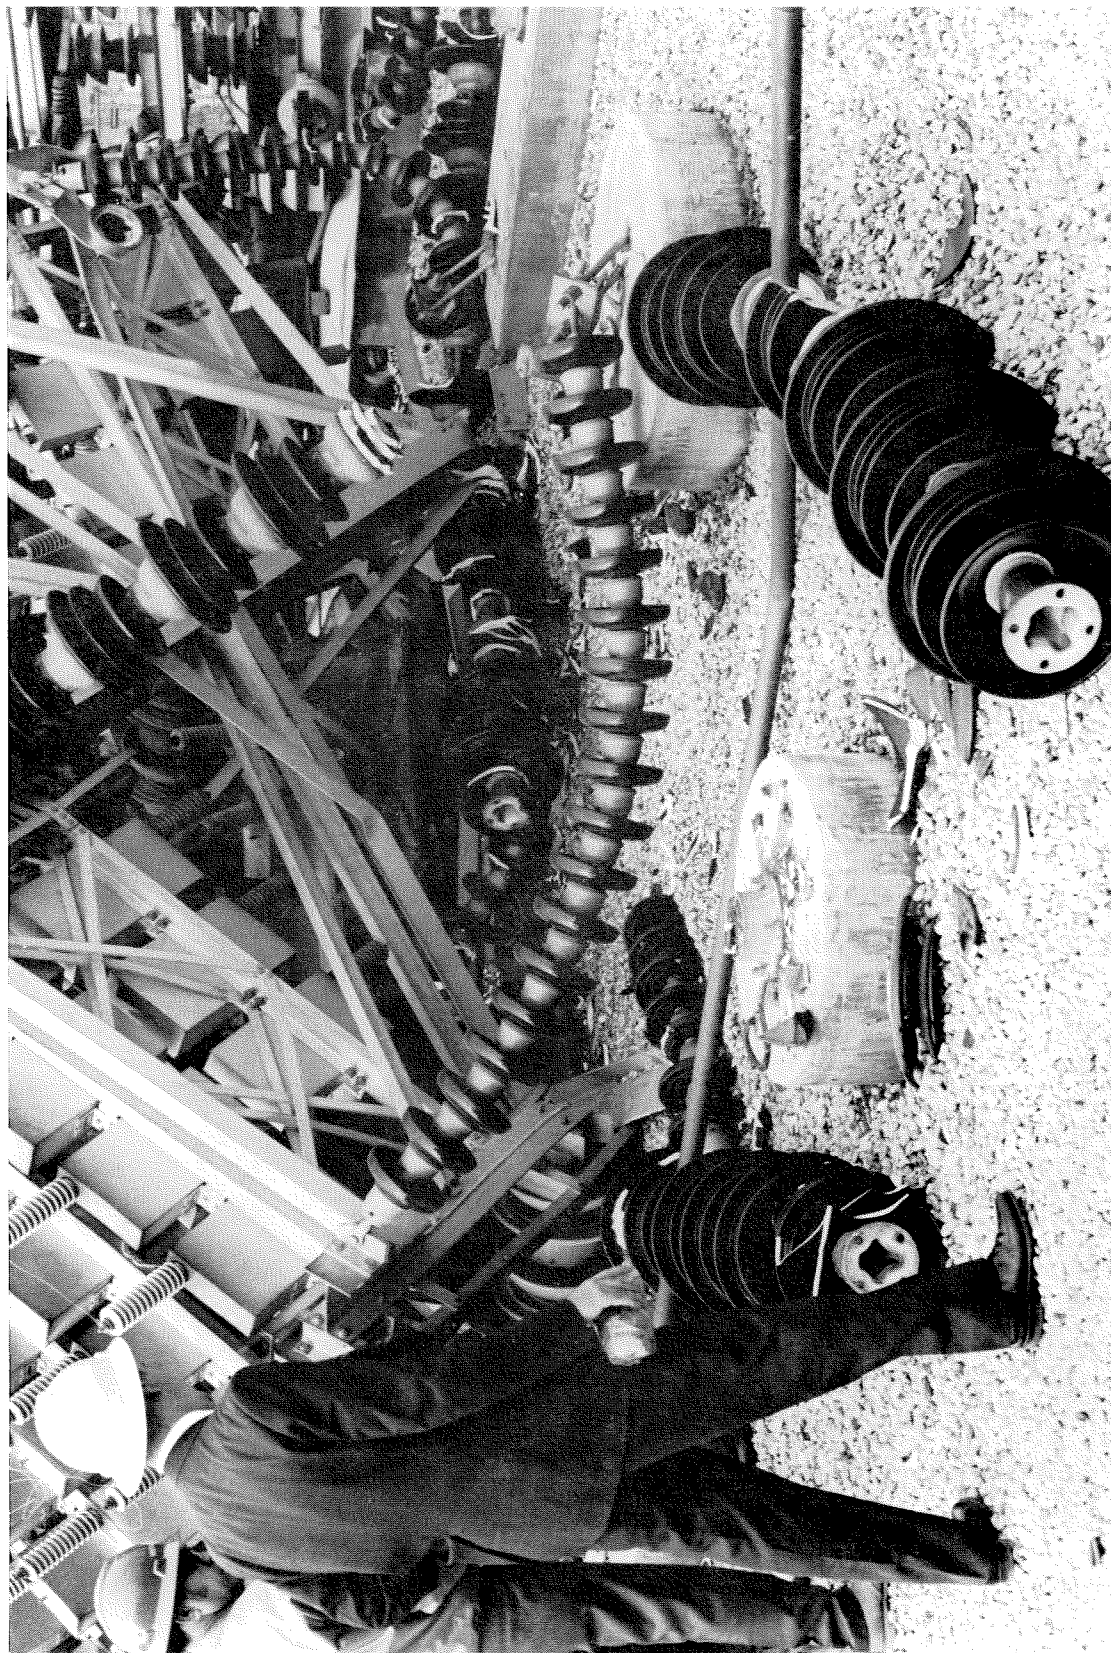
Figure 5. 17 Detailed view of fallen capacitor stacks, Sylmar Converter Station.

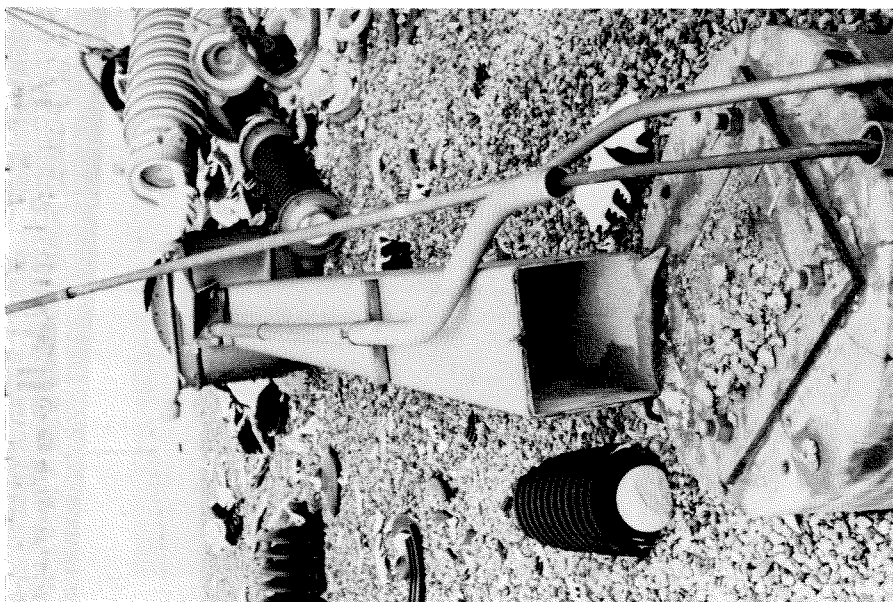
Figure 5.24 Failed equipment support in yard of Sylmar Converter Station.

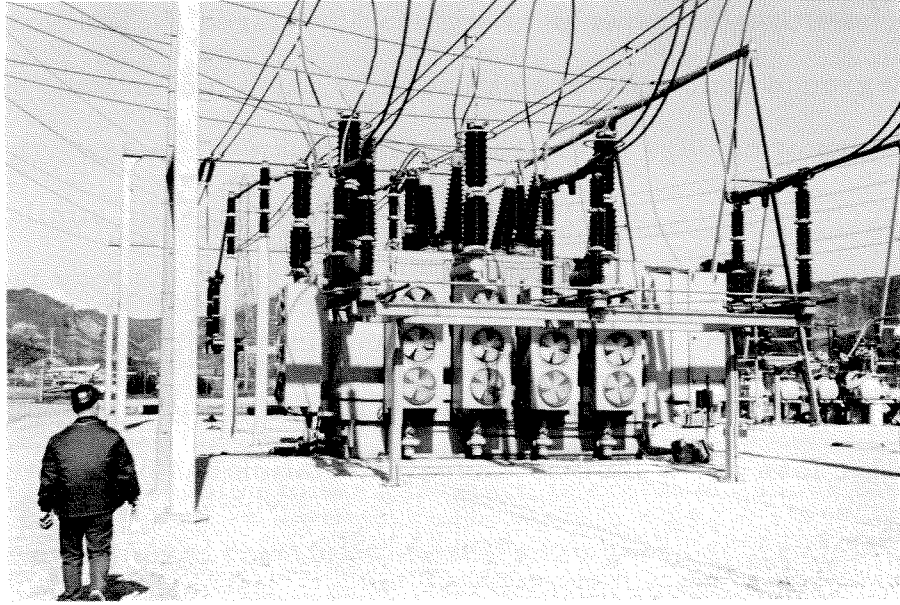
Figure 5.26 View of relatively undamaged equipment at the Sylmar Converter Station.

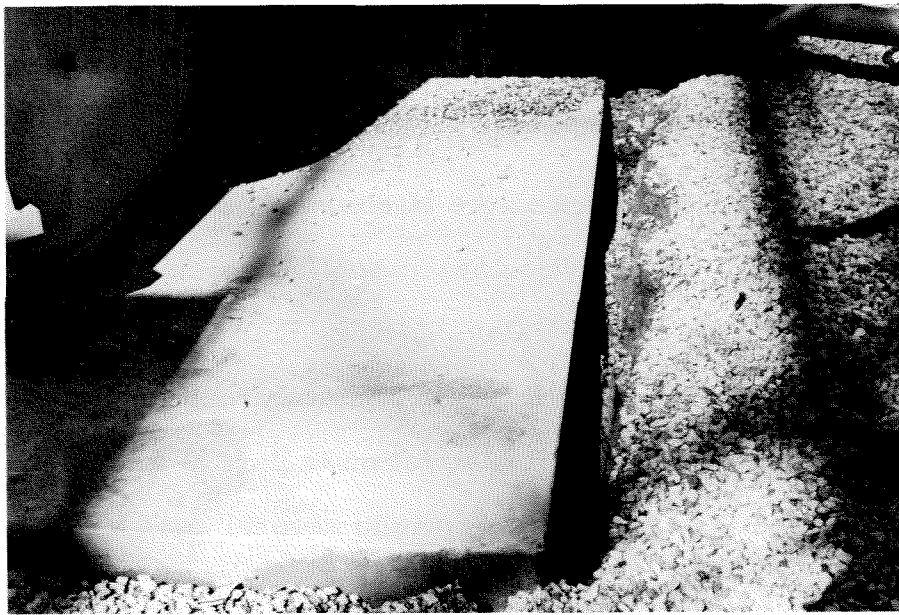
Figure 5.27 Valve transformer footing, showing evidence of footing movement. Sylmar Converter Station.

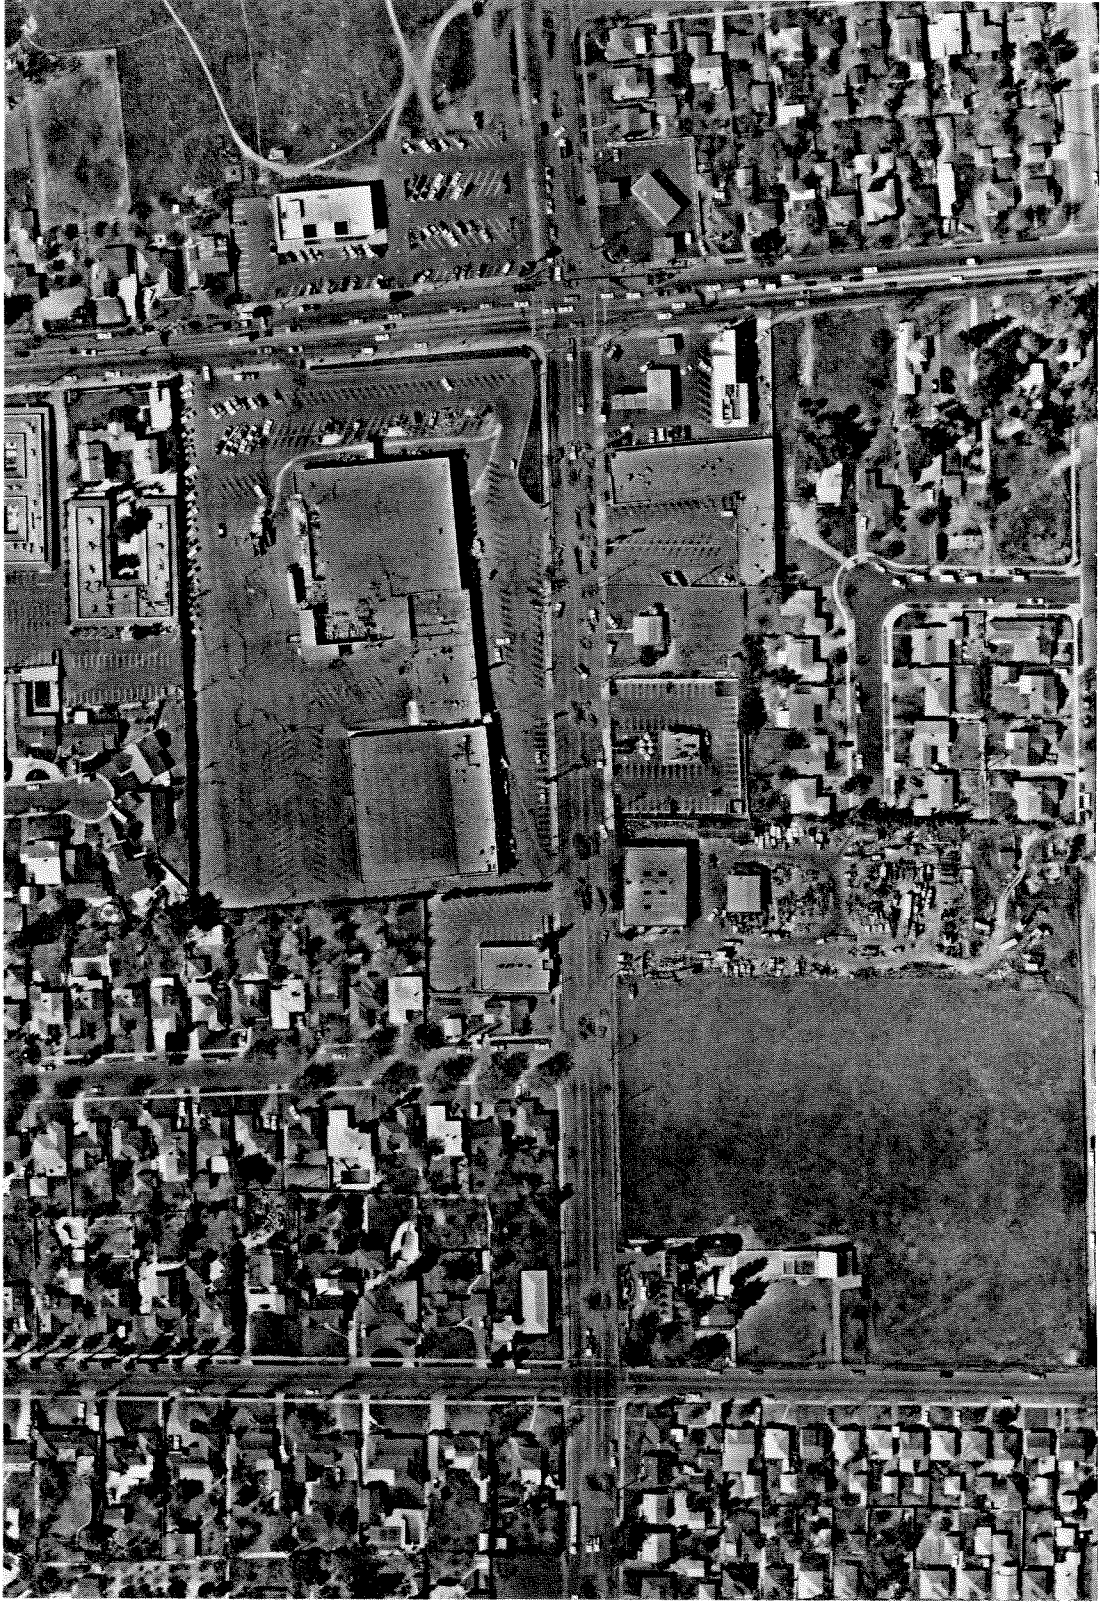
Figure 5. 28 Aerial photo of area near intersection of Hubbard Street and Glenoaks Boulevard showing craters from ruptured gas main.

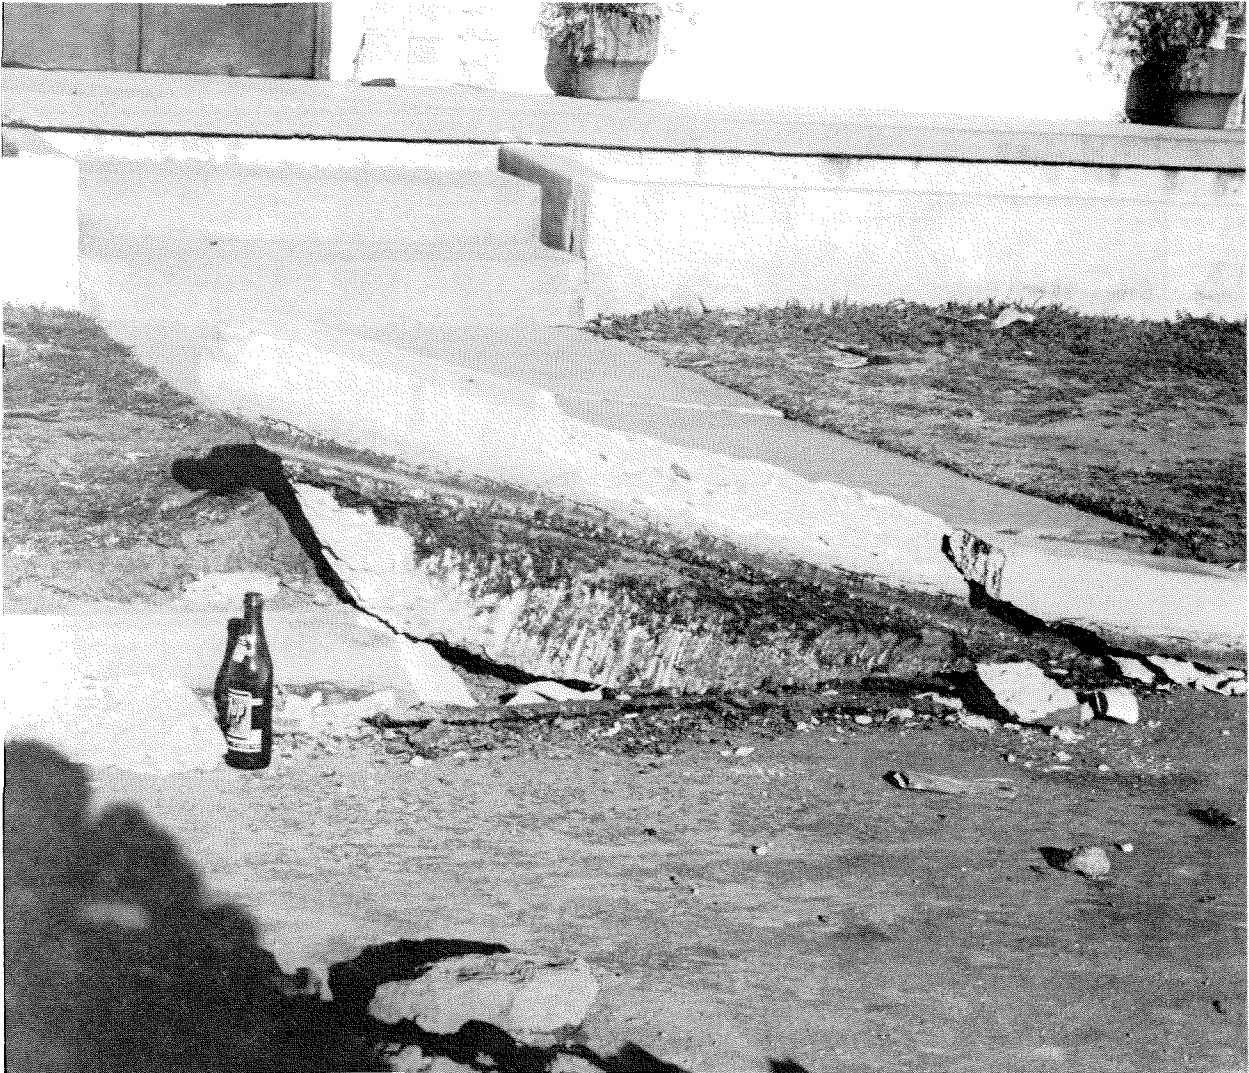
Figure 5.29 Shattered curb on northeast side of Glenoaks Boulevard about one block southeast of Hubbard Street. This approximately 18" of displacement of curb reflects the compressive deformation of the soil along this street where numerous gas line failures occurred.

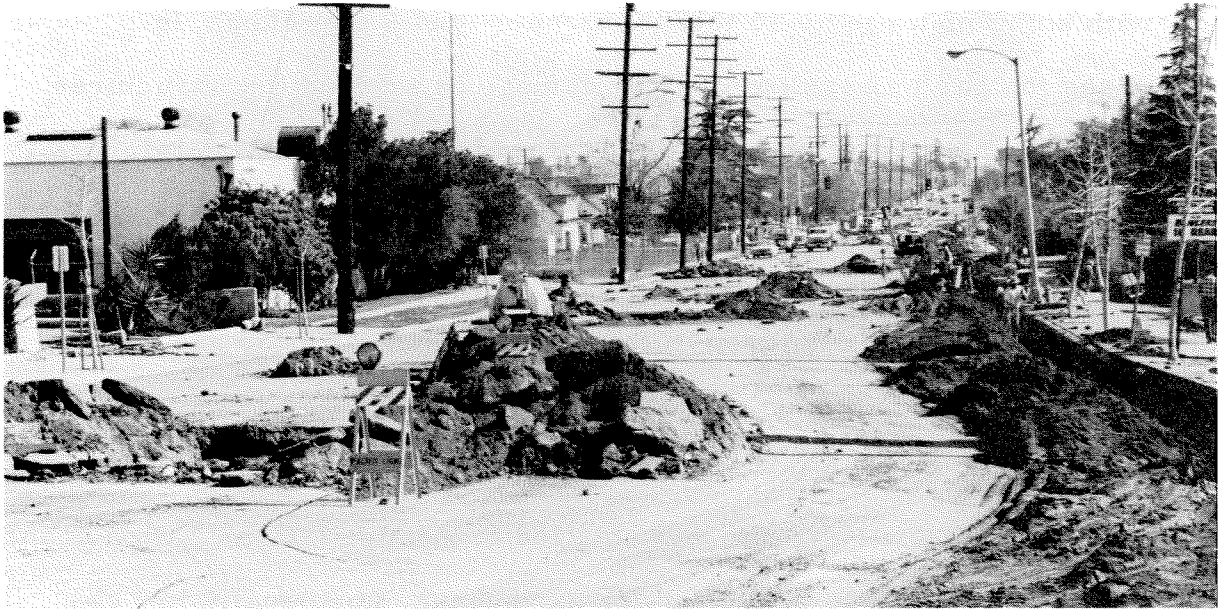
Figure 5.30 Craters from ruptured gas main on Glenoaks Boulevard. Fourteen such craters were formed.

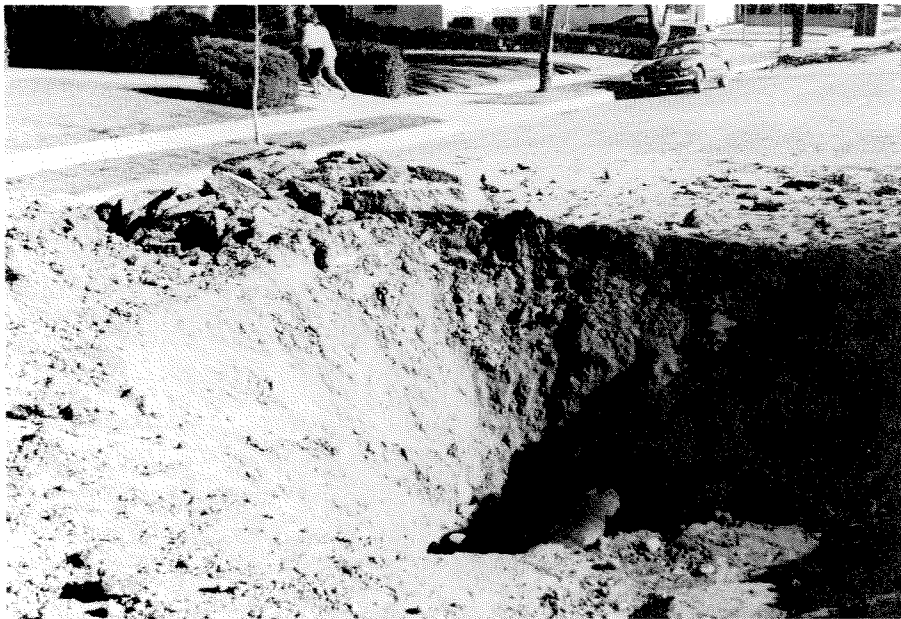
Figure 5.31 Crater from ruptured gas main on Glenoaks Boulevard. The 16 in diameter line has already been repaired.

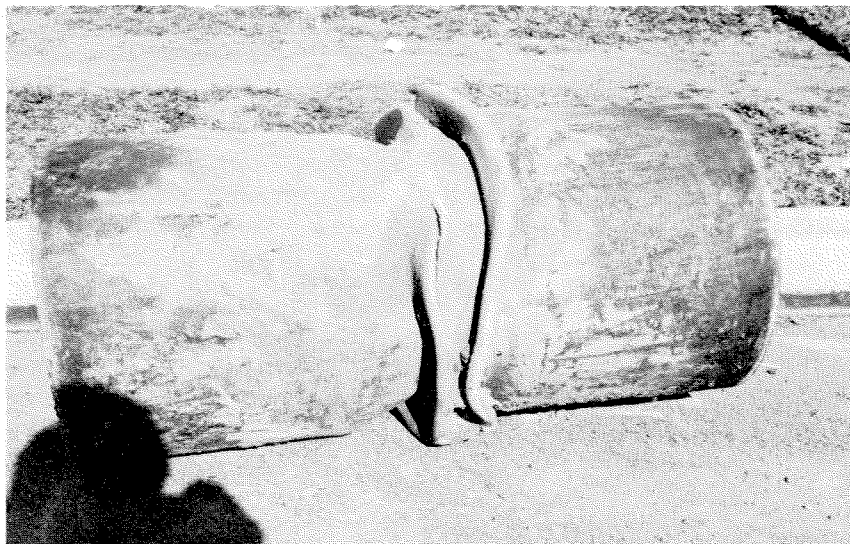
Figure 5.32 Section of 16 in ruptured gas line from Glenoaks Boulevard.

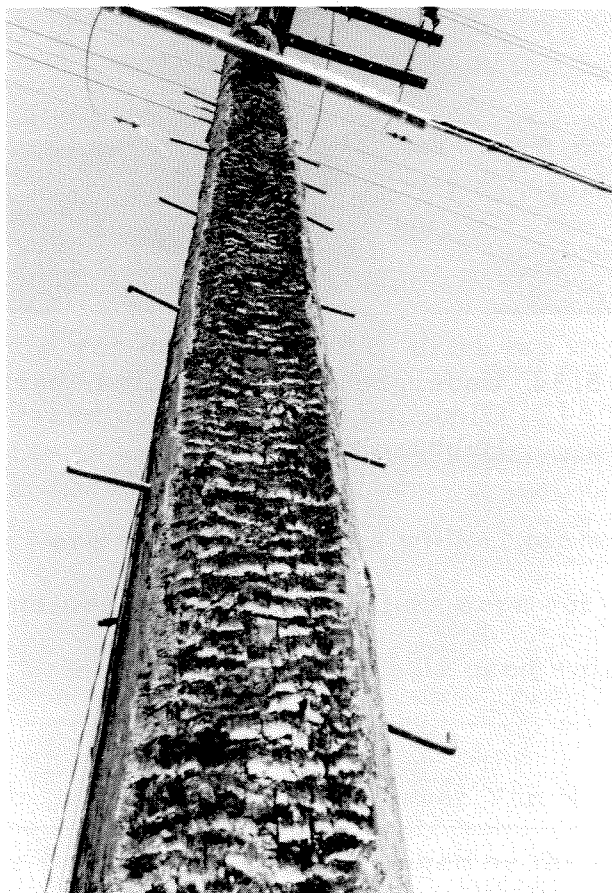
Figure 5.33 Utility pole damaged by fire following rupture of gas main on Glenoaks Boulevard.
