ENGINEERING FEATURES
OF THE
SAN FERNANDO EARTHQUAKE OF FEBRUARY 9, 1971

Paul C. Jennings, Editor

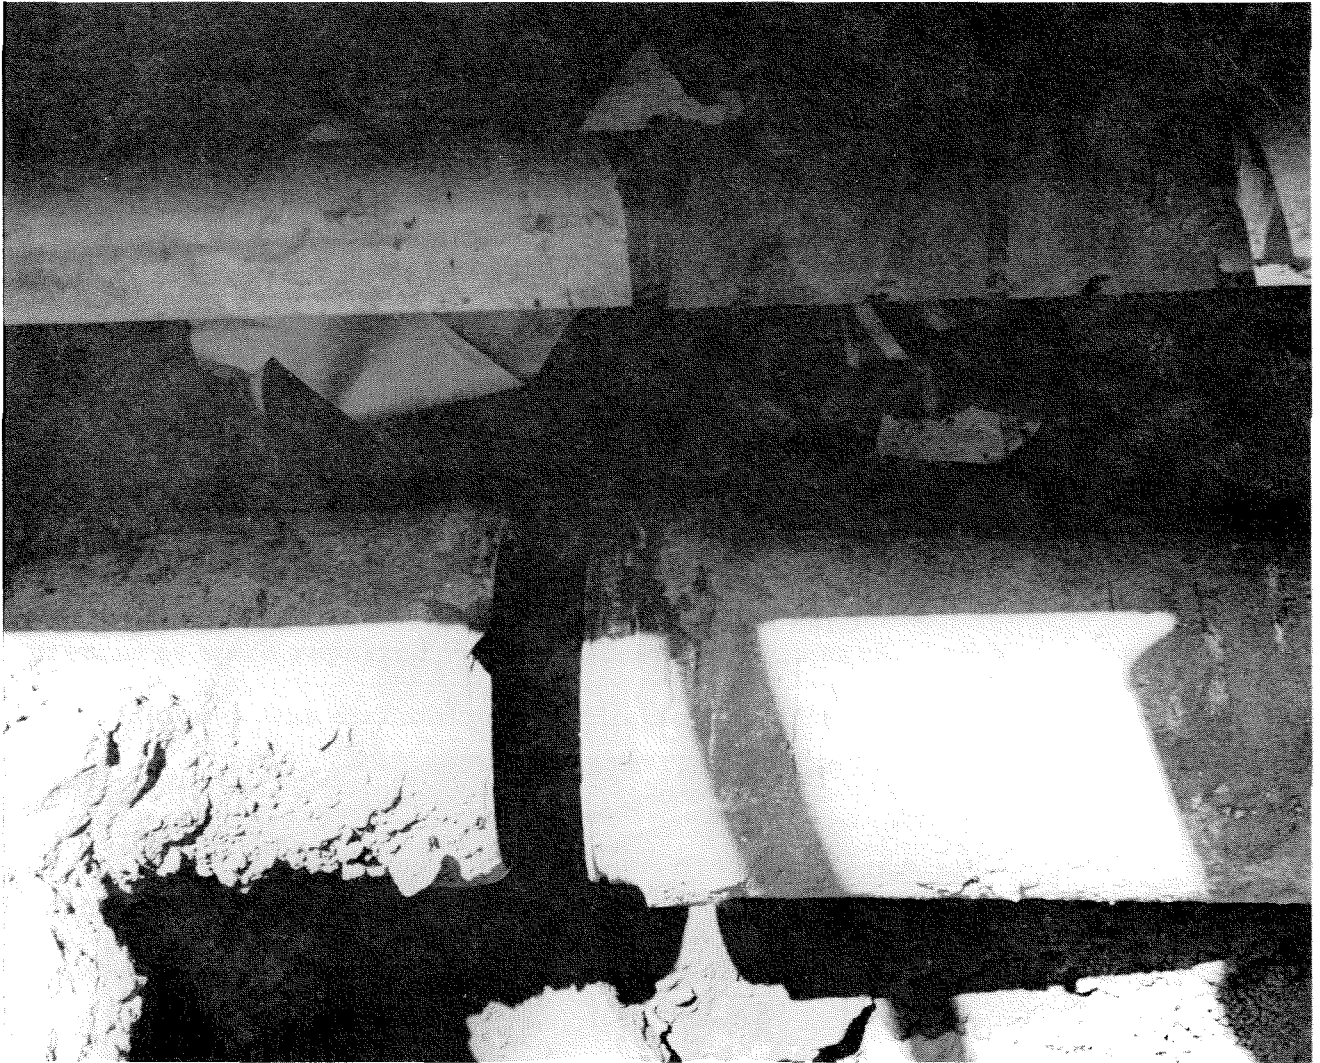
Figure 5.34. Underground pipes pulled apart on
Glenoaks Street just southeast of
Hubbard Street.

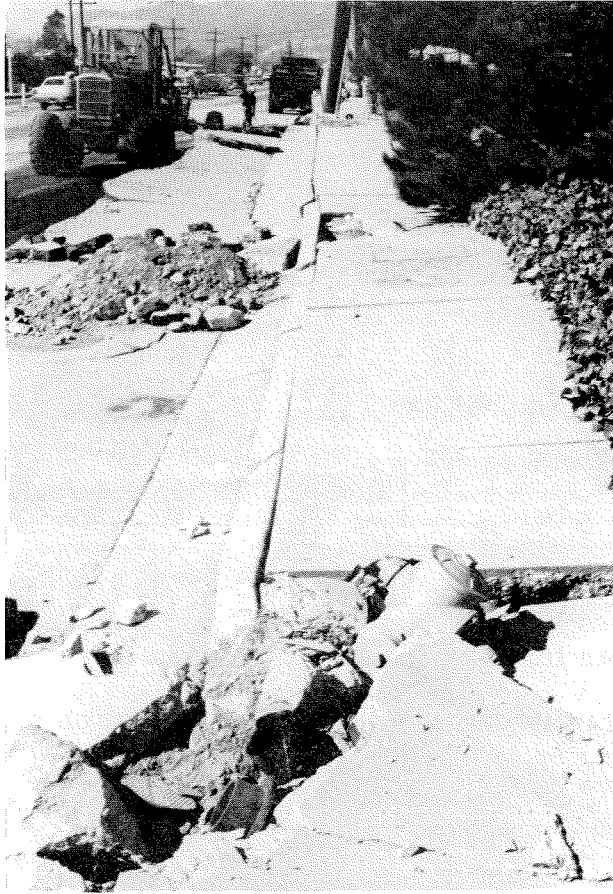
Figure 5.35 Fire hydrant broken by ground movements, Sylmar area.

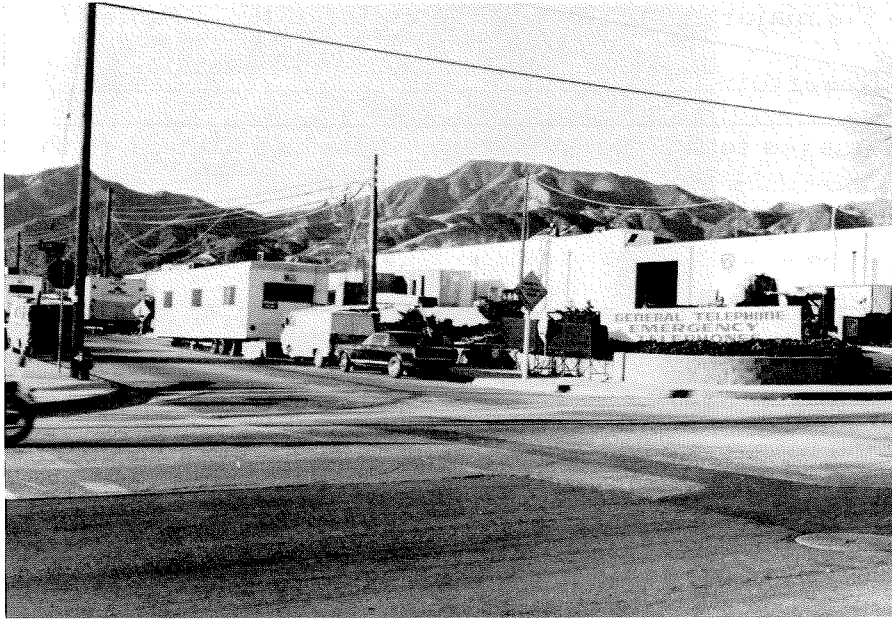
Figure 5. 36 General Telephone switching facility at Polk Street and Borden Avenue.

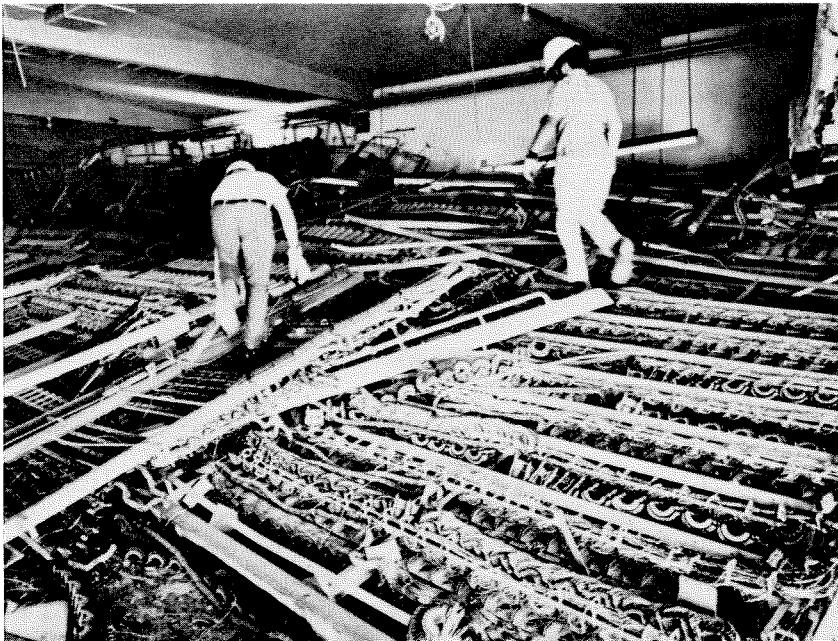
Figure 5.37 Interior of damaged General Telephone switching facility at Polk Street and Borden Avenue.

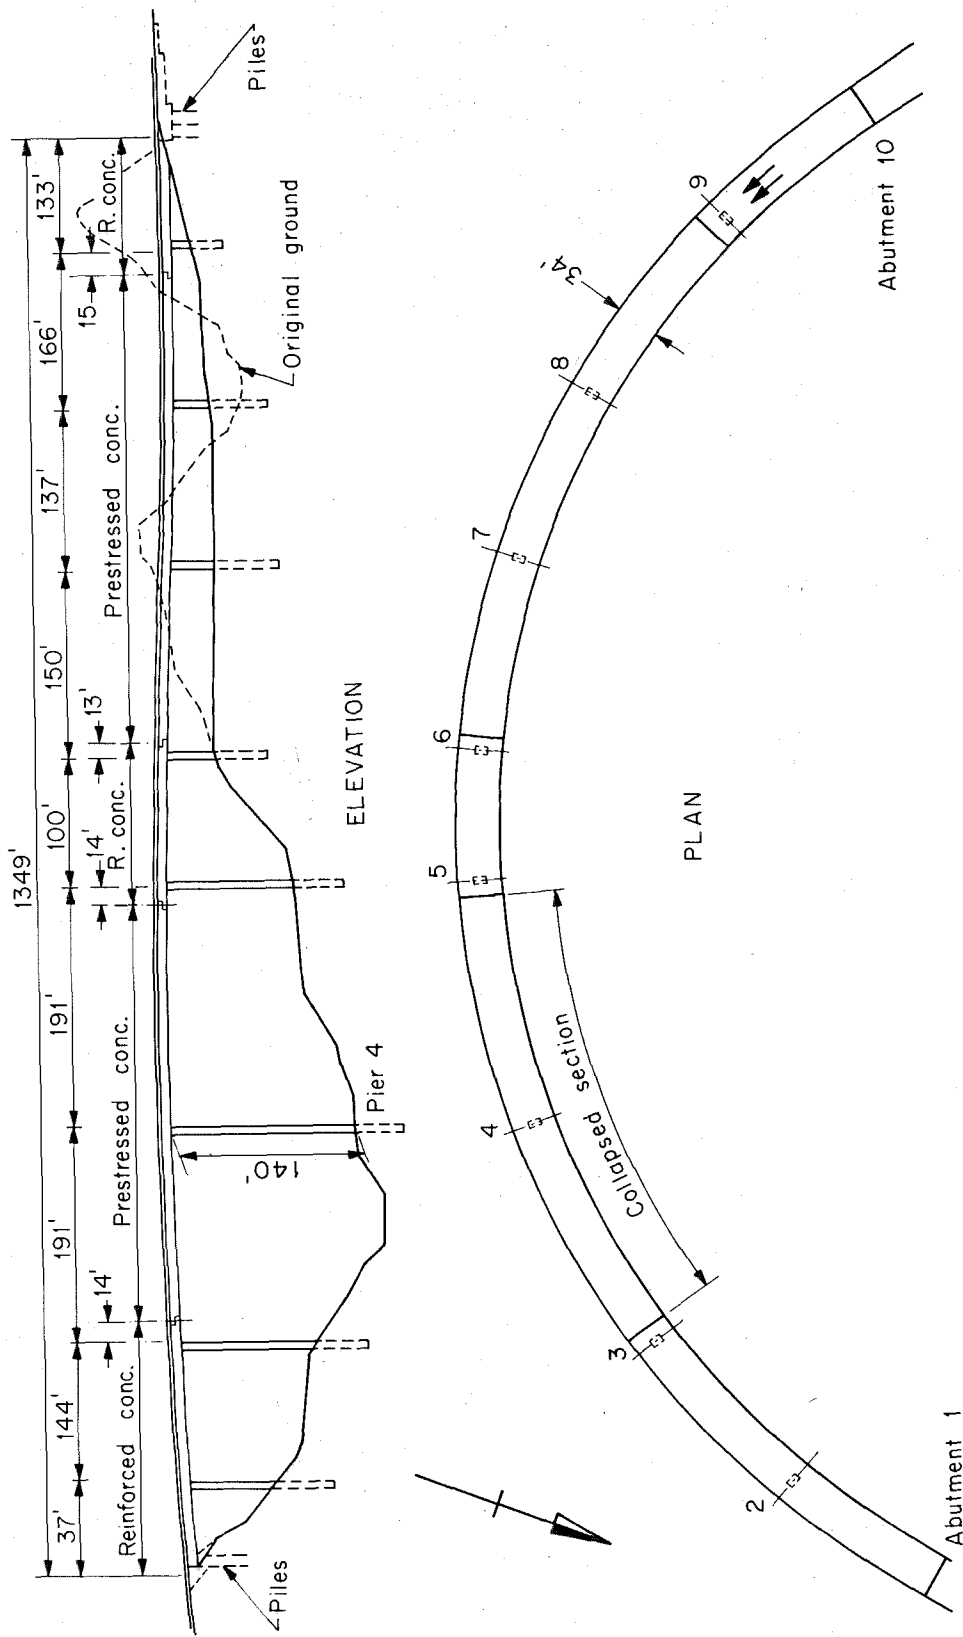
SOUTH CONNECTOR OVERCROSSING

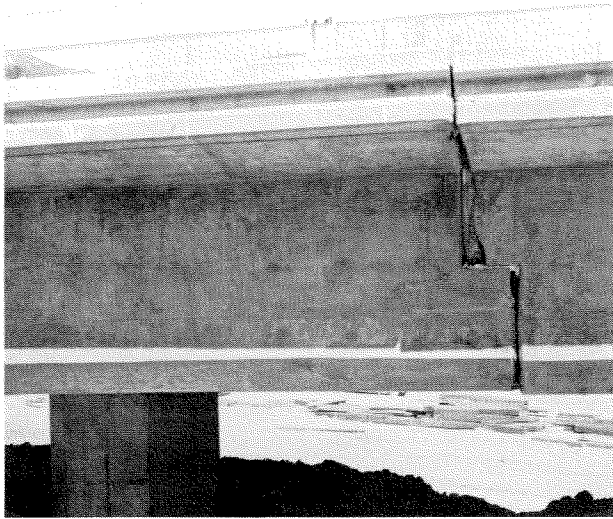
Figure 6.12 Damaged joint on the remaining western section of the collapsed overcrossing, Golden State-Antelope Valley freeway interchange.

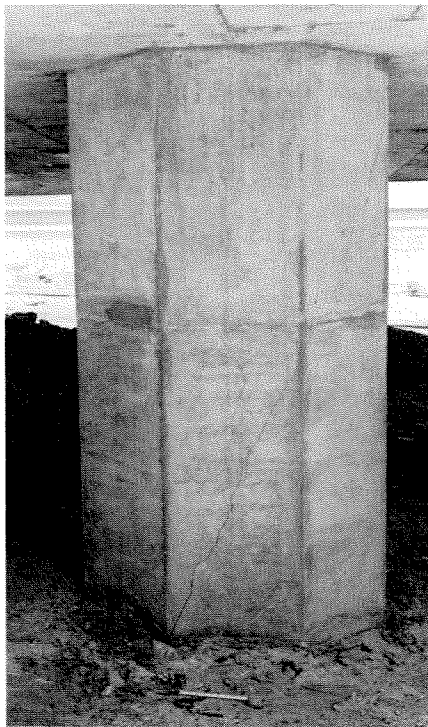
Figure 6.13 Damaged column on the remaining western section of the collapsed overcrossing, Golden State-Antelope Valley interchange.

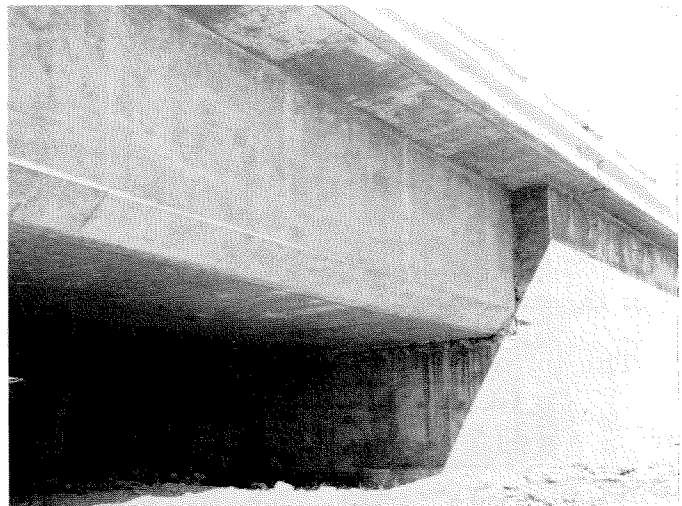
Figure 6.14 Abutment of the remaining eastern section of the collapsed overcrossing, Golden State-Antelope Valley freeway interchange.

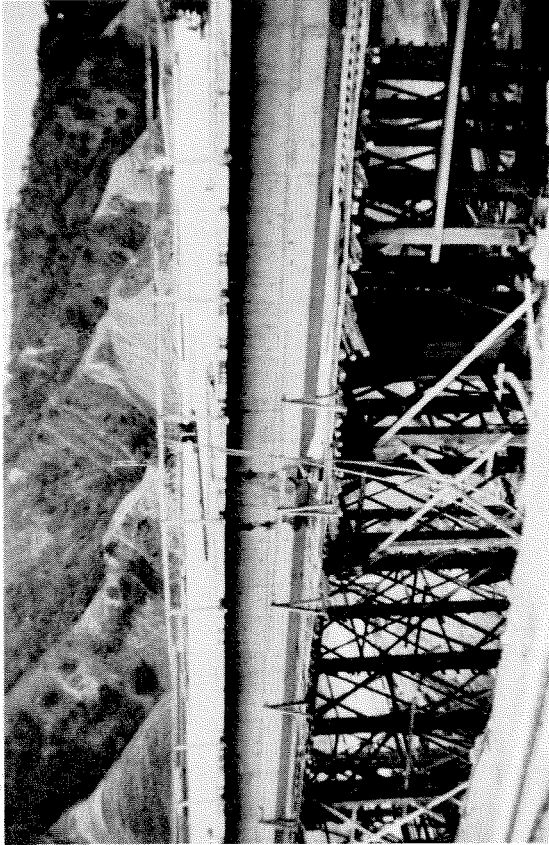
Figure 6.16 Damage caused by settlement of falsework, Golden State-Antelope Valley freeway interchange.

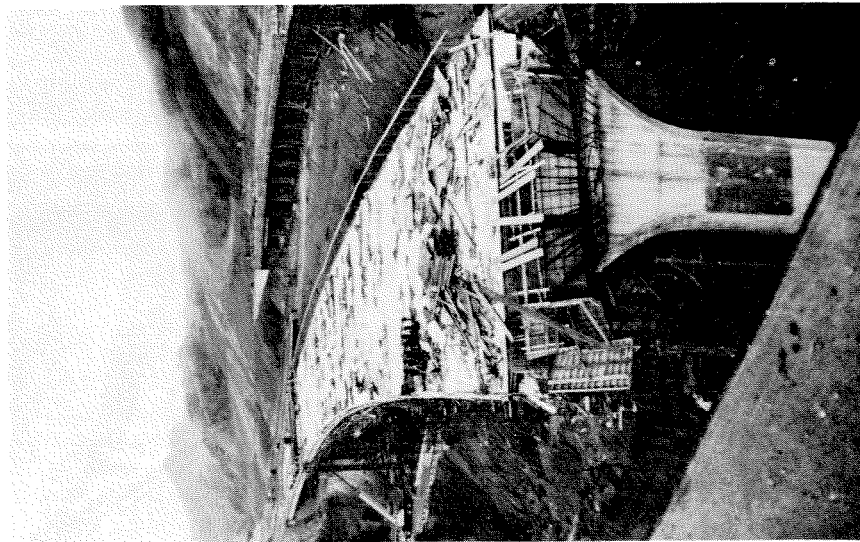
Figure 6.15 Bridge under construction at the time of the earthquake, Golden State-Antelope Valley freeway interchange.

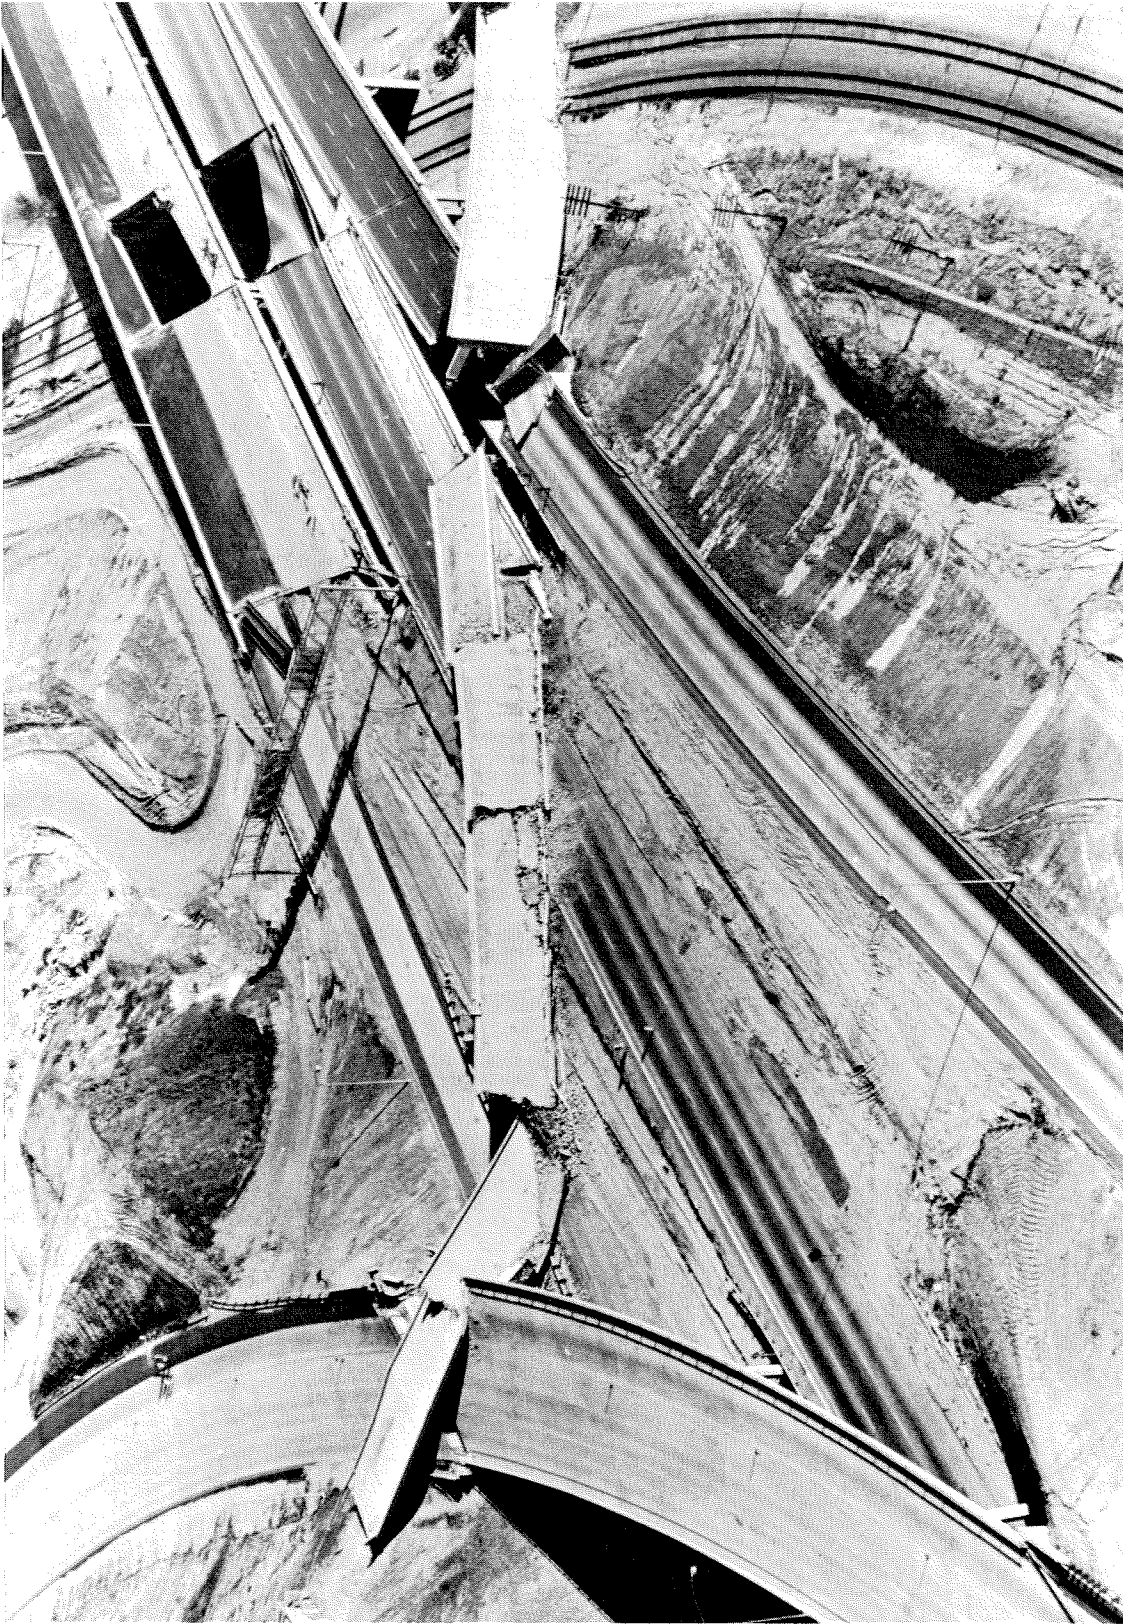
Figure 6.17 Earthquake damage to Golden State-Foothill freeway interchange. L.A. Times photograph. Taken the day of the earthquake.

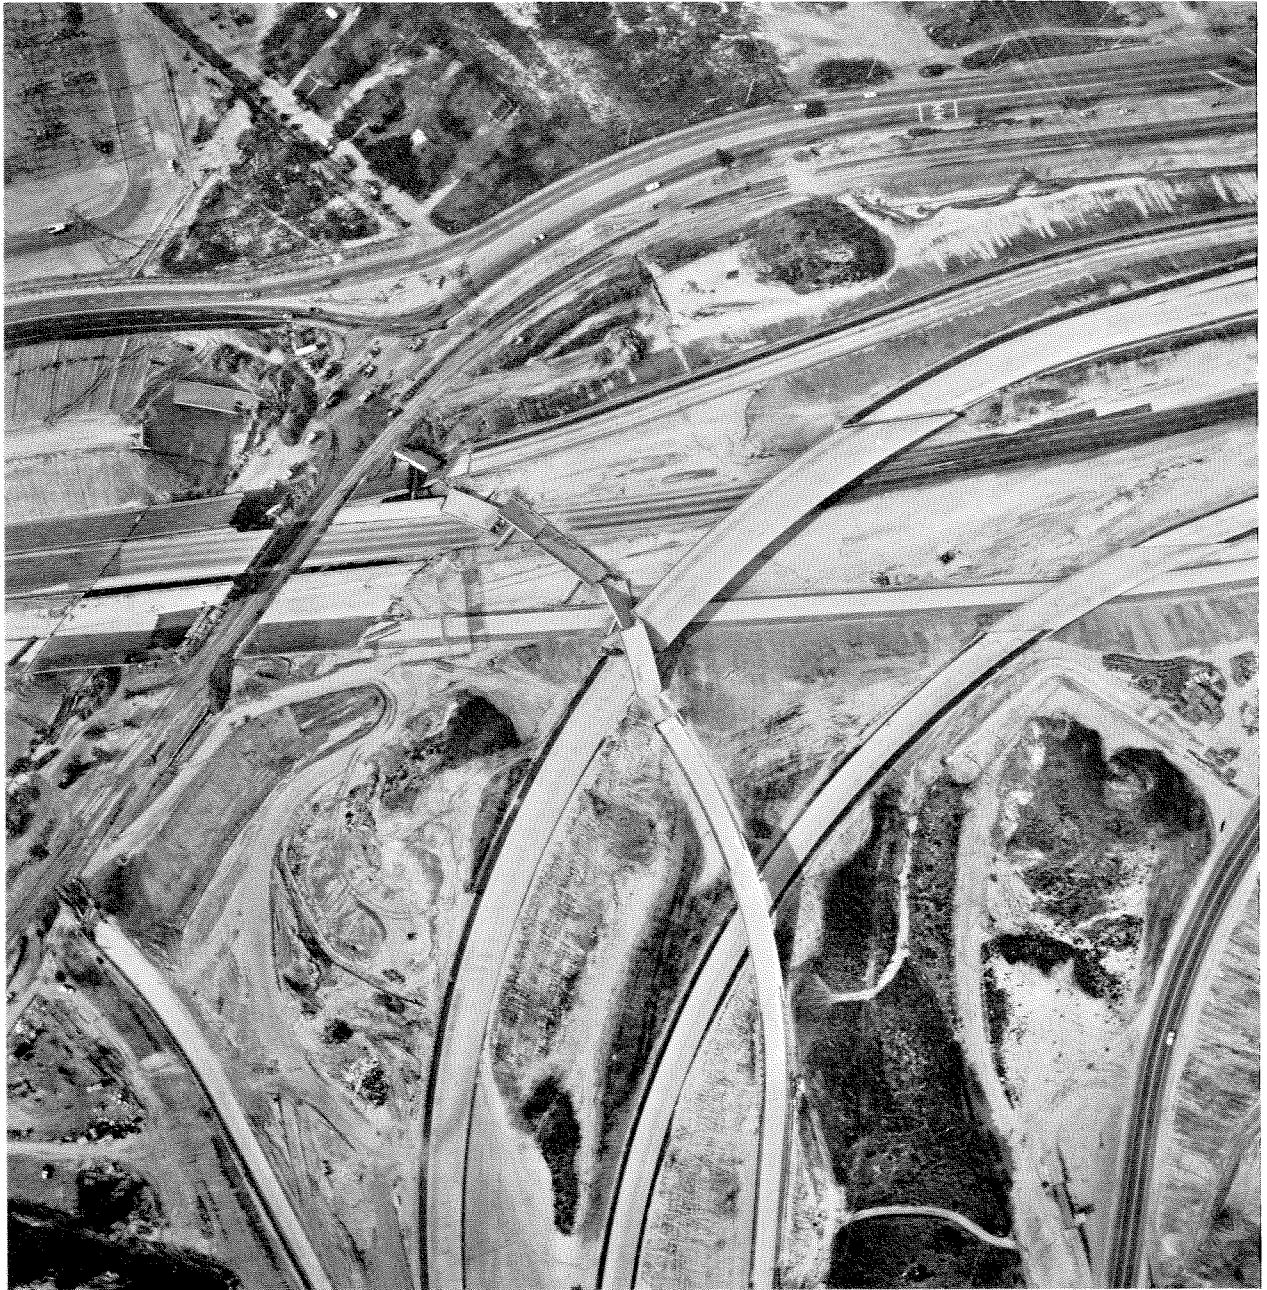
Figure 6. 18 Vertical aerial photograph of the Golden State-Foothill freeway interchange, taken February 12, 1971.

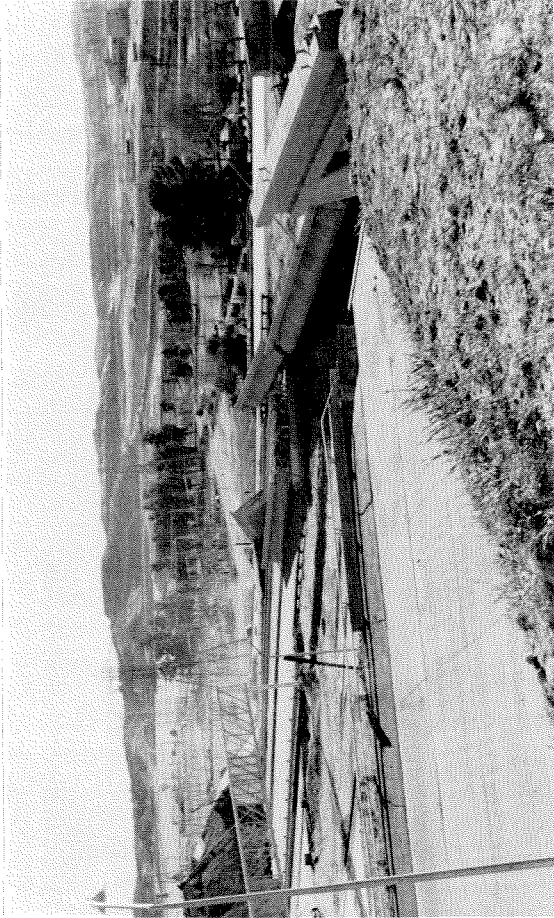
Figure 6.20 Southern portion of collapsed separation and overhead structure, Golden State-Foothill freeway interchange.

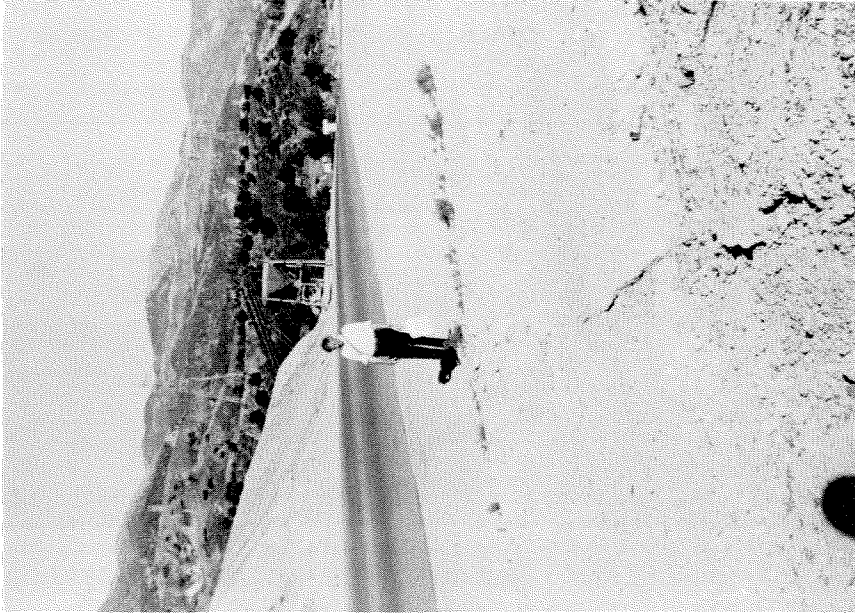
Figure 6.24 Looking northeast along a through-going crack in the area of the Golden State-Foothill freeway interchange.

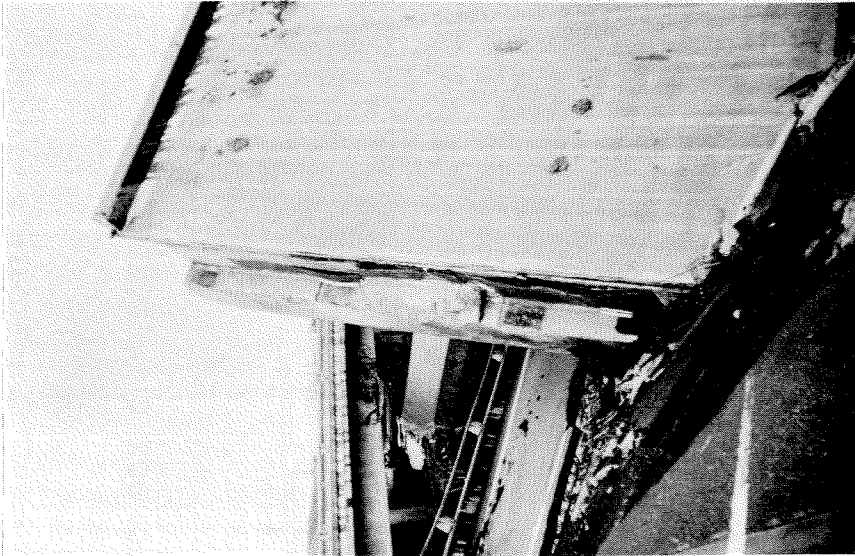
Figure 6.23 Seating details of fallen separation and overhead structure, Golden State-Foothill freeway interchange.

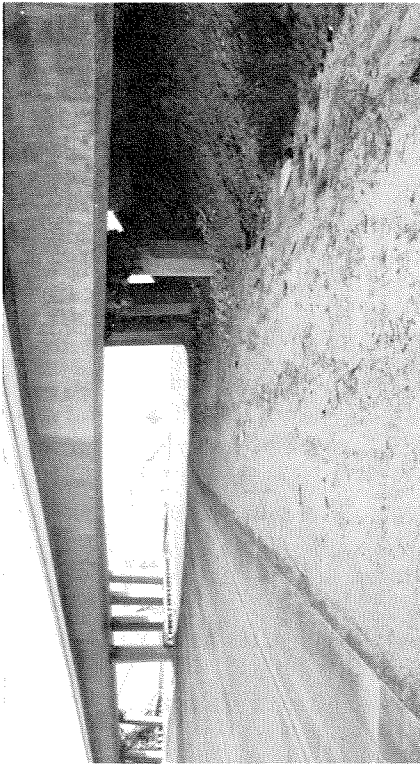
Figure 6.25 Northwest connector overcrossing, Golden State-Foothill freeway interchange.

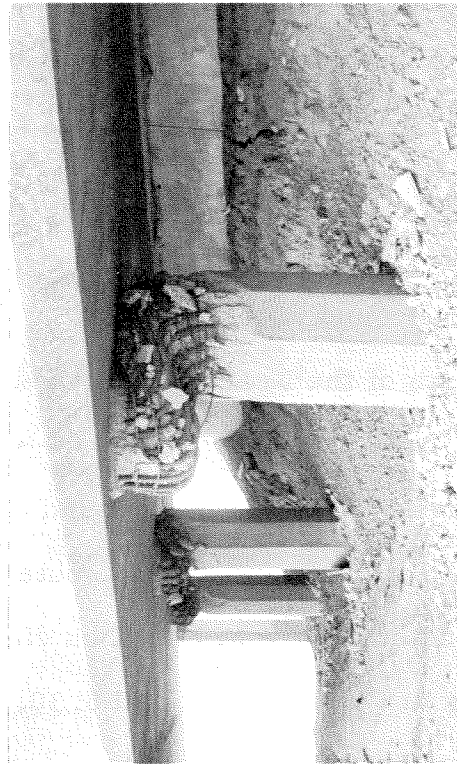
Figure 6.27 Column failures, northwest connector overcrossing, Golden State-Foothill freeway interchange.

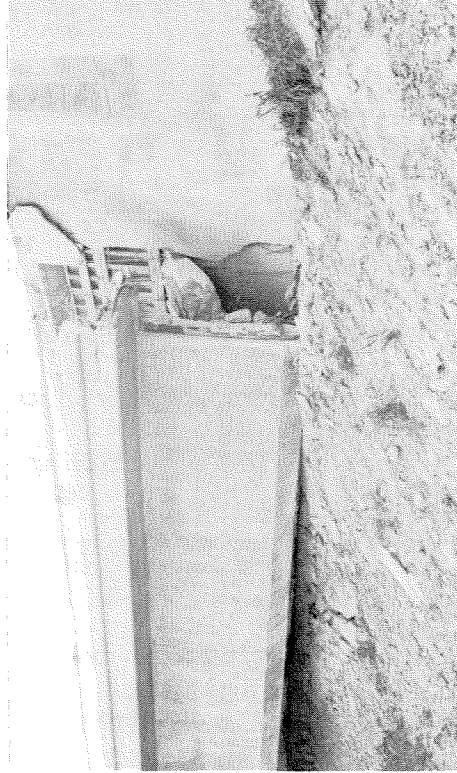
Figure 6.28 Northwest abutment of the northwest connector overcrossing, Golden State-Foothill freeway interchange.

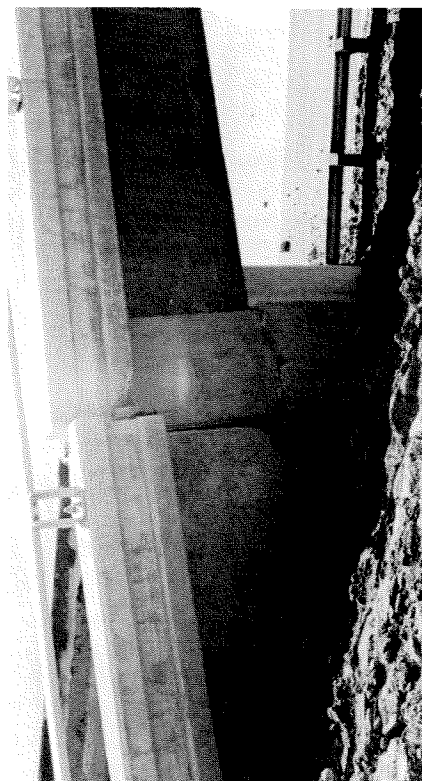
Figure 6.31 Eastern abutment, northbound Truck Route undercrossing, Golden State-Foothill freeway interchange.

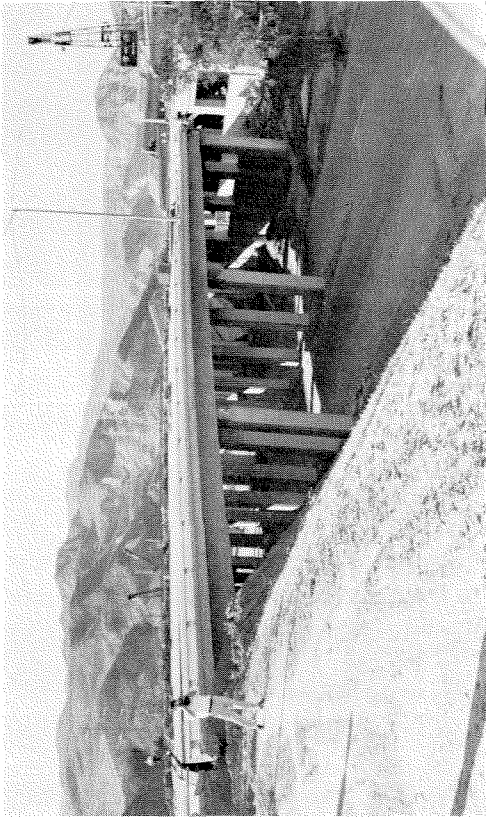
Figure 6.34 San Fernando Road overhead, looking northwest. Golden State-Foothill freeway interchange.

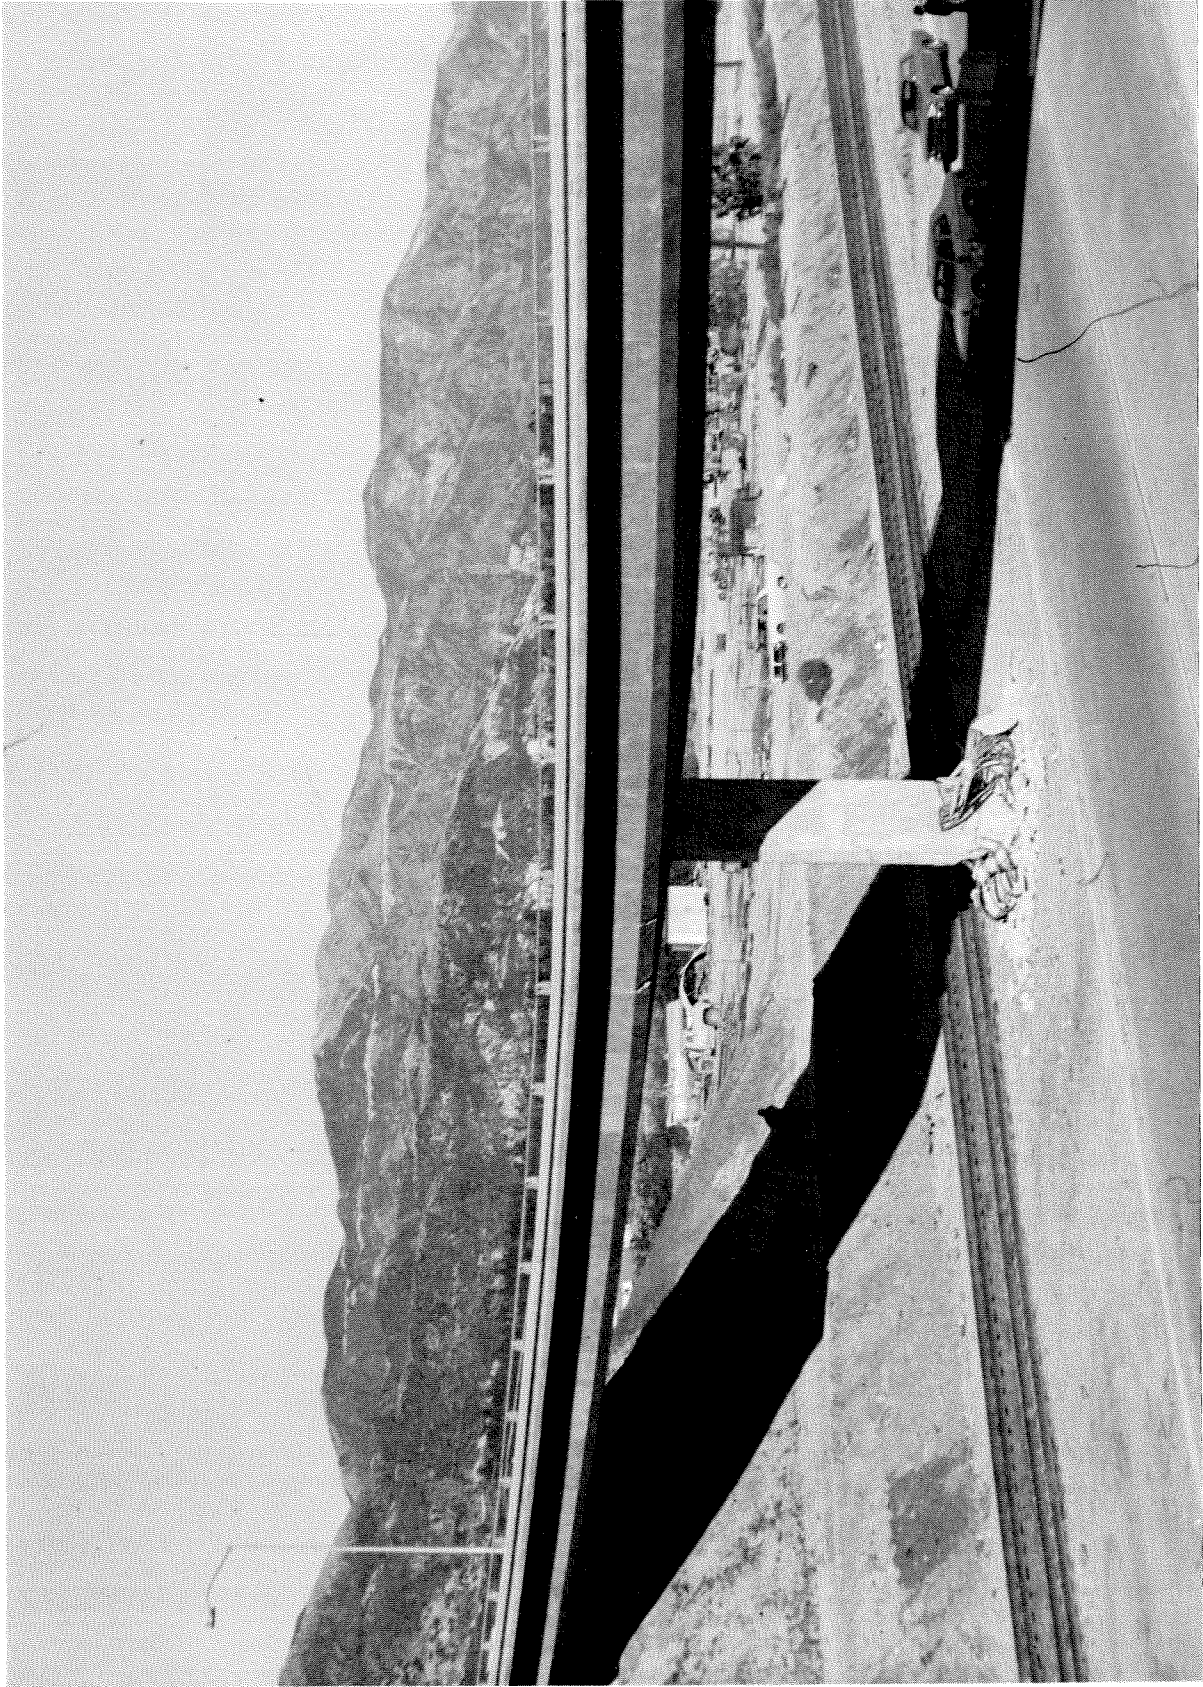
Figure 6. 37a San Fernando Road overhead transition bridge showing damage to the base of the single column. The top of the column was reported to be undamaged.

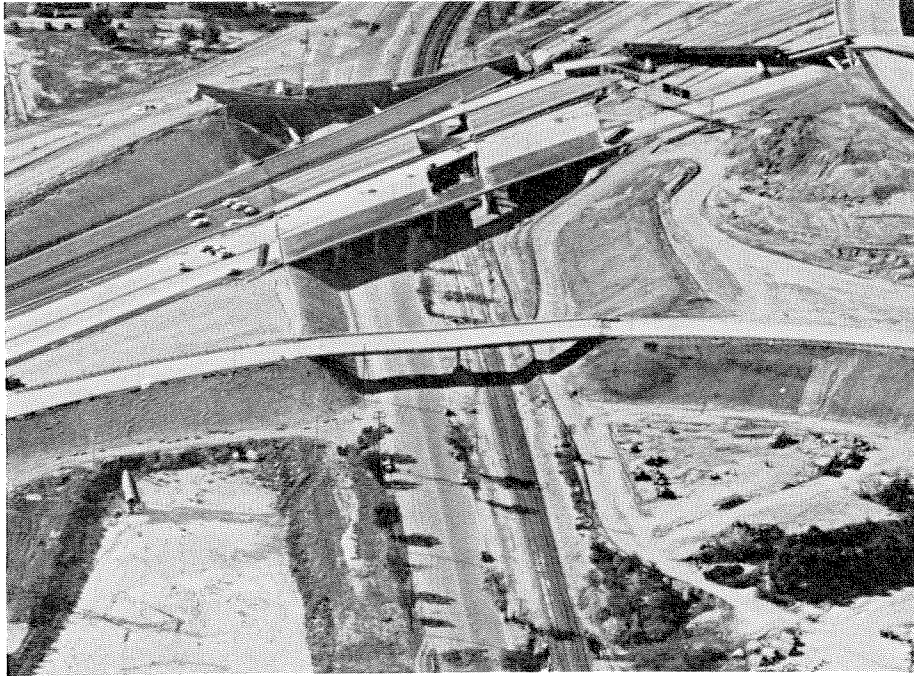
Figure 6. 37b. Aerial view of the San Fernando Road overhead.

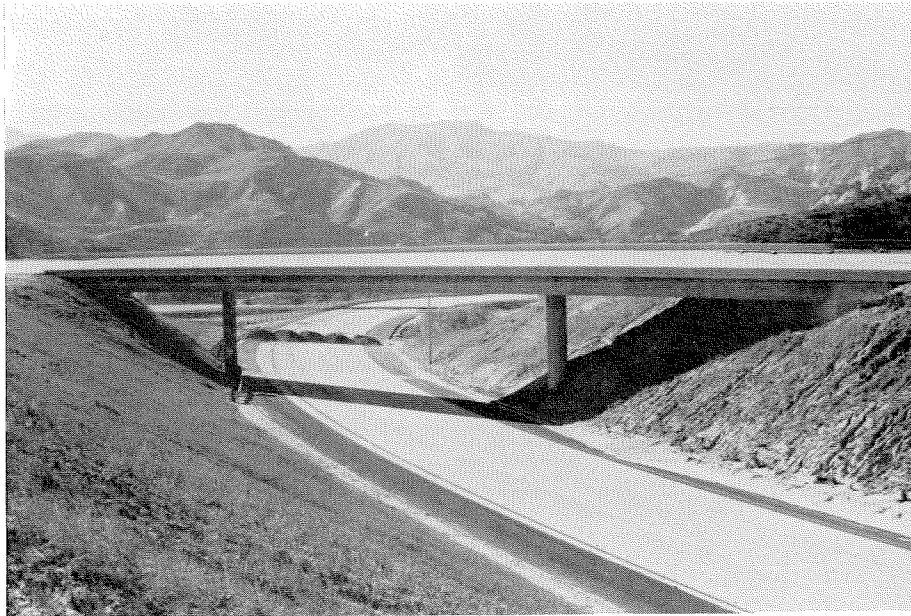
Figure 6. 38 North connector undercrossing, Golden State-Foothill freeway interchange. Bridge suffered only minor damage at abutment backfill.

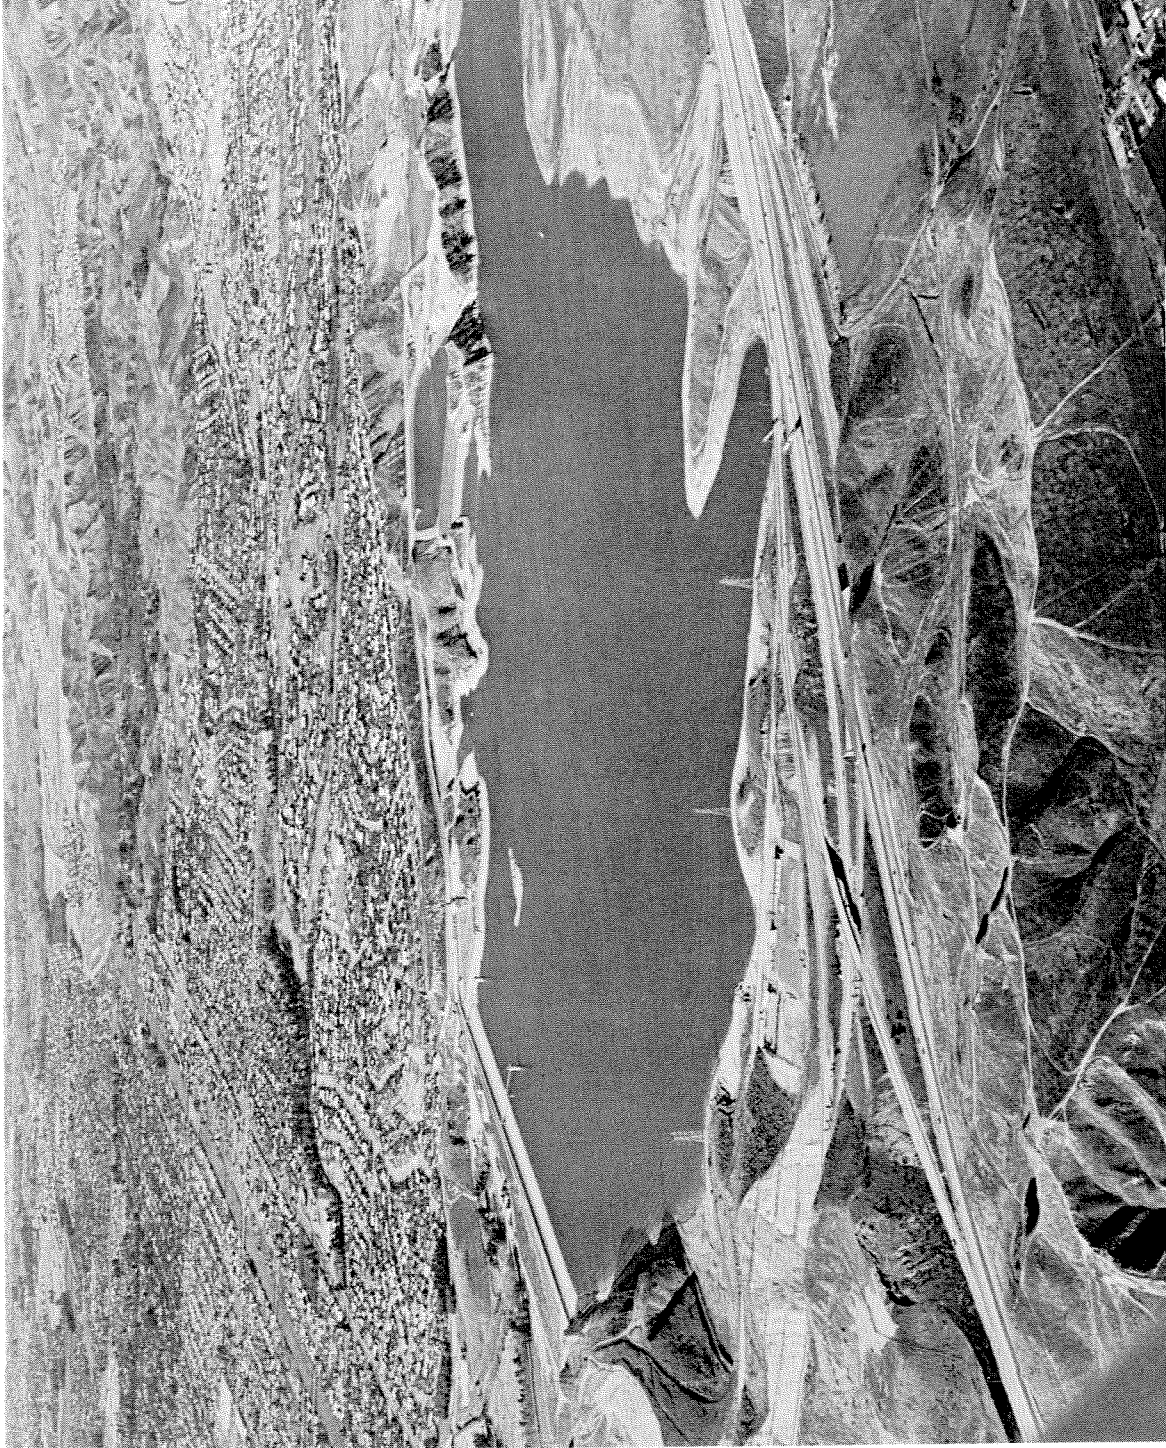
Figure 6. 39 Pre-earthquake view of the Golden State-San Diego freeway interchange and lower Van Norman Lake. North is to the right. Photographed by Ralph Samuels.

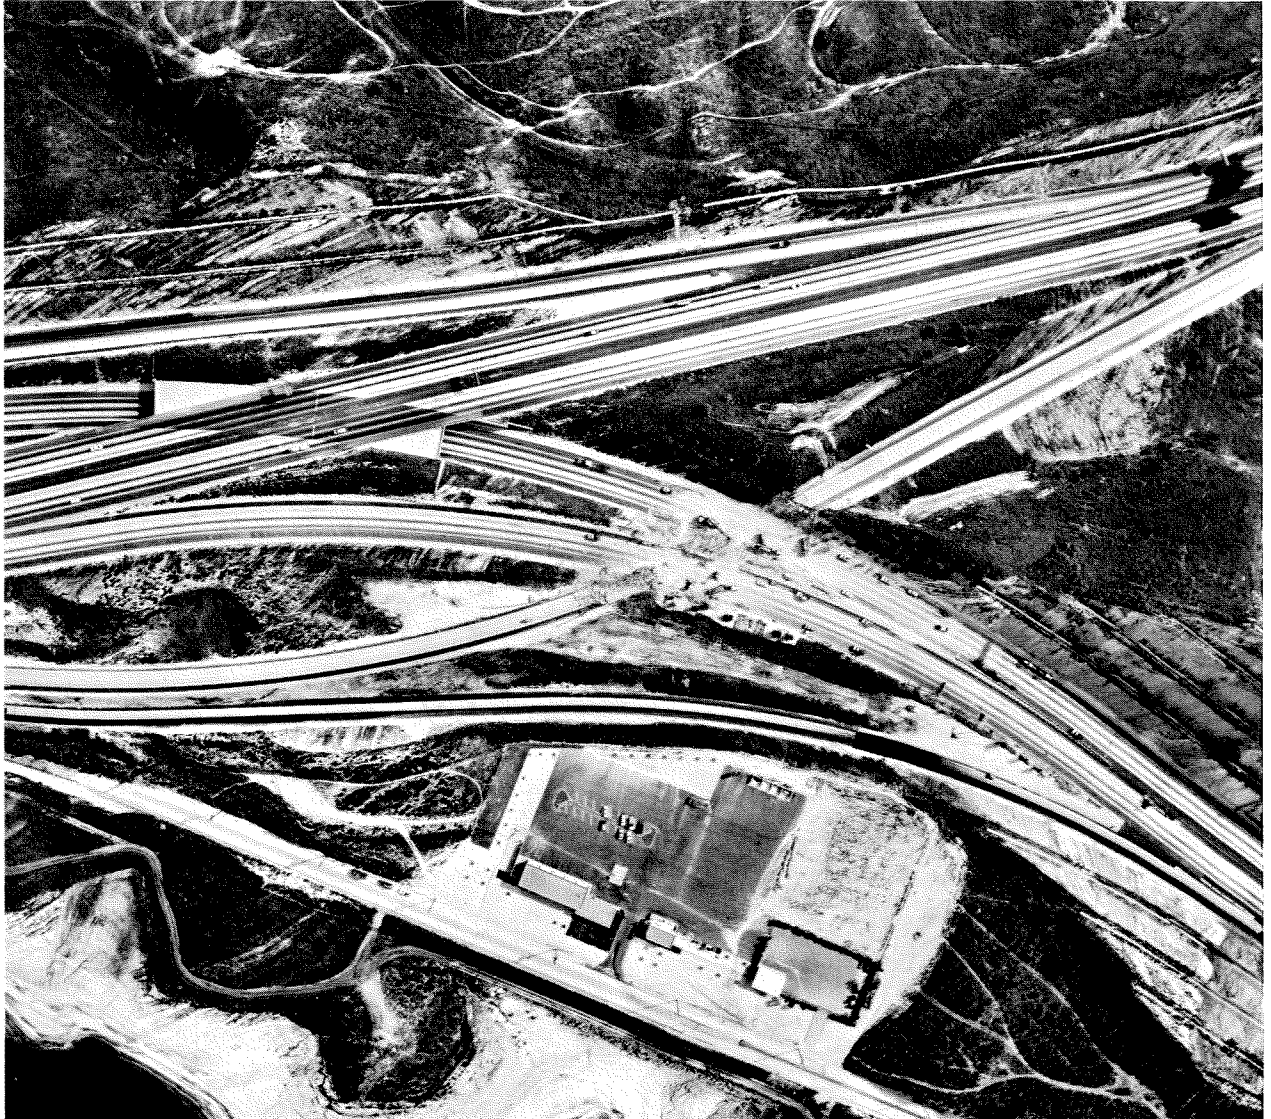
Figure 6. 40b Vertical aerial photograph of the Golden State-San Diego freeway interchange, taken February 12, 1971. North is to the right.

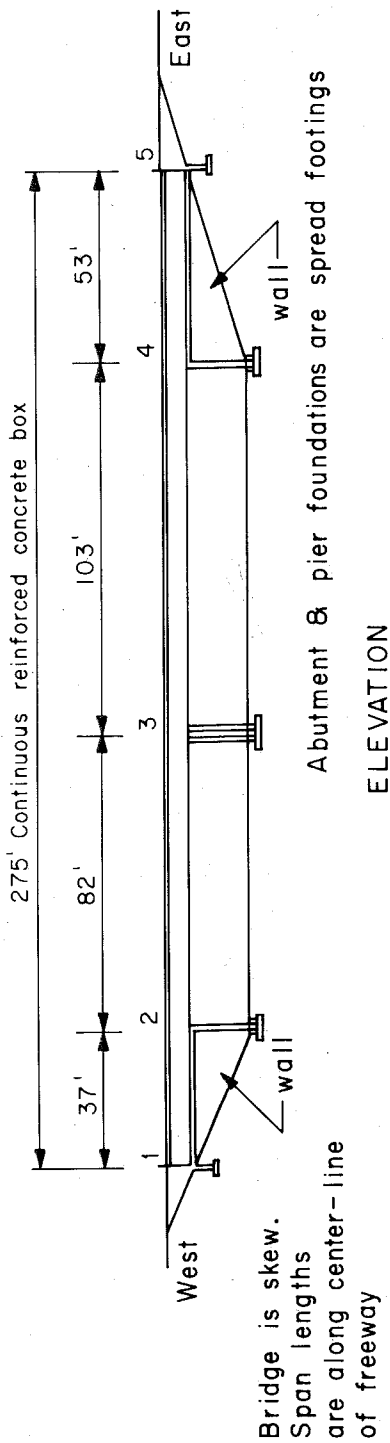
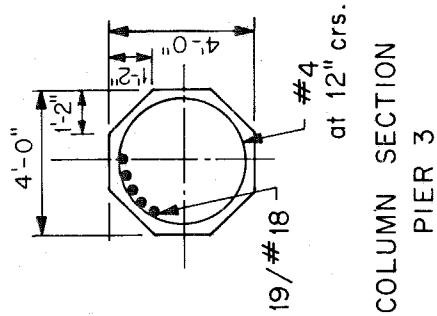
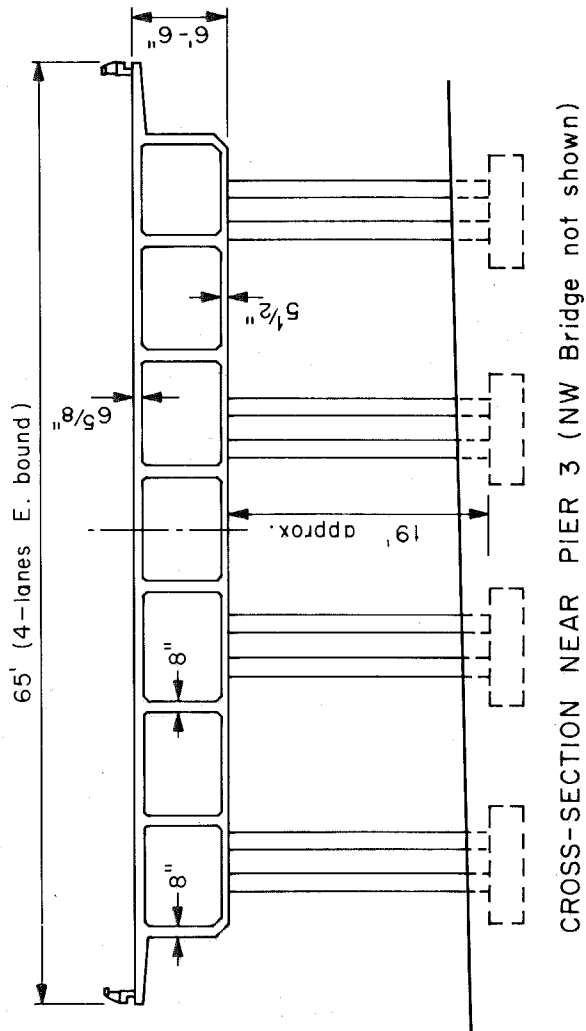
FOOTHILL BLVD. UNDERCROSSING - S. E. BRIDGE

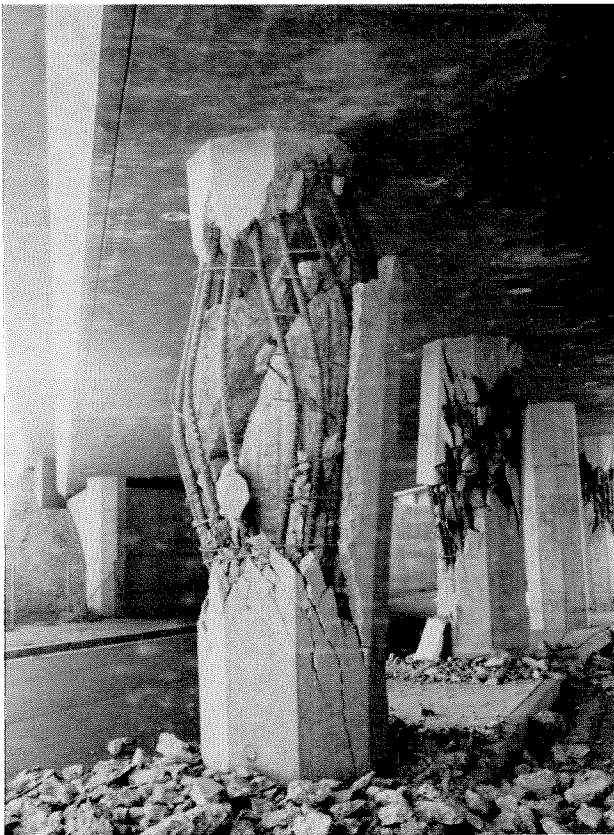
Figure 6.43 Failed columns of the southeastern bridge, Foothill Boulevard undercrossing, Foothill freeway.

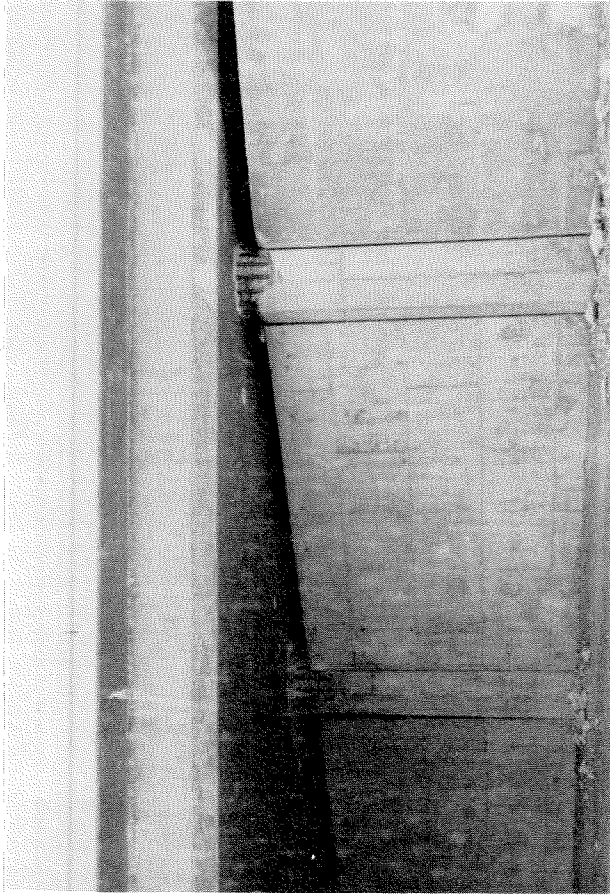
Figure 6.46 Column damage at tops of retaining walls, Foothill Boulevard undercrossing, Foothill freeway.

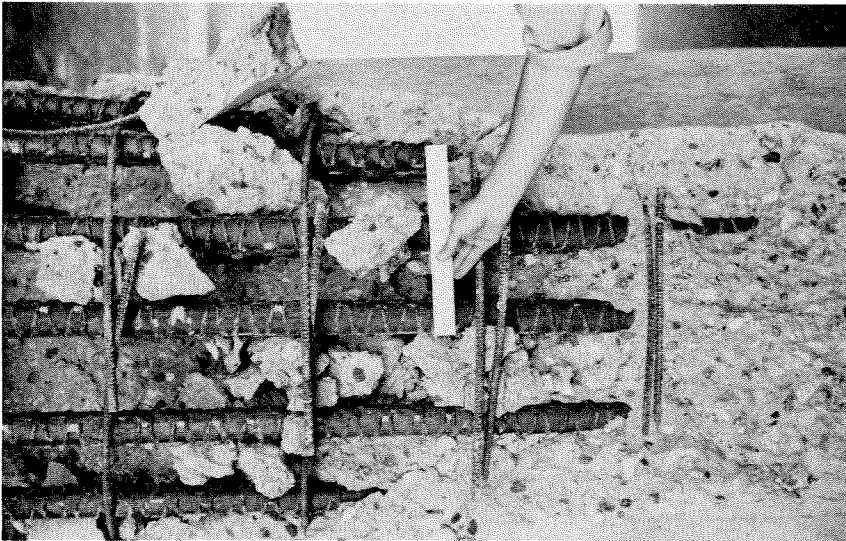
Figure 6.45 Details of column construction, Foothill Boulevard undercrossing, Foothill freeway.
