ENGINEERING FEATURES
OF THE
SAN FERNANDO EARTHQUAKE OF FEBRUARY 9, 1971

Paul C. Jennings, Editor

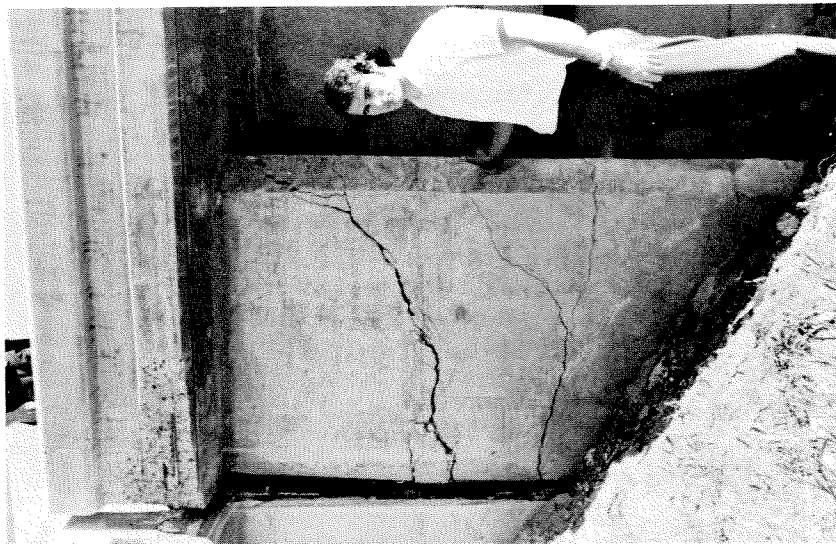
Figure 6.47 Northernmost abutment of the northwestern bridge, Foothill Boulevard undercrossing, Foothill freeway.

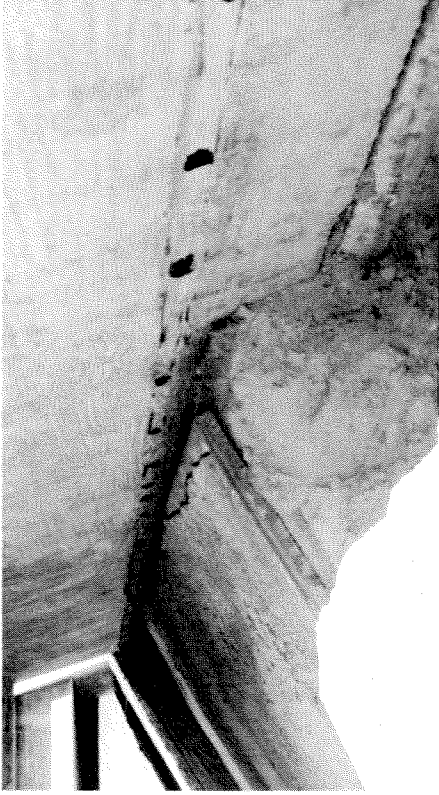
Figure 6. 50 Movement of concrete apron, Yarnell Street undercrossing, Foothill freeway.

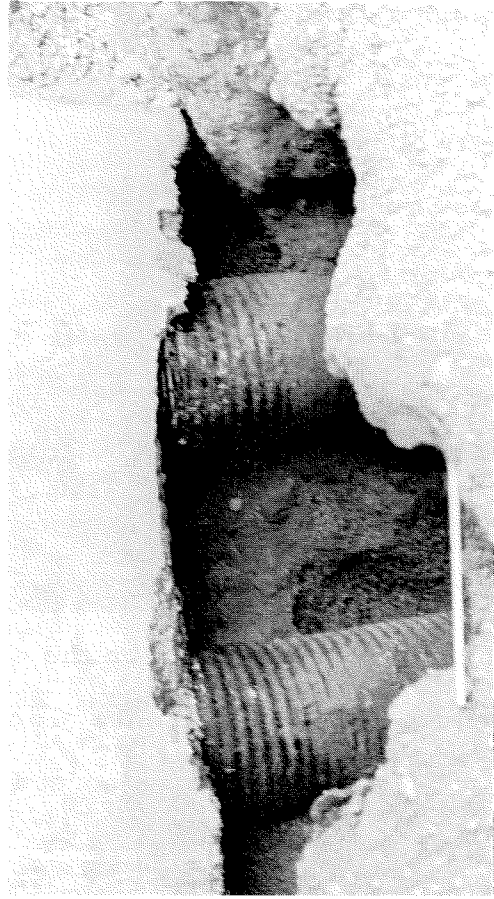
Figure 6.57 Piling damage at the western abutment of the southern bridge, Roxford undercrossing of the Foothill freeway.

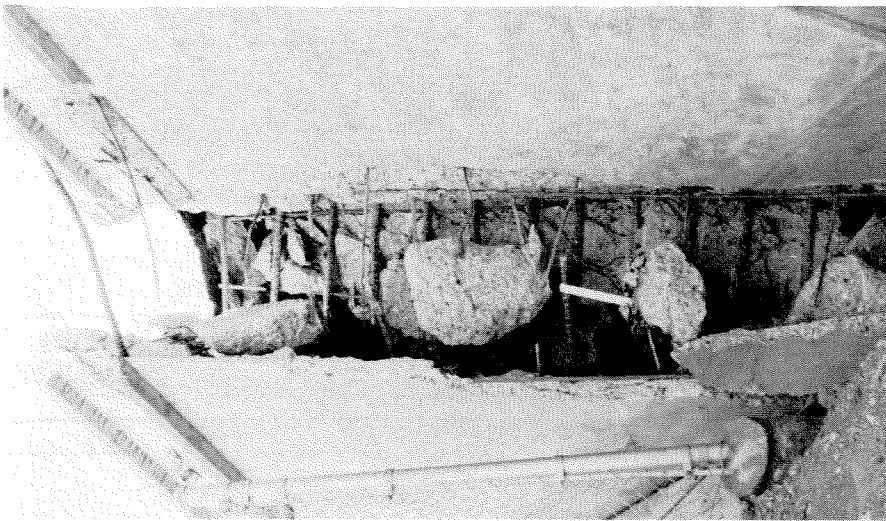
Figure 6.55 Eastern abutment of the southern bridge of the Roxford Street undercrossing, Foothill freeway.

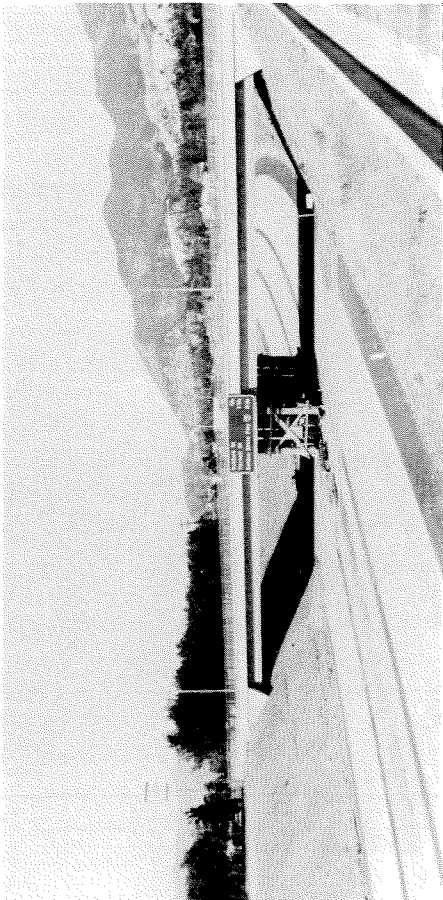
Figure 6.58 Bledsoe Street overpass, Foothill freeway.

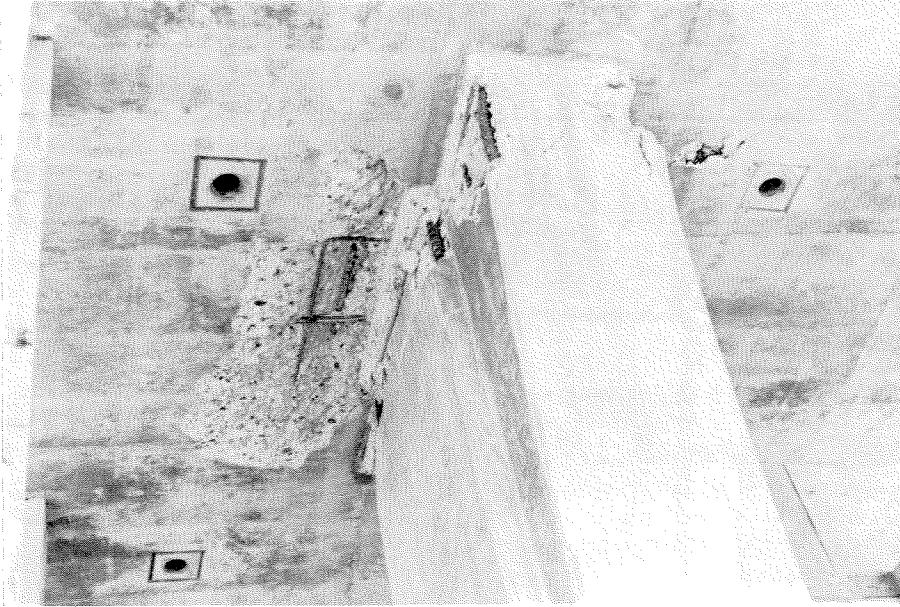
Figure 6.61 Column damage at the Bledsoe Street overpass, Foothill freeway.

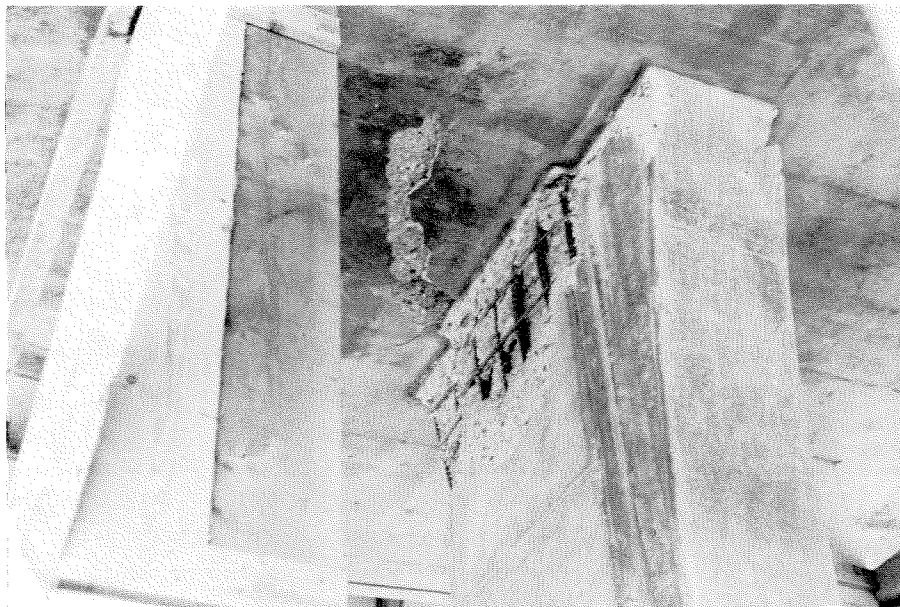
Figure 6.62 Column damage at the Bledsoe Street overpass, Foothill freeway.

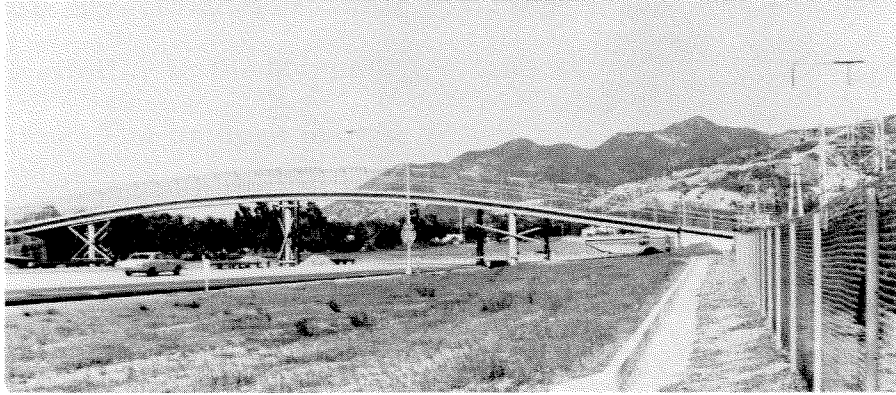
Figure 6.63 Tyler Street footbridge, Foothill freeway.

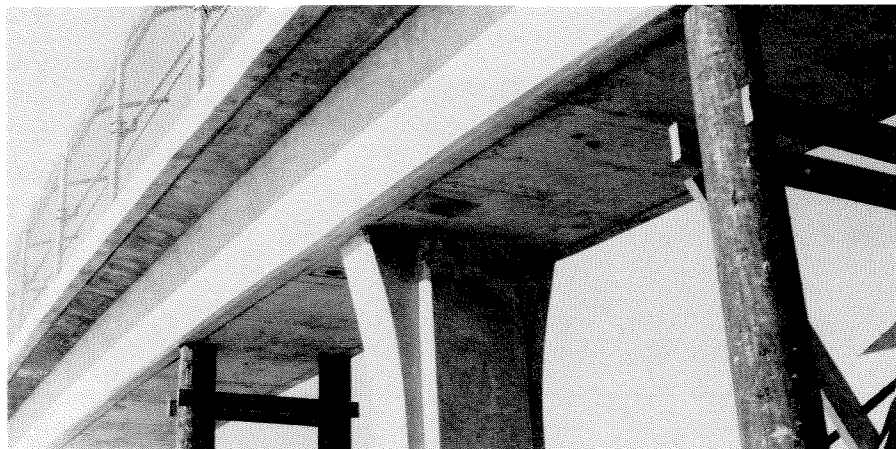
Figure 6.65 Damage to the tallest column of the Tyler Street footbridge, Foothill freeway.

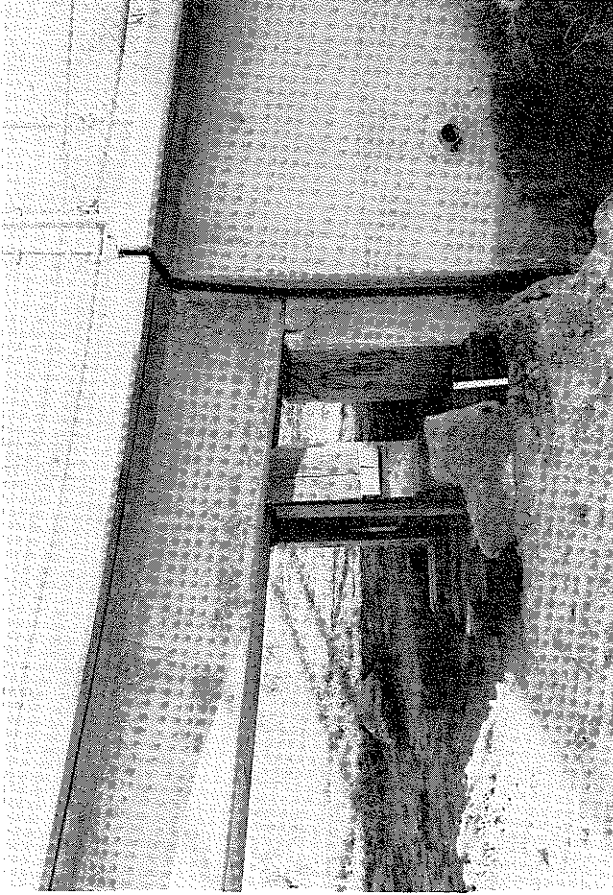
Figure 6.69 Southwestern abutment of the Astoria Street footbridge, Foothill freeway.

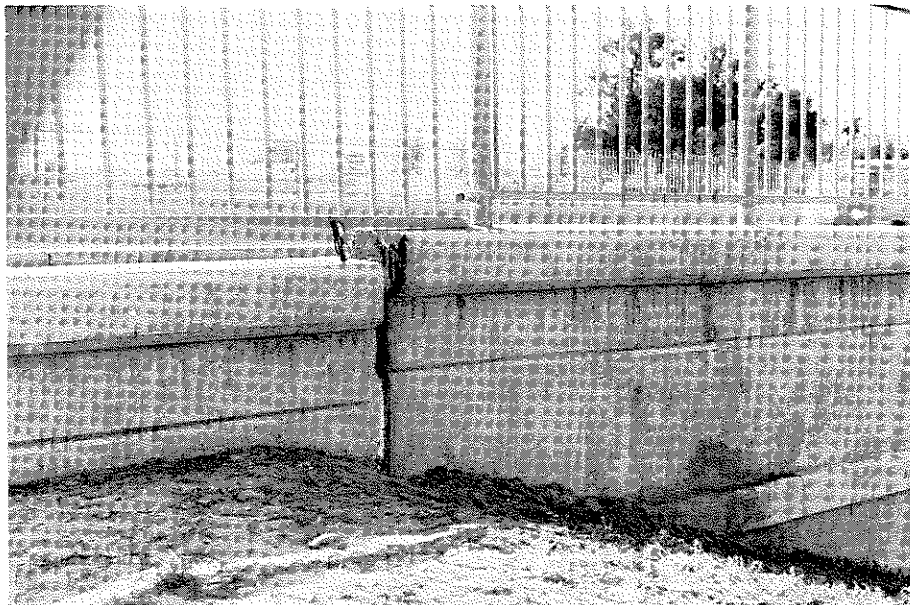
Figure 6.71 Southwest abutment of the
Sayre Street overpass, Foothill freeway.

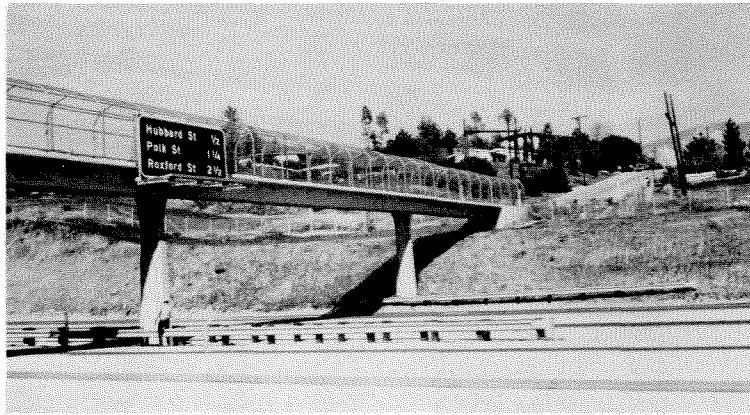
Figure 6.72 Harding Street footbridge, Foothill freeway.

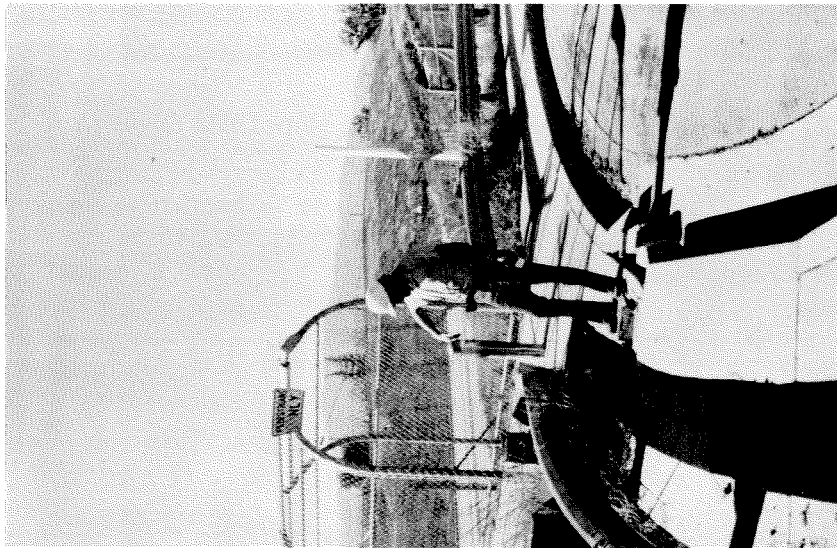
Figure 6.75 Sidewalk damage caused by abutment pounding, Harding Street footbridge, Foothill freeway.

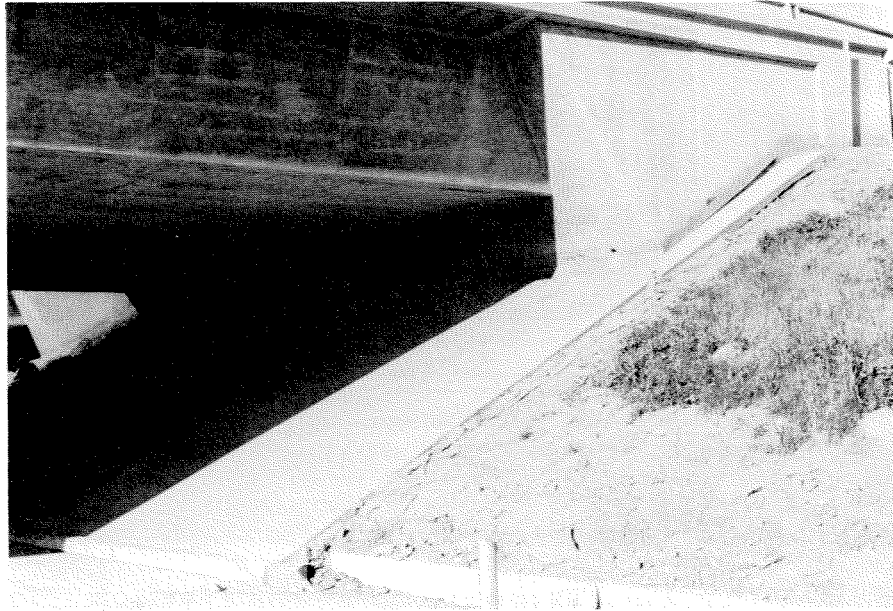
Figure 6.77 Northwestern abutment of the Maclay Street undercrossing, Foothill freeway. Note the movement of the concrete apron and the settlement of the embankment.

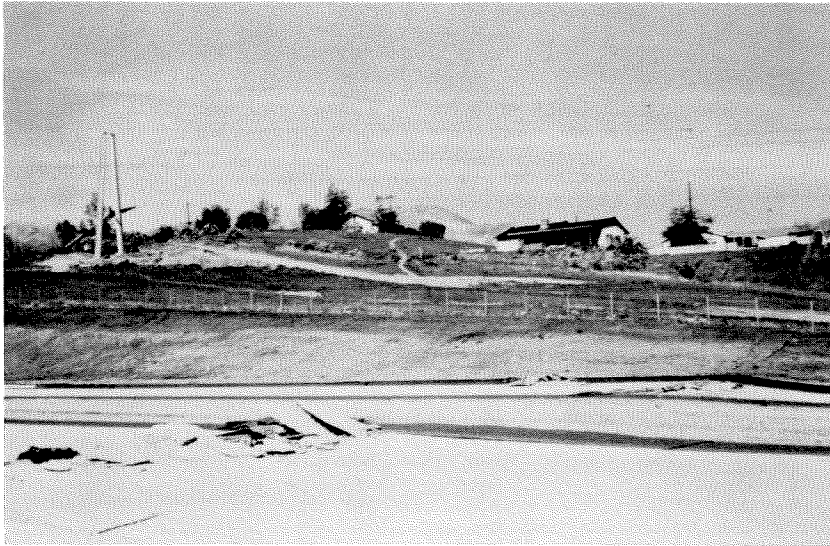
Figure 6.79 Pavement damage from surface faulting. Foothill freeway northwest of Maclay Street.

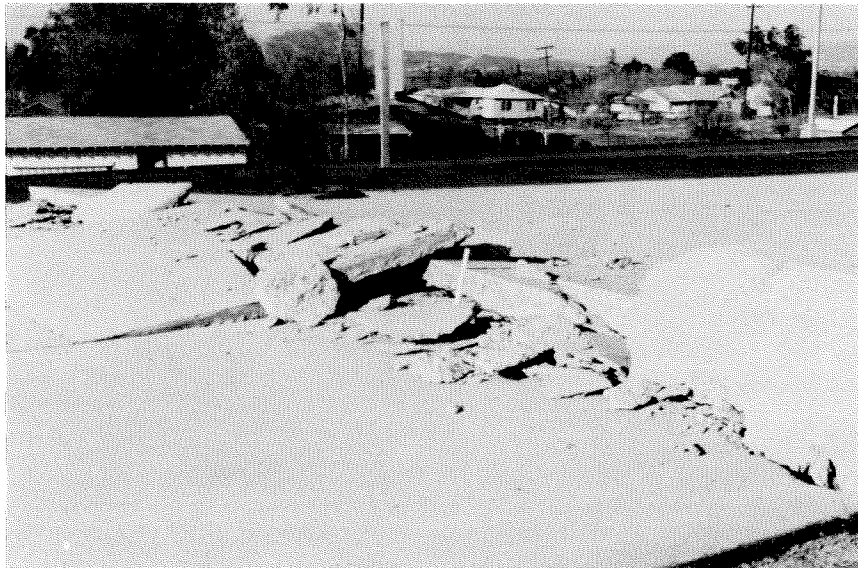
Figure 6.80 Shortening of freeway pavement caused by faulting. Foothill freeway near Maclay Street.

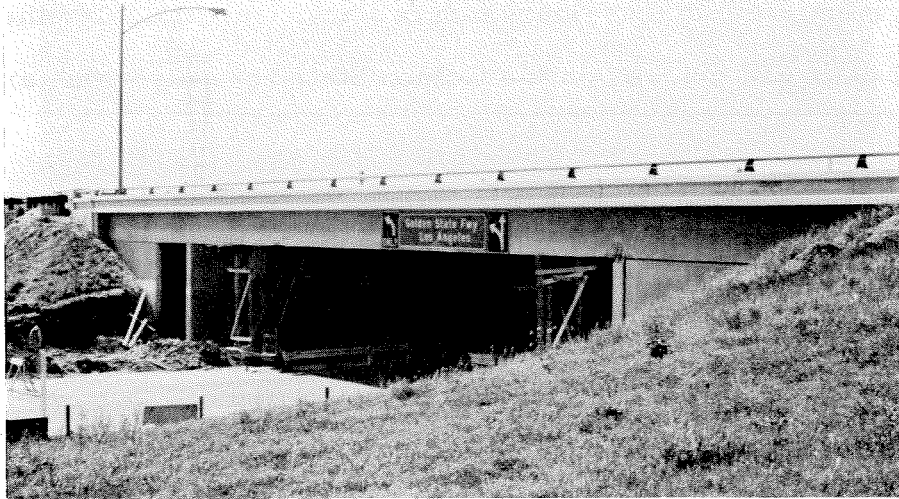
Figure 6.81 Roxford Street undercrossing, looking south, Golden State freeway.

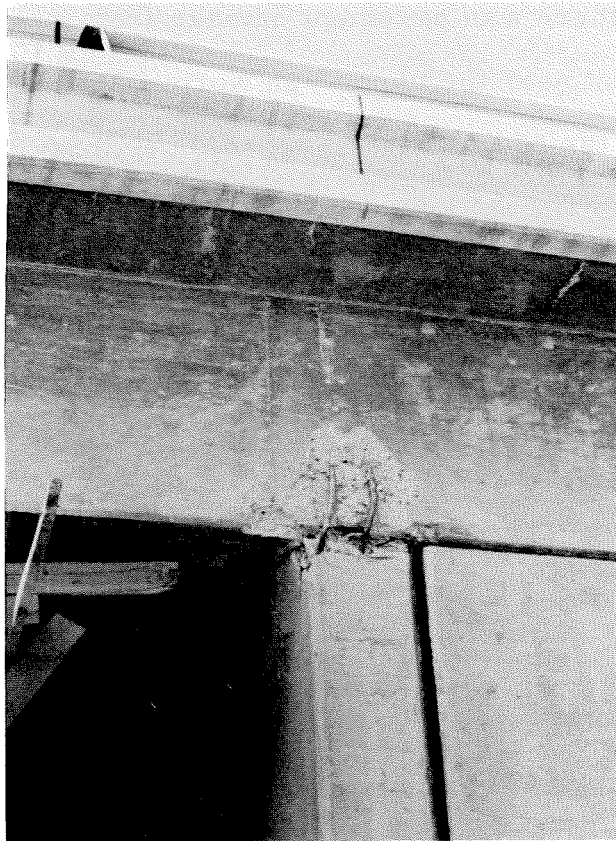
Figure 6.82 Damage to northern pier wall of the Roxford Street undercrossing, Golden State freeway.

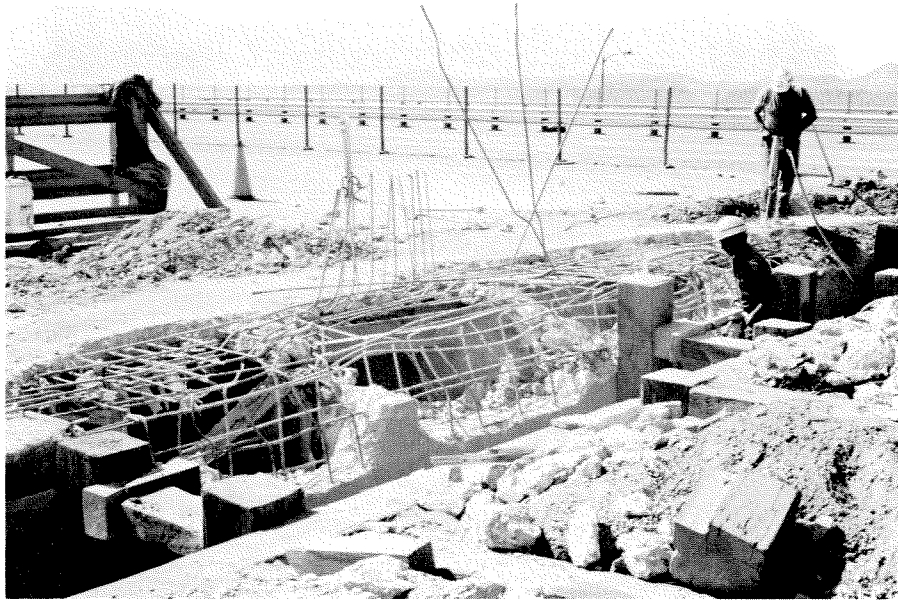
Figure 6.83 Concrete removal prior to repair of northern abutment of northbound lanes of Roxford Street undercrossing, Golden State freeway.

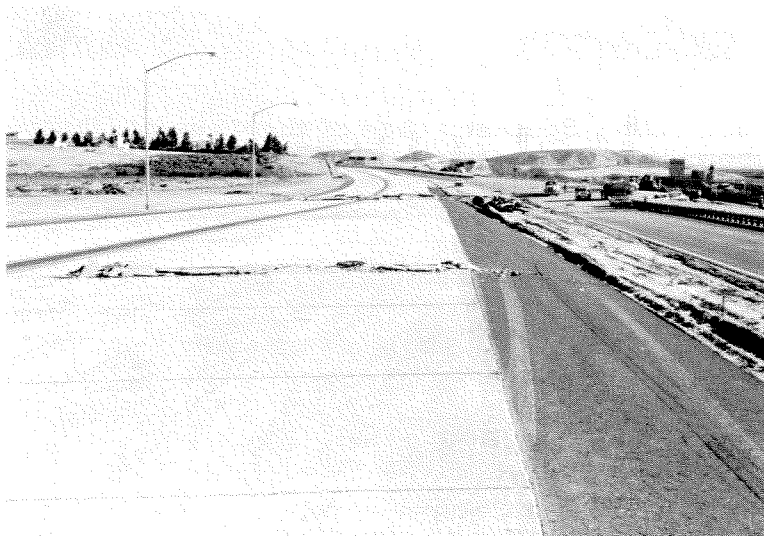
Figure 6.84 Pavement damage from ground movements. Looking south on the Golden State freeway north of the Roxford undercrossing.

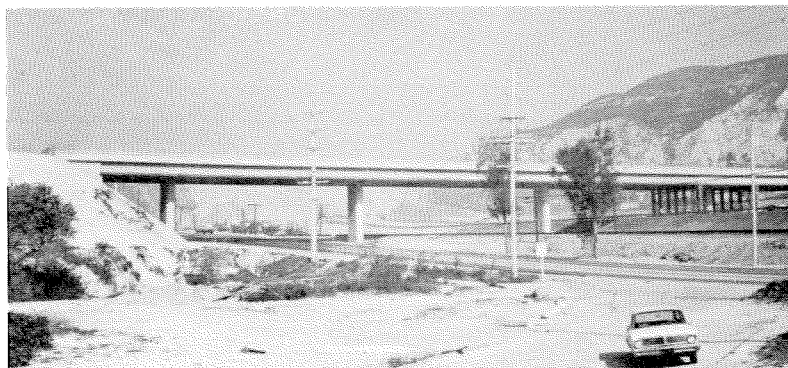
Figure 6.85 Balboa Street overcrossing, Golden State freeway

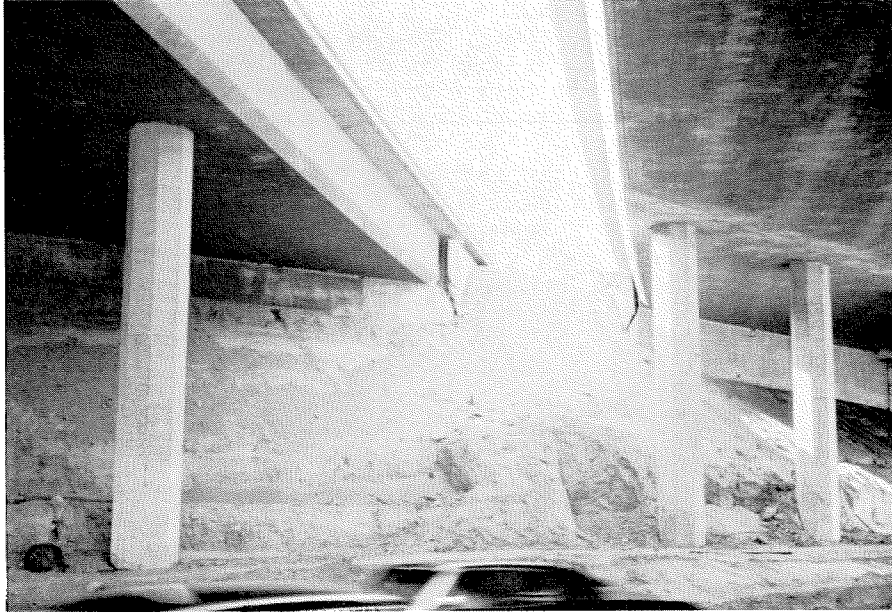
Figure 6.90 Damage to the northern abutment of the West Sylmar Overhead, Golden State freeway.

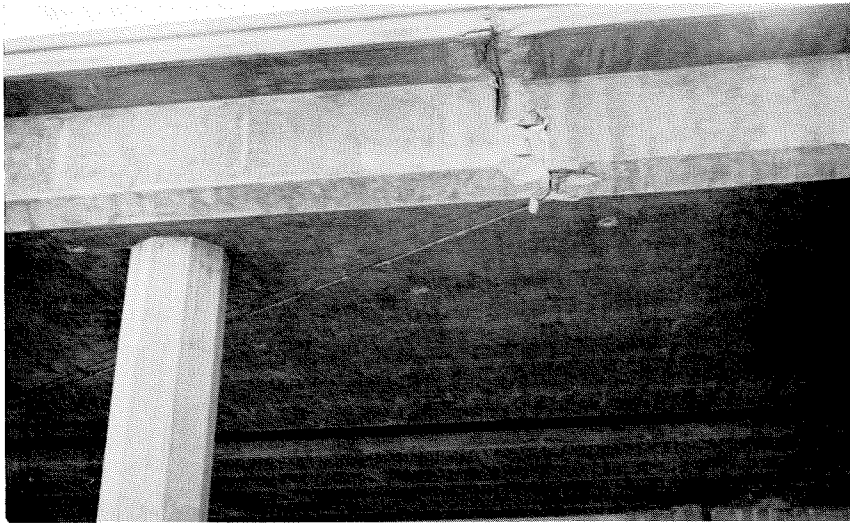
Figure 6.91 Spalling on the eastern face of the West Sylmar Overhead, Golden State freeway.

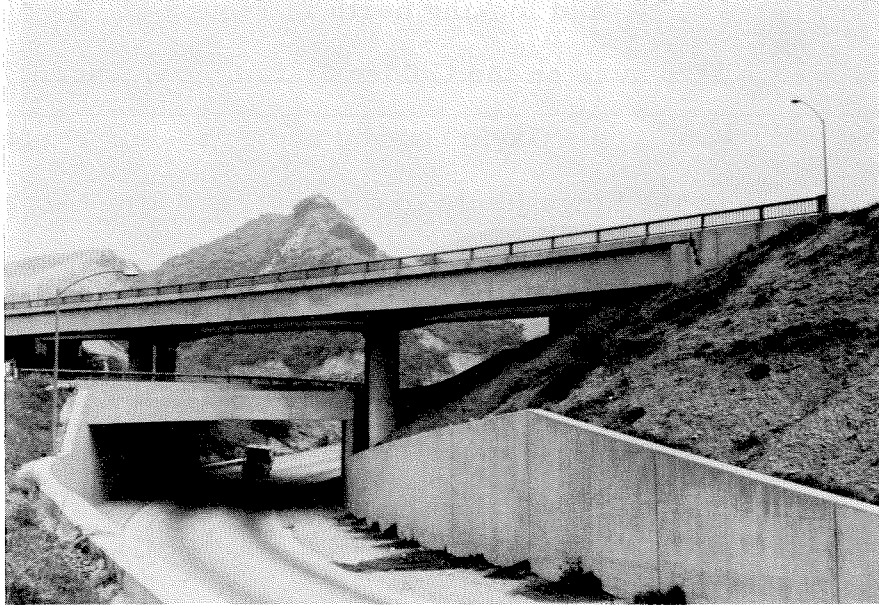
Figure 6.92 The Sierra Highway undercrossing on the Golden State freeway just south of the interchange with the Antelope Valley freeway. View looking south.

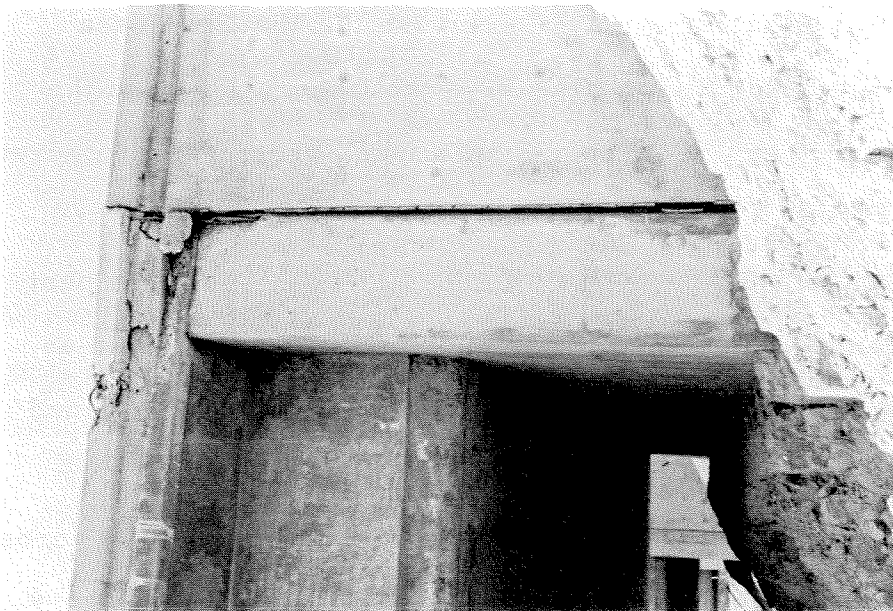
Figure 6. 95 Damaged southern face of the eastern abutment of the Sierra Highway undercrossing, Antelope Valley freeway.

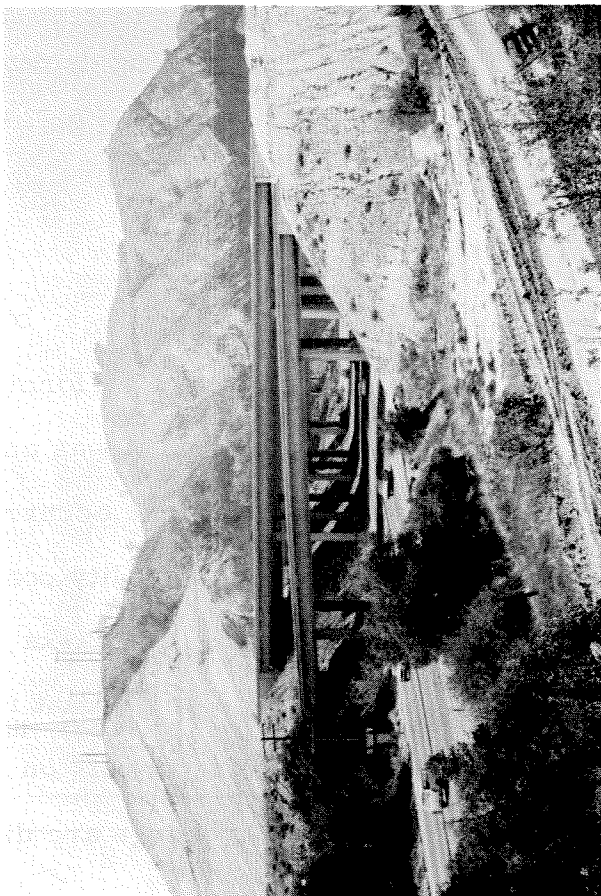
Figure 6. 94 Sierra Highway undercrossing on the Antelope Valley freeway near the Golden State - Antelope Valley freeway interchange.

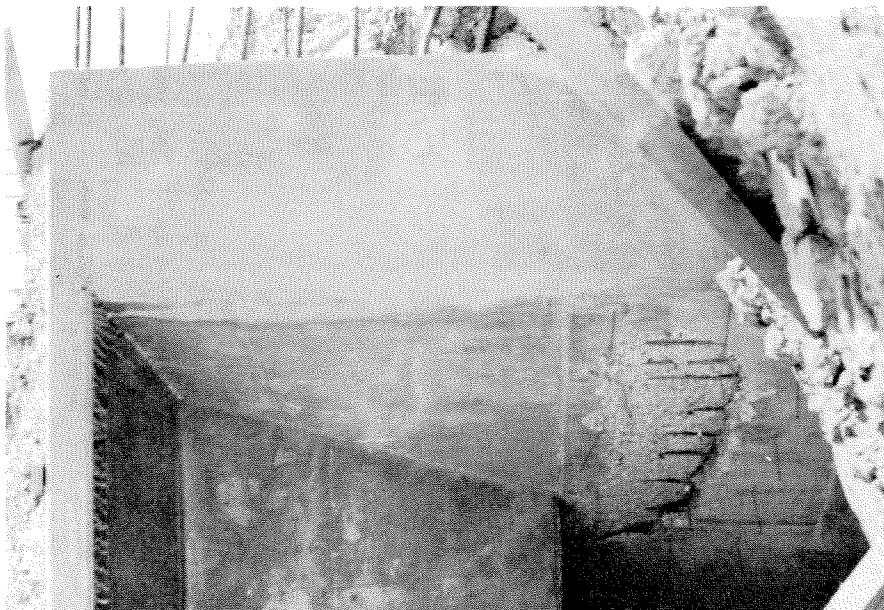
Figure 6.97 East abutment of the westbound lanes of the Via Princesa undercrossing, Antelope Valley freeway.

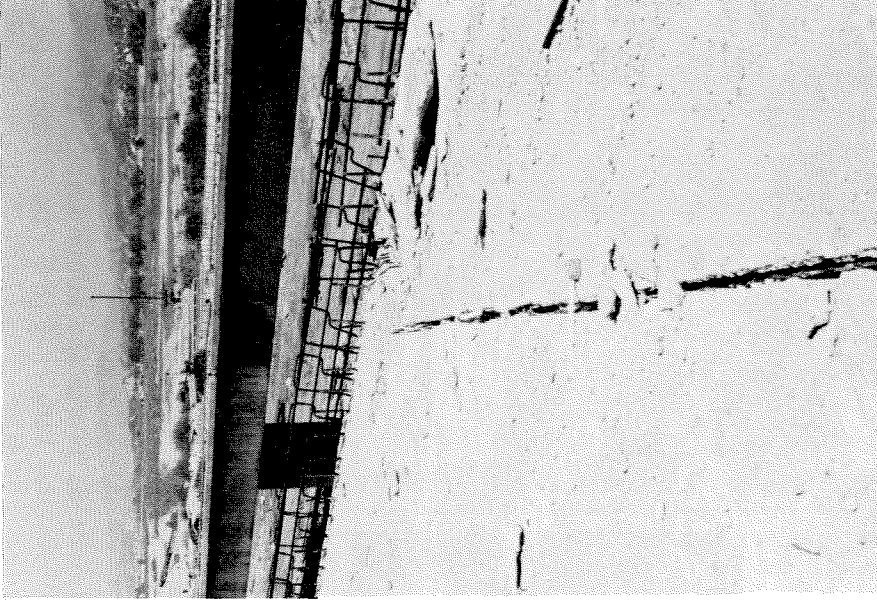
Figure 6. 99 Pounding damage at a girder joint of one of the Santa Clara River bridges, Antelope Valley freeway.

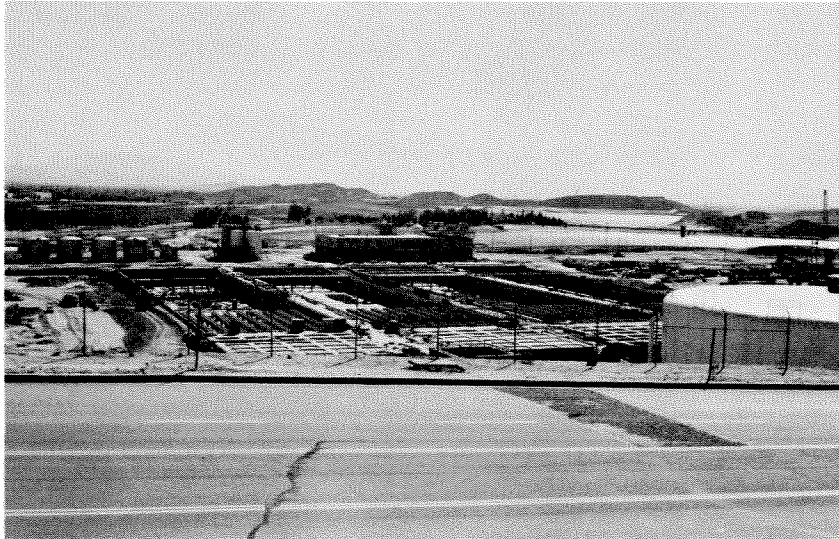
Figure 7.1 View looking east across Balboa Blvd. and the MWD settling basins. The two-story concrete control building is in the background; it suffered no cracking during the earthquake but did settle several inches and moved east several inches.

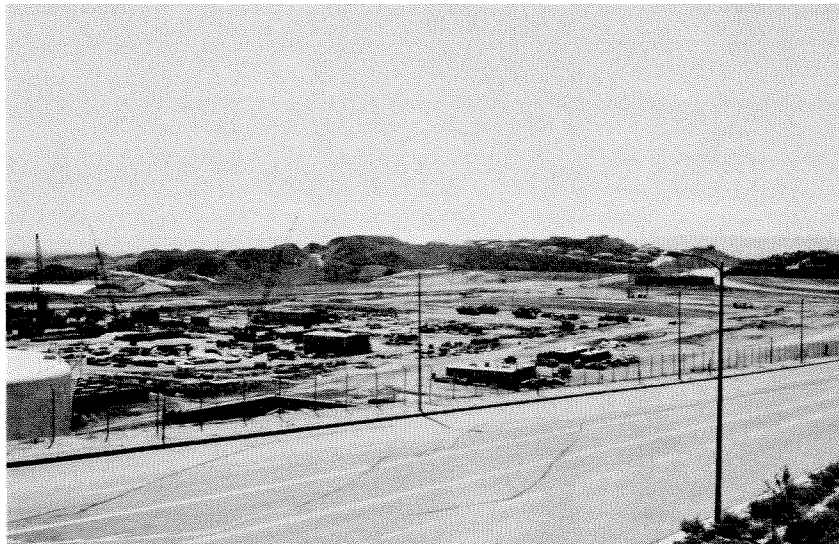
Figure 7.2 View looking southeast across Balboa Blvd. with the underground reservoir site in the background. Cracks in the Balboa Blvd. asphalt surface developed during the earthquake.

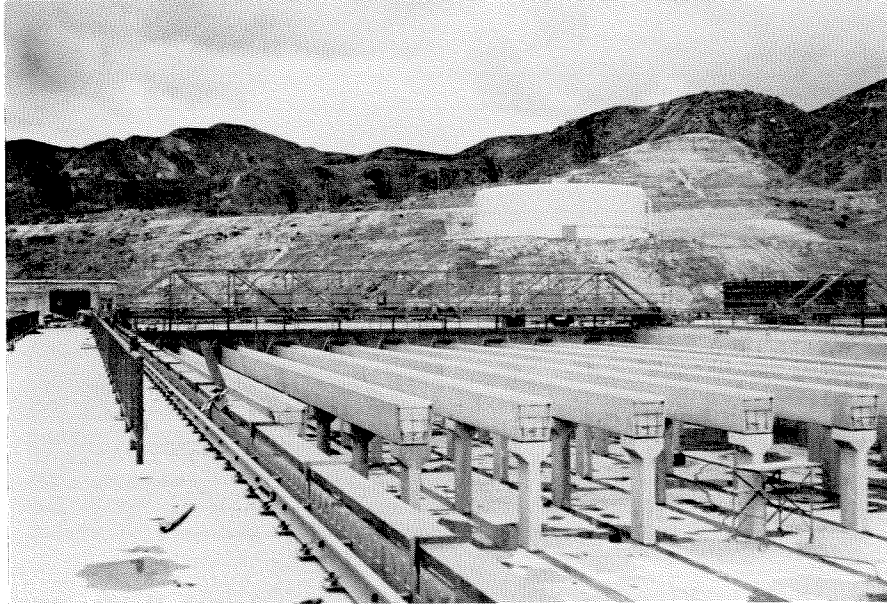
Figure 7.3 Looking westward across the incompletd settling basins, with the large MWD water tank in the background.

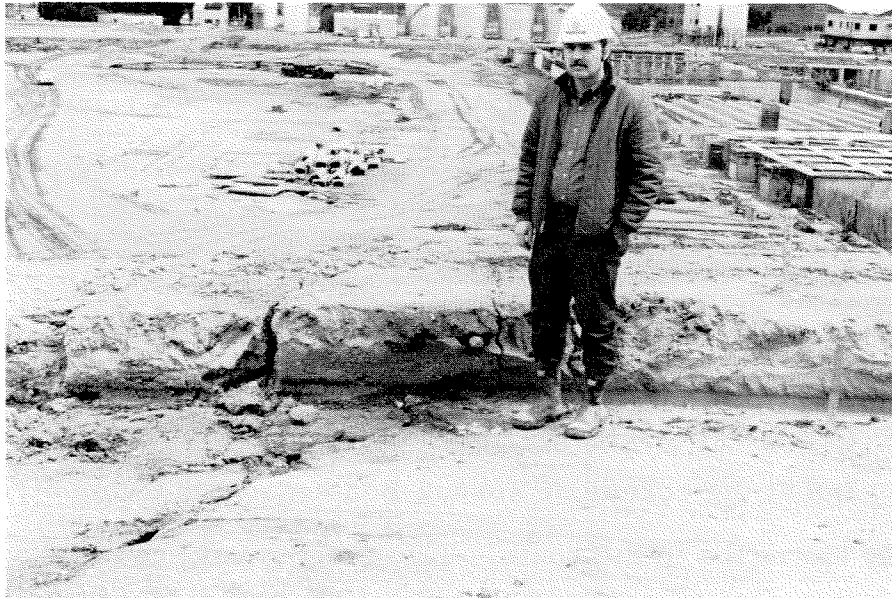
Figure 7.6 Cracks in access road to large water tank. In right-hand background is the control building which settled several inches; to the left is the steel frame chemical building which was damaged by excessive vibrations (cross-bracing failed).

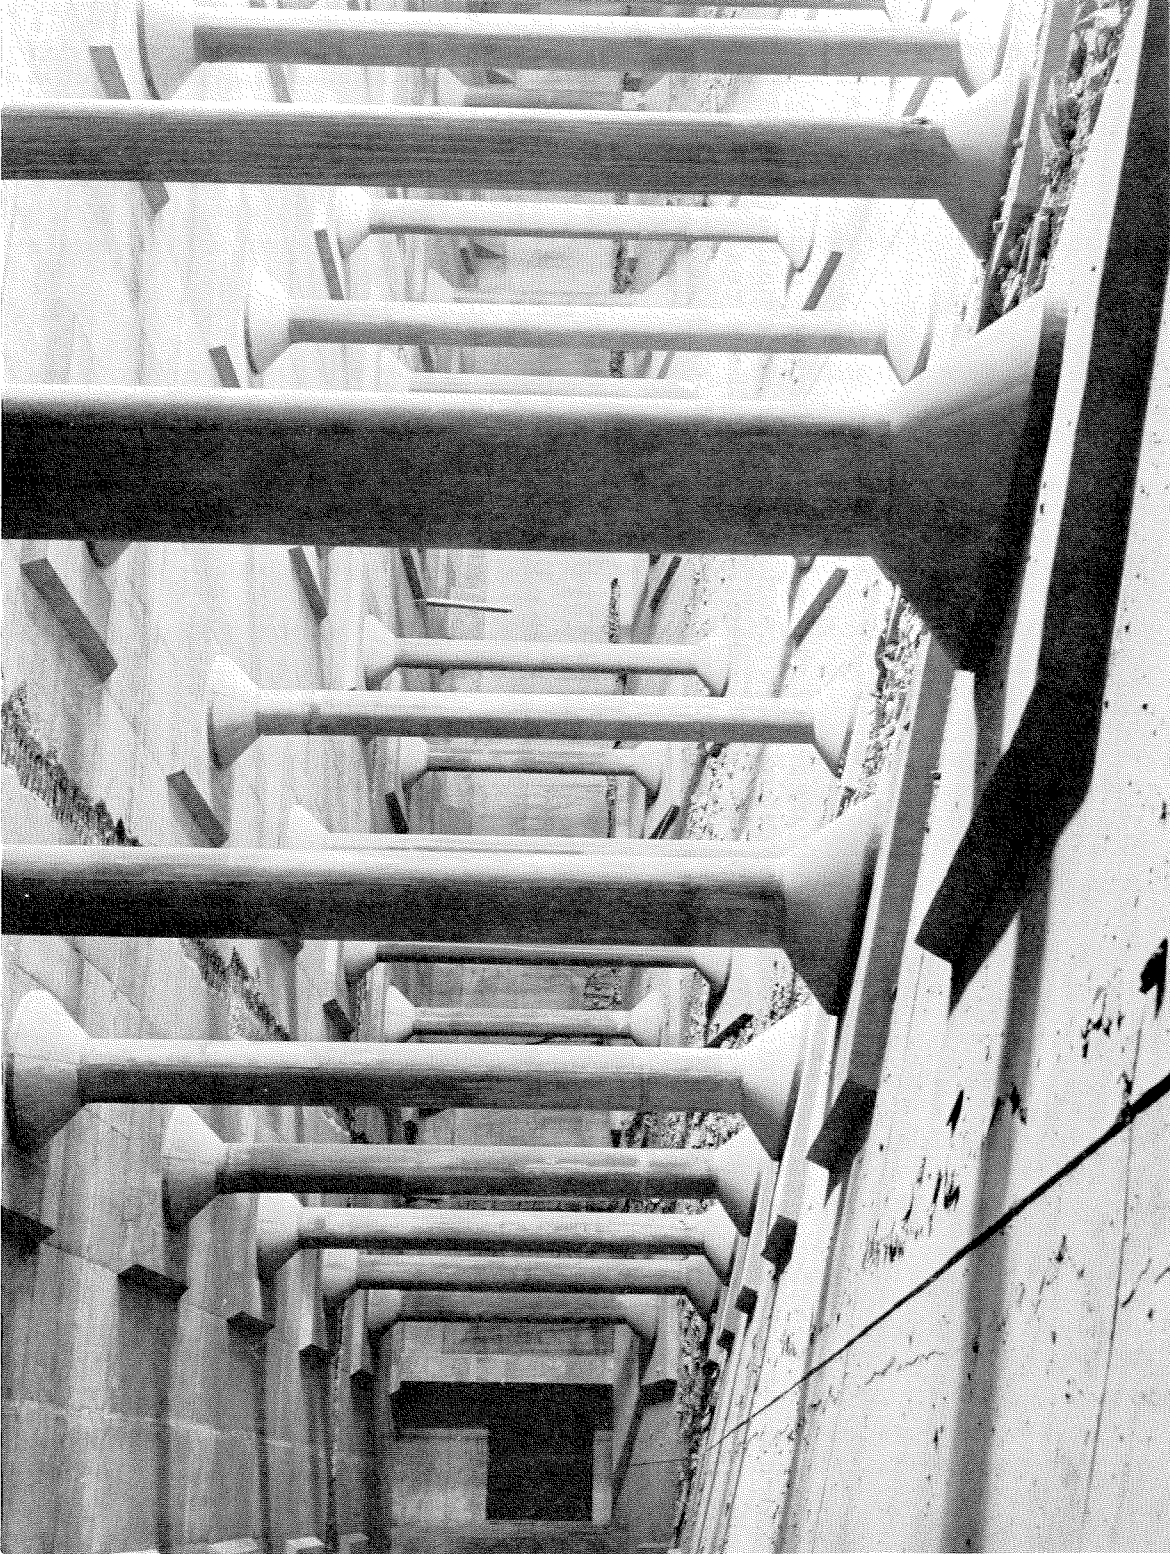
Figure 7. 9 Interior view of reservoir showing damage to roof slab, and what appears to be compression failure in floor slab along a construction joint. (MWD photograph).

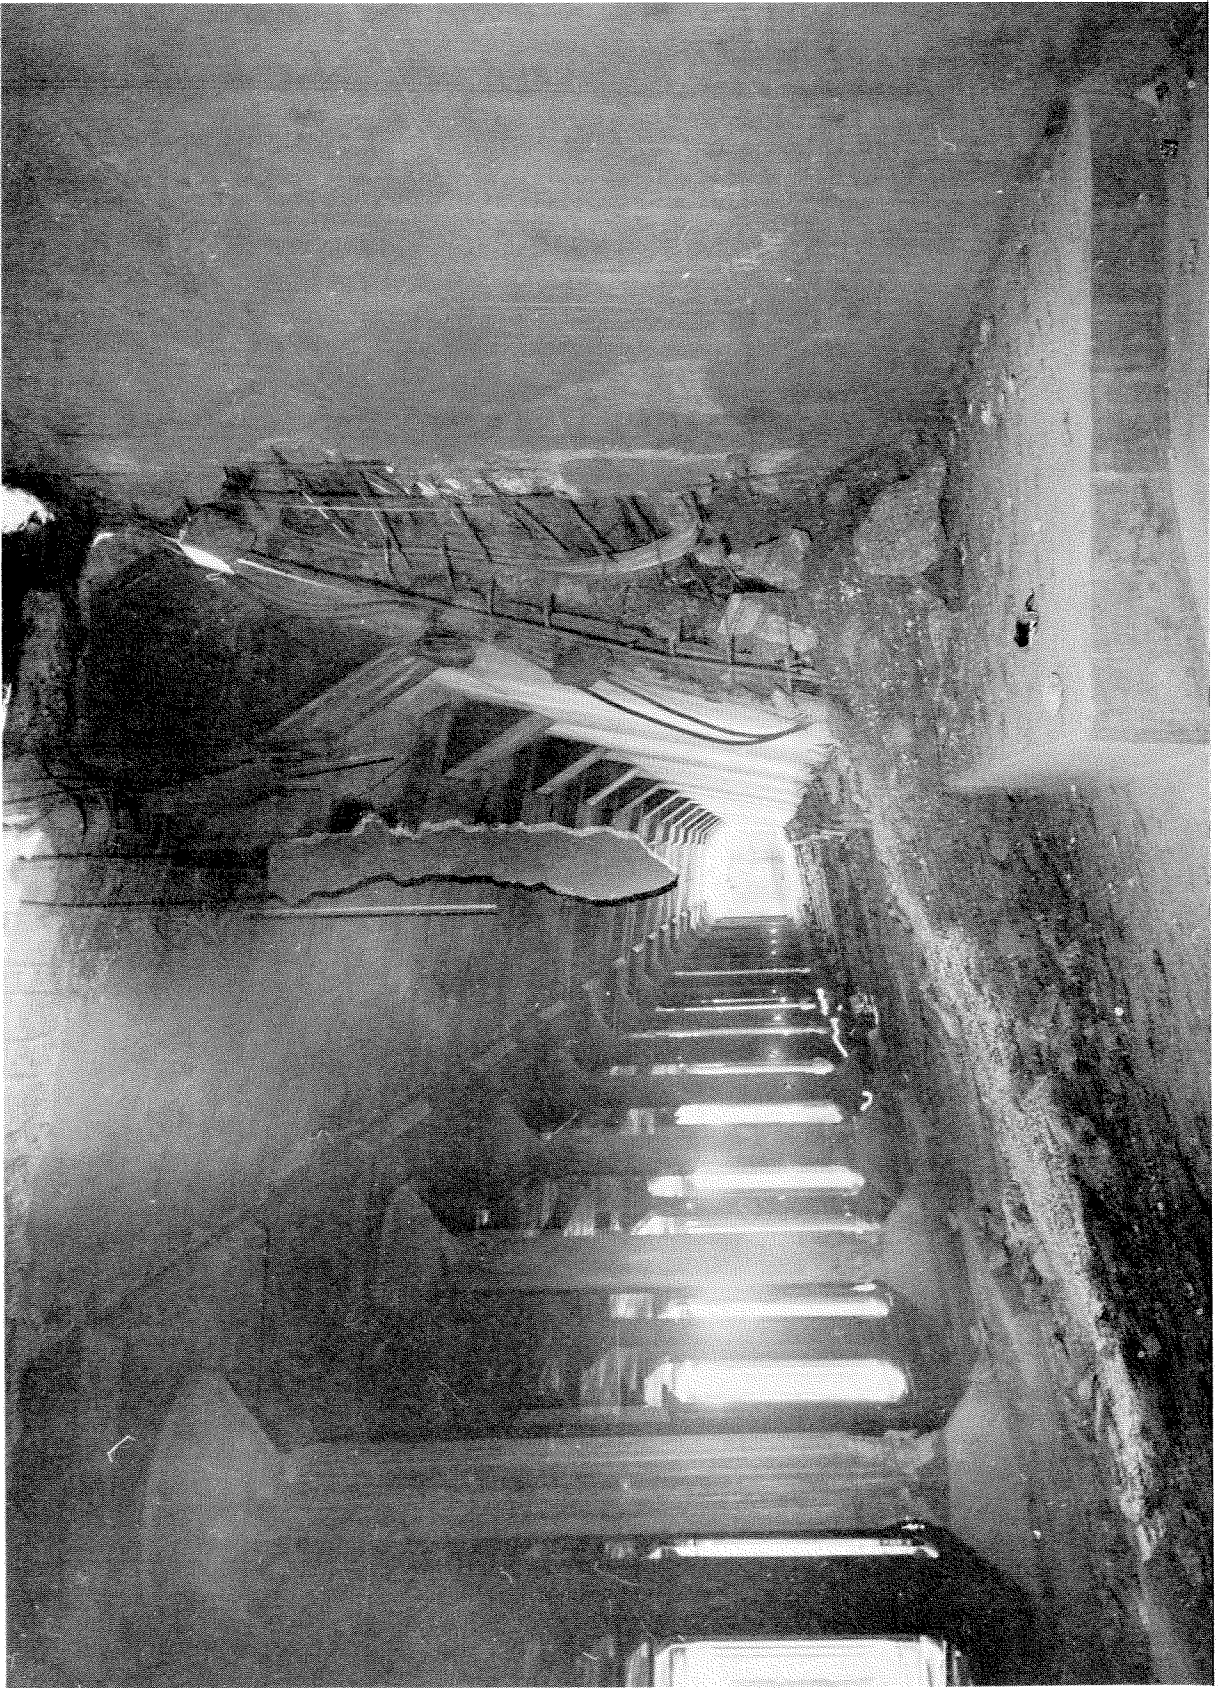
Figure 7. 10 Interior view of reservoir showing failure of west wall at bottom pour joint. (MWD photograph)

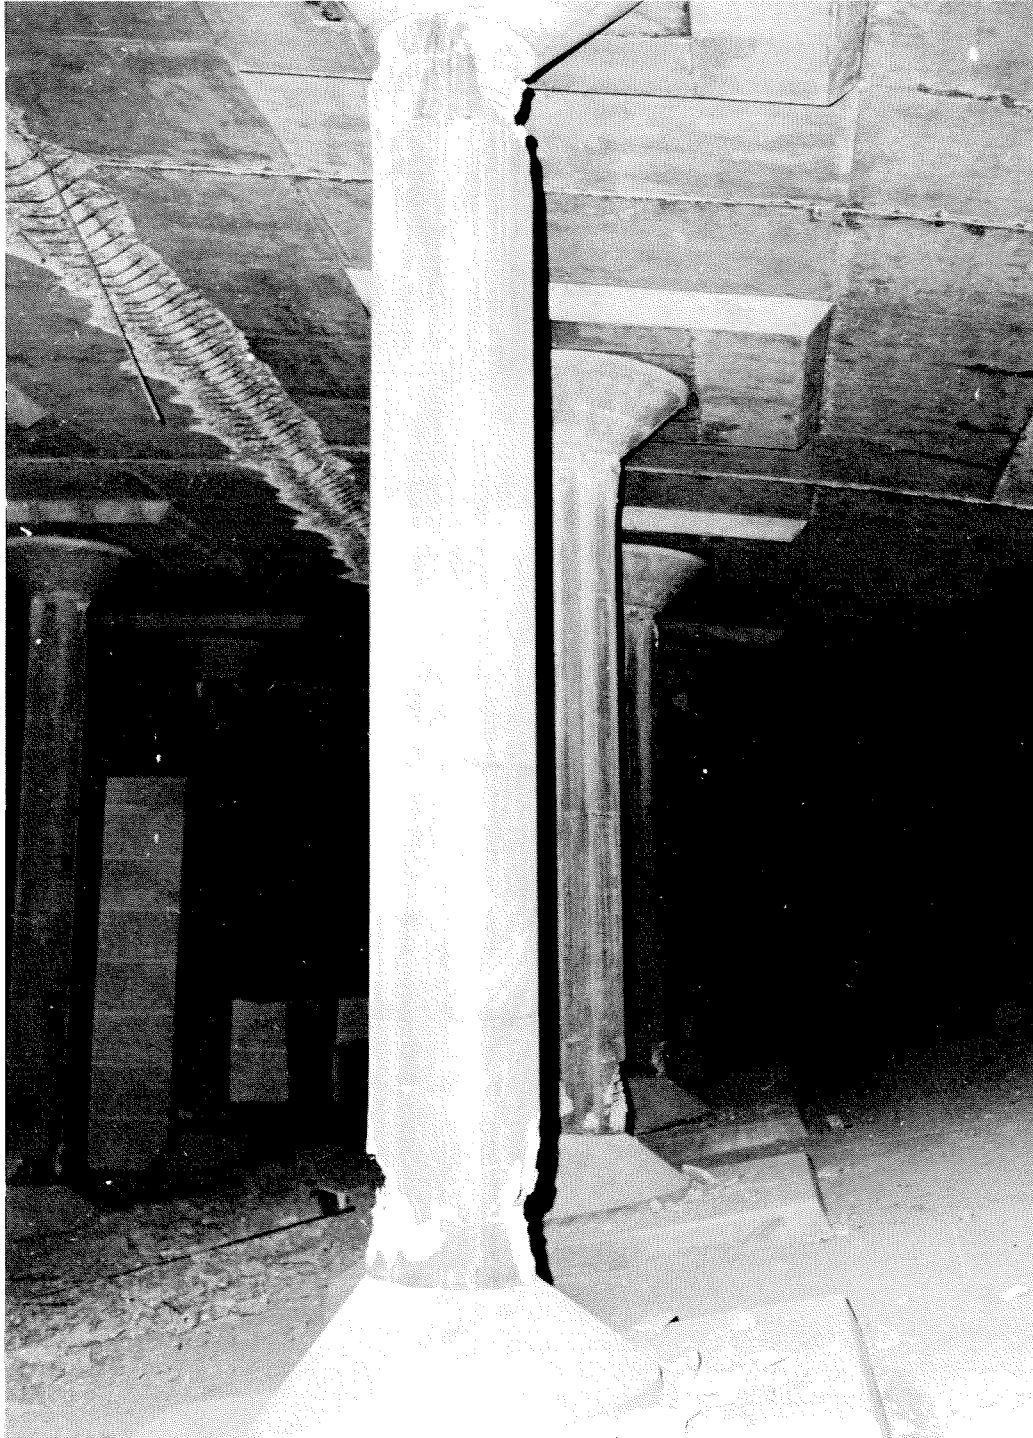
Figure 7.11 Interior view of reservoir showing typical column failures and a difference in elevation across roof slab damage along the construction joint. (MWD photograph).

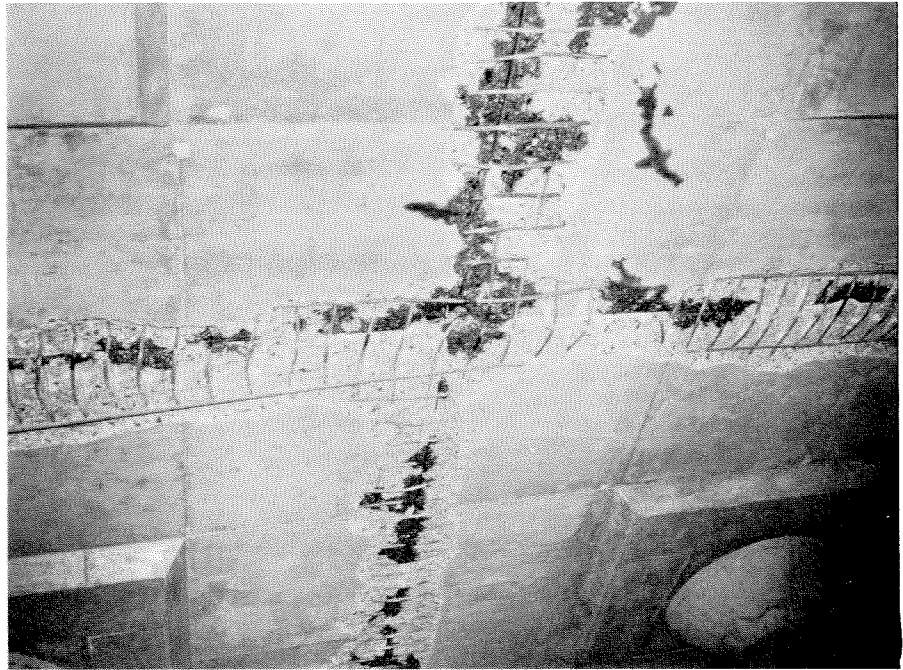
Figure 7.12 Typical damage to roof slab along construction joints. (MWD photograph).

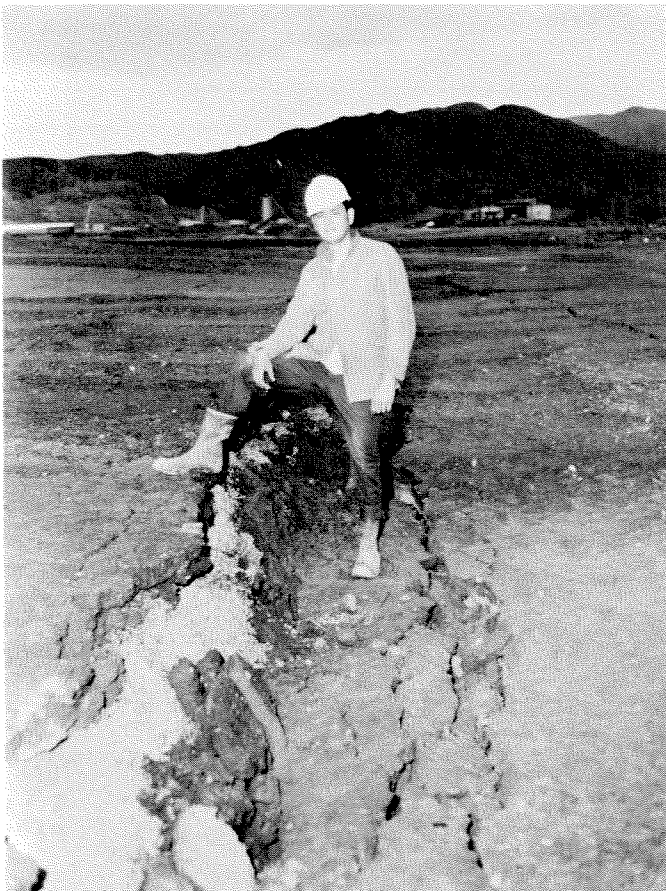
Figure 7.13 Looking north along eastern edge of reservoir, showing settlement of filled ground.
