ENGINEERING FEATURES
OF THE
SAN FERNANDO EARTHQUAKE OF FEBRUARY 9, 1971

Paul C. Jennings, Editor

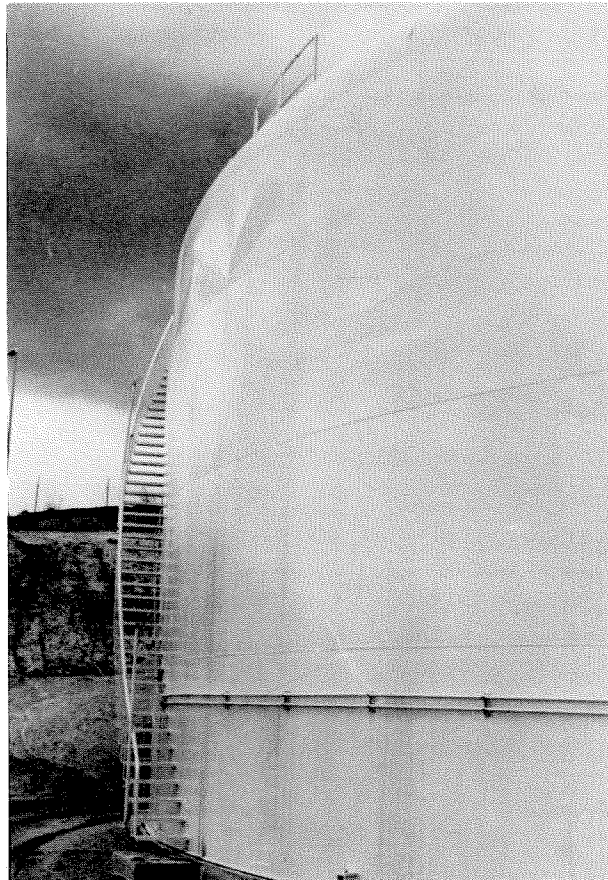
Figure 7.15 Buckle along top of tank at southern side.

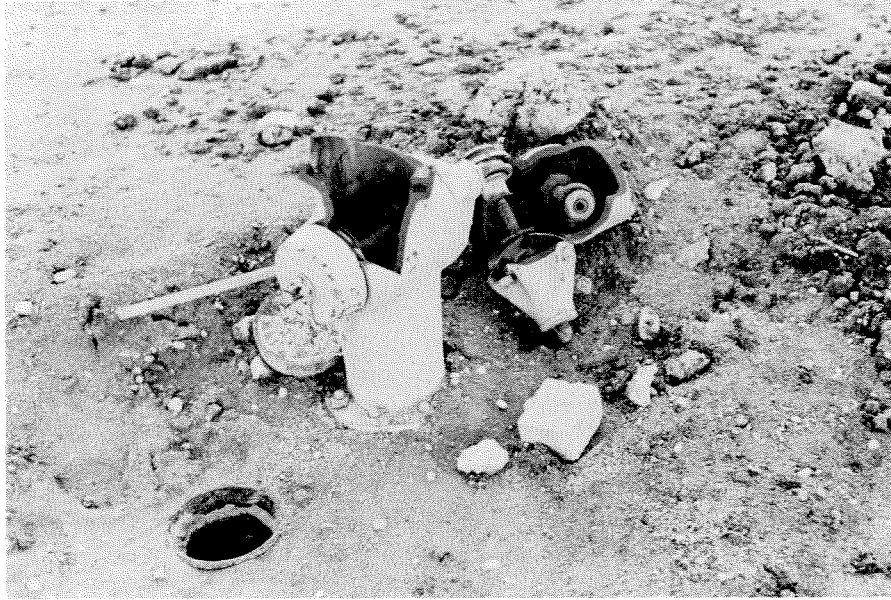
Figure 7.22 Cast iron water hydrant east of the settling basins was found shattered after the earthquake. MWD treatment plant.

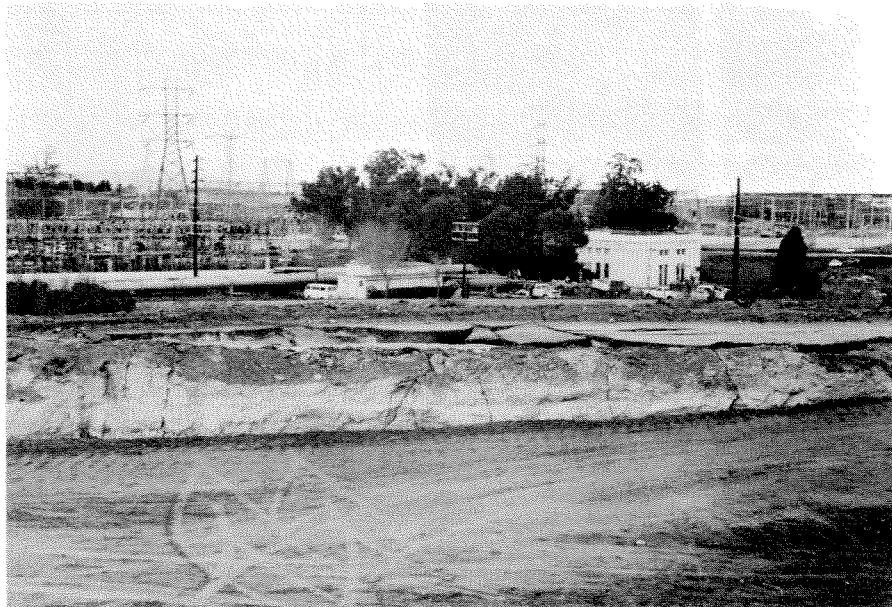
Figure 7.23 Old San Fernando power plant east of the settling basins was damaged by gross soil movements in an easterly direction.

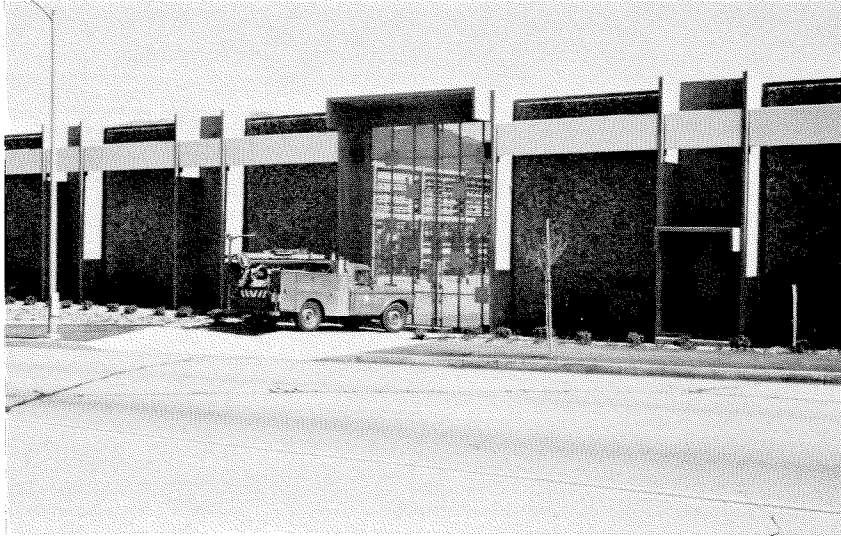
Figure 7.24 Balboa Blvd. switchyard is surrounded by decorative cantilevered walls, presumably designed according to the requirements of the building code.

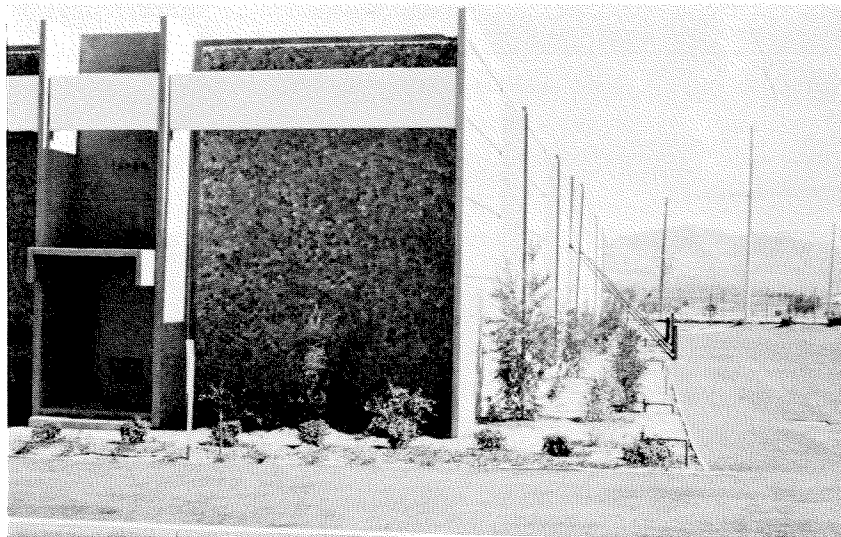
Figure 7.25 Walls of Balboa Blvd. switchyard are braced following the earthquake.

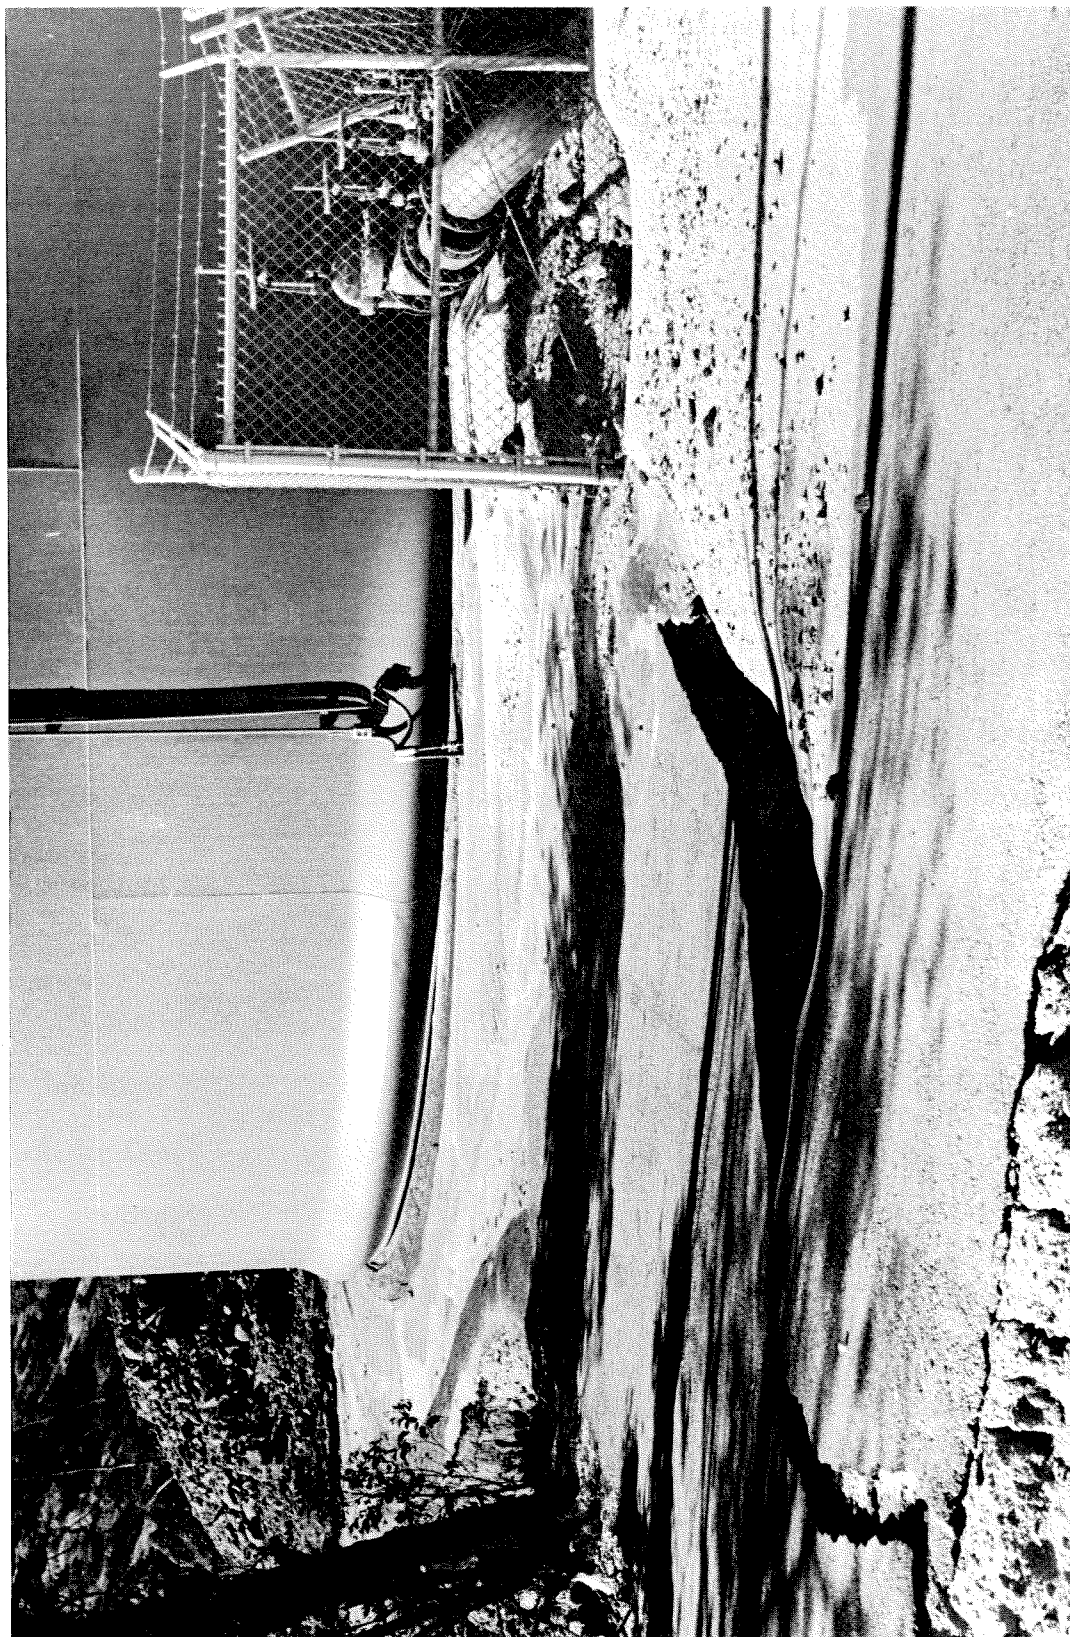
Figure 7.26 Water tank at Olive View Hospital. The vibrational damage caused failures of the tank base and adjoining piping, and the water was lost.

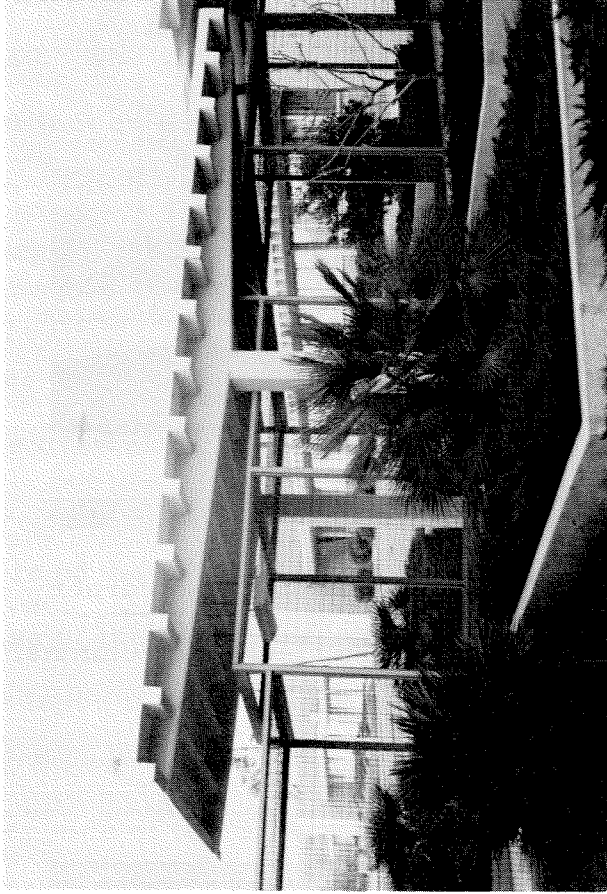
Figure 7.28 Reinforced concrete pergola at the San Fernando Juvenile Facility. The pergola was about 5° out-of-plumb after the earthquake.

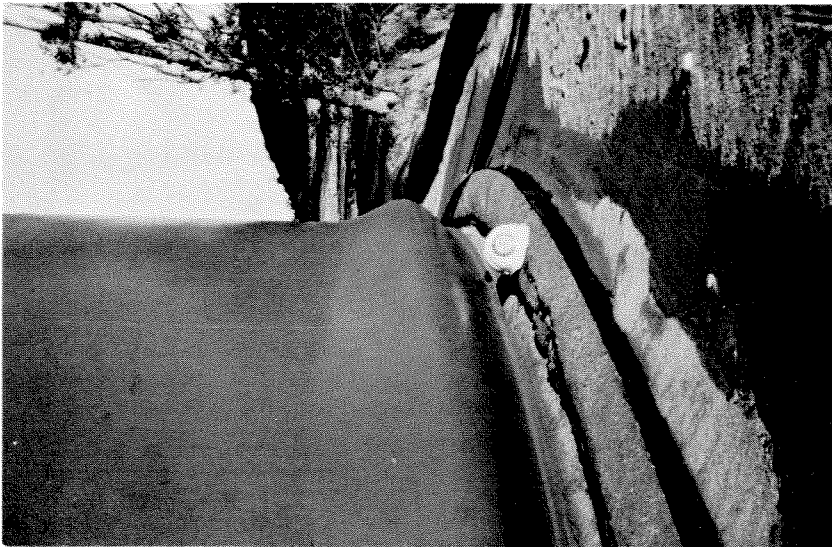
Figure 7.27 Olive View water tank showing damage to base of tank.

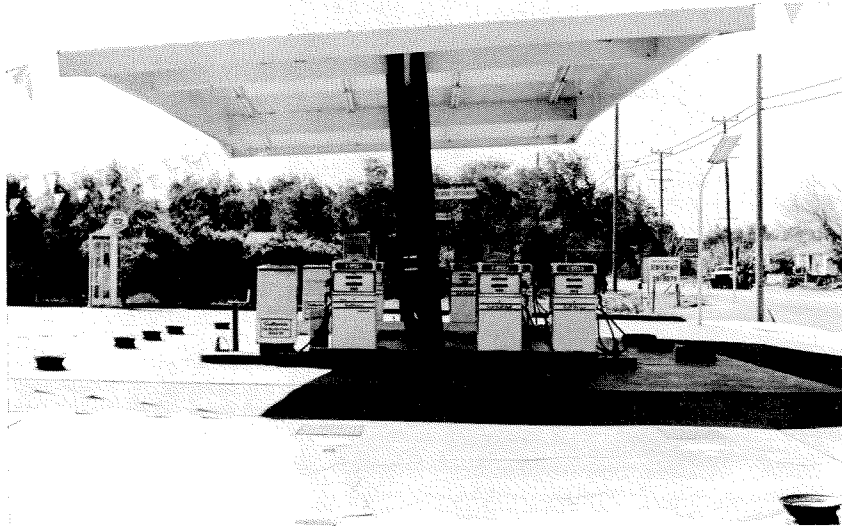
Figure 7.29 Pergola at gasoline station at the corner of Glenoaks Boulevard and Roxton Avenue yielded at base. The supporting members are steel pipe columns.

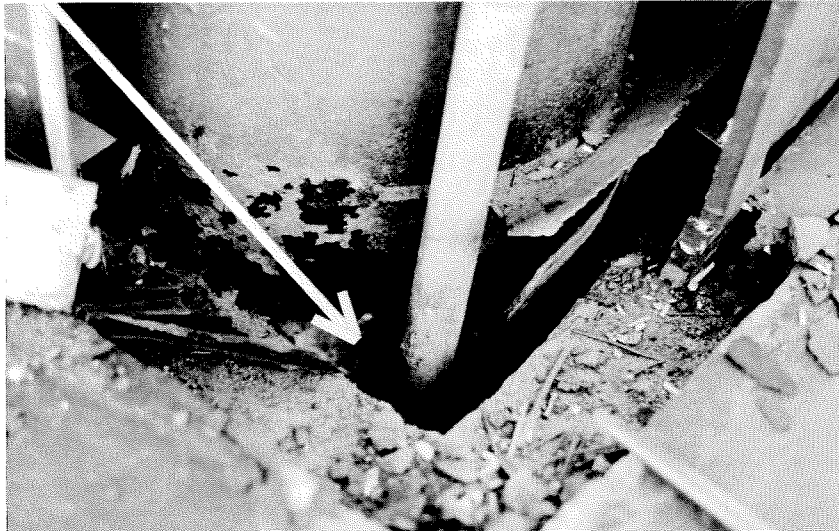
Figure 7.30 Yielded base of pipe column supporting pergola seen in Figure 7.29. A circumferential buckle is partly visible at the base of the columns.

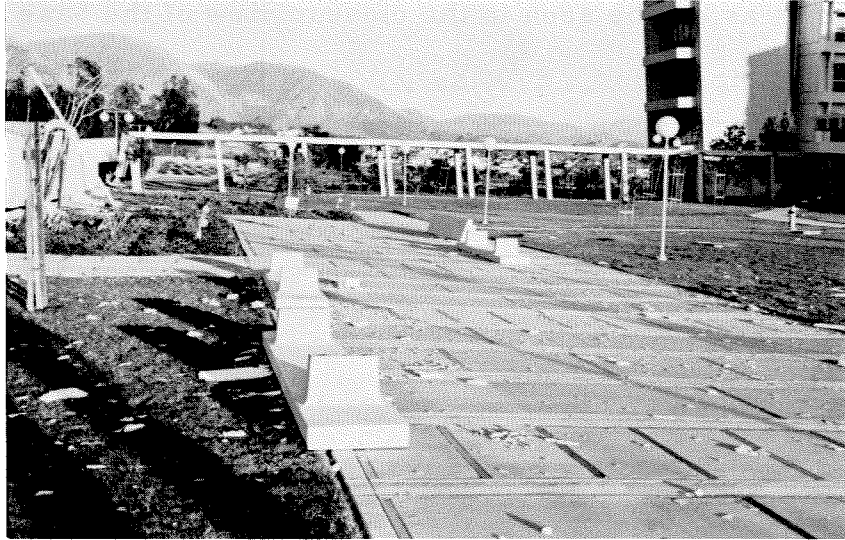
Figure 7.31 Overturned benches on the grounds of the Olive View Hospital. The cantilevered light standards did not fail, except for one which lost a bulb.

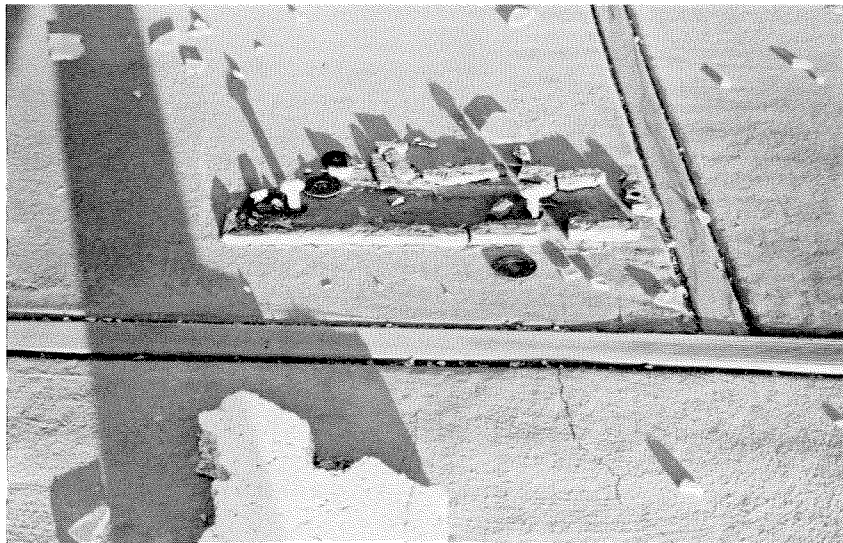
Figure 7.32 Details of mounts for overturned concrete benches, Olive View Hospital.

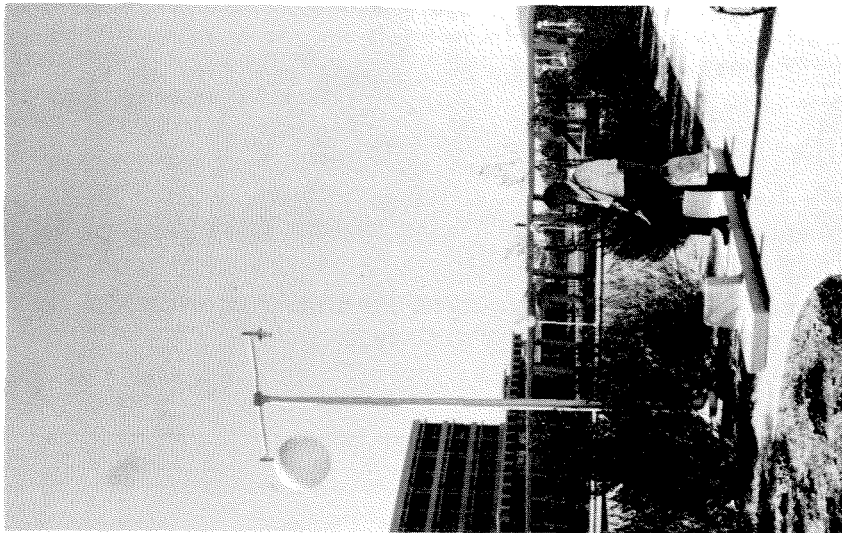
Figure 7.33 Overturned bench and damaged light standard at Olive View Hospital.

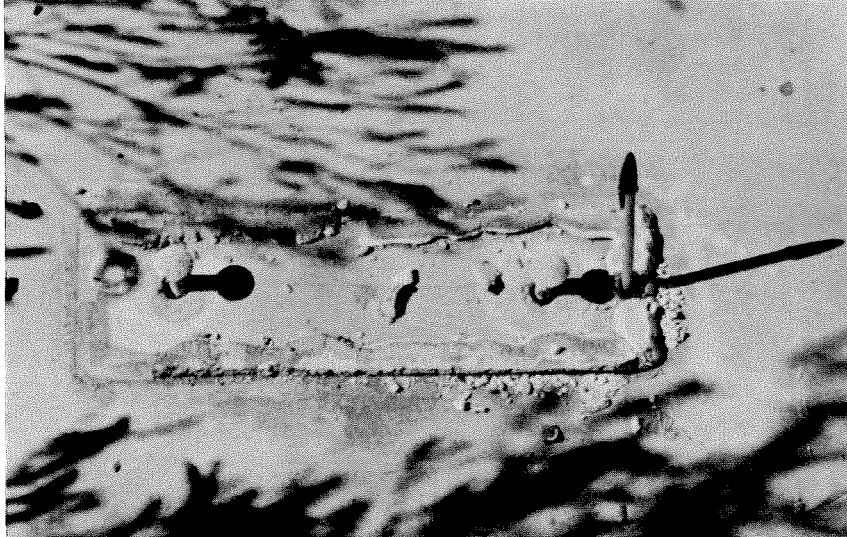
Figure 7.35 Mounting details of overturned bench shown in Figures 7.33 and 7.34.

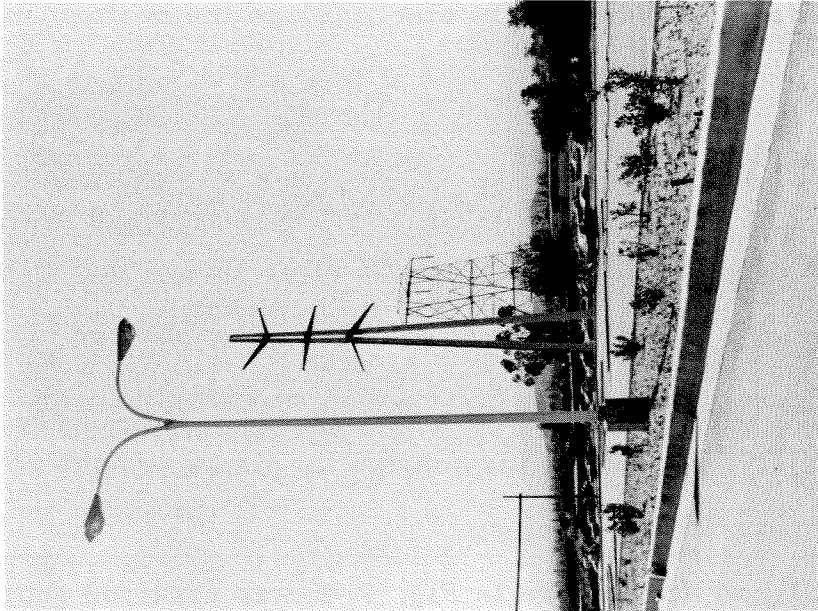
Figure 7.37 Light standard and new and old transmission towers near Olive View Hospital. The three structures were not damaged.

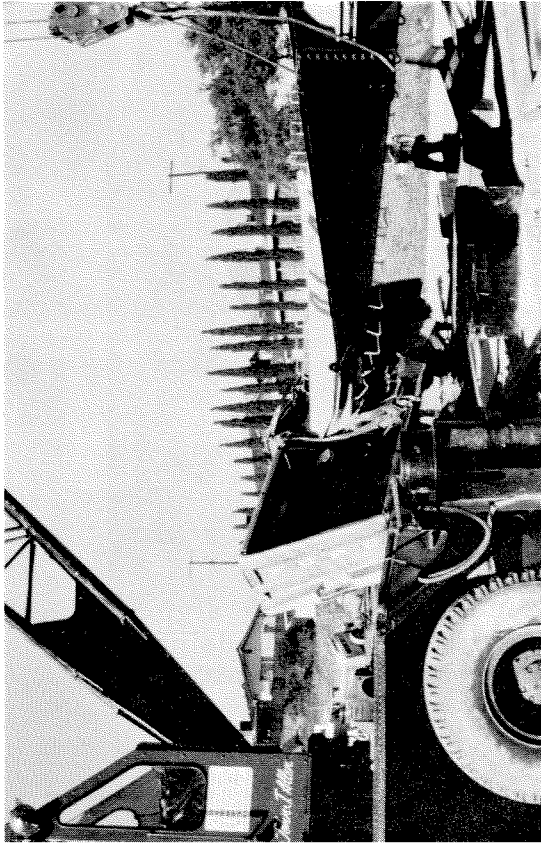
Figure 7.40 An electrical transmission tower under construction failed at an incomplected joint near the base of the tower.

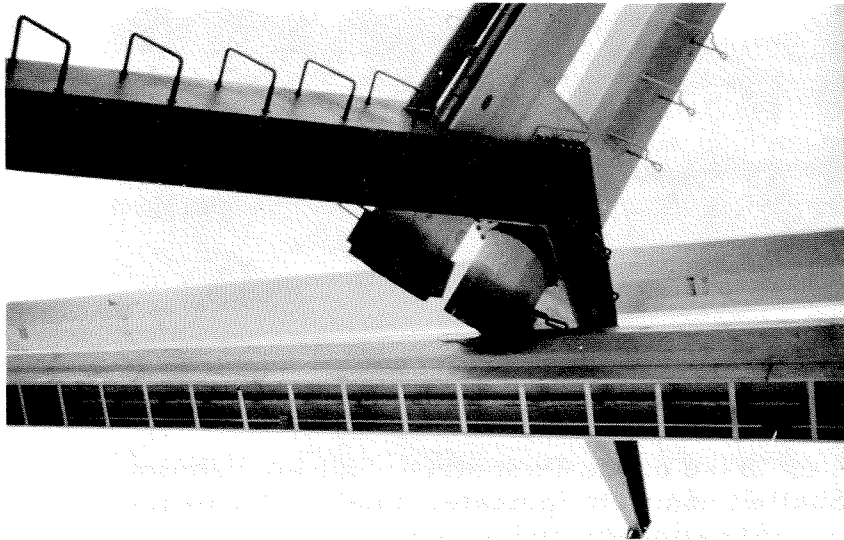
Figure 7.39 Two electrical transmission towers not yet welded at the construction joint failed during the earthquake. The completed towers were not damaged.

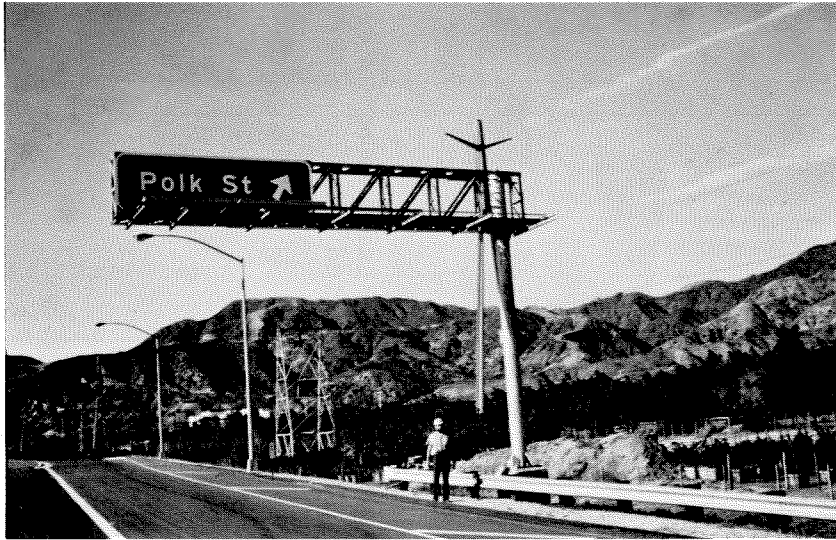
Figure 7.41 A cantilevered, eccentric freeway sign near Polk Street on the Foothill freeway was undamaged by the earthquake. Olive View Hospital is in the left background.

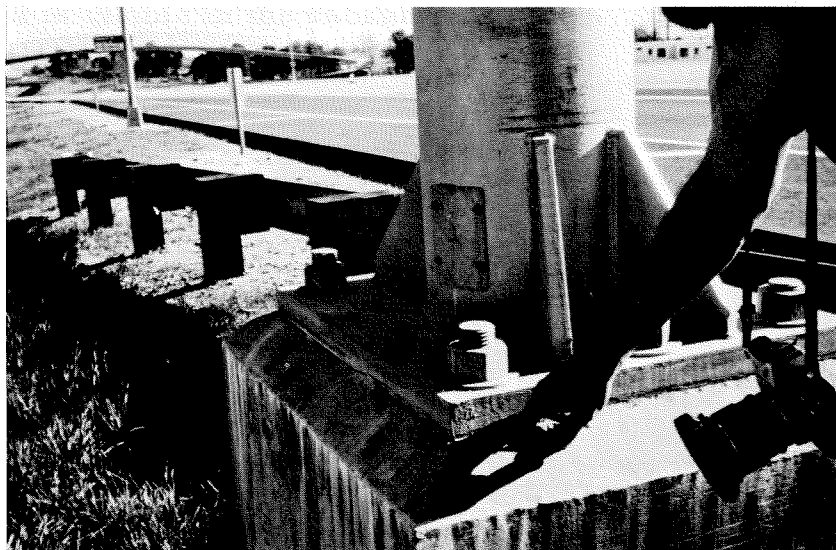
Figure 7.42 Base of the Polk Street exit sign shown above. Spalled concrete indicates small movements at the base of the undamaged structure.

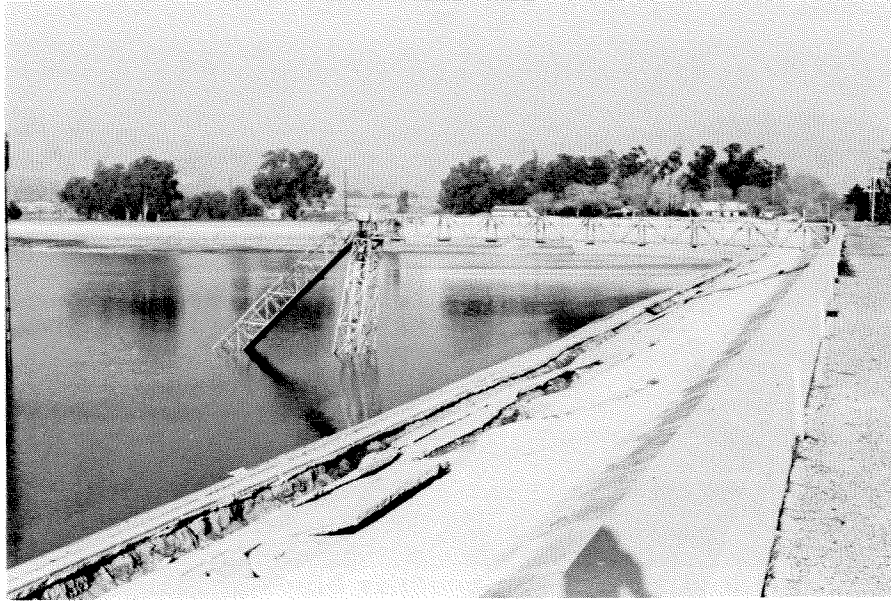
Figure 7.43 Collapsed elevated walkway at upper Van Norman Reservoir.

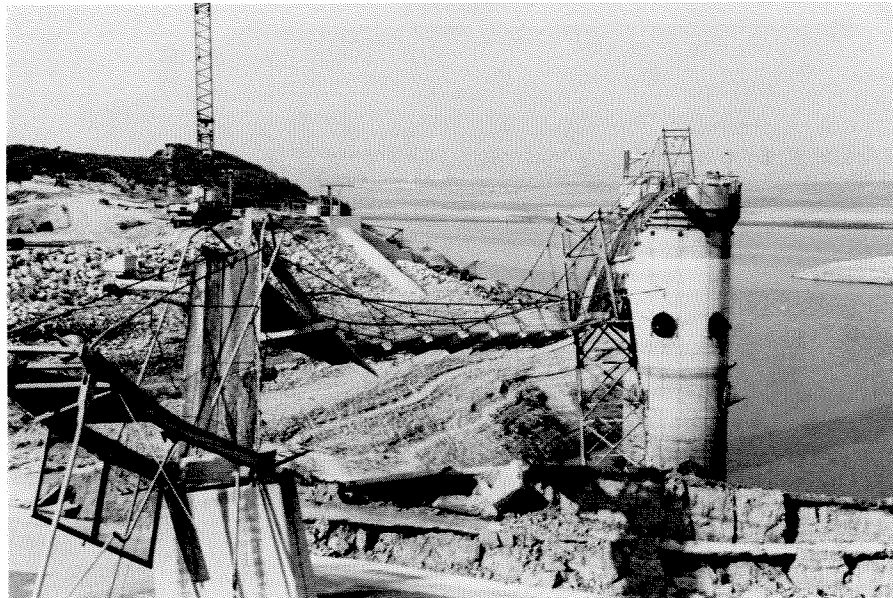
Figure 7.44 Damaged elevated walkway at the lower Van Norman Reservoir.

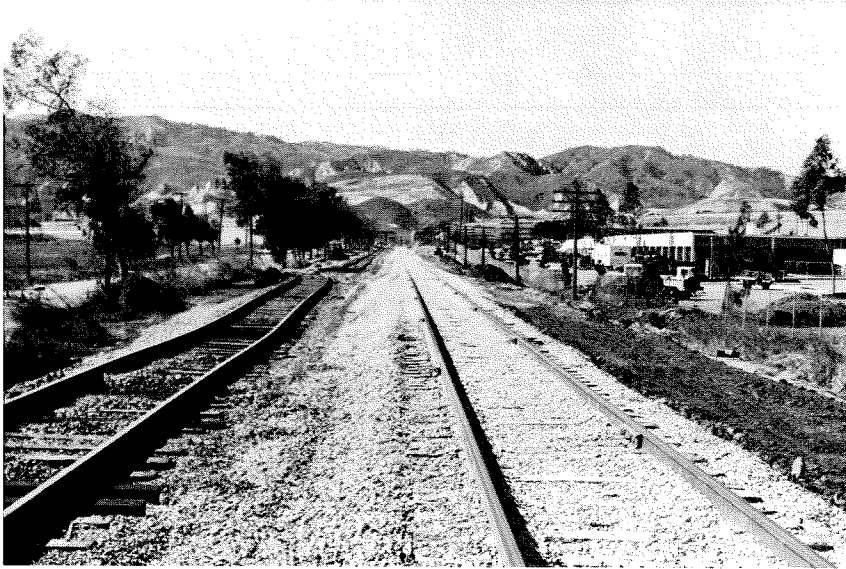
Figure 7.45 Damaged and repaired railway lines near San Fernando Juvenile Hall. The repaired line shows post-earthquake movements to the left, toward upper Van Norman Reservoir.

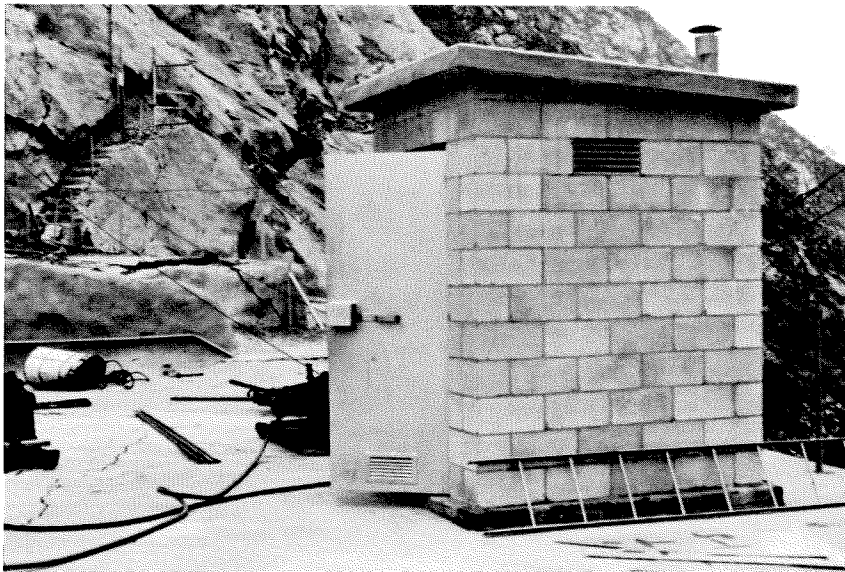
Figure 7.46 A small concrete block structure on the abutment thrust block at Pacoima Dam was undamaged by the earthquake.

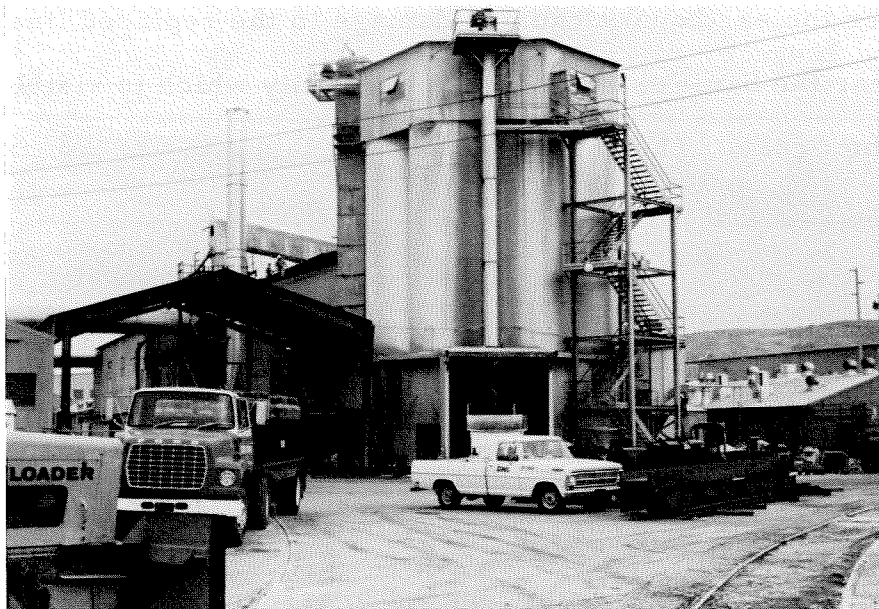
Figure 7.47 Thatcher Glass Factory between Newhall and Saugus. This large cluster of storage bins had its first-story supports damaged. The bins are supported on steel columns with I-beam bracing. The bracing was overloaded and underwent permanent deformations.

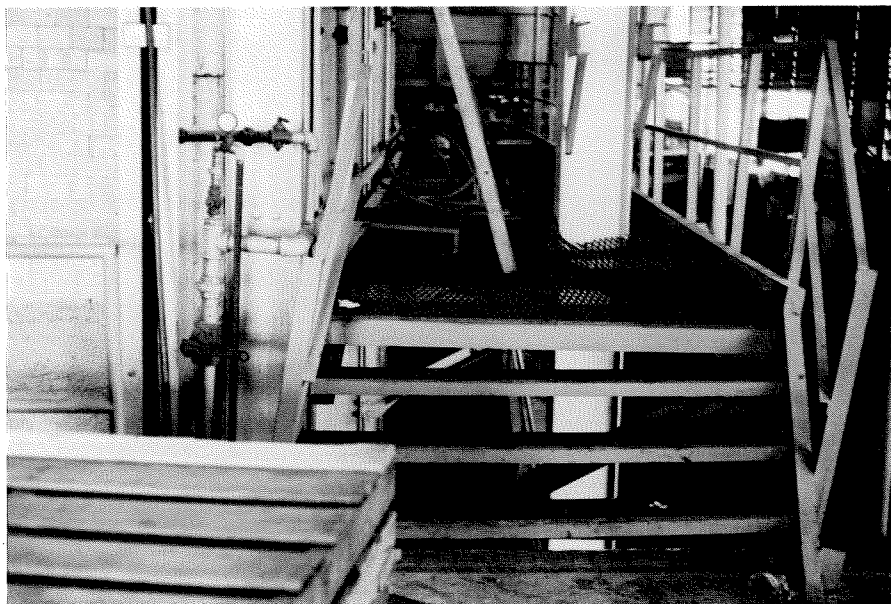
Figure 7.48 Thatcher Glass Factory. Massive glass furnace underwent a permanent horizontal displacement of about six inches.

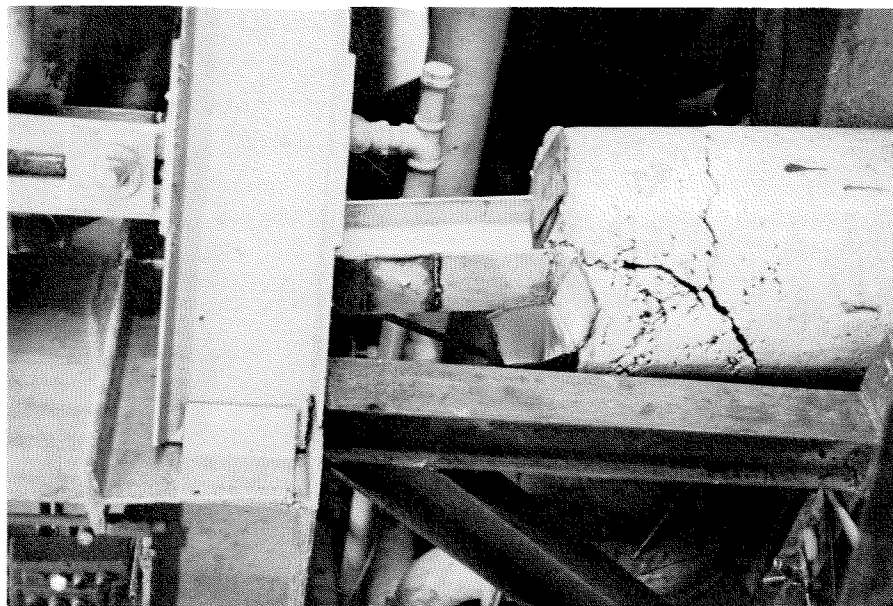
Figure 7.50 Thatcher Glass Factory. Deformed supports under a glass furnace.

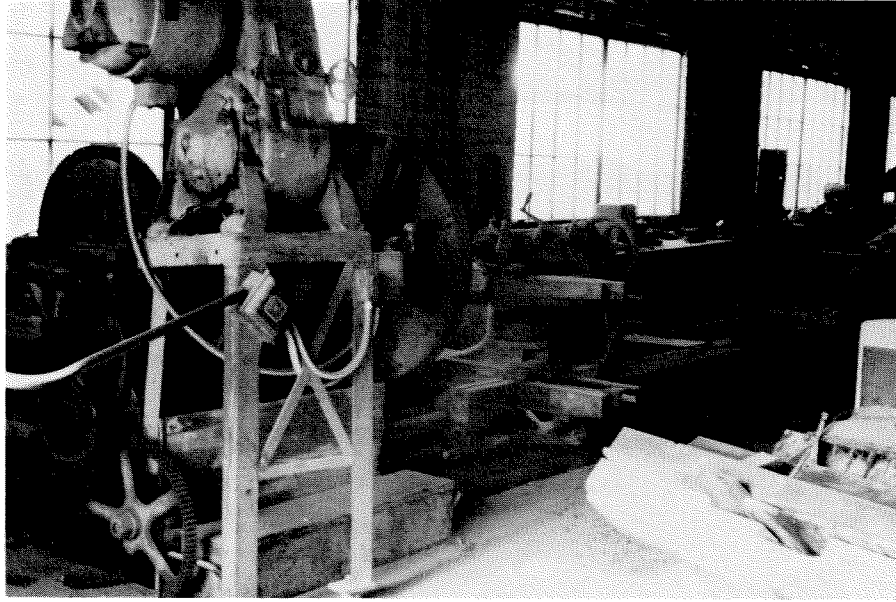
Figure 7.51 Heavy lathe at Brown's contracting yard on Glenoaks Avenue southeast of Hubbard Avenue. This heavy metal working lathe moved about 9 ft, relative to the floor, in a northerly direction, leaving a straight skid mark.

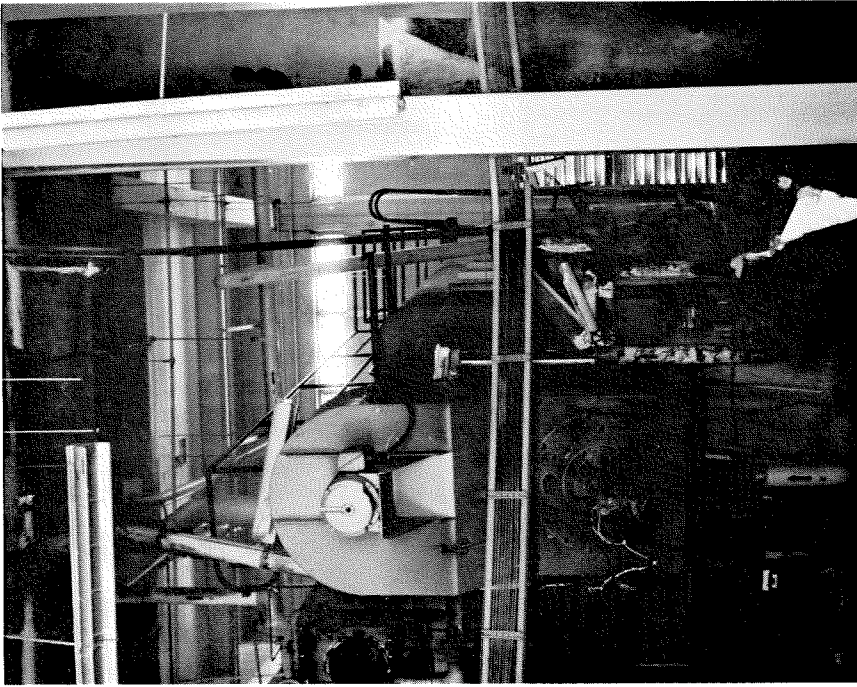
Figure 7.54 View, looking west, of one of the boilers in the new power building at Olive View Hospital. The western end of the boiler had not been anchored to the floor and it moved about four feet, relative to the floor, in a northerly direction. Equipment in this building that had been anchored to the floor did not break loose.

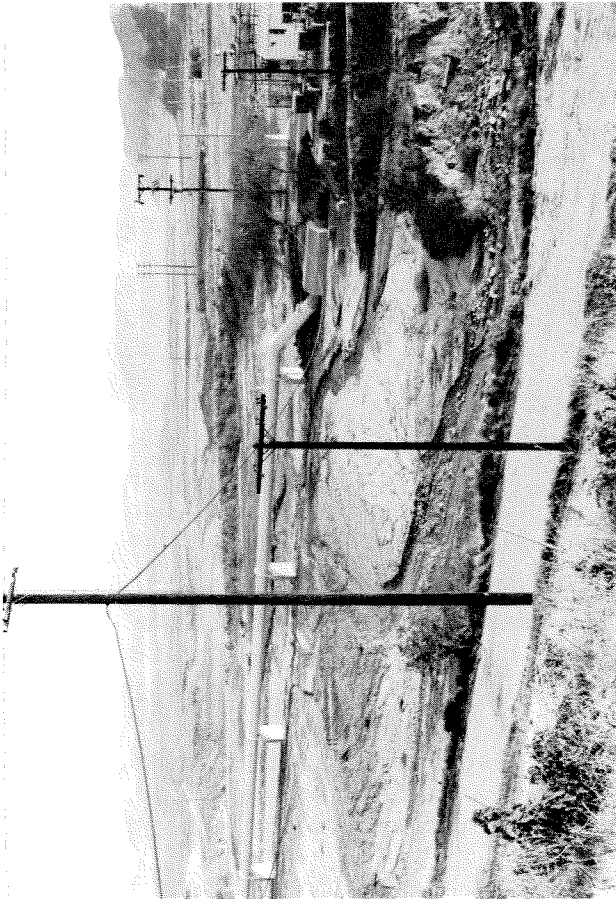
Figure 7.53 The supports of this steel water pipe, parallel to and just below upper Van Norman Dam had its supports deformed. The damage indicated a relative compression of the ground parallel to the pipe. The steel supports of the pipe underwent as much as several inches of deformation but the pipe was not damaged.

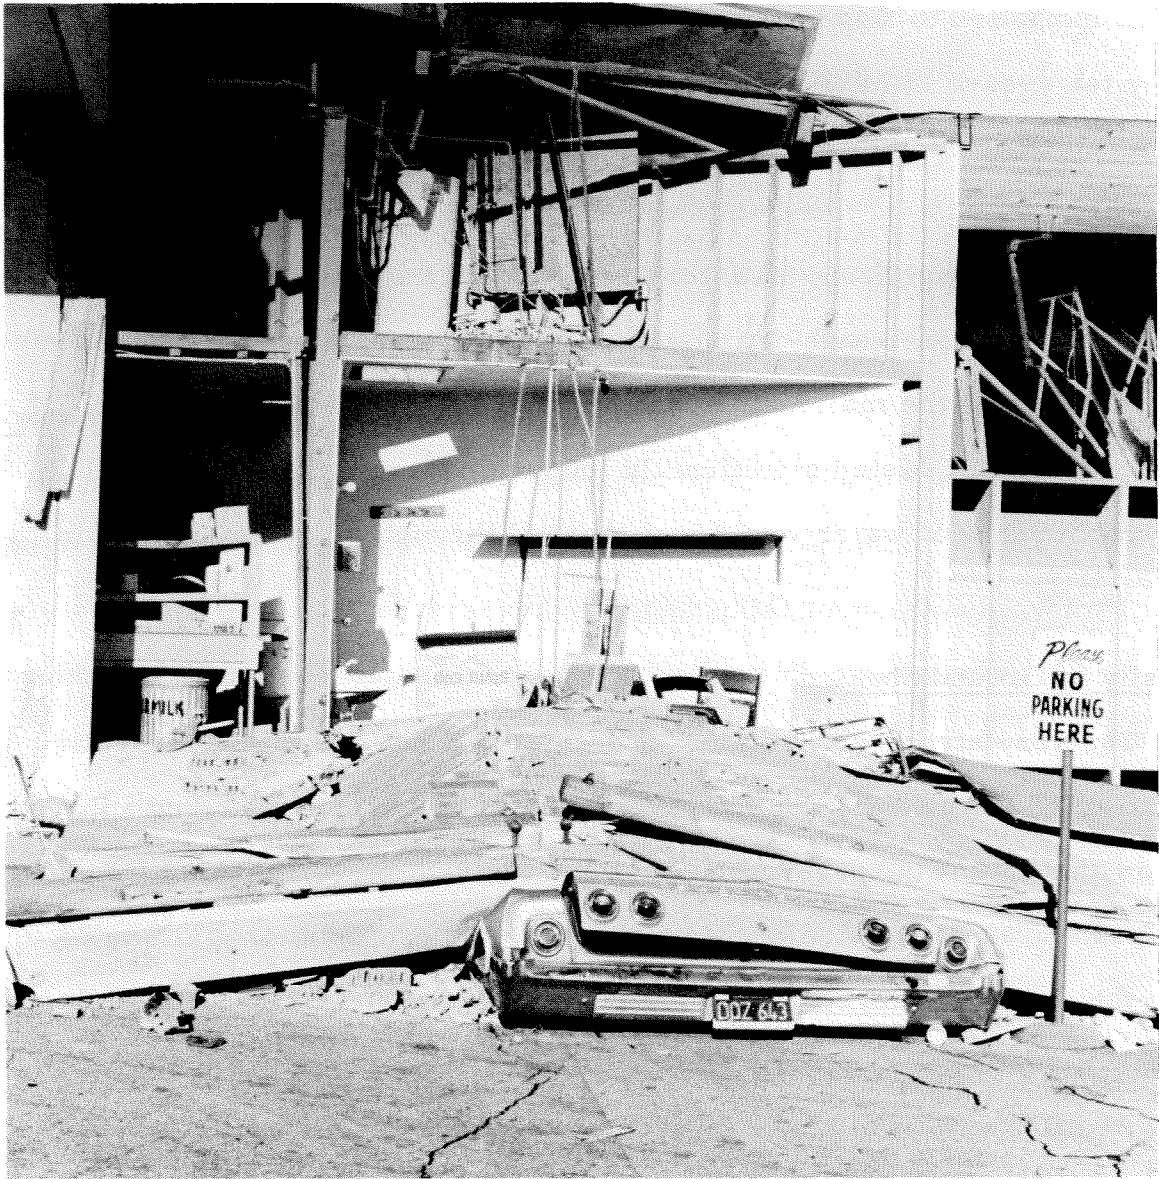
Figure 8.2 A market at the corner of Glenoaks Boulevard and Hubbard Avenue. Had the earthquake occurred during business hours the casualties would have been much greater.

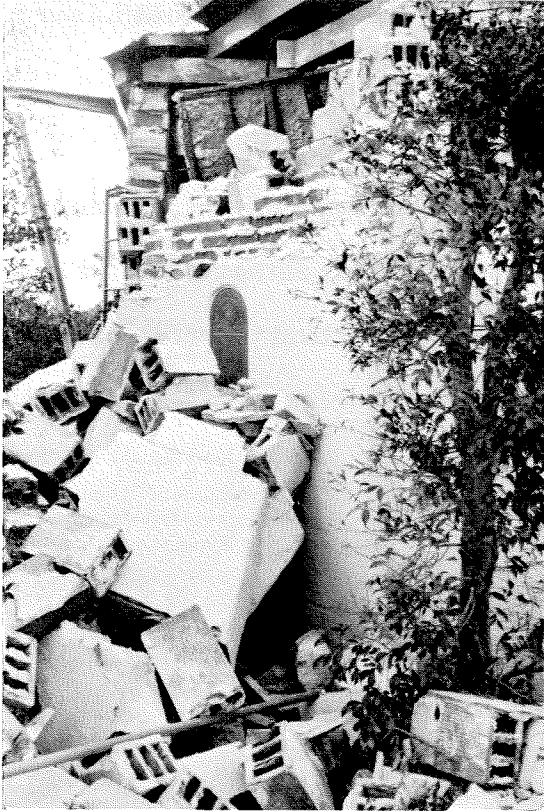
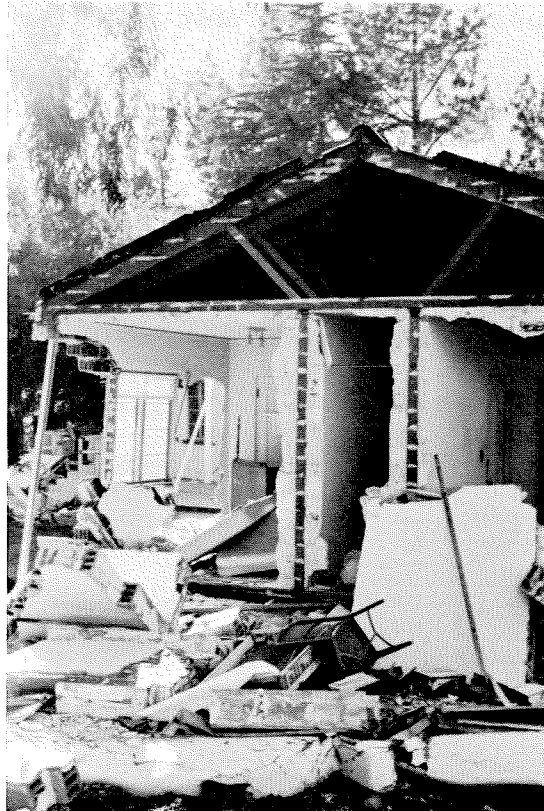
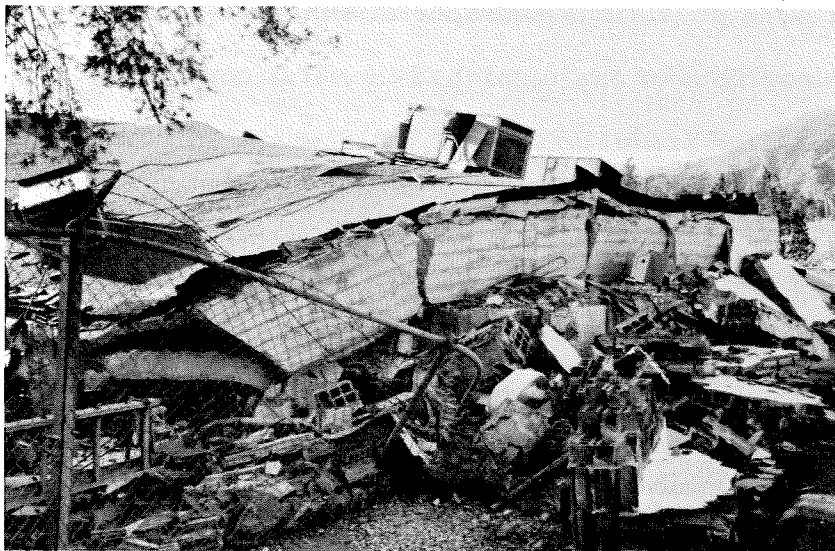
Figure 8.3 Old buildings at the Veterans Hospital. The greatest hazard to human life in California earthquakes comes from the older buildings, built before earthquake-resistant design provisions were incorporated in the building codes.

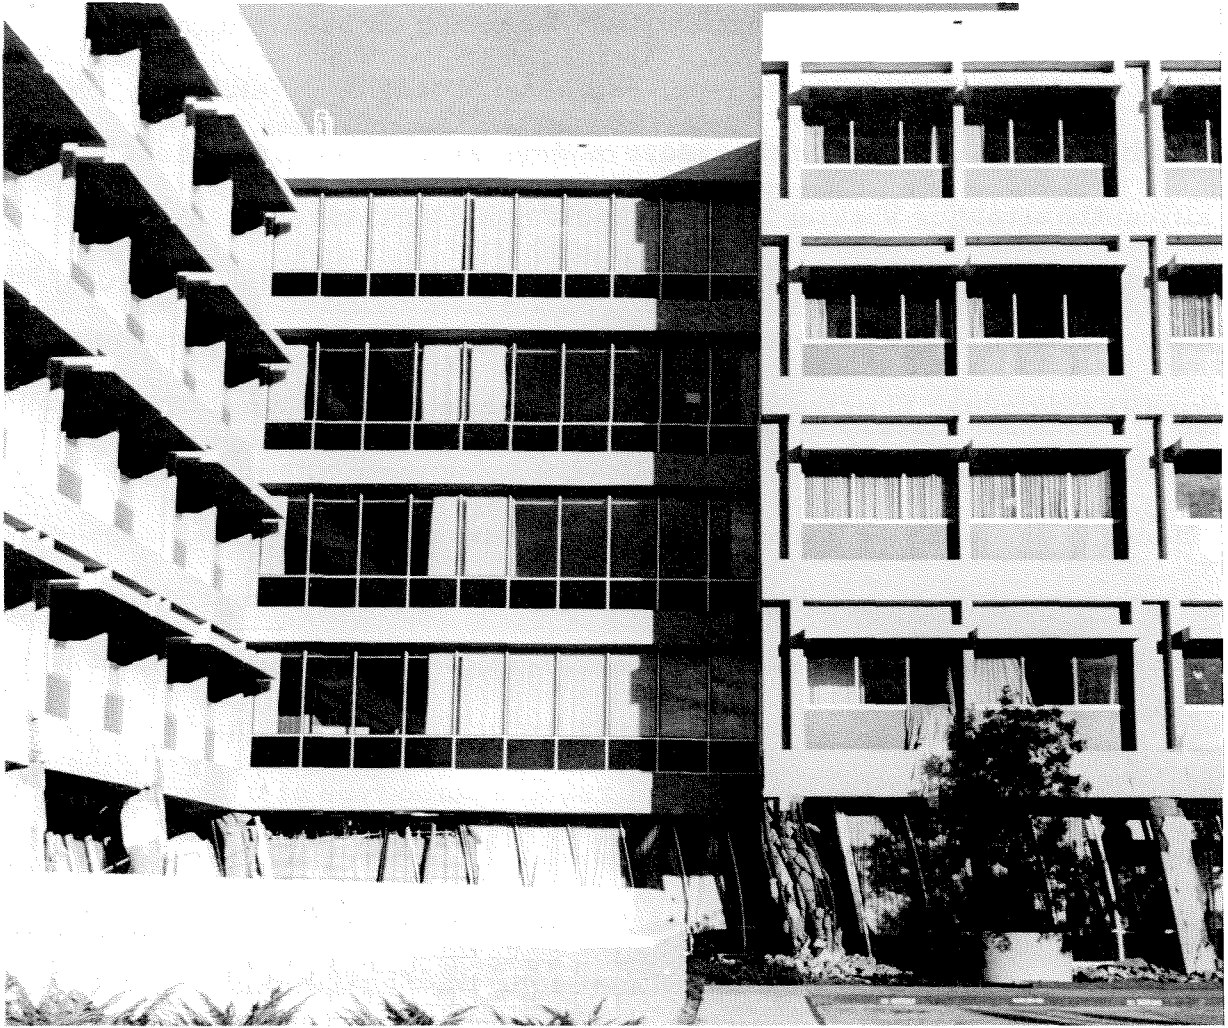
Figure 8.4 West elevation of the Olive View Hospital. The failure of this major new building and the collapse of the neighboring Psychiatric Day-Care Center show the need for improvement of seismic provisions in modern building codes.

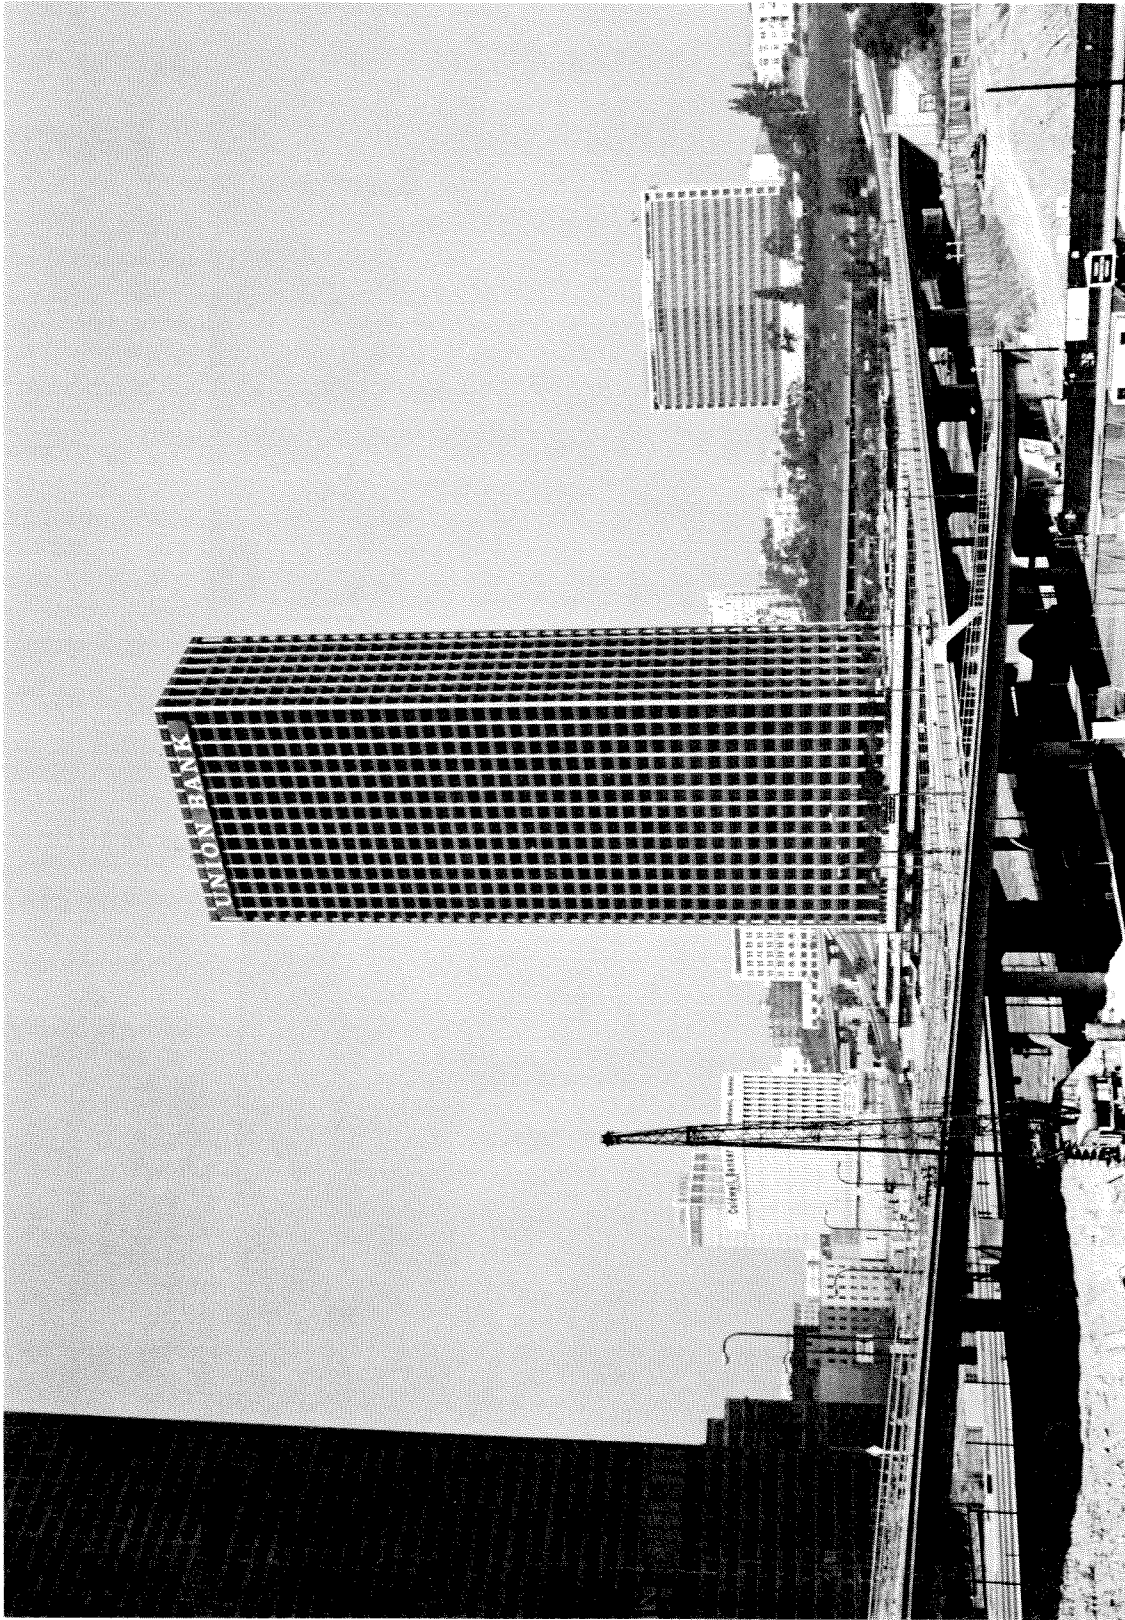
Figure 8.5 Tall buildings in downtown Los Angeles responded as expected to the strong shaking and did not receive structural damage from the earthquake. The shaking was not severe enough in downtown Los Angeles, however, to test the ultimate strength of these structures.
