ENGINEERING FEATURES
OF THE
SAN FERNANDO EARTHQUAKE OF FEBRUARY 9, 1971

Paul C. Jennings, Editor

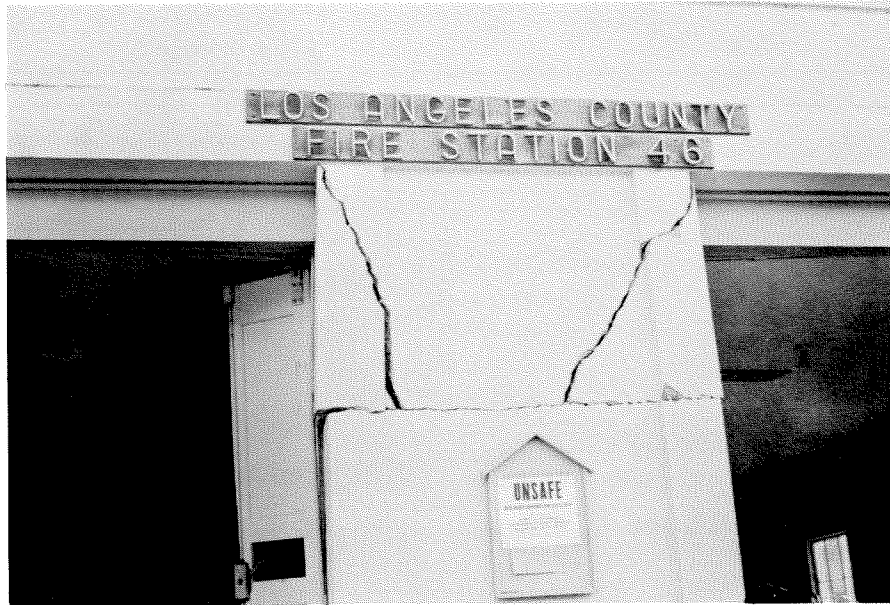
Los Angeles County Fire Station Number 46.

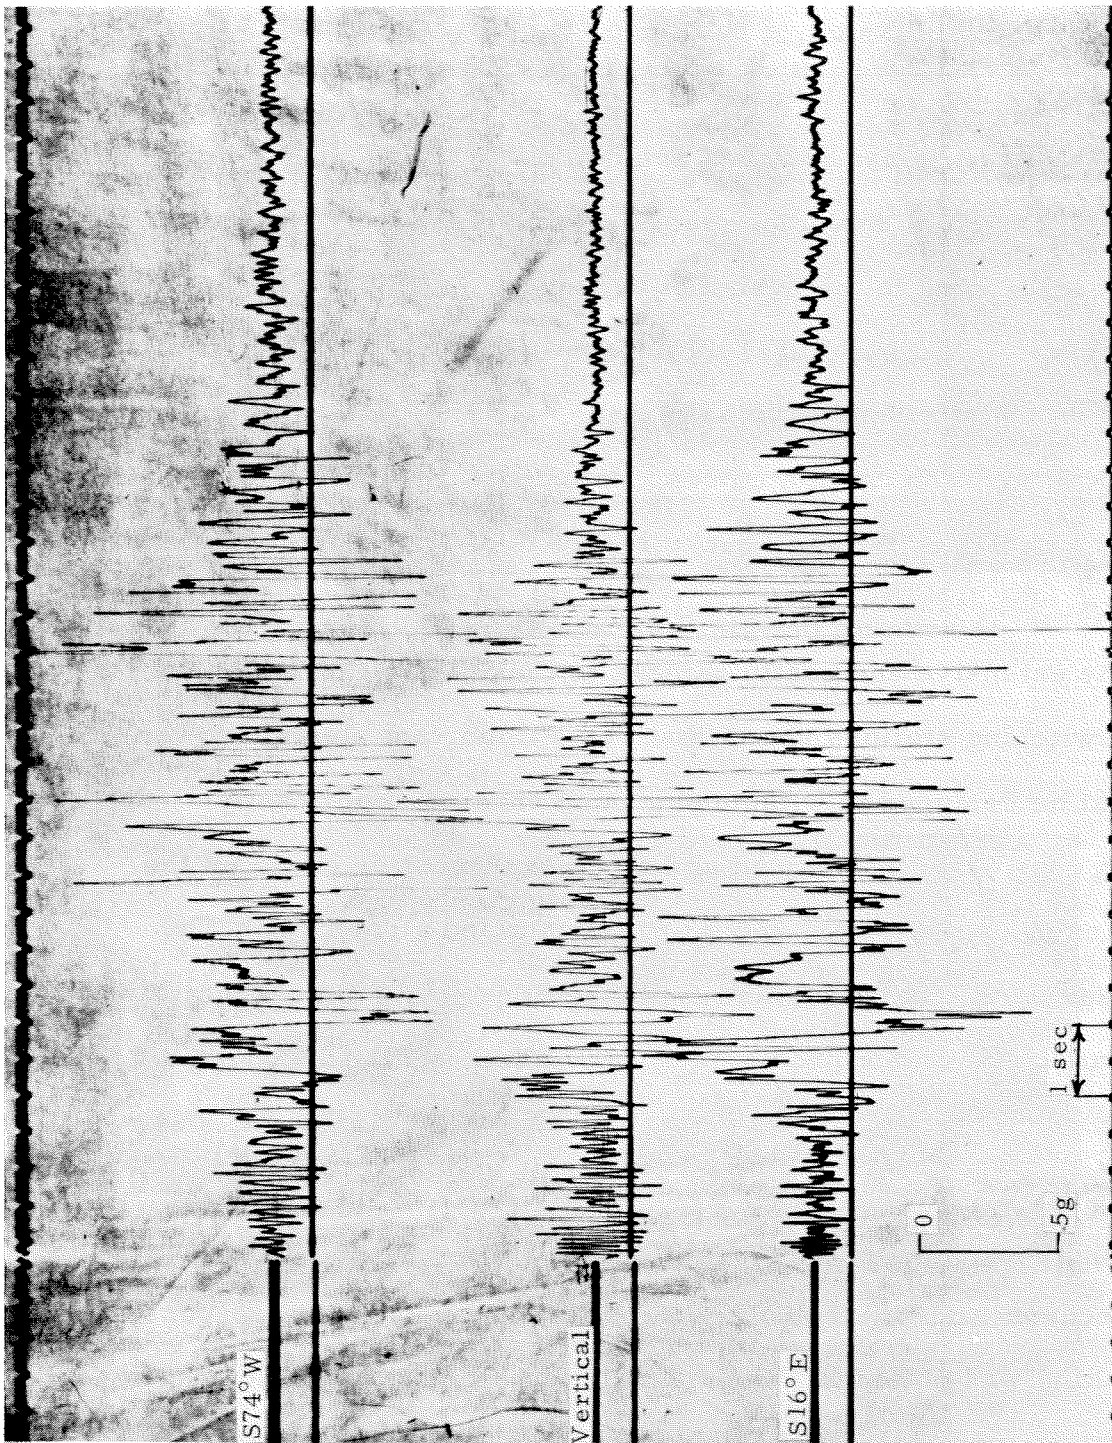
Figure 8.7 A photograph of the original record obtained at Pacoima Dam in the earthquake of February 9, 1971. The strong motion lasted about 8 secs and included the most intense accelerations yet recorded, with a few peaks of the horizontal motion exceeding 1g.

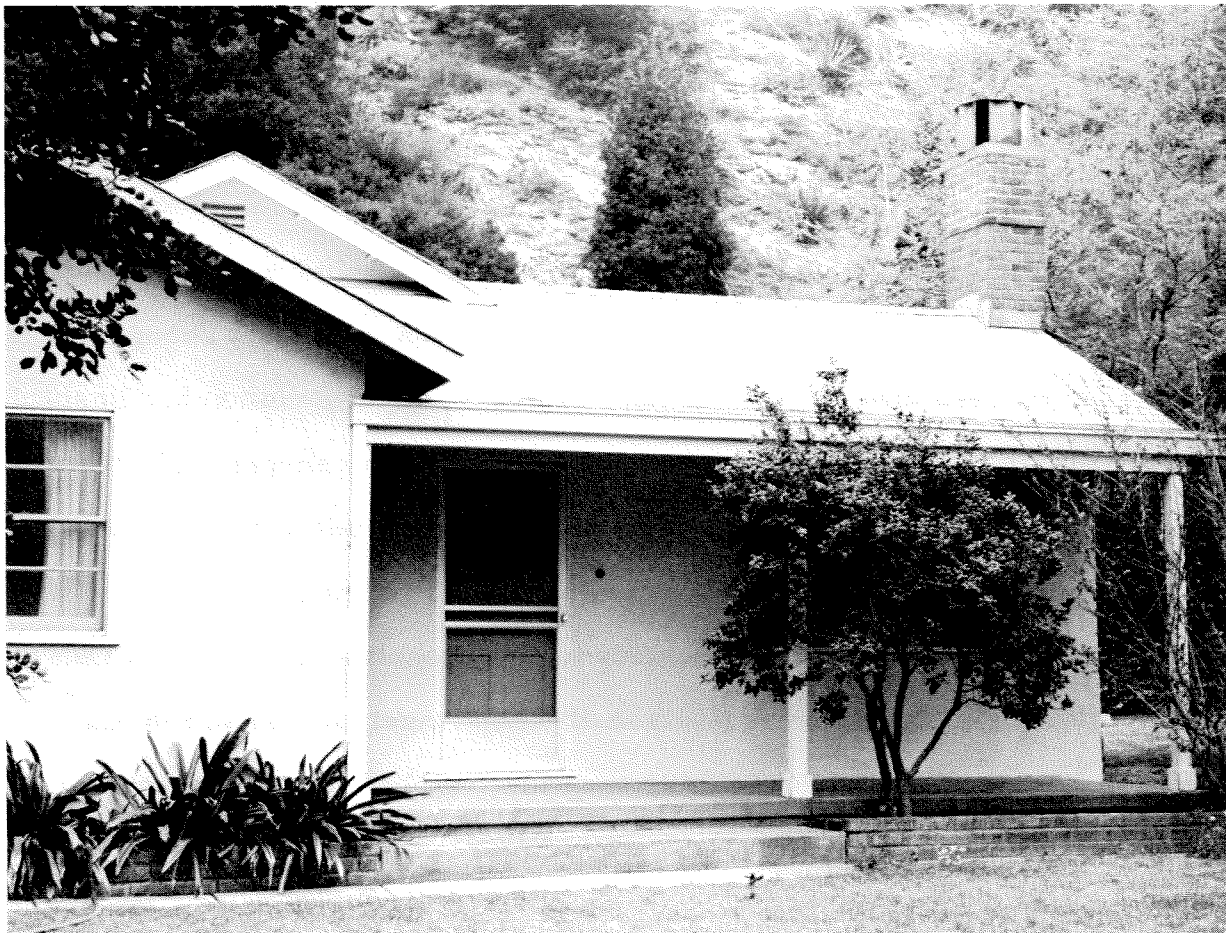
Figure 8.8 The Pacoima Dam caretaker's house at the mouth of Pacoima Canyon. This older structure, with a brick chimney, was not damaged by the shaking even though it was within one-half mile of Pacoima Dam and within one mile of the Veterans Administration Hospital. The degree to which the ground shaking here might have differed from that at these other sites is not known.
