## **CHAPTER 6: EARTHQUAKE RELIEF AND RECONSTRUCTION OF TANGSHAN**

### **DISASTER RELIEF AFTER THE TANGSHAN EARTHQUAKE**

## THE REPAIR AND RESTORATION OF THE KAILUAN COAL MINE

## **EMERGENCY AT THE BAIHE RIVER MAIN DAM OF THE MIYUN RESERVOIR**

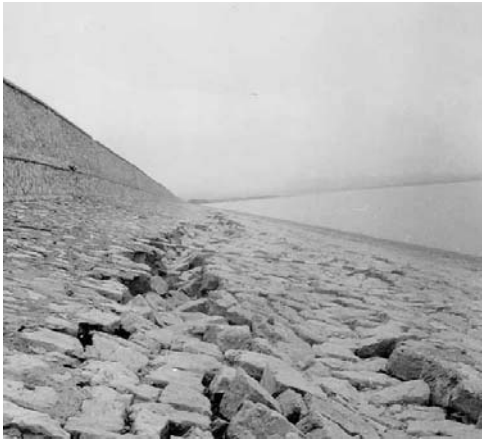
Photo 1. Damage to the upper reaches of the main dam.

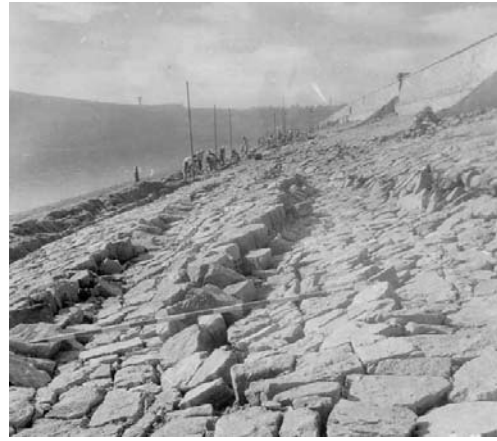
Photo 2. Damage to the lower reaches of the main dam.

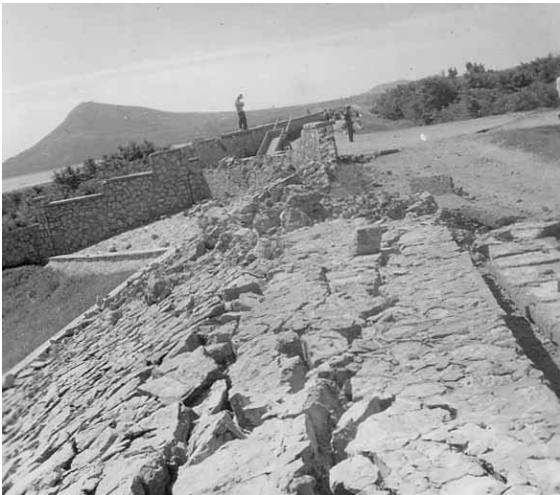
Photo 3. Damage to the upper reaches of the sub-dam.

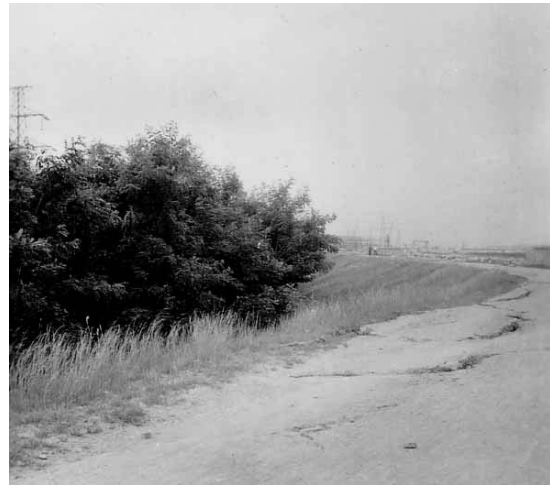
Photo 4. Damage to the lower reaches of the sub-dam.

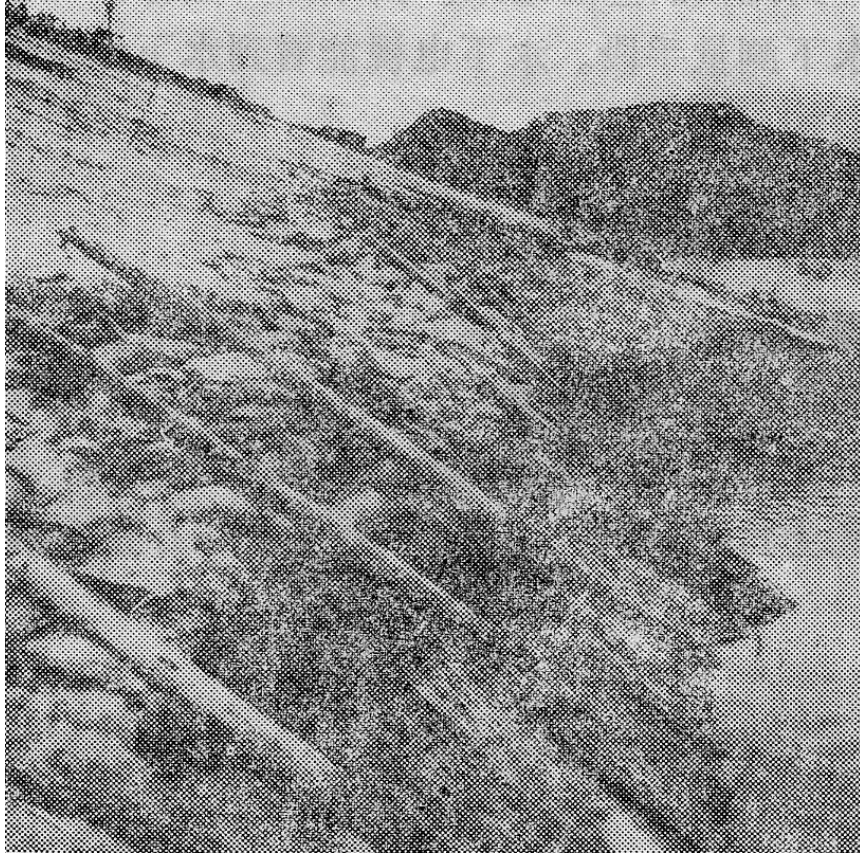
Through analysis of the survey data it was concluded that the slide on the upper part of the slope of the dam occurred mainly in the gravel portion of the protection layer. In some locations the scratched clay slanting wall was exposed. A few places the clay was softened especially at the sections of pile Nos. 0+300 and 0+425, with an elevation of 120 m and 122.6 m, and the depth of scratches entering into the clay was 0.5 m. Most of the slide was underwater; the elevation of the top was 140-141 m; the elevation of the bottom of the slide was 107 m. The most serious parts of sliding were at the elevation of 120 m or so. The total area of the sliding slope was about 60,000 m<sup>2</sup>, and its volume was 150,000 m<sup>3</sup> in total.

Photo 1. Earth slide on the upstream face of the Baihe main dam.

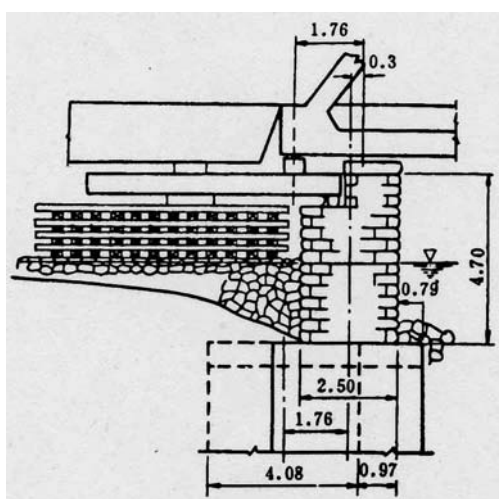
Figure 6. Sketch of the dislocated and temporarily repaired No. 5 pier of the Ji Canal down-line bridge (unit: m).
