A STUDY TO IDENTIFY HYDROGEN MASER FAILURE MODES*

A. E. Popa, H. T. M. Wang, W. B. Bridges, A. N. Chester, J. E. Etter, and B. L. Walsh**
 Hughes Research Laboratories
 Malibu Canyon Road
 Malibu, California 90265

Summary

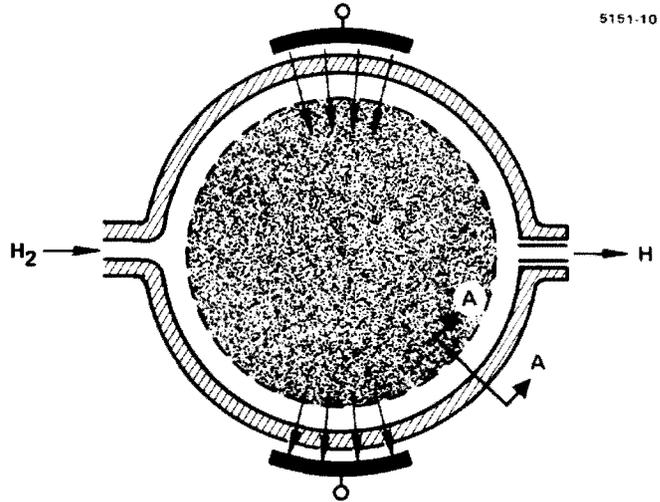
Fig. 1.

Difficulties with the rf discharge plasma hydrogen dissociator have been common in the past, but recent experience has improved typical operating life to three or more years. Figure 1 is a schematic representation of a typical spherical glass bulk dissociator plasma with capacitively coupled electrodes. The power is fed into the bulb by displacement current through the glass walls to the conducting hydrogen plasma within.

Schematic representation of the plasma within an rf excited dissociator showing displacement current through the walls under the electrodes.

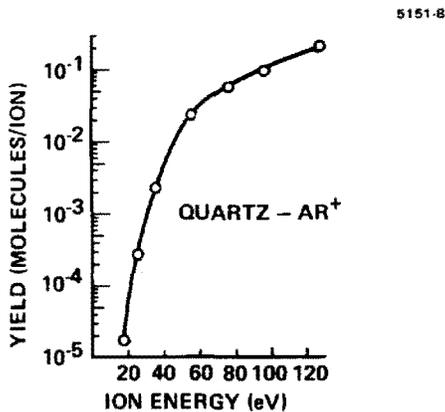
Fig. 3.

on ion energy for the low energies typical of the wall sheath. Only a one or two volt change in wall sheath can cause an order of magnitude change in the sputtered material yield.

Sputtering yield of SiO₂ molecules from a SiO₂ surface under bombardment of low energy argon ions.

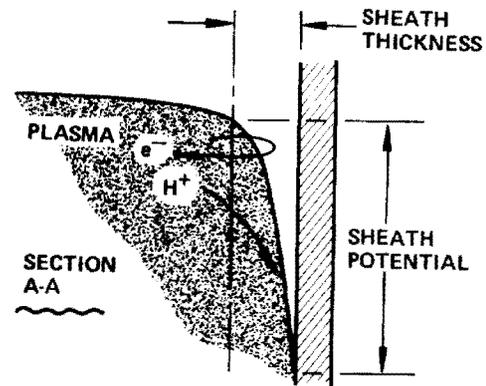
Fig. 2.

Figure 2 illustrates the potential distribution near the glass walls, showing the potential fall or "wall sheath" necessary to satisfy boundary conditions on wall current. The wall sheath has the effect of increasing the energy with which positive ions strike the wall; this, in turn, greatly increases the yield of wall material sputtered by the incident ions. Figure 3 shows the typical steep dependence of sputtering yield

Plot of potential versus radius in a section through the plasma sheath near the glass wall.

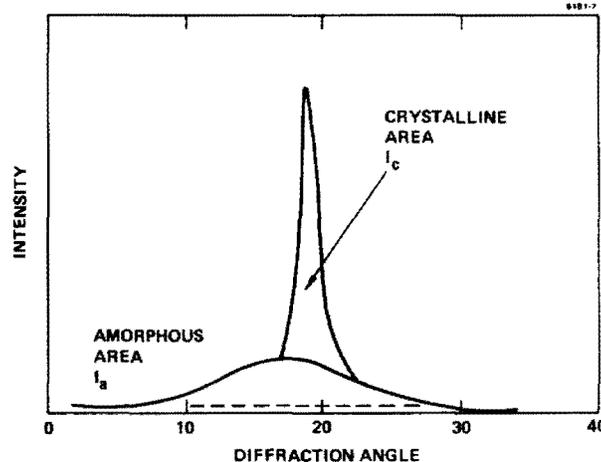
A spaceborne maser development program will require accelerated radiation testing to determine if any wall shift and linewidth changes occur for the radiation dose encountered in the Navstar orbit. We have found x-ray diffraction measurements can detect slight changes in Teflon[®] below the threshold of gross radiation damage. For example, thin Teflon[®] solar cell covers exposed to doses several times greater than that encountered by Navstar show a development of crystallinity as illustrated in Fig. 4. Whether changes observed by x-ray diffraction will correlate with degradation in maser performance remains to be determined.

Fig. 4. X-ray diffraction pattern of radiation-damage Teflon solar cell covers.

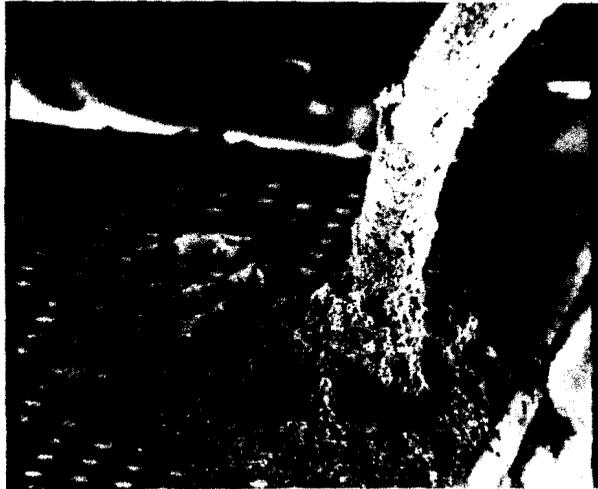
In Table 3 the principal failure modes for the hydrogen maser electronics unit are listed. The highest risk is associated with space-radiation damage and inadequate thermal sinking of the higher power solid state devices. In the past, point contact devices, such as Schottky mixers, have been subject to contact failure in vibration; however, recent work at Hughes and other laboratories has produced techniques to greatly reduce the occurrence of this potentially serious problem. Many electronic problems can be eliminated by careful inspection as shown in the Scanning Electron Microscope (SEM) pictures, Figs. 5, 6, and 7. Figure 5 is a mechanically stable Schottky diode whisker contacting a gold electrode imbedded in the semiconductor surface. Figure 6 shows a blunted whisker that has mechanically moved off the gold electrode causing a failure. The SEM picture shown in Fig. 7 graphically illustrates the result of electromigration. In this case potassium contamination left from wafer processing has migrated to the whisker causing diode failure.

Fig. 7. SCM of a potassium contaminated Schottky diode illustrating the electromigration process.
