STRUCTURAL DAMAGE IN MEXICO CITY

John F. Hall and James L. Beck

Earthquake Engineering Research Laboratory, California Institute of Technology

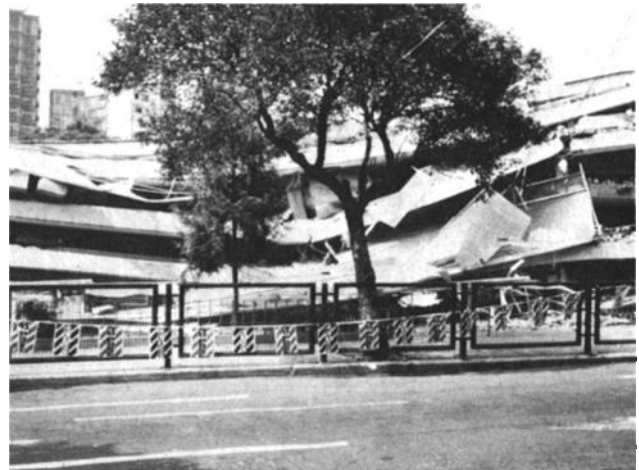
Most of the buildings that suffered full or partial collapses probably lacked ductility, that is, the ability to undergo considerable yielding without losing strength. Since even most well-built buildings yield during strong ground shaking, ductility is essential to avoid collapse, especially for long-duration earthquakes when a number of yield cycles occur. In reinforced concrete construction, proper detailing and placement of the steel reinforcing bars is an important element in providing ductility. Perhaps with longer bar anchorages and extra hoops to confine the concrete, the school shown in Figure 1 would have survived the shaking.

Fig. 1. Collapsed school.

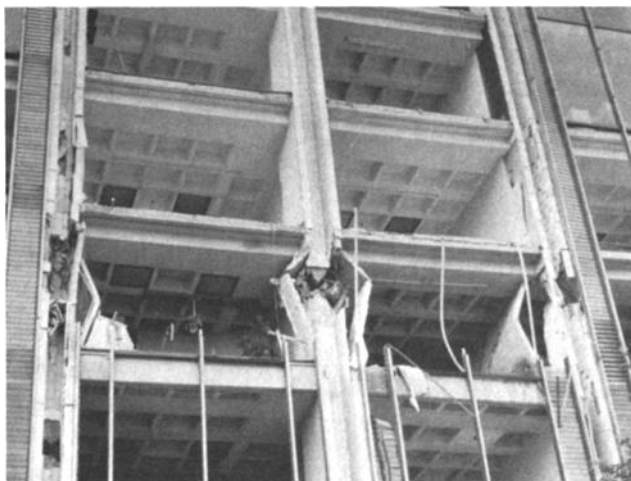
In design, ductility is interrelated with strength because if the strength of a building is too low, then the ductility demanded by an earthquake is very high. In Mexico City, lack of strength was evident in the columns of many buildings (Figure 2), a violation of an important principle of seismic resistant design. This principle states that proportioning columns to be stronger than the girders is essential to distri-

Fig. 2. Weak columns.

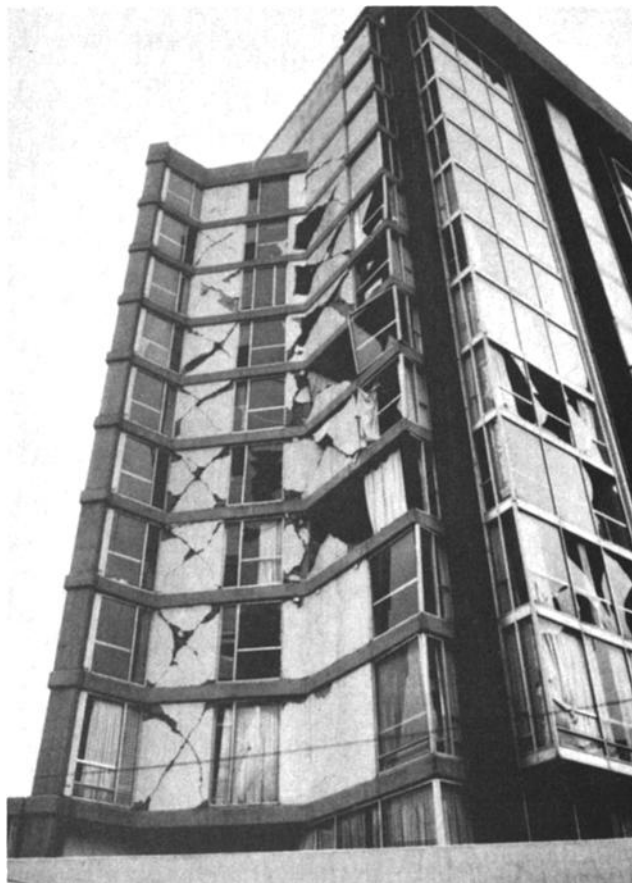
The use of unreinforced masonry to fill in exterior walls between reinforced concrete frames is a common construction practice in Mexico City. The masonry panels, being stiff, attracted a large share of the earthquake load and, being brittle, often failed. Diagonal cracks resulting from an overstress in shear are a characteristic of such failures (Figure 4). In addition, use of masonry infills on three sides of a building, while leaving the front open, created a nonsymmetric distribution of stiffness, causing a torsional response that increased the stress on the structural elements in the perimeter of the building.

Fig. 4. Cracked masonry infills.

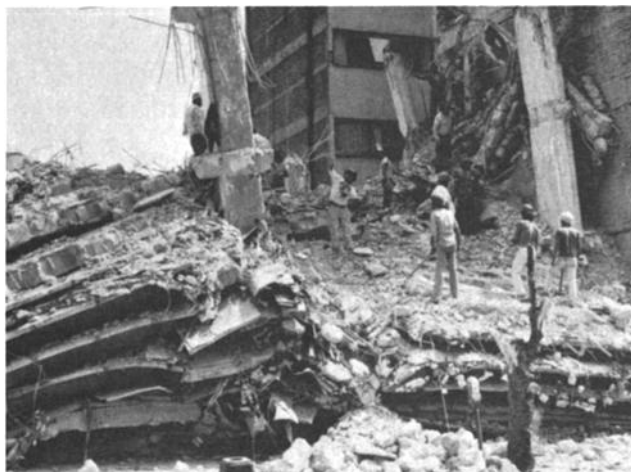
Flat-plate construction, consisting of reinforced concrete columns and slabs without beams, did not fare well in the earthquake. One type of failure mode was caused by inadequate shear strength in the slab-to-column connections which resulted in pancake failures of the slabs with the columns remaining upright in some cases (Figure 3).

Fig. 3. Flat plate construction.

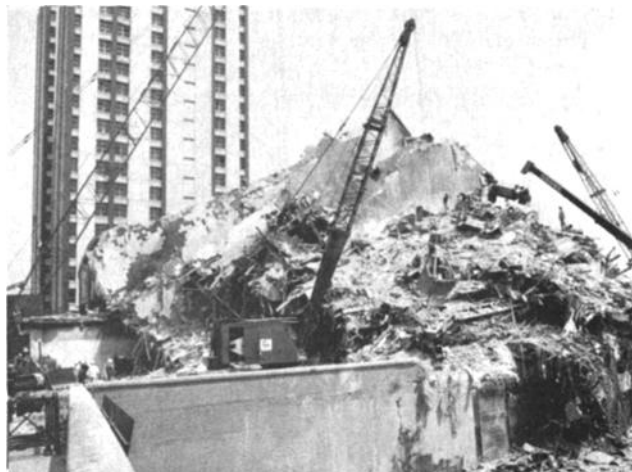
Steel construction is rare in Mexico City, yet one of the most spectacular examples of damage occurred to the complex of five steel-frame buildings at Conjunto Pino Suarez. A 21-story tower overturned at the 3rd floor level and fell to the south onto another tower of 14 stories (Figure 5). A clue to the collapse mechanism was obtained after the neighboring identical 21-story tower (background of Figure 5) was stripped revealing buckled columns on its southern column line at the 3rd story. These were steel box columns, and their plates separated at the welds.

Fig. 5. Toppled tower at Pino Suarez.

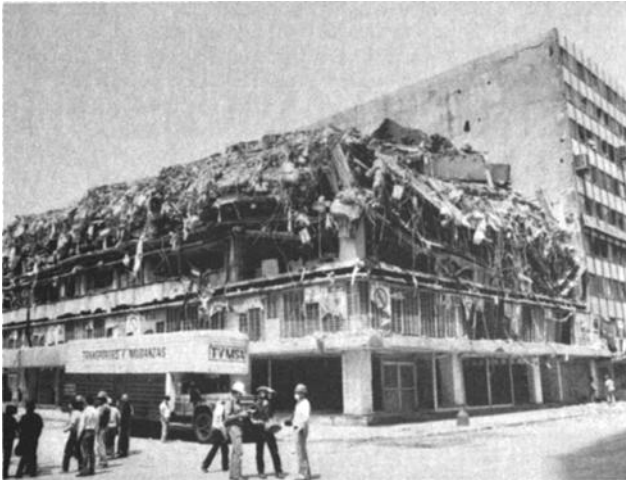
collapsed in their upper stories, leaving the lower portion intact (Figure 6). One possible reason for this behavior is that designers tapered the column sizes severely in the upper stories, permissible if only gravity and wind loads act, but unwise for earthquake loads. Another possibility is through impact between two buildings of different heights, spaced closely together (Figure 7).

Fig. 6. Upper story collapse.

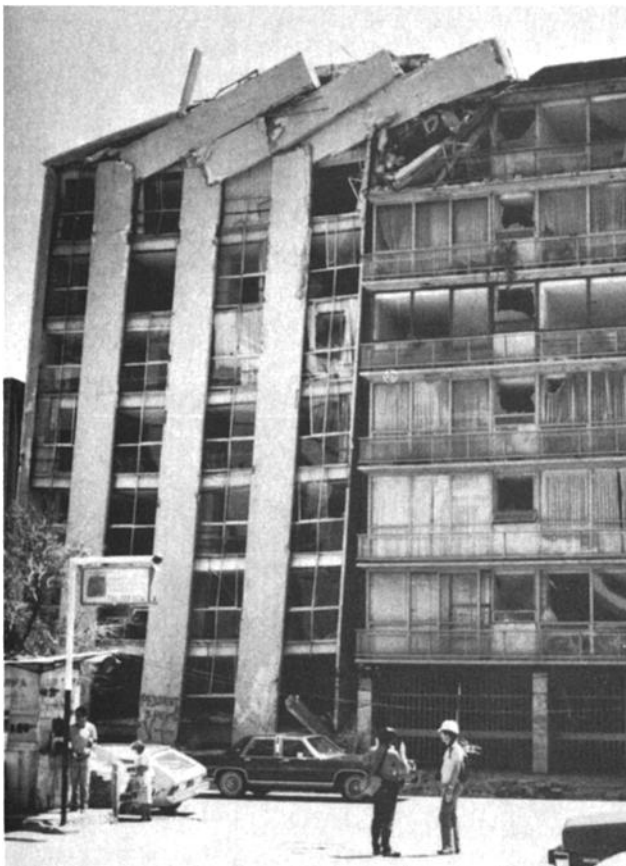
Fig. 7. Impact damage.

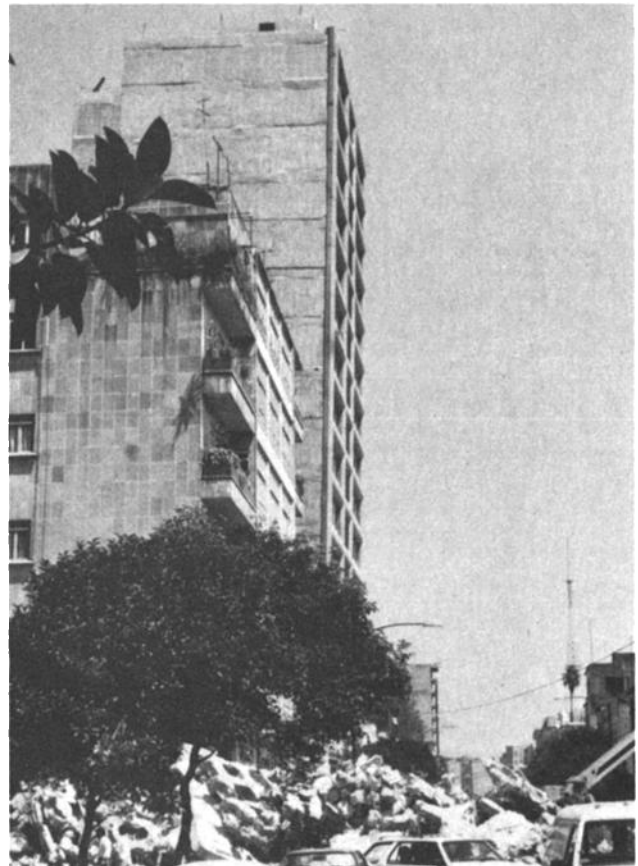
Although most of the damage occurred to superstructures, there were some foundation failures. Those multistory buildings in Mexico City founded on piles that were not long enough to bear on the firm stratum below the soft clay layer may have slipped downward during the earthquake. This may be why the building shown in Figure 8 tilted.

Fig. 8. Foundation failure.

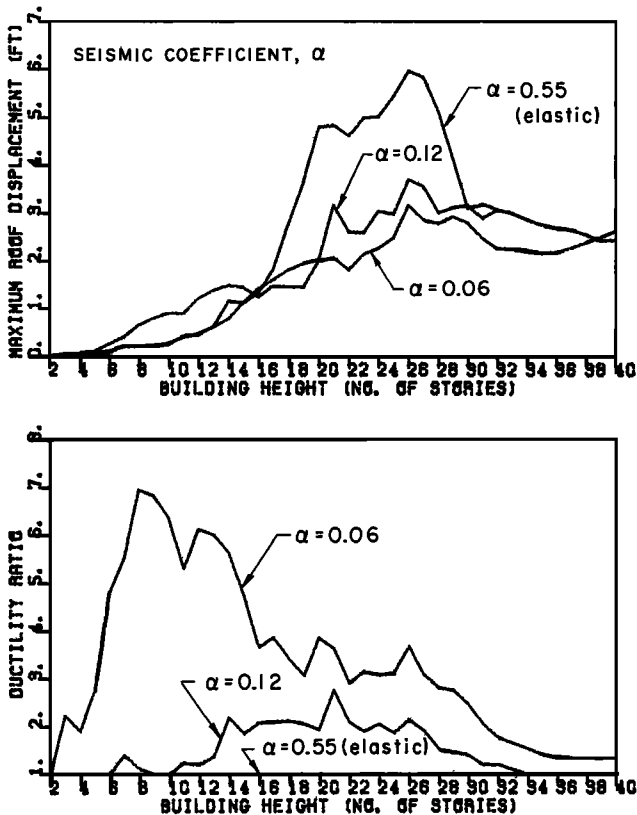
Fig. 9. Building responses computed for the SCT east-west ground motion.

east-west input are presented in Figure 9 (maximum roof displacement vs. building height and ductility ratio vs. building height) for three designs based on seismic coefficients of 0.06 (as in the Mexico City code), 0.12, and 0.55 (a value sufficiently high so that no yielding occurs). The ductility ratio, or ductility demand, is the maximum roof displacement experienced during the earthquake divided by the roof displacement at which yielding commences. If no yielding occurs, the ductility ratio is defined to be unity.

The elastic response (Figure 9, top) shows a considerable resonance for buildings 20 to 25 stories in height due to the coincidence of their elastic vibration periods with the predominant period range in the ground motion input. For buildings designed with lower seismic coefficients (0.06 or 0.12), this resonance disappears due to the lengthening of the building period as yielding takes place.

The seismic attack on the building is best measured in terms of ductility demand (Figure 9, bottom). The demand is highest for buildings 6 to 15 stories in height. Apparently, yielding has moved the 6 to 15 story buildings into a resonance condition (relative to the yield displacement) and moved taller buildings away. The ductility ratio requirement of 5 to 7 as shown by the analysis can be met with good design and detailing practices, but could cause considerable trouble otherwise, especially for earthquakes of

long duration which produce many cycles of yielding. Increasing the seismic coefficient to 0.12 greatly reduces the ductility demand. The post-earthquake code in Mexico City now has essentially this seismic coefficient (Rosenblueth and Meli, 1986).
