GROUND FAILURE ALONG THE NEW RIVER CAUSED BY THE OCTOBER 1979 IMPERIAL VALLEY EARTHQUAKE SEQUENCE

BY THOMAS H. HEATON, JOHN G. ANDERSON, AND PETER T. GERMAN

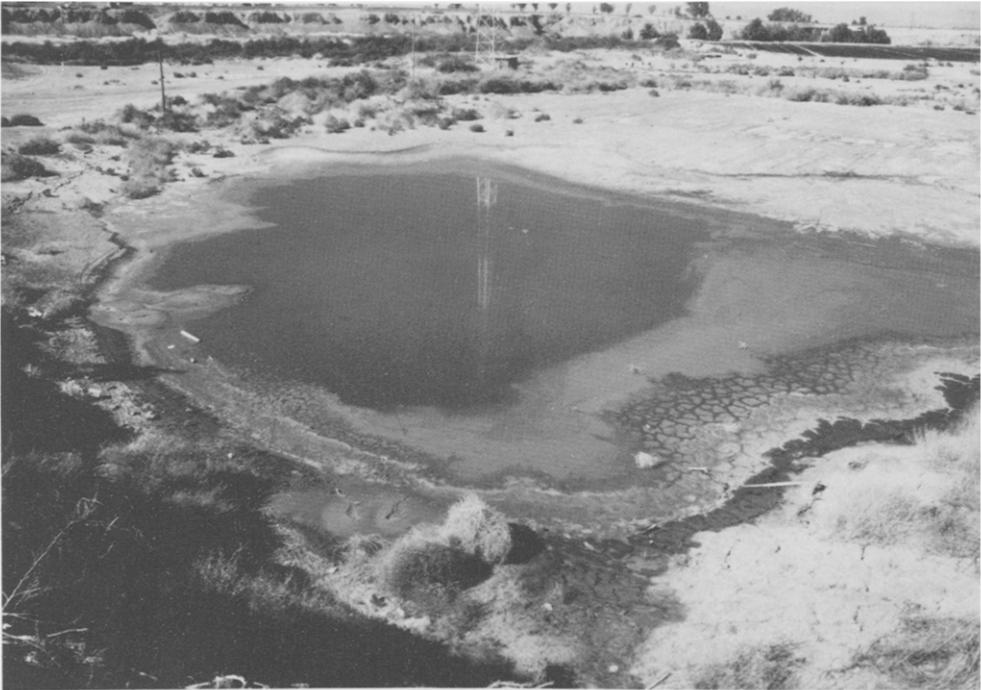
5. *Liquefaction Area Adjacent to the KROP Radio Tower.* A sizable pond was apparently created when liquefaction occurred in the New River Valley adjacent to the KROP radio transmitter (Figure 2). This pond is one of the most dramatic examples of liquefaction we saw anywhere for the Imperial Valley earthquake sequence. Numerous sand boils around the margin of the pond were still oozing water on 2 November, 2 weeks after the earthquake. A discontinuous zone of extensile cracks was found along about 50 per cent of the perimeter of this pond suggesting that the flood plain had subsided. We estimate the dimension of this pond to be about 50 x 75 m, with a depth of probably less than 30 cm. A N5°E-trending extensile crack ran from the perimeter of the pond, subparallel to the river bluff, and then up the side of the river bluff (Figure 3). It could not be followed into the golf course which lies on the flat land above the bluff. Ground failure is the most reasonable explanation for these observations.

FIG. 2. Pond formed in New River Valley next to the Del Rio Country Club (location 5 on the index map). The pond was apparently formed by liquefaction during the earthquake sequence. Extensile cracks were found along much of the perimeter of the pond, and numerous sand volcanoes were still oozing water 2 weeks after the main shock. View is to the northwest.

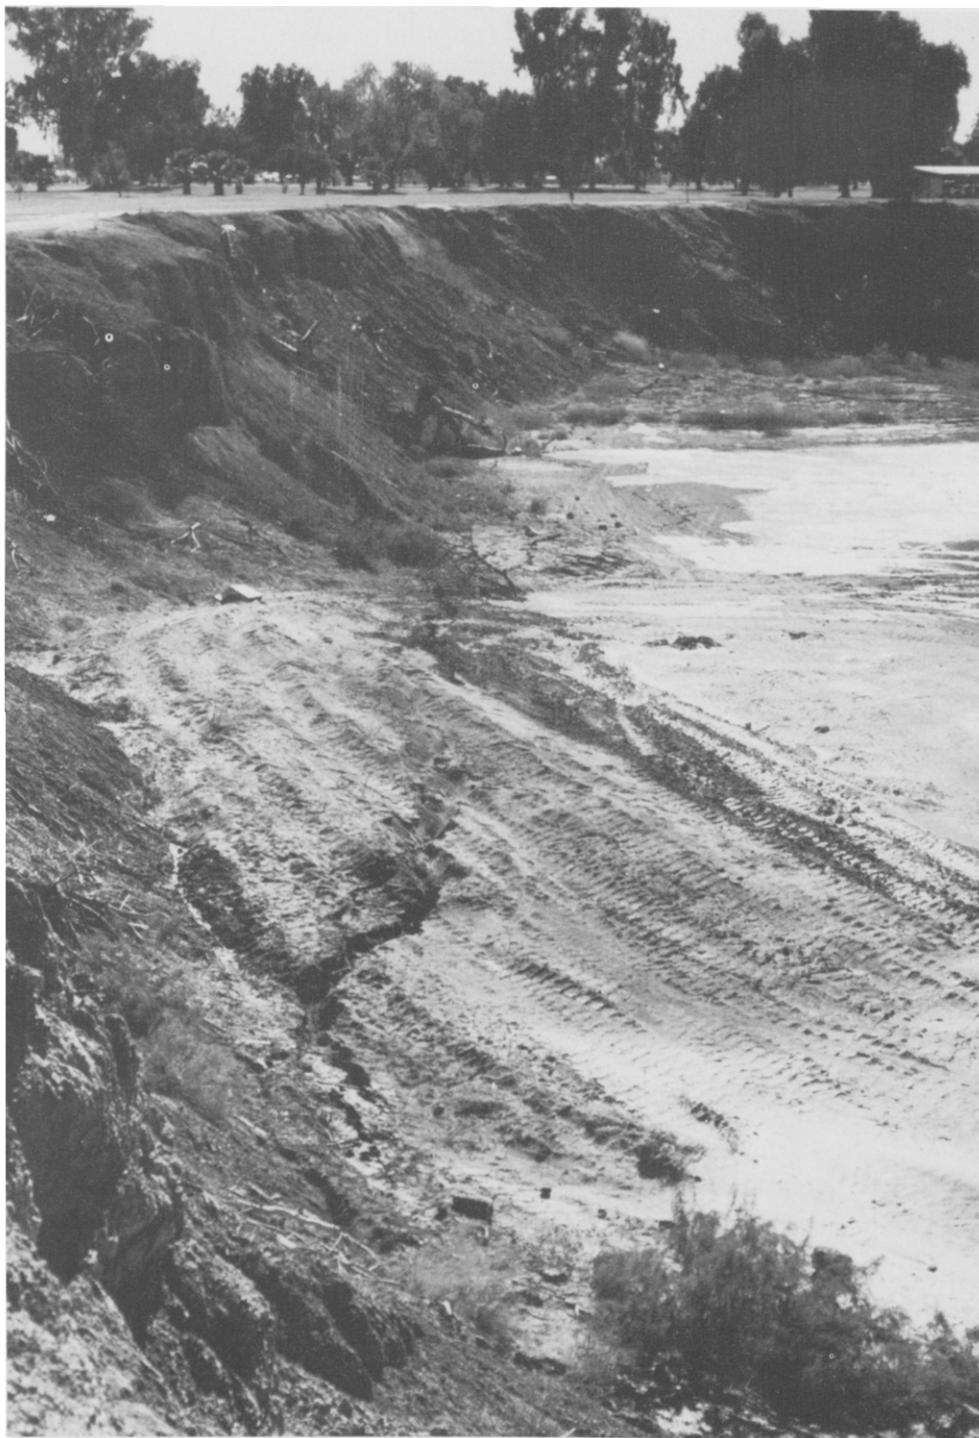
FIG. 3. Linear extension crack at Del Rio Country Club. Crack is subparallel to the river bank and can be seen running obliquely up the bank in the foreground. View is to the south. Liquefaction pond and clubhouse are in the background.
