Enduring Lessons and Opportunities Lost from the San Fernando Earthquake of February 9, 1971

Paul C. Jennings, M.EERI

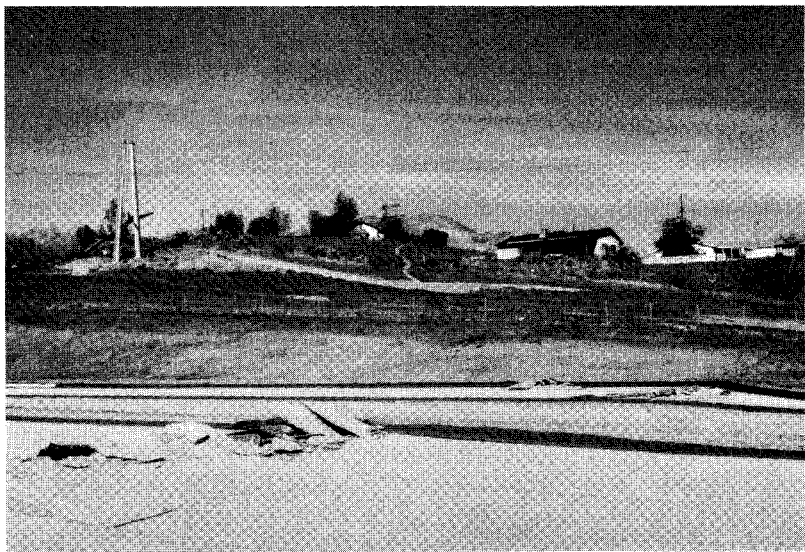
Figure 2. Damage to the 210 Freeway from fault rupture. Faulting caused extensive damage to underground utilities and structures along its surface traces. The transmission tower in the left background was under construction and failed at an uncompleted joint.

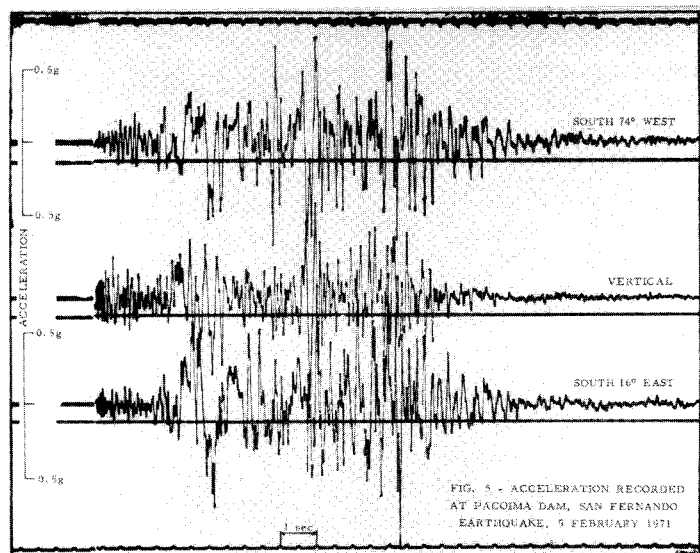
Figure 3. The original Pacoima Dam accelerogram (notes added). The large pulse in the motion begins about three seconds after the instrument was triggered.

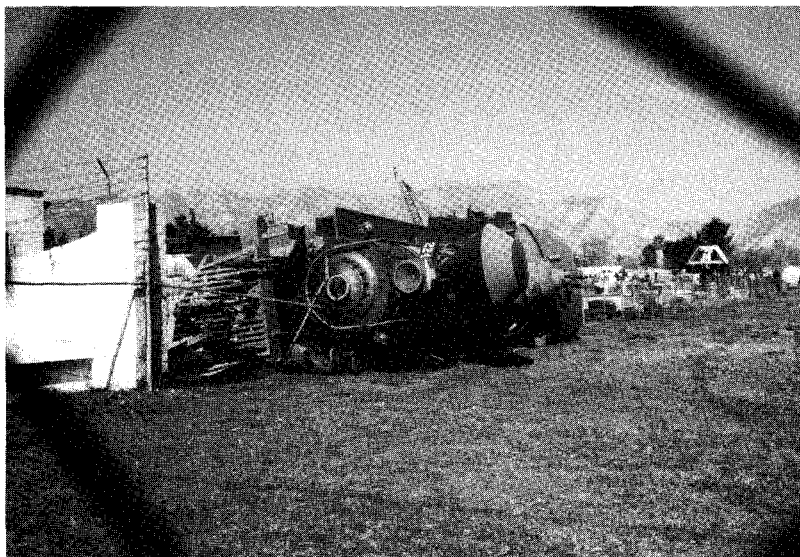
Figure 5. This overturned locomotive near Glenoaks Boulevard and Hubbard Street provides additional possible evidence of very strong shaking in the northern San Fernando valley, although flexibly-mounted structures can overturn under moderate shaking if conditions are right.

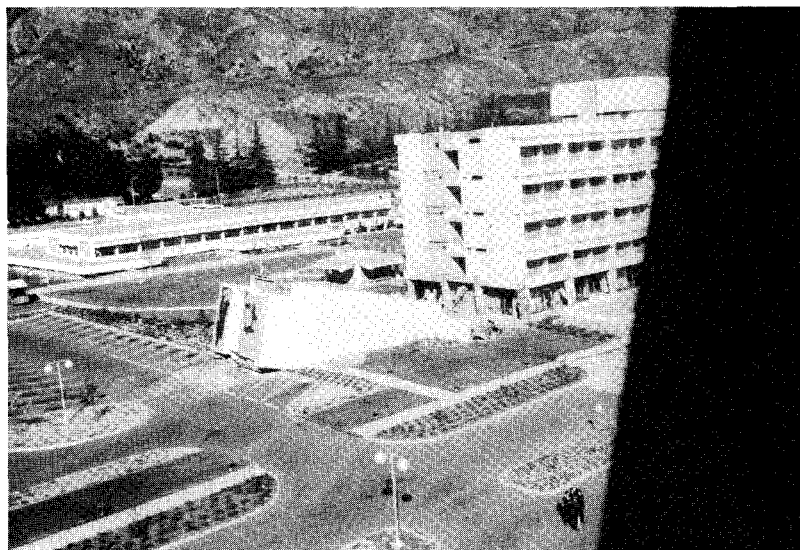
Figure 6. A portion of Olive View hospital as seen from a helicopter the afternoon of the earthquake. The stair tower in the foreground fell into the basement. The first floor of the two story Psychiatric Day Care Center collapsed in such a way as to leave the second story virtually intact.

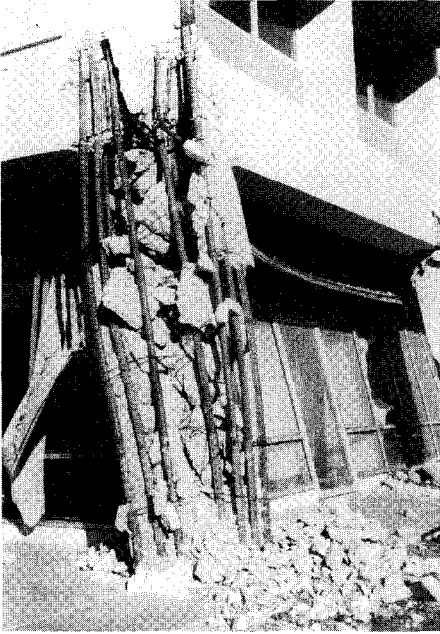
Figure 7. A first story corner column of the main building of Olive View hospital. The dramatic failure of columns with such light horizontal ties, #3's ($\frac{3}{8}$ in. dia.) at 18 in., provided convincing arguments for changes in the building code.

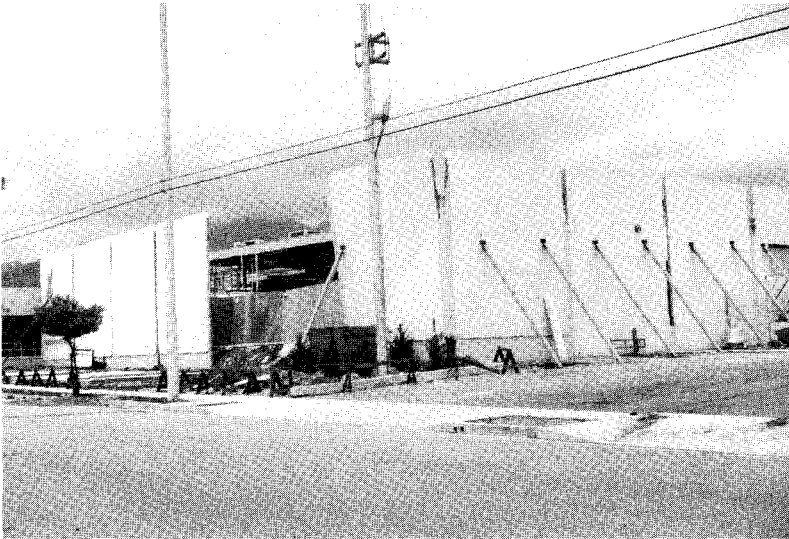
Figure 8. Failures in tilt-up construction were a common feature in the San Fernando earthquake. Significant improvements in the applicable codes were made afterwards, but failures of tilt-ups in the Northridge earthquake showed that additional improvements were needed.

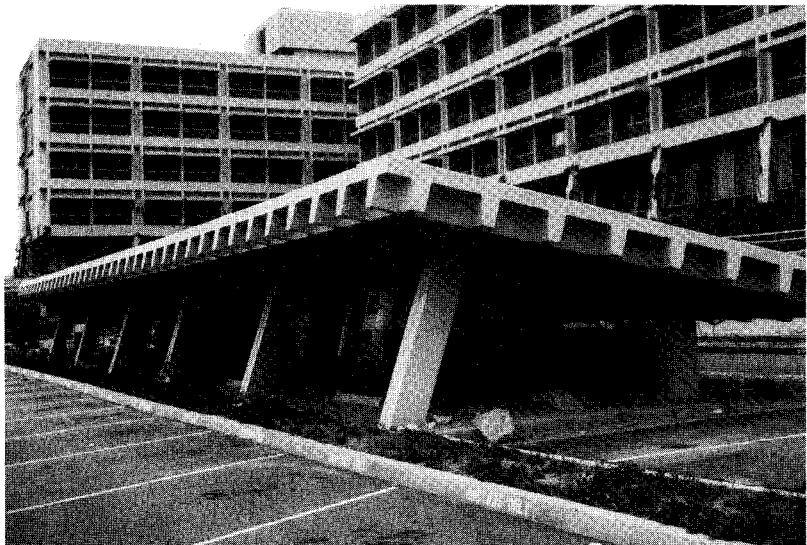
Figure 9. The collapsed pergola at the Olive View hospital destroyed the hospital's emergency vehicles. The stresses on the emergency services from the moderate-sized San Fernando earthquake pointed to the need for back-up facilities and careful planning in the event of a larger shock.

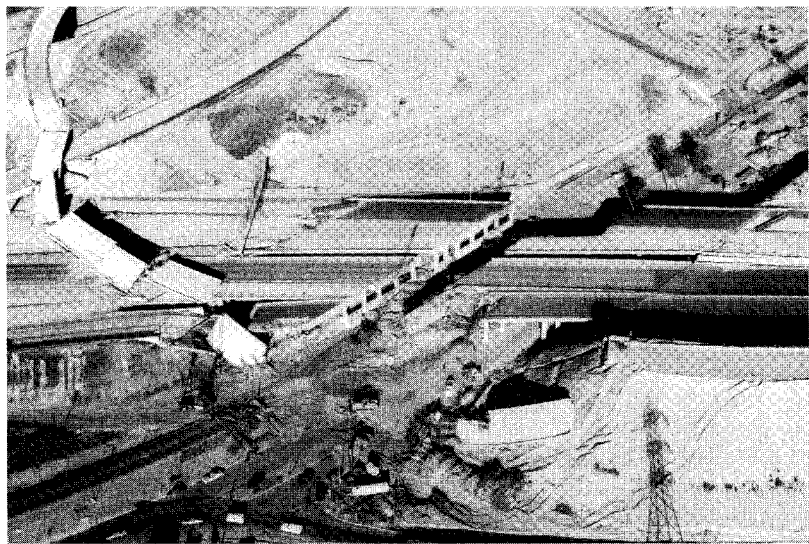
Figure 10. Aerial view of the 5-210 freeway interchange a few days after the San Fernando earthquake. Aerial reconnaissance and photography proved very useful in the earthquake, particularly in the early hours afterward when there was confusion about the damaged hospitals and freeway structures.

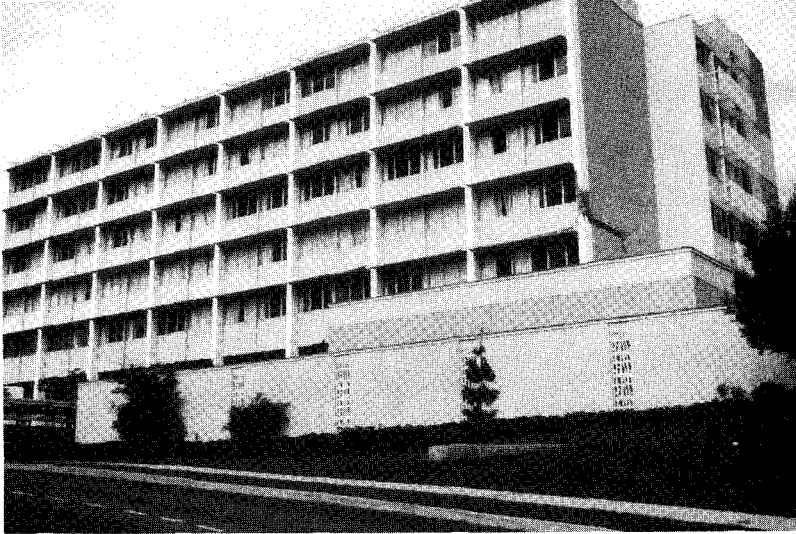
Figure 11. Holy Cross hospital was one of four hospitals that were very heavily damaged during the San Fernando earthquake and were unusable at a time when they were most needed. This experience led to special considerations for the design of hospitals, similar to the Field Act for schools.

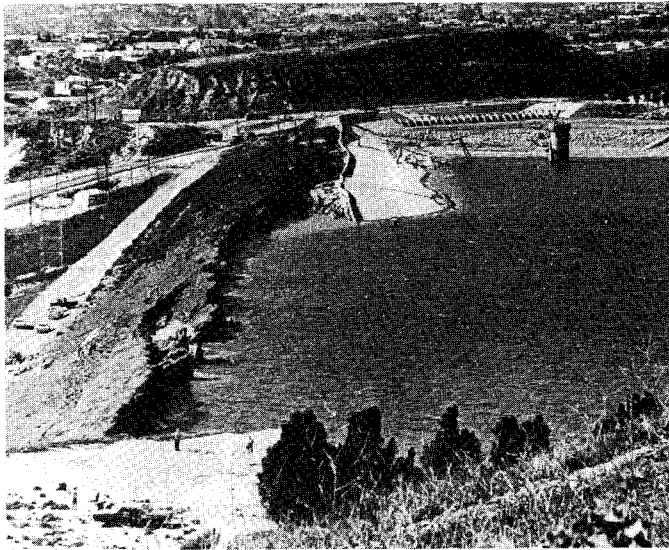
Figure 12. Lower San Fernando dam on the day of the earthquake, looking west. The crest of the dam, a second outlet tower and the concrete erosion apron all slid into the reservoir. The reservoir surface was within a few feet of the top of the escarpment at this time, but the remaining part of the dam held and the water level was safely lowered.

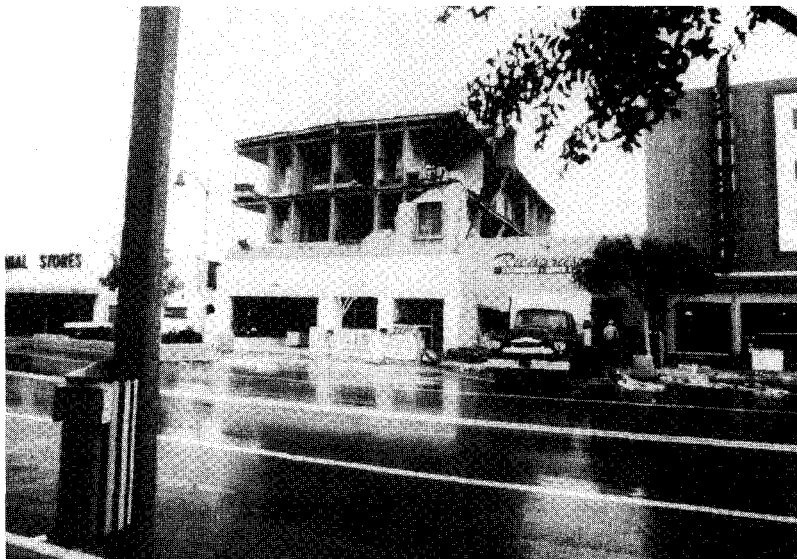
Figure 13. Failure of old buildings was an expectable feature of the San Fernando earthquake, accounting for nearly all of the casualties. This old brick building in downtown San Fernando showed the classic loss of exterior walls, while the partitions held up the remaining structure. Any occupants of the upper story bedrooms must have had an unforgettable experience.

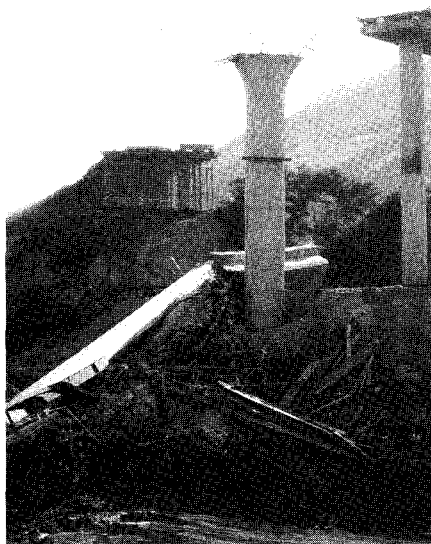
Figure 14. The San Fernando earthquake was the first to show the vulnerability of some modern freeway structures to very strong shaking. This figure shows damage to the 5-14 freeway interchange, which was under construction at the time. The overpass structure on the ground came off its seat near the pillar on the right and slightly damaged the closer pillar during its fall.

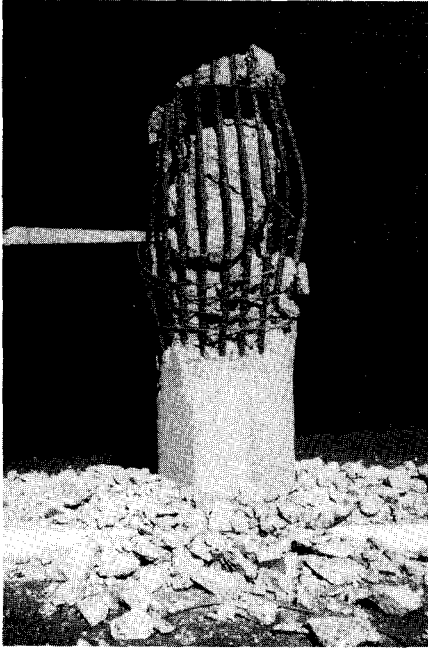
Figure 15. One of the failed columns supporting the Foothill Boulevard undercrossing of the 210 freeway, near Olive View hospital. The column failed in shear because of inadequate horizontal ties. The vertical reinforcing bars were #18's (2- $\frac{1}{4}$ in. dia.), while the lateral ties were #4's ($\frac{1}{2}$ in. dia.) at 12 in. spacing. The unacceptable performance of bridge and freeway structures in the San Fernando earthquake quickly led to changes in design practices.

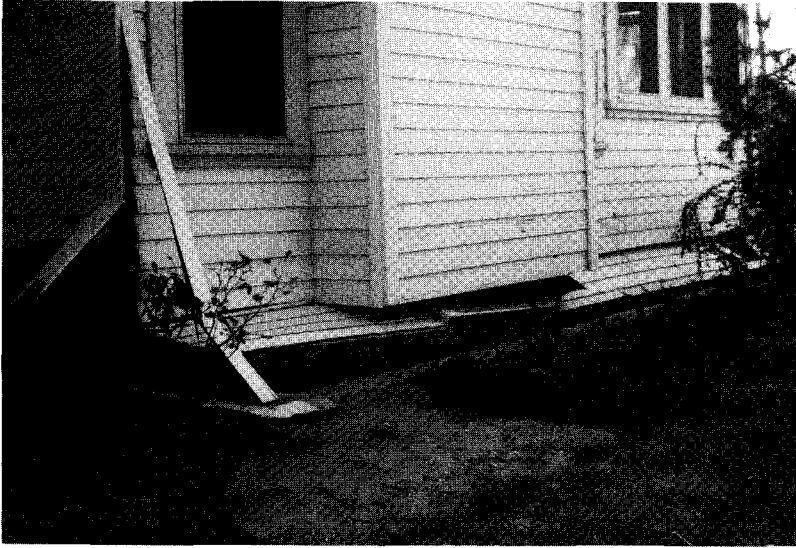
Figure 17. Failure of older wooden homes on unbraced foundations was evident in the San Fernando earthquake, and continues to be a common, preventable feature of California earthquakes in the areas of strong shaking.

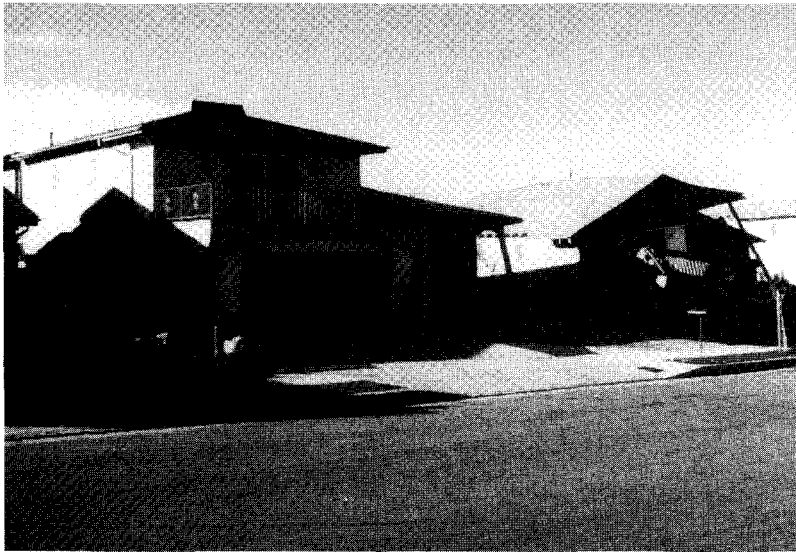
Figure 18. Some failures to new wood frame housing also occurred in this earthquake, primarily because of defects in construction and lack of sufficient shear strength in two-story structures. These two features later were major causes of the much more extensive damage to wood frame structures in the Northridge earthquake.

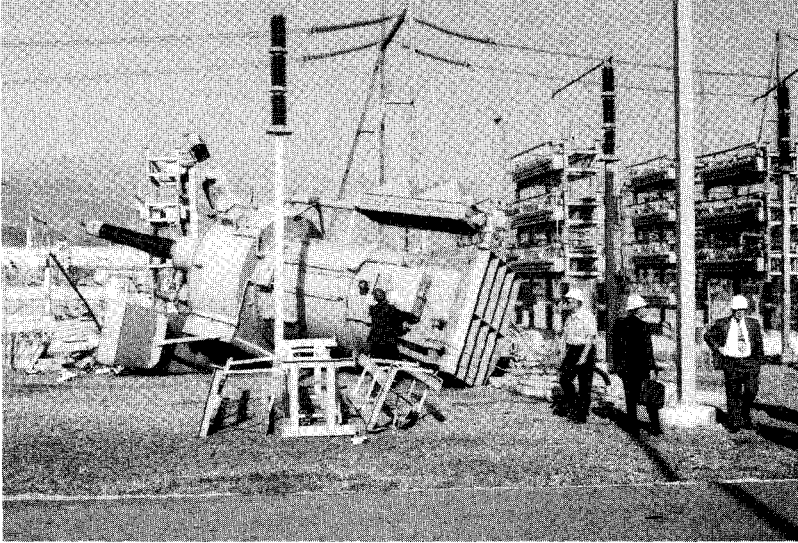
Figure 19. Extensive damage to equipment at the Sylmar Converter station during the San Fernando earthquake was very costly (an estimated \$28 million loss in 1971 dollars) as well as disruptive to the restoration of normal electric power services.

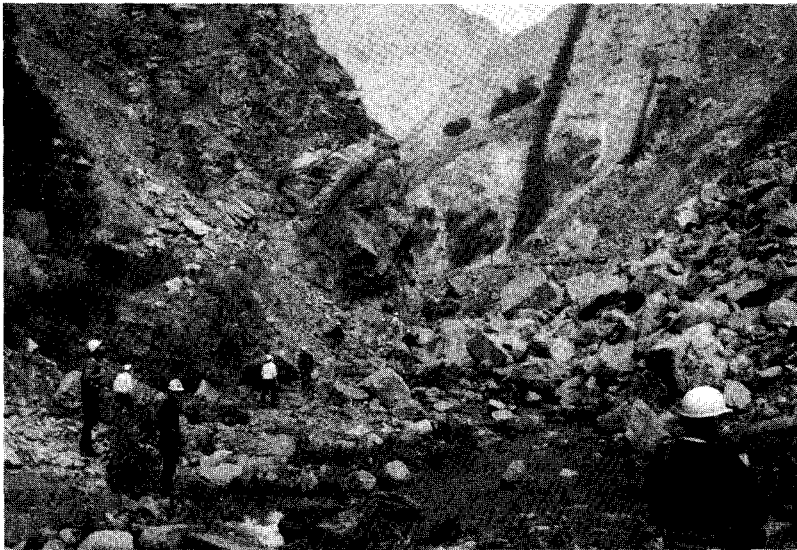
Figure 20. Landslides were very common in the nearby mountains during the main shock and continued to a lesser degree during the larger aftershocks. This photograph shows a party cautiously working its way up Pacoima canyon to the accelerograph site a few days after the San Fernando earthquake.
