8. A Review of Geological Effects and Damage Distribution of the June 9, 1980 Mexicali Valley Earthquake

F. Suarez V., K.E. Sieh, W.E. Elders

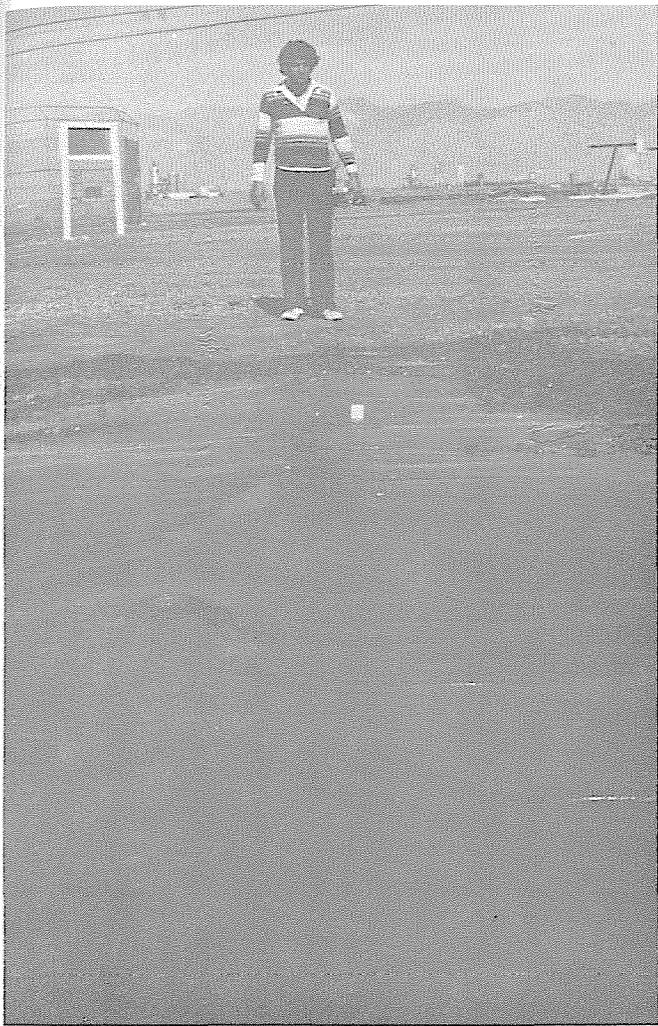
Photo No. 1 Sandblows located at the main entrance of the Cerro Prieto Geothermal plant. 48 hours after the earthquake, many of these structures were emitting water. The general orientation of the sandblows at this particular point was E-W.

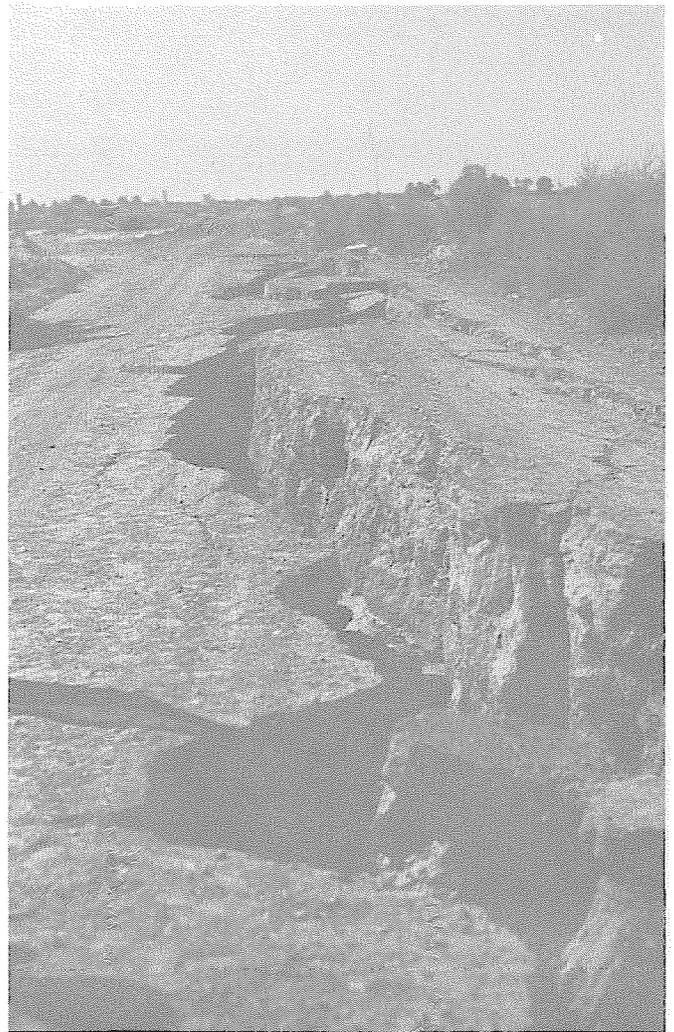
The largest fractures seen in this area were found near drains or irrigation canals. These fractures seem to be purely extensional features associated with the canals and also with the shallow liquefied layer. Perhaps, the digging of the canal involved removal of a significant portion of the overlying stiff silt of clay. The failure took place along the weakest part of the overlying stiff material (photo 3). We did not see any major damage to structures moving south of the geothermal field and passing the towns of Delta and Oaxaca. However, immediately upon leaving Oaxaca the road at the southeast of the town had many extensional transverse cracks (photo 4). Some of these cracks showed right lateral movement of about 2cm. Following this main road, we drove for about 5km looking for some evidence of the Cerro Prieto fault. Using seismic evidence alone, (Reyes 1979), this is a place where the fault can be traced, and therefore this should be the site to look for any tectonic features related to the fault; unfortunately, we could not find any of these features.

Photo No. 3 A large fracture (100m long) found 2km SE from the Cerro Prieto Geothermal plant, just west of irrigation canal located behind the bush on the right side of the picture.

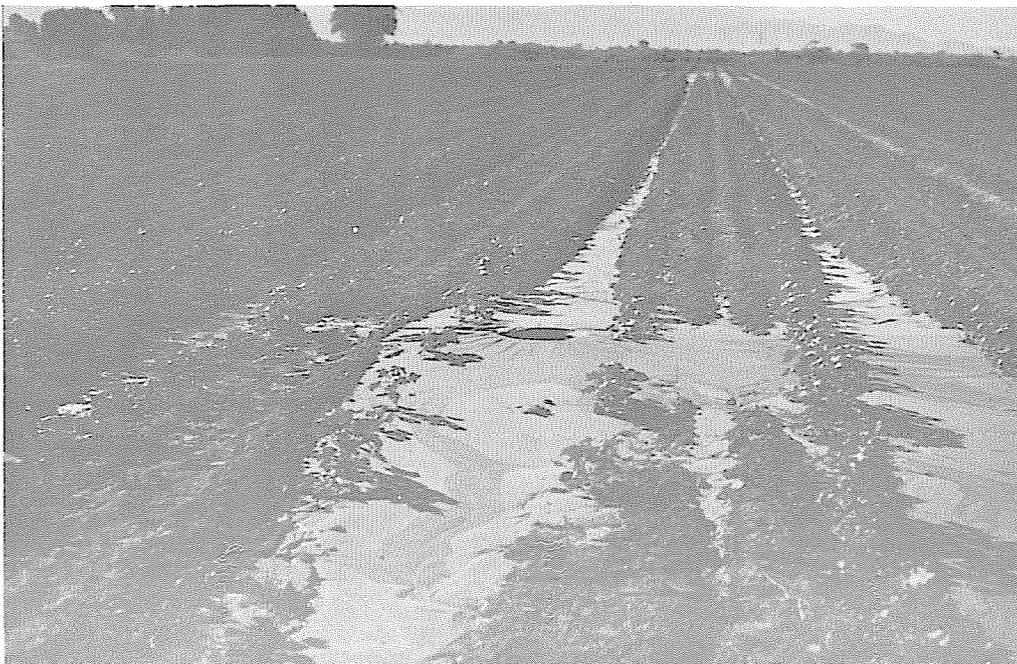
Photo No. 2 A typical sand-blow developed within a cultivated field after the earthquake. According to the owner of the ranch, some of the water that came up with the sand was hot and, in fact, killed his tomatoes.

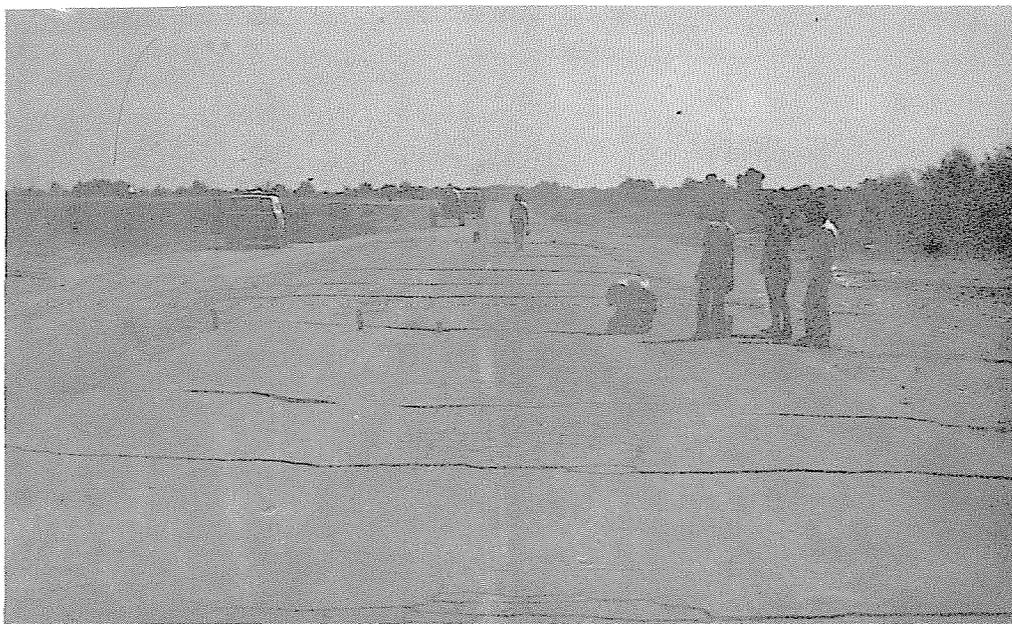
Photo No. 4 Transverse cracks found on the main highway at the southeast end of Oaxaca. Some of these cracks show a right lateral displacement of 2cm with a vertical component of about 5–7cm.

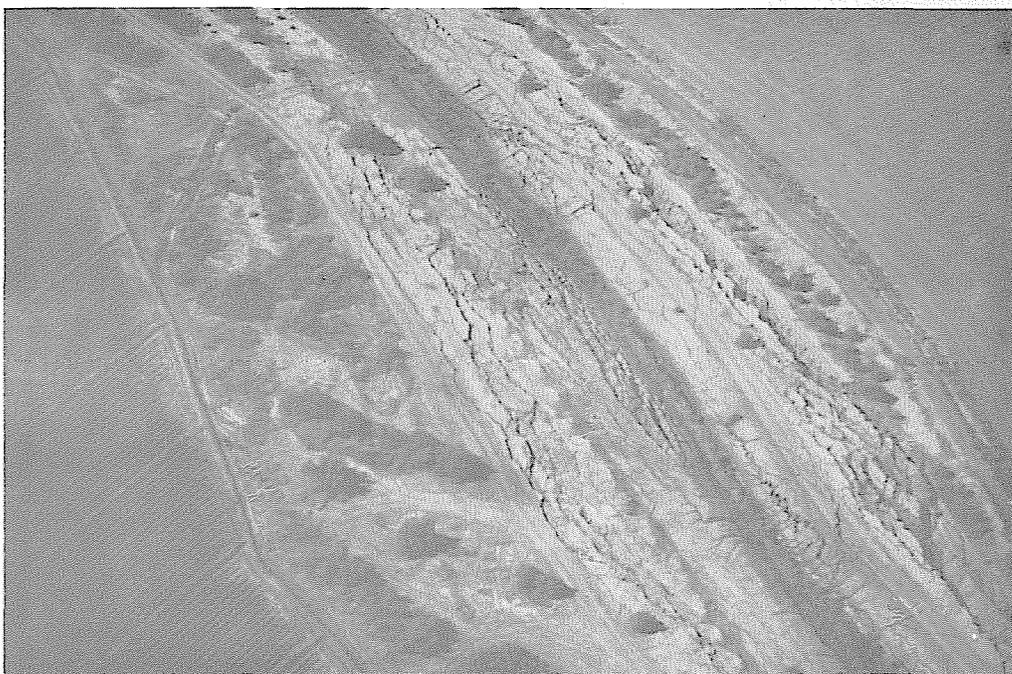
Photo No. 5 Several views of a drain located north of Pescaderos observe the collapse of these structures and all the fractures developed after the earthquake.

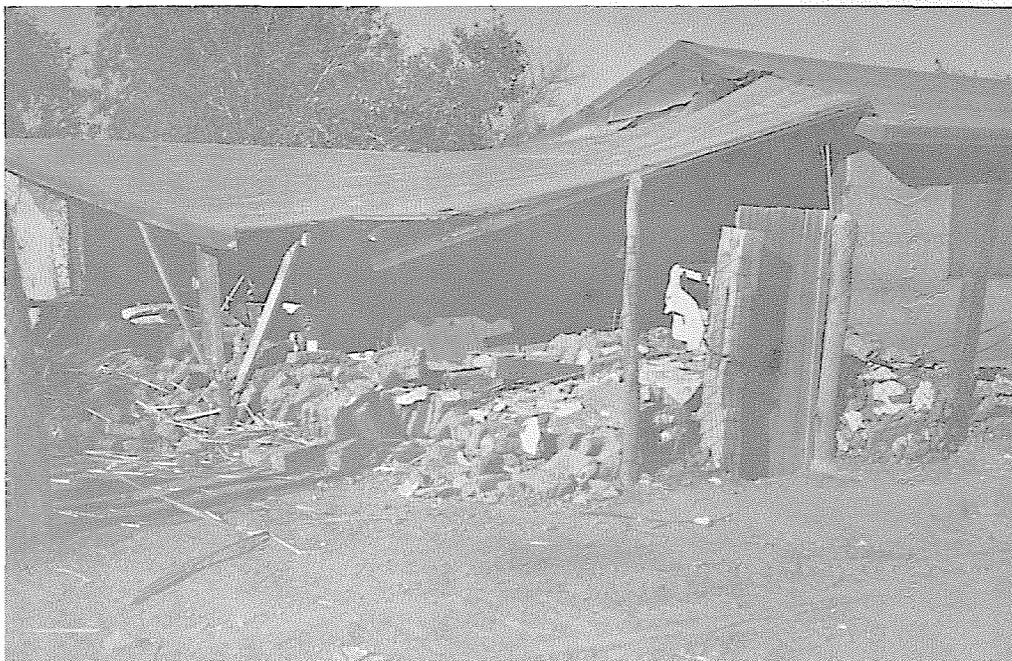
Photo No. 6 An adobe house in Pescaderos partially destroyed.

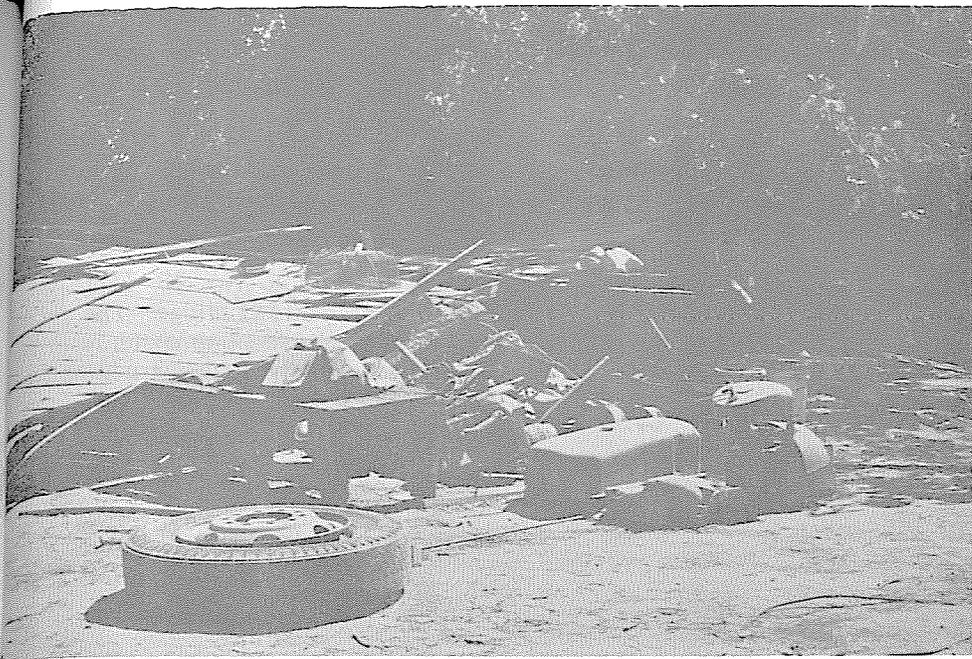
Photo No. 7 An adobe house in Pescaderos, complete collapse of the structure.

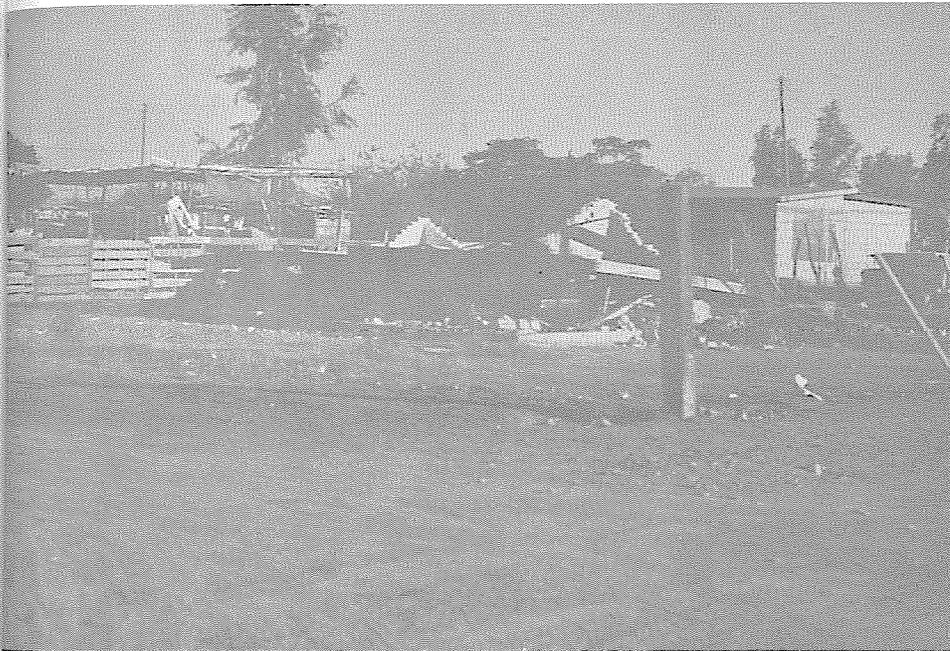
Photo No. 8 A totally destroyed concrete block house in Pescaderos Village.

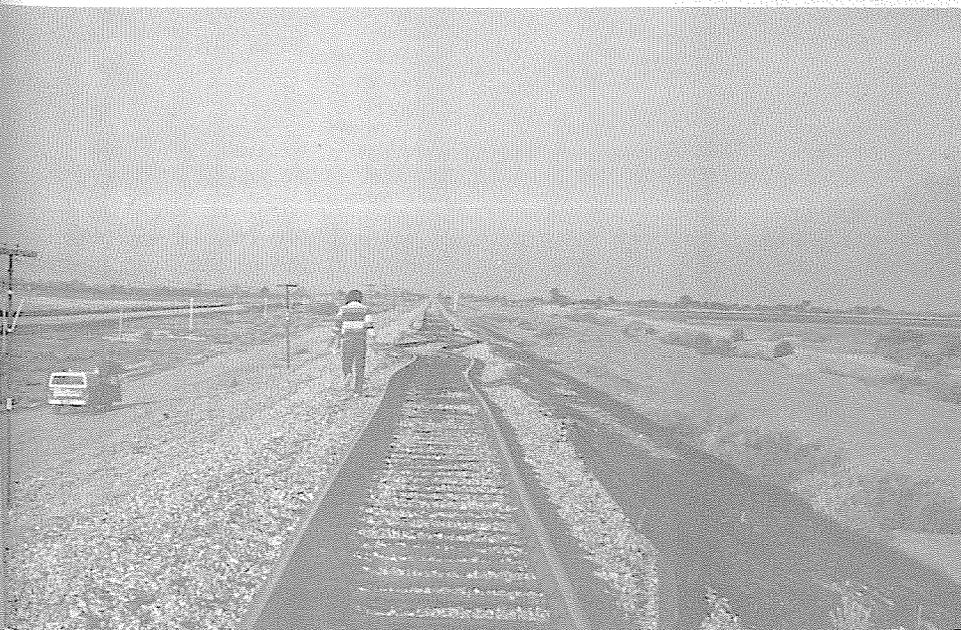
Photo No. 9 The rails were bent between Olachea and Pescaderos. This photo is courtesy of David Chavez, a CICESE seismologist.

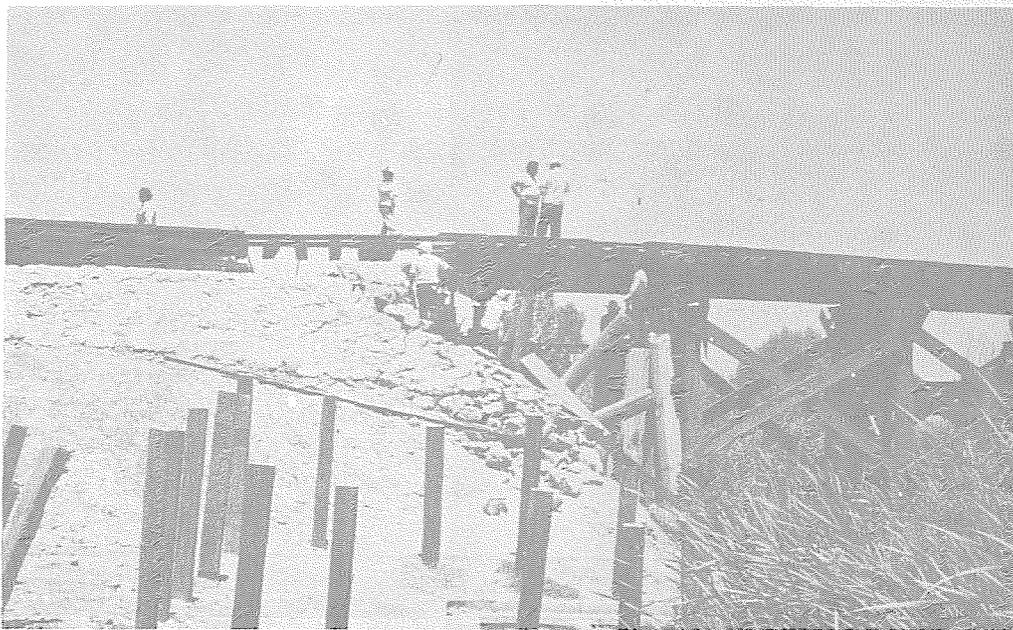
Photo No. 10 Damage in the railroad bridge. The abutment moved one meter with respect to the bridge structure.

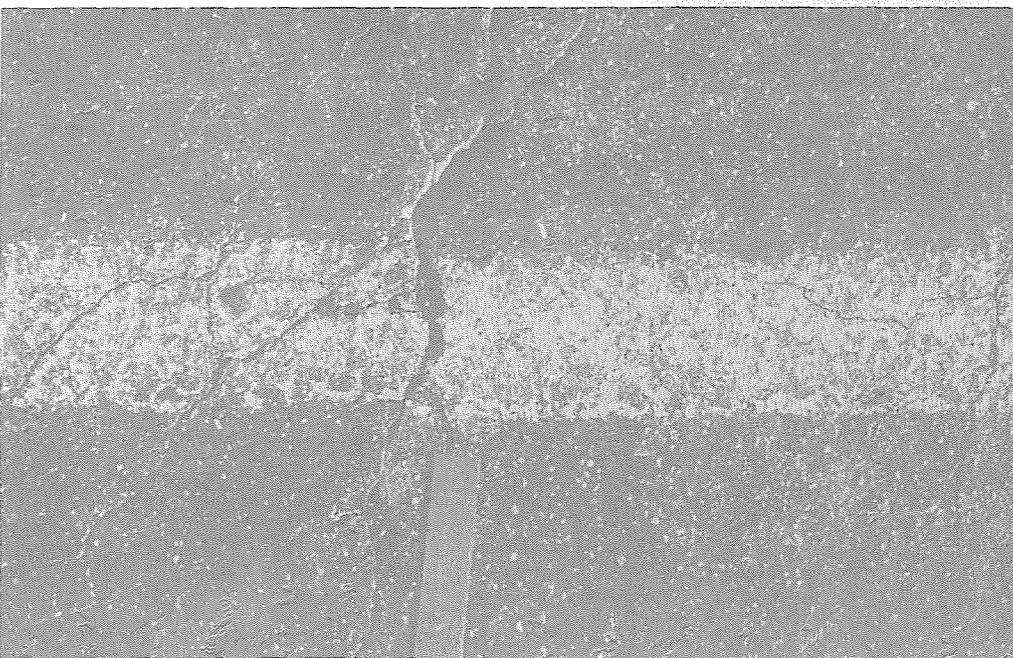
Photo No. 12 A fresh fracture found in the main highway just east of Murguía railroad station. The fracture shows a right lateral displacement of 1–2cm. The location coincides with the trace of the Cerro Prieto fault.

Traveling to the north toward Mexicali we finished the survey just east of the Murguía railroad station. At 2.5km driving west of this section and from where the highway bends, we found cracks which were perpendicular to the roadway showing a right lateral motion of about 1cm (photo 12). Near this point, we found a dirt roadway crossing this highway. Perpendicular to the roadway we found a 6m wide zone of fracturing. One crack in the middle of this zone shows a right lateral motion of about 1cm. We also observed here cracks within the cultivated fields which are primarily slumping features. The shapes of these cracks are arcuate and oriented in various directions. One of these fractures found at the last site was oriented N37°W and showed a displacement of about 1cm in the right lateral sense. The importance of this feature is that its location is within a narrow zone which matches with the trace of the Cerro Prieto fault.
