# The ShakeOut Scenario

## High-Rise Steel Buildings

By  
Swaminathan Krishnan and Matthew Muto  
**California Institute of Technology**  
Pasadena CA  
May 2008

**SHAKEOUT 2008: Tall Steel Moment Frame Building Response**  
**Swaminathan Krishnan and Matthew Muto**  
**California Institute of Technology**

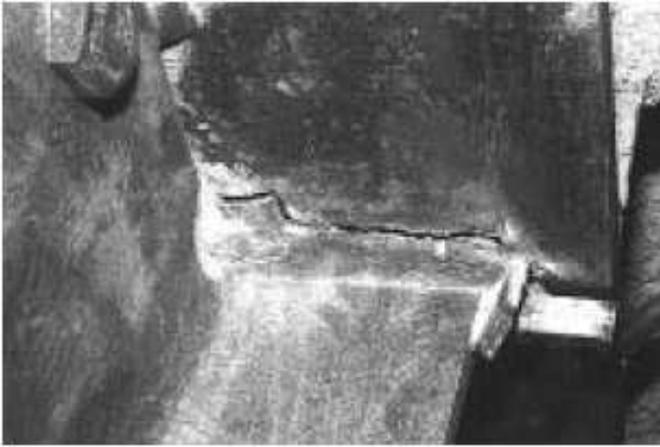
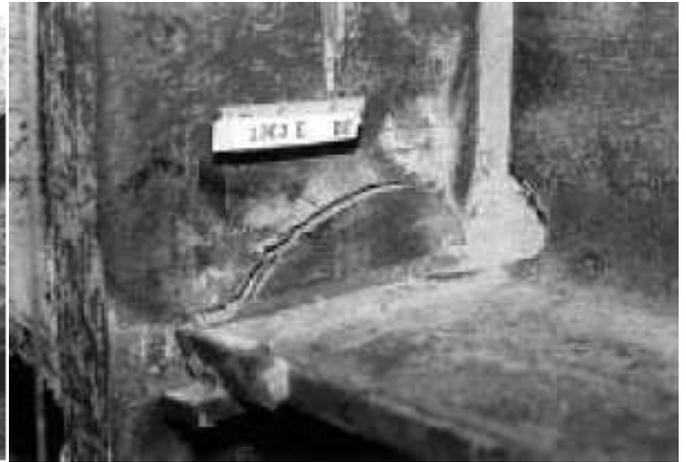
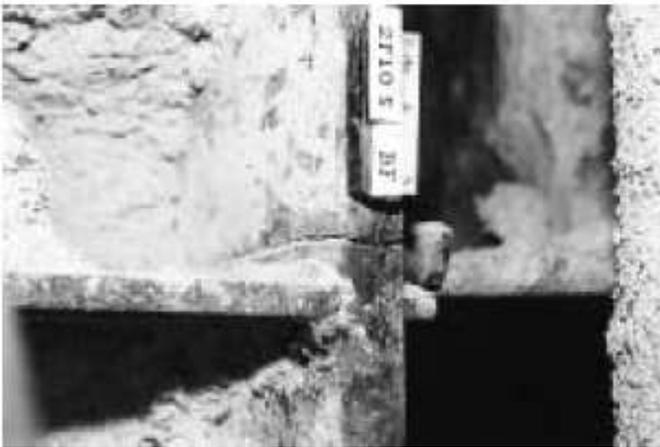
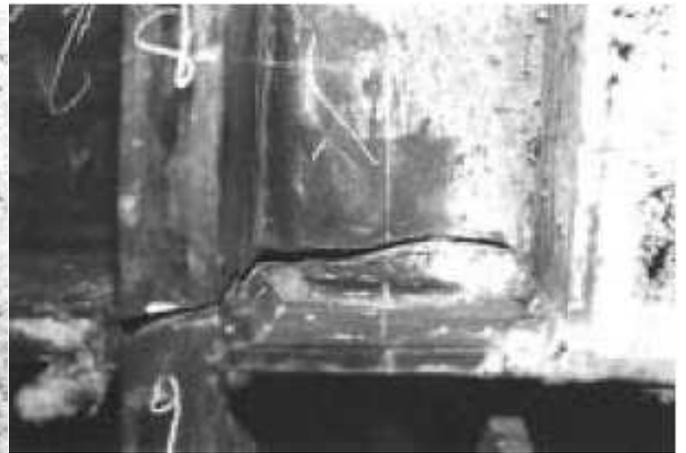
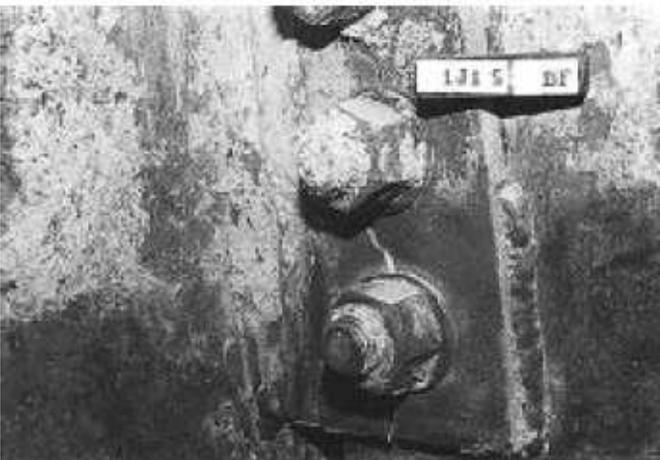
entire column cross-section (Figure 4). Such fractures can lead to a significant loss of stiffness and strength in the moment frames and can dramatically lower the capacity of the structure to resist collapse.

Figure 4: Fractures observed in beam-to-column connections during the 1994 Northridge earthquake (Source: FEMA-355E): [A] Fracture at the fused zone; [B] Column flange “divot” fracture; [C] Fracture through column flange; [D] Fracture progresses through column web; and [E] Vertical fracture through beam shear plate connection.

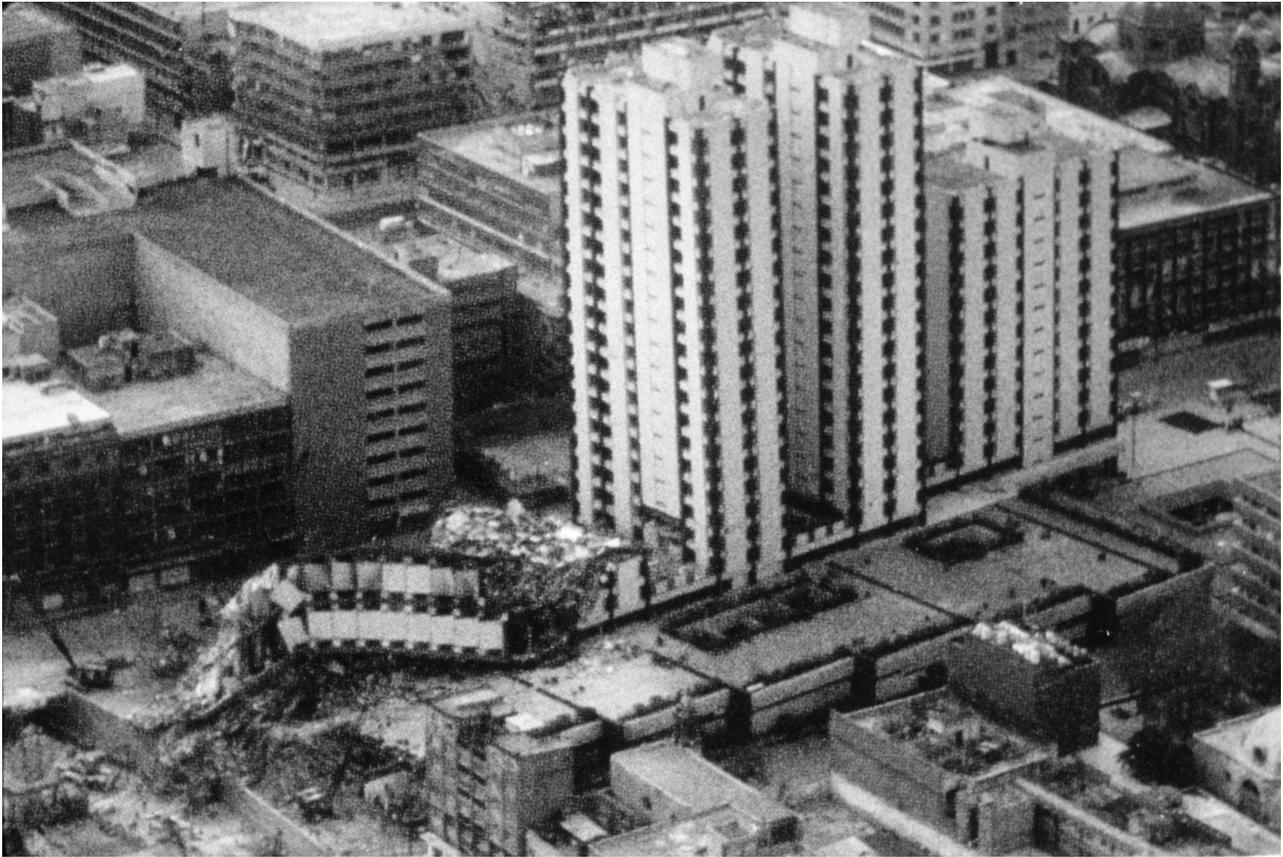
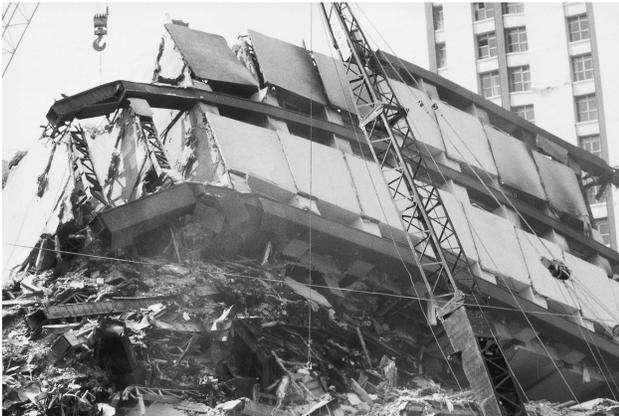
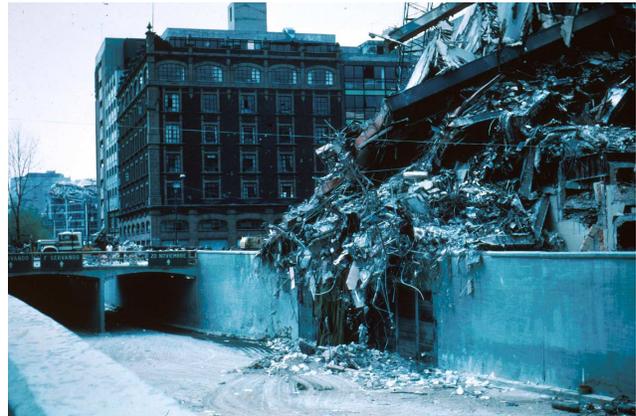
Figure 5: Mexico City Earthquake, September 19, 1985: [A] Collapse of a 21-story building on top of a 14-story building in the Pino Suarez complex. Three towers are left standing with extensive damage to the two 21-story towers. Source: Bob Reitherman; [B] Failure in the welds connecting the flanges and webs of built-up box column possibly led to local flange-buckling of the column and eventual collapse. Source: Bob Reitherman; [C] Debris of tower collapse spilled on to the streets. Source: Mehmet Celebi, USGS.

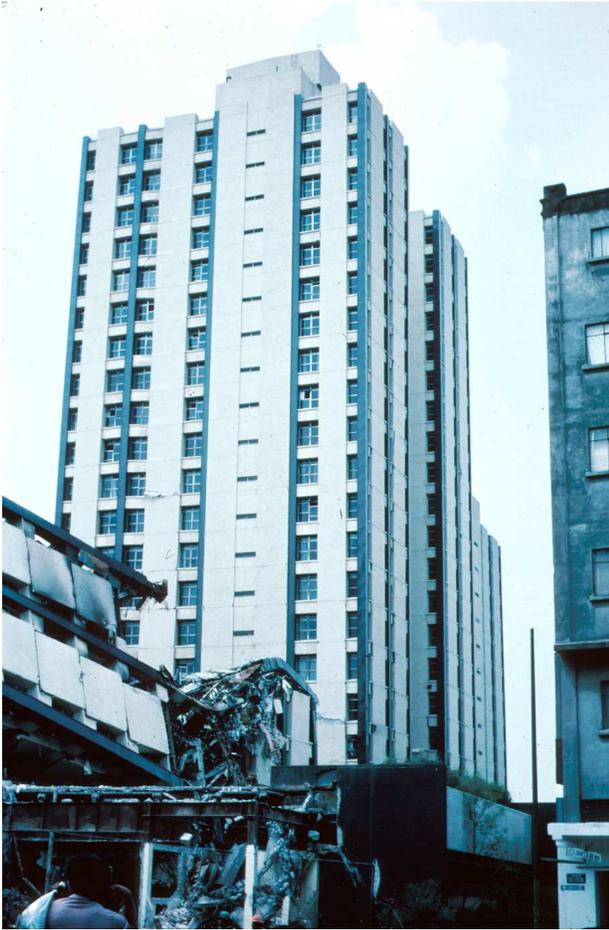
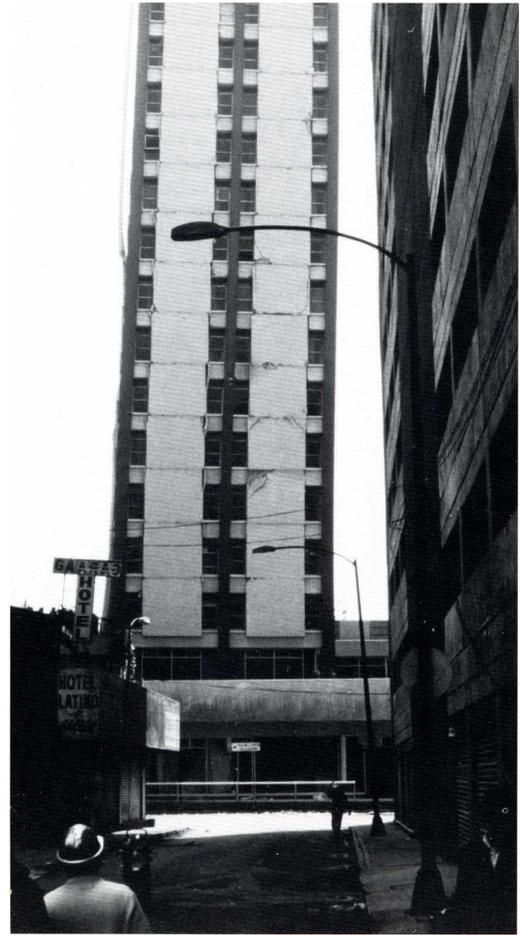
Figure 6: Mexico City Earthquake, September 19, 1985: [A] Wreckage of a 21-story steel building in the Pino Suarez Apartment Complex (Source: Mehmet Celebi, USGS); and [B] A second 21-story steel building in the same complex remained standing, but was leaning six feet out of plumb at the roof level due to yielding that resulted in a permanent interstory drift (Source: Jim Beck, Caltech). Such permanent tilting following an earthquake would most likely render the vertical transportation system (elevators) unusable due to misalignment. In addition, doors to staircase shafts may be jammed due to deformation of the frames, possibly hampering evacuation efforts.

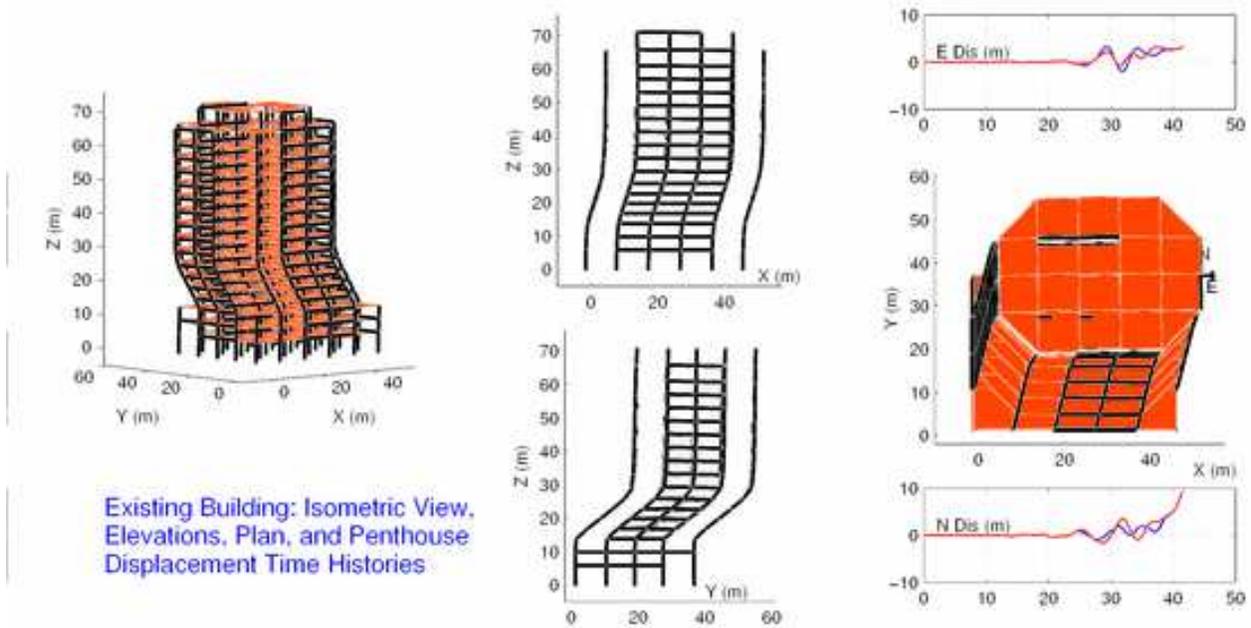
Figure 12: Snapshot of the response of the susceptible connection model of building 1, located at Baldwin Park with base orientation, at the initiation of collapse. The displacements are scaled by a factor of 2 for better visualization of the collapse mechanism.
