Results of 1/4-Scale Experiments.
Vapor Simulant And Liquid Jet A Tests

17 July 1998 **Revised January 28, 2000**
Explosion Dynamics Laboratory Report FM98-6

A quarter-scale engineering model of the center wing tank (CWT) of a 747-100 was constructed. This engineering model replicated the compartmentalization, passageways, and venting to the atmosphere. The model was designed to scale the fluid dynamical and combustion aspects of the explosion, not the structural failure of the beams or spars. The effect of structural failure on combustion was examined by using model beams and spars with deliberately engineered weak connections to the main tank structure. The model was filled with a simulant fuel (a mixture of propane and hydrogen) and ignited with a hot wire. The simulant fuel was chosen on the basis of laboratory testing to model the combustion characteristics (pressure rise and flame speed) of Jet A vapor created by a Jet A liquid layer at 50°C at an altitude of 13.8 kft.

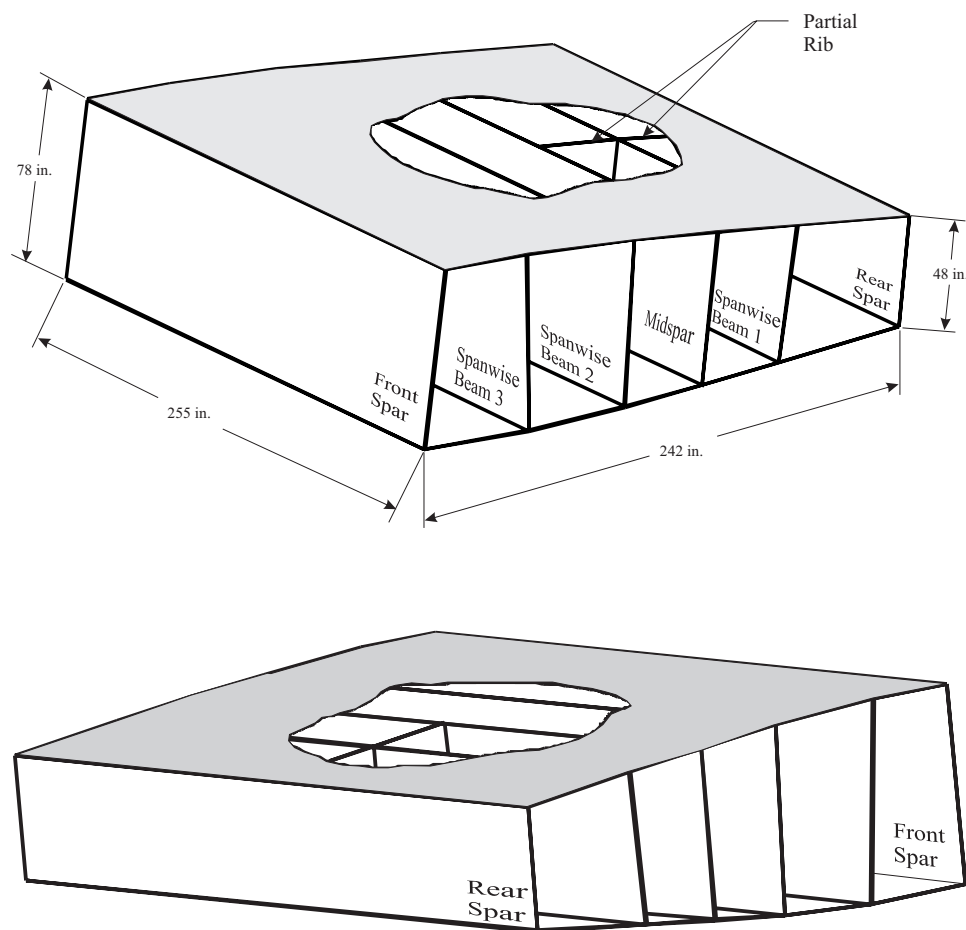
Figure 2.1: Perspective views of actual center wing tank.

The quarter-scale test facility is designed to be an engineering model that duplicates certain key features of the center wing tank, shown in Fig. 2.1. The model does not look exactly like a center wing tank and many features of the center wing tank are not included. The main purpose of the model is to have a facility in which the following issues may be investigated: ignition location; fuel type and amount; flame propagation; venting; the effect of structural failure of the beams and spars on combustion. For these issues, the most important features to model are compartmentalization of the center wing tank into bays, the flow passageways, and the venting. The precise way in which these features are scaled is described in detail in the test plan document (Shepherd et al. 1997b). Briefly, the volumes of the bays in the facility are 1/64 of the full-scale bays and the areas of the flow passageways and vent tubes are 1/16 of the corresponding full-scale features. The location of the passageways and vent tubes in the model are in approximately scaled locations. The fuel used in the model experiments was also scaled so that it had the same flame speed and combustion overpressure as the Jet A vapor-air mixture at the explosion altitude and a nominal tank temperature of 50°C.

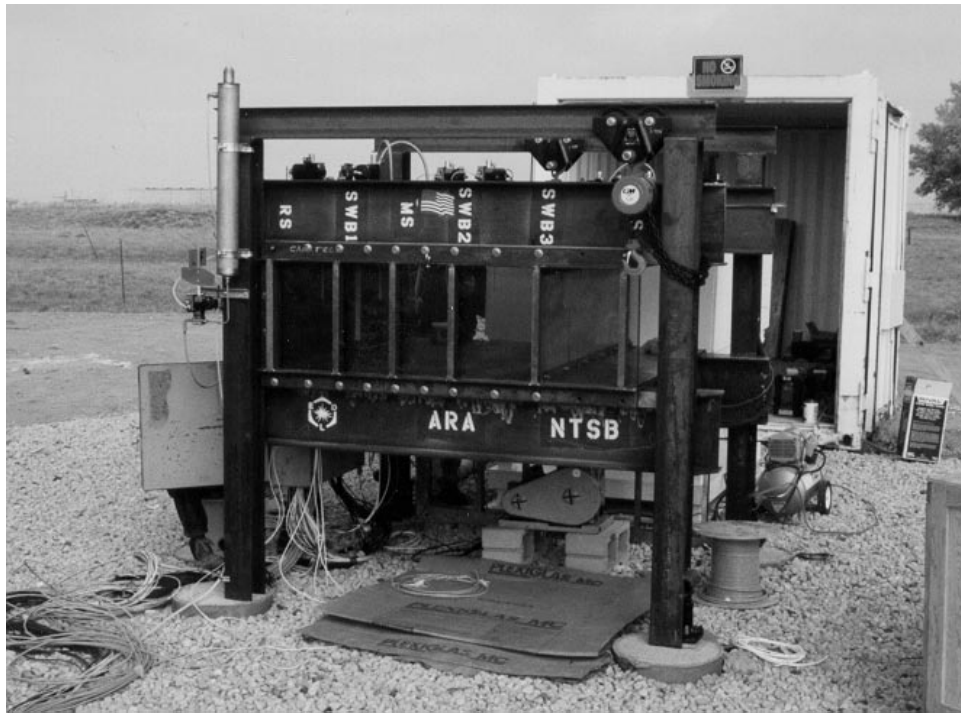
Figure 2.6: Test facility with majority of support hardware attached.

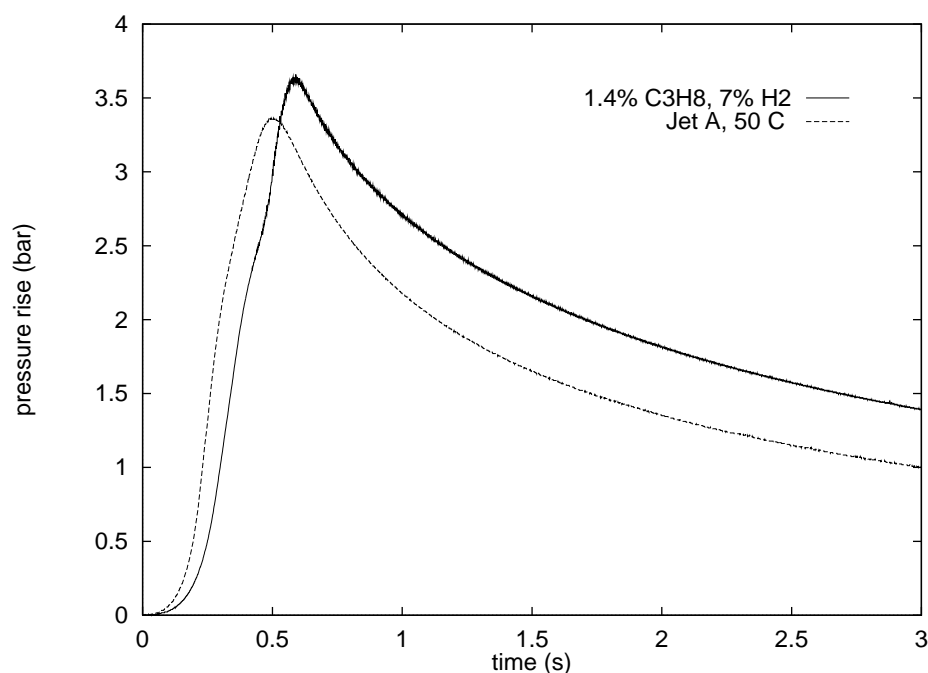
Figure 2.12: Comparison of combustion tests using LAX Jet A at 50°C mass loading of 3 kg/m³ and 0.585 bar, and propane/hydrogen (1.4%/7%) at 25°C and 0.83 bar in the Hyjet Facility (1180 liters), both with spark ignition.

Analysis of these pressure traces indicates that peak pressure rise is slightly larger for the simulant ($\Delta P_{max} = 3.65 \text{ bar}$) than for the Jet A ($\Delta P_{max} = 3.36 \text{ bar}$). However, the simulant has

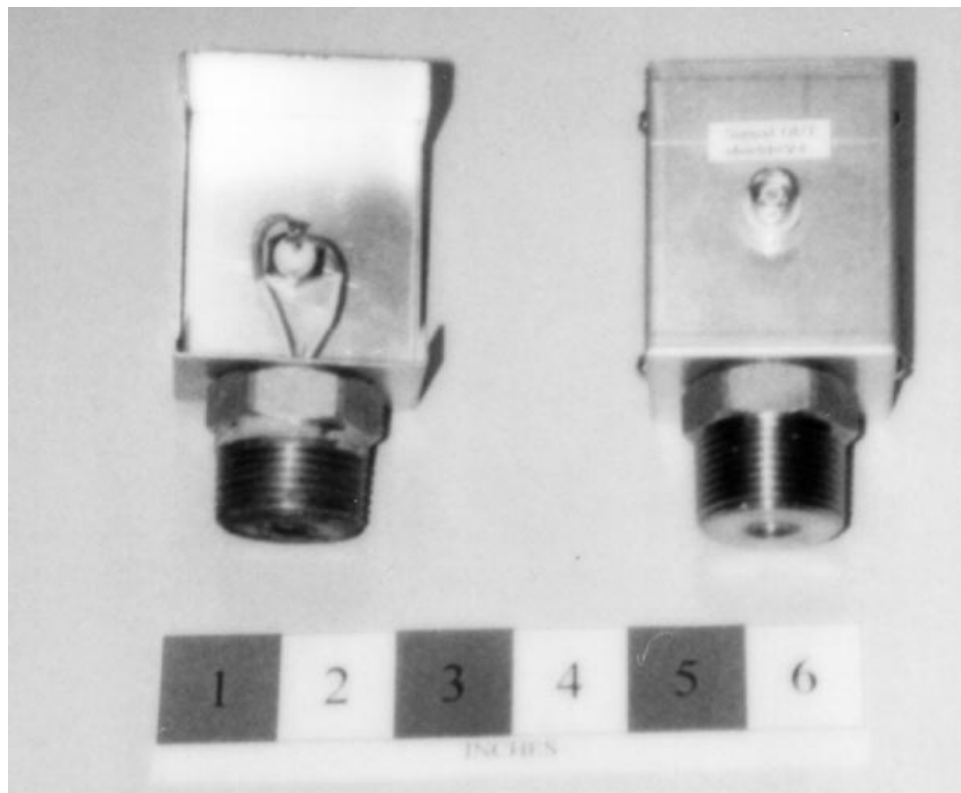
Figure 2.17: Photo detector assembly.

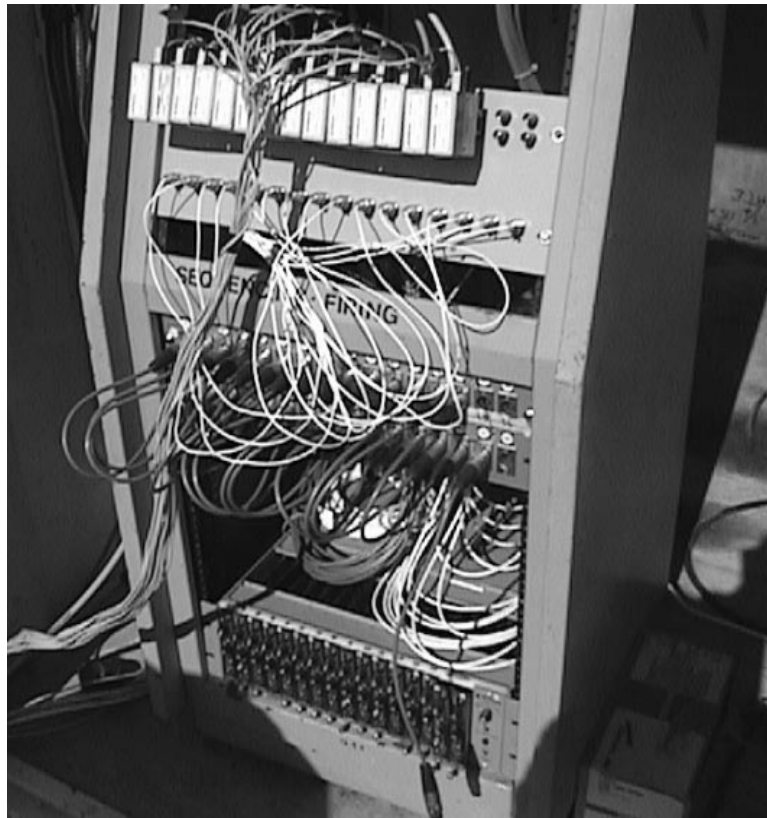
Figure 2.25: Thermocouple signal conditioning with patching.

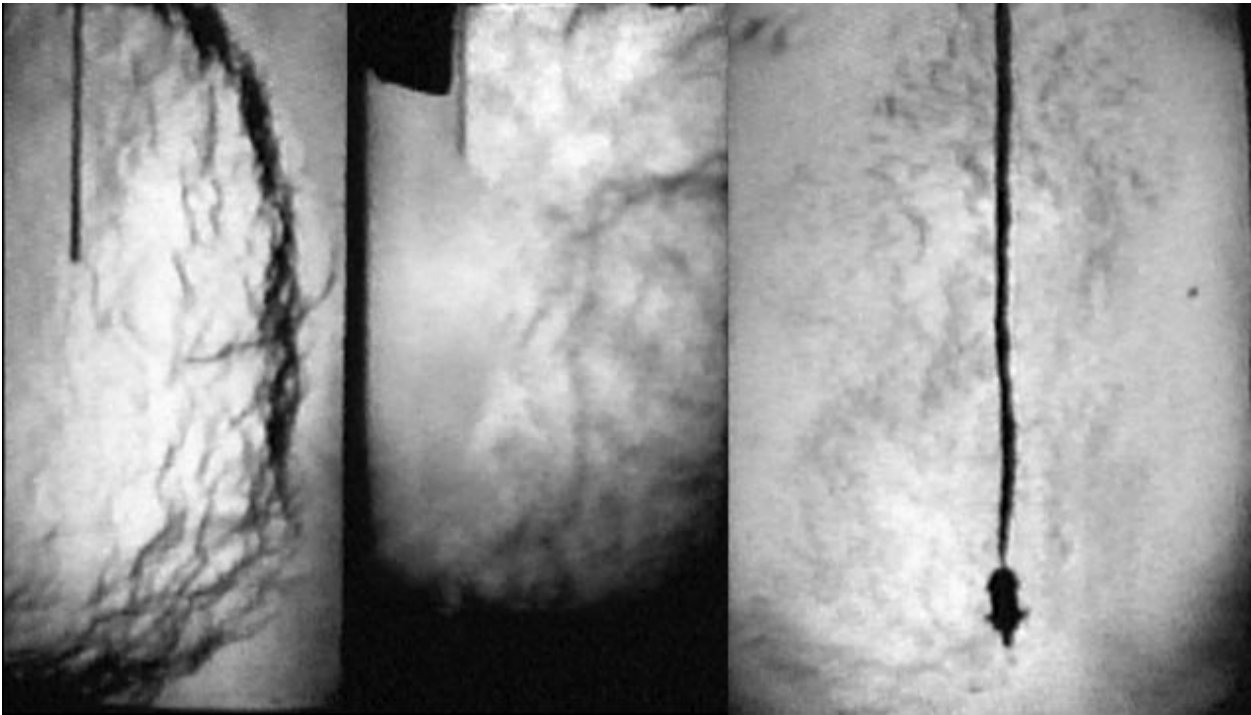
Figure 5.8: Composite of schlieren images from Test 10. (Bay camera 1 malfunctioned, so the image from the bay 5/6 location is missing from the left of the picture.) Note ignition of forward bays through vent stringers.

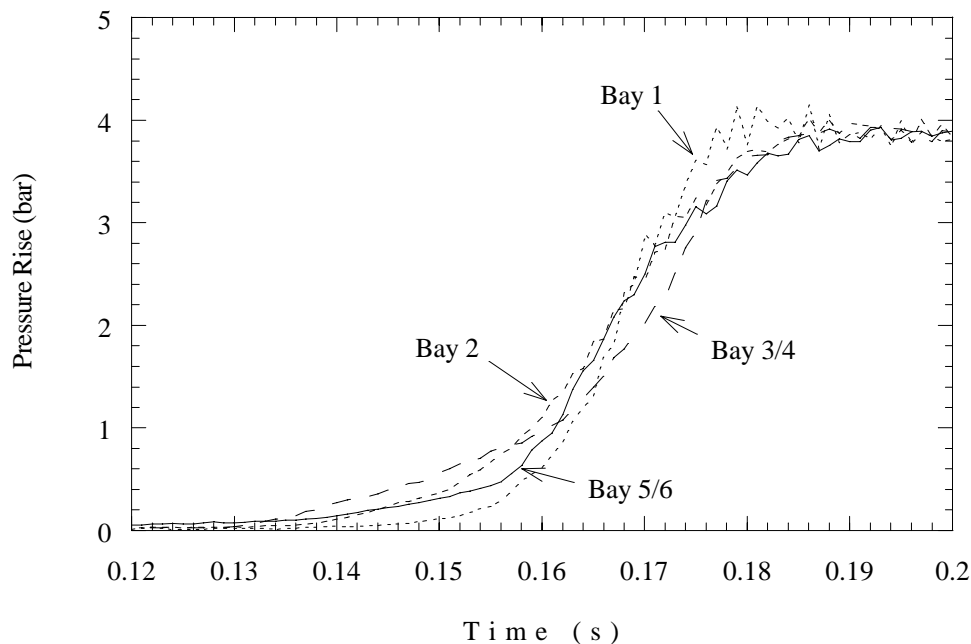
Figure 5.11: Pressure traces from four-compartment configuration. Test 9.

This seems unusual, but this is the first time that SWB1 has been installed. In previous configurations, the partition closest to the ignitor was the MS, which was approximately 15 in from the point of ignition. SWB1 is only about 5 in from the ignitor, so it is possible for the flame to reach the partition and pass through the passageway early in the combustion process, when only a moderate amount of turbulence has been generated (compared to the earlier cases). Therefore, the flame enters bays 3/4 at about 135 ms, and burns somewhat faster. Bay 2 is ignited shortly thereafter, with a slightly faster pressure rise. The ignition delay is most pronounced in bay 1, where the pressure slowly rises until ignition occurs, and the pressure rises at a higher rate than in the previous bays. We also see the first evidence of pressure piling here, as the pressure in bay 1 peaks at a slightly higher value than that of the other bays.

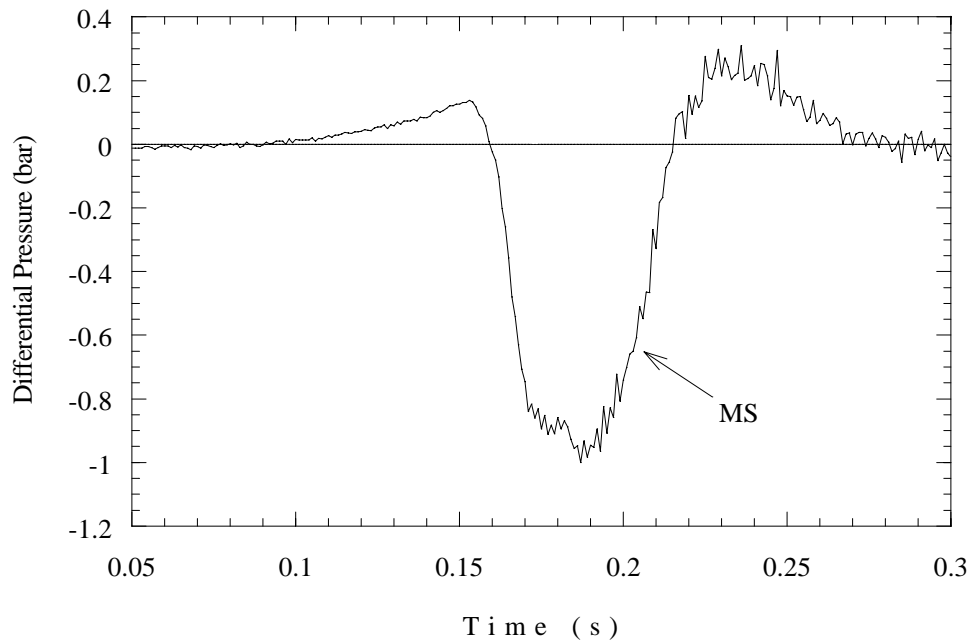
Figure 5.22: Differential pressure across MS from two-compartment code validation configuration. Test 12.

The schlieren footage from Test 12 is simple, yet very interesting. The initial flame propagates and expands smoothly before it approaches MS. The expanding flame is driving flow of unburnt gas through the hole in MS, developing a jet in the forward half of the tank. The schlieren system isn't sensitive enough to resolve this. When the flame front gets halfway through the bay 3/4 region, the leading tip of the spherical flame reaches the jet flow area, and appears to get sucked through MS. The flame follows the path of the jet as it enters the forward bays, running straight to the wall, expanding to 1/3 – 1/2 of the bay height before impact. As

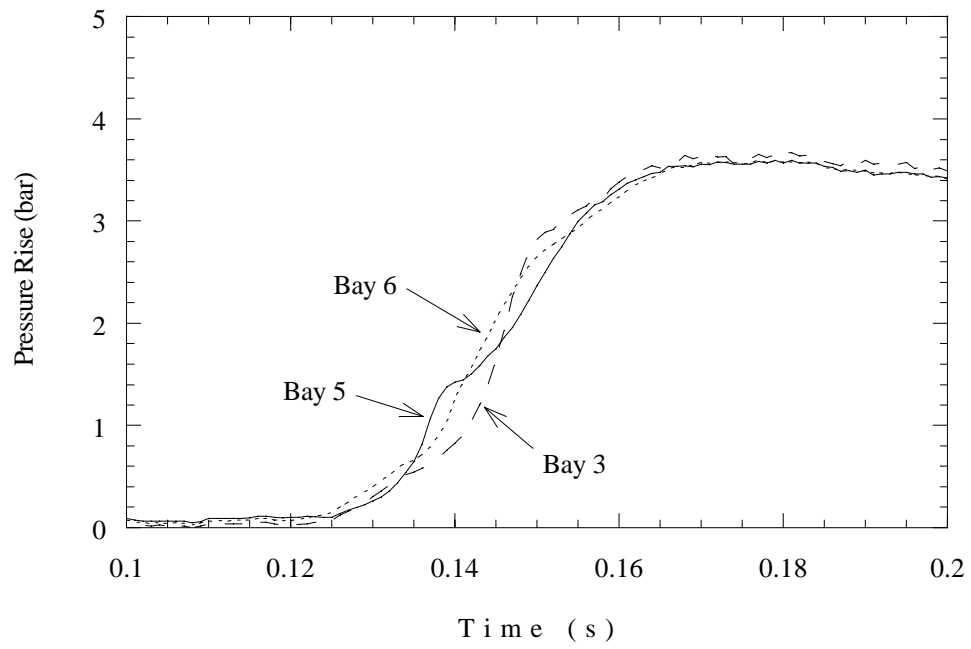
Figure 5.25: Pressure traces from bays 3, 5, 6, ignition in bay 5. Test 4.

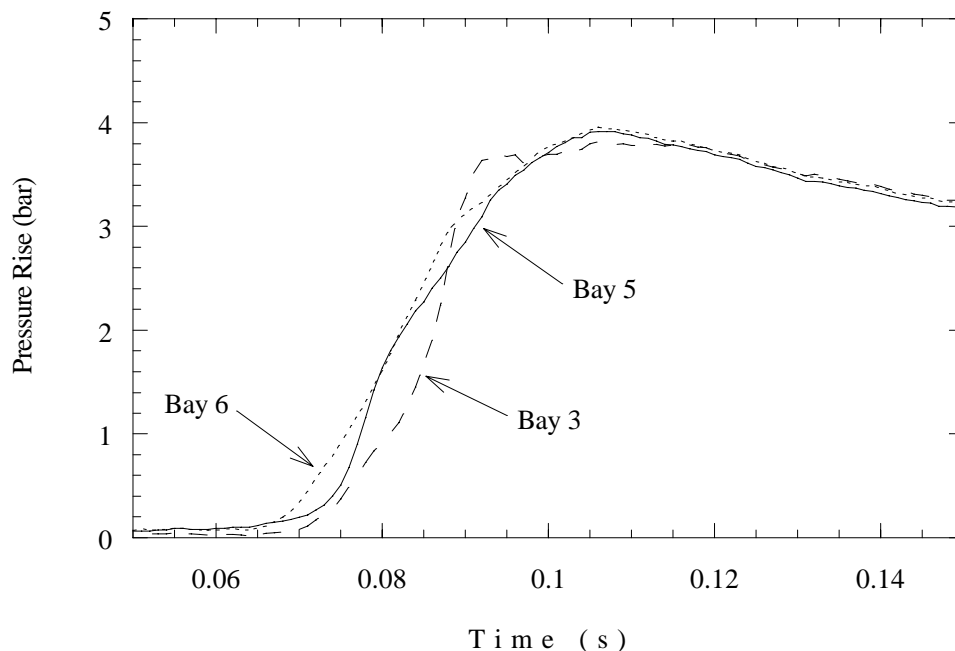
Figure 5.33: Pressure traces for bays 3, 5, 6, ignition in bay 5, with a cool liquid Jet A layer. Test 8.

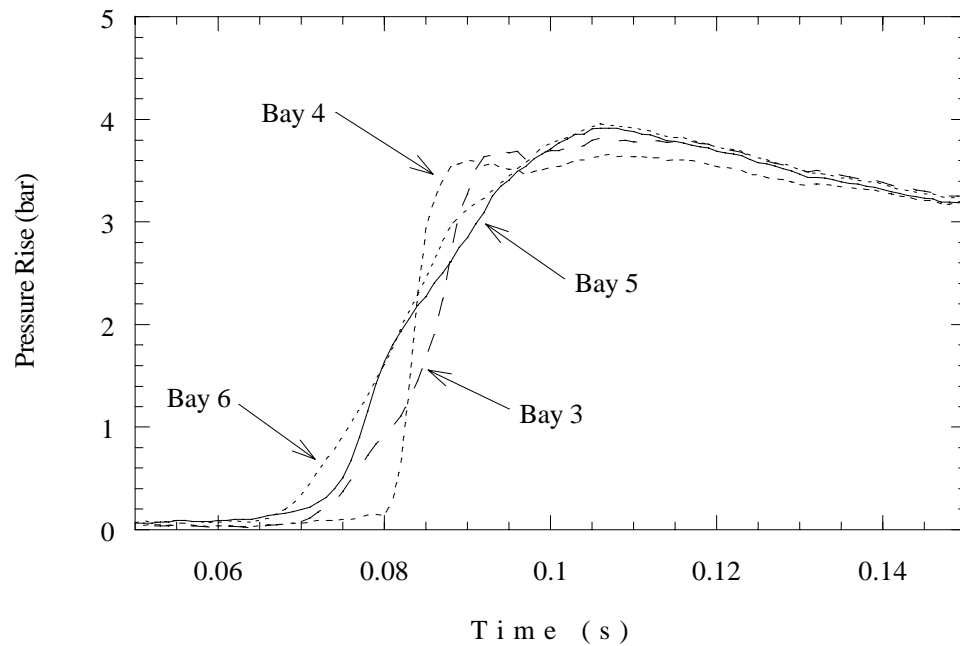
Figure 5.34: Pressure traces for bays 3 – 6, ignition in bay 5, with a cool liquid Jet A layer. Test 8.

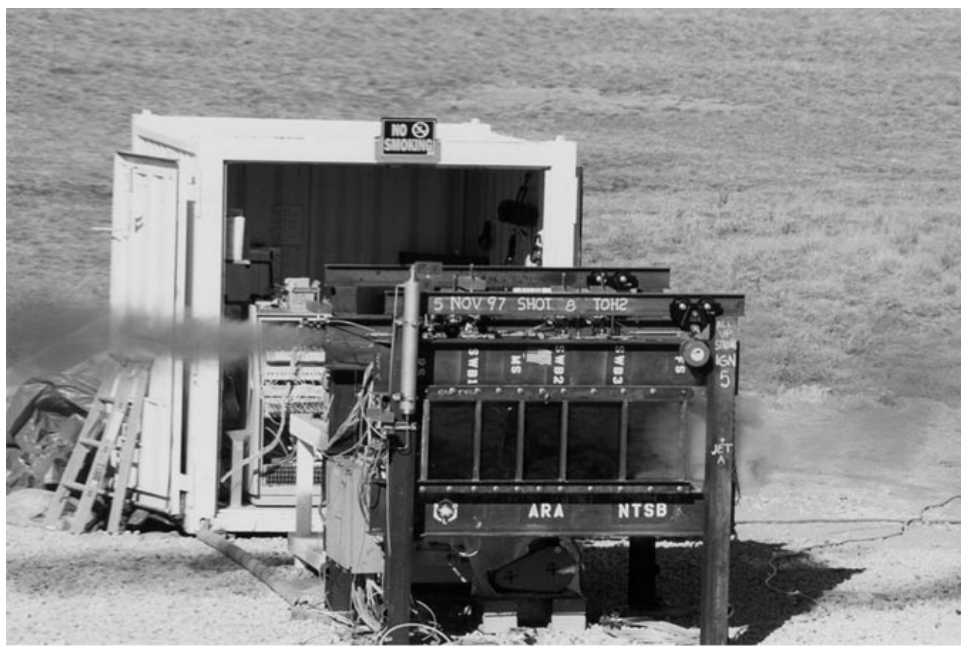
Figure 5.41: Venting of combustion products from vent stringers and leaks in SWB3. The soot acts as a tracer for the flows. Test 8.

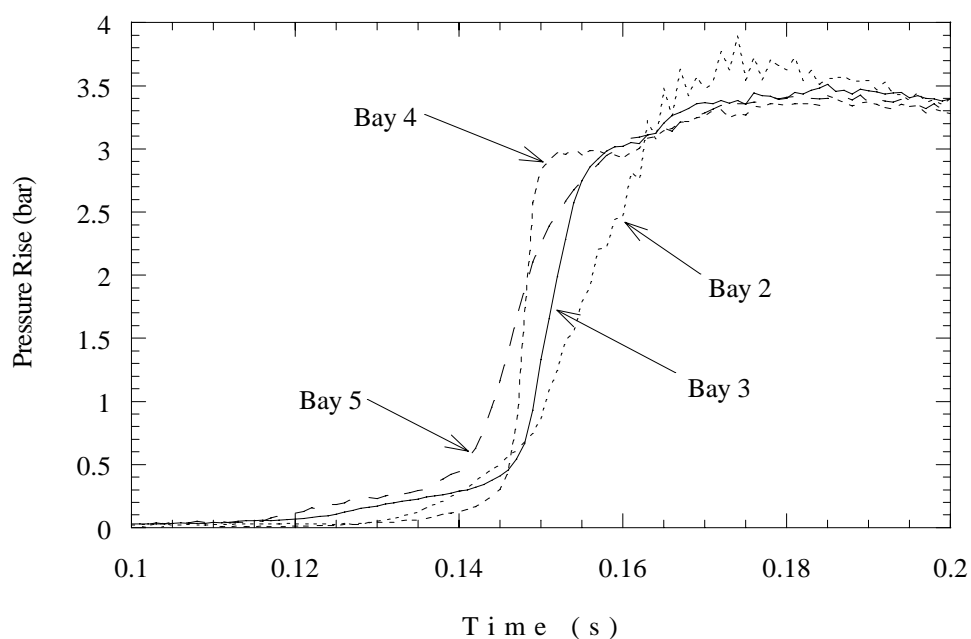
Figure 5.42: Pressure traces from bays 2 – 5, ignition in bay 3. Test 5.

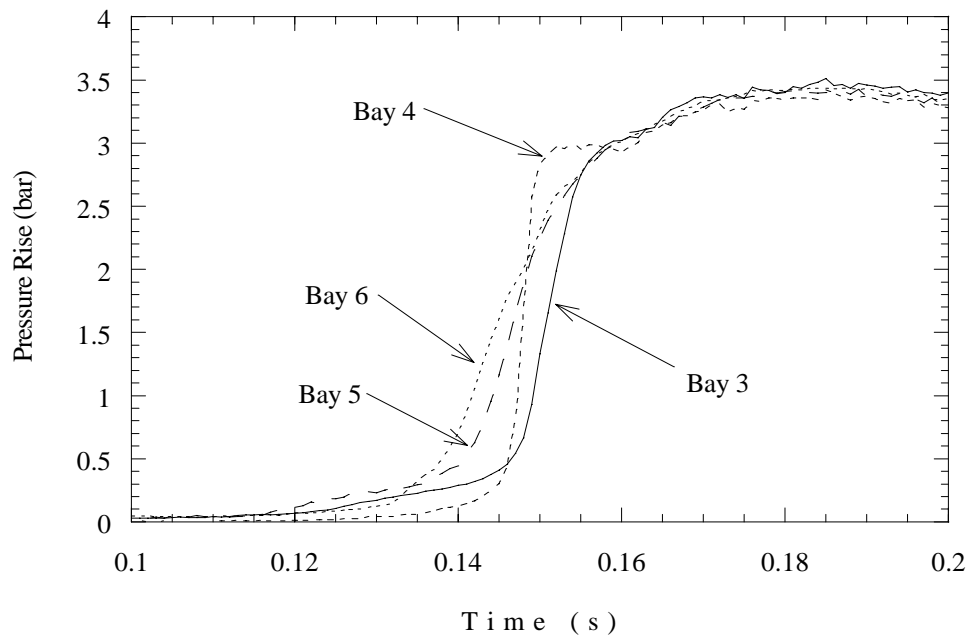
Figure 5.43: Pressure traces from bays 3 – 6, ignition in bay 3. Test 5.

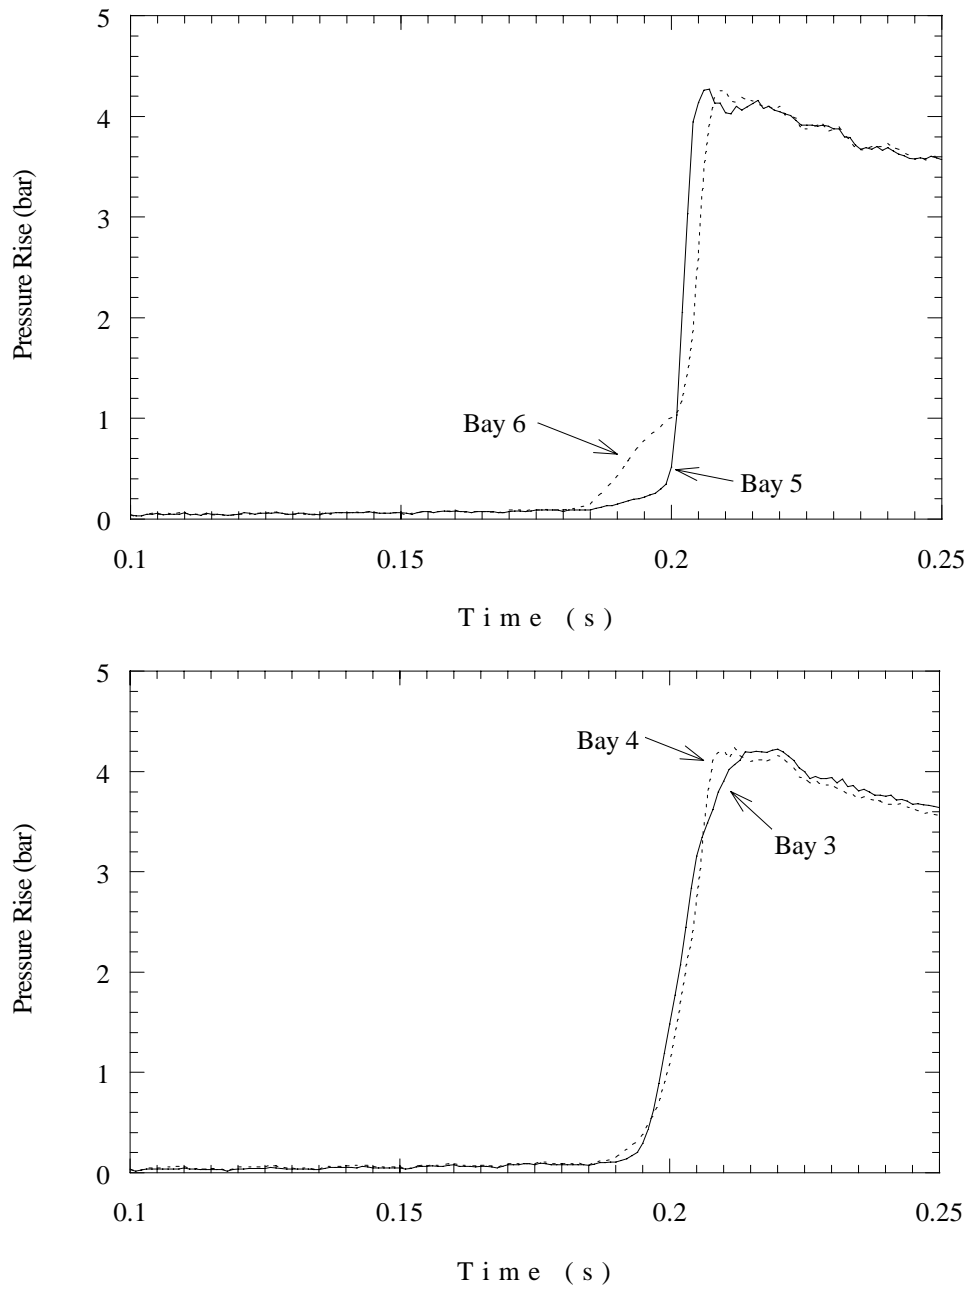
Figure 5.52: Comparison of bays 5, 6 and 3, 4, ignition in bay 1. Test 7.

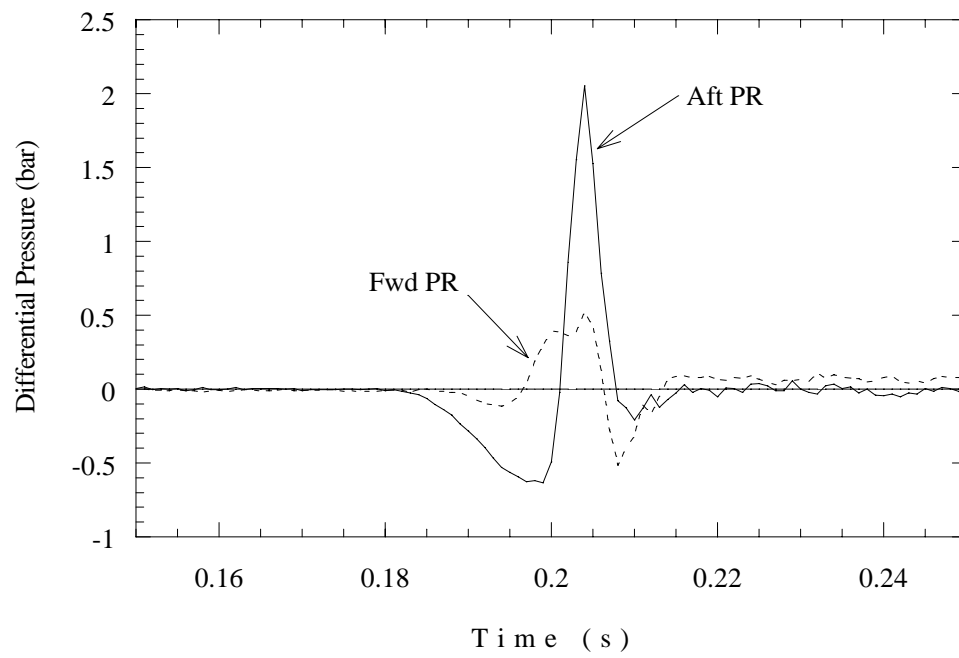
Figure 5.59: Differential pressure across PRs, ignition in bay 1. Test 7.

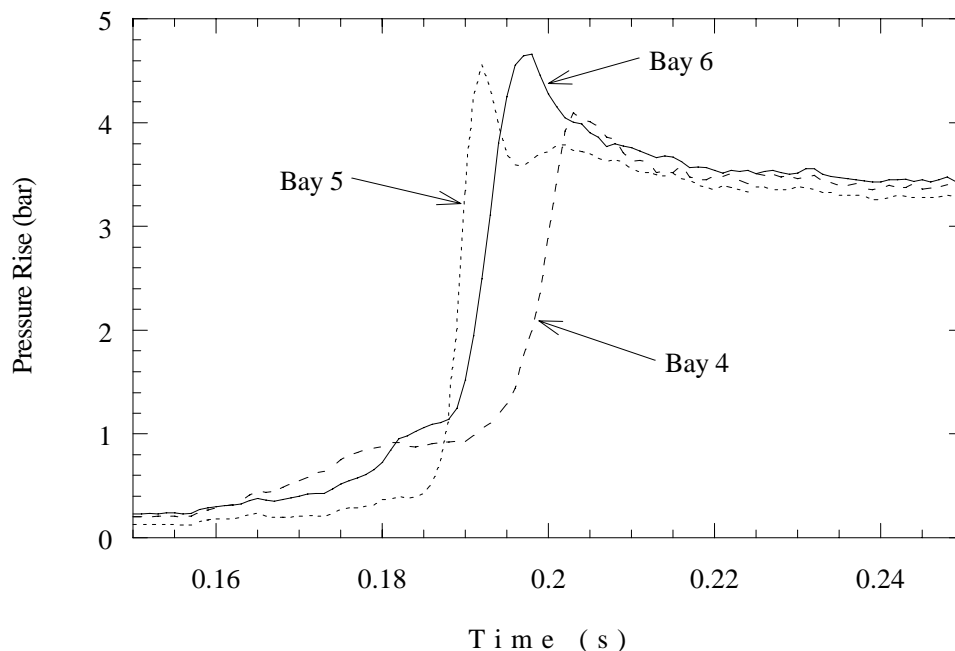
Figure 5.60: Pressure traces for bays 4, 5, 6, ignition in bay 6R. Test 15.

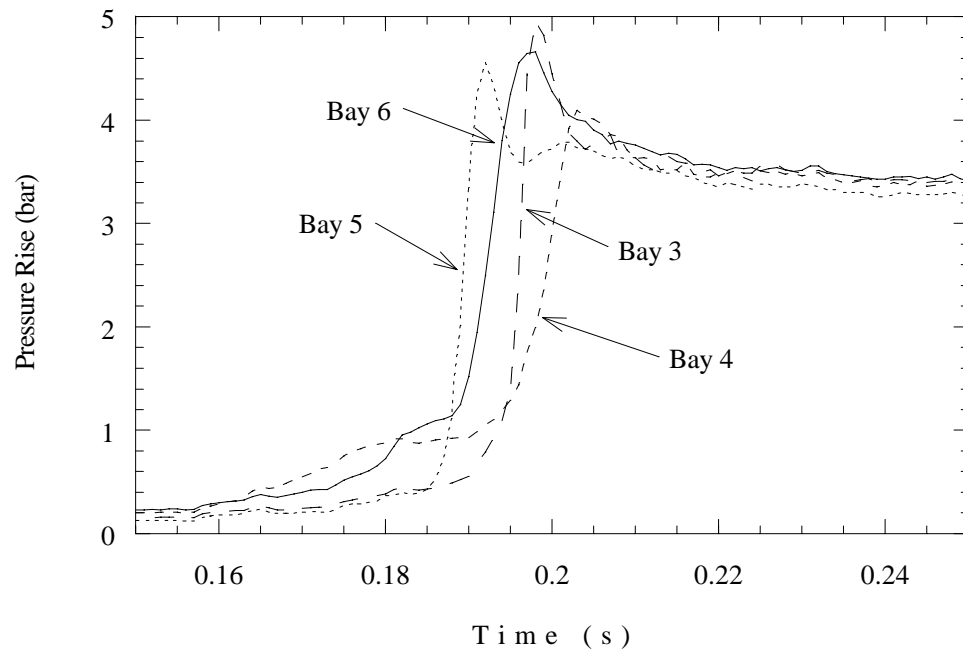
Figure 5.61: Pressure traces for bays 3 – 6, ignition in bay 6R. Test 15.

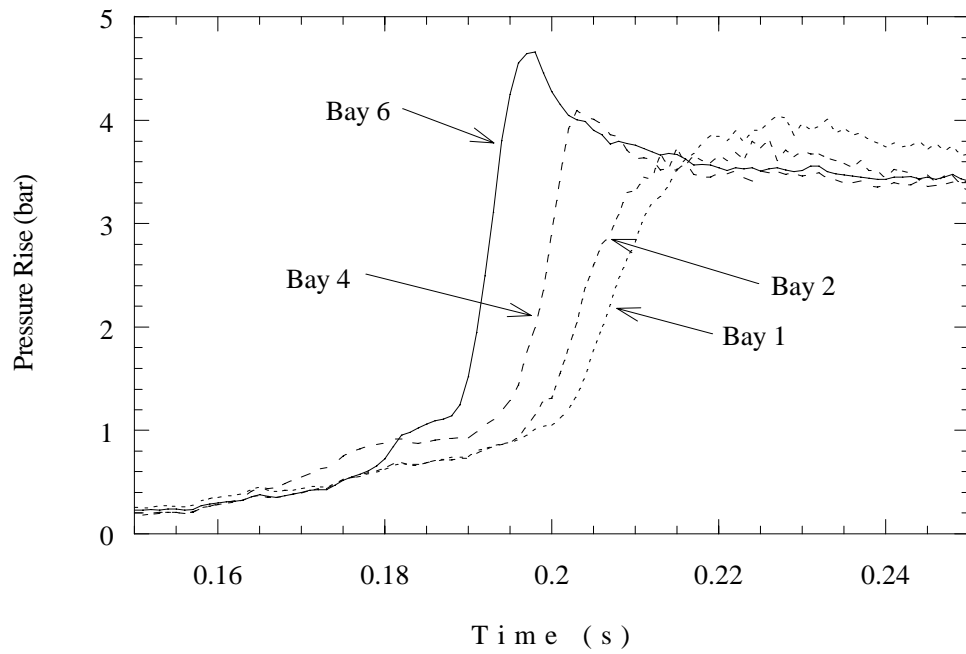
Figure 5.62: Pressure traces for bays 1, 2, 4, 6, ignition in bay 6R. Test 15.

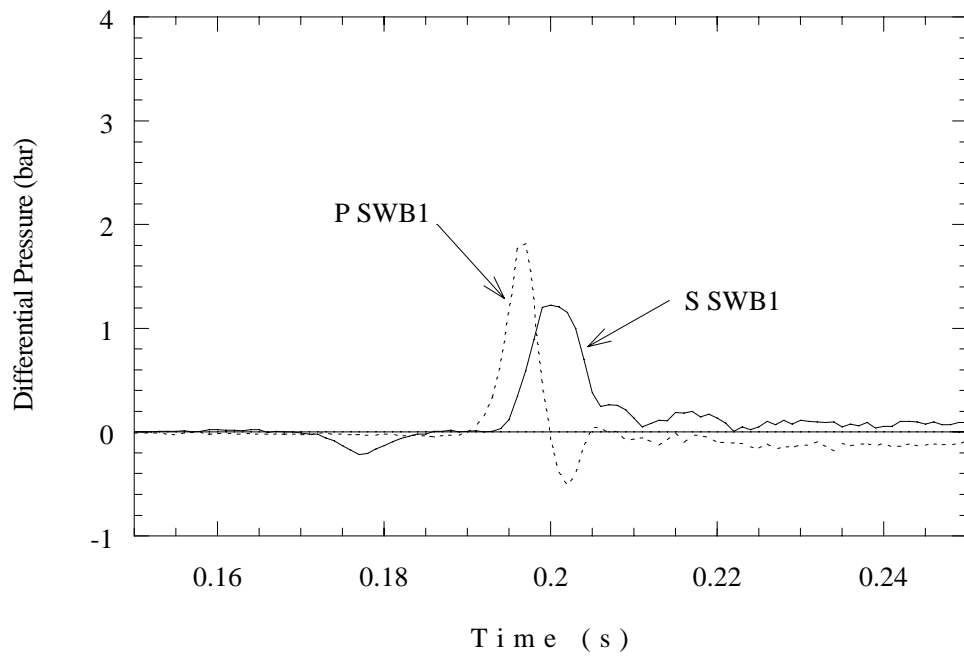
Figure 5.69: Differential pressure across SWB1, ignition in bay 1R. Test 16.

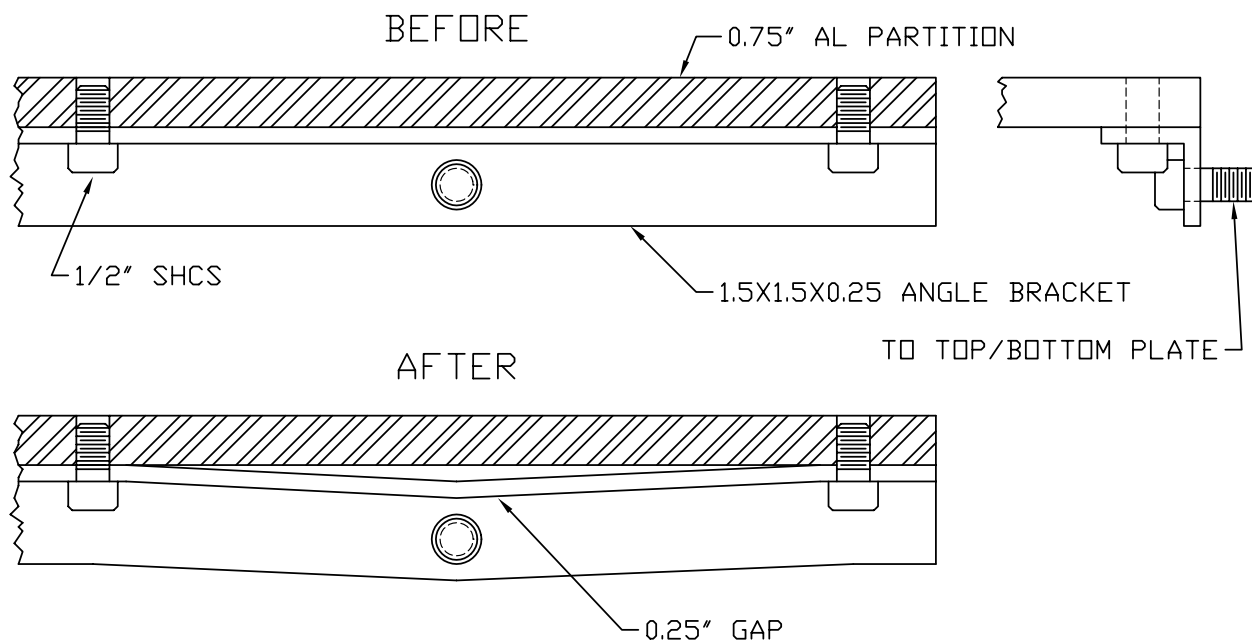
Figure 5.87: Damage to strong partition mounting brackets. View looking at top or bottom plate. Partition forced forward (toward bolts securing bracket to top/bottom plates), end of partition folded around last bolt.

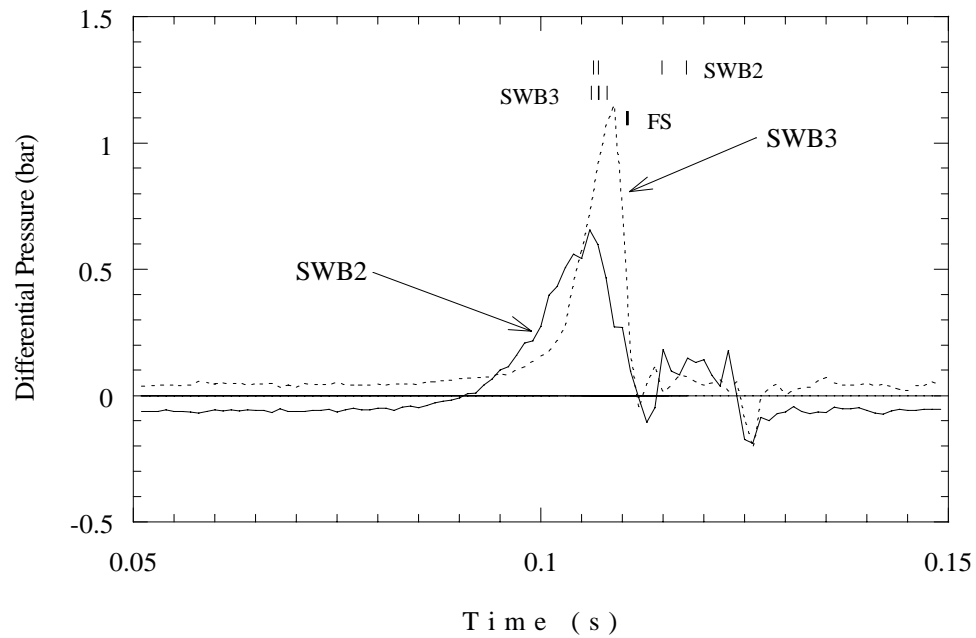
Figure 5.98: Differential pressure across SWB2 and SWB3. Test 18.

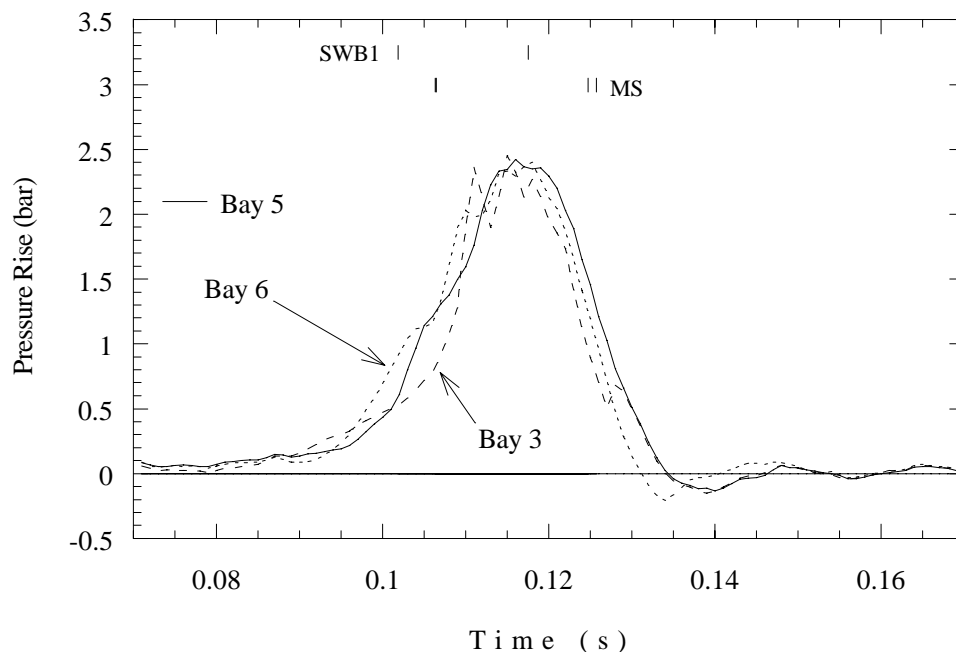
Figure 5.101: Pressure traces from bays 3, 5, 6, ignition in bay 5, with a cold liquid Jet A layer. Test 19.

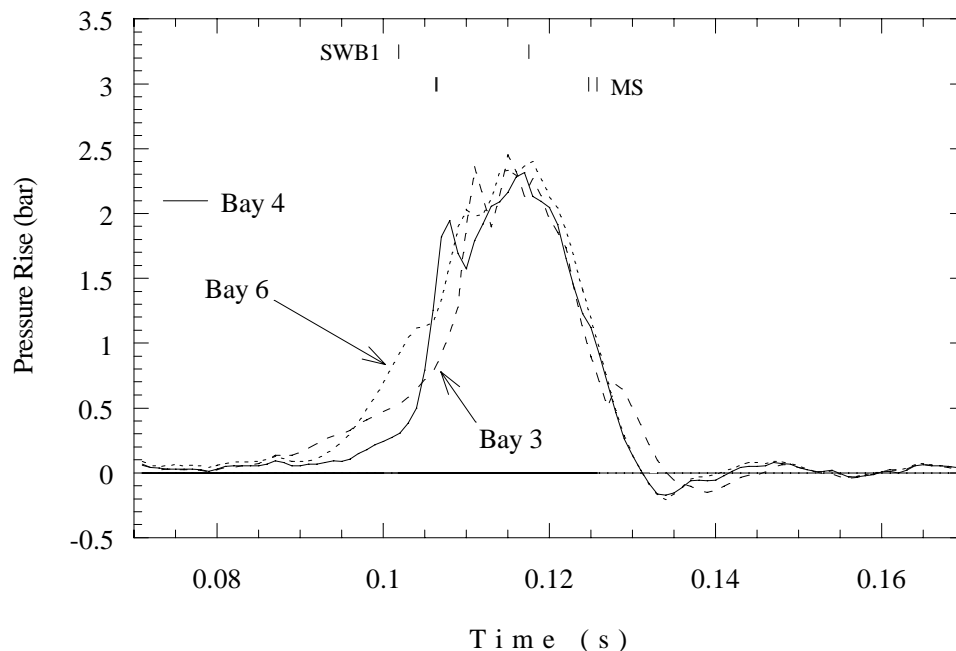
Figure 5.102: Pressure traces from bays 3, 4, 6, ignition in bay 5, with a cold liquid Jet A layer. Test 19.

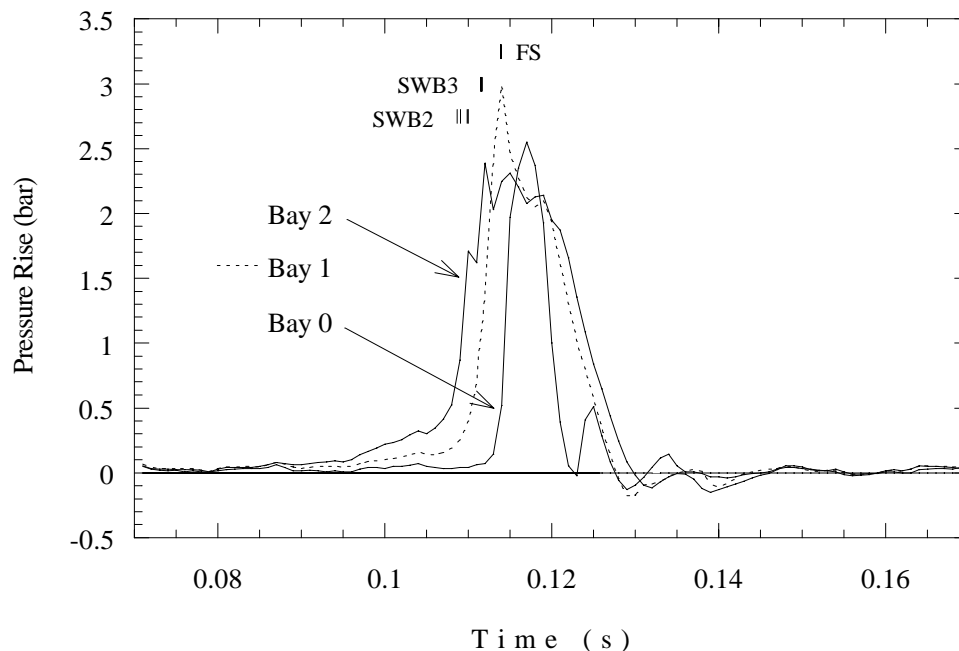
Figure 5.104: Pressure traces from bays 0 – 2, ignition in bay 5, with a cold liquid Jet A layer. Spike in bay 0 at 125 ms corresponds to failure of port side of MS. Test 19.

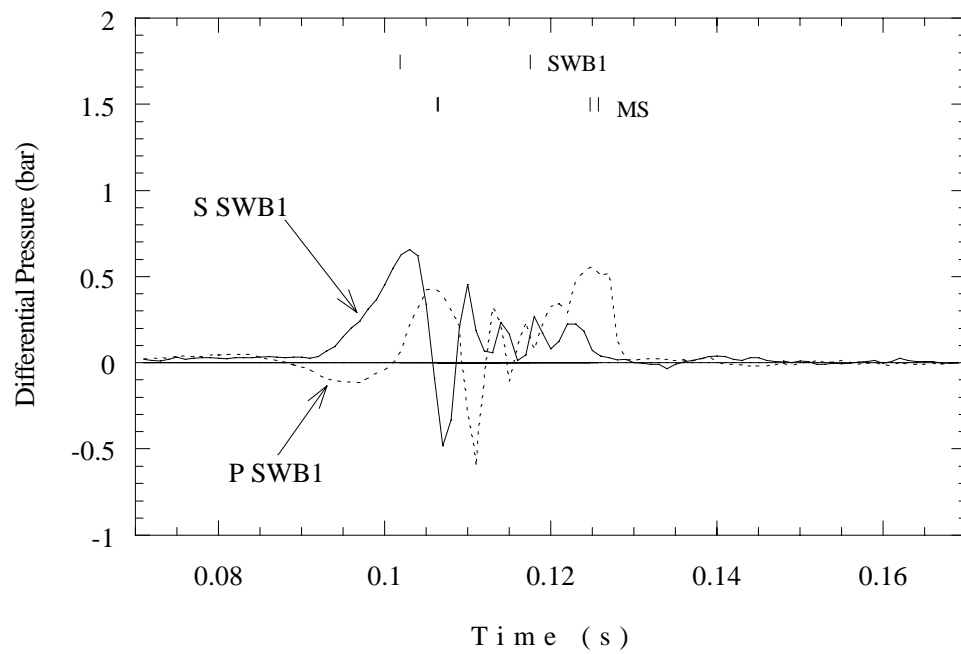
Figure 5.105: Differential pressure across SWB1, ignition in bay 5, with a cold liquid Jet A layer. Test 19.

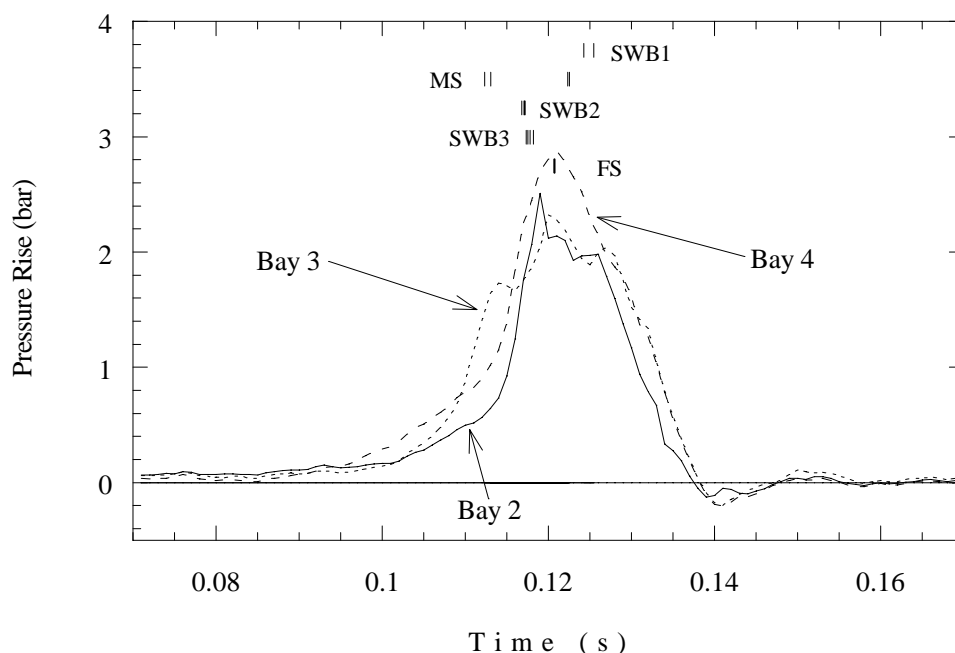
Figure 5.112: Pressure traces from bays 2 – 4, ignition in bay 2Lo, with a cold liquid Jet A layer. Test 20.

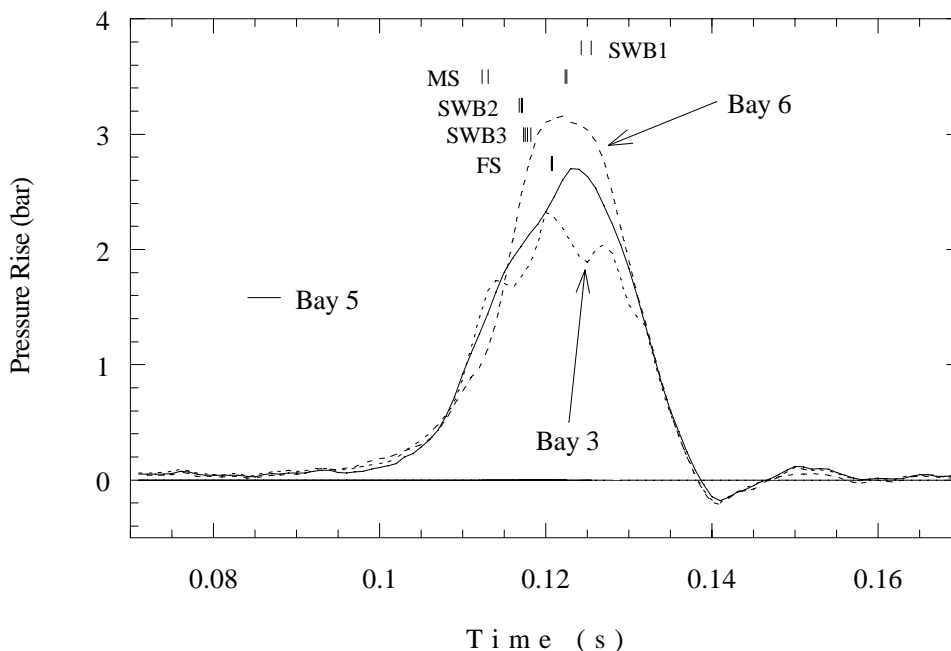
Figure 5.113: Pressure traces from bays 3, 5, 6, ignition in bay 2Lo, with a cold liquid Jet A layer. Test 20.

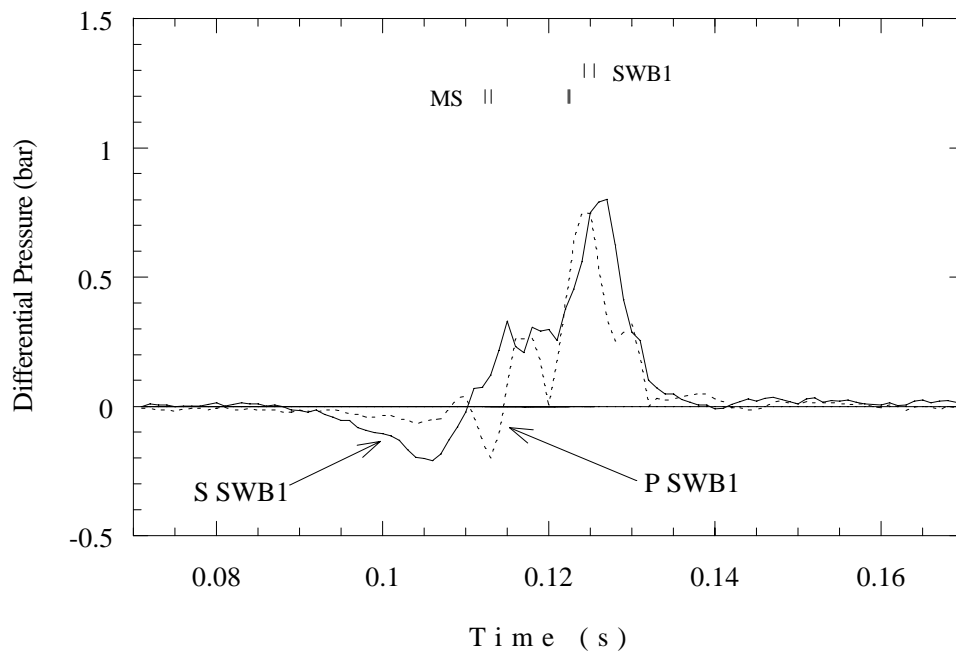
Figure 5.115: Differential pressure across SWB1, ignition in bay 2Lo, with a cold liquid Jet A layer. Test 20.

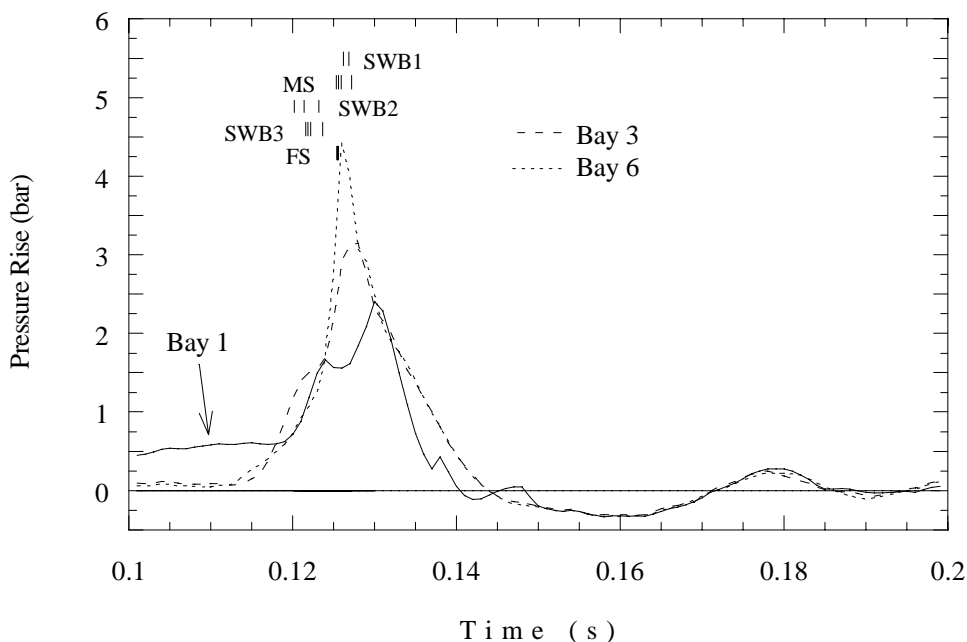
Figure 5.121: Pressure traces from bays 1, 3, 6, ignition in bay 1, with a cold liquid Jet A layer. Test 21.

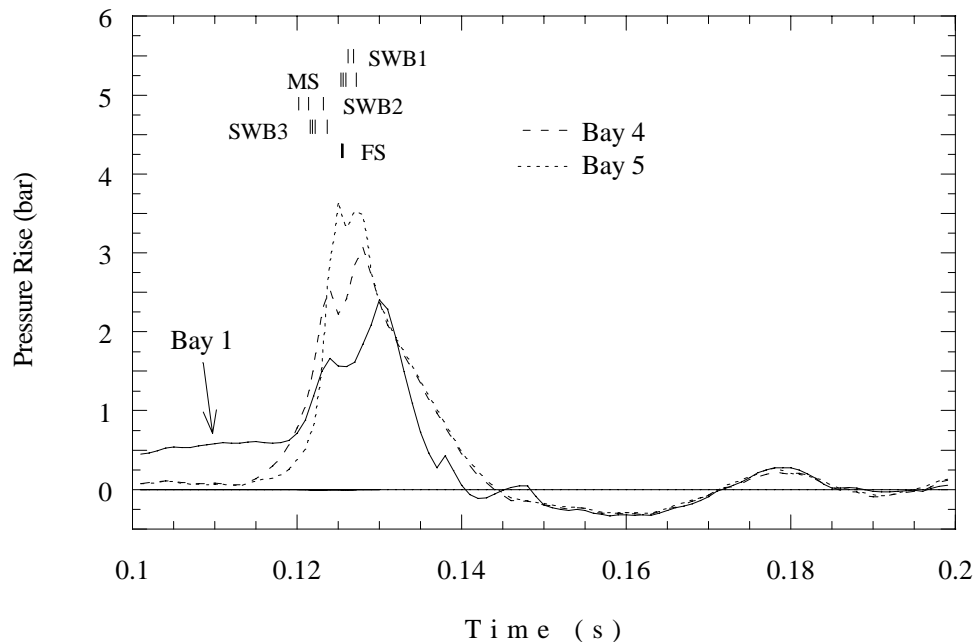
Figure 5.122: Pressure traces from bays 1, 4, 5, ignition in bay 1, with a cold liquid Jet A layer. Test 21.
