Results of 1/4-Scale Experiments.
Vapor Simulant And Liquid Jet A Tests

17 July 1998 **Revised January 28, 2000**
Explosion Dynamics Laboratory Report FM98-6

A quarter-scale engineering model of the center wing tank (CWT) of a 747-100 was constructed. This engineering model replicated the compartmentalization, passageways, and venting to the atmosphere. The model was designed to scale the fluid dynamical and combustion aspects of the explosion, not the structural failure of the beams or spars. The effect of structural failure on combustion was examined by using model beams and spars with deliberately engineered weak connections to the main tank structure. The model was filled with a simulant fuel (a mixture of propane and hydrogen) and ignited with a hot wire. The simulant fuel was chosen on the basis of laboratory testing to model the combustion characteristics (pressure rise and flame speed) of Jet A vapor created by a Jet A liquid layer at 50°C at an altitude of 13.8 kft.

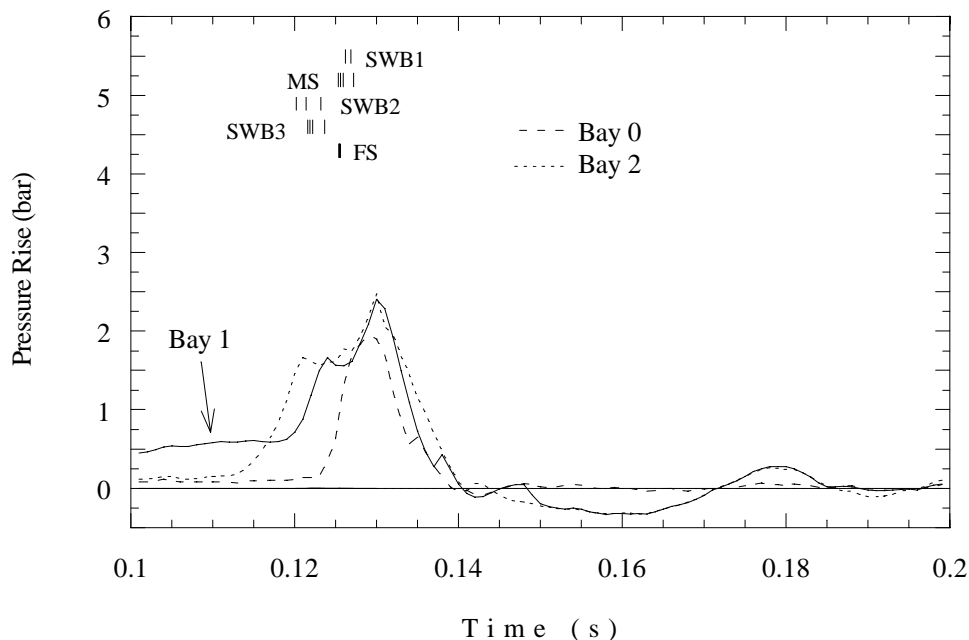
Figure 5.123: Pressure traces from bays 0 – 2, ignition in bay 1, with a cold liquid Jet A layer. Test 21.

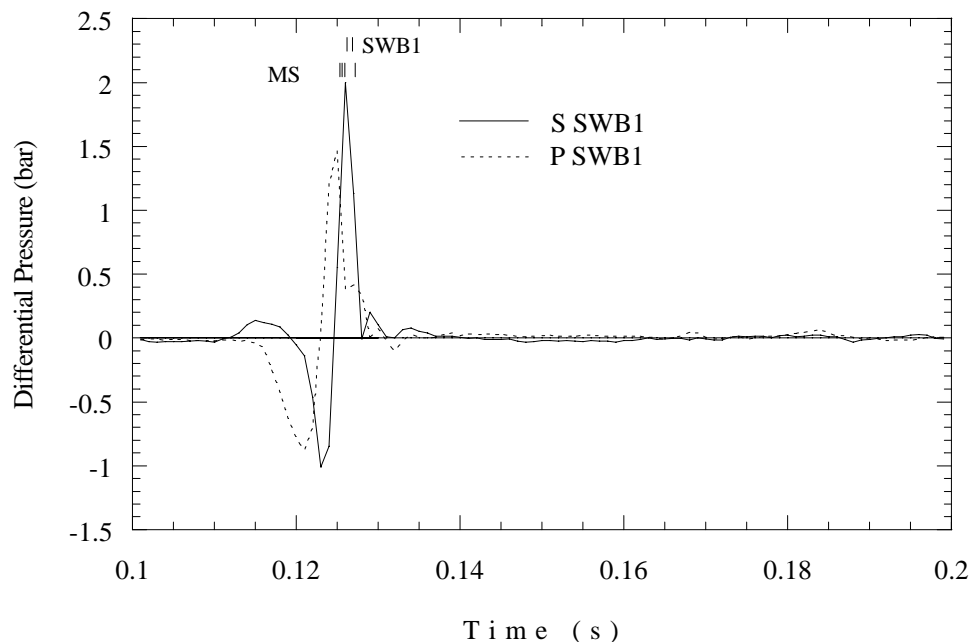
Figure 5.124: Differential pressure across SWB1, ignition in bay 1, with a cold liquid Jet A layer. Test 21.

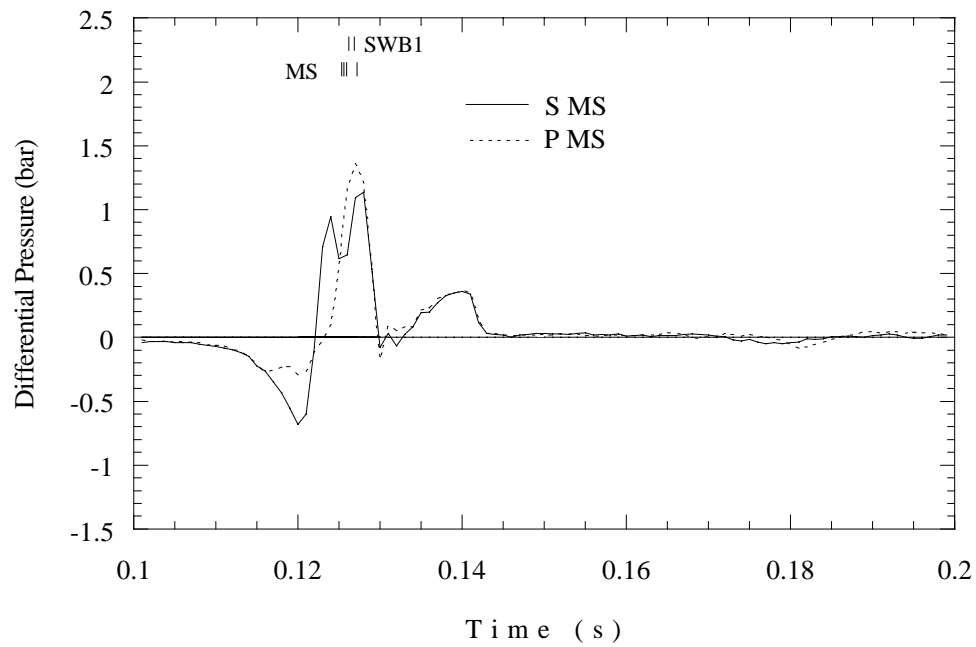
Figure 5.125: Differential pressure across MS, ignition in bay 1, with a cold liquid Jet A layer. Test 21.

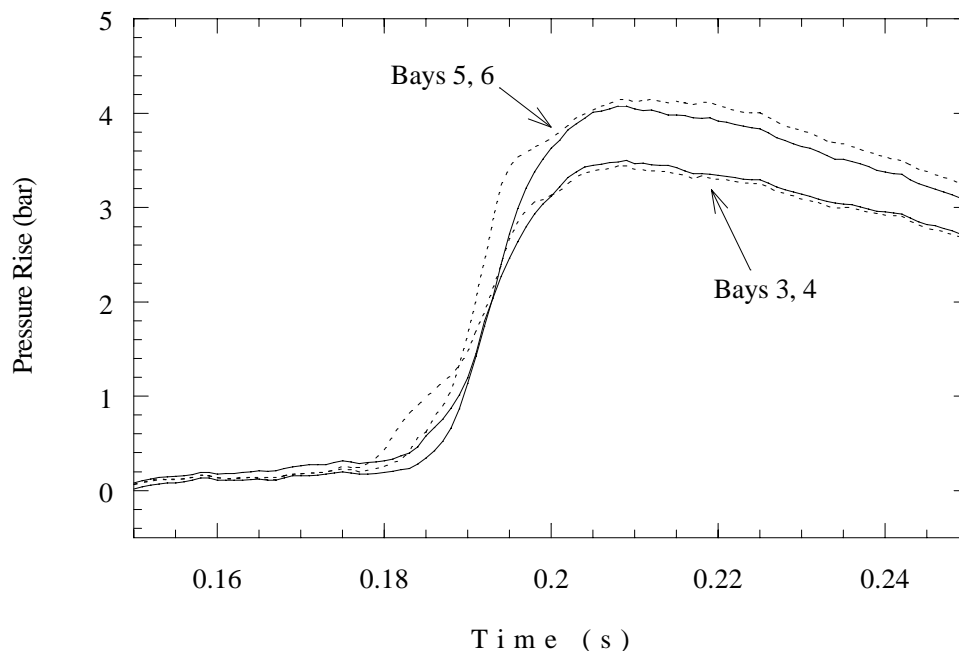
Figure 5.130: Pressure traces for bays 3 – 6, 8.4% fuel, ignition in 2Lo. Dashed lines indicate even-numbered bays. Early liftoff is in bay 4, late liftoff is in bay 5. Test 22.

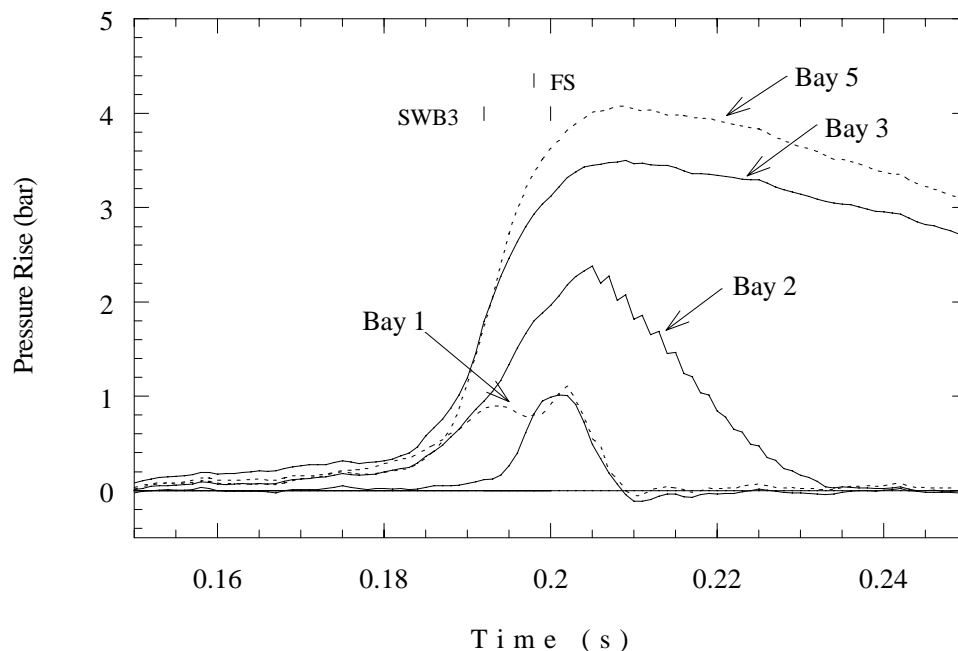
Figure 5.131: Pressure traces for bays 1 – 3, 5, 8.4% fuel. Test 22.

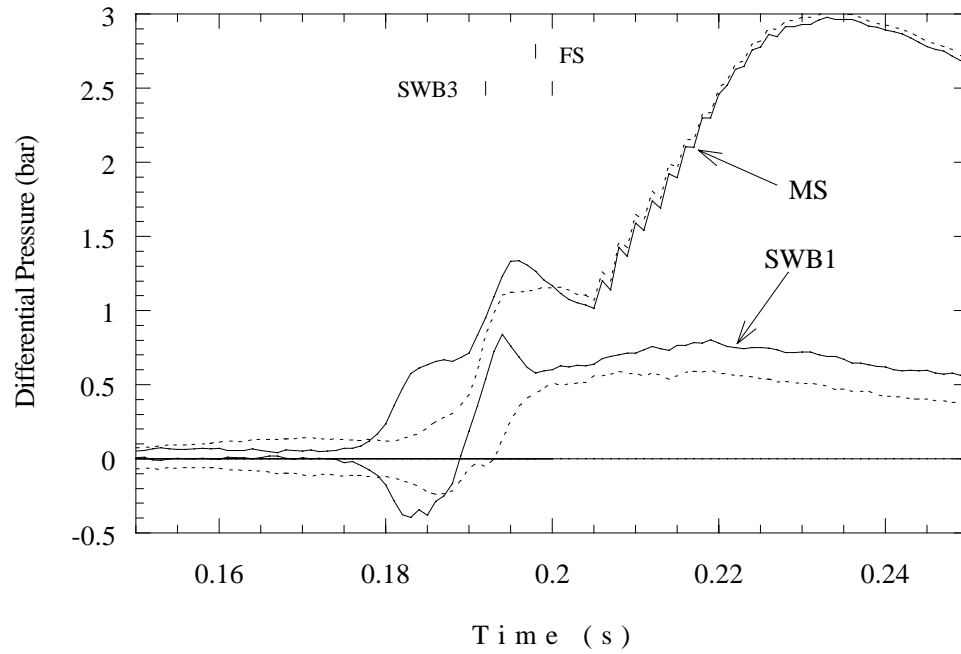
Figure 5.132: Differential pressure across SWB1 and MS, 8.4% fuel. Dashed lines for port side, solid lines for starboard. Test 22.

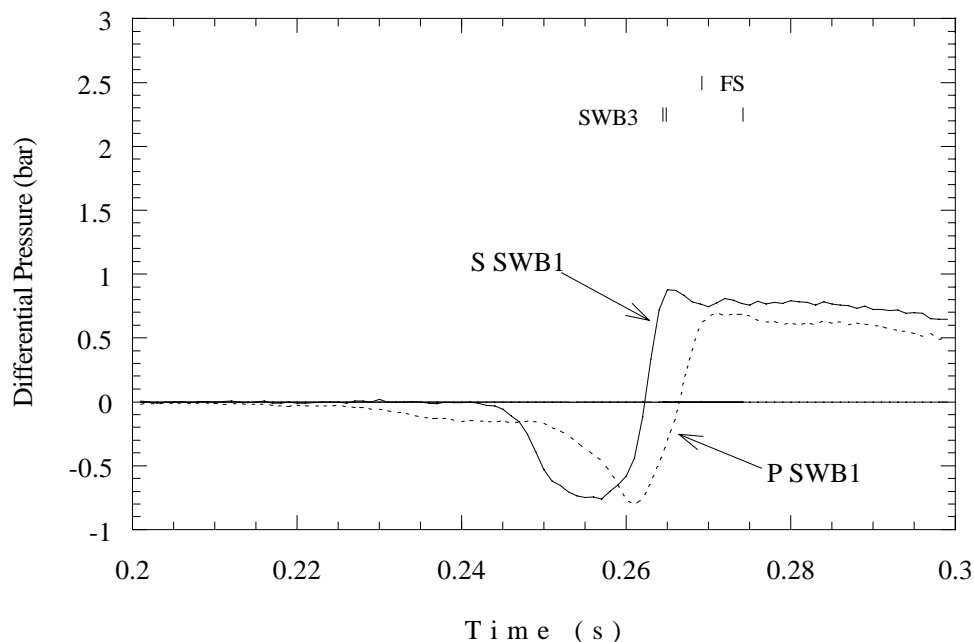
Figure 5.138: Differential pressure across SWB1, 7.5% fuel. Test 23.

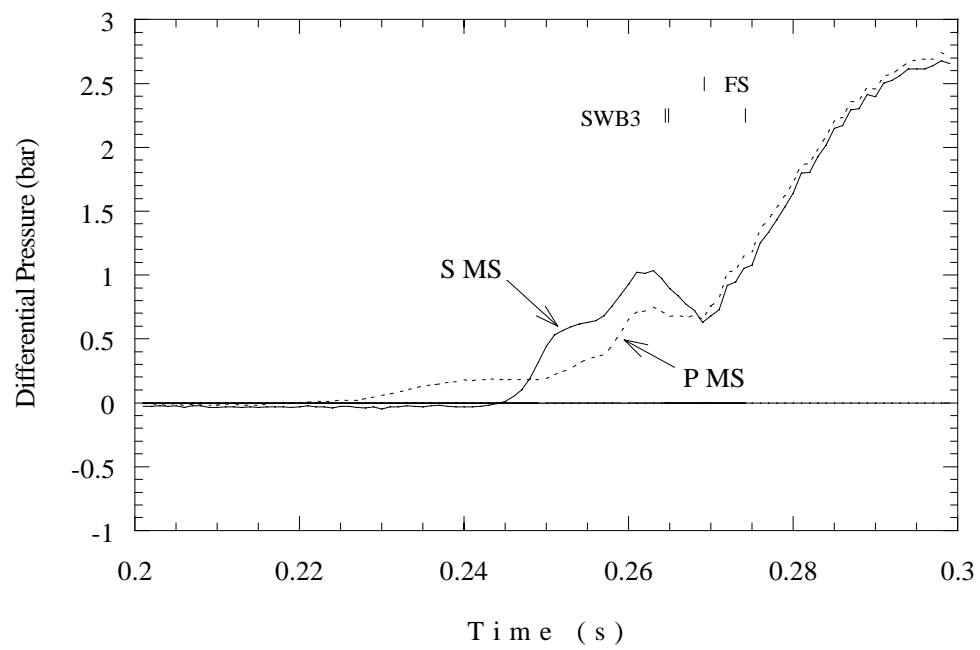
Figure 5.139: Differential pressure across MS, 7.5% fuel. Test 23.

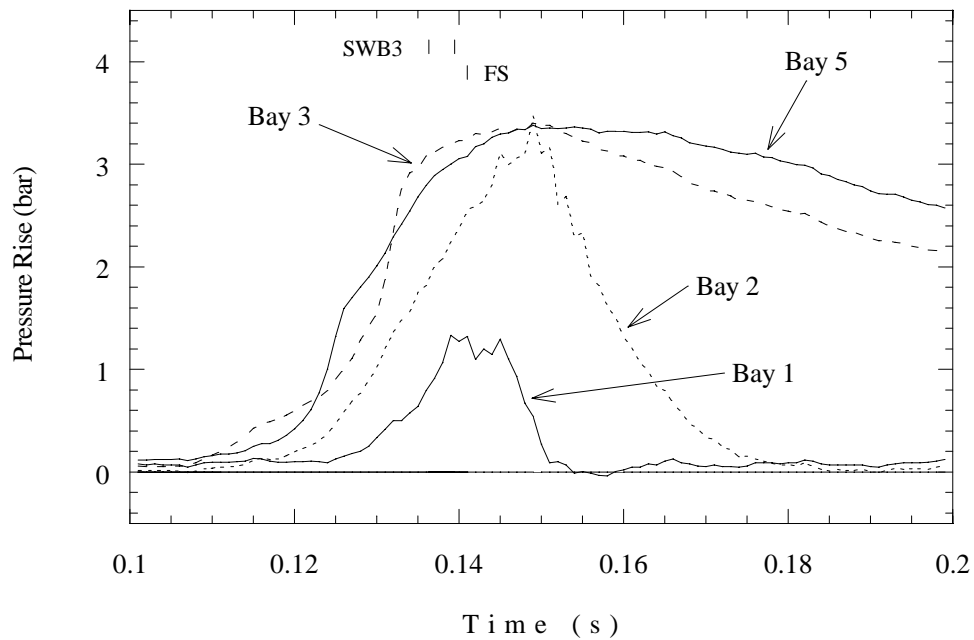
Figure 5.151: Pressure traces from bays 1 – 3, 5, ignition in bay 5. Test 17.

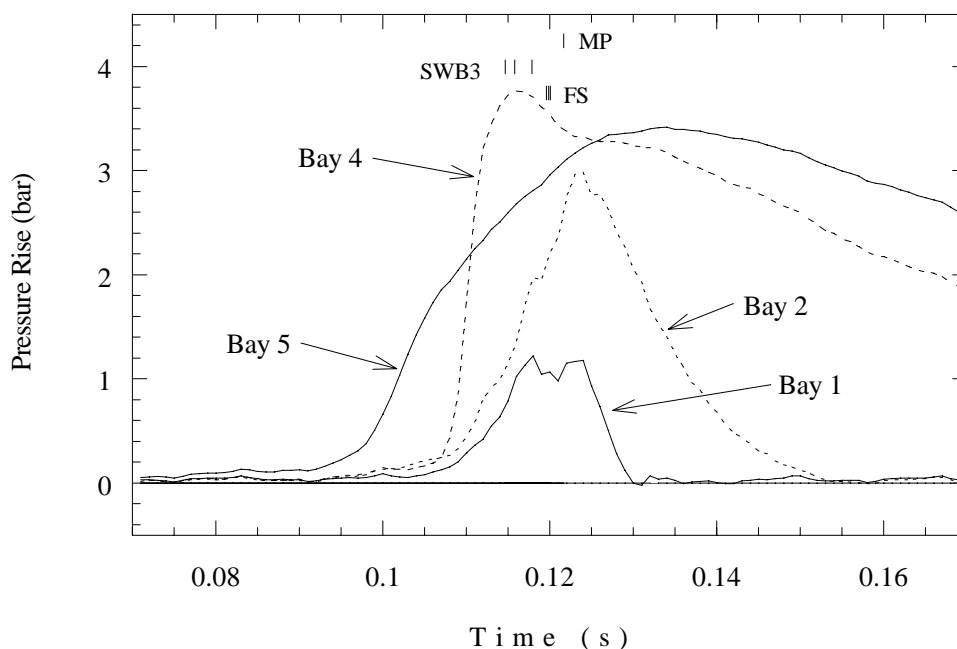
Figure 5.158: Pressure traces from bays 1, 2, 4, 5, ignition in bay 5, layer of cold liquid Jet A. Test 28.

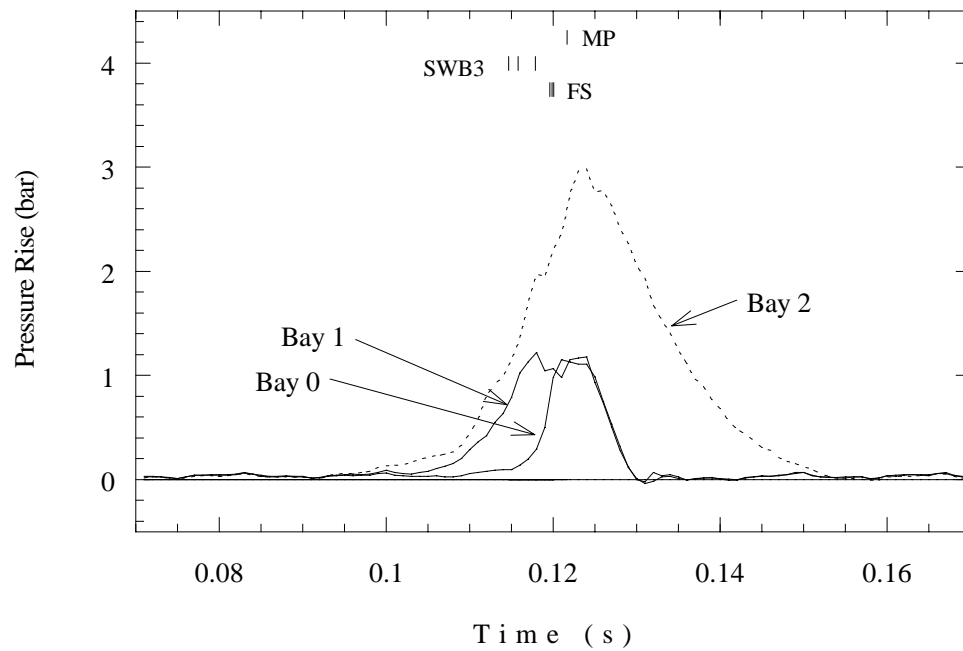
Figure 5.159: Pressure traces from bays 0 – 2, ignition in bay 5, layer of cold liquid Jet A. Test 28.

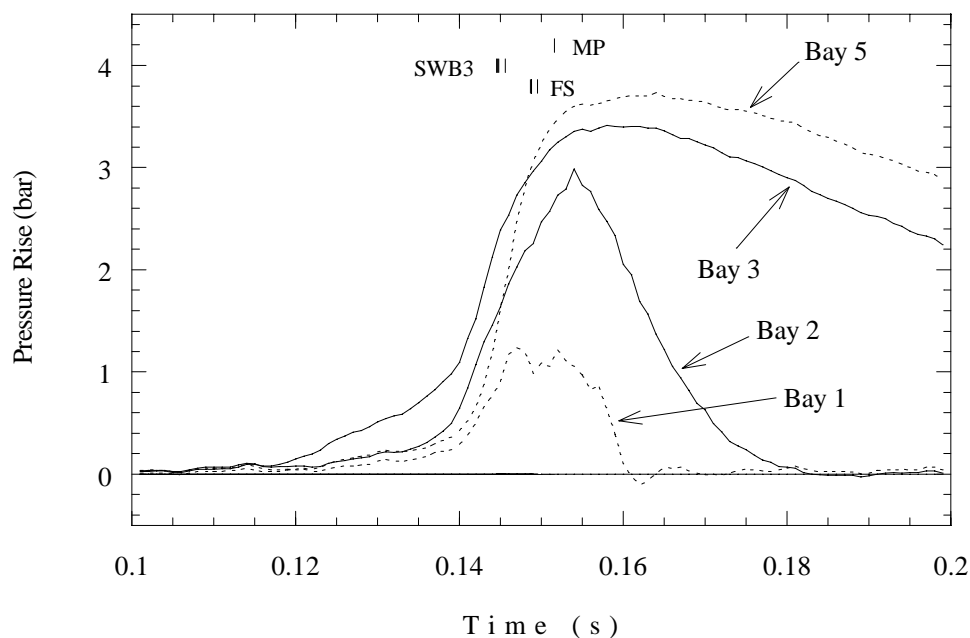
Figure 5.167: Pressure traces from bays 1 – 3, 5, ignition in bay 2Lo, cold liquid Jet A layer. Test 27.

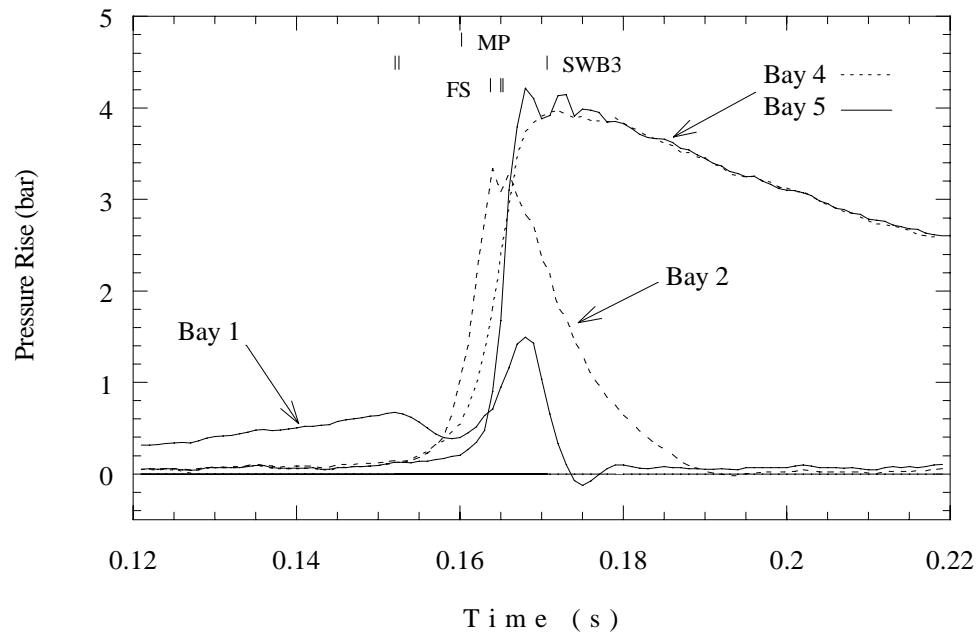
Figure 5.174: Pressure traces from bays 1, 2, 4, 5, ignition in bay 1, cold liquid Jet A layer. Test 29.

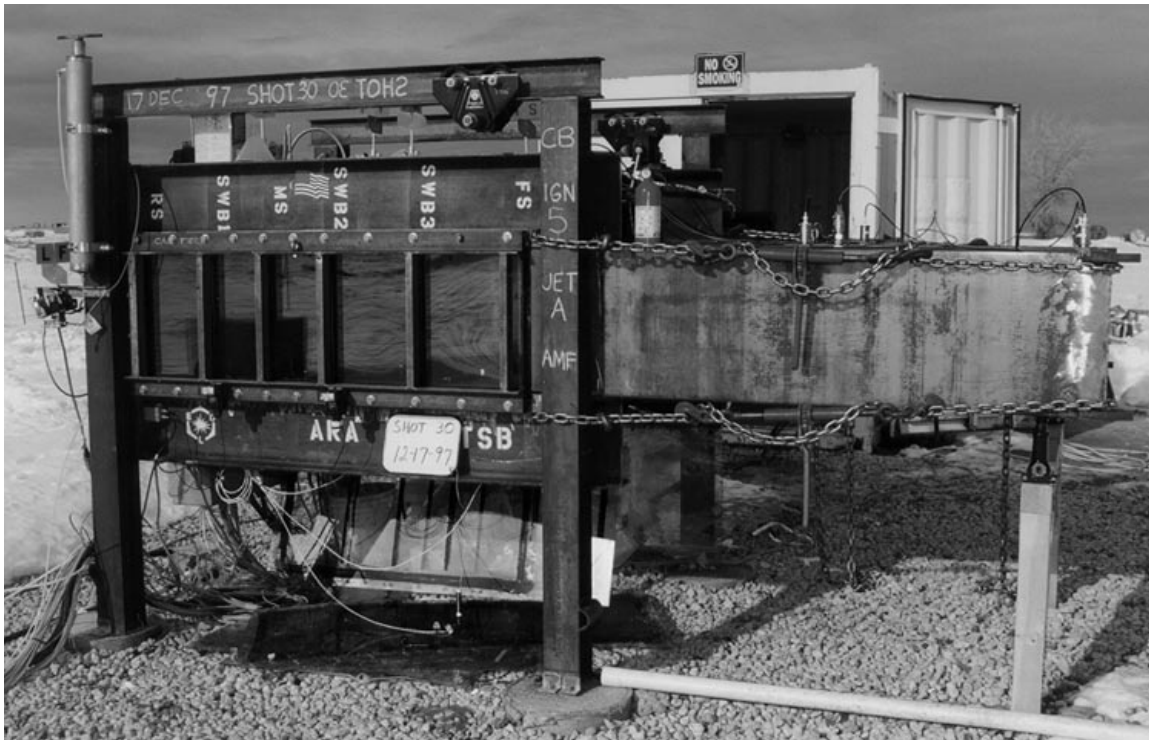
Figure 5.182: Setup of cargo bay for Test 30.

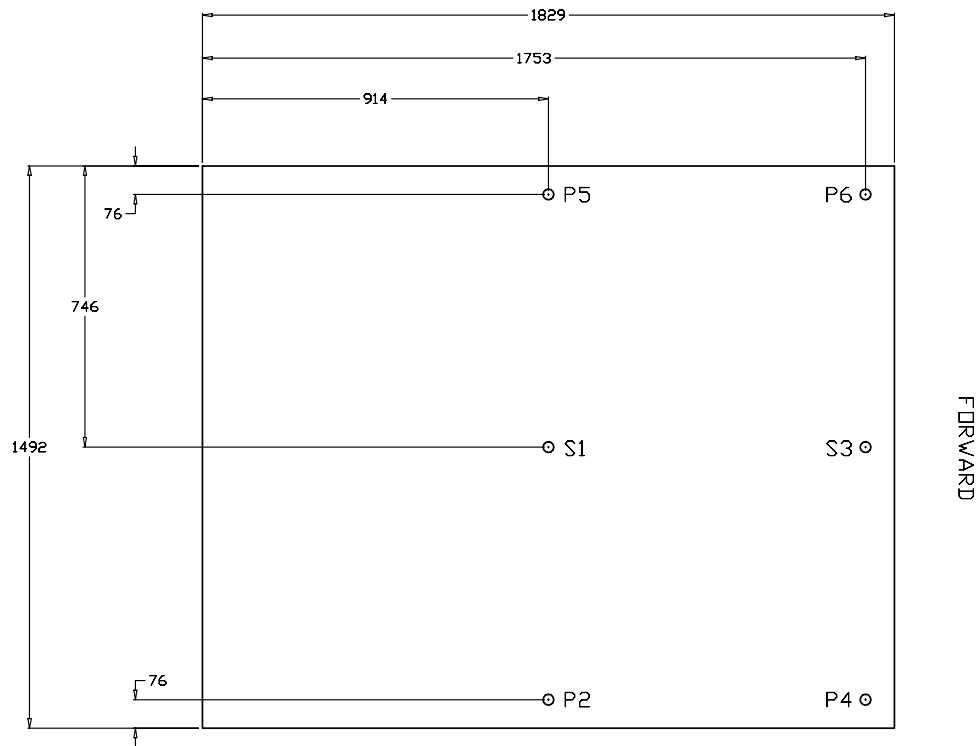
CARGO BAY TRANSDUCER LAYOUT
 TRANSDUCERS IN TOP PLATE
 ALL DIMENSIONS IN mm

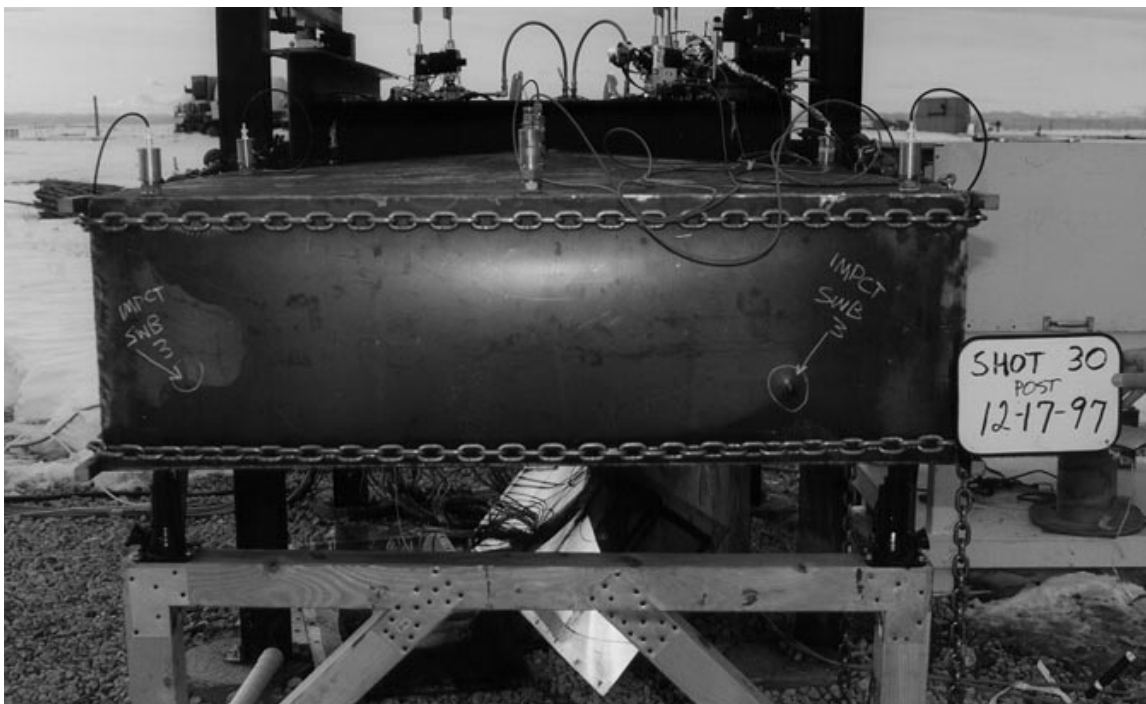
Figure 5.184: End of cargo bay after Test 30. Note that the end plate is bulged, and two dents are present from impact of SWB3. The top and bottom plates of the cargo bay are bulged out approximately 3 in at the centers of the open end.

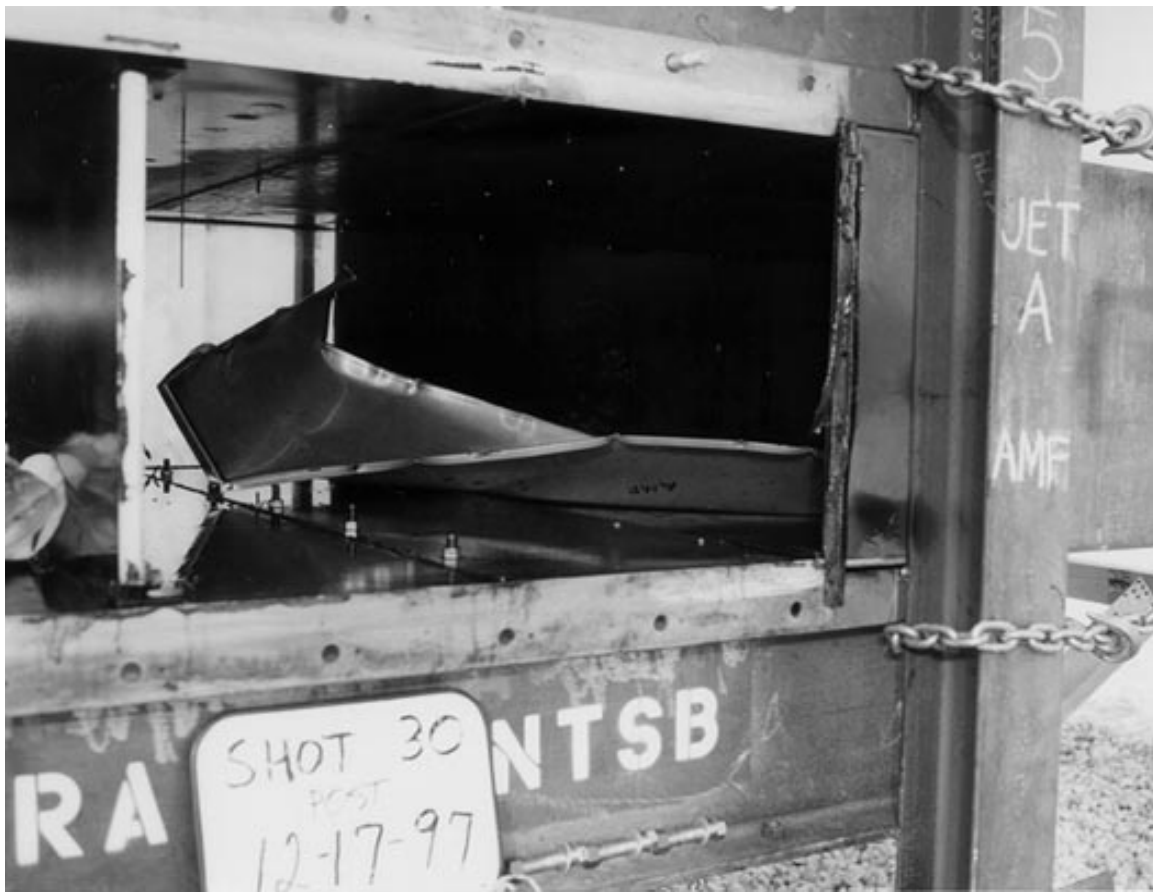
Figure 5.185: Interior of cargo bay after Test 30 (starboard window removed). SWB3 rebounded from the far end and came to rest back in the fuel tank.

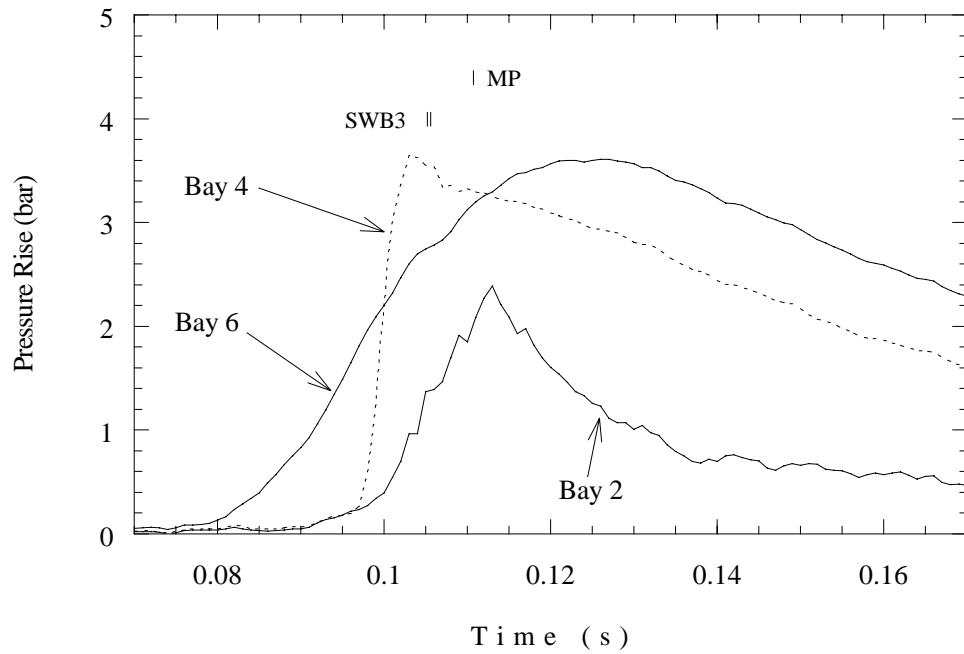
Figure 5.186: Pressure traces from bays 2, 4, 6, cargo bay test. Test 30.

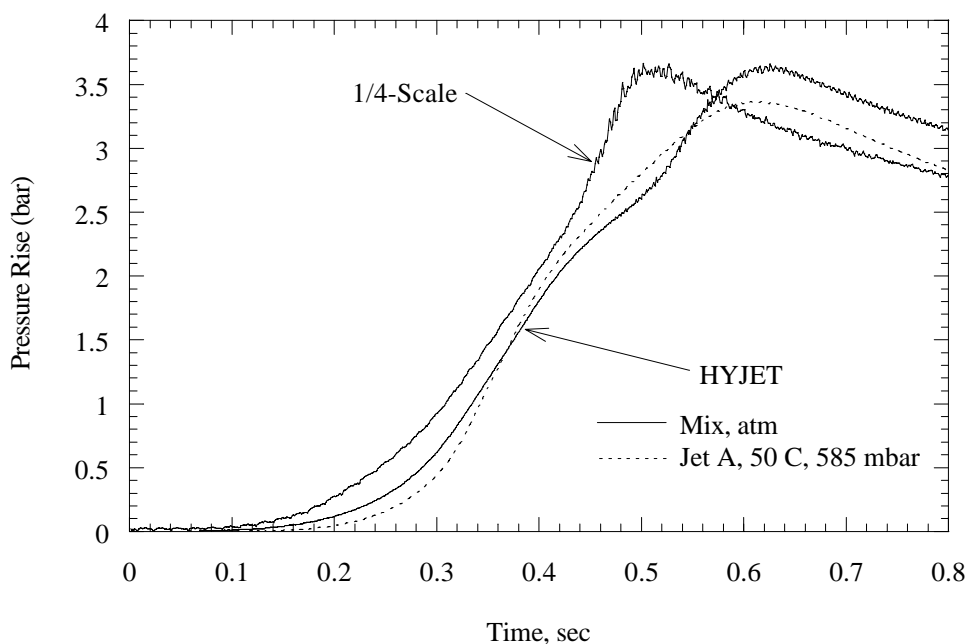
Figure 6.1: Comparison of pressure traces for explosions in the 1/4-scale (1 bay, Test 11) and HYJET facilities. The HYJET simulant test was run at 25°C and 843 mbar (run 484), while the Jet A test was at 50°C and 585 mbar (run 470).

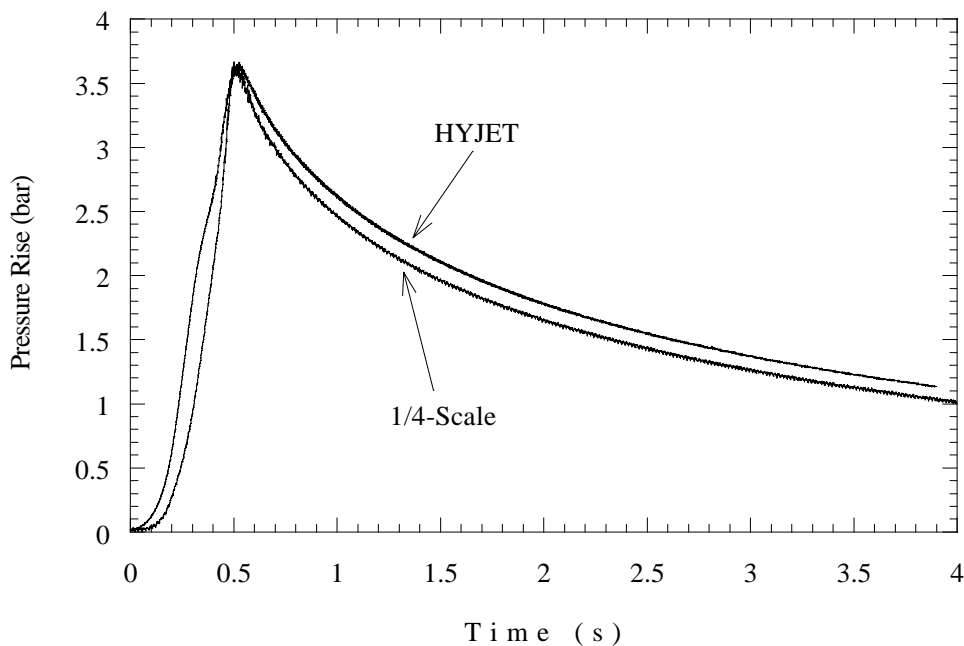
Figure 6.2: Comparison of 1/4-scale and HYJET pressures during the burn and cooldown processes. The trace from HYJET has been shifted to the left by 100 ms in order to compensate for timing differences in the data acquisition systems.

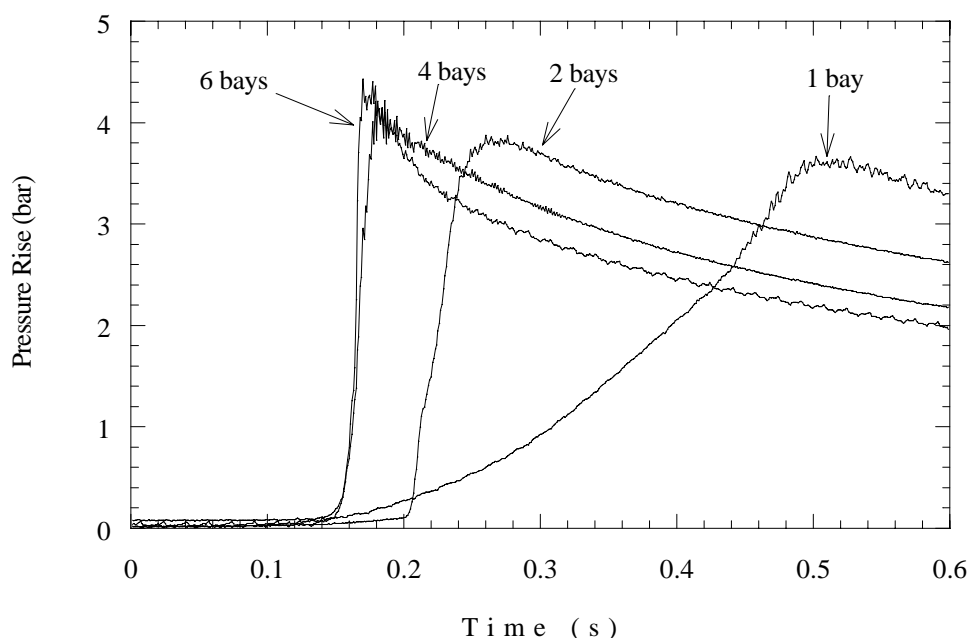
Figure 6.5: Effect of number of bays on pressure history. For each configuration, the bay with the highest peak pressure was chosen to represent the configuration.

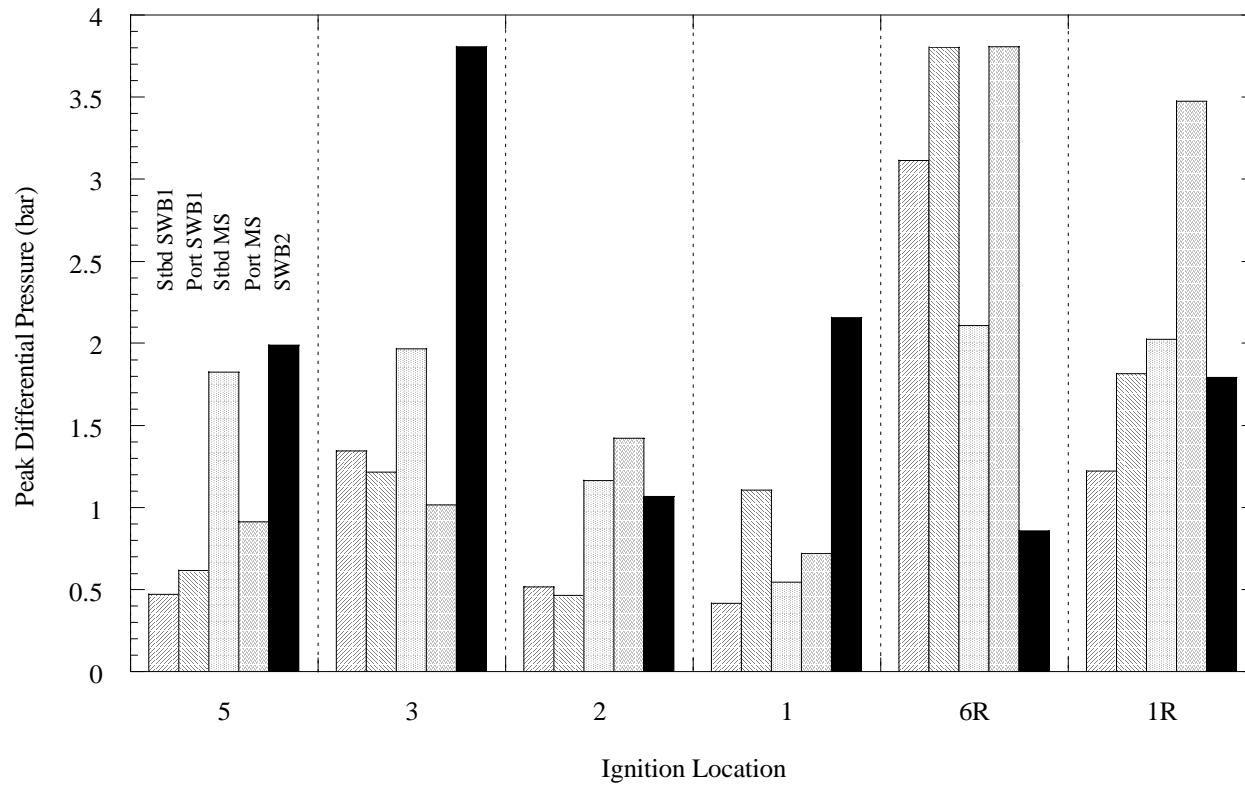
Figure 6.9: Comparison of differential pressures for ignition locations used in the all-strong configuration (BETA series Tests 5, 6, 7, 15, 16). Only the positive peak values are shown here, see the data in Appendix B for tabulated positive and negative peak values.

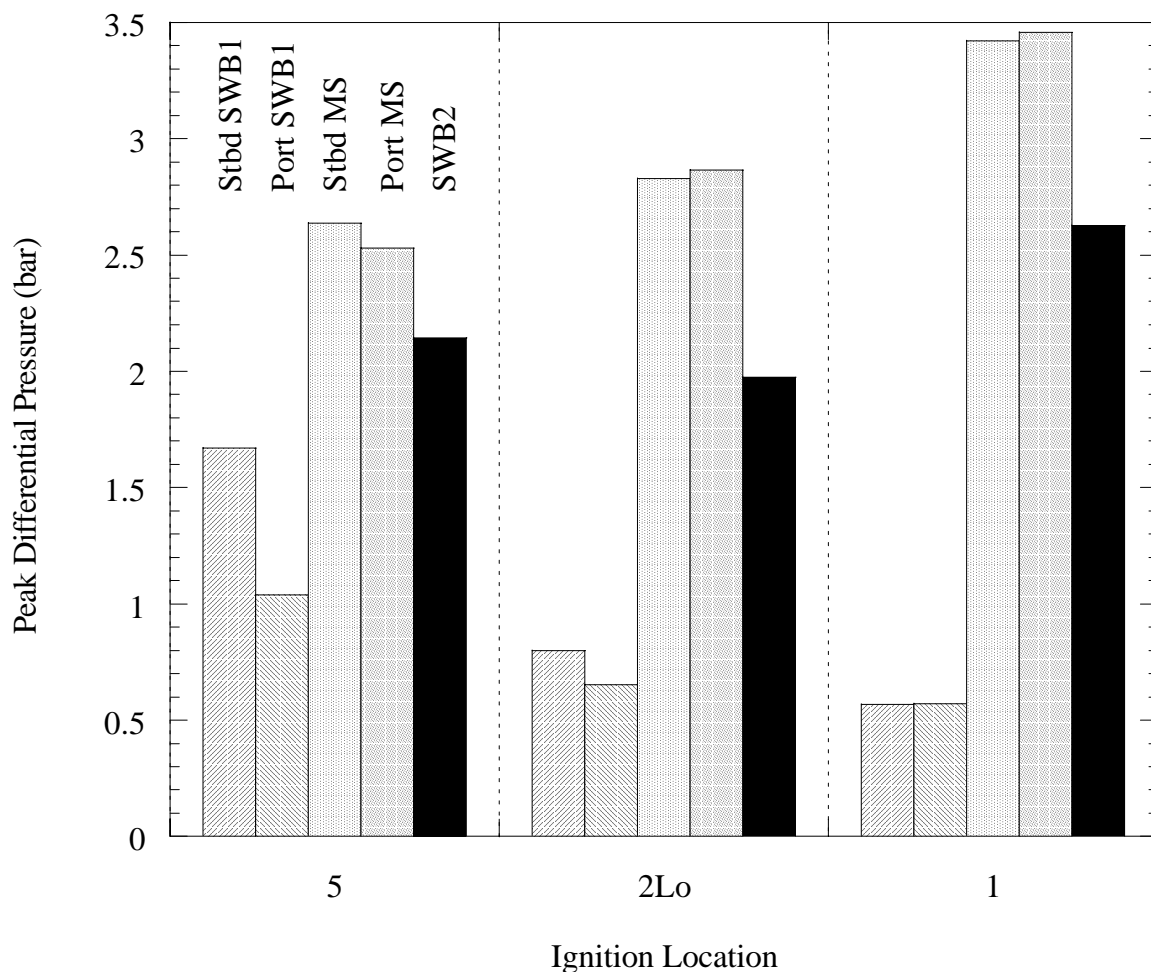
Figure 6.20: Comparison of peak differential pressures for different ignition locations in part-strong configuration (Tests 27, 28, and 29). Only the positive peak values are shown here, see the data in Appendix B for tabulated positive and negative peak values.

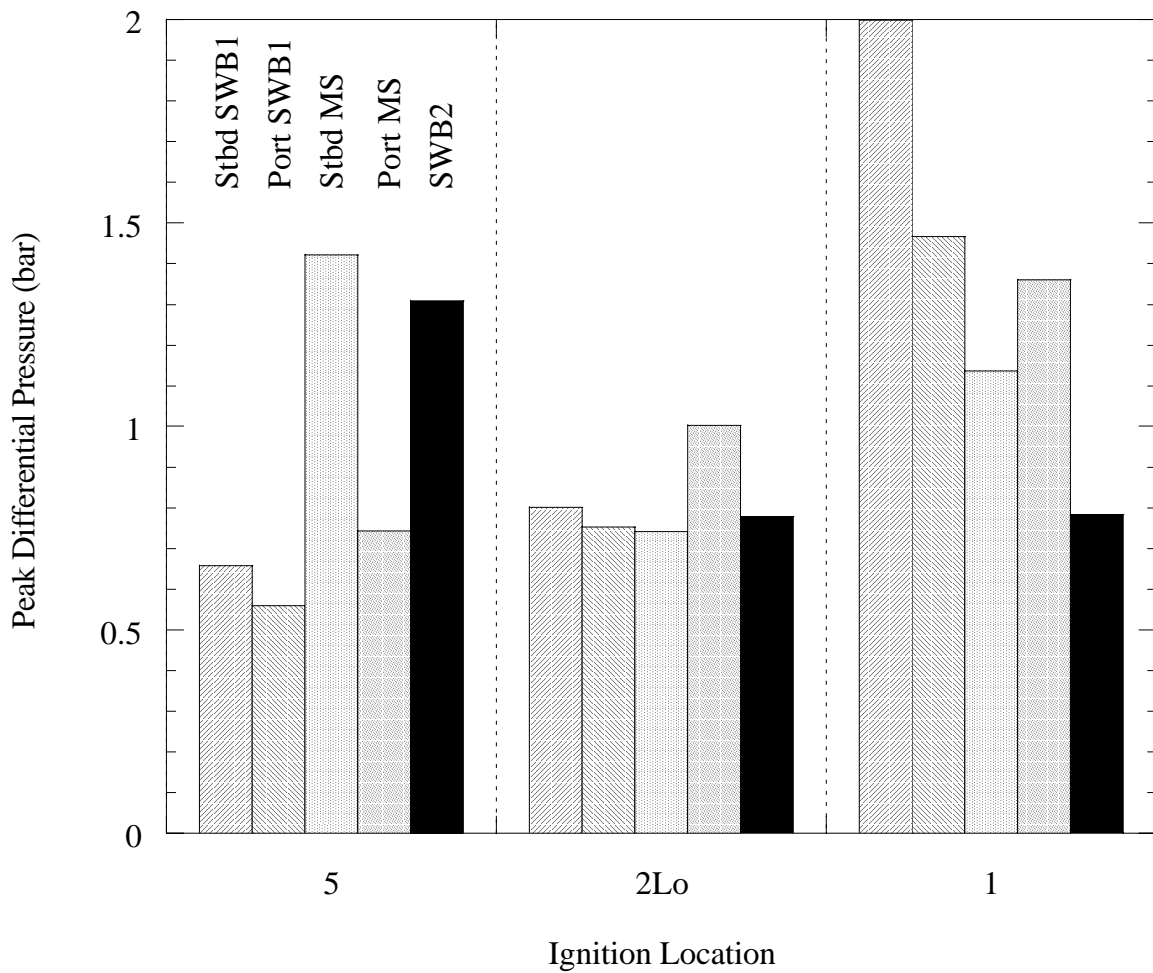
Figure 6.26: Comparison of peak differential pressures for different ignition locations in all-weak configuration (Tests 19, 20, and 21). Only the positive peak values are shown here, see the data in Appendix B for tabulated positive and negative peak values.

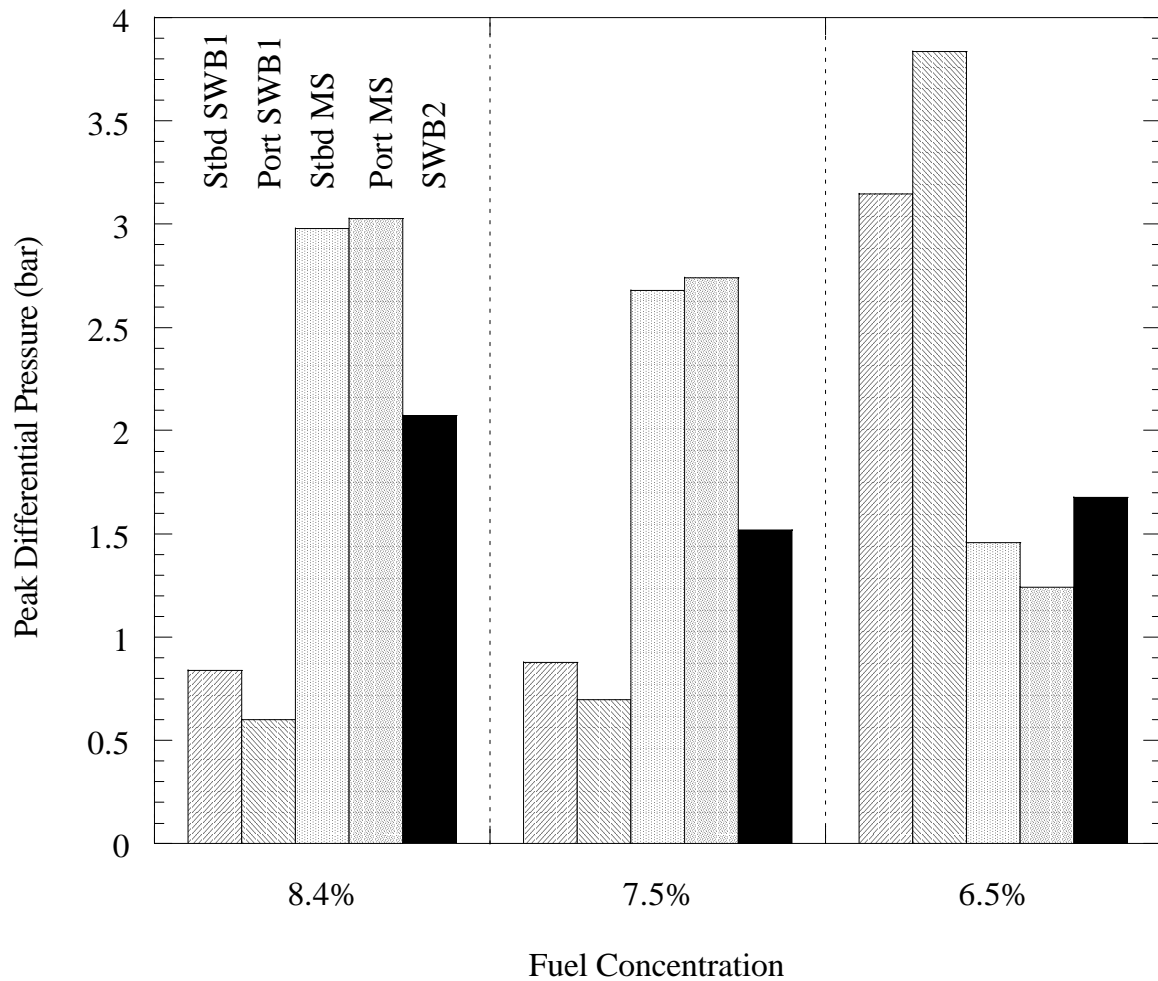
Figure 6.31: Comparison of peak differential pressures for fuel concentrations of 8.4% (Test 22), 7.5% (Test 23), and 6.5% (Test 24). Only the positive peak values are shown here, see the data in Appendix B for tabulated positive and negative peak values.

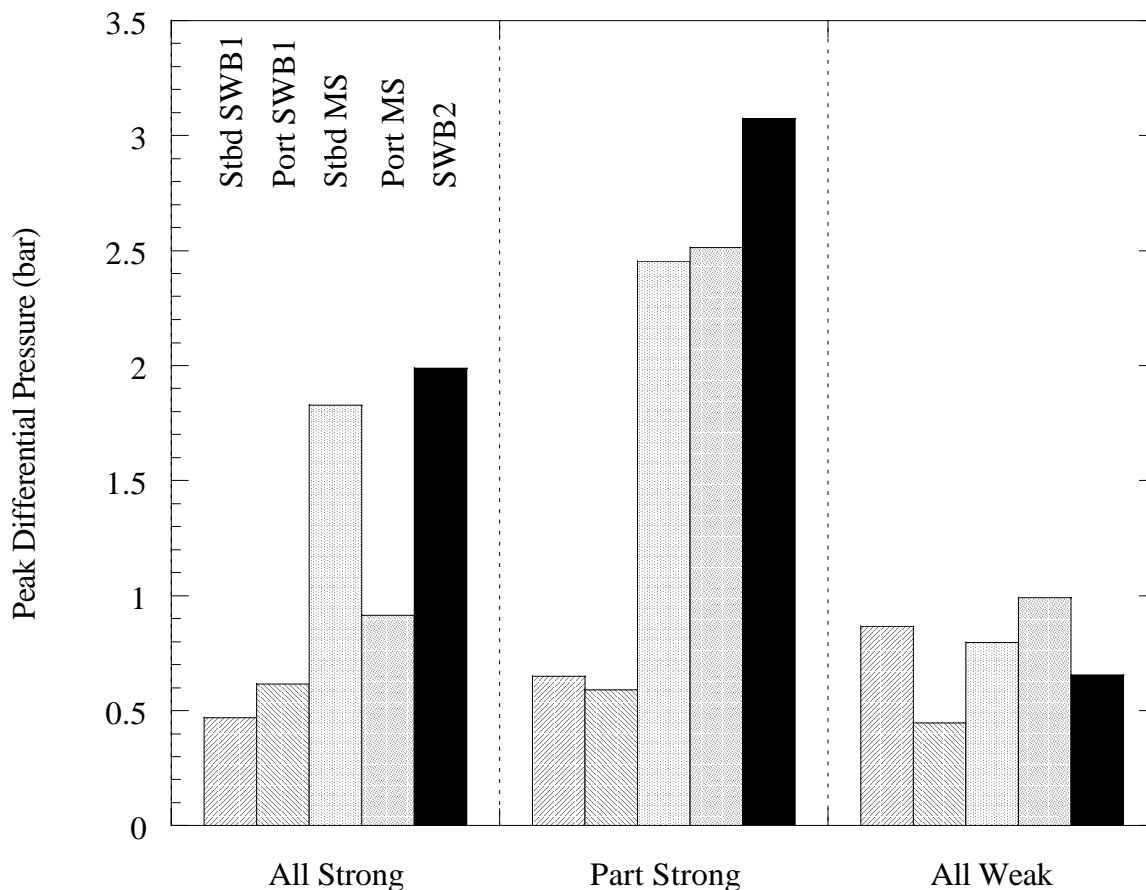
Figure 6.37: Comparison of peak differential pressures for different structural configurations, Test 4 (all-strong), Test 17 (part-strong), and Test 18 (all-weak). Ignition in bay 5 for all tests. Only the positive peak values are shown here, see the data in Appendix B for tabulated positive and negative peak values.

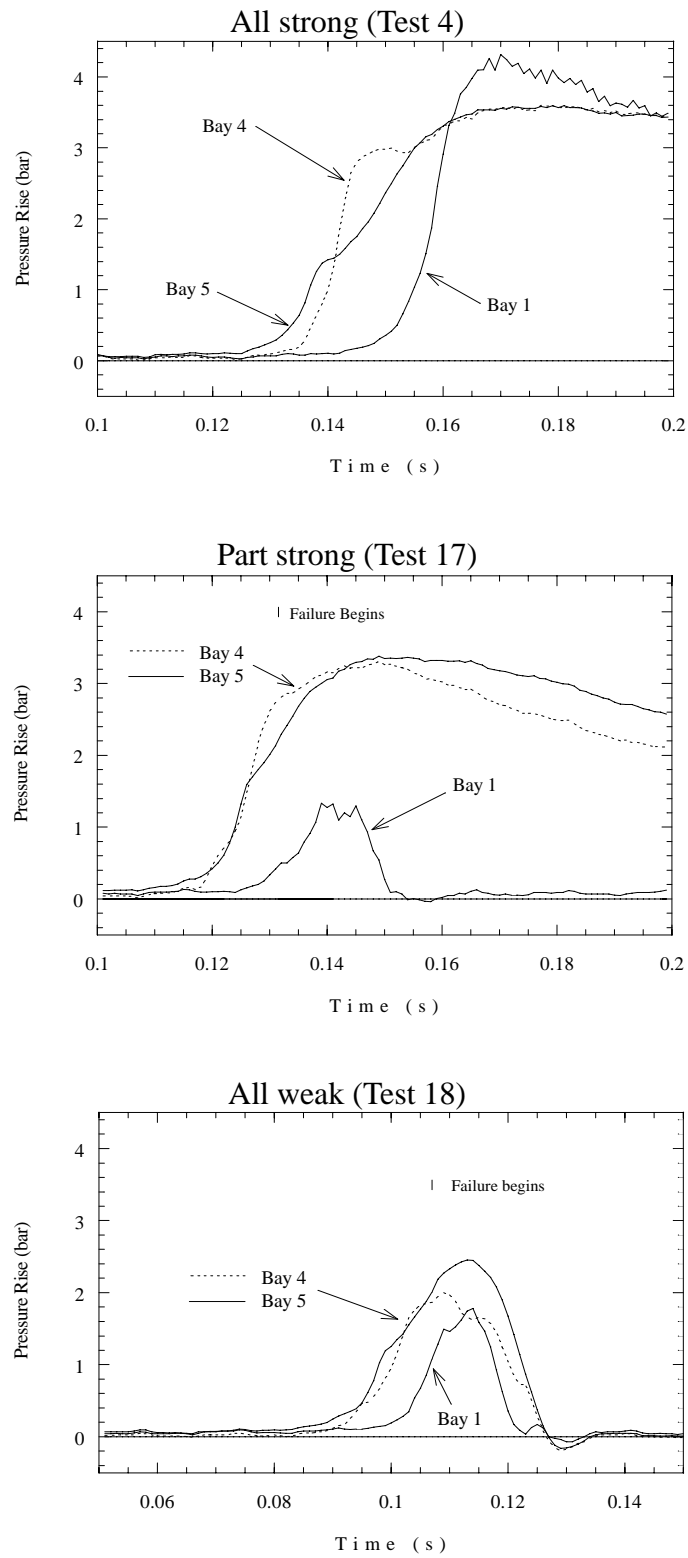
Figure 6.38: Pressure traces for three structural configurations, Tests 4, 17, and 18. Ignition in bay 5 for all tests.

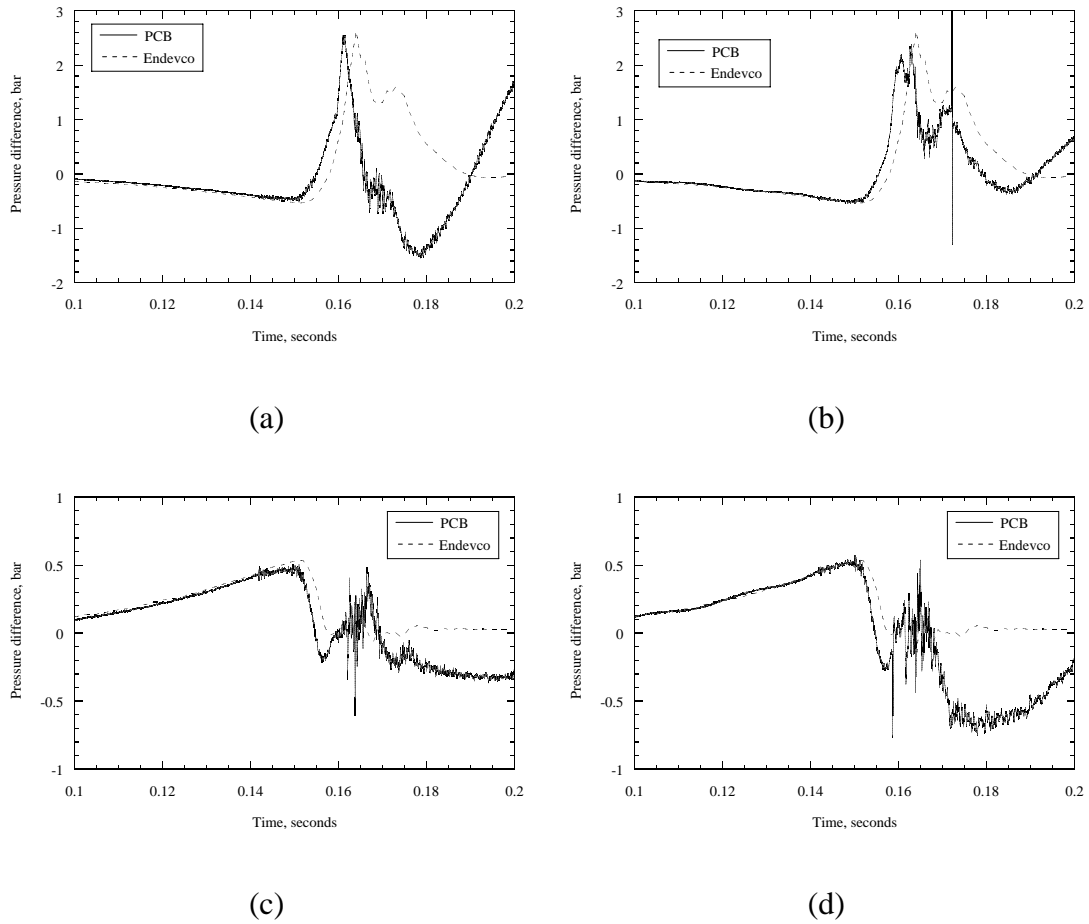
Figure 7.7: Pressure differentials obtained from static (Endevco) and dynamic (PCB) signals for Test 29 between bays 1 and 2 on the (a) port side and (b) the starboard side; and also between bays 0 and 1 on the (c) port side and (d) the starboard side.
