Results of 1/4-Scale Experiments.
Vapor Simulant And Liquid Jet A Tests

17 July 1998 **Revised January 28, 2000**
Explosion Dynamics Laboratory Report FM98-6

A quarter-scale engineering model of the center wing tank (CWT) of a 747-100 was constructed. This engineering model replicated the compartmentalization, passageways, and venting to the atmosphere. The model was designed to scale the fluid dynamical and combustion aspects of the explosion, not the structural failure of the beams or spars. The effect of structural failure on combustion was examined by using model beams and spars with deliberately engineered weak connections to the main tank structure. The model was filled with a simulant fuel (a mixture of propane and hydrogen) and ignited with a hot wire. The simulant fuel was chosen on the basis of laboratory testing to model the combustion characteristics (pressure rise and flame speed) of Jet A vapor created by a Jet A liquid layer at 50°C at an altitude of 13.8 kft.

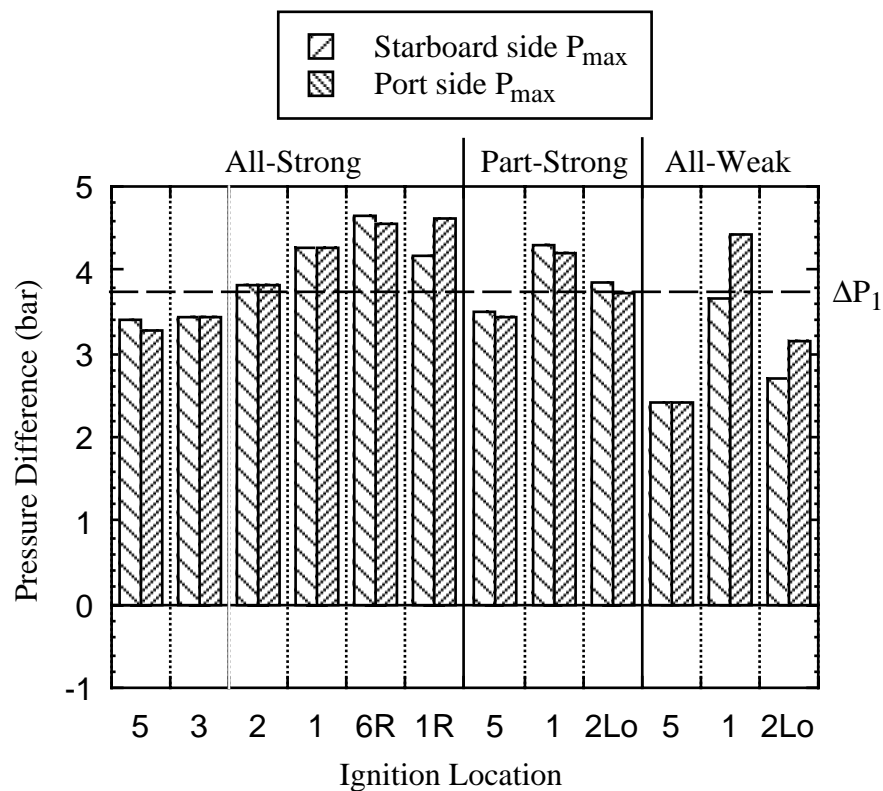
Figure 9.1: Summary of peak differential pressure on RS for selected tests given in Table 9.1.

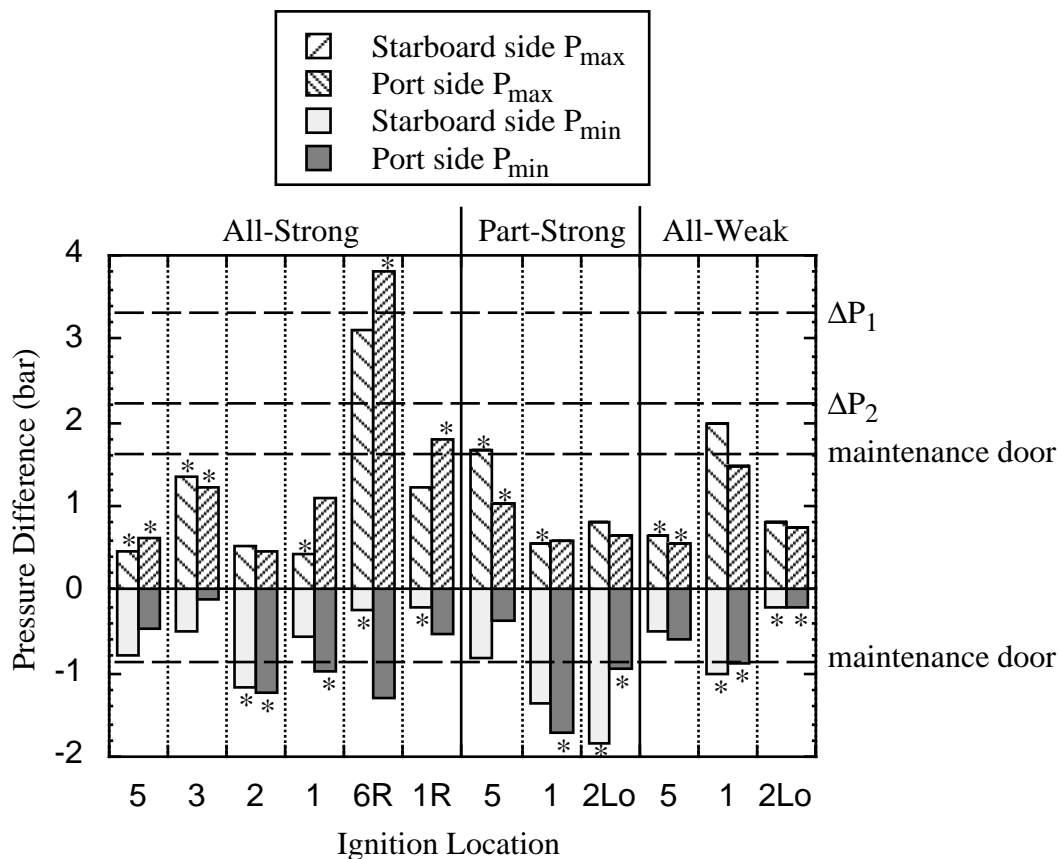
Figure 9.2: Summary of peak differential pressure on SWB1 for selected tests given in Table 9.1. The pressure peak that occurred first is indicated by an asterisk.

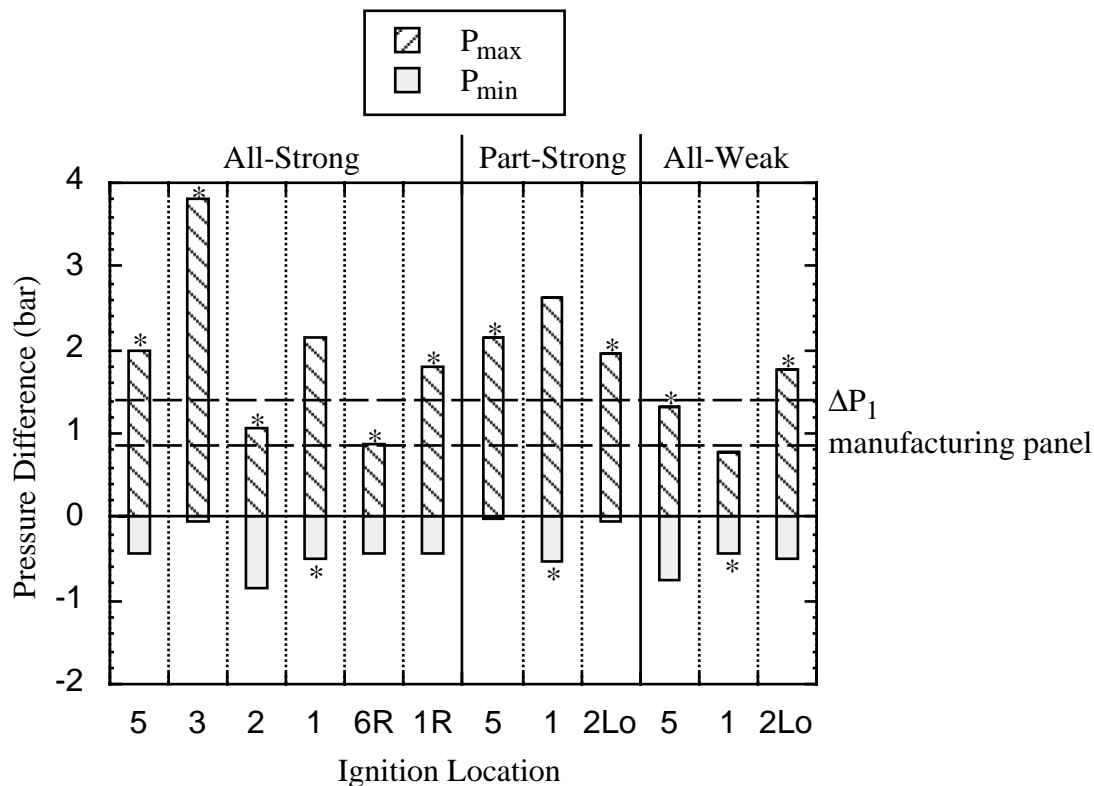
Figure 9.4: Summary of peak differential pressure on SWB2 for selected tests given in Table 9.1. The pressure peak that occurred first is indicated by an asterisk.

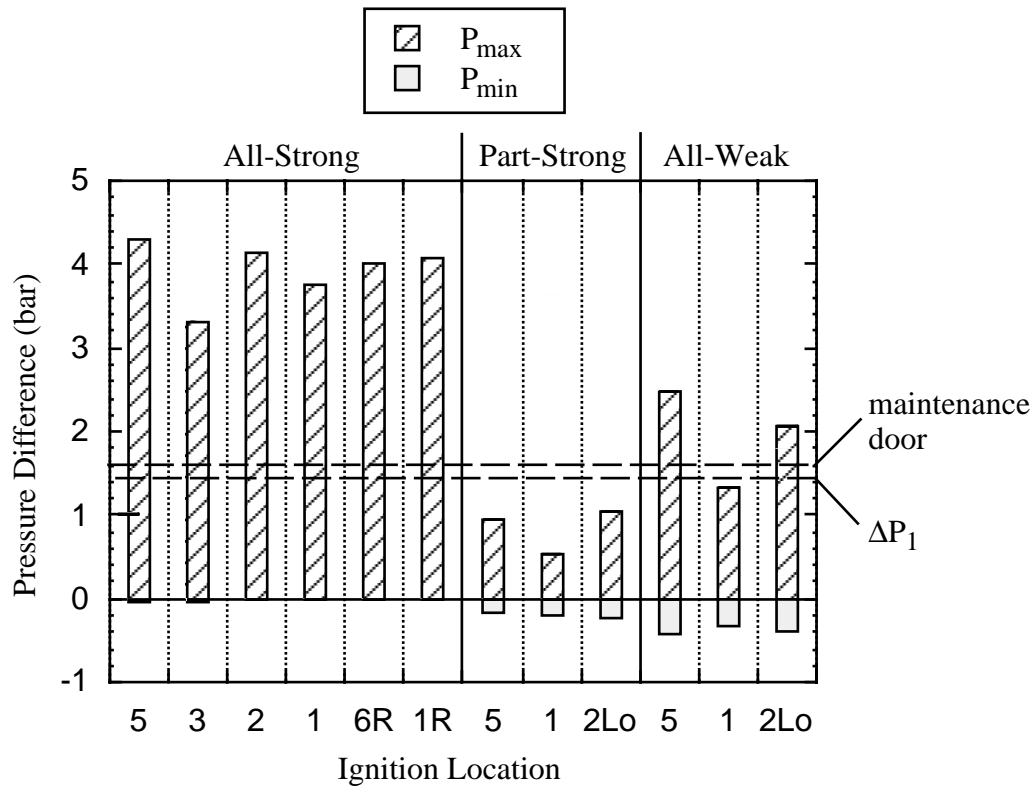
Figure 9.5: Summary of peak differential pressure on SWB3 for selected tests given in Table 9.1.
