CALIFORNIA INSTITUTE OF TECHNOLOGY

EARTHQUAKE RESEARCH LABORATORY

Response of a Structure
to an Explosive-Generated Ground Shock

THIRD TECHNICAL REPORT

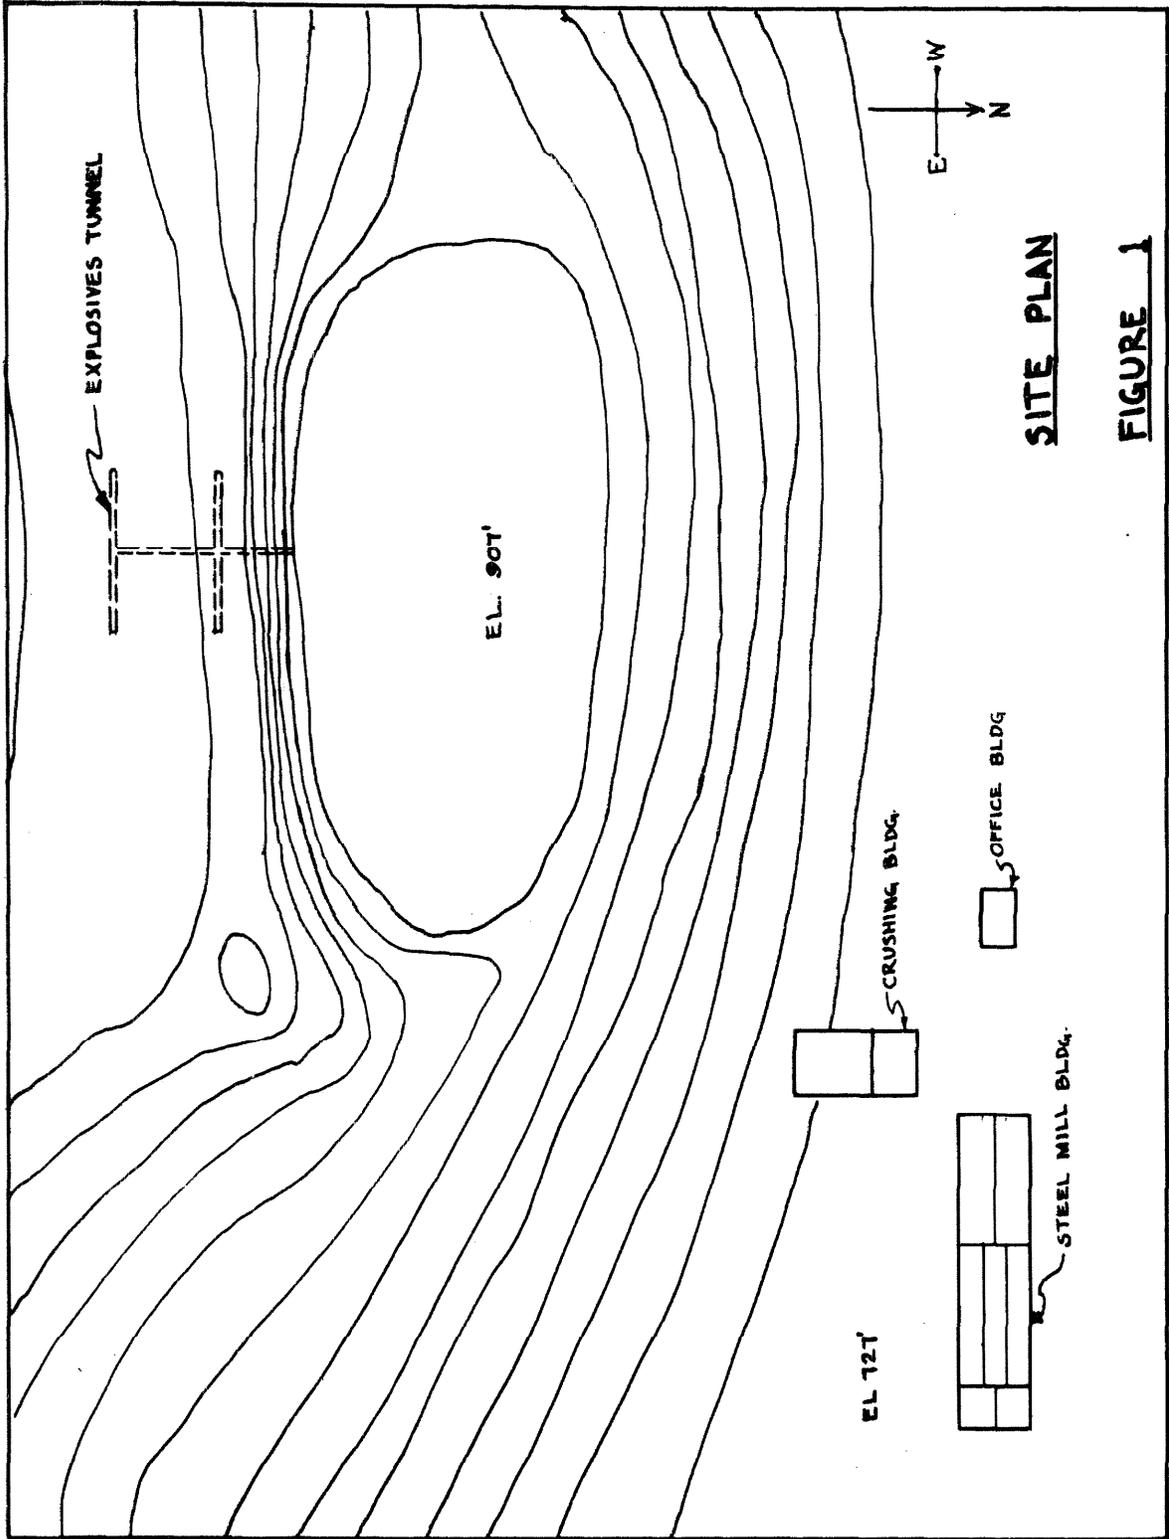
FIGURE 1

SITE PLAN

The quarry operated by the Minnesota Mining and Manufacturing Company, at which the explosive was detonated, is located approximately five miles south of the town of Corona, California. The site of the quarry is in a canyon between low hills from one of which the rock is quarried. Figure 1 shows the topography of the quarry site and the location of the mill building in which measurements were made. The building is at the eastern end of the quarry grounds and the measuring instruments that were used were located at the eastern end of the building. The structure stands on the flat bottom of the canyon and the explosive charge was detonated at a horizontal distance of 370 yards from the east end of the building and 60 yards above the elevation of the ground upon which the building stands. Figure 2 shows the relation between the end of the building where the measuring instruments were located and the point on the hillside where the explosives were detonated. It is seen from this figure that because of the difference in elevation the shortest distance through the ground from the point of the explosion to the point where the measurements were made was not a straight line.

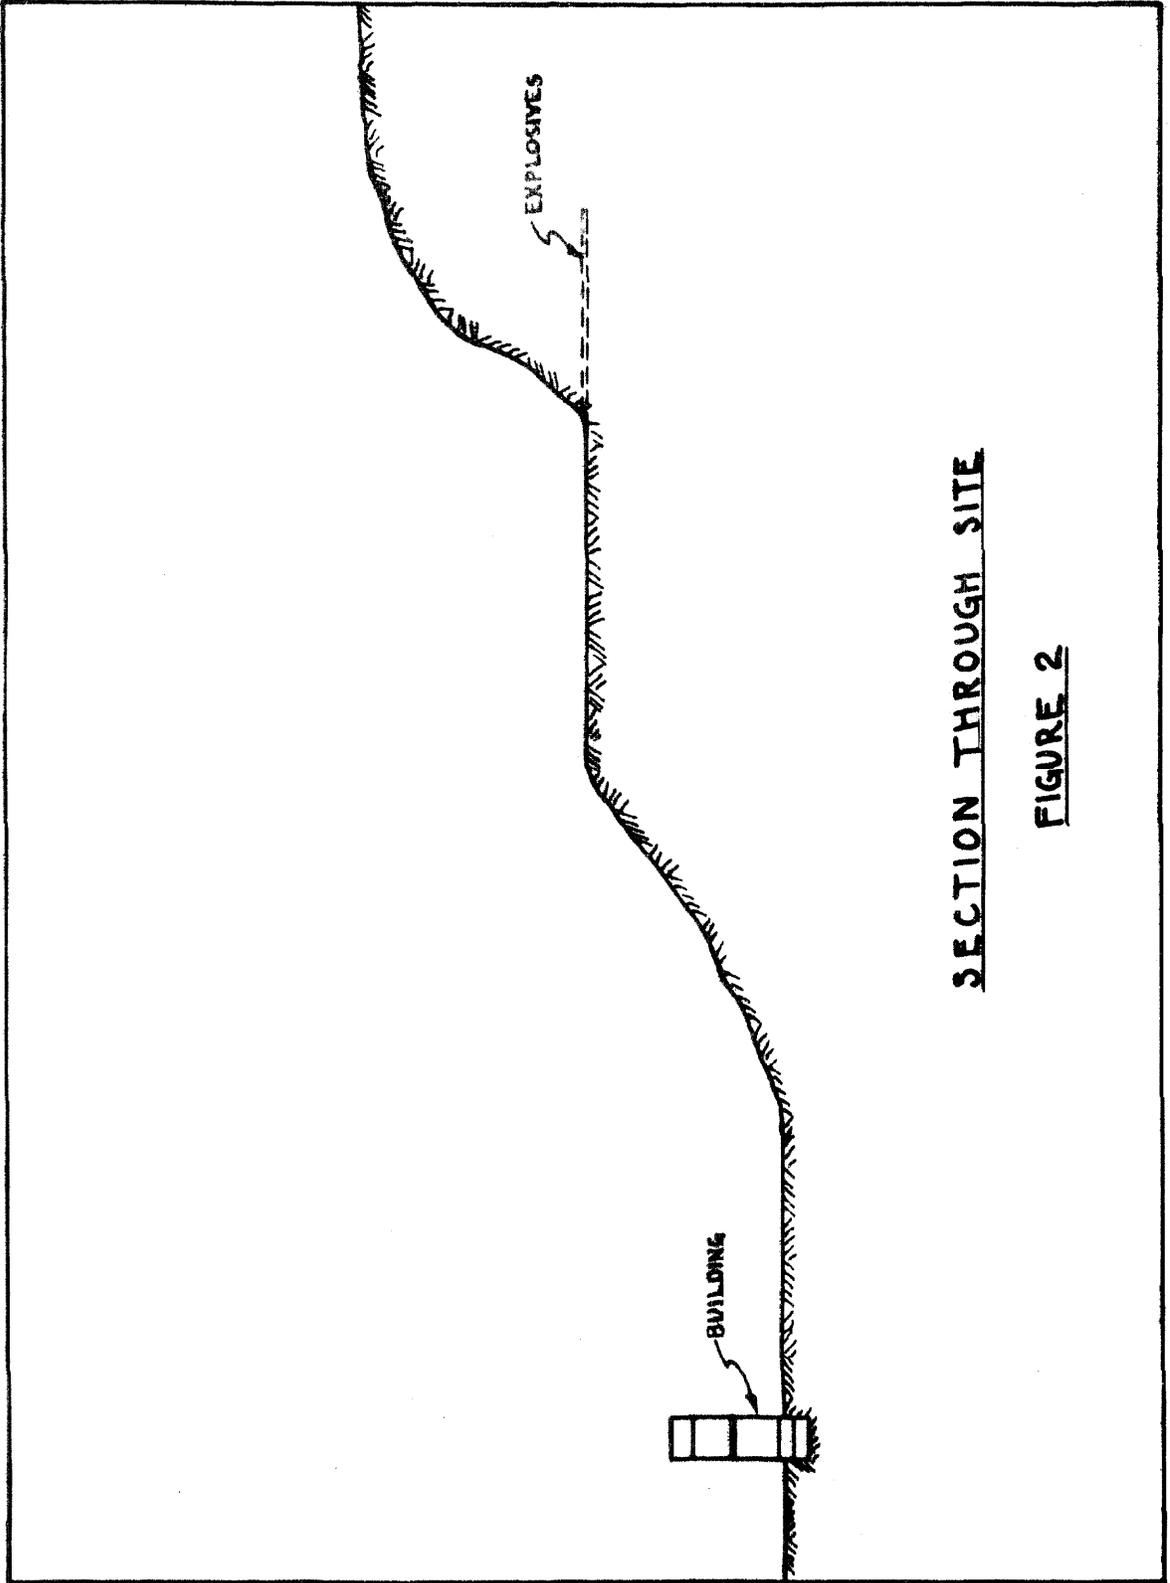
FIGURE 2

SECTION THROUGH SITE

In preparation for the blast a horizontal shaft approximately five feet in diameter was driven into the side of the hill approximately 170 feet with lateral galleries extending from it. The explosive, 370,000 pounds of Nitramon plus 1500 pounds of Primer, was placed in the shafts and back-filled to give a tamped explosion. The explosion worked as planned, slightly lifting and moving out a portion of the hill with no scattering of rocks.

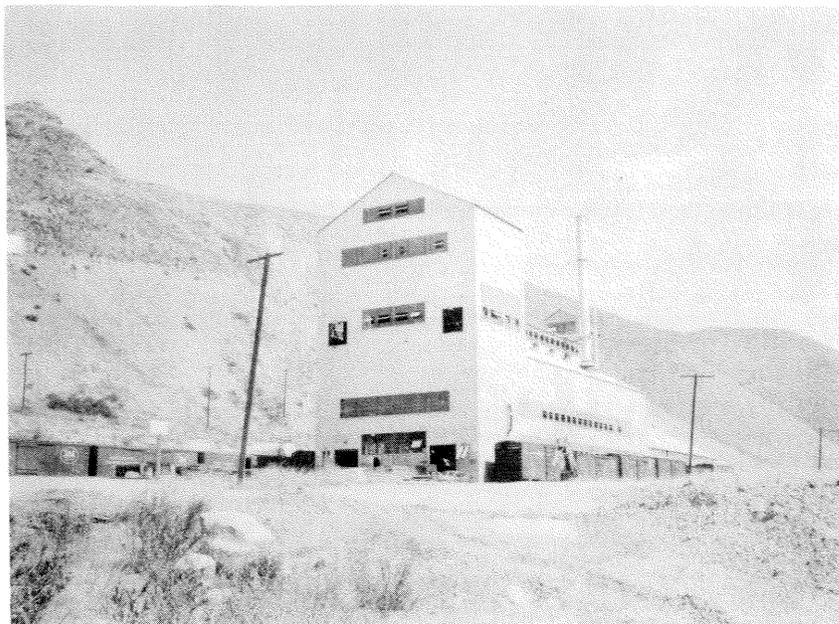
Figure 3. Looking west at steel-frame mill building. Explosion occurred at face of hill just left of upper part of building.

The building in which the measurements were made is a steel-frame mill building constructed in 1947. It has corrugated iron siding and roofing and its plan dimensions are 65 feet by 285 feet. A photograph of the building is shown in Figure 3, looking west. The face of the hill where the explosives were detonated is visible just to the left of the building. The east end of the building is taller than the west end which is a typical one-story mill building. Details of the framing of the one-story portion are shown in Figure 4. The east end of the building has plan dimensions of 65 feet by 37 feet. The overall height of this portion of the building is 103 feet above the ground floor. At an elevation of 45' - 8" above the ground floor there is a 6" thick concrete floor slab (65' x 37'). This floor slab is at approximately the same elevation as the roof of the one-story portion so that the heaviest mass of the building is concentrated at this elevation. Above this floor slab there is the steel wall and roof framing, the corrugated iron siding and roofing, and a steel deck floor at an elevation 84' - 6" above the ground floor. The framing of the east wall is shown in Figure 5. The ground floor of the building is an 8" reinforced concrete slab. There is a single basement beneath the one-story portion of the building and a double basement beneath the east end of the building, with 18" thick reinforced concrete walls. The sub-surface structure of the building thus is essentially a concrete box upon which the steel frame building is standing. A plan of the building is shown in Figure 6.

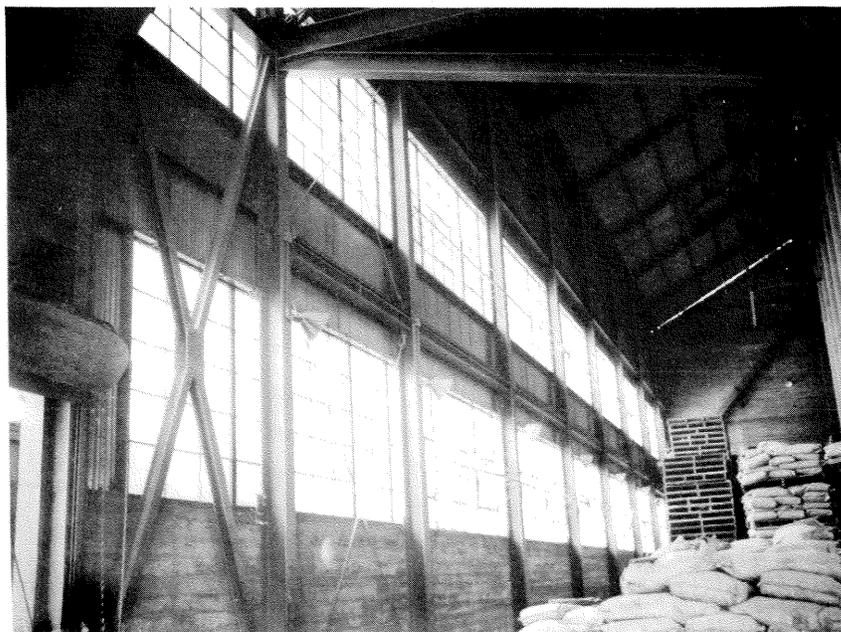
Figure 4. South wall of mill building.

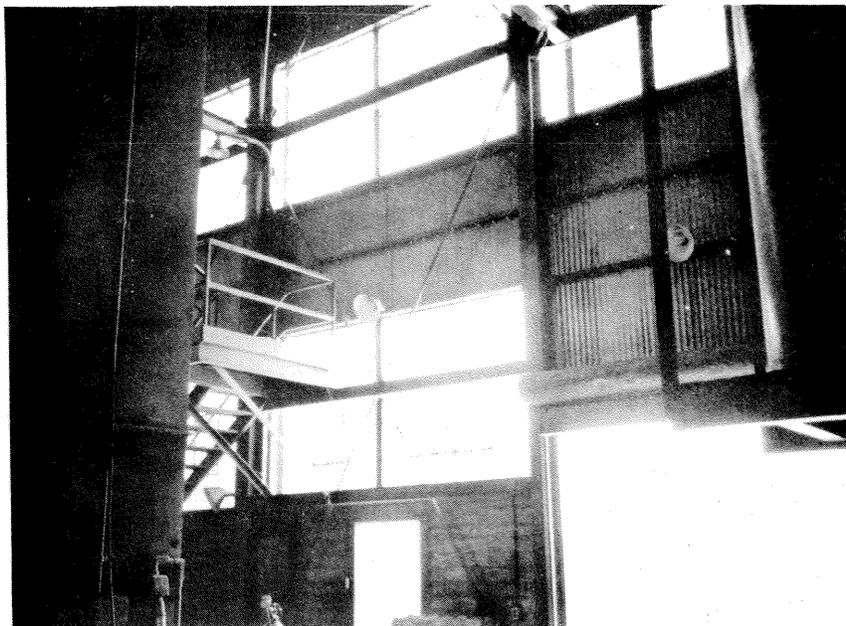
Figure 5a. East wall of mill building.

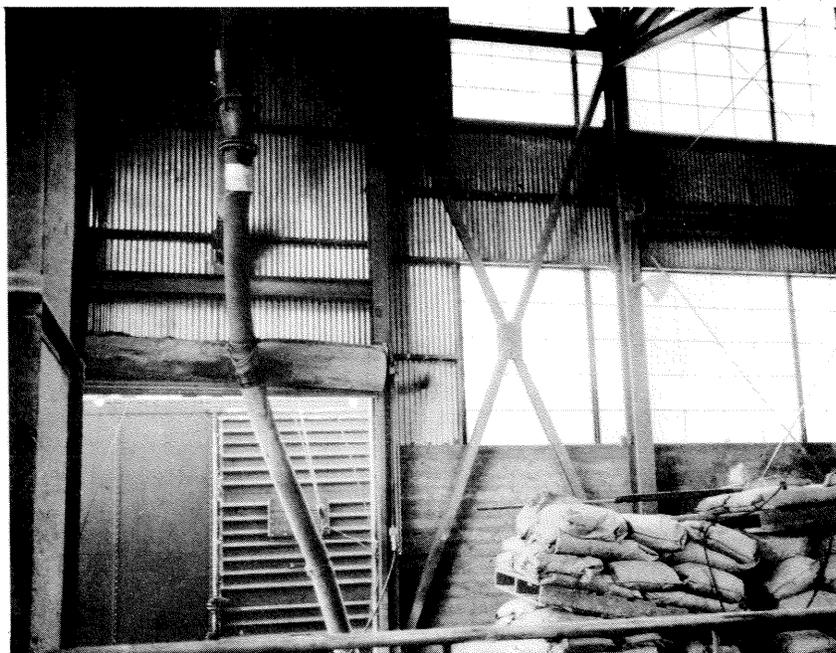
Figure 5b. South wall of mill building.

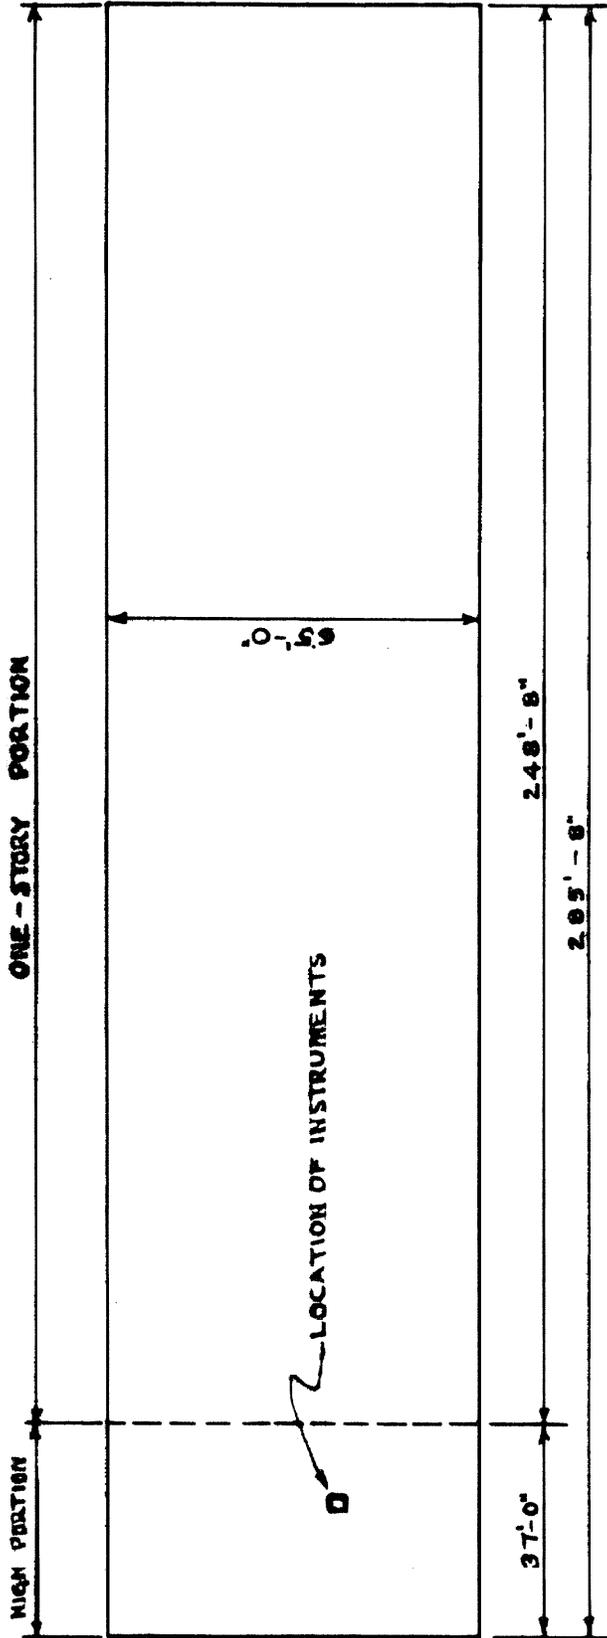
FIGURE 6

PLAN OF BUILDING

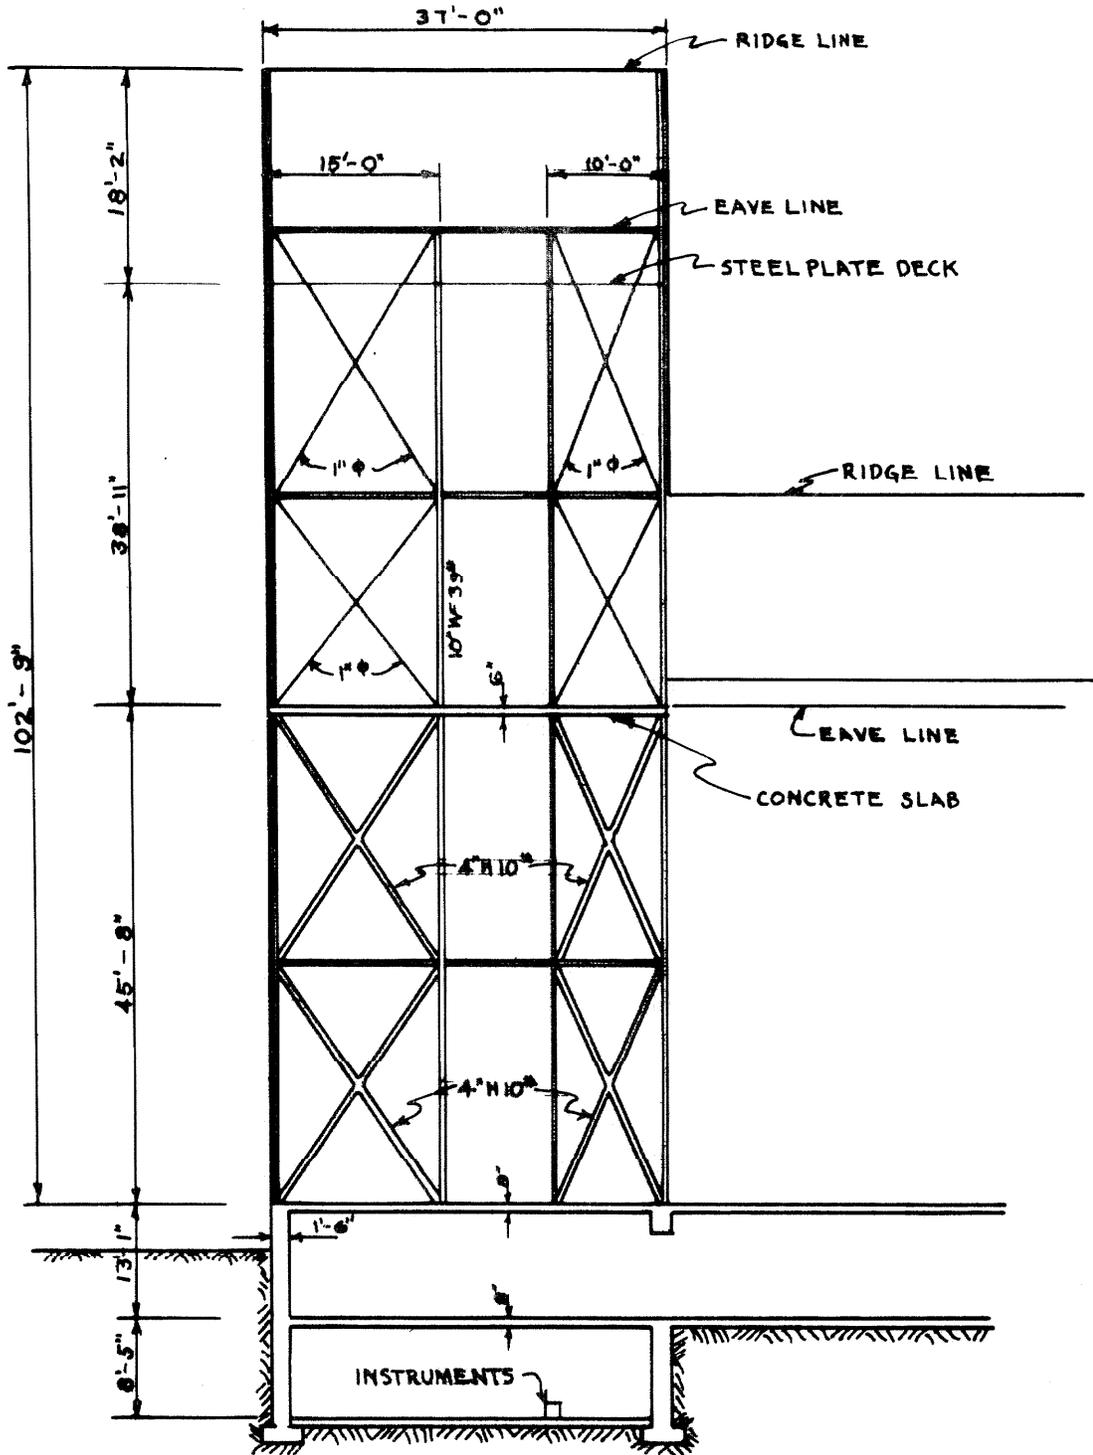
FIGURE 7

SECTION THROUGH BUILDING - LOOKING SOUTH

An east-west section through this portion of the building is shown in Figure 7. There are two sets of X-bracing in both the north and south walls which provide lateral bracing for the elevated concrete floor slab. This bracing is made of 4" - H - 10# sections. The steel columns in this portion of the building are 10" WF 39 # sections. The east wall of the building is framed similarly except that it has a double set of X-bracing made of 1 1/2" round rods as shown in Figure 8.

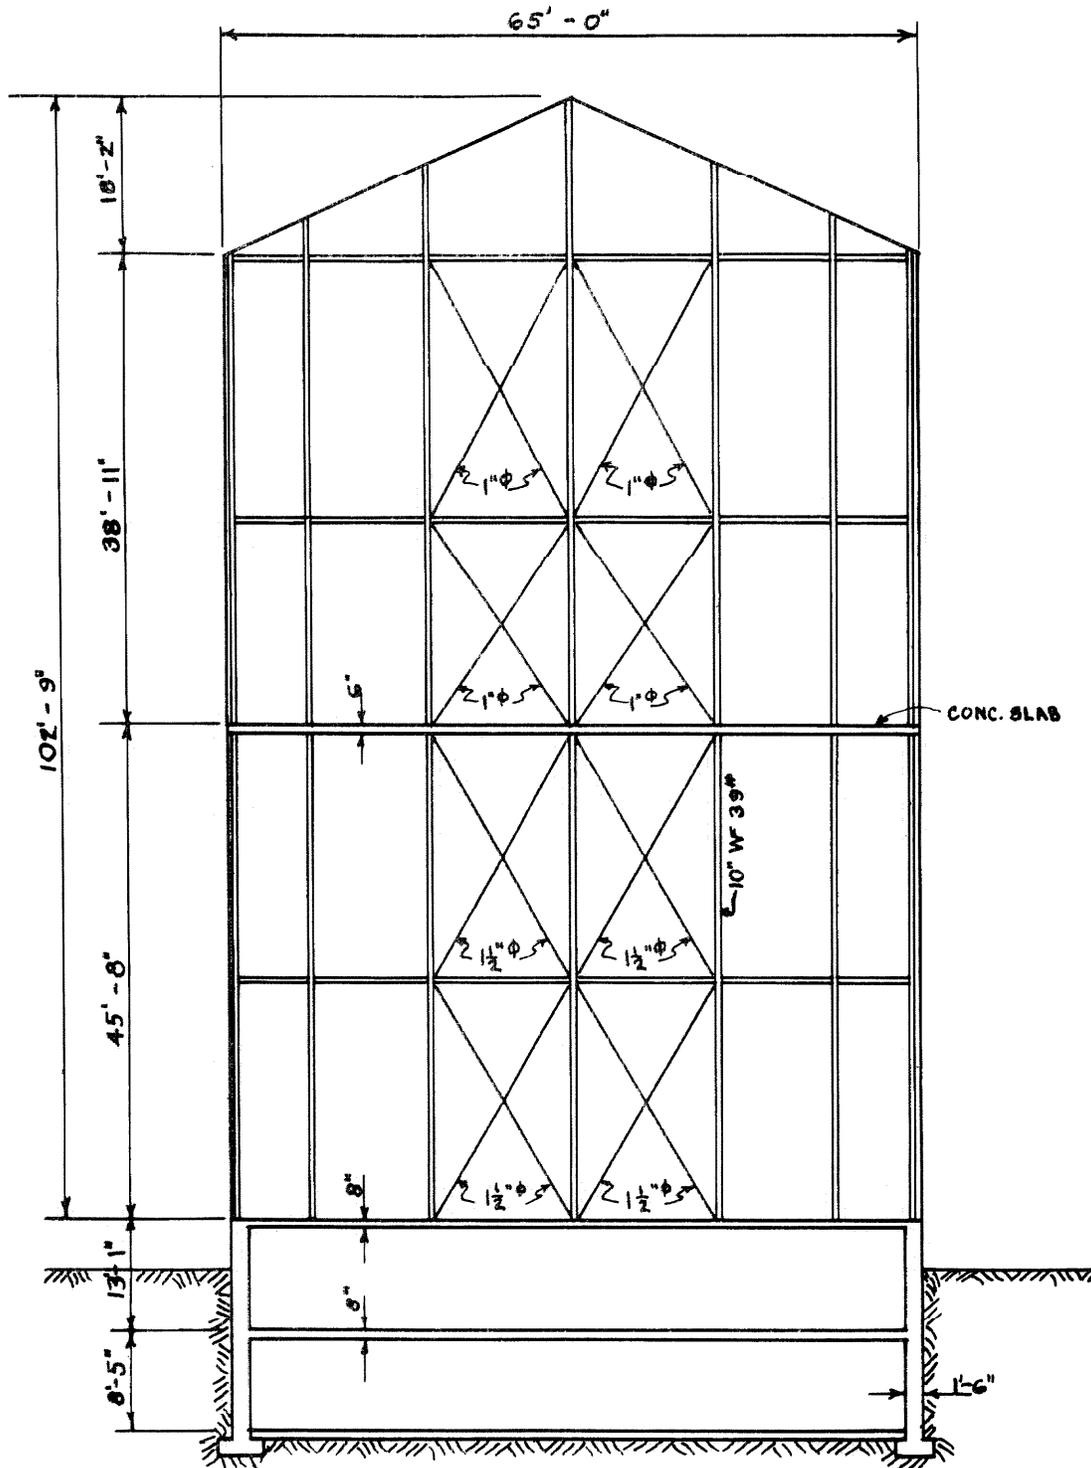
FIGURE 8

SECTION THROUGH BUILDING - LOOKING EAST

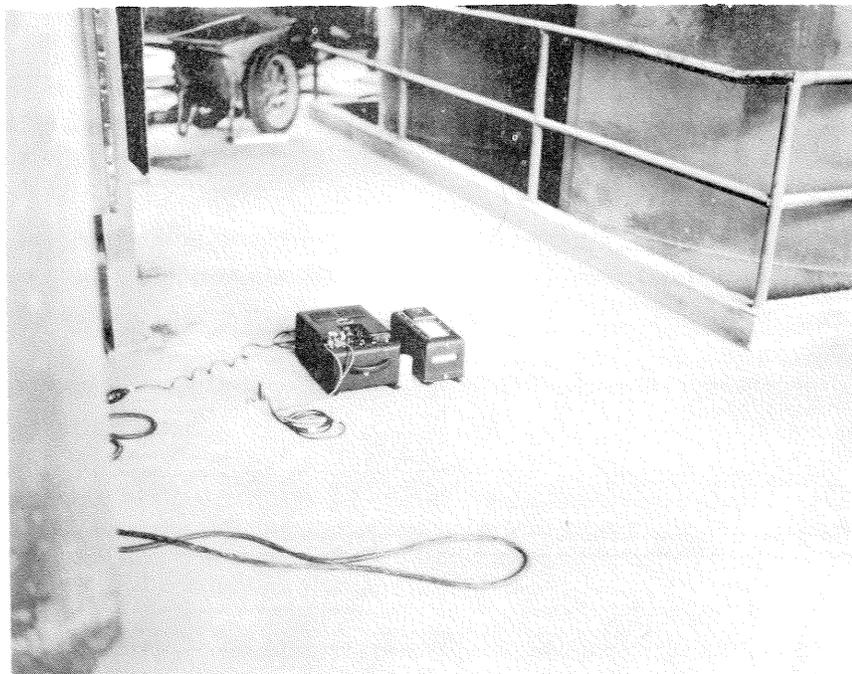
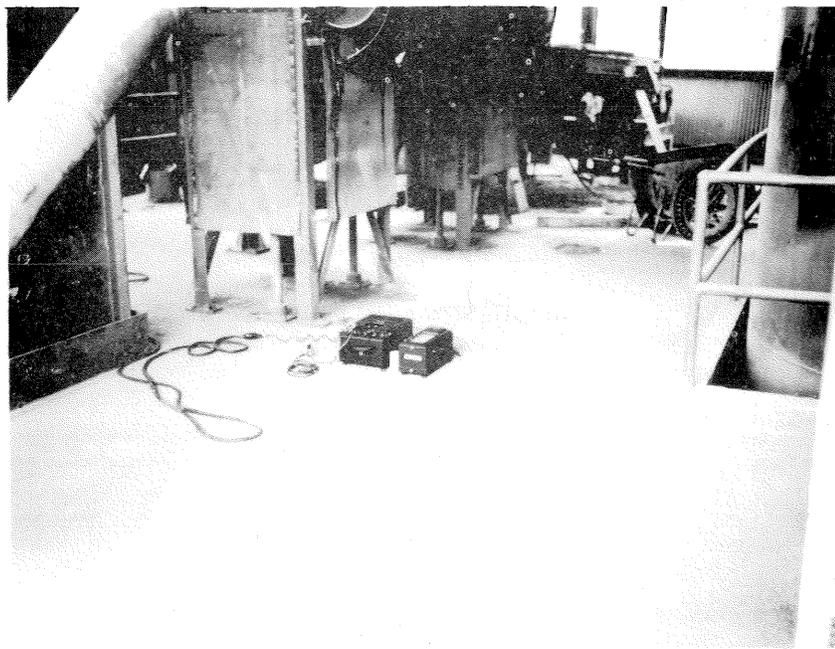
Figure 9a. Location of instruments on upper floor.

Figure 9b. Location of instruments on upper floor.

The output of the oscillator-amplifier was fed into a Brush Development Company, Type BL-202, Direct Inking Oscillograph, Serial No. 3027. The Amplifier-Oscillograph combination has a flat frequency response from 0 to 100 cycles per second. A photograph of this instrumental set-up is shown in Figure 9.

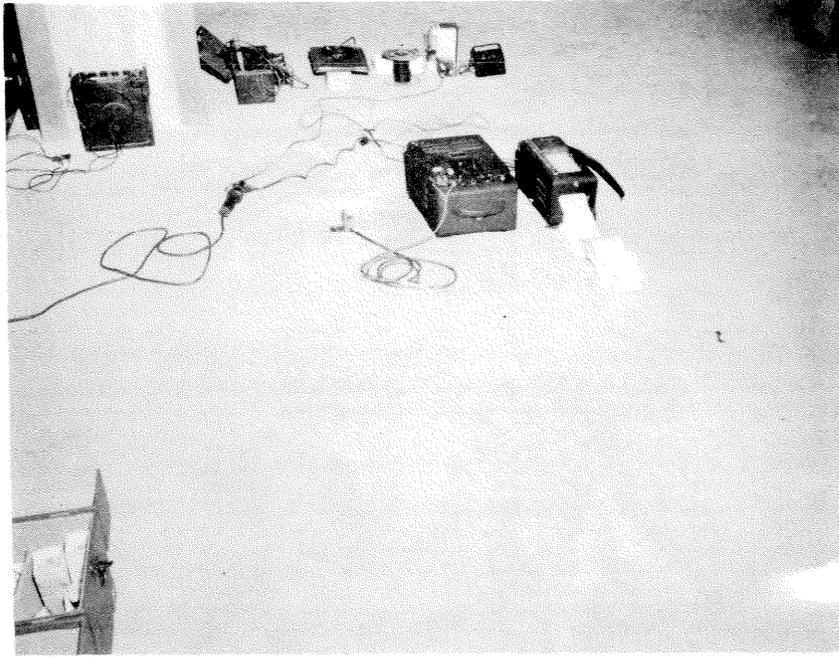
Figure 10. Location of instruments on floor of sub-basement.

Direct-Inking Oscillograph Serial No. 1189. The accelerometer was bolted to the concrete floor slab and was oriented in an east-west direction. A photograph of the installed instruments is shown in Figure 10.

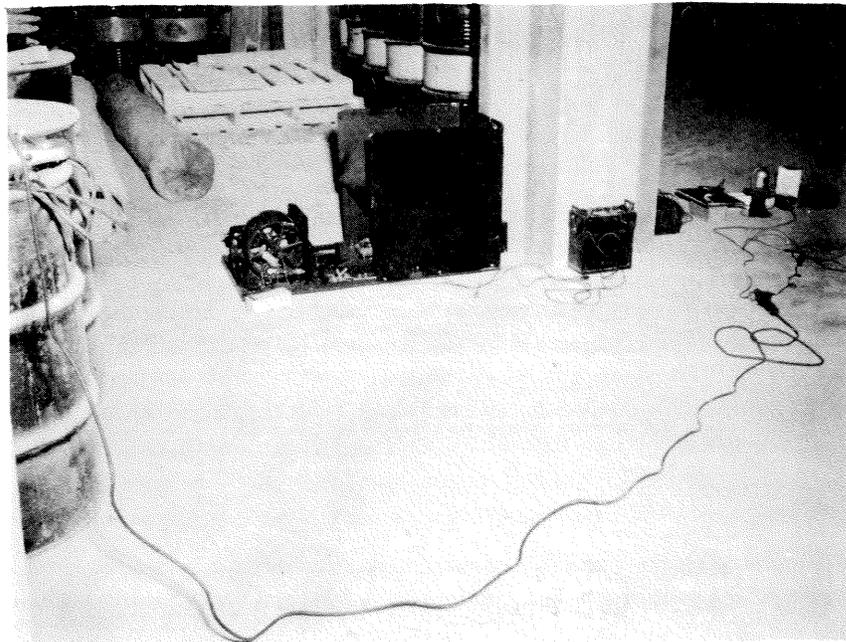
Figure 11. Location of U.S. Coast and Geodetic Survey accelerometer on floor of sub-basement.

The unit contains three accelerometers of the torsion-suspension type which record two horizontal and one vertical component of motion. The response of the accelerometers is recorded optically on photographic paper with automatic time recording. The natural frequency of the accelerometers is 12 cycles per second and they have magnetic damping (approximately 60% of critical). A photograph of the instrument installed in the sub-basement, with its cover lifted, is shown in Figure 11.

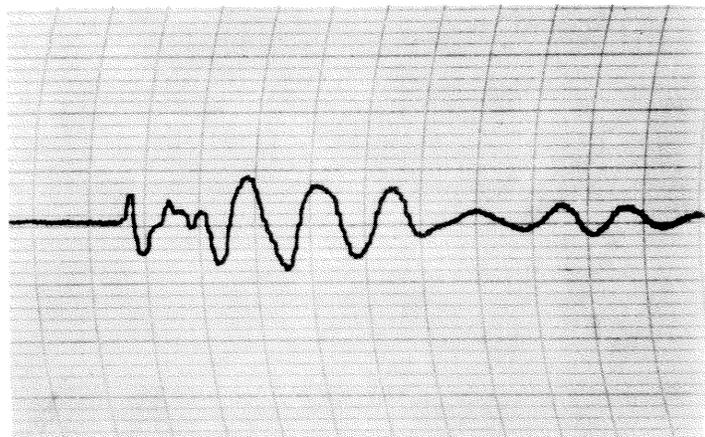
Figure 12. Photograph of east-west acceleration record from Brush recorder on floor of sub-basement.

Photographs of the records of the ground motion, that is, the motion of the floor of the sub-basement, are shown in Figures 12 and 13. The same records drawn to a common scale are shown in Figures 14, 15, 16 and 17. Comparing Figures 14 and 15, which represent the same ground motion recorded by two different instruments, it is seen that there is very close agreement between the two records. Practically the same maximum accelerations were recorded and the shapes of the two records are virtually the same. The fact that the two instruments are so dissimilar, one being an electrical instrument with mechanical pen recording and the other a mechanical instrument with optical recording, and that they both gave the same record for the ground motion is a good check on the reliability of the instruments.

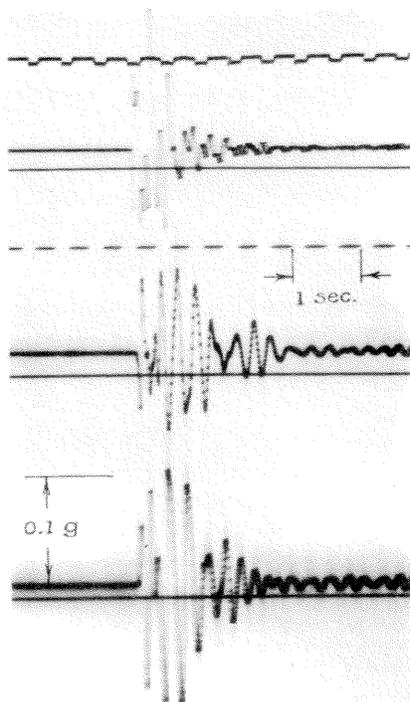
Figure 13. Photograph of records from U.S.C.G.S. accelerometer on floor of sub-basement.

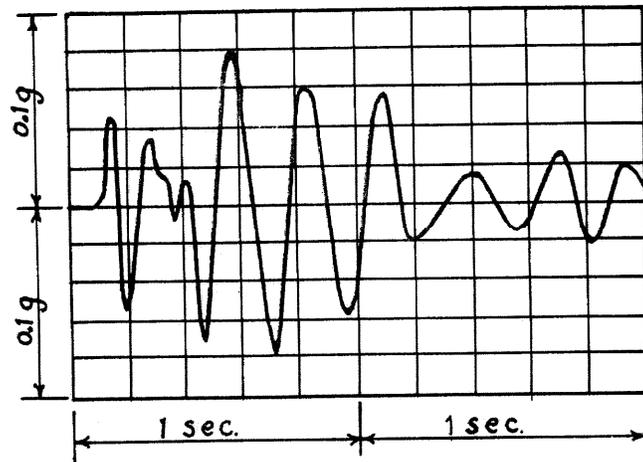
Figure 14. East-west ground acceleration obtained with Brush recorder.

From Figures 14, 15, 16 and 17, it is seen that the maximum recorded ground acceleration in the east-west direction was 8% g, the maximum acceleration in the north-south direction was 10.5% g and in the vertical direction the maximum acceleration was 12.4% g. Accelerations of this magnitude correspond to the ground motion experienced during a moderately strong earthquake. For purposes of comparison there is shown in Figure 18 a portion of a horizontal component of motion recorded at Hollister, California during the earthquake of March 9, 1949. Comparing the records, it is seen that the ground motion recorded during the explosion is very similar to the recorded earthquake motion. The ground motion produced by the detonation of the explosives is thus practically the same as a moderately strong but a very short duration earthquake.

Figure 26 is a photograph of the cathode-ray tube of the Analog Computer; the upper trace shows the exciting ground motion, as reproduced in the form of an electric voltage for use in the computer. Comparison with Figure 14 will show that the essential

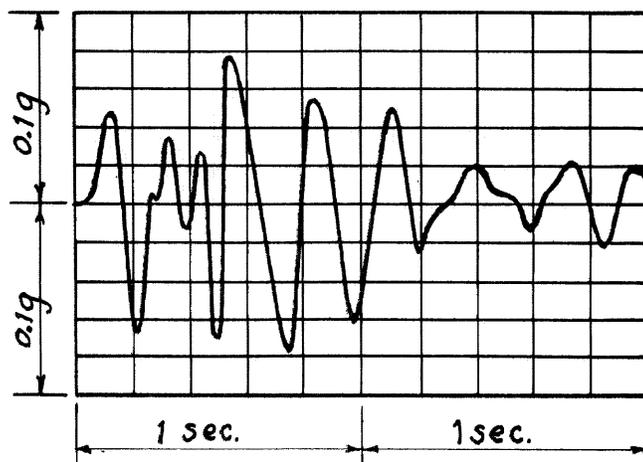
Figure 15. East-west ground acceleration obtained with U.S.C.G.S. accelerometer.

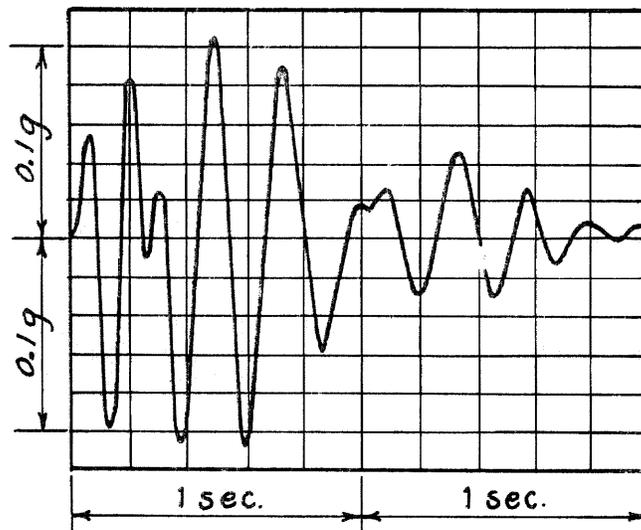
Figure 16. North-south ground acceleration obtained with U. S. C. G. S. accelerometer.

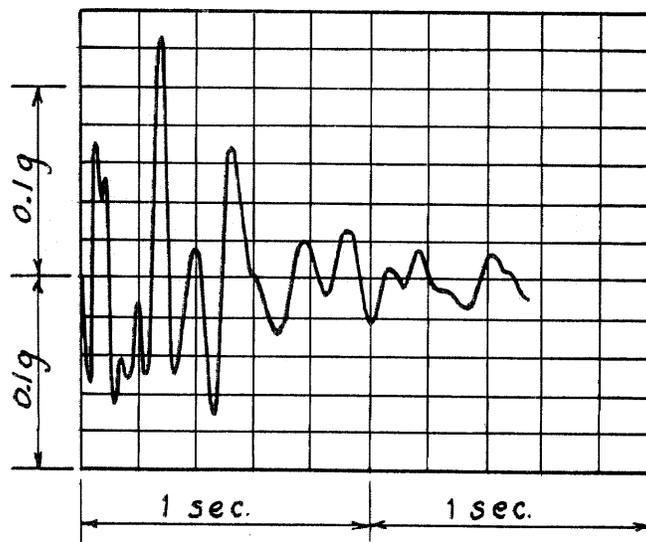
Figure 17. Vertical ground acceleration obtained with U. S. C. G. S. accelerometer

The recorded vertical ground motion during the blast shows distinctly sharper peaks, that is, higher frequency components, than the horizontal ground motion. This also agrees with the strong-motion earthquake records, which invariably show the vertical motion to have significantly higher frequency components than the horizontal motion.

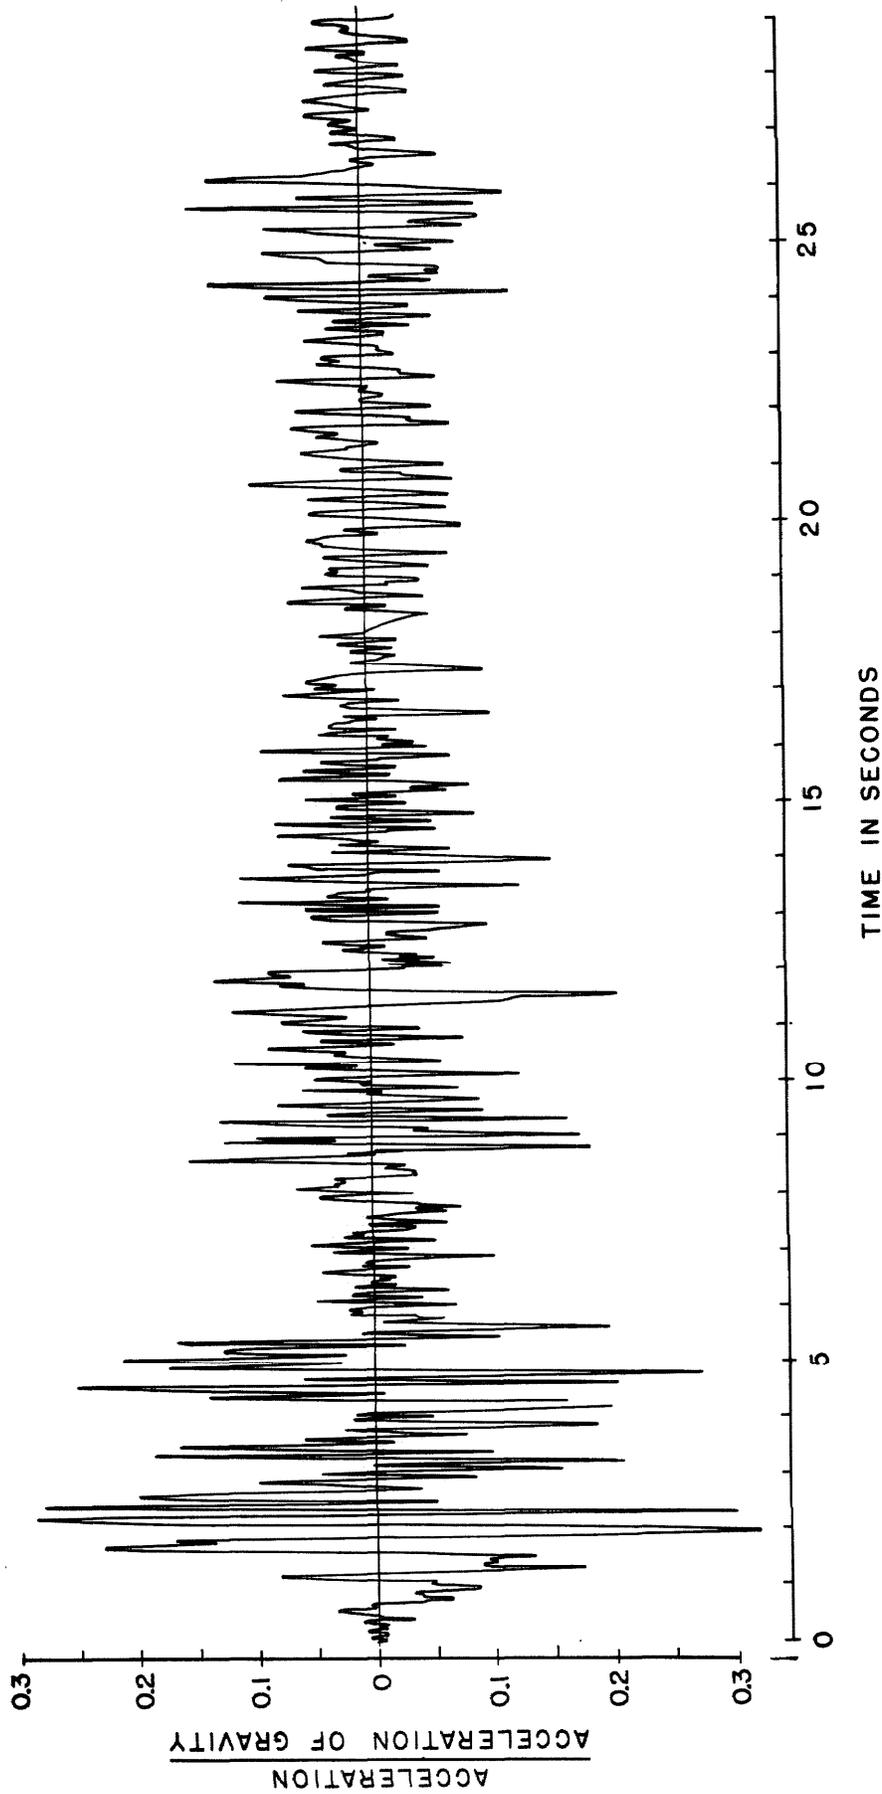
Figure 19. - Accelerogram for El Centro, California; earthquake of May 18, 1940. Component N-S.

For purposes of comparison the most intense ground motion recorded in California is shown in Figure 19. This is a horizontal component of the ground motion recorded at El Centro, California during the shock of May 18, 1940. The maximum acceleration recorded here was 33% g as compared to 13% g recorded during the blast. The duration of the intense ground motion during the El Centro shock was 25 seconds as compared to the one second duration of the strong ground motion produced by the blast.

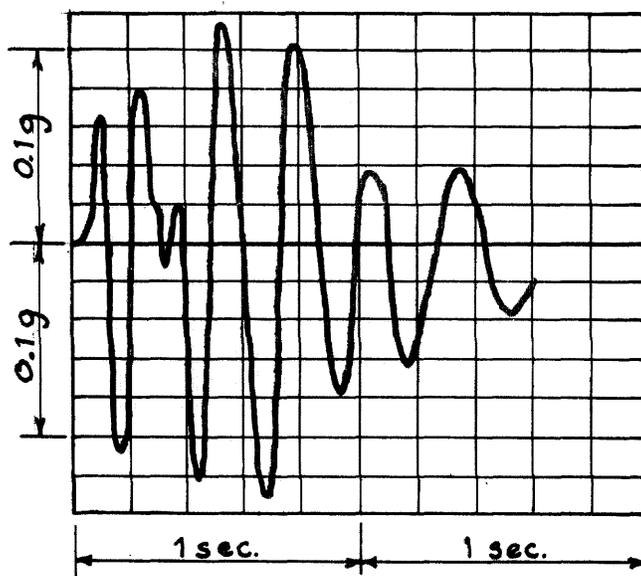
Figure 20. Ground acceleration resolved along a radial line from the blast source.

parallel to the axes of the building, which were approximately 45° from the direction of the blast. The most intense ground motion is in a radial direction from the point of detonation and when the two recorded components are resolved to give the radial and tangential components of acceleration the accelerograms shown in Figures 20 and 21 are obtained. It is seen that practically all of the motion was in the radial direction and only relatively small accelerations in the tangential direction. The maximum resolved acceleration (Figure 20) is 13% g.

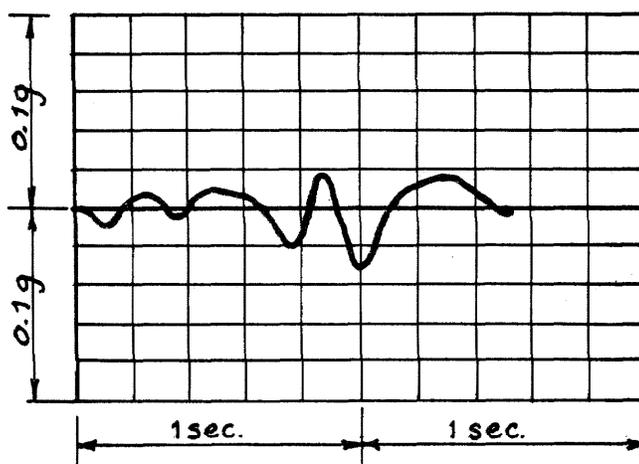
Figure 21. Ground acceleration resolved along a line perpendicular to the radial direction.

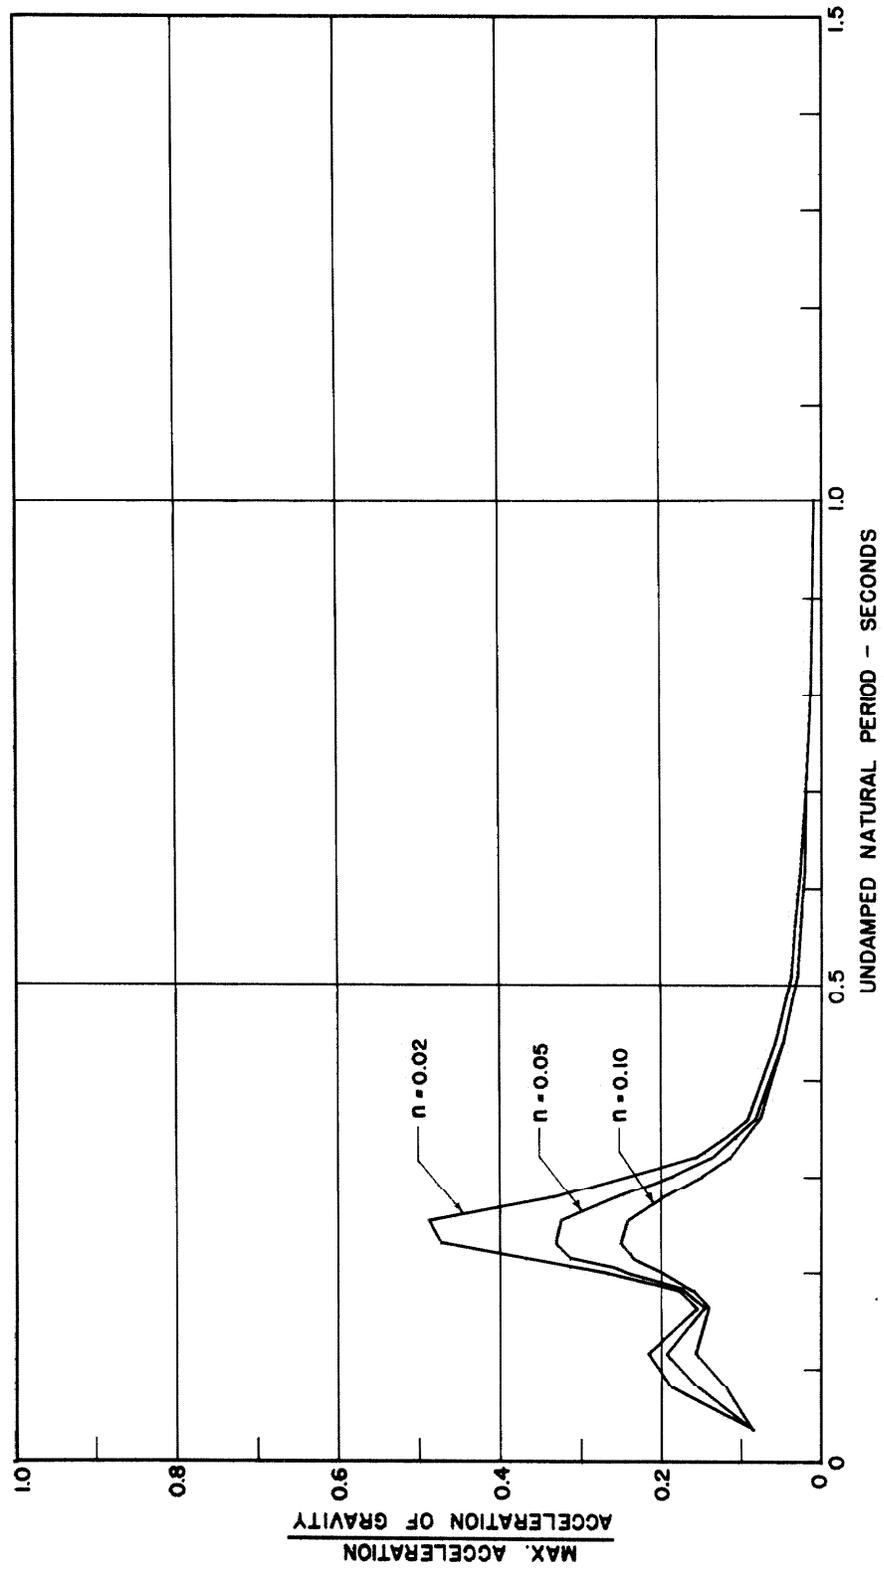
Figure 22. Acceleration spectra for Corona quarry blast, July 26, 1952. Component E-W.

The effect of a ground shock upon structures is conveniently summarized in the spectrum, which has been described in detail in an earlier report.* Briefly, the acceleration spectrum consists of the maximum acceleration experienced by a single degree of freedom oscillator when subjected to the given ground motion plotted as a function of the natural period of the oscillator. Such a spectrum was computed for the quarry blast, by means of the electric analog computer, and is shown in Figure 22. Spectra are shown for structures having 2%, 5% and 10% of critical damping. Several points about these spectra are noteworthy: first, the significant response is confined to a narrow range of periods at the short-period end of the spectrum; second, the maximum response (with 2% of critical damping) is approximately 0.5 g.

The computed response was not sufficiently sensitive to changes in damping of the system to permit a determination of the amount of damping in the building. This lack of sensitivity to damping is attributed to the short time duration of the ground shock. It has been found that damping is most effective in reducing the response of an oscillator to earthquake ground motion during the latter part of long-duration disturbances and least effective in disturbances of short duration*. The response shown in Figure 24 corresponds to a damping of about 1/2% of critical. Previous experience has indicated that low damping is to be expected in structures of this type, although the actual building damping is probably somewhat greater than 1/2%** . The maximum response of the structure can also be read from the spectra of Figure 22.

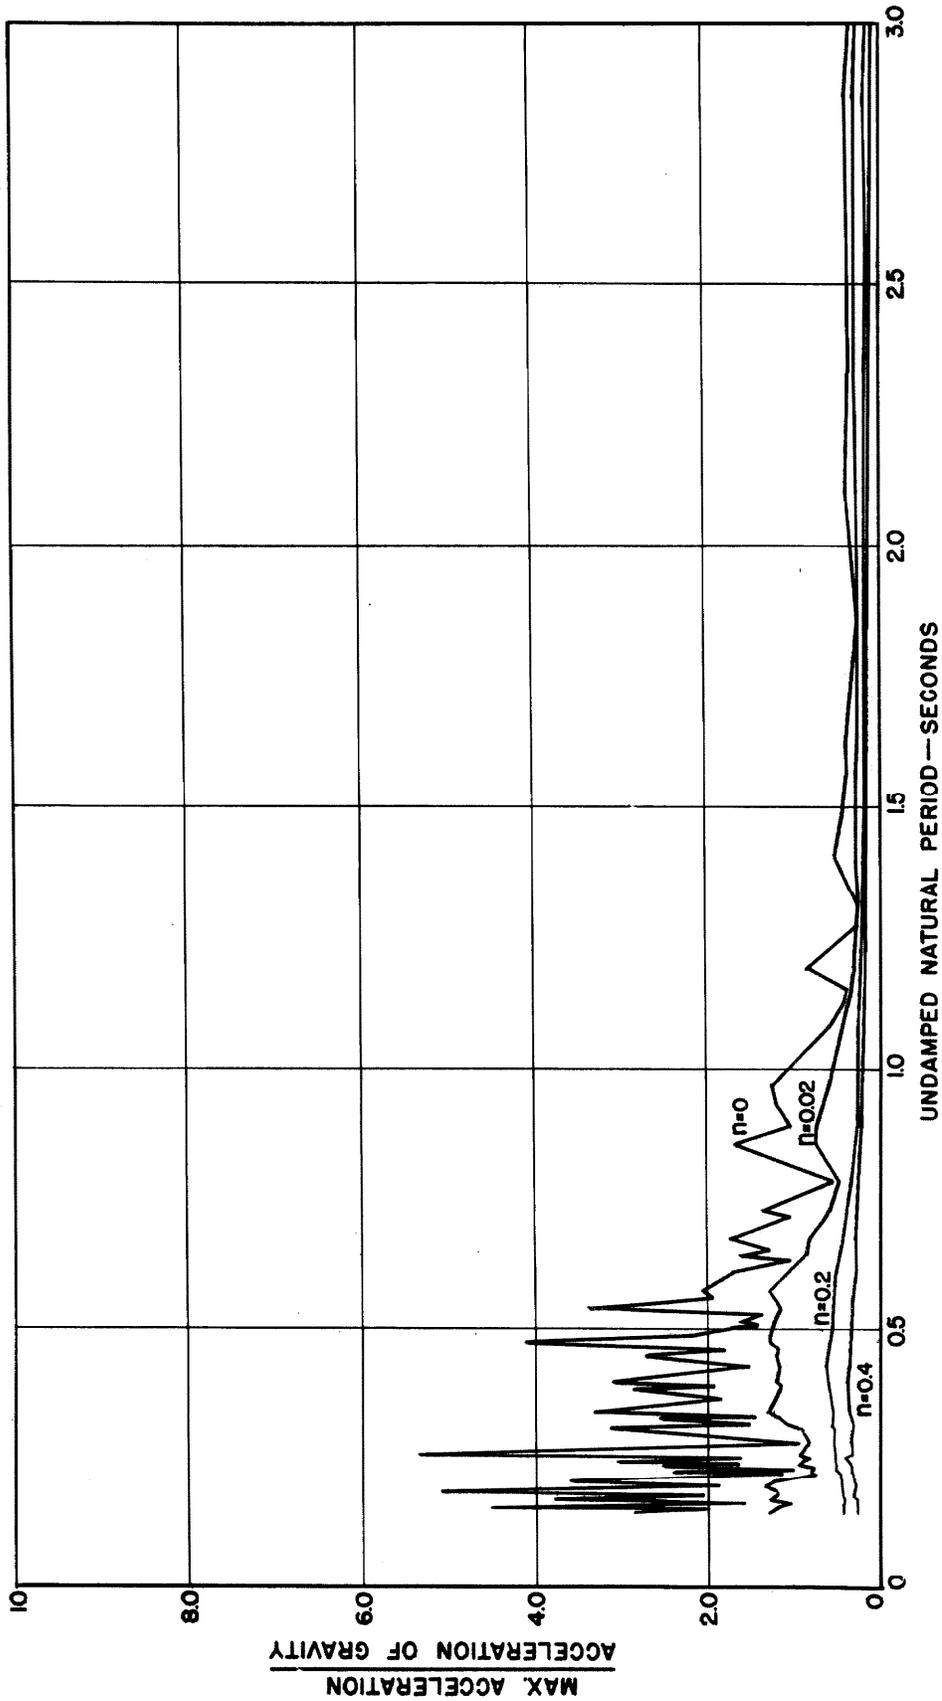
Figure 23. Acceleration spectra for El Centro, California; earthquake of May 18, 1940. Component N-S.

It is instructive to contrast the blast spectrum to that of the El Centro earthquake (Figure 23), which may be considered as typical of strong-motion earthquakes. It can be seen, first, that the region of high response covers a much broader range of periods and, second, that the maximum response for the same degree of damping is nearly three times as great.
