CALIFORNIA INSTITUTE OF TECHNOLOGY

EARTHQUAKE RESEARCH LABORATORY

Response of a Structure
to an Explosive-Generated Ground Shock

THIRD TECHNICAL REPORT

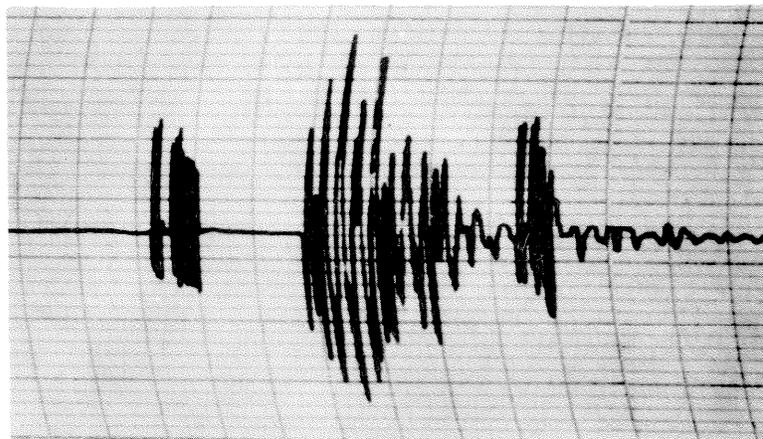
Figure 24. Photograph of east-west acceleration record from Brush recorder on upper floor.

A photograph of the record obtained on the concrete floor slab at elevation 45' - 8" above the first floor level is shown in Figure 24. A redrawn copy of the record is shown in Figure 25 to same scale as Figure 14. This record shows the east-west acceleration of the concrete floor slab. The maximum acceleration attained by the slab in this direction was 11.8% g. The recorded acceleration time picture agrees with what would be anticipated, namely, a building-up of the amplitude during the period of intense ground motion followed by a gradual diminution in amplitude of motion. At the instant of maximum acceleration the bracing in the building was stressed as if 11.8% of the weight of the floor slab were acting horizontally in an east-west direction.

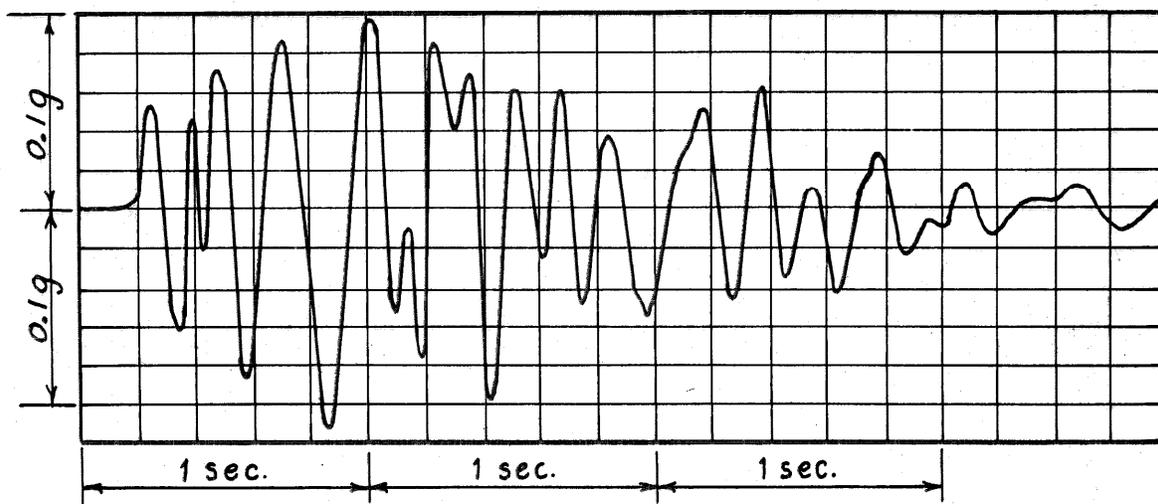
Figure 25. East-west acceleration at upper floor of the mill building.

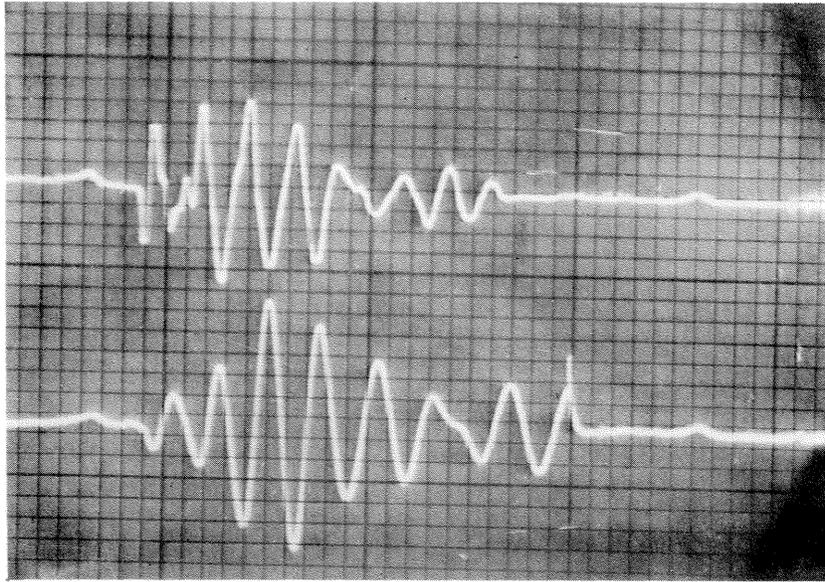
Figure 26. Photograph of computer solution. Upper trace: ground acceleration. Lower trace: east-west acceleration of the upper floor.

Figure 26 is a photograph of the cathode-ray tube of the Analog Computer; the upper trace shows the exciting ground motion, as reproduced in the form of an electric voltage for use in the computer. Comparison with Figure 14 will show that the essential

features of the ground acceleration have been faithfully reproduced. The lower trace of Figure 26 is the computed response of the floor slab, as simulated by a 2.9 cyc/sec, single degree of freedom oscillator. In Figure 27 this computed response has been redrawn to the scales used in Figures 14 and 25, and the measured response has been included in the same figure for comparison. It will be seen that the magnitudes and periods of the major peaks check very well, and that the general shapes of the curves are similar except for the high-frequency components in the measured record, which do not appear in the computed curve since only one degree of freedom was used for the dynamic model.

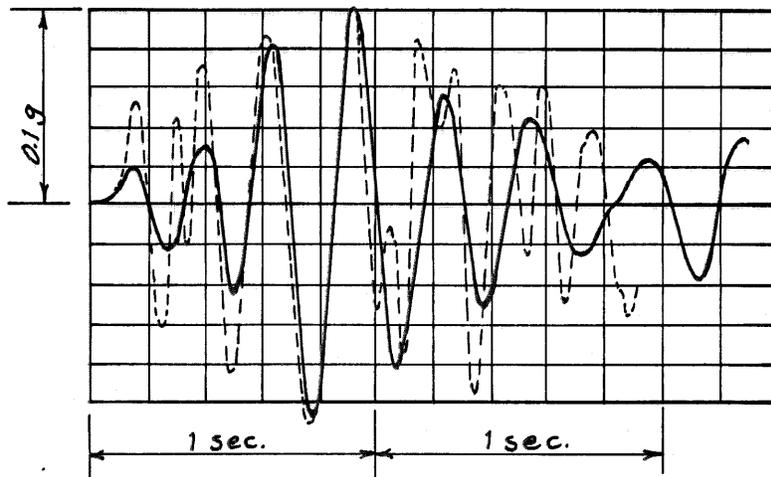
Figure 27. Comparison of computed and measured accelerations of the upper floor.

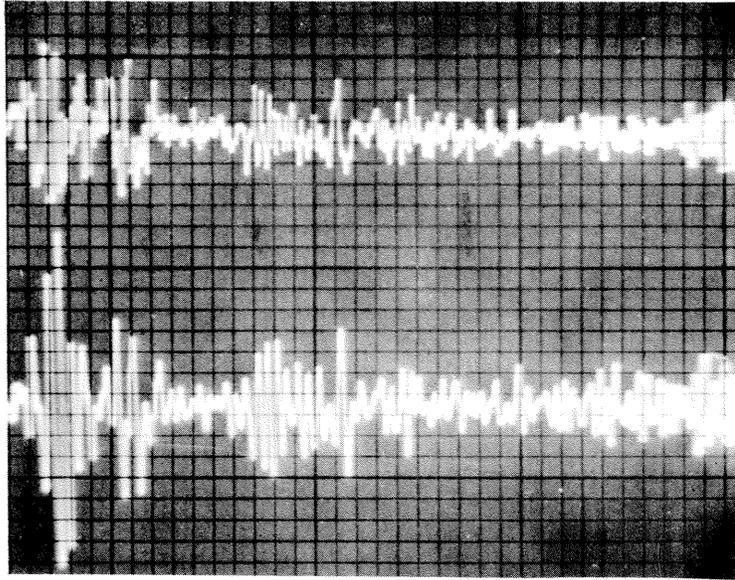
Figure 28. Upper trace: north-south ground acceleration at El Centro, California, May 18, 1940. Lower trace: computed acceleration at upper floor of mill building with 8% of critical damping.

The response of the same structure was also computed for the ground motion of the El Centro, California earthquake of May 18, 1940 (Figure 19). A photograph of the response obtained with the Analog Computer is shown in Figure 28 for 8% of critical damping and in Figure 29 for 16% of critical damping. Since the El Centro earthquake was one of long duration and since the test building

The maximum acceleration of the slab (with 8% of critical damping) was 65% g, so that the maximum stresses produced in the cross-bracing would correspond to a lateral force equal to 65% of the weight of the slab. This assumes, of course, that the dynamic properties of the structure do not change during the motion. The maximum acceleration of the slab with 16% of critical damping was 45% g.

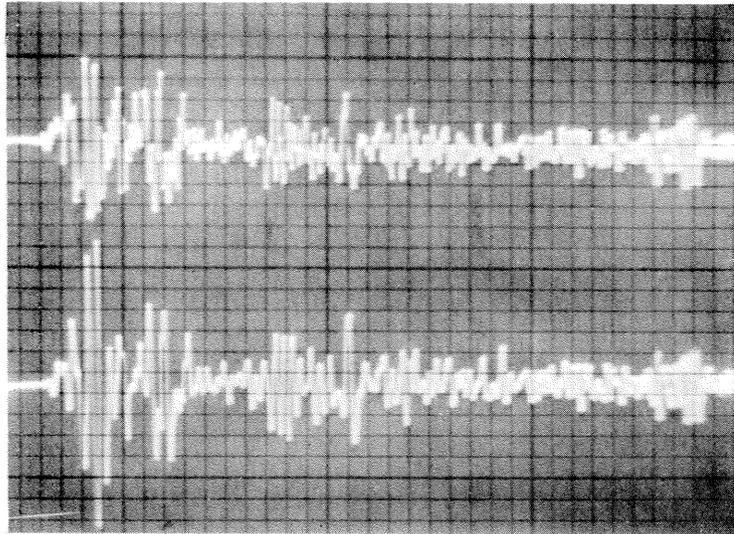
Figure 29. Upper trace: north-south ground acceleration at El Centro, California, May 18, 1940. Lower trace: computed acceleration at upper floor of mill building with 16% of critical damping.
