Lunar Surface Mechanical Properties—Surveyor 1

Engineering telemetry data and lunar surface photographs by Surveyor 1 have been evaluated for information on the mechanical properties of the lunar surface material at the Surveyor 1 landing site. Based primarily on photographic evidence, estimates of soil density, cohesion, and other soil characteristics are presented. Also, the mechanisms in which the lunar material is believed to have failed under the footpad impacts are discussed. Because dynamic soil reactions cannot be interpreted directly from the available data, a comparative study using computer-simulated landings was initiated. Preliminary results of this study, which is still in progress, are presented.

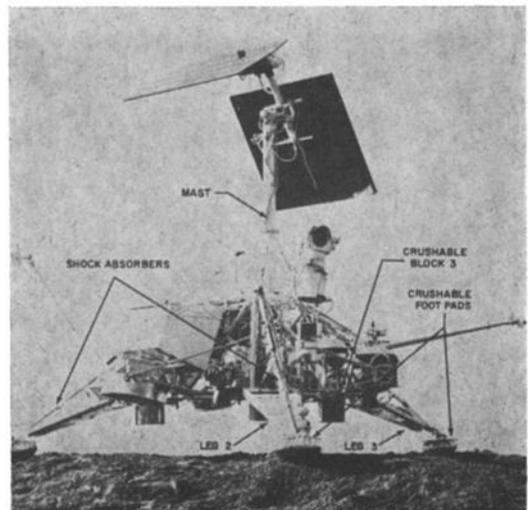
Fig. 1. Surveyor spacecraft.

The interpretation of the lunar surface properties discussed here is based on (1) television photographs showing the lunar surface areas disturbed by the footpads and the frame-mounted crushable blocks, (2) histories of axial loads in the shock absorber on each of the three legs during landing (Figure 1), and (3) other engineering telemetry data pertinent to landing dynamics. The dimensions of the landing gear assembly are shown in Figure 2, and the motion of each leg set during landing is shown schematically in Figure 3. The spacecraft landed with a vertical velocity of approximately 3.5 m/sec (11.6 ft/sec) and a horizontal velocity of approximately 0.3 m/sec (1 ft/sec). At touchdown, the angle between the plane of the three footpads and the local lunar surface was approximately 1.2°. At rest on the surface, the spacecraft frame is now estimated to be parallel to the local lunar surface within 1°.

shock absorber. (Computer-simulated landing data for landing on a hard surface are presented in Figure 5.) It can be seen that surface contact for all three footpads was almost simultaneous, indicating that the spacecraft mast (Figure 1) at touchdown was approximately normal to the surface. The footpads impacted at intervals of approximately 0.01 sec. Footpad 2 touched first, followed by footpad 1 and then footpad 3.

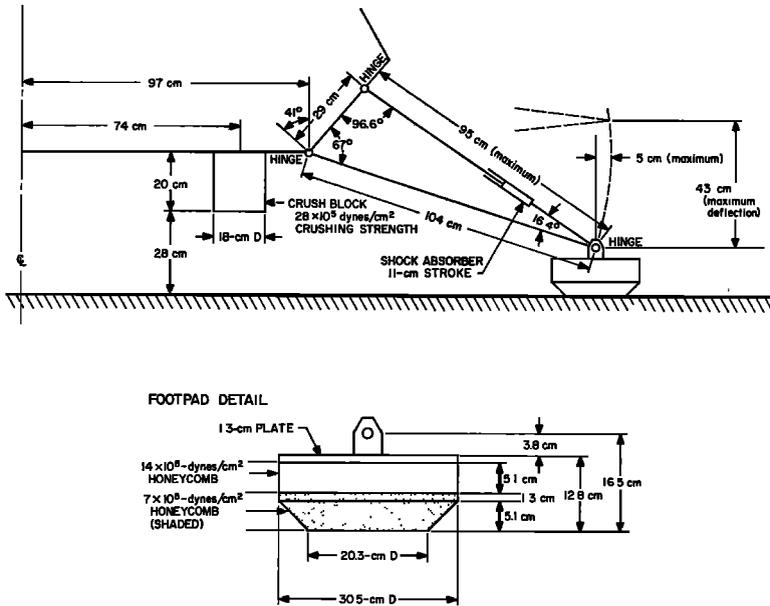
Fig. 2. Dimensions of landing gear assembly.

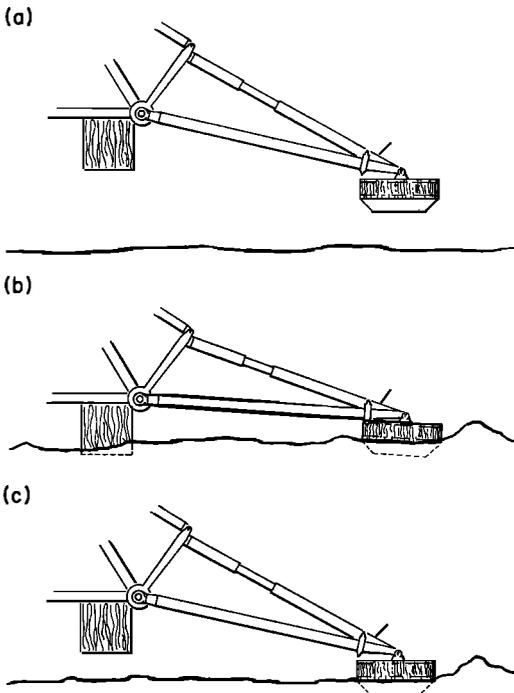
Fig. 3. Surveyor landing leg assembly, showing articulation in events during landing. Assembly is shown fully extended in (a); during landing, the shock absorber compresses and the footpad moves up and away from the spacecraft, as shown in (b); assembly is shown reextended after landing in (c).

The appearance of the disturbed lunar surface near footpad 3 (Figure 6) and footpad 2 (Figure 7) indicates a similar behavior of the material displaced by the two footpads. They appear to have landed in a granular material, to have extended laterally approximately 5 cm (2 in.) during impact (Figure 3), forcing the

To determine whether any surface erosion could be caused, the attitude-control jet on leg 2 (Figures 3 and 7) was operated after landing. The jet used cold nitrogen gas to produce a thrust of 0.3 newton (0.06 lb). It was located approximately 12 cm (5 in.) from, and at an angle of 72° to, the surface. Pictures were taken before, during, and after the firings, which consisted of short pulses repeated for

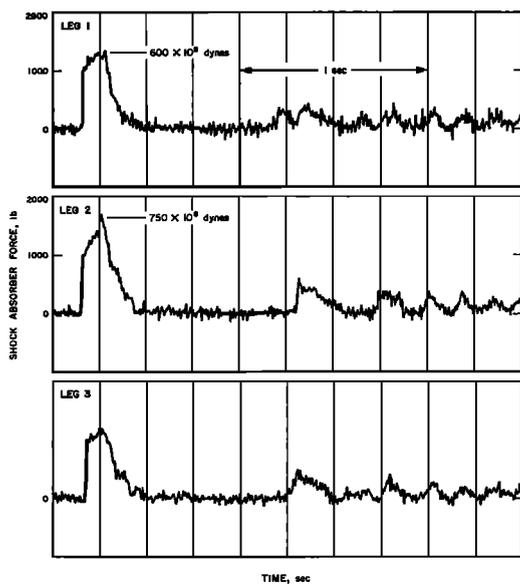
Fig. 4. Axial shock absorber strain gage data. (Maximum force developed by shock absorber 3 is not shown because of uncertainties in no. 3 strain gage calibration.)

Figure 4 shows the time records of the axial load, as measured by a strain gage, on each

The record also shows that, approximately 500 msec after initial touchdown, the spacecraft rebounded. A second impact is registered approximately 1.1 sec after the first one. This timing of events indicates that the footpads

cleared the lunar surface by about 6 cm (2.5 inches) during the rebound phase. The second impact developed maximum loads equal to approximately one-quarter of the maximum loads developed during initial impact. The maximum vertical load applied to a footpad by the lunar surface material during initial impact was approximately 1900 to 2200 newtons (450 to 500 lb), which was determined by comparing analytical landing simulations with Surveyor 1 telemetry data. Conversion of this load into a dynamic pressure applied to the surface depends on the footpad area in contact with the soil at the instant the load is measured. Since the lower portion of the footpad is a truncated cone (Figure 2), this contact area depends primarily on the penetration depth; thus, a maximum loading of between 4.2×10^6 and 6.9×10^6 dynes/cm² (6 and 10 psi) was applied to the surface during the dynamic stages of the impact. The static load required to support the spacecraft on the three landing pads is approximately 3×10^4 dynes/cm² (0.5 psi). The earth weight of the spacecraft at the time of landing was 2863 newtons (643 lb); its mass was 291.8 kg (20.0 slugs).

Oscillations of the forces in all the shock absorbers are seen to follow the second impact (Figure 4) with maximum peak-to-peak ampli-

tude of several hundred pounds and a frequency near 7 cps. The oscillations are in phase and of about equal amplitude, thus indicating a rectilinear vertical motion of spacecraft center of gravity. (Maximum amplitude displacement of spacecraft center of gravity is approximately 0.2 cm, or 0.08 in., assuming a linear system.) The frequency of the oscillations is related to the elasticity of the spacecraft structure and the lunar surface material. Consequently, for frequencies appreciably lower than 7 cps, the spacecraft is well coupled to the moon. This observation is important for a lunar seismograph experiment, in which the seismographic sensor is mounted rigidly in the spacecraft frame, since it permits one to expect reliable recording of seismographic signals with frequencies below 7 cps. Higher-frequency signals would be attenuated, with the possible exception of certain discrete resonant frequencies.

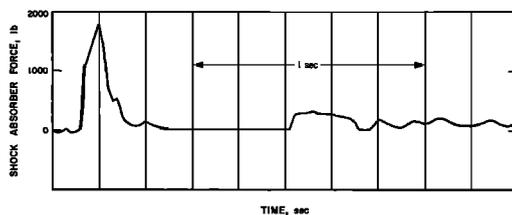
Fig. 5. Computer-simulated axial shock absorber strain gage data for landing on a hard surface.

Preliminary results of these investigations show that the rigid surface landing agrees well with Surveyor 1 data with respect to pulse shape, elapsed time between first and second impact, and reimpact pulse shape (Figure 5). The time to build up to the peak shock absorber forces was essentially the same for Surveyor 1 and the rigid surface landing simulation. For the hard-surface simulations, however, the peak forces are 10 and 15% too high, and the duration of the first impact pulse is slightly too short. These discrepancies seem to be due primarily to the observed penetration into the lunar material.

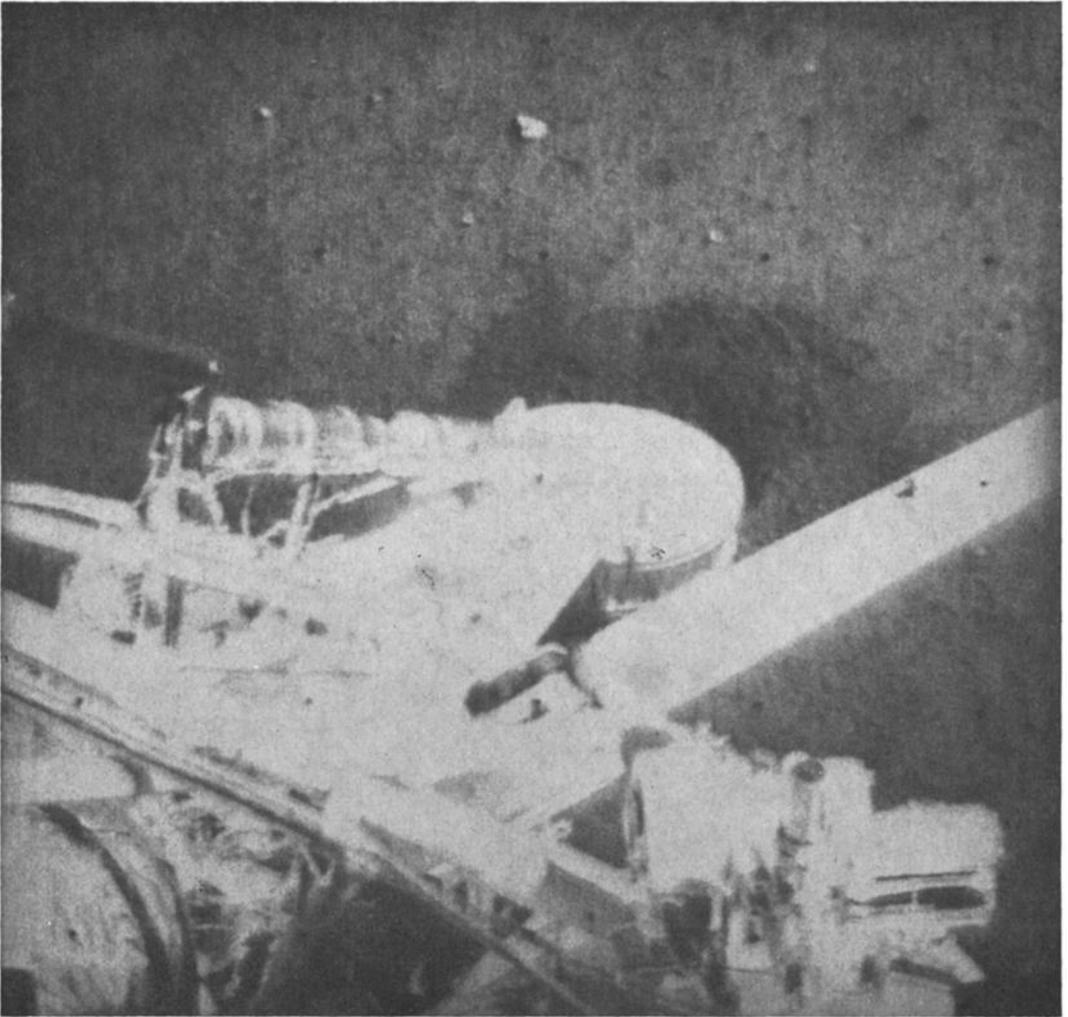
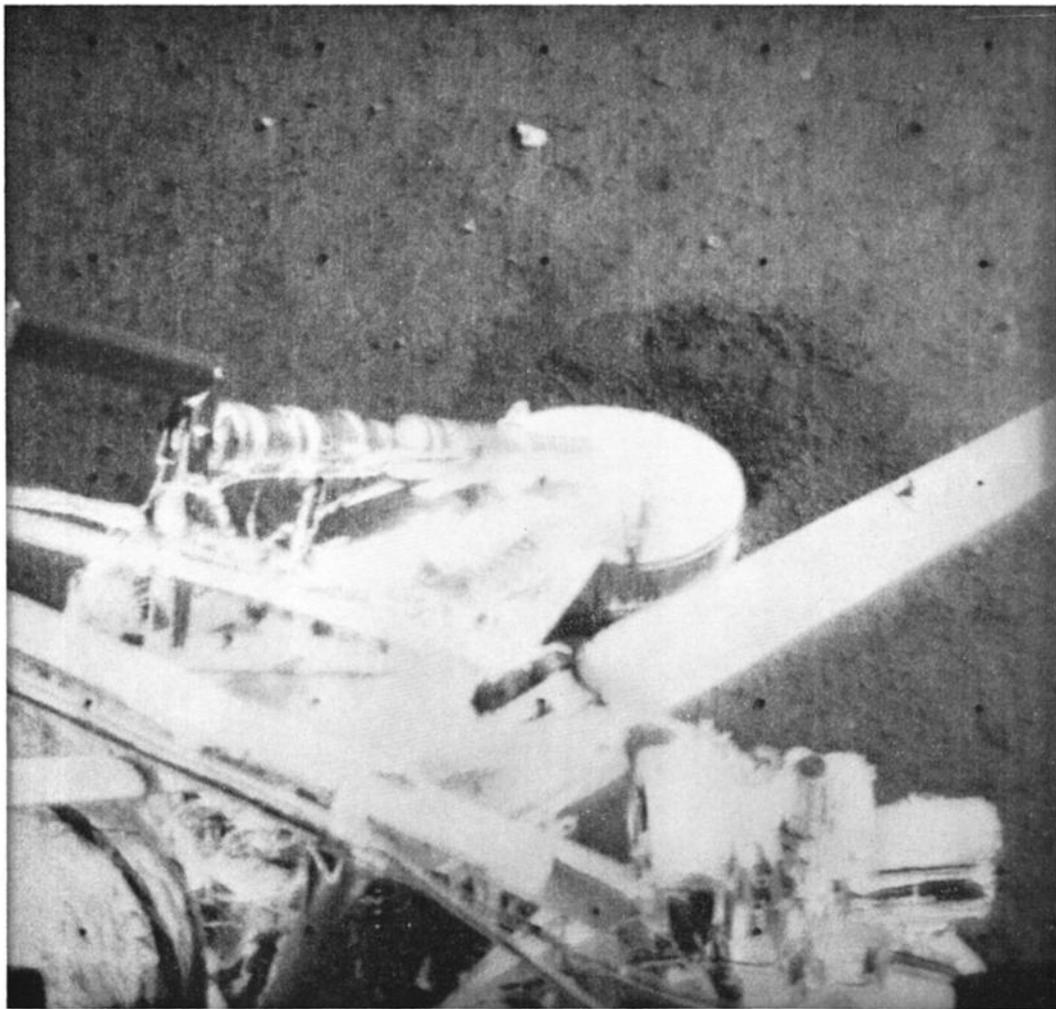
Fig. 6. Wide-angle picture of footpad 3. Note similarity of throwout material to material shown in Figure 7. (A better reproduction can be found at the back of the Journal. See Plate 15.)

Fig. 6. *Christensen et al.* Wide-angle picture of footpad 3. Note similarity of throwout material to material shown in Figure 7.

At footpads 2 and 3, there is a throwout pattern over the surface (Figures 6 and 7), including rays of apparently fine-grained material, to a distance of 0.5 to 0.8 meter (1.5 to 2.5 ft) from the edge of the footpad. Nearer the footpad, the lunar material was displaced to form a raised rim. The sides of the depression and the rim have a chunky or blocky appearance (Figures 7 and 8), the blocks or clumps of material are irregular, have a range of sizes, and appear to consist of aggregates of fine-grained material rather than of individual stones or pebbles. The basic grain size seems to be below the limit of resolution of the narrow-angle pictures in 600-line mode, about 0.5 mm (0.02 in.) at the distance of footpad 2 (approximately 2 meters, or 7 ft). Footpad 2 movements during landing caused some small deformations of the surface adjacent to the footpad on the side nearest the camera (Figure 9). The deformations resulted in an irregular pattern of cracks or fissures at the surface of the material.

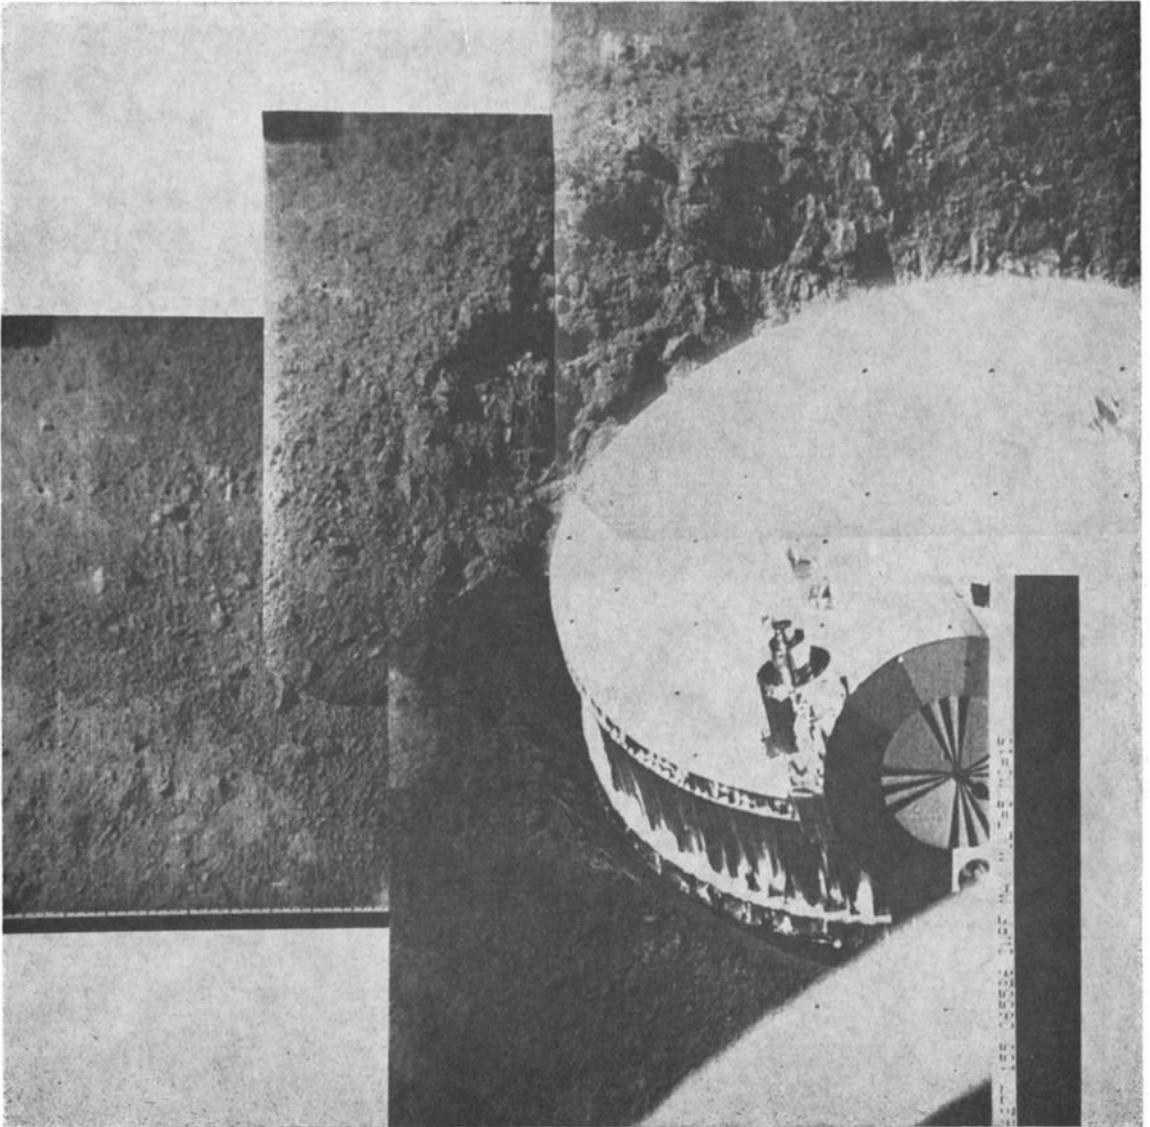
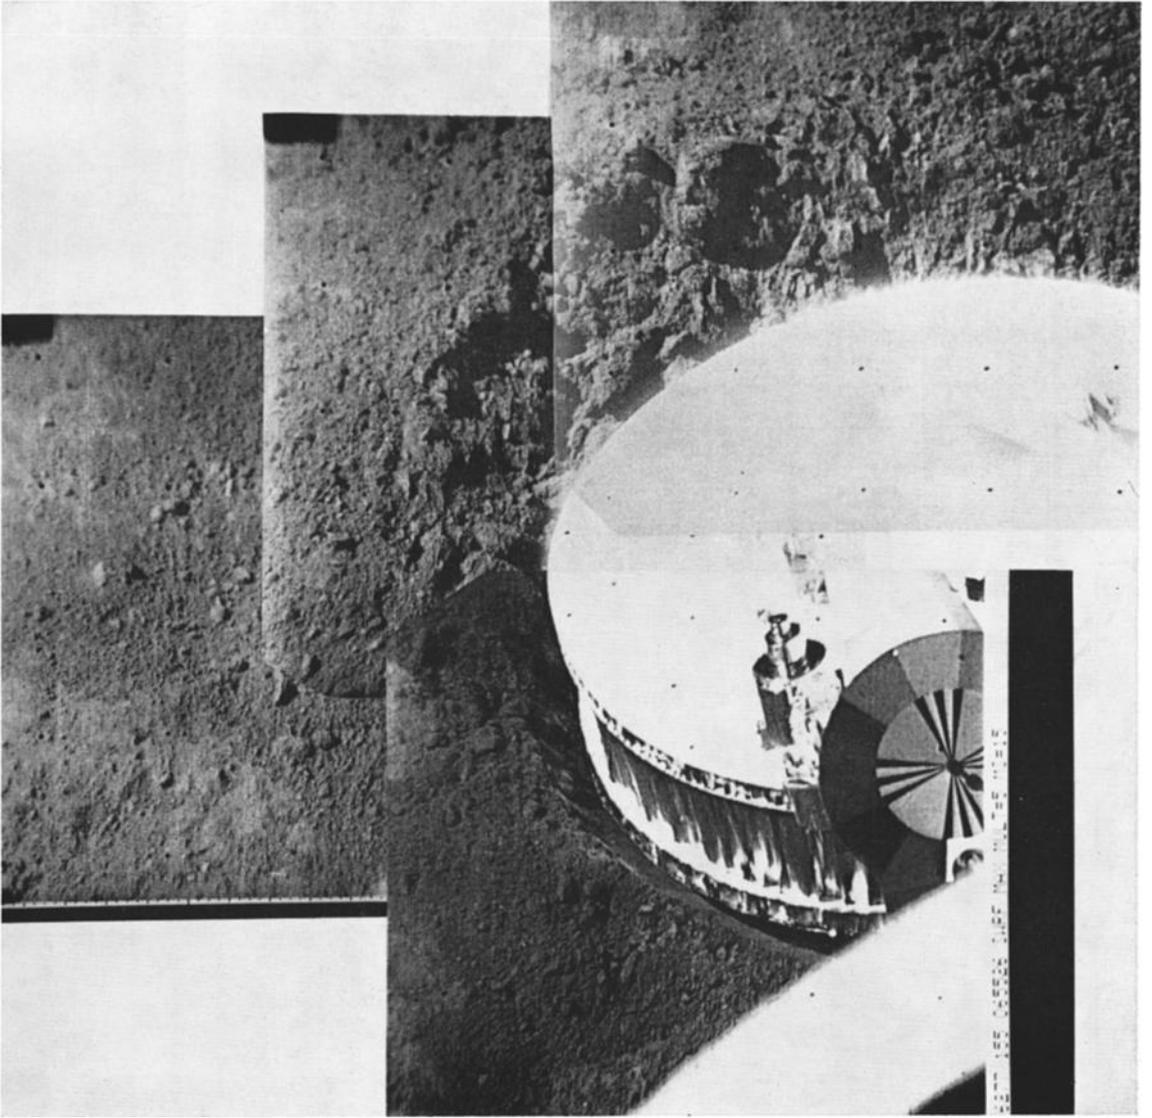
Fig. 7. Mosaic of computer-processed narrow-angle pictures of footpad 2 area taken on June 4, 1966. Sun angle is 54° . (A better reproduction can be found at the back of the Journal. See Plate 16.)

Fig. 7. *Christensen et al.* Mosaic of computer-processed narrow-angle pictures of footpad 2 area taken on June 4, 1966. Sun angle is 54° .

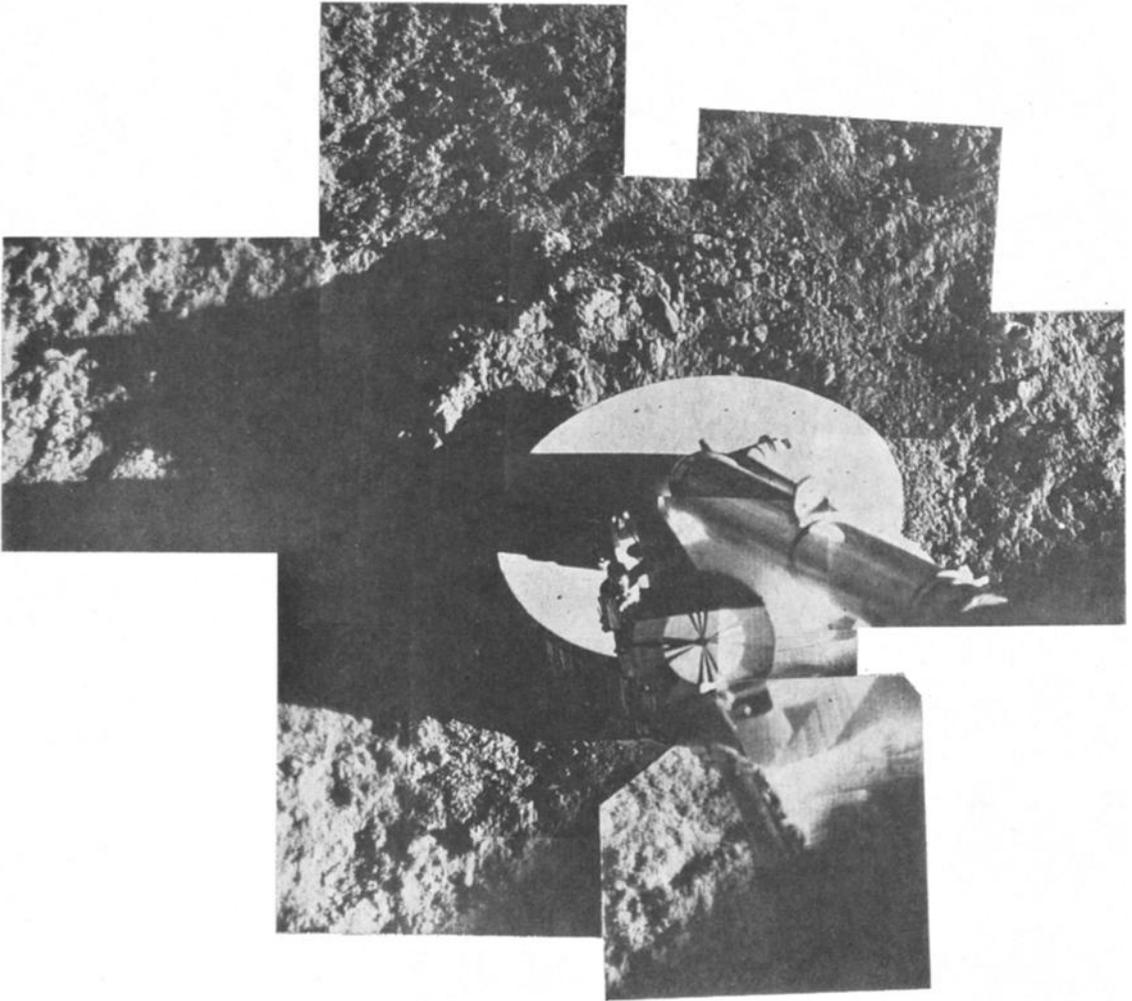
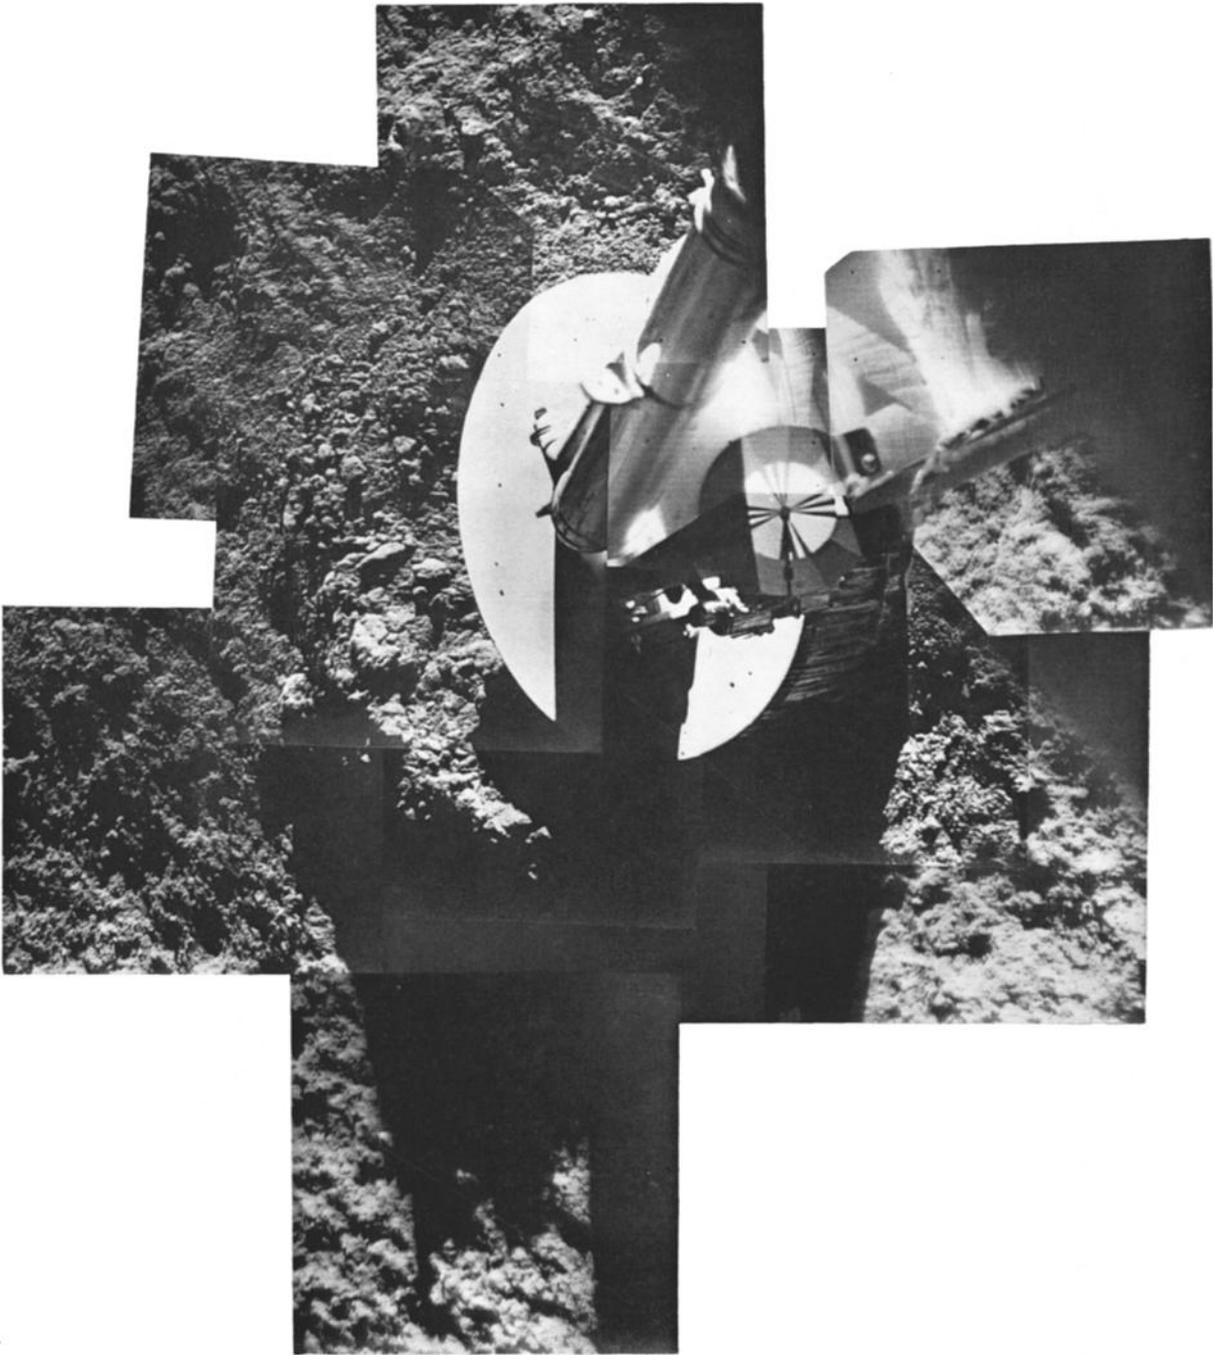
Fig. 8. Mosaic of computer-processed narrow-angle pictures of footpad 2 area taken on June 13, 1966. Sun angle is 10° . Note that four frames are not computer-processed. (A better reproduction can be found at the back of the Journal. See Plate 17.)

Fig. 8. *Christensen et al.* Mosaic of computer-processed narrow-angle pictures of footpad 2 area taken on June 13, 1966. Sun angle is 10° . Note that four frames are not computer-processed.

The penetration of the pads in their final position has been estimated from shadow measurements and observations of numerous photographs. Assuming that there is no pad crushing, the best estimate is that the bottom surface of pad 2 is 4 to 8 cm (1.5 to 3 in.) below the adjacent undisturbed surface (Figures 8 and 11); the bottom surface of footpad 3 penetrated at least 3 cm (1.25 in.). By using morning and afternoon shadow measurements, it has been determined that the top of the footpad 2 is 9 cm (3.5 in.) above the lunar surface to the west of the footpad and 5 cm

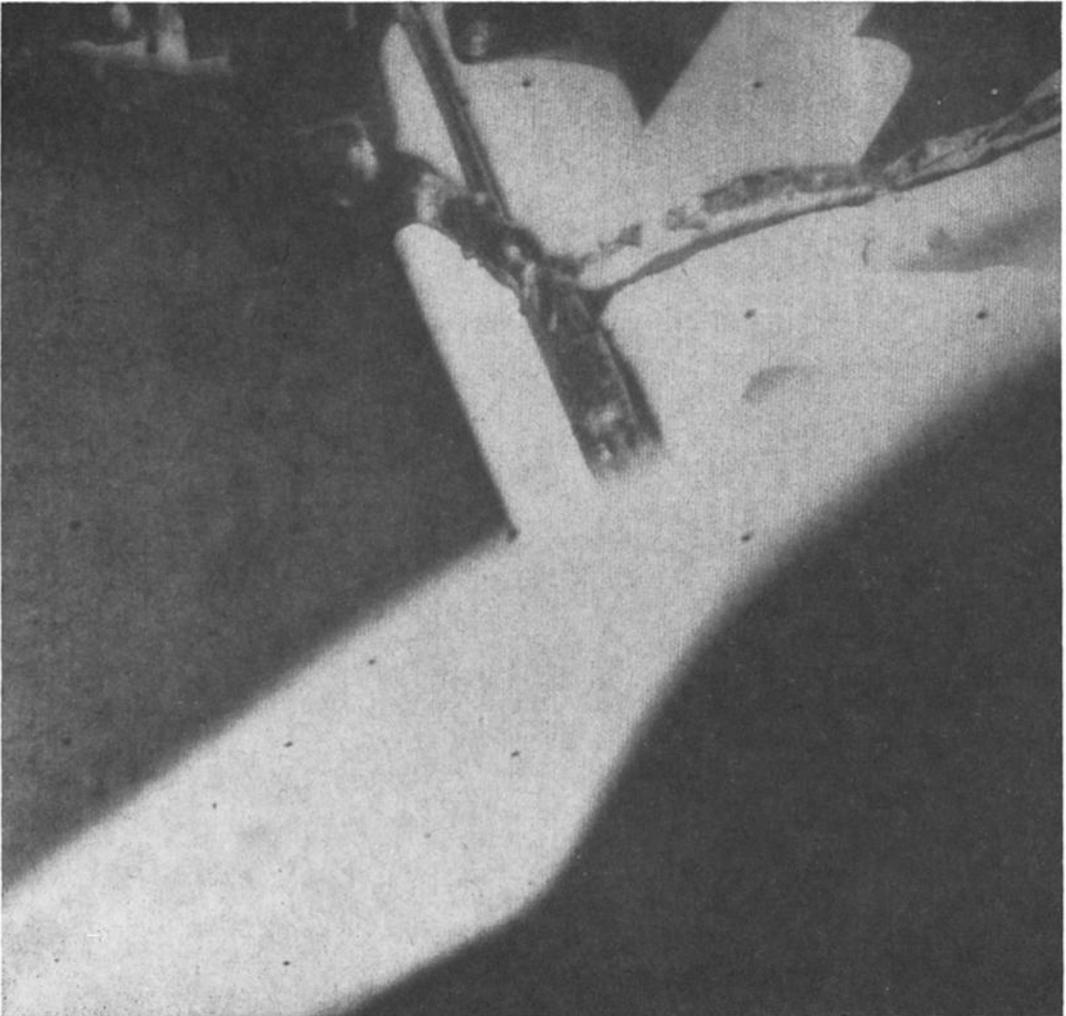
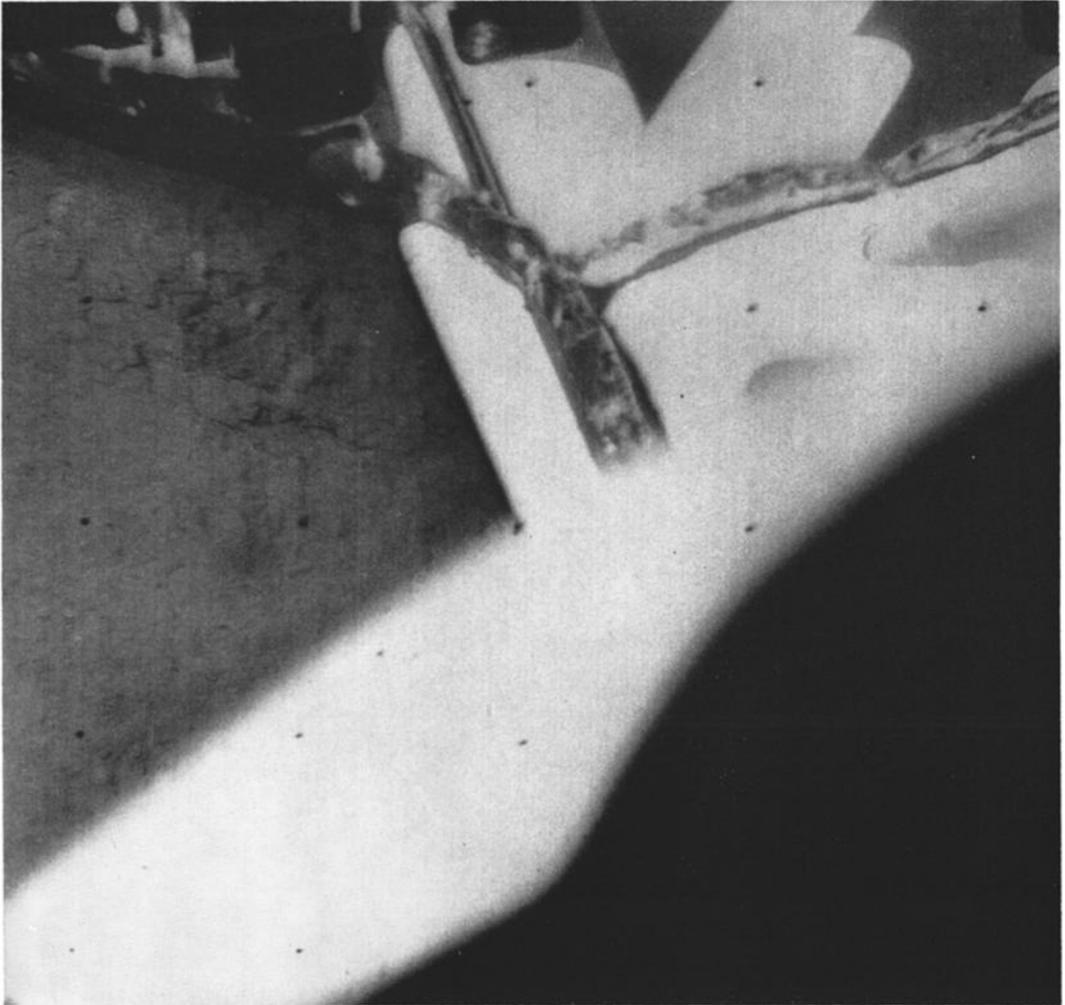
Fig. 9. Narrow-angle picture of disturbed lunar surface material near footpad 2. Disturbed lunar material is in the approximate area in which the exhaust of the attitude control jet impinged on the surface. (A better reproduction can be found at the back of the Journal. See Plate 18.)

Fig. 9. *Christensen et al.* Narrow-angle picture of disturbed lunar surface material near footpad 2. Disturbed lunar material is in the approximate area in which the exhaust of the attitude control jet impinged on the surface.

periods up to 12 sec. The pulse duration was 20 msec with a 30-msec pause between pulses. No soil disturbance has been observed except for a single anomaly. Pictures taken after the firing indicate the existence of a slight dimple crater in the surface in the approximate area in which the gas jet struck the lunar material (Figure 9); however, the pictures taken before the firing are inadequate for determining

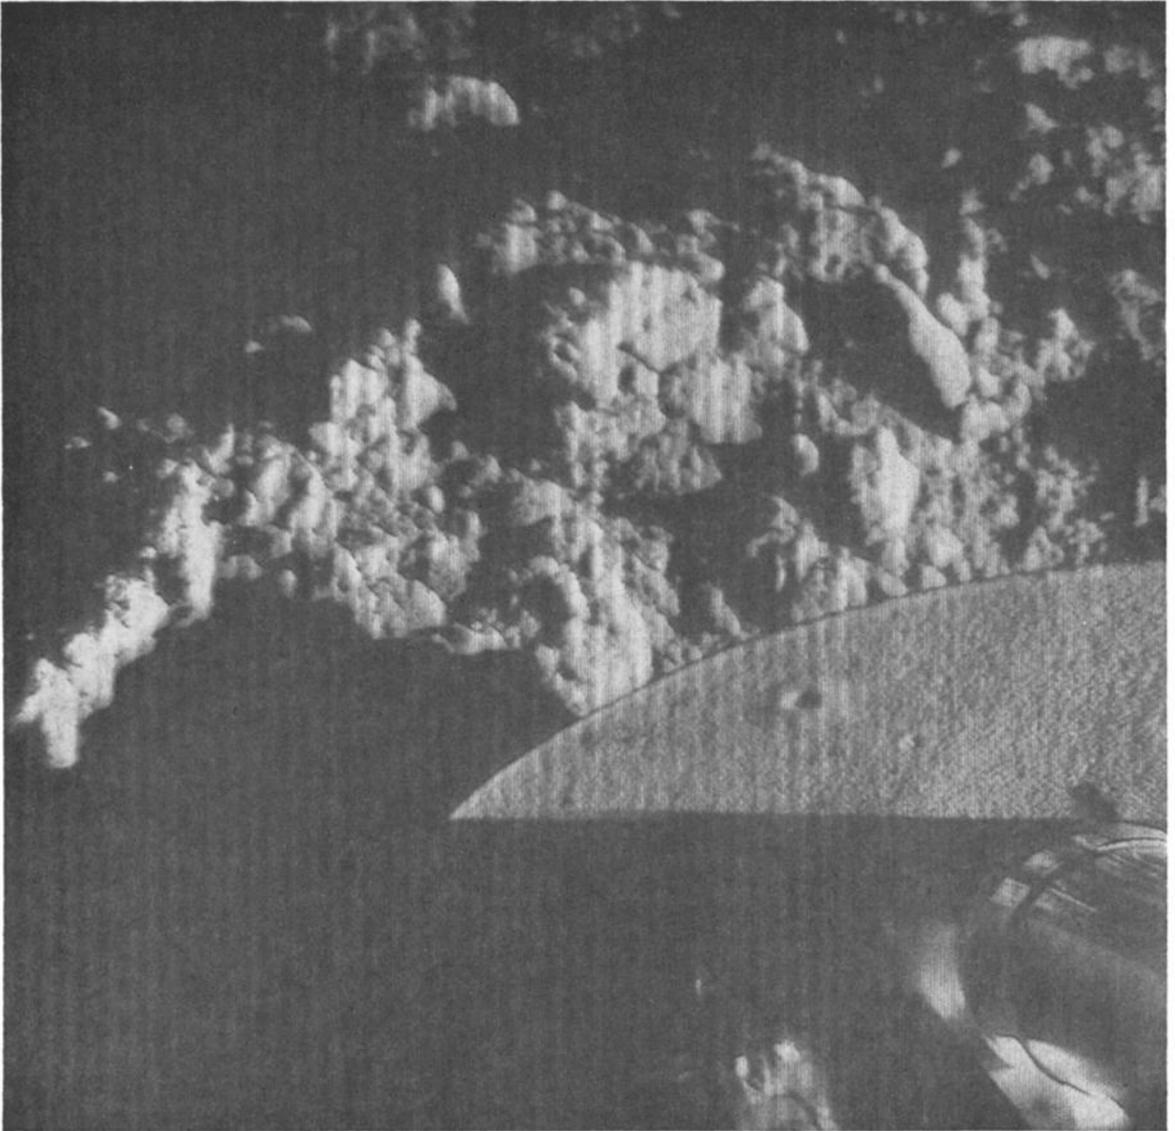
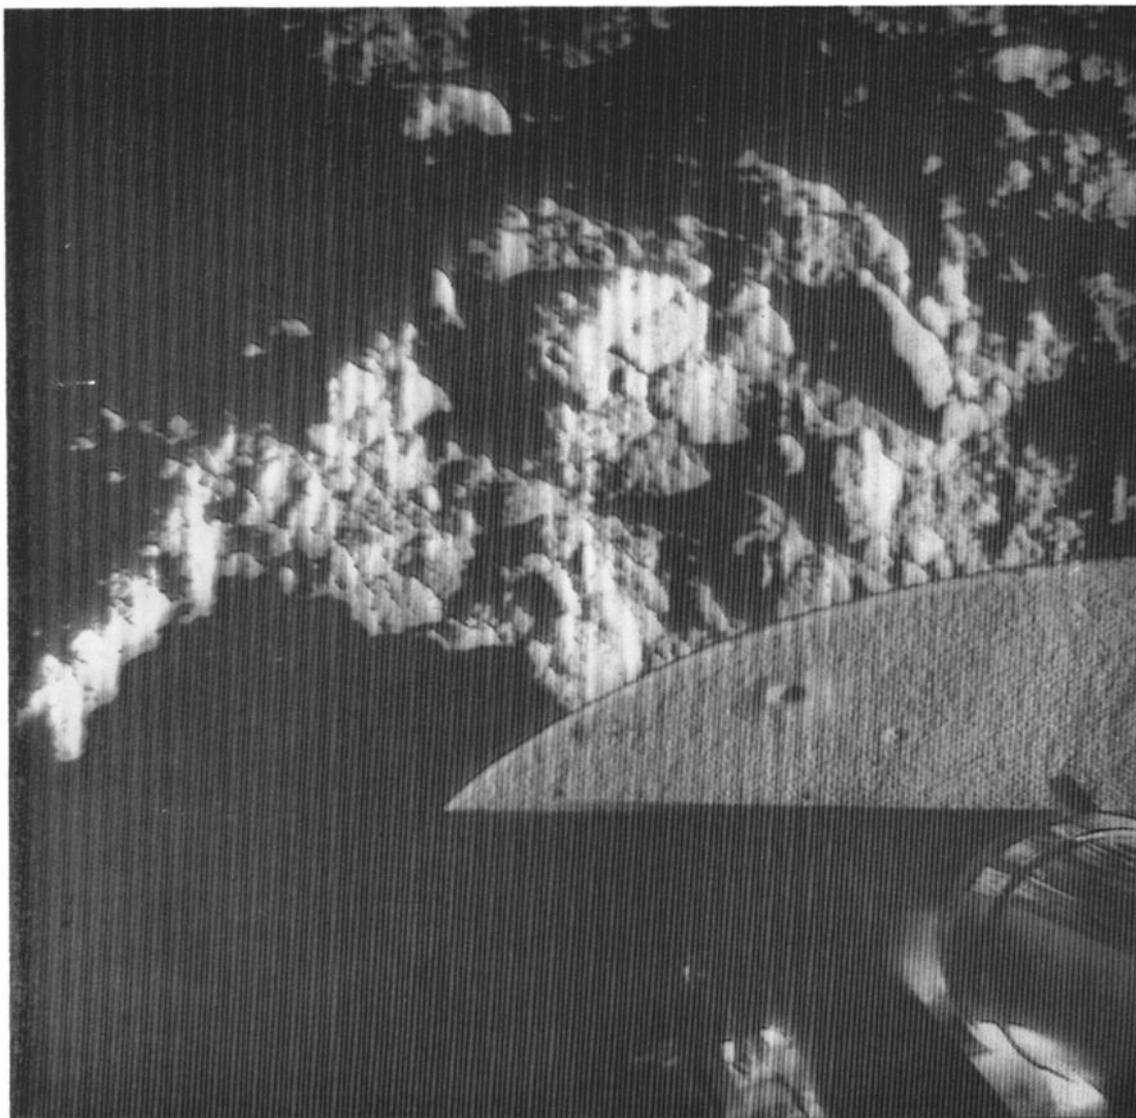
Fig. 10. Narrow-angle picture of footpad 2. Sun angle is 6° above horizon; texture on pad top is unexplained. (A better reproduction can be found at the back of the Journal. See Plate 19.)

Fig. 10. *Christensen et al.* Narrow-angle picture of footpad 2. Sun angle is 6° above horizon; texture on pad top is unexplained.

Late in the second lunar day, a picture of footpad 2 (Figure 10) was obtained. The top of the footpad has the texture of a layer of fine lunar material; however, because none of the earlier pictures indicate such a layer, and because there is no known event that could have deposited it, the texture is possibly the result of unevenness in the paint, accentuated by the low sun angle of 6° that prevailed at the time this picture was taken.

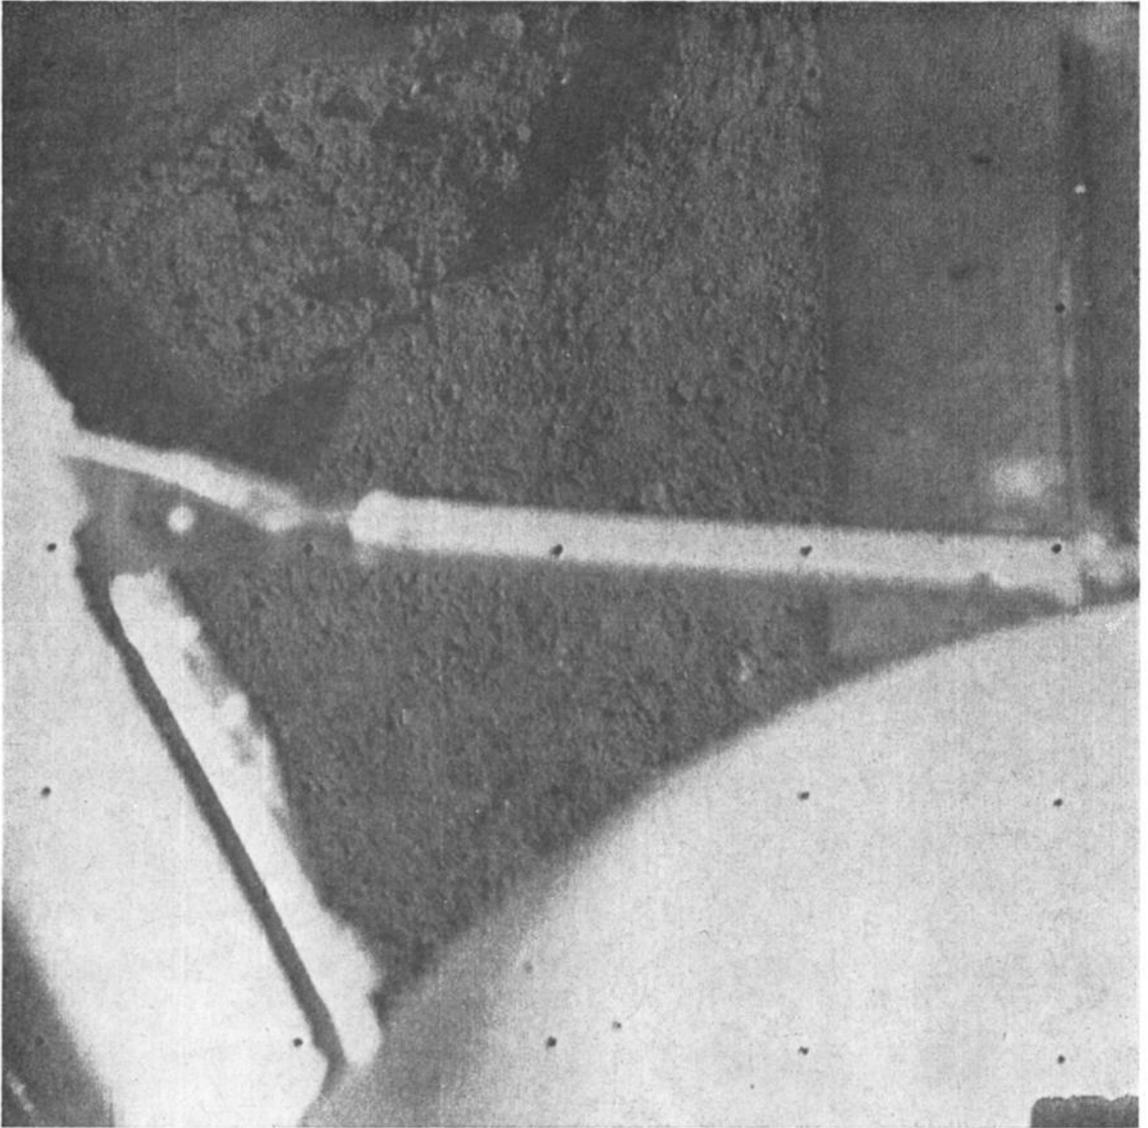
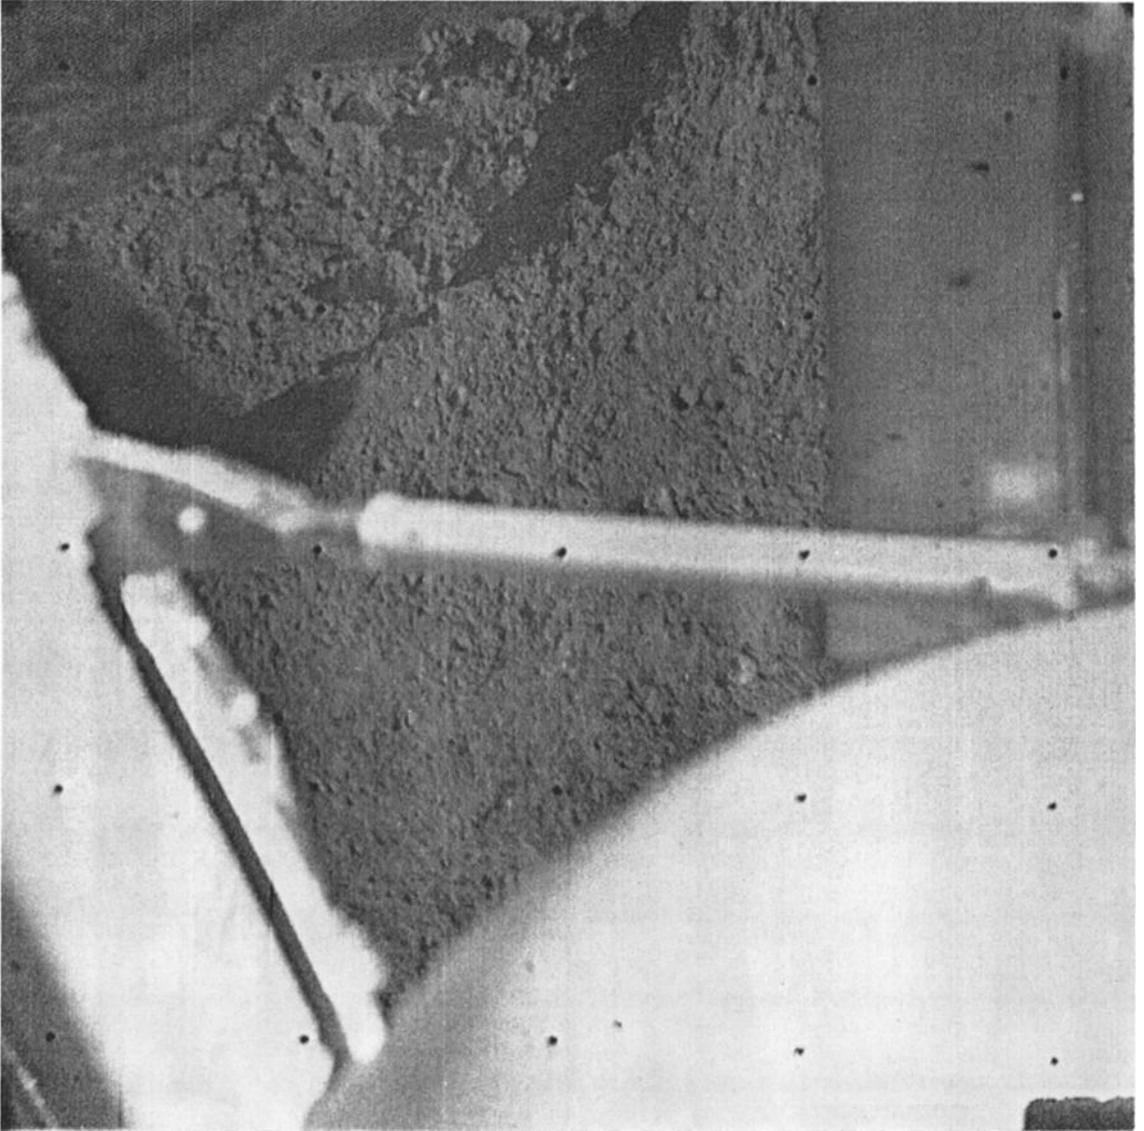
Fig. 12. Computer-processed picture of surface depression made by crushable block assembly 3. Note the lunar surface depression in upper left-hand corner; part of the propellant tank obscures the imprint in the extreme left-hand corner. Sun angle is 41° and from the right of the picture. (A better reproduction can be found at the back of the Journal. See Plate 21.)

Fig. 12. *Christensen et al.* Computer-processed picture of surface depression made by crushable block assembly 3. Note the lunar surface depression in upper left-hand corner; part of the propellant tank obscures the imprint in the extreme left-hand corner. Sun angle is 41° and from the right of the picture.

Pictures of a depression in the lunar surface under crushable block assembly 3 (Figures 12

and 13) indicate that it also made contact with the lunar surface. It has not been possible to identify any lunar surface depression under crushable block assembly 1 because of spacecraft shadows in that area. The area beneath crushable block assembly 2 and the crushable blocks themselves cannot be seen with the Surveyor television camera. The symmetry of the impact and the general local flatness of the lunar surface, however, lead to the conclusion that all three of the crushable blocks made contact with the lunar surface.

proximately 2 cm (0.75 in.). However, the depression, or imprint (Figures 12 and 13), was not made by block 3 itself. The sharp outline of the imprint was made by the thermal insulator that partly surrounds the block (Figure 14). It appears that, as the block penetrated into the soil, some material was pushed into the annular space between the block and the insulator. Then, as the spacecraft rose, this material fell back, partly into the depression. This explains the fact that the lunar material in the imprint does not have a crushed appearance and that the material was not sprayed out around the imprint. Factors that can be

1. Block assembly 3 penetrated more than 2 cm (0.75 in.).
2. Lunar material is compressible to some extent because an appreciable depression was formed with only a slight visible raising of adjacent material. (This conclusion is tentative because of the small percentage of depressed area and of the visible surrounding region.)
3. Lunar material has cohesion; i.e., the

edge remains standing at an angle of at least 58° . (In Figures 12 and 13, the edge appears vertical; however, the camera line of sight to block 3 is 58° above the horizon.)
