Lunar Surface Mechanical Properties—Surveyor 1

Engineering telemetry data and lunar surface photographs by Surveyor 1 have been evaluated for information on the mechanical properties of the lunar surface material at the Surveyor 1 landing site. Based primarily on photographic evidence, estimates of soil density, cohesion, and other soil characteristics are presented. Also, the mechanisms in which the lunar material is believed to have failed under the footpad impacts are discussed. Because dynamic soil reactions cannot be interpreted directly from the available data, a comparative study using computer-simulated landings was initiated. Preliminary results of this study, which is still in progress, are presented.

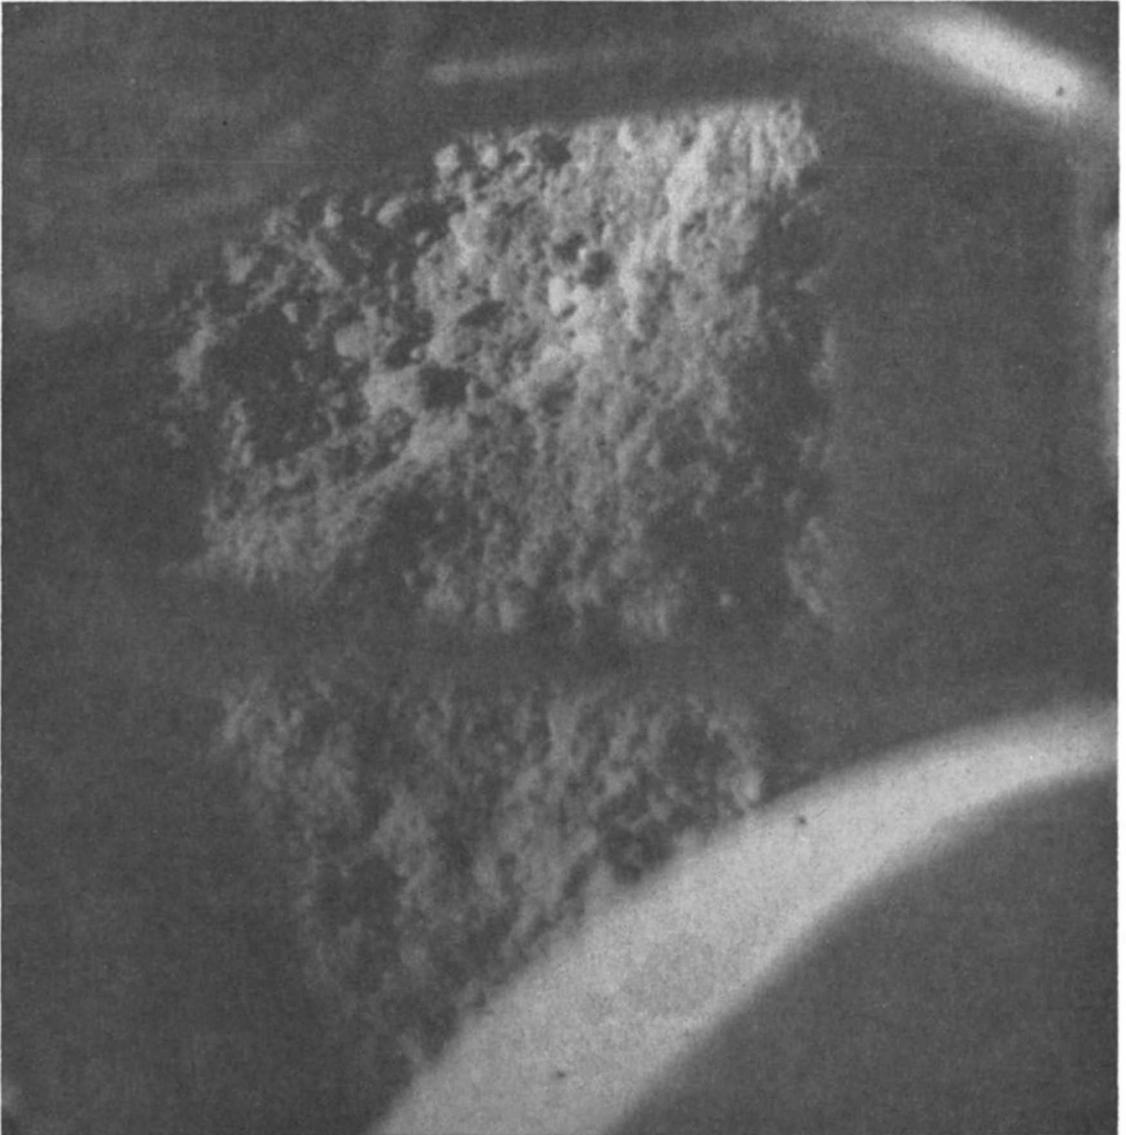
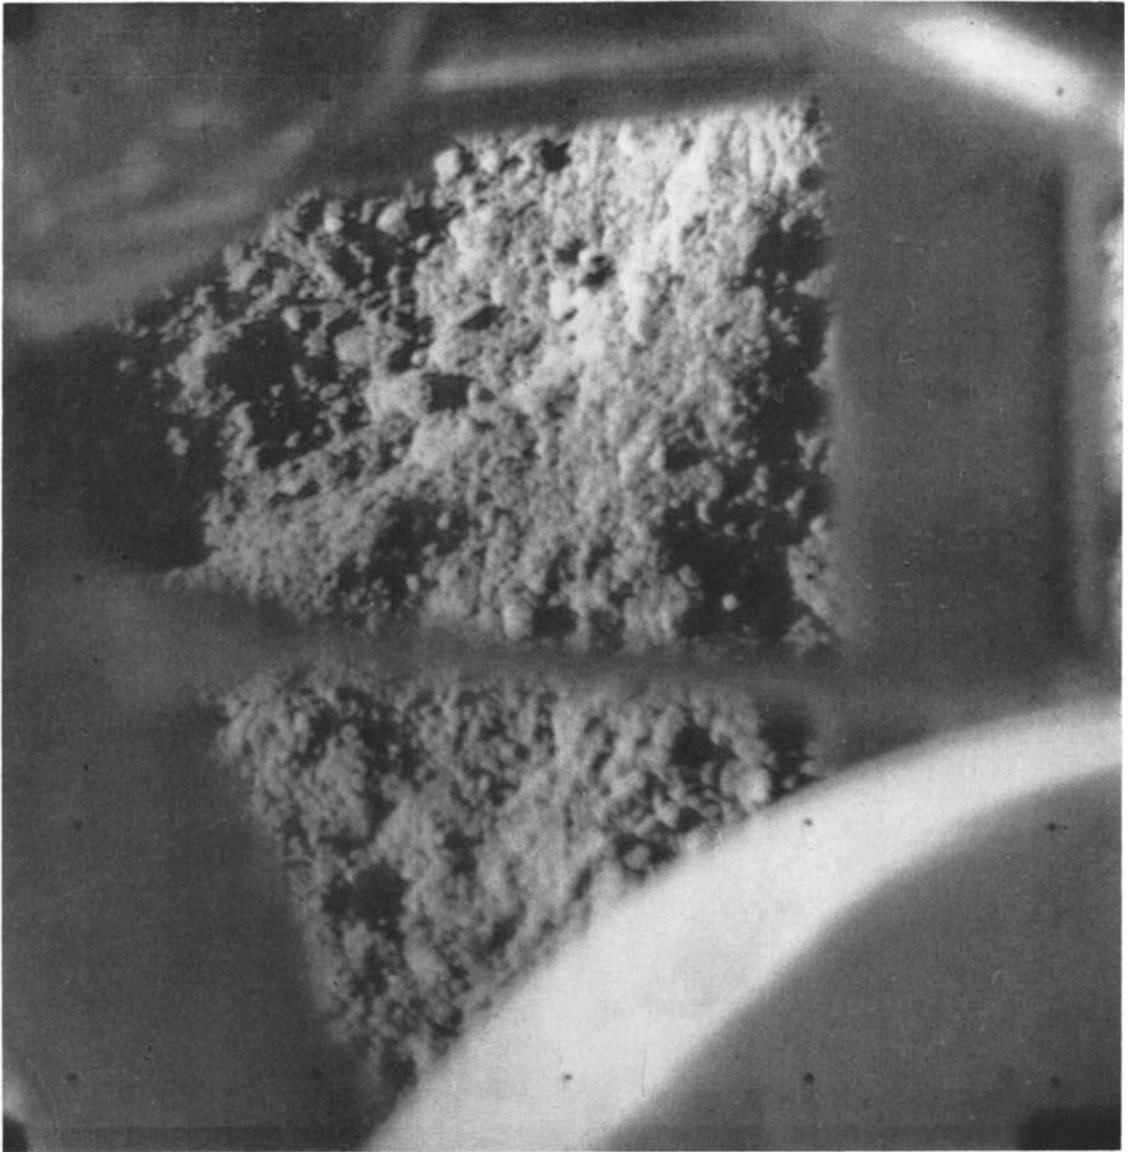
Fig. 13. Block assembly 3 imprint taken late on the second lunar day. Sun angle is 22° and from the left of the picture. No noticeable change in the disturbed material has been observed during a time period greater than 5 weeks. (A better reproduction can be found at the back of the Journal. See Plate 22.)

Fig. 13. *Christensen et al.* Block assembly 3 imprint taken late on the second lunar day. Sun angle is 22° and from the left of the picture. No noticeable change in the disturbed material has been observed during a time period greater than 5 weeks.

Pictures of a depression in the lunar surface under crushable block assembly 3 (Figures 12

and 13) indicate that it also made contact with the lunar surface. It has not been possible to identify any lunar surface depression under crushable block assembly 1 because of spacecraft shadows in that area. The area beneath crushable block assembly 2 and the crushable blocks themselves cannot be seen with the Surveyor television camera. The symmetry of the impact and the general local flatness of the lunar surface, however, lead to the conclusion that all three of the crushable blocks made contact with the lunar surface.

proximately 2 cm (0.75 in.). However, the depression, or imprint (Figures 12 and 13), was not made by block 3 itself. The sharp outline of the imprint was made by the thermal insulator that partly surrounds the block (Figure 14). It appears that, as the block penetrated into the soil, some material was pushed into the annular space between the block and the insulator. Then, as the spacecraft rose, this material fell back, partly into the depression. This explains the fact that the lunar material in the imprint does not have a crushed appearance and that the material was not sprayed out around the imprint. Factors that can be

edge remains standing at an angle of at least 58° . (In Figures 12 and 13, the edge appears vertical; however, the camera line of sight to block 3 is 58° above the horizon.)

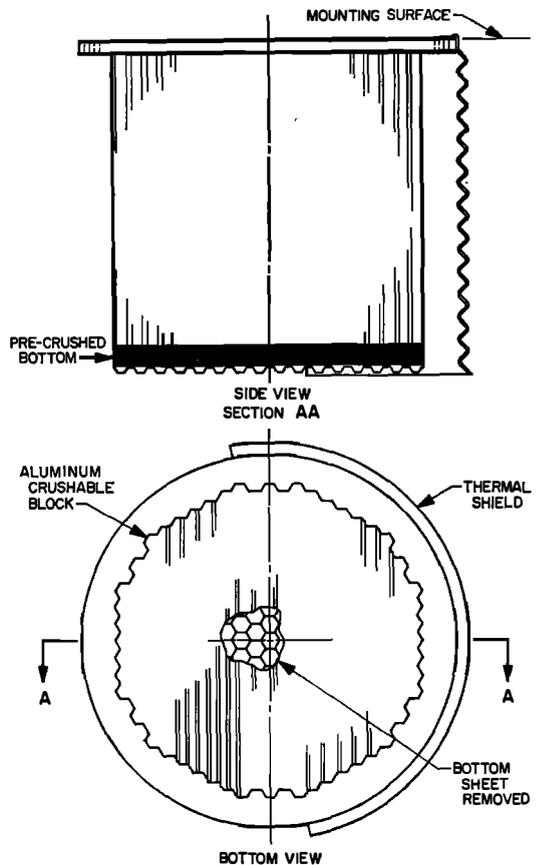
Fig. 14. Two views of crushable block assembly 3 including thermal shield, side view and bottom view.

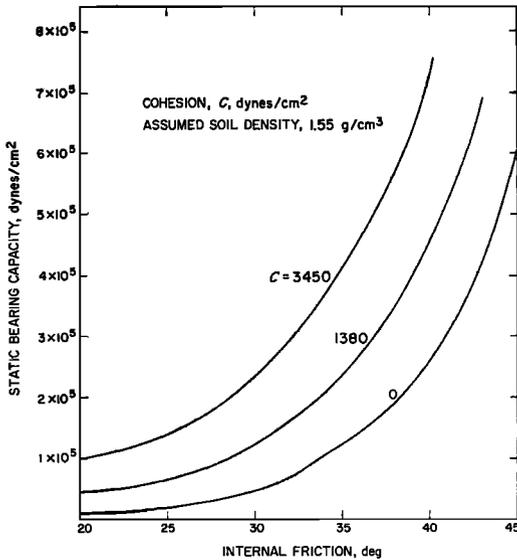
Fig. 15. Possible static bearing capacity of a 30.5-cm- (1 ft) diameter footing on moon.

A number of materials that have a wide range of properties can develop a specific static bearing capacity. By assuming a static bearing capability of 3.5×10^6 dynes/cm² (5 psi), one possibility is a soil with a cohesion in the range of 1.3 to 4×10^6 dynes/cm² (0.02 to 0.05 psi) and a friction angle between 30° and 40° , at a density typical of terrestrial soil (1.5 g/cm³ or 3 slugs/ft³, Figure 15).

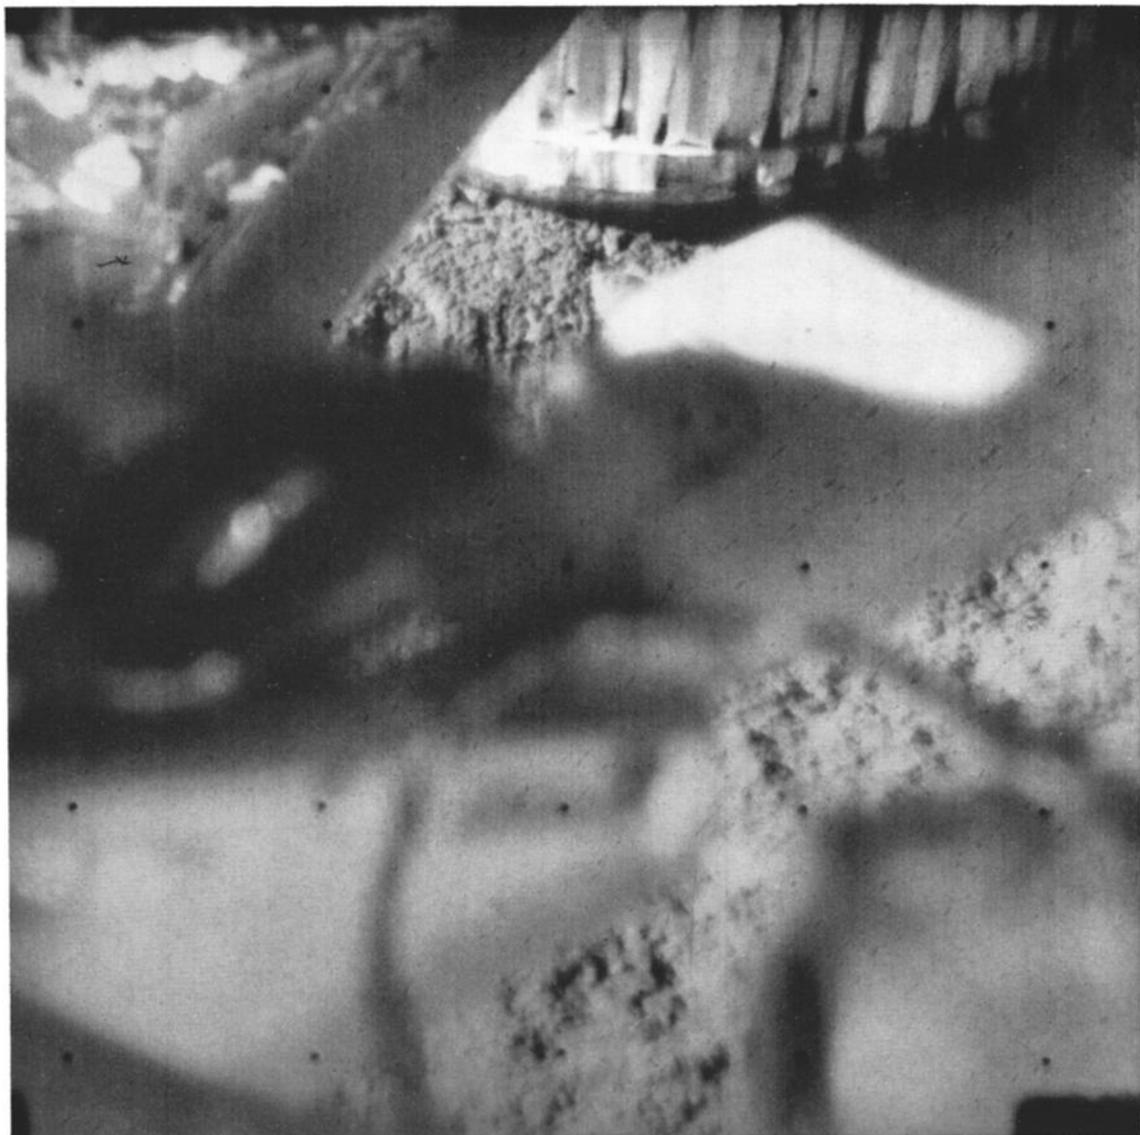
Fig. 11. Narrow-angle picture of footpad 3. Sun angle is 25° ; camera angle from which this picture was taken enabled the surface in foreground of footpad to be seen. (A better reproduction can be found at the back of the Journal. See Plate 20.)

Fig. 11. *Christensen et al.* Narrow-angle picture of footpad 3. Sun angle is 25° ; camera angle from which this picture was taken enabled the surface in foreground of footpad to be seen.
