Relating geologic units and mobility system kinematics contributing to Curiosity wheel damage at Gale Crater, Mars

Curiosity landed on plains to the north of Mount Sharp in August 2012. By June 2016 the rover had traversed 12.9 km to the southwest, encountering extensive strata that were deposited in a fluvial-deltaic-lacustrine system. Initial drives across sharp sandstone outcrops initiated an unacceptably high rate of punctures and cracks in the thin aluminum wheel skin structures. Initial damage was found to be related to the drive control mode of the six wheel drive actuators and the kinematics of the rocker-bogie suspension. Wheels leading a suspension pivot were forced onto sharp, immobile surfaces by the other wheels as they maintained their commanded angular velocities. Wheel damage mechanisms such as geometry-induced stress concentration cracking and low-cycle fatigue were then exacerbated. A geomorphic map was generated to assist in planning traverses that would minimize further wheel damage. A steady increase in punctures and cracks between landing and June 2016 was due in part because of drives across the sharp sandstone outcrops that could not be avoided. Wheel lifet

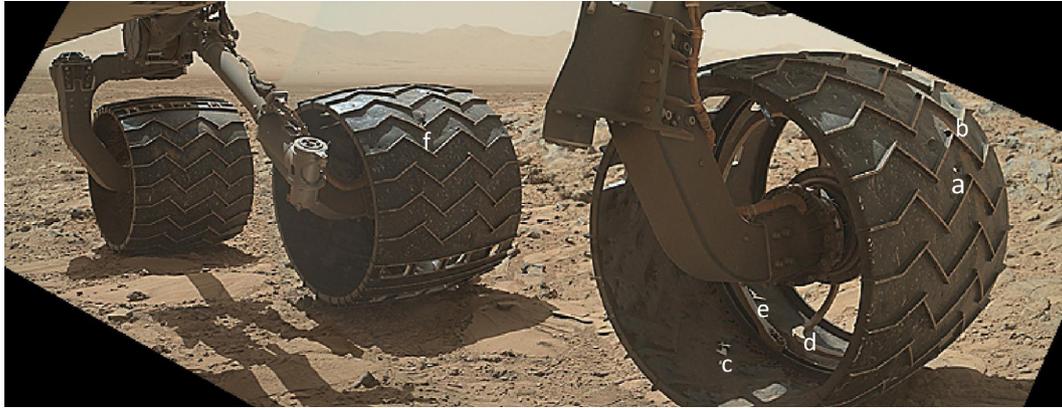
Fig. 4. Mosaic of Curiosity left wheels taken on sol 488. MAHLI-based mosaic showing the left wheels on sol 488 after crossing initial irregular sandstones that have been shaped by fracturing and wind into sharp surfaces. Letters labeled on wheels show individual punctures (denoted by letter a) and tears (remaining letters) for the front (L1) and middle (L2) wheels. None were found for the rear (L3) wheel. Image products 0488MH 000262000 0200500 E01_DRCL, 0488MH0002630000200498E01_DRCL, and 0488MH0002640000200496E01_DRCL used in generating the mosaic.

sharp, immobile surfaces (Fig. 3b). Images of the wheels acquired by MAHLI showed new punctures and cracks after a few of these outcrops were traversed (Fig. 4). Analysis of HiRISE images (McEwen et al., 2007) showed that the plains along the route to Mount Sharp transitioned to even more exposures of eroded and likely sharp sandstone outcrops, and then to broad plateaus capped by these sandstone deposits. Relatively planar and recessive mudstone bedrock was inferred to be exposed in the valleys located between the plateaus, variably covered by wind-blown sand ripples and regolith. This geomorphic pattern was interpreted to be a consequence of wind erosion, with more indurated sandstones capping the plateaus, and valleys formed by wind-induced scarp retreat, locally trapping wind-blown sands and regolith, and exposing underlying and less resistant mudstones.

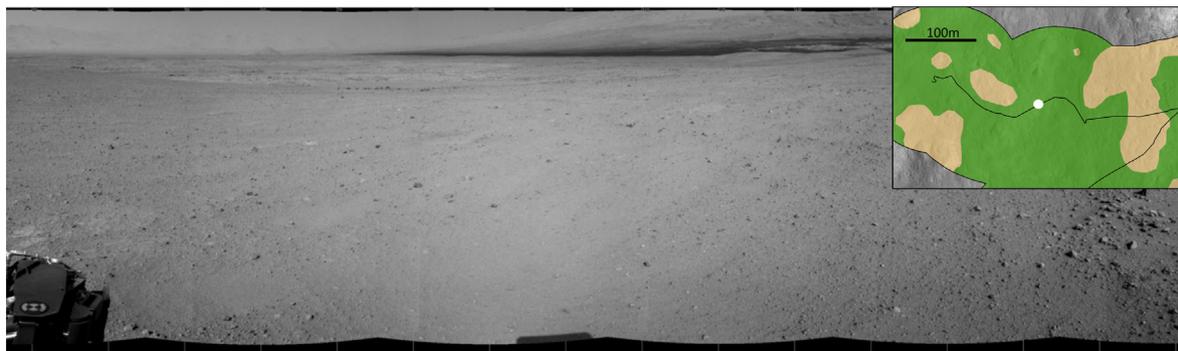
Fig. 9. **Smooth plains: Sol 40 Navcam mosaic.** Navcam mosaic centered on the white dot is shown for the *smooth plains* map unit type locality: rolling or hummocky plains dominantly covered with regolith with few dispersed rocks. Also shown on this and subsequent unit type locality figures is a map inset keyed to Fig. 8 and Navcam mosaics used are given in Table 2. The mosaic extends from ~30° to 175° in azimuth clockwise from north.

The *smooth plains* unit dominated exposures from Bradbury Landing to Yellowknife Bay (Fig. 9), and exiting Yellowknife Bay until extensive patches of irregular, sharp sandstone outcrops of the Bradbury group were encountered. These rolling and largely regolith-covered plains presented innocuous drives in which relatively small pebbles and cobbles were pushed into the regolith by the wheels, or larger cobbles were rotated by the wheels, both without discernable wheel damage.
