## **CHAPTER 6: EARTHQUAKE RELIEF AND RECONSTRUCTION OF TANGSHAN**

### **DISASTER RELIEF AFTER THE TANGSHAN EARTHQUAKE**

## THE REPAIR AND RESTORATION OF THE KAILUAN COAL MINE

## **EMERGENCY AT THE BAIHE RIVER MAIN DAM OF THE MIYUN RESERVOIR**

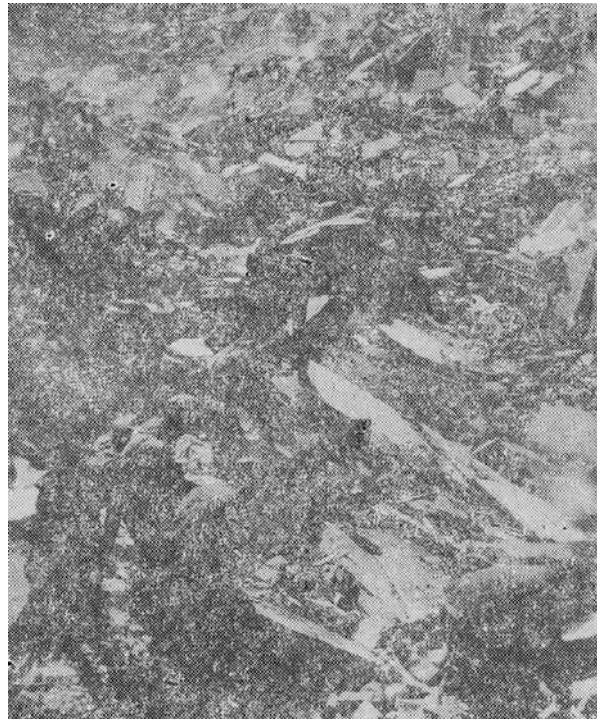
More than 100,000 officers and soldiers of the PLA went to the disaster region from Beijing, Shenyang, Hebei and other areas. They played a central role during the emergency disaster relief (see Photo 1). Under the direct jurisdiction of the central government all the provinces and cities as well as the autonomous regions sent medical workers and specialized personnel from industry, communications, postal and telecommunication, construction, water and power supply, mining rescue, etc. to the disaster area. At the same time large quantities of medicine, grain, food, construction equipment and daily necessities were transported to the disaster area.

Photo 1. Removing victims from underneath the rubble of buildings.

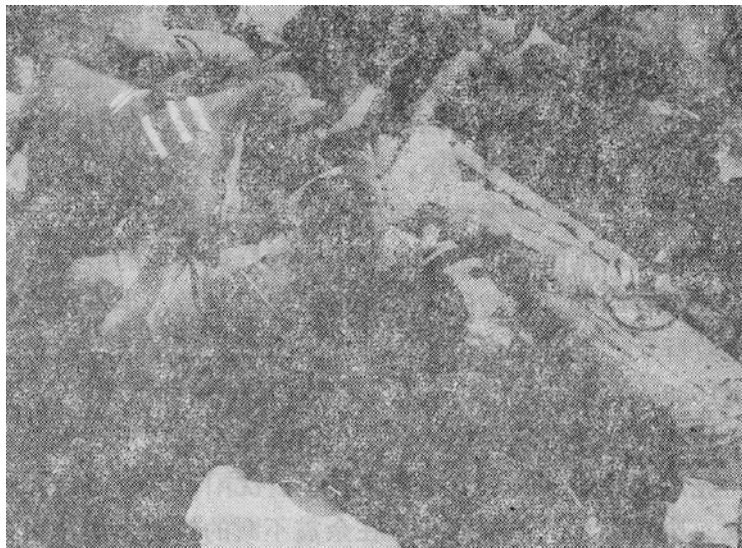
Photo 2. Saving survivors excavated from the rubble.

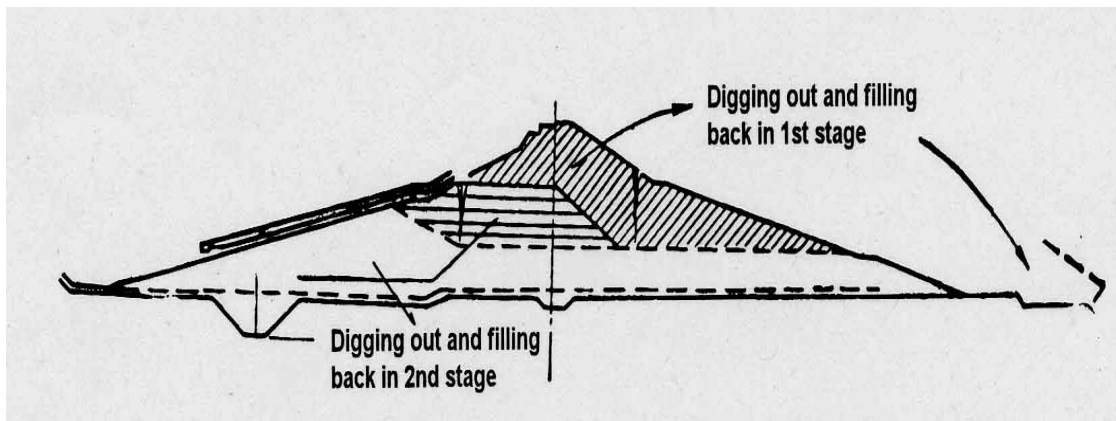
Figure 2. A map of the main dam repaired in stages.

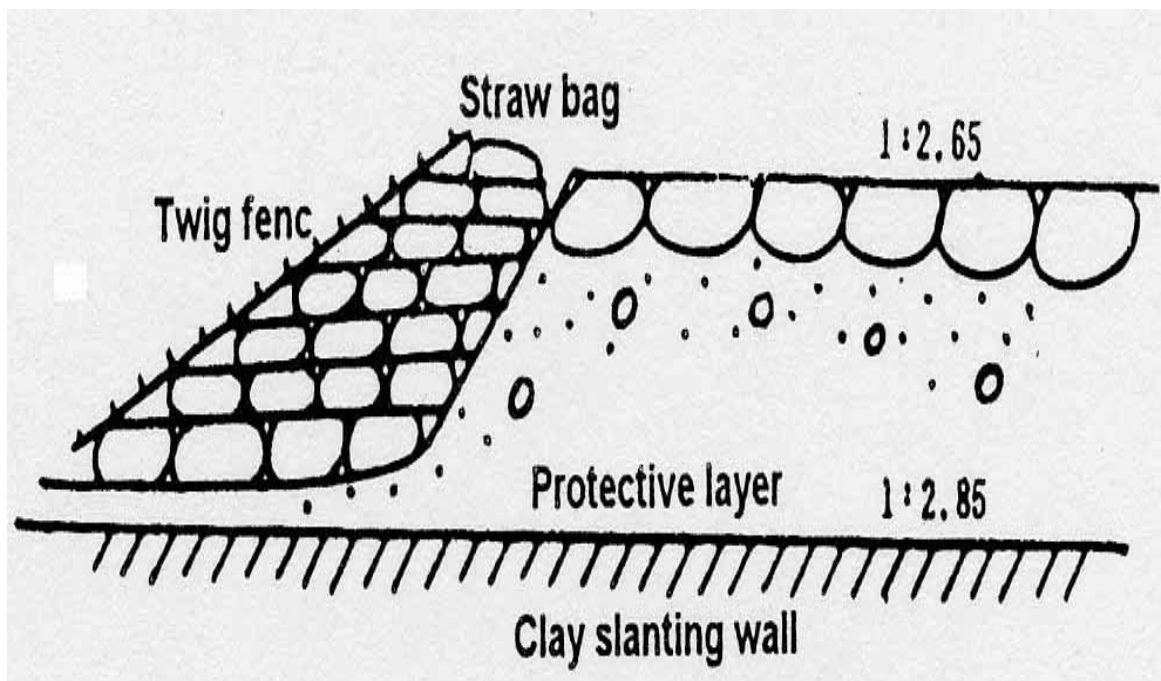
Figure 1. Section of the enforced dam.  
Note: (1) straw bag; (2) twig fence; (3) protective layer; (4) clay slanting wall

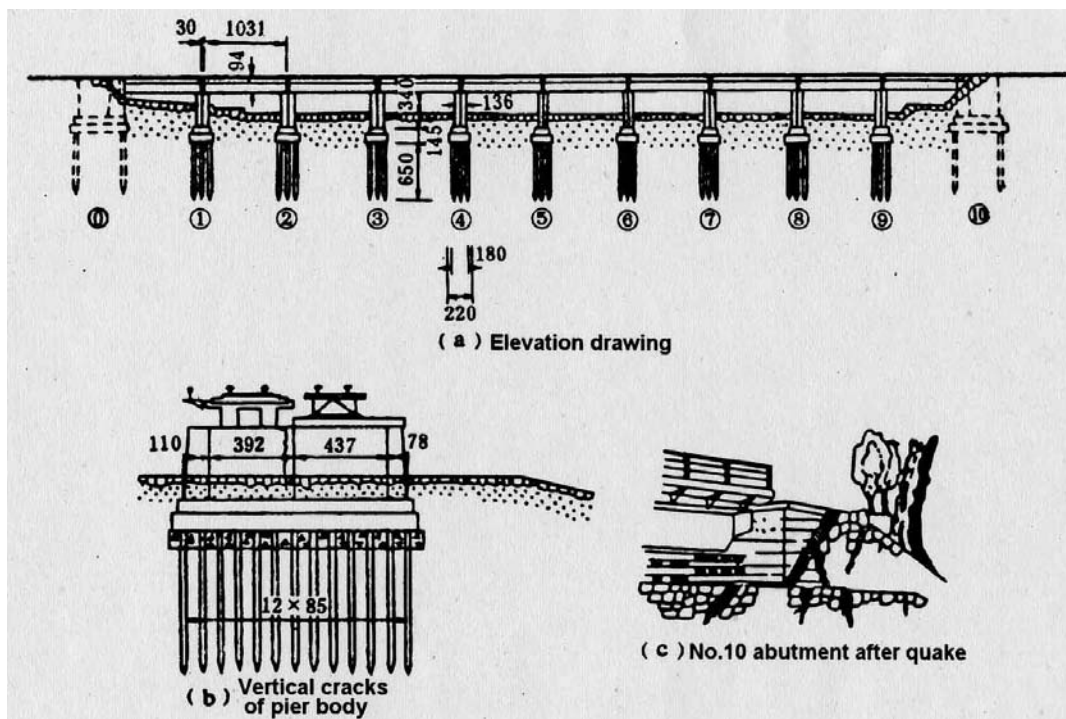
Figure 1. A sketch of the Shiman Shahe River Bridge (unit: cm).

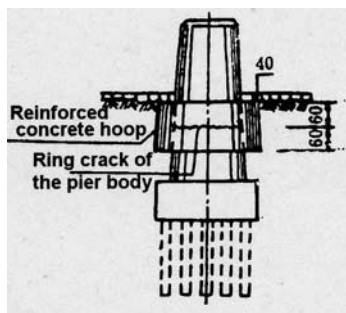
On the bank the No. 1 and No. 2 pier body cracked in a ring shape. Connecting rods and reinforced concrete hoops were built to strengthen them (see Fig. 5 for the hoop arrangement of the No. 1 pier).

Figure 5. Reinforced concrete hoop of the No. 1 pier of the Ji Canal down-line bridge on (unit: cm).

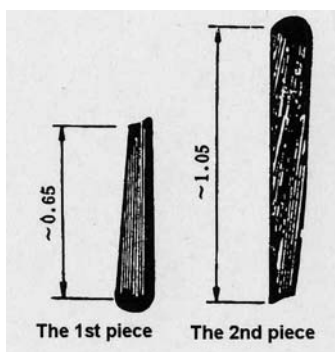
The first drilling hole went through 0.57 m of stone chips before reaching concrete, at that time it was considered to be a construction wall but when drilling 1 m farther black sandy clay was found. After going through 0.89 m of the sandy clay a piece of wedge-shaped wood about 0.65 m in length was discovered. Further drilling was carried out and as a result it was verified that the front edge of the concrete was 1.2 m off horizontally from the pier body top. The second hole drilled was 0.4 m from the first hole toward the center of the river and at the same depth as the first hole where the concrete was found the thickness of the concrete layer was 0.93 m. Passing through the concrete the drilling reached the wood immediately; the wood was cylinder shaped with a sharp edge and was 1.05 m in length. Under the wood there was again black sandy clay. The wood shape determined from the 2 holes is shown in Fig. 7. The second piece of wood, where of its sharp edge changed to 90°, had a length, which was parallel to the drilling hole. The appearance of the second wood piece further indicated that a wood pile foundation existed. For its possible arrangement see Fig. 8. The third drill hole was 0.8 m from the first and second holes at the lower reaches and 0.42 m from the top side of the pier body. Neither wood piles nor concrete walls were found.

Figure 7. Wood pile samples from a drilling hole at the No. 5 pier of the Ji Canal down-line bridge (unit: m).

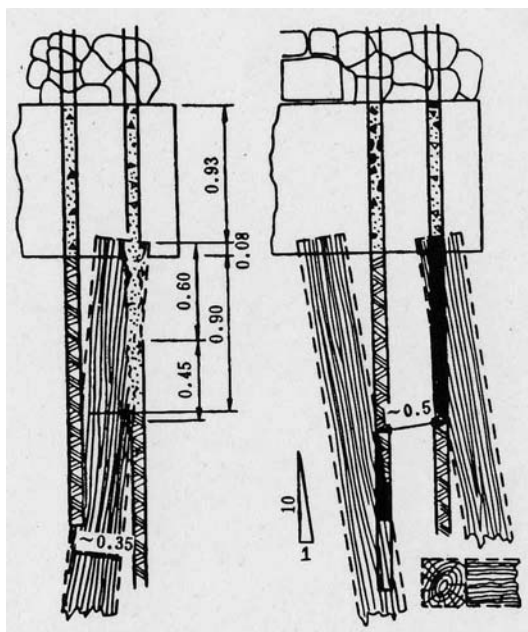
Inferring that the slanting pile inclined towards the bank and that it was a square pile as used in the past, the pile could move 0.3 meters and the center distance was about 0.8 m. There should be one straight pile at 0.4 m to the right or left of the center line of the bridge. The position of the No. 4 drilling hole was determined here. The result was as expected, a straight pile with a length of 1.1 m was found. At the same time, wood piles were also discovered both in a drill hole of the No. 3 pier and in another drill hole in front of the No. 0 abutment. Therefore it was concluded that all pile-foundations were made completely different from the original report on the pier foundations. The restored No. 5 pier foundation is shown in Figure 9. The length of the piles were 16-20 m and there were both straight piles and slanting ones. This showed that the ground fissures on the riverbanks parallel to the river made both the riverbed and the piles move as a single body so that the repair plan of shifting steel beam support points was adopted.

Figure 8. The possible position of the slanting pile at the No. 5 pier of the Ji Canal down-line bridge (unit: m).

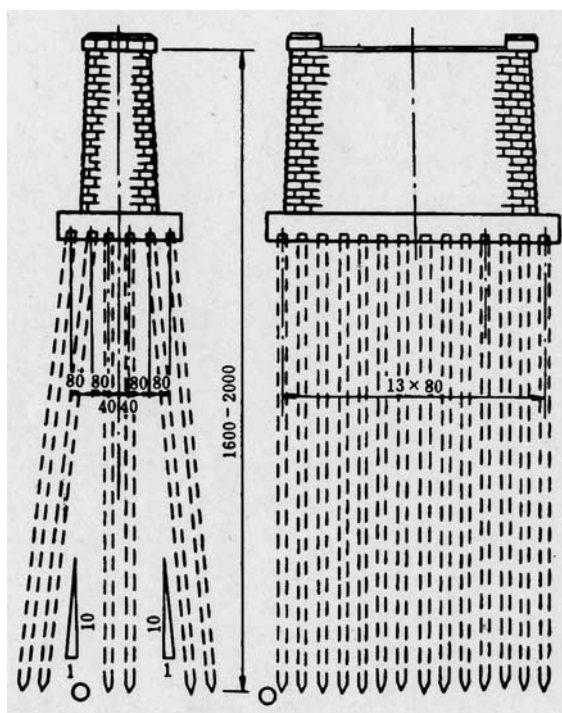
Figure 9. The inferred pile arrangement at the No. 5 pier of the down-line bridge (unit: cm).

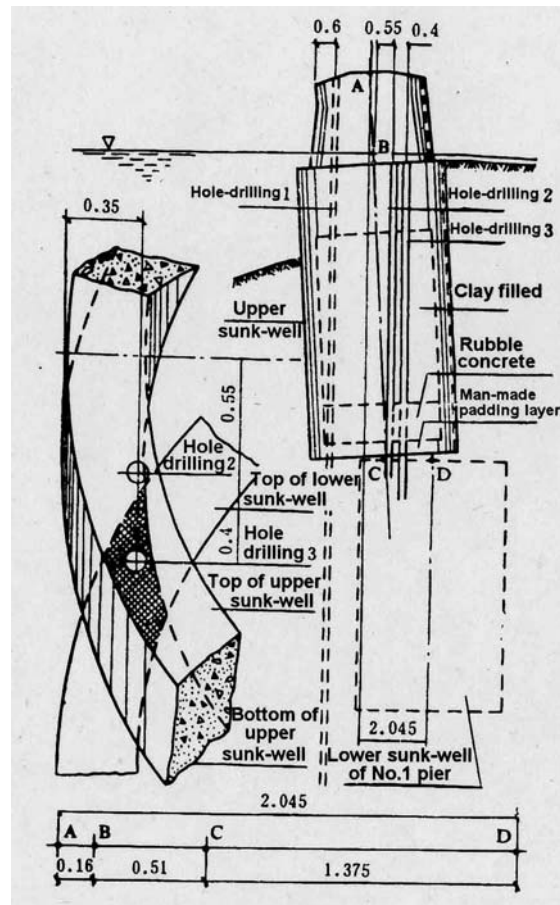
The main problems of the up-bridge were at the No. 1 pier. An examination using hole-drilling was adopted. The hole-drilling position is shown in Fig. 10. The results showed that the foundation of the No. 1 pier was a sunk-well, the depth of which was 8.9 m or so (original data was 16.5 m in the archives). The repair to the No. 1 pier of the up-bridge is shown in Fig. 11. The repaired up and down-bridges are shown in Fig. 12.

Figure 10. Layout of the No. 1 pier hole-drilling of the up-line bridge (unit: m).

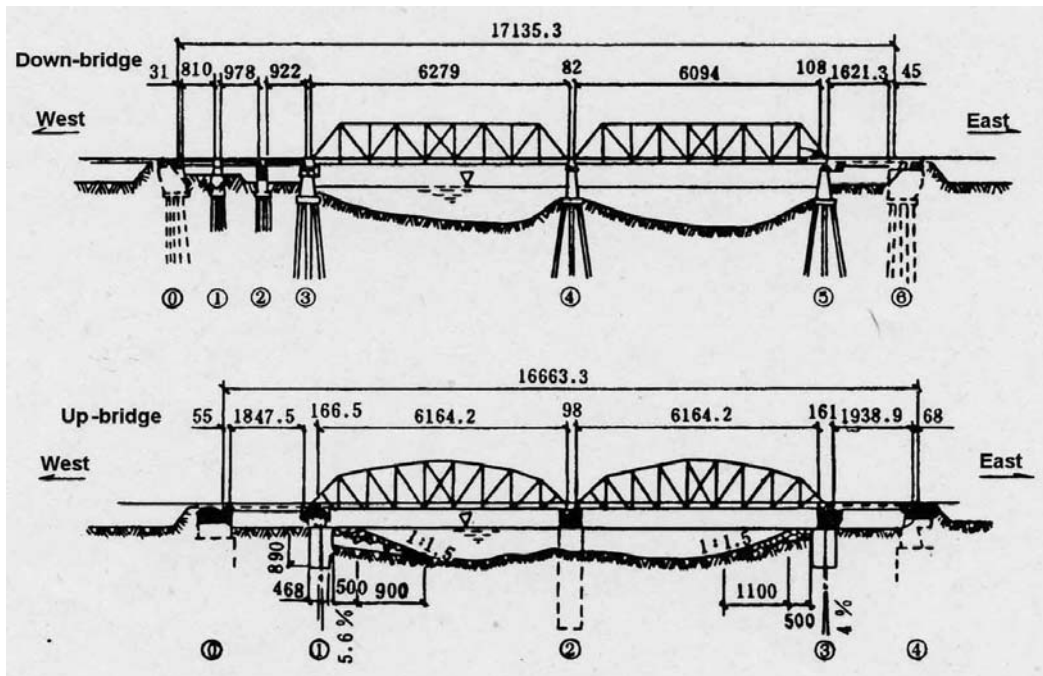
Figure 12. Ji Canal up-line and down-line bridges after being repaired (unit: cm).

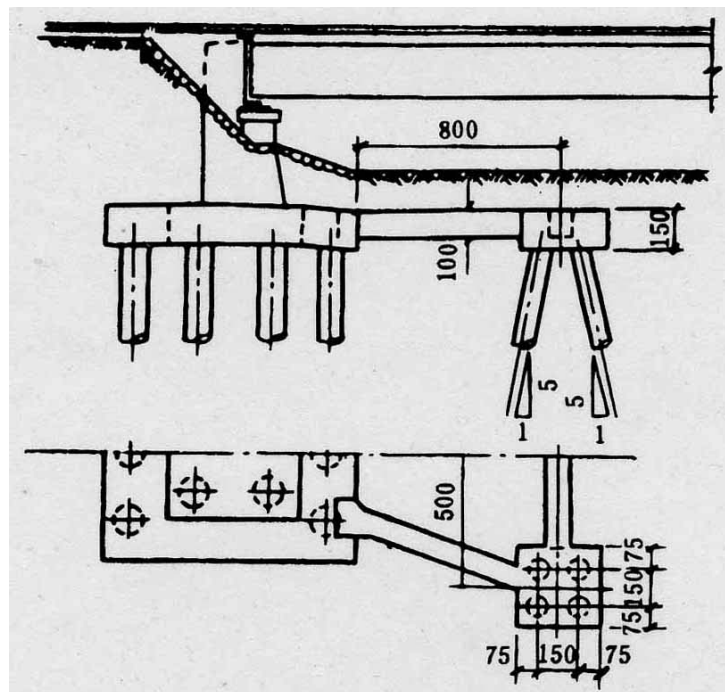
Figure 13. Bracing struts at the abutment of the new Yongding River Bridge (unit: cm).

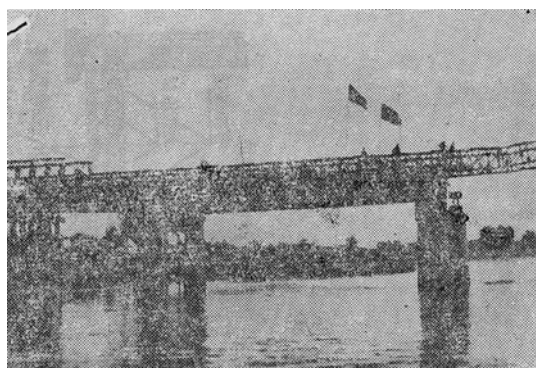
While lifting there was a rocking roller and a flat roller at every second panel point. The weight of the rocking roller was 25 tons and that of the flat roller was 6 tons. The friction coefficient between the steel girder and the rocking roller or the flat roller was estimated to be 0.07 so the traction force was about 21 tons. On both sides there were 5 tons of single roller electric hoists with 3-4 pulley groups. See Photo 3 for the scene of steel girder towing.

Photo 3. Towing the simple steel bridge into place.

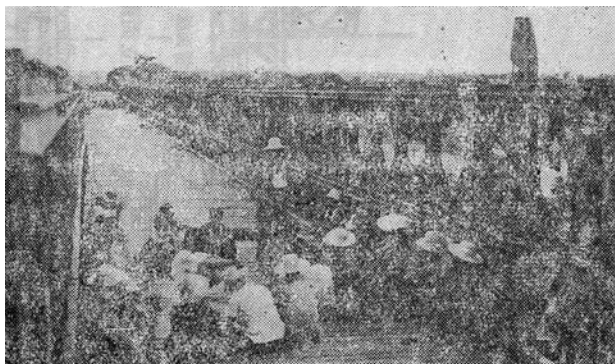
A group of pulleys were set up on the steel bridge so that the assembled girder truss could be hoisted into place on top of pier 4 and pier 5. The rocker bearings were fixed then the steel bridge was lowered and leveled. A single layer woodpile was set up for every other support. Finally, it was connected with the approach spans. Taking into consideration the possibility of aftershocks and in order to avoid distortion the bridge was braced with cables. Then, the transverse girder and the bearing plates on pier 4 and pier 5 were welded together. The transverse girder was tied firmly to the piers with wire rope to avoid falling or displacement. After the connections the bridge could be opened to traffic if the deflection of the middle span was less than the allowable value and no obvious distortion was seen in the bolts of each component. Photo 4 is the erected bridge in place.

Photo 4. The finished Lutai Steel Bridge.

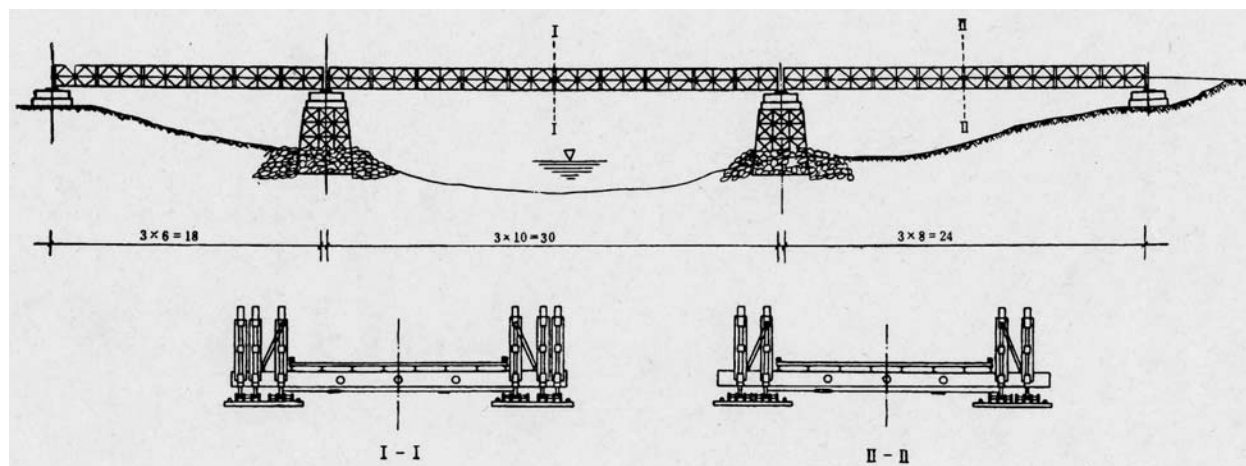
Figure 1. The temporary steel structure of the Shengli Bridge (unit: m).

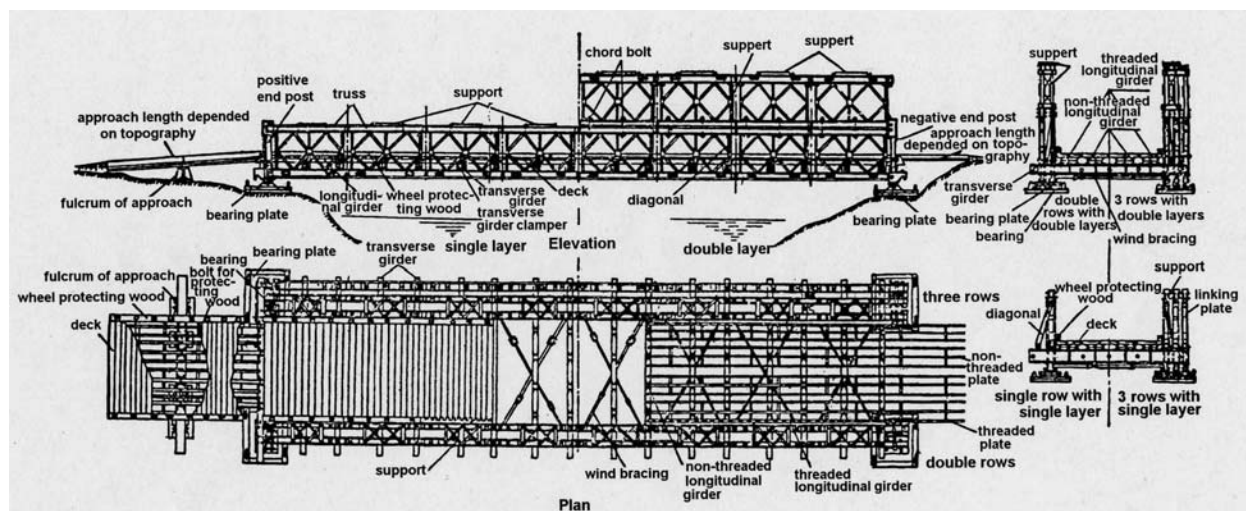
Figure 2. The simple steel bridge adopted to repair the Lutai Bridge.
