GROUND FAILURE ALONG THE NEW RIVER CAUSED BY THE OCTOBER 1979 IMPERIAL VALLEY EARTHQUAKE SEQUENCE

BY THOMAS H. HEATON, JOHN G. ANDERSON, AND PETER T. GERMAN

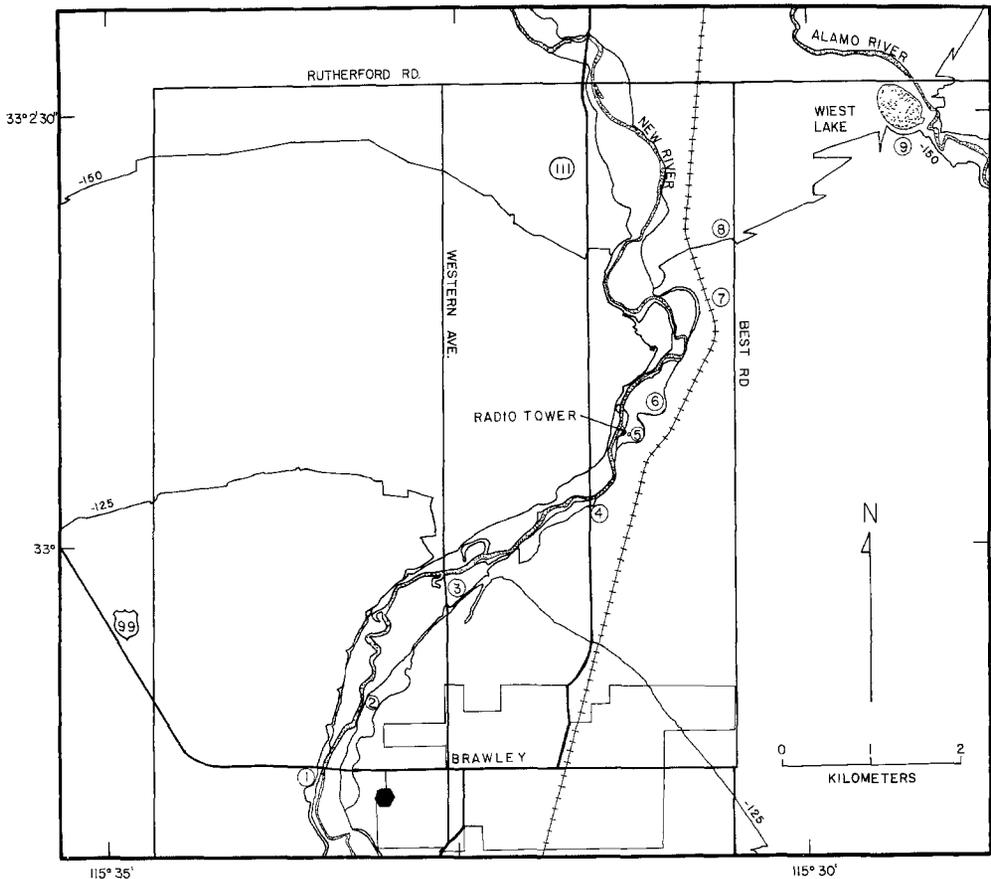
Ground disturbances between Brawley and Wiest Lake are confined to a zone which coincides with the $N45^{\circ}E$ -trending lineament in seismicity discussed in Johnson and Hutton (1982). The following numbered descriptions refer to numbered locations shown in Figure 1 and begin at the southwest end of the zone of seismicity and ground disturbance.

FIG. 1. Index map showing locations of disturbed ground following the Imperial Valley earthquake sequence. Numbered locations are described in the text. Hexagon shows the epicenter of the M_L 5.8 aftershock. The contour interval is 25 ft (8 m), and topography related to irrigation systems has been removed.

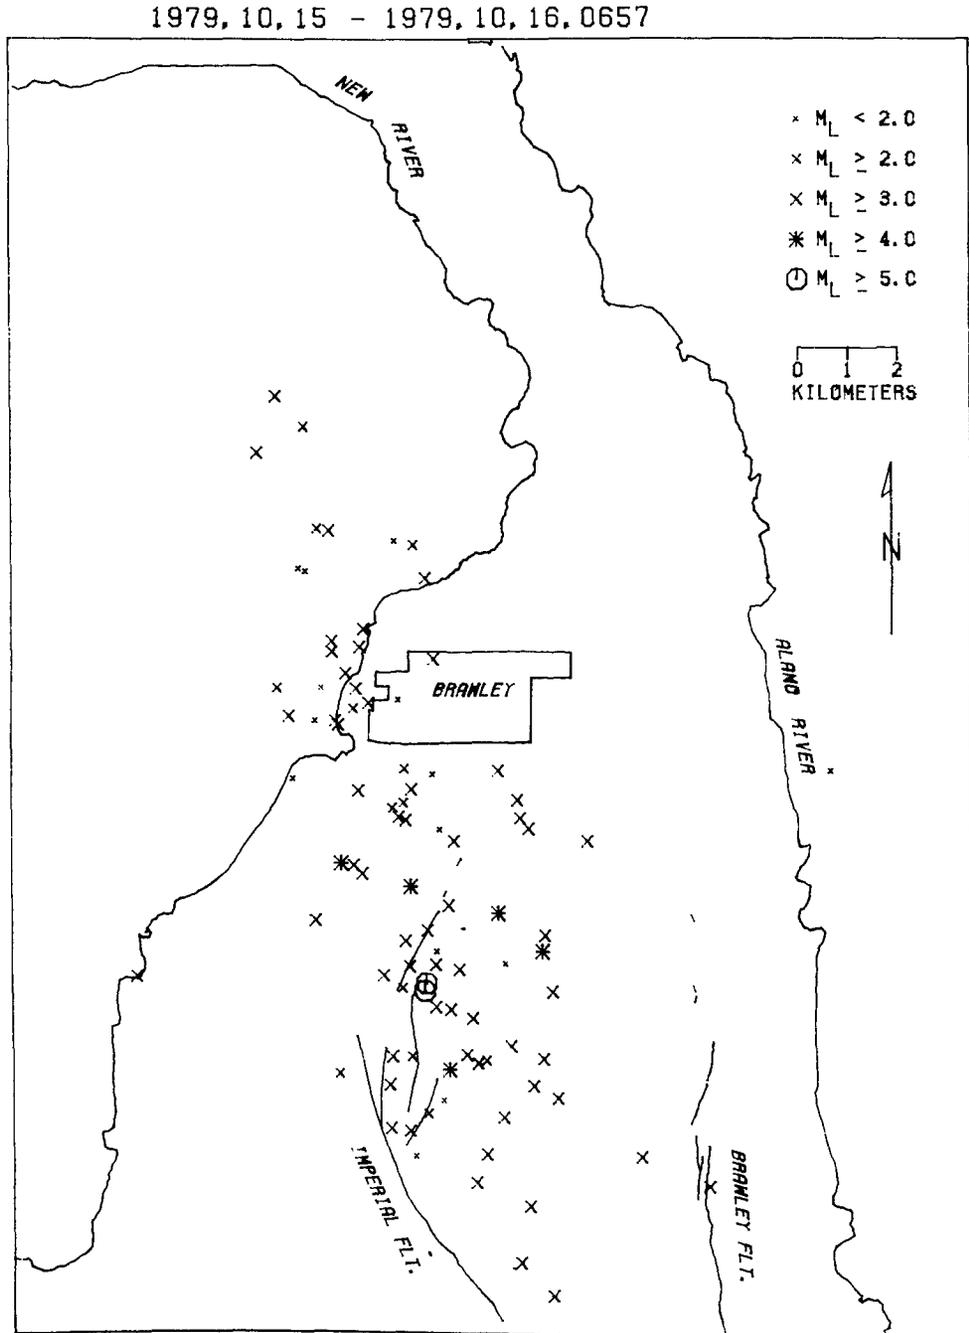
Figure 4 shows aftershock activity in the vicinity of Brawley for the 8 hr between the occurrence of the Imperial Valley main shock and the M_L 5.8 Brawley earthquake. Figures 5 and 6 show aftershock activity for the same region for 8 and 48 hr after the occurrence of the Brawley earthquake, respectively. Although a clear seismicity trend running along our transect can be seen in the 2 days after the Brawley earthquake (Figure 6), this trend is not obvious in the first 8 hr after it (Figure 5). In fact, given only the first 8 hr of seismicity, either of Johnson and Hutton's (1982) focal planes appears to be a plausible choice for the New River earthquake. However, the clear development of a northeast-southwest trend in the later aftershocks suggests that a northeast-southwest trending fault is the more reasonable interpretation of the source of this earthquake. Based on the seismicity evidence of Figure 6, the location of the surface trace of this postulated fault is uncertain by 2 to 3 km perpendicular to its trend. Because the aftershock zone lengthens with time, it is not possible to estimate the rupture length of the main shock.

FIG. 4. Aftershocks of the Imperial Valley earthquake in the vicinity of Brawley before the M_L 5.8 Brawley earthquake. This map shows all "a" and "b" quality locations.

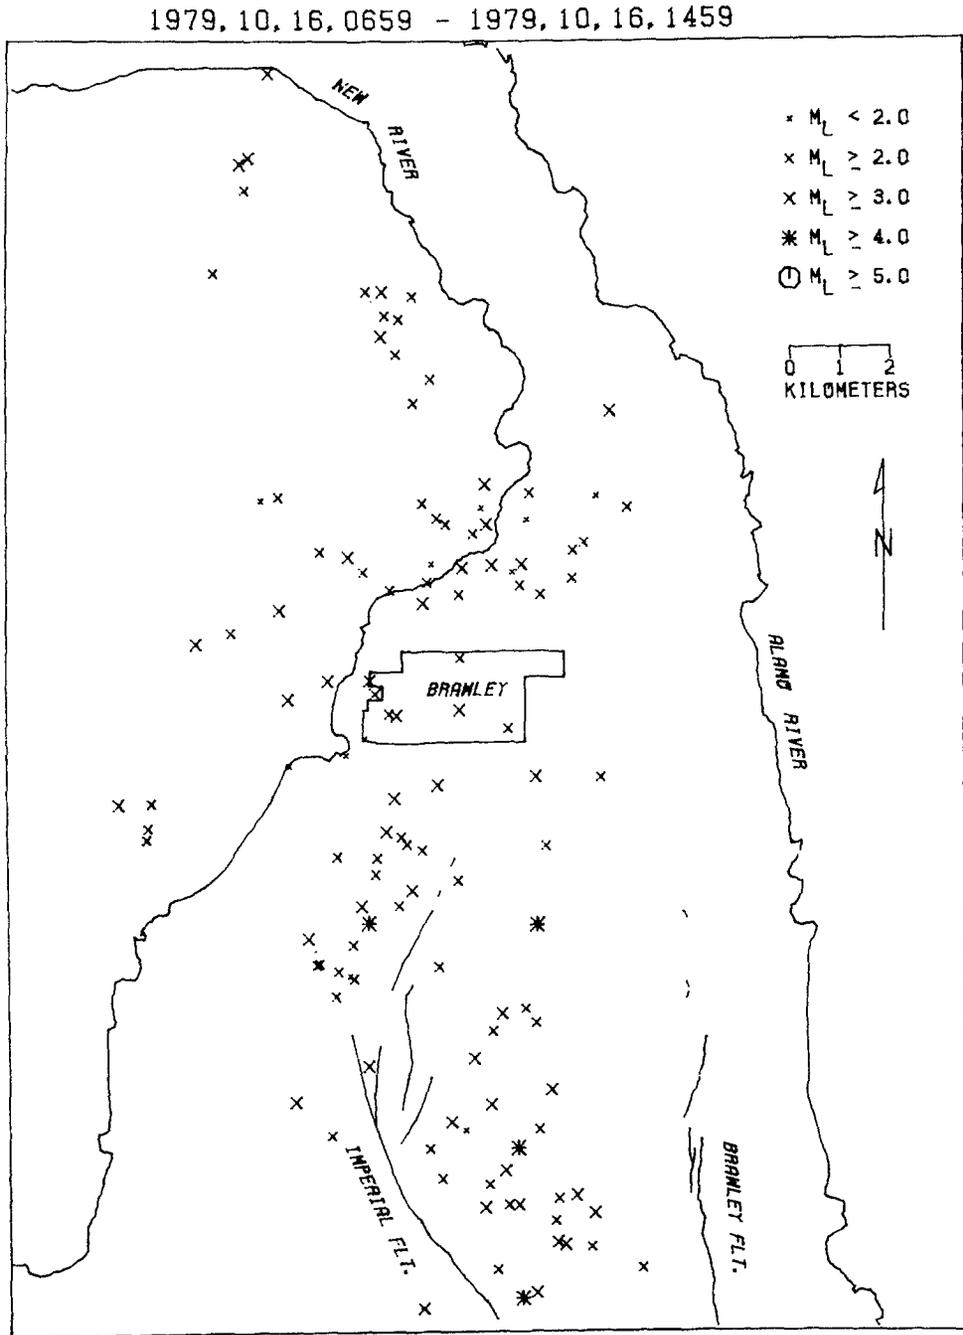
FIG. 5. Aftershocks of the Imperial Valley earthquake in the first 8 hr following the M_L 5.8 Brawley earthquake.

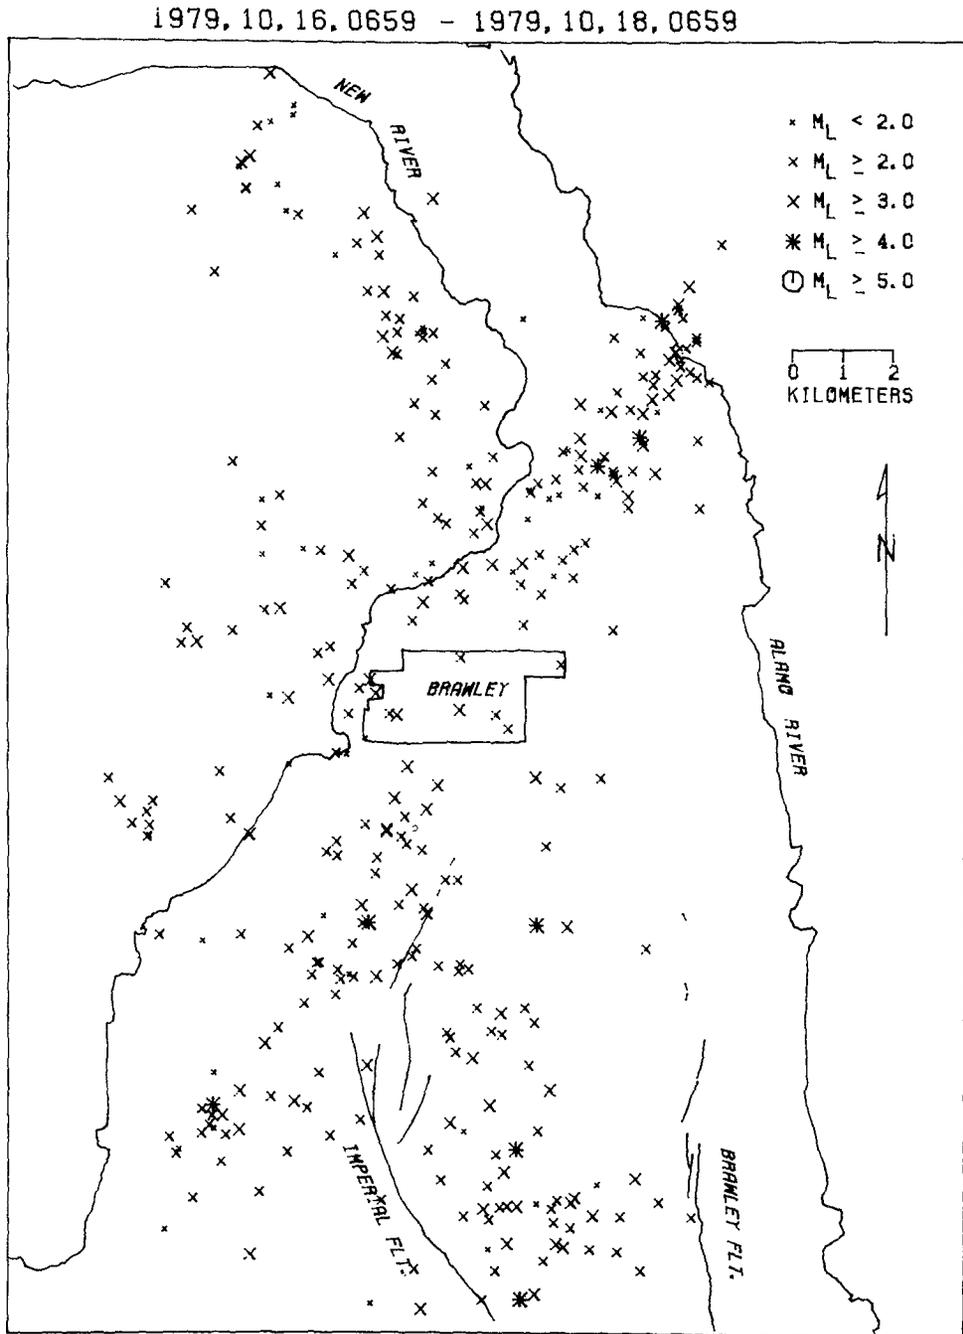
FIG. 6. Aftershocks of the Imperial Valley earthquake in the first 48 hr after the Brawley earthquake.
