Enduring Lessons and Opportunities Lost from the San Fernando Earthquake of February 9, 1971

Paul C. Jennings, M.EERI

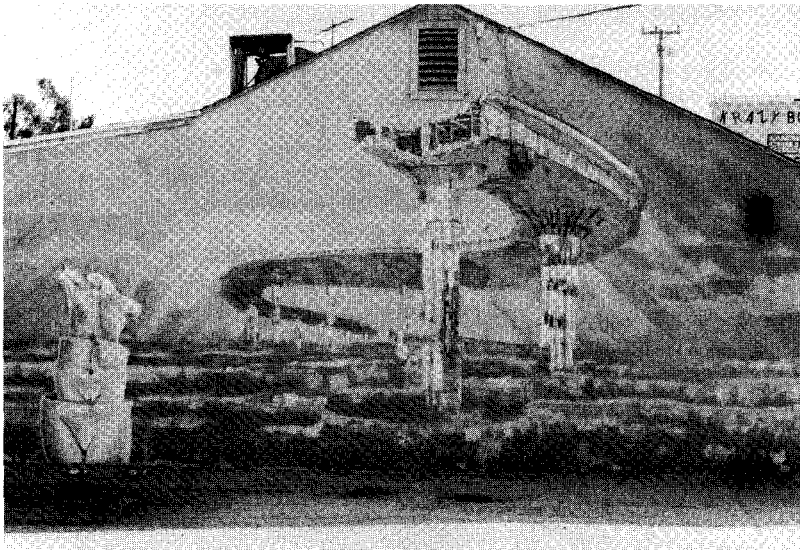
Figure 16. The spectacular failure of some freeway structures in the earthquake inspired this mural on a building in Los Angeles. The damage to freeway structures seen in the San Fernando, Loma Prieta, Northridge and Kobe earthquakes was so dramatic that images of such damage have become a kind of symbol of the risk of living in earthquake country.
