8. A Review of Geological Effects and Damage Distribution of the June 9, 1980 Mexicali Valley Earthquake

F. Suarez V., K.E. Sieh, W.E. Elders

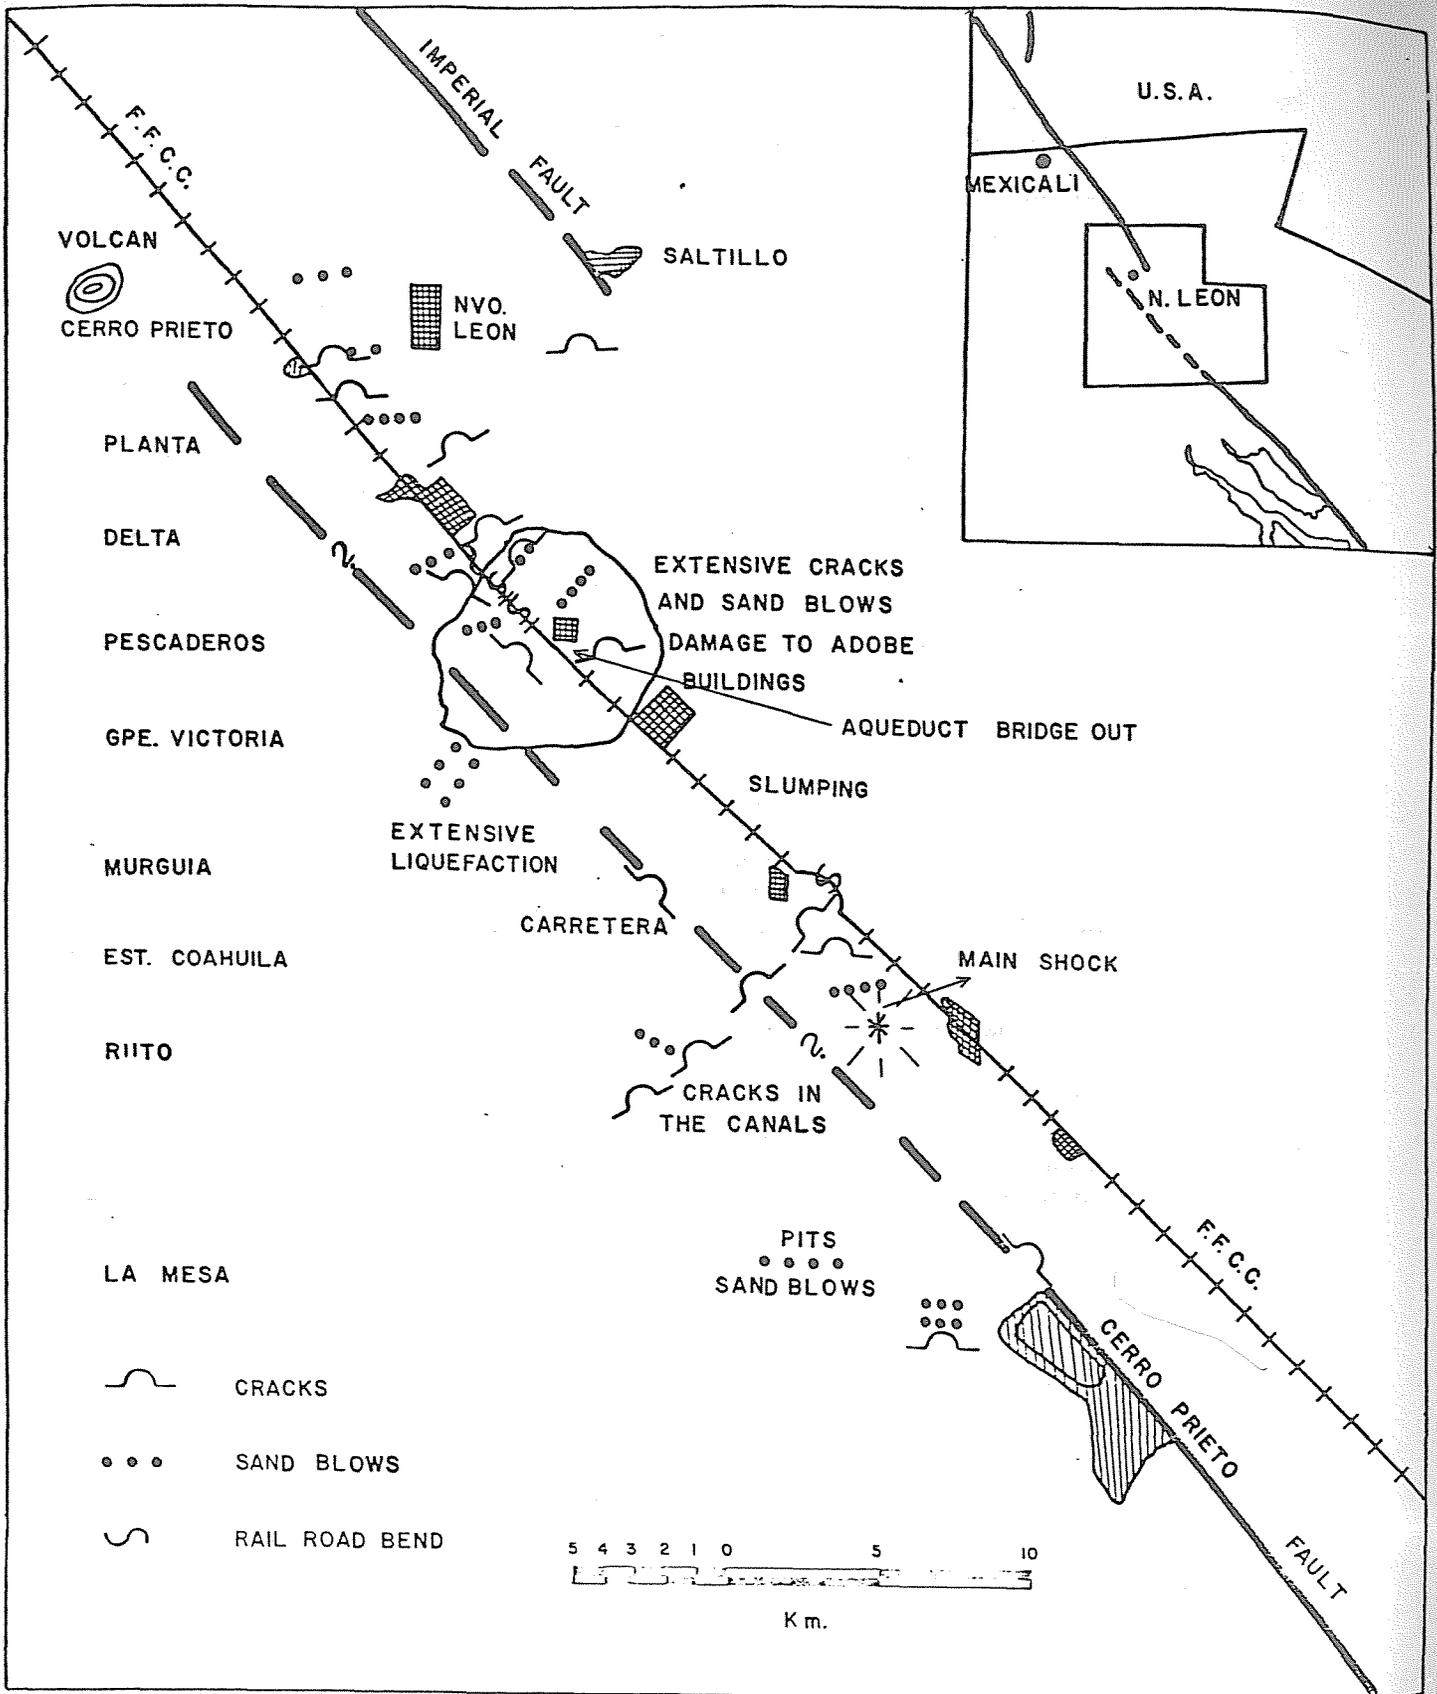
Figure 8.1 General map of the Mexicali Valley. Sites visited during the ground reconnaissance, and schematic illustration of damages and earthquake related features observed.
