Observation of Damage Growth in Compressively Loaded Laminates

The phenomenological aspects of composite-panel-failure under compressive in-plane loading and low-velocity transverse impact are studied experimentally via real-time recording of the failure-propagation event

by H. Chai, W.G. Knauss and C.D. Babcock

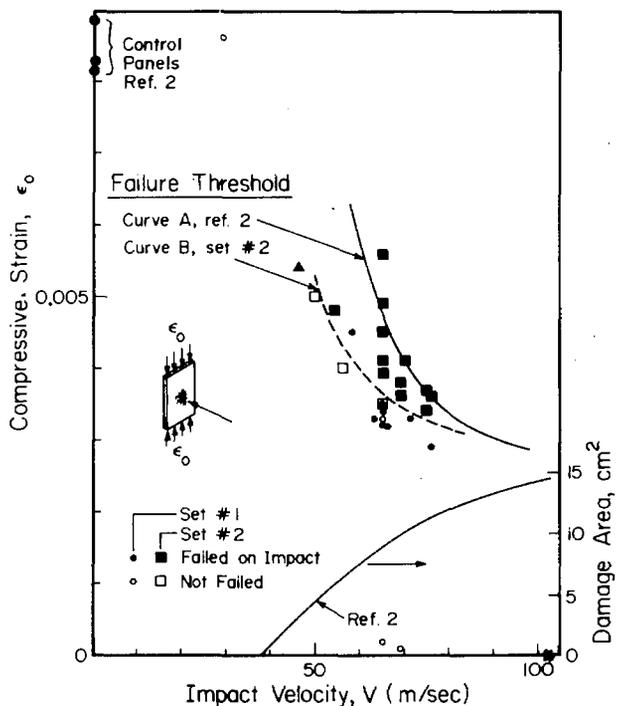
Fig. 1—Impact conditions for T300/5208 laminates. Impactor is 12.7-mm aluminum sphere. Triangular symbol represents panel (set No. 2) which failed due to global plate response

The effect of impact damage on the strength degradation in compressively loaded laminates can be characterized by a threshold for catastrophic failure such as that shown by curve A or B in Fig. 1. This curve is generated by impacting panels preloaded in compression and assessing the post-impact results. Panels that fail completely upon impact generate data for strains ('loads') and impact velocities above the threshold curve whereas those which did not fail generate data points below this curve. Also shown in Fig. 1 is a graph of the damage area

caused upon impact vs. impact velocity. This curve was generated by impacting unloaded panels and determining the extent of damage using the C-scan technique. Figure 1 shows that for small impact velocities [i.e., $V < 40$ m/s (130 ft/s)] there is no damage and no apparent strength reduction in the laminate. For larger impact velocities, the damage area increases while the plate strength decreases. At impact velocity on the order of 100 m/s (330 ft/s) the plate strength approaches a minimum which is only about 30 percent of the undamaged plate strength. It should be noted that variations in test parameters such as plate thickness, layup and projectile mass can lead to variations in the nominal value of projectile speed at which strength degradation begins to take place or strength degradation approaches a maximum.¹

The panels, supported by the fixtures, are impacted at the center while under compressive load applied along the 0-deg ply direction. The impact event is photographed. Table 1 summarizes the test conditions and the photographic procedure. The test results are displayed in Fig. 1 along with a rough estimate of a curve indicating the failure threshold of panels belonging to set No. 2 (curve B). The lower segment of this curve is drawn relatively accurately. The high-speed photographs of the two 'large' panels closest to this segment (i.e., panel No. 3 and No. 6 in Table 1) exhibit a phase of initial delay in the damage growth. This is in contrast to the rest of the panels in that segment of the curve which show damage growth without such a delay, the growth rate which increases with increasing strain. Therefore, the test conditions for the two panels under discussion represent nearly threshold data. The rest of the curve could not be drawn with such an accuracy. Note first that establishing

a failure threshold curve was not our prime motivation in this work. Secondly, we recognize that the limited supply of test material is inadequate to define such a curve well. The available data, however, are sufficient to indicate the existence of limit behavior in the threshold curve at both relatively low and relatively high projectile speeds; at these velocity ranges the failure strain seems to be little affected by changes in the impact speed. It is also clear that in between these two extremes a transition region exists in the threshold curve where the failure strain degrades rapidly with increasing impact velocity. Also shown in Fig. 1 is a failure threshold curve obtained in Ref. 2 (curve A) for the same material as in this work but for a slightly different plate size [25 × 13 × 0.68 cm (10 × 5 × 0.27 in.)]. The differences observed between the data of Ref. 2 (curve A) and our data (curve B and the data for the panels of set No. 1) are probably due to lot variations in material properties.

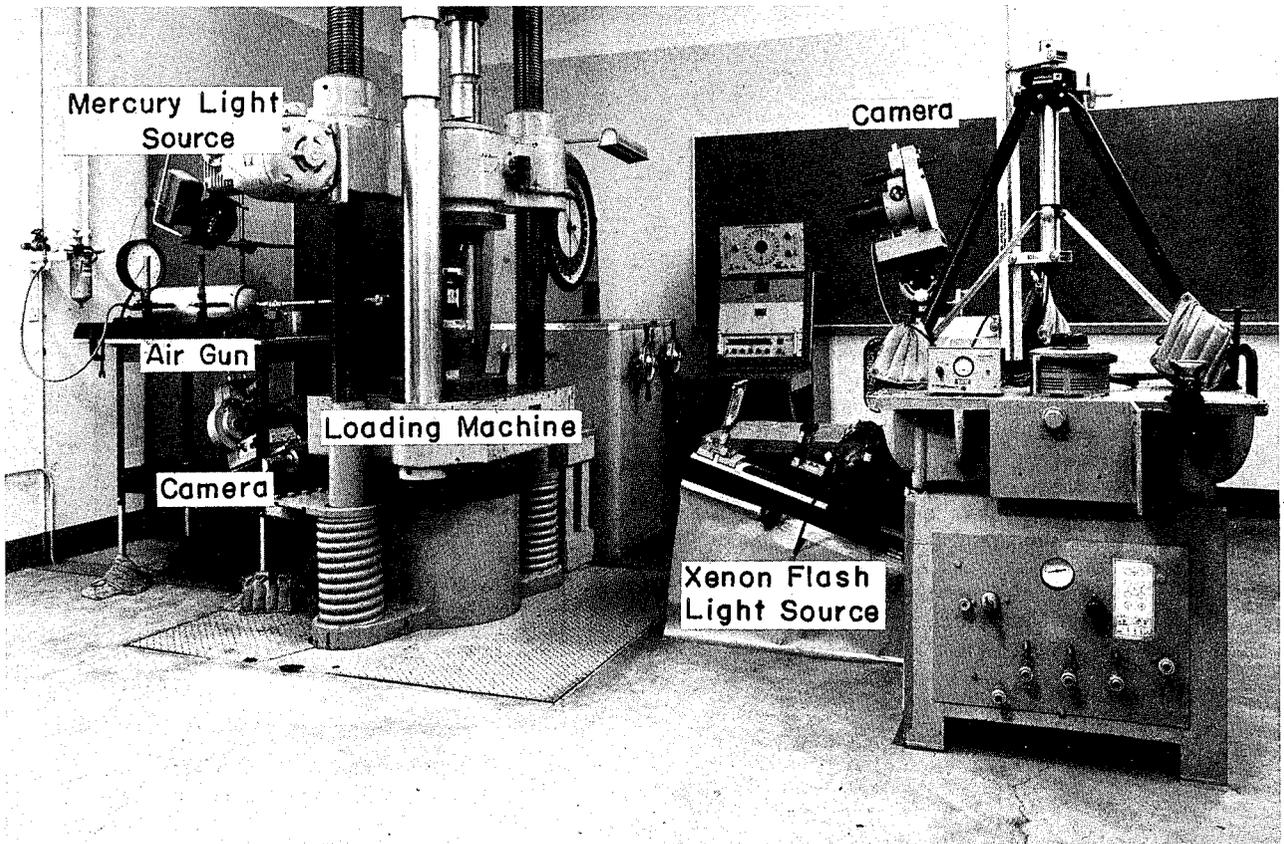
Fig. 2—Impact and recording test setup

A photograph of the test setup is shown in Fig. 2 and includes the panel support fixture, the loading machine, the impact device (air-gun), the light sources and two high-speed cameras. A review of the main components follows.

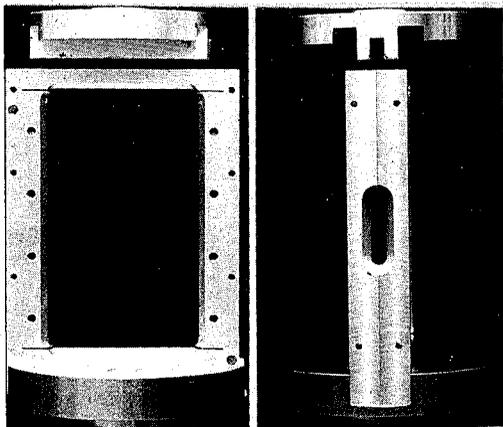
Fig. 3—Test-panel support fixture

Two fixtures are used to support two sets of graphite/epoxy panels having different sizes, i.e., $20.3 \times 10.2 \times 0.60$ cm ($8 \times 4 \times 0.24$ in.) in set No. 1, and $25.4 \times 15.2 \times 0.60$ cm ($10 \times 6 \times 0.24$ in.) in set No. 2. The 'small' fixture is shown in Fig. 3. The upper and lower edges of the panel which transmit the load are bonded to aluminum plates in grooves filled with a bonding agent (Devcon A). The depth of the grooves in the 'small' and 'large' panel fixtures are 1 cm (0.4 in.) and 2.5 cm (1.0 in.), respectively. Both sides of the specimens are held by narrow strips. These strips are adjustable along the length of the specimen to ensure a close, but non-binding, support.

To further examine the relation of the surface deformation to internal damage, a 4-cm (1.5-in.) long clearance was cut along the edge of the panel fixture as shown in Fig. 3. A simultaneous recording of the edge and the back surface of a specimen is shown in Fig. 9. Note that the characteristic deformation in the upper sequence has reached the left edge of the panel at approximately 300 μ s after impact. This event occurs at about the same time as the appearance of the first crack at the edge, i.e., the frame at 345 μ s in the lower sequence in Fig. 9. The results of this experiment suggest that the internal-damage front practically coincides with the first or lowest order fringe in the moiré pattern. This association will be used later in this work in the construction of the delamination growth rate in Fig. 11. Subsequent frames in both motion pictures show only the final stages in the collapse of the panel.

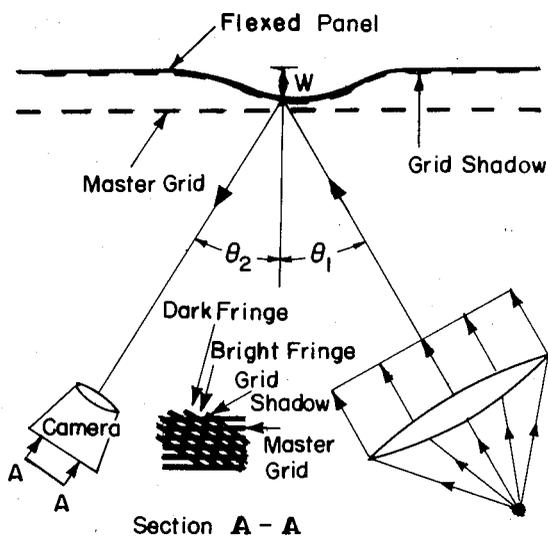
Fig. 4—Shadow-moiré optical setup

where n is the fringe number, p is the grating pitch and θ_1 and θ_2 are the angles formed between the normal to the plate and the directions of the incident and viewing light, as shown in Fig. 4.

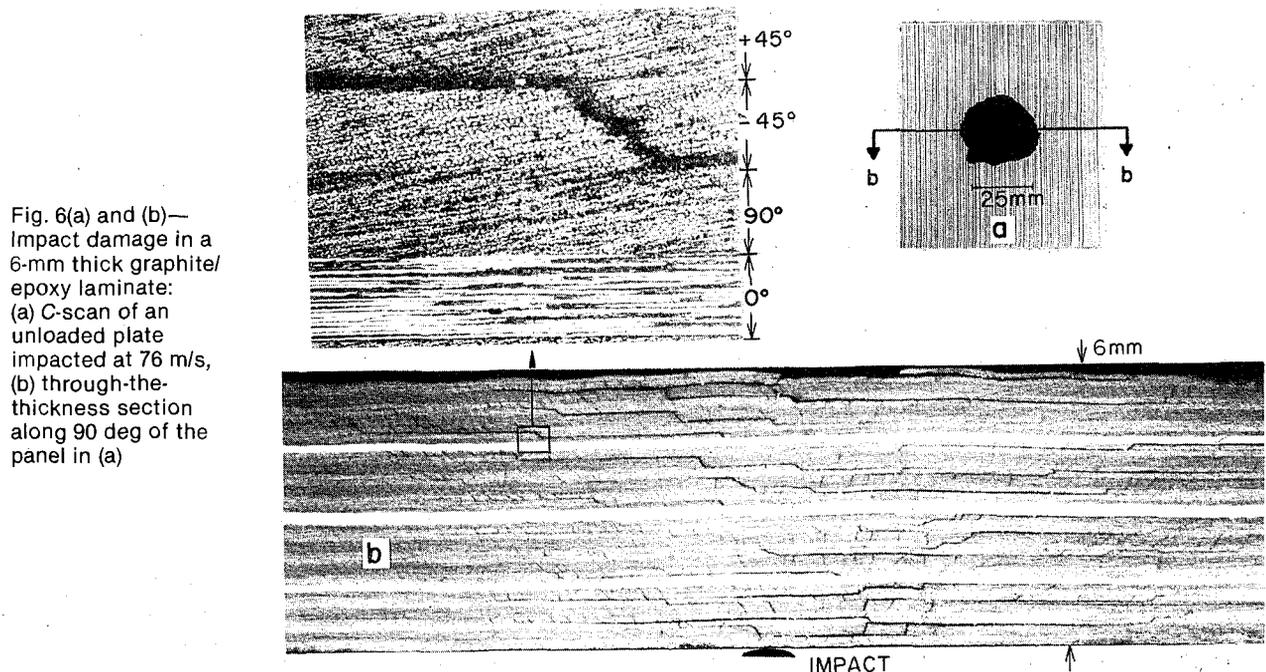
Fig. 6(a) and (b)—Impact damage in a 6-mm thick graphite/epoxy laminate: (a) C-scan of an unloaded plate impacted at 76 m/s, (b) through-the-thickness section along 90 deg of the panel in (a)

Some panels that did not fail catastrophically upon impact were examined ultrasonically and/or sectioned through the plate thickness at different locations and examined microscopically for interior damage. Figure 6(a) shows an ultrasound C-scan* record of a plate impacted while under zero load. From this record, the damage area appears roughly circular in shape with approximately 3 cm (1.2 in.) in diameter. A section of this panel along the 90-deg ply direction and through the impact point is shown in Fig. 6(b). The damage in Fig. 6(b) is characterized by delamination and intraply cracking extending across the full thickness of the plate. This damage is extended laterally more toward the unimpacted panel face than toward the impacted face.

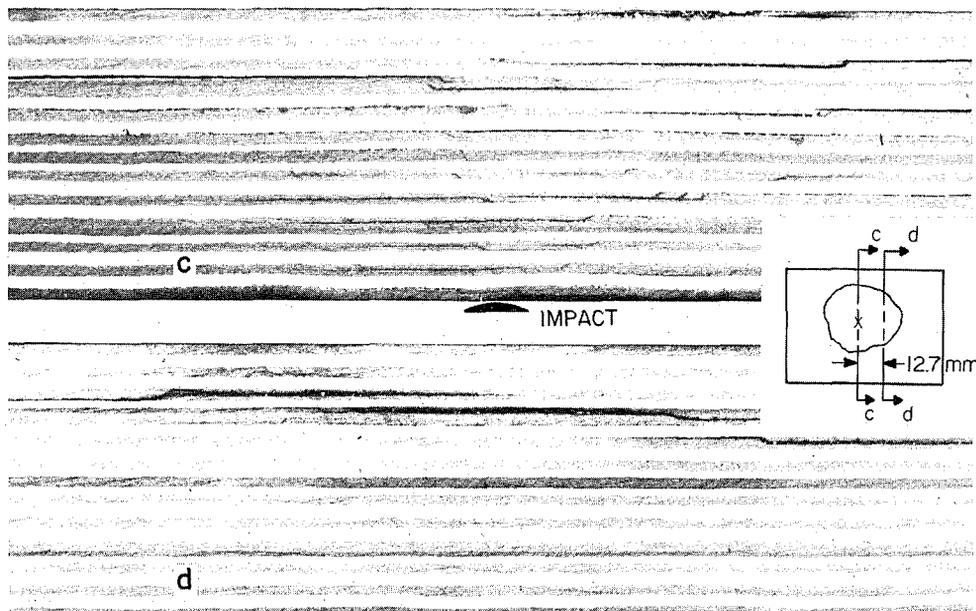
Fig. 6(c) and (d)—
Two sections
along 0 deg,
12.7-mm apart, of
a panel loaded to
 $\epsilon_0 = 0.0035$ and
impacted at 65 m/s

but did not fail catastrophically, is shown in Fig. 6(c). The appearance and distribution of the damage in this section is quite similar to that of the unloaded case shown in Fig. 6(b), though the damage extends over a larger area, probably due to the effect of the load. A section parallel to this section, but 12.7 mm (0.5 in.) away, is shown in Fig. 6(d). This view indicates that the delaminated area is confined only to the vicinity of the surface opposite to the impact face. Since the conditions at impact were close to the threshold condition, the initial damage area is similar to that of the panels that did fail completely upon impact.

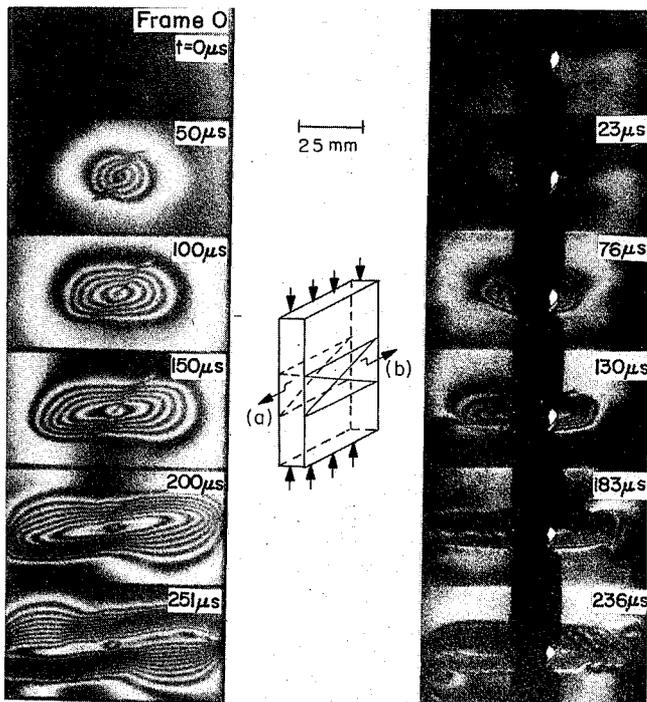
Fig. 7—Simultaneous back- and front-surface-moiré motion pictures showing panel (set No. 1) failure, $\epsilon_0 = 0.0033$, $V = 71$ m/s; (a) back-surface, $w/n = 0.32$ mm, (b) front-surface, $w/n = 0.31$ mm

We turn now to a consideration of the real-time surface deformation of the impacted plates. A moiré pattern recorded from the back-surface showing the failure process of a panel belonging to set No. 1 is given in Fig. 7(a). The test conditions for this panel [$V = 71$ m/s (233 ft/s), $\epsilon_0 = 0.0033$] are at the far right of the threshold curve where the strength degradation due to impact is most pronounced, and are typical of the majority of the tests for this set of panels. The load is only about 20 percent of the buckling load for this panel. This selection reflects our desire to study the local growth process as independent as possible from the global plate response due to impact, the latter increases with increasing applied load. The displacements in Fig. 7(a) are summarized in Fig. 8 as a function of horizontal and vertical (load-parallel) coordinates which originate at the impact point. These displacements include both permanent and vibra-

Frame 0 in Fig. 7(a) represents the condition just prior to impact and has been assigned the time $t = 0$. In the subsequent frame the impact caused a bulging of the surface near the impact region with a peak displacement on the order of 1 mm (0.05 in.). Based on the results of the interior-damage characterization, this bulging of the surface is interpreted as a local buckling of the delaminated area under the action of the compressive load.** Subsequent frames, at 50 μ s time interval, show that this buckled region propagates laterally (normal to the loading direction) at a velocity on the order of 300 m/s (1000 ft/s) with the peak displacement increasing during the growth.

While the growth history of the bulge at the panel back surface is fairly clear from Fig. 7(a), no direct information is revealed concerning the damage extension in the interior of the plate during the growth process. It appears appropriate, therefore, to record simultaneously the two opposite surfaces of the panel during the impact event. Figure 7(b) shows the front surface moiré version of the panel in Fig. 7(a). The grid center is perforated by a 15-mm (0.6-in.) diam hole to allow for impact without destroying the grid. The dark area in this series of photographs is the shadow of the gun barrel. The time relationship between the two motion pictures, evaluated with the aid of the common timing light pulse, is marked in Fig. 7(b). Impact has occurred in the second frame in Fig. 7(b) ($t = 23 \mu$ s). Subsequent frames show that a characteristic deformation*** has developed and propagated across the panel with little growth in the 'vertical' direction. The existence of deformation on both faces of the panel at a given time indicates that the propagating damage extends through the plate thickness.

*The analysis, based upon orthotropic-plate theory and a Hertzian contact model for the impact-load history, has indicated that the maximum displacement expected under conditions that simulate the test conditions would be at most 0.3 mm (0.01 in.) or approximately a single fringe in Fig. 7(a).

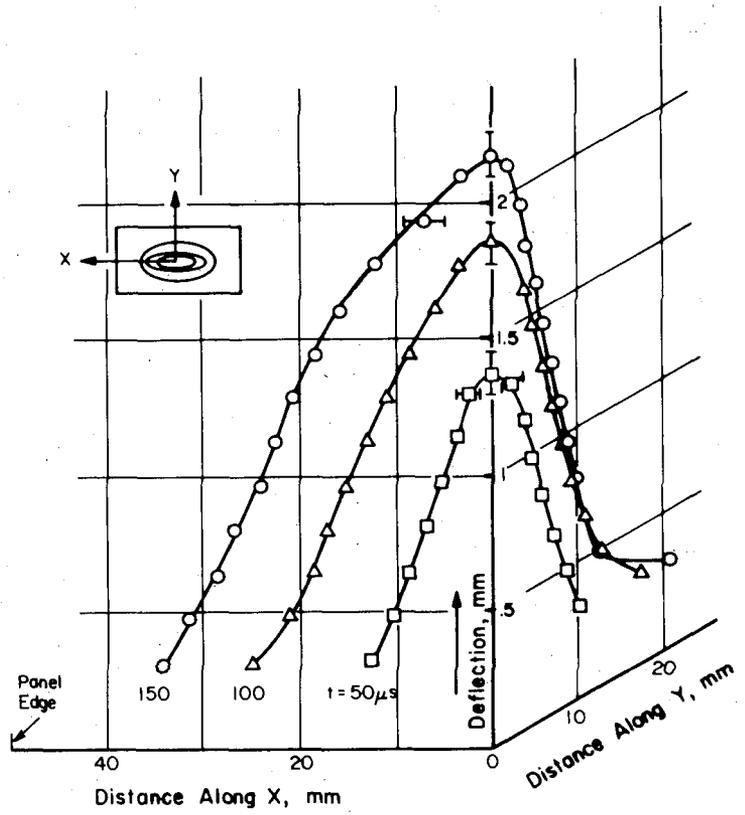
Fig. 8—Out-of-plane displacement corresponding to Fig. 7(a)

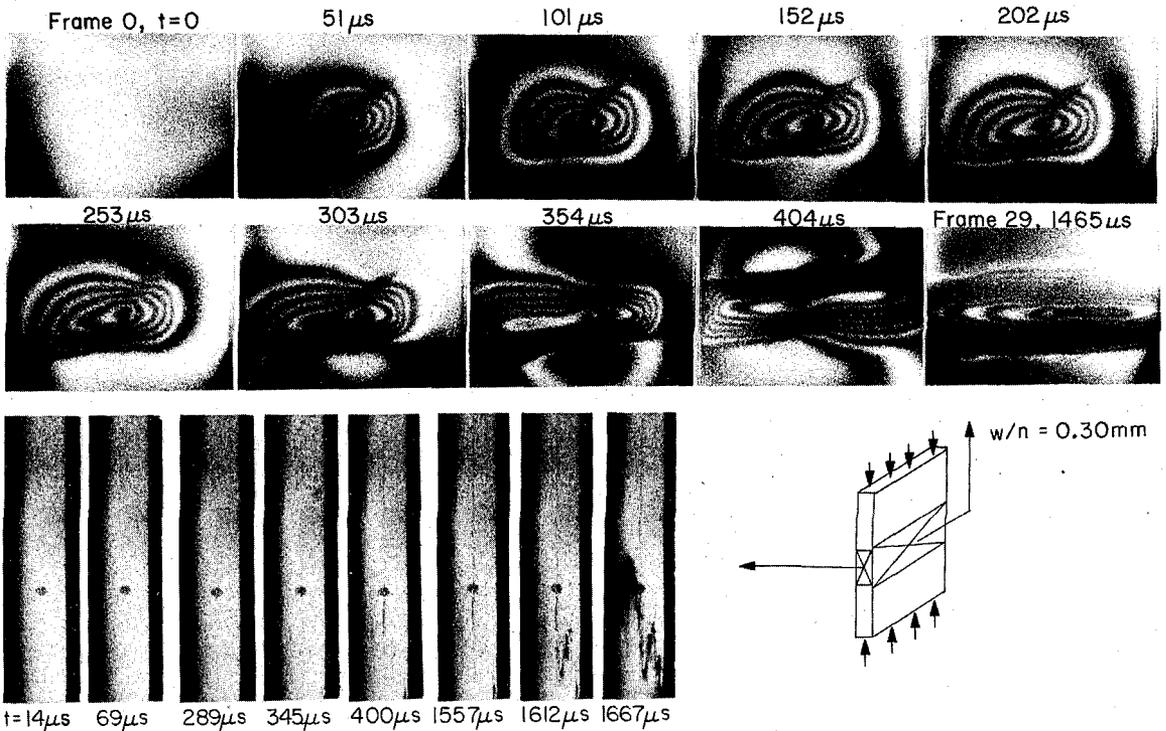
Fig. 9—Simultaneous back-surface (upper sequence) and edge motion pictures (panel of set No. 1), $\epsilon_0 = 0.0029$, $V = 76 \text{ m/s}$

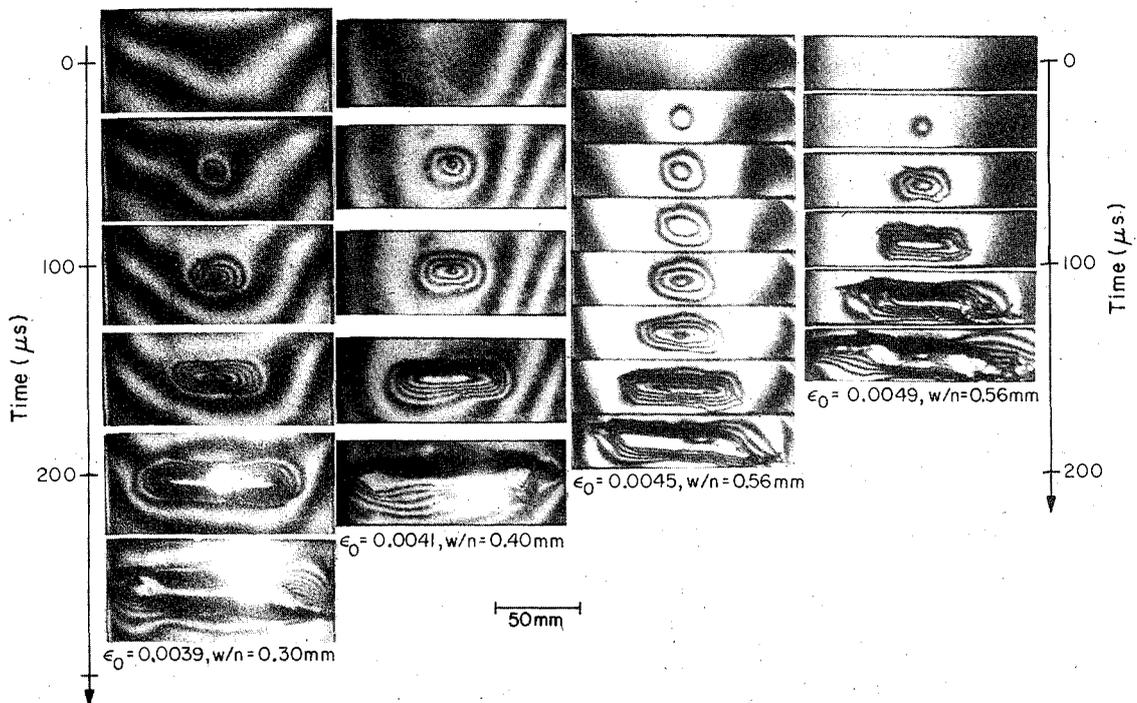
Fig. 10—Damage propagation under different loadings in panels (set No. 2) impacted at $V = 65$ m/s

more detailed aspects of the damage-growth phenomenon. Figure 10 shows a series of four back-surface motion pictures for four panels impacted at the same velocity but

range in the loading allow the evaluation of the dynamics of the growth process. Figure 10 shows that the rate of damage growth increases as the damage spreads, and is larger for higher compression strains. Figure 11 gives the growth-rate history of the delamination area for four different panels. The growth rate is evaluated based on the amount of the 'horizontal' extension of the damaged area, as defined in the insert in Fig. 11, over the time

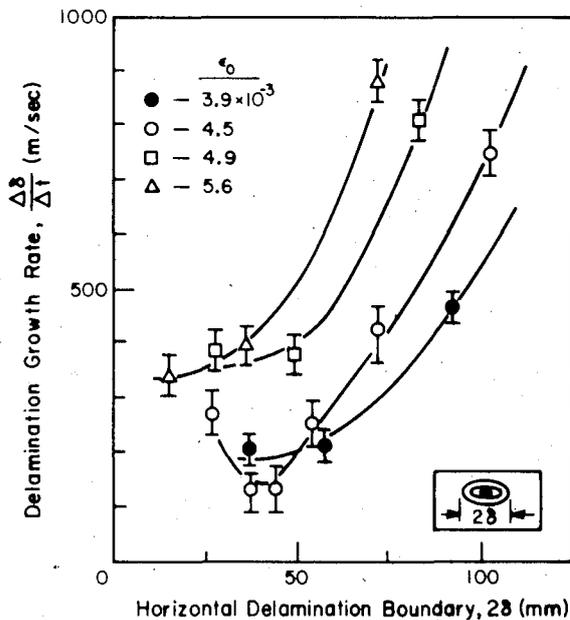
Fig. 11—Delamination growth rate for panels (set No. 2) loaded to different degrees but impacted at $V = 65$ m/s

interval between two adjacent frames in the moiré sequence. All tests exhibit a phase of relatively slow growth followed by a 'smooth' and rapid growth as the delamination area spreads. A systematic transition between these two phases of growth is not strictly apparent from the data presented, but it is seen that the phase of rapid propagation starts after the damage has extended over about 5 cm (2 in.). For a delamination of twice this size, the growth rate is more than doubled, reaching a value of up to 850 m/s (2800 ft/s) for the test with the highest load.

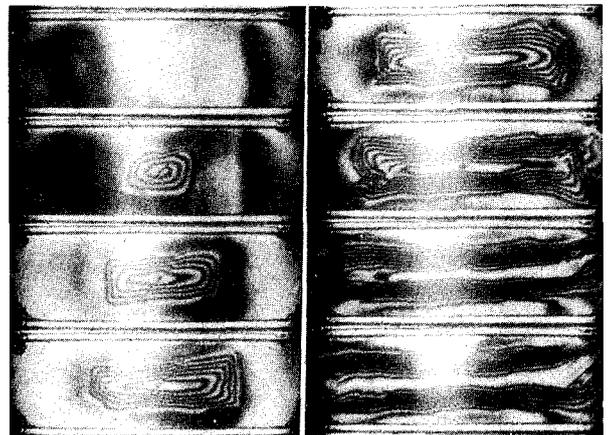
Fig. 12—A 'rectangular'-type delamination boundary (panel of set No. 2), $w/n = 0.42$ mm, $\Delta t = 55.6$ μ s, $\epsilon_0 = 0.0036$, $V = 76$ m/s

Some panels have failed in a manner which differs from that shown before. Figure 12 shows a 'rectangular'-type boundary of a propagating delamination which differs from the smooth elliptical ones observed in other

experiments of similar test conditions. Most likely, it is associated with a delamination at a different interface. We note, however, that this change in the growth geometry has not altered the growth characteristics (i.e., as before the growth is predominantly normal to the loading and the out-of-plane deflection increases with increasing delamination size).

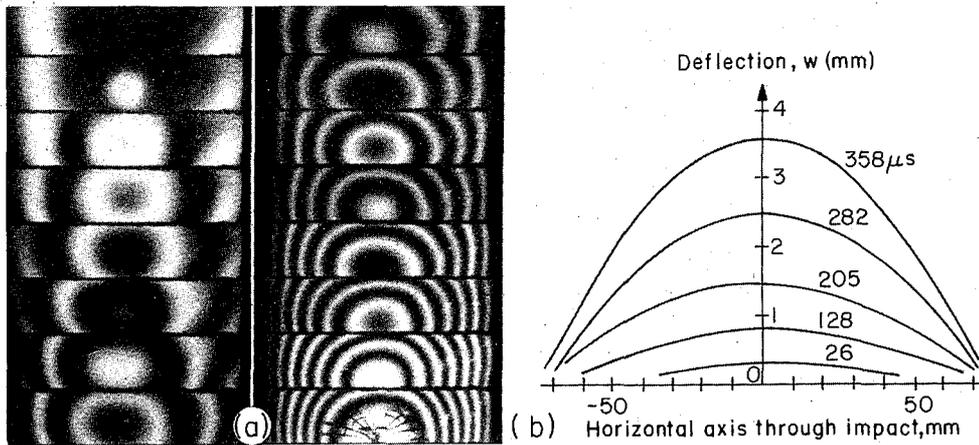
Fig. 13—Failure of a panel (set No. 2) due to global plate response: (a) back-surface moiré showing the initial phase in the development of failure (complete failure occurred later in time), $w/n = 0.56$ mm, $\Delta t = 25.6 \mu$ s, $\epsilon_0 = 0.0054$, $V = 46$ m/s; (b) out-of-plane deflection under the impact point vs. time of the panel in (a)

Another uncommon test result is shown in Fig. 13. The test conditions for this panel, represented by the triangular symbol in Fig. 1, correspond to a relatively small impact velocity and a relatively large load ($\epsilon_0 = 0.0054$). The relatively large time scale of the failure [Fig. 13(a)] (note that this figure shows only the initial phase in the development of failure) and the sizable deflections [Fig. 13(b)] indicate that this panel has not failed as a result of local-damage spread but in a dynamically induced global-buckling mode. The result of this test indicates that the failure of a panel depends on the buckling stiffness, or, equivalently, on the ratio of applied load to laminate buckling load. This assessment is manifested by the test result of panel No. 13 of set No. 1 (see Table 1 and Fig. 1). Although loaded to a higher level than the larger panel of Fig. 13 (i.e., $\epsilon_0 = 0.0086$), it did not fail globally upon impact. It is noted that the ratio of applied load to buckling load for this panel is approximately 0.55* which is smaller than the corresponding ratio for the panel of Fig. 13, of approximately 0.75.
