# EARTHQUAKE RECORDINGS ON OR NEAR DAMS

P. Morrison, R. Maley, G. Brady, R. Porcella

USCOLD

November 1977

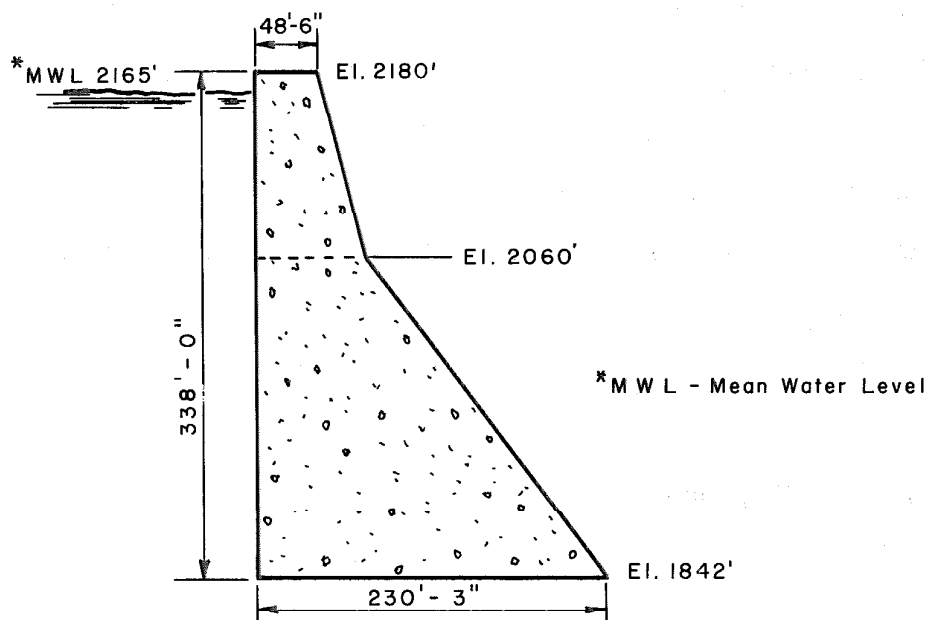
Figure 2. Section through highest monolith of Koyna Dam. The main crack produced by the earthquake of December 11, 1967 passed horizontally through the monolith at elevation approximately 2060 ft. (After Housner, 1970)

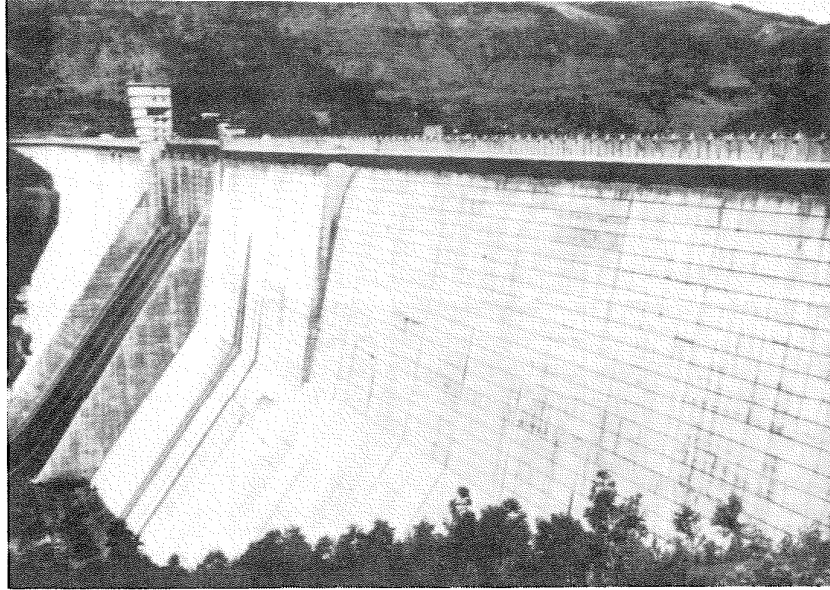
Figure 3. Koyna Dam. View of downstream face following the earthquake.  
(Photo by G.V. Berg)

A downstream view of the dam is shown in Figure 3. Figure 4 shows damage sustained by the guard rail on the crest of the dam.

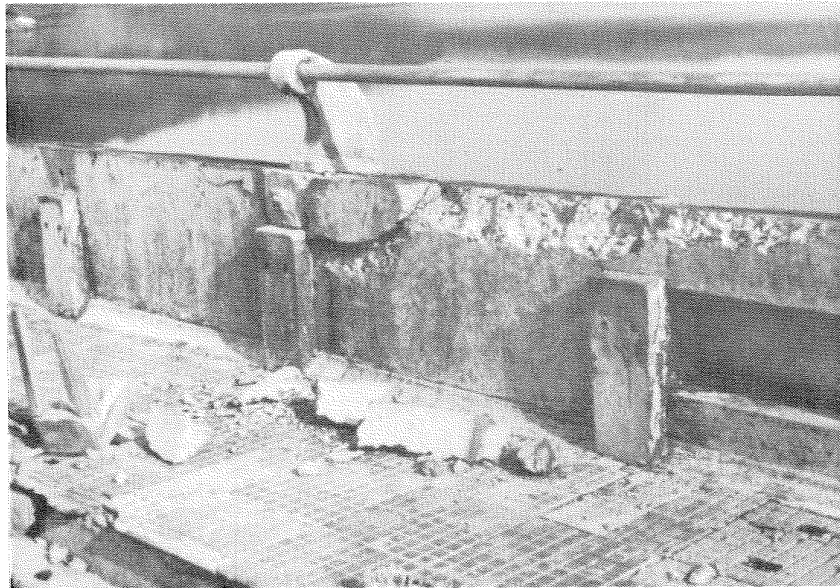
Figure 4. Damage sustained by guard rail on crest of dam.(Photo by G.V.Berg)

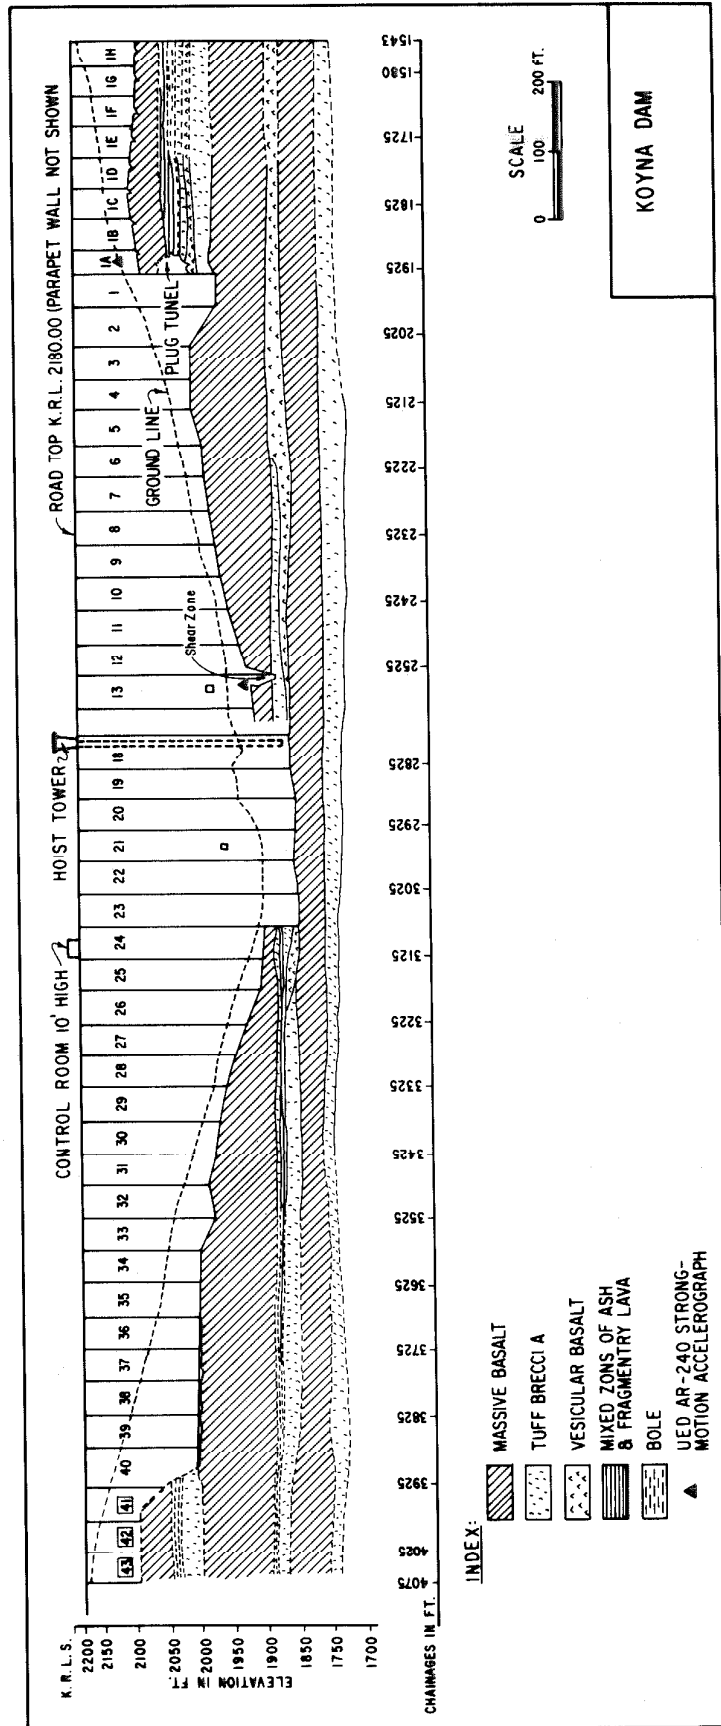
FIGURE 5. KOYNA DAM FOUNDATION GEOLOGY (AFTER COMMITTEE OF EXPERTS, 1968)

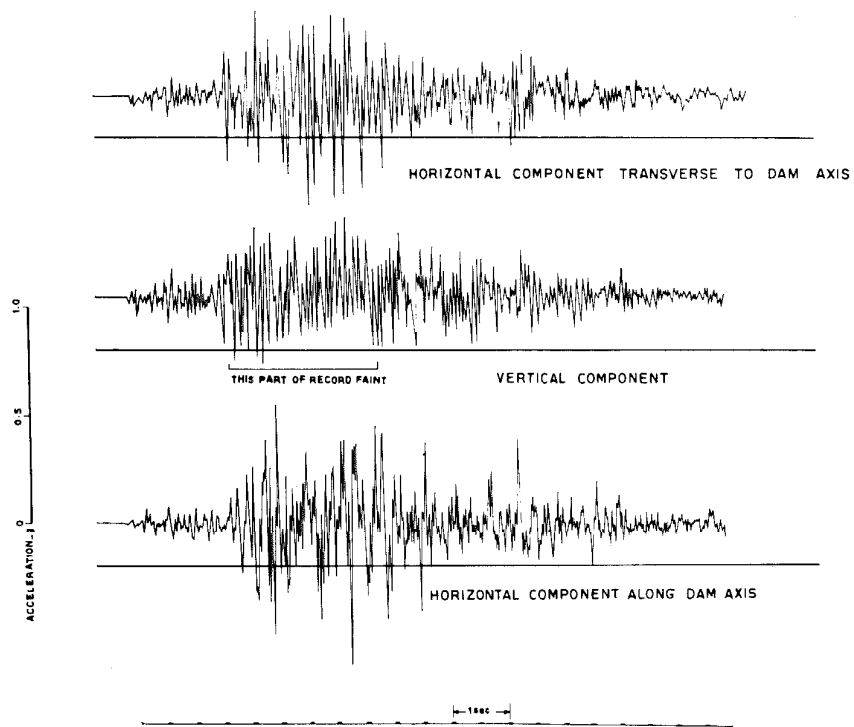
Figure 6. Accelerogram recorded in Block 1-A of Koyana Dam during the earthquake of December 11, 1967. (After Krishna et al, BSSA vol 59, no. 4, August 1969)

The December accelerogram was in some parts too faint to reproduce photographically, so a tracing was made (Figure 6). However, because of the tracing, there is some doubt as to the correct value of the peak acceleration. The maximum acceleration (0.45 g) shown in Figure 6 occurs on the horizontal component aligned with the longitudinal axis of the dam.

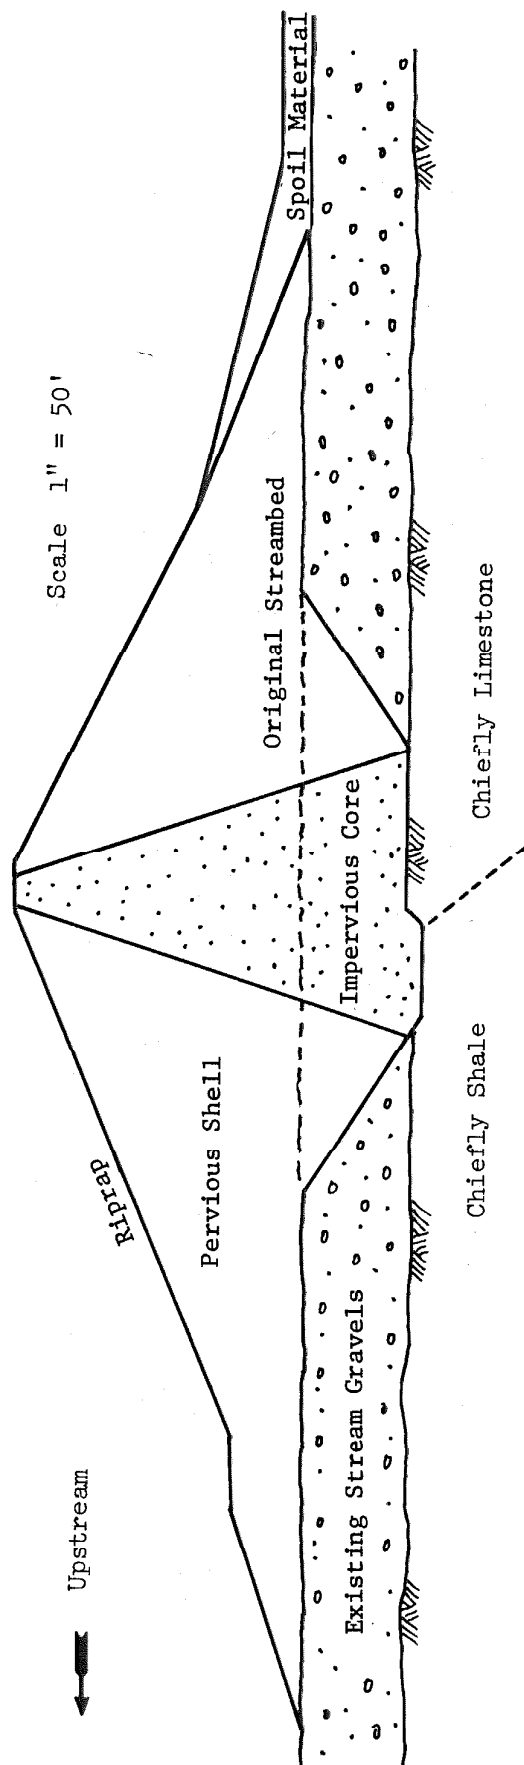
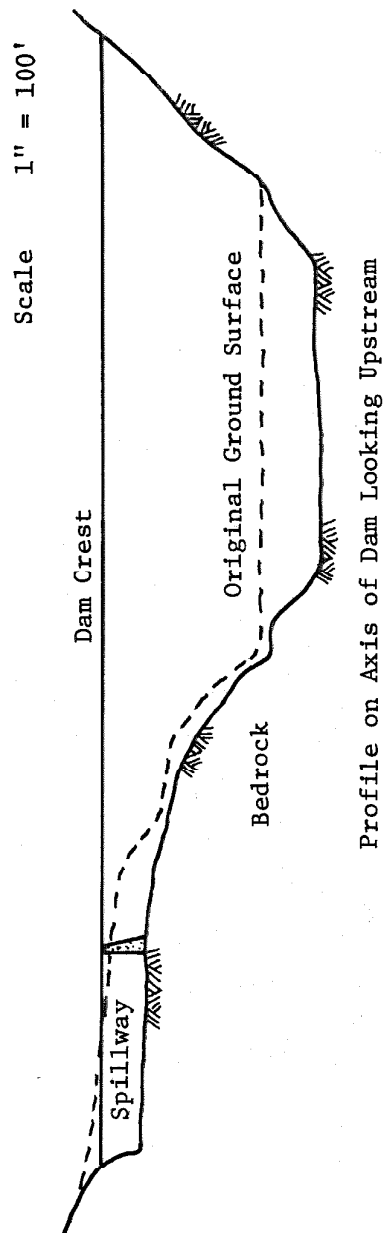
Figure 3. Cross-section and profile of Santa Felicia Dam.

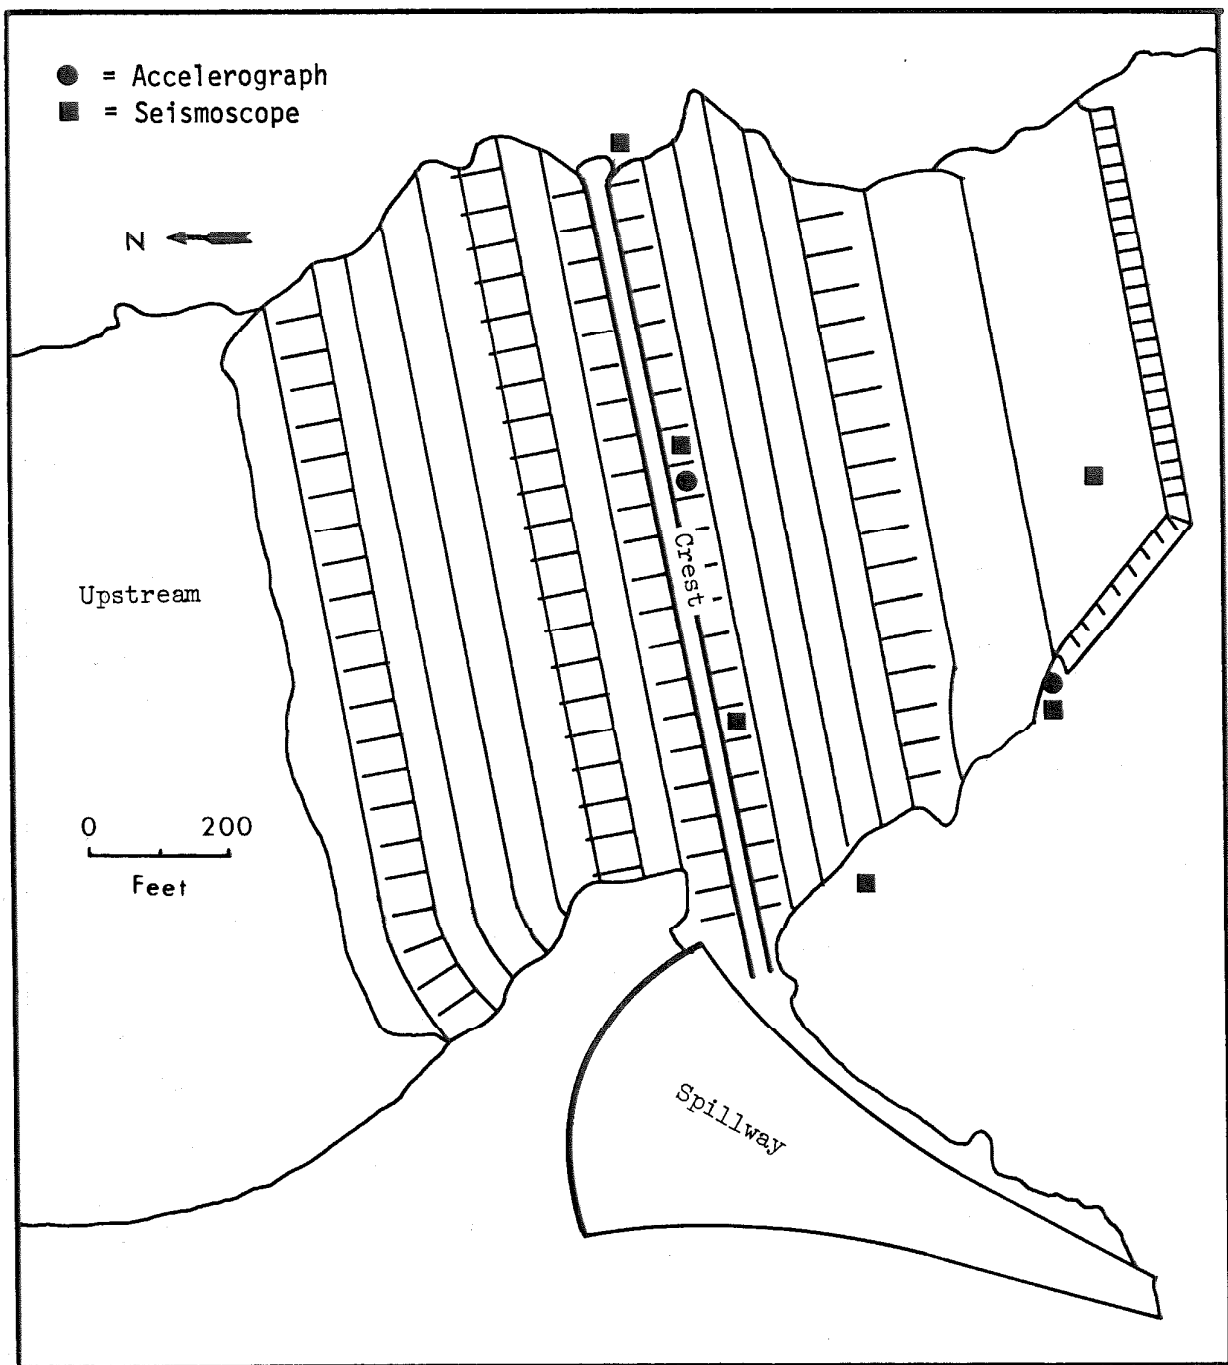
FIGURE 4. Location of strong-motion instruments at Santa Felicia Dam in 1971.

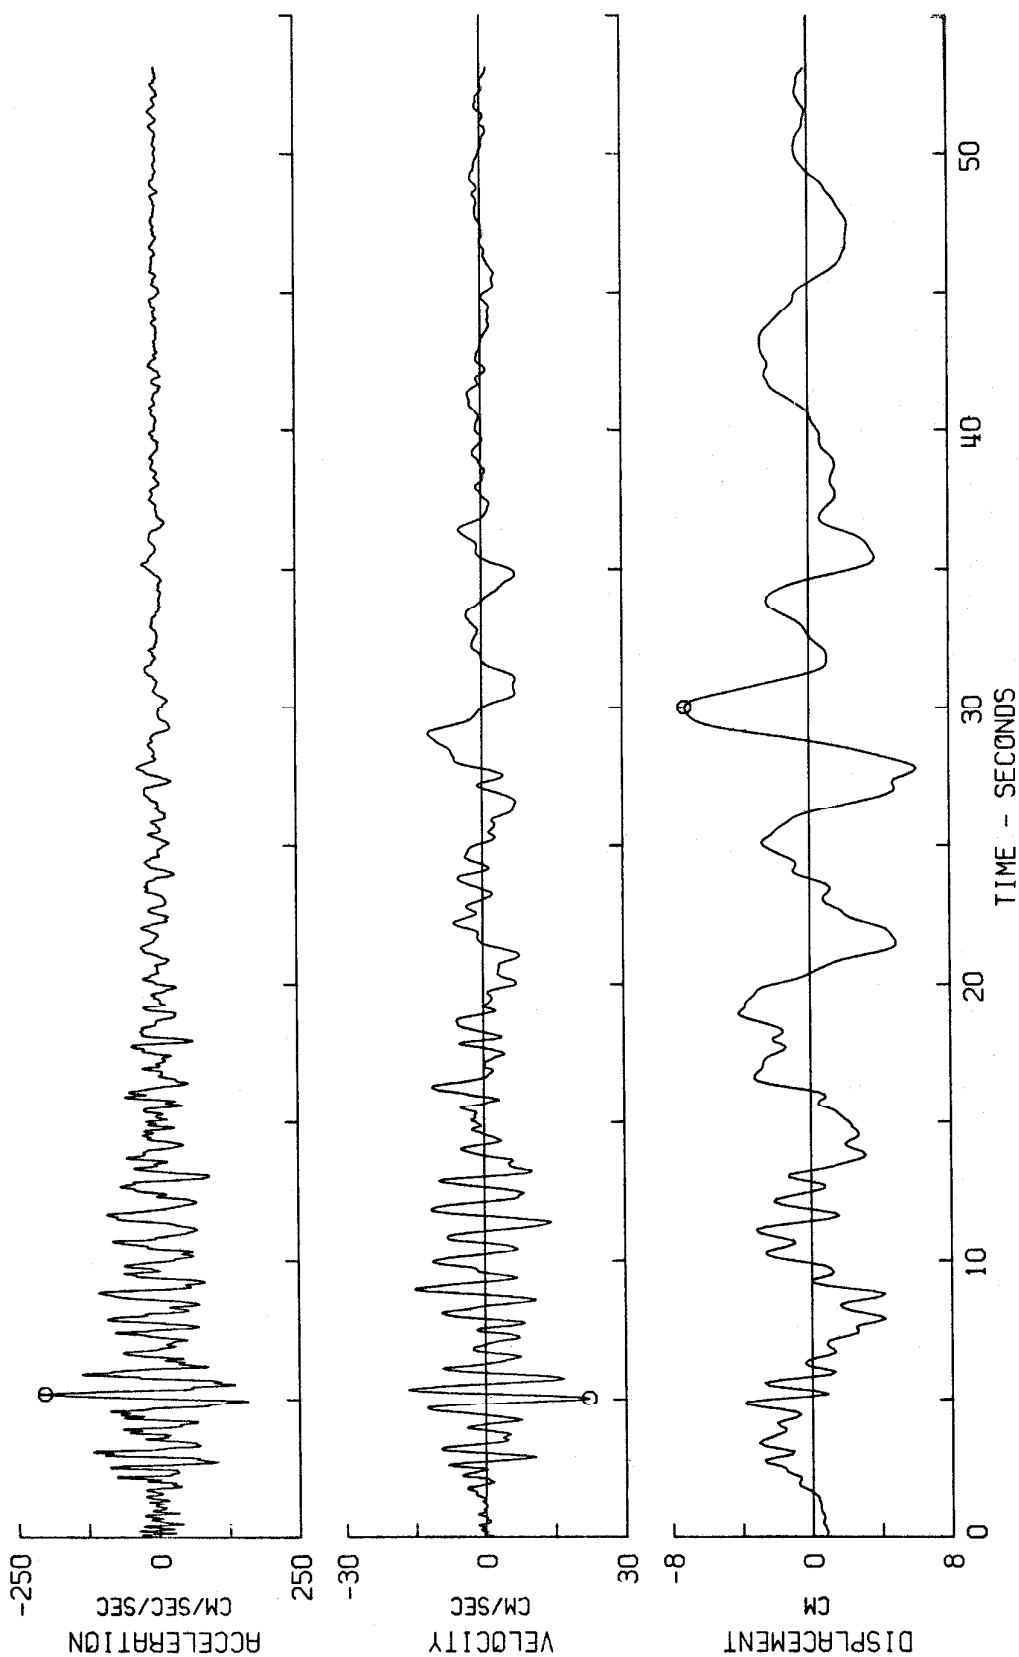
FIGURE 5.

SAN FERNANDO EARTHQUAKE FEB 9, 1971 - 0600 PST  
 11E082 71.063.0 SANTA FELICIA DAM, CAL., CREST COMP S15E  
 ○ PEAK VALUES : ACCEL = -203.3 CM/SEC/SEC VELOCITY = 22.2 CM/SEC DISPL = -7.1 CM

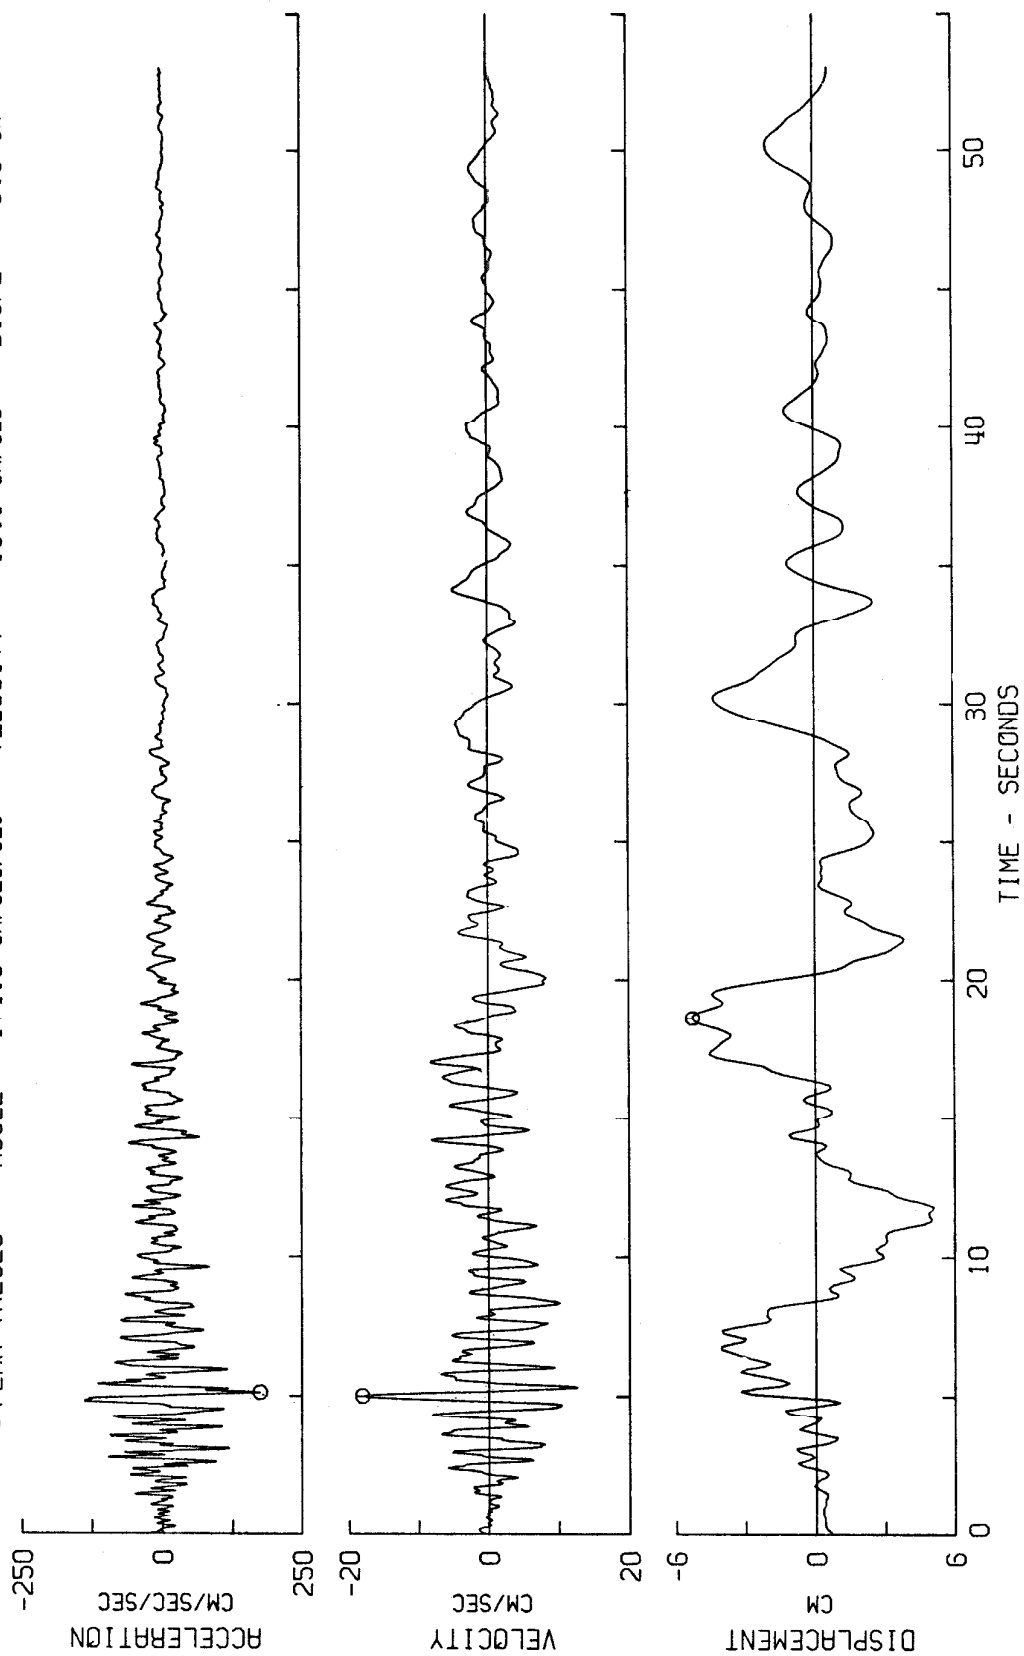
FIGURE 6.

SAN FERNANDO EARTHQUAKE FEB 9, 1971 - 0600 PST  
 IIE082 71.063.0 SANTA FELICIA DAM, CAL., CREST COMP S75W  
 ○ PEAK VALUES : ACCEL = 174.0 CM/SEC/SEC VELOCITY = -18.1 CM/SEC DISPL = -5.3 CM

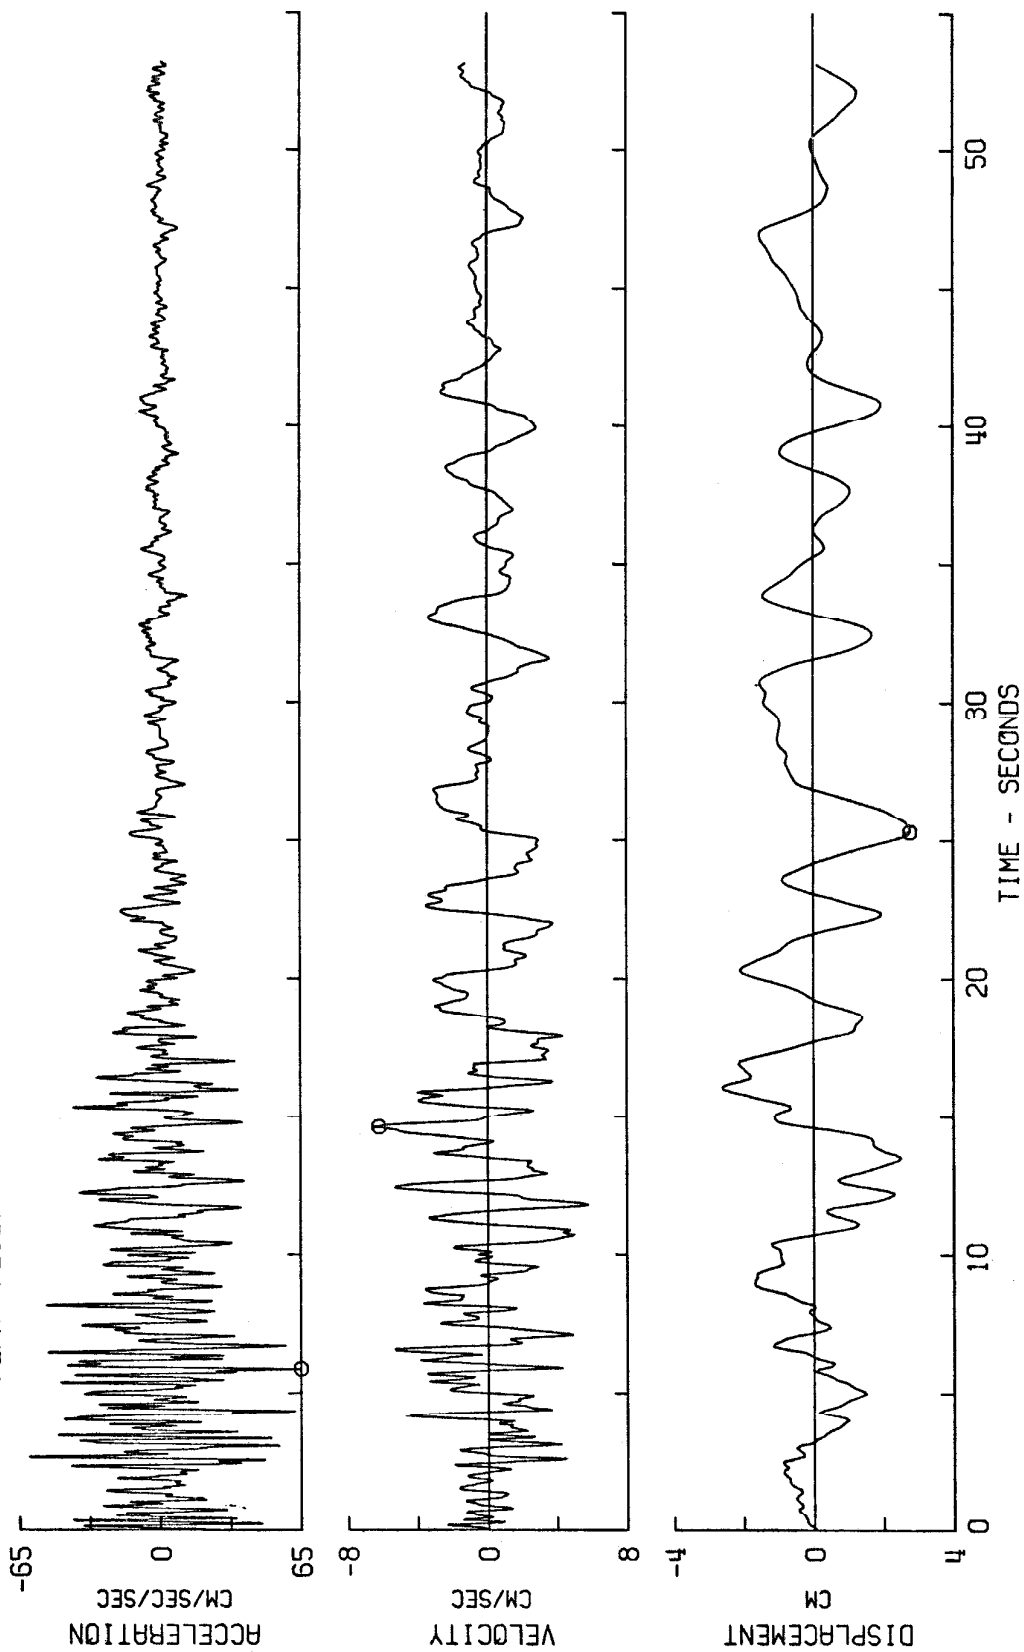
FIGURE 7.

SAN FERNANDO EARTHQUAKE FEB 9, 1971 - 0600 PST  
 IIE082 71.063.0 SANTA FELICIA DAM, CAL.. CREST COMP DOWN  
 ○ PEAK VALUES : ACCEL = 65.0 CM/SEC/SEC VELOCITY = -6.2 CM/SEC DISPL = 2.8 CM

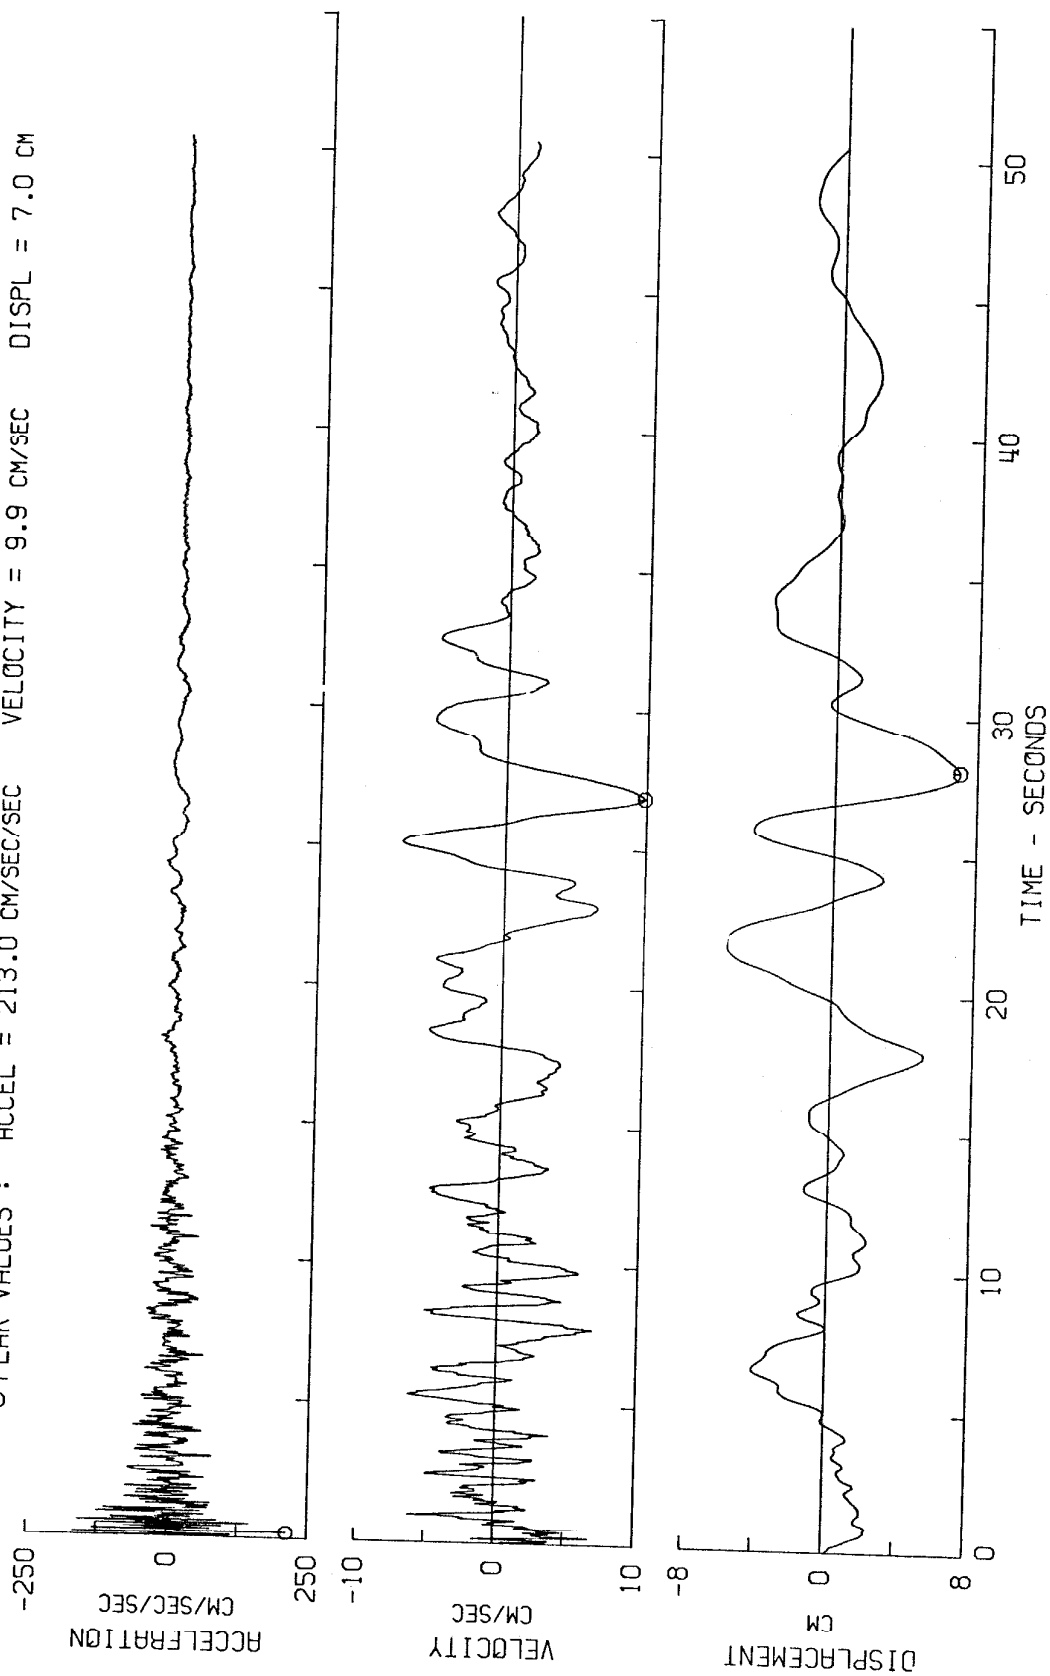
SAN FERNANDO EARTHQUAKE FEB 9, 1971 - 0600 PST  
 11E081 71.062.0 SANTA FELICIA DAM, CAL., OUTLET WORKS COMP S08E  
 ○ PEAK VALUES : ACCEL = 213.0 CM/SEC/SEC VELOCITY = 9.9 CM/SEC DISPL = 7.0 CM

Figure 8. Santa Felicia Dam Outlet Works Accelerogram, Component S08E

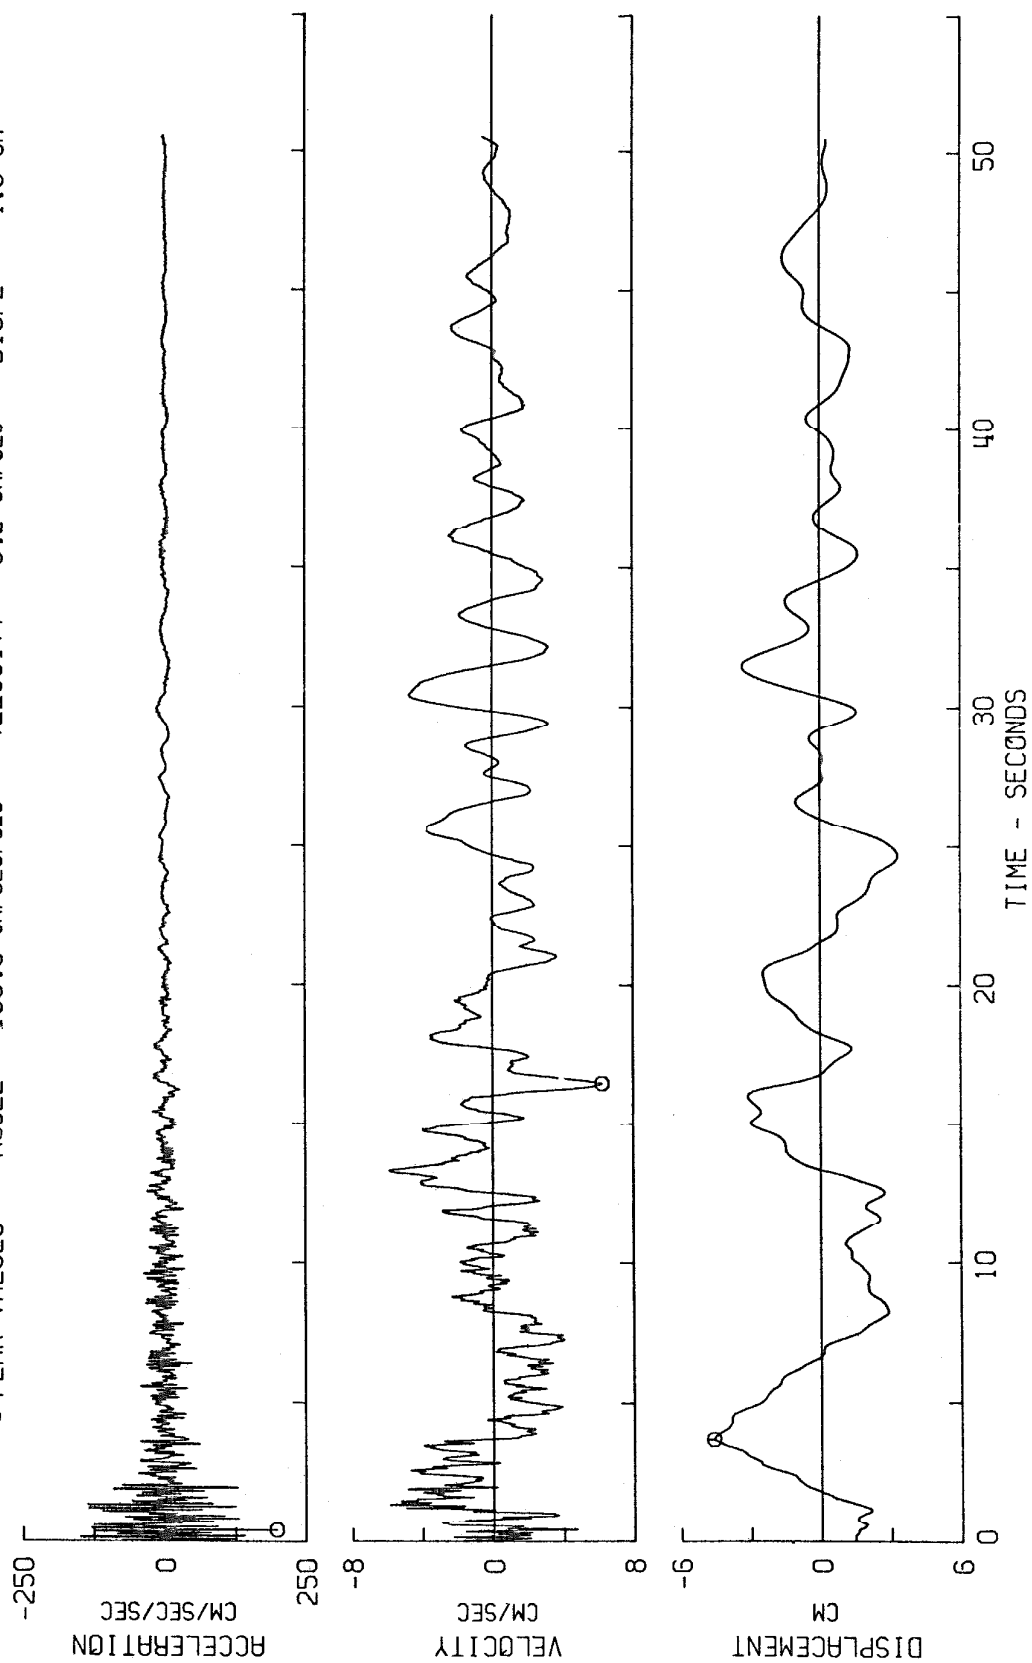
SAN FERNANDO EARTHQUAKE FEB 9, 1971 - 0600 PST  
 IIE081 71.062.0 SANTA FELICIA DAM, CAL., OUTLET WORKS COMP S82W  
 ○ PEAK VALUES : ACCEL = 198.3 CM/SEC/SEC VELOCITY = 6.2 CM/SEC DISPL = -4.6 CM

Figure 9. Santa Felicia Dam Outlet Works Accelerogram, Component S82W

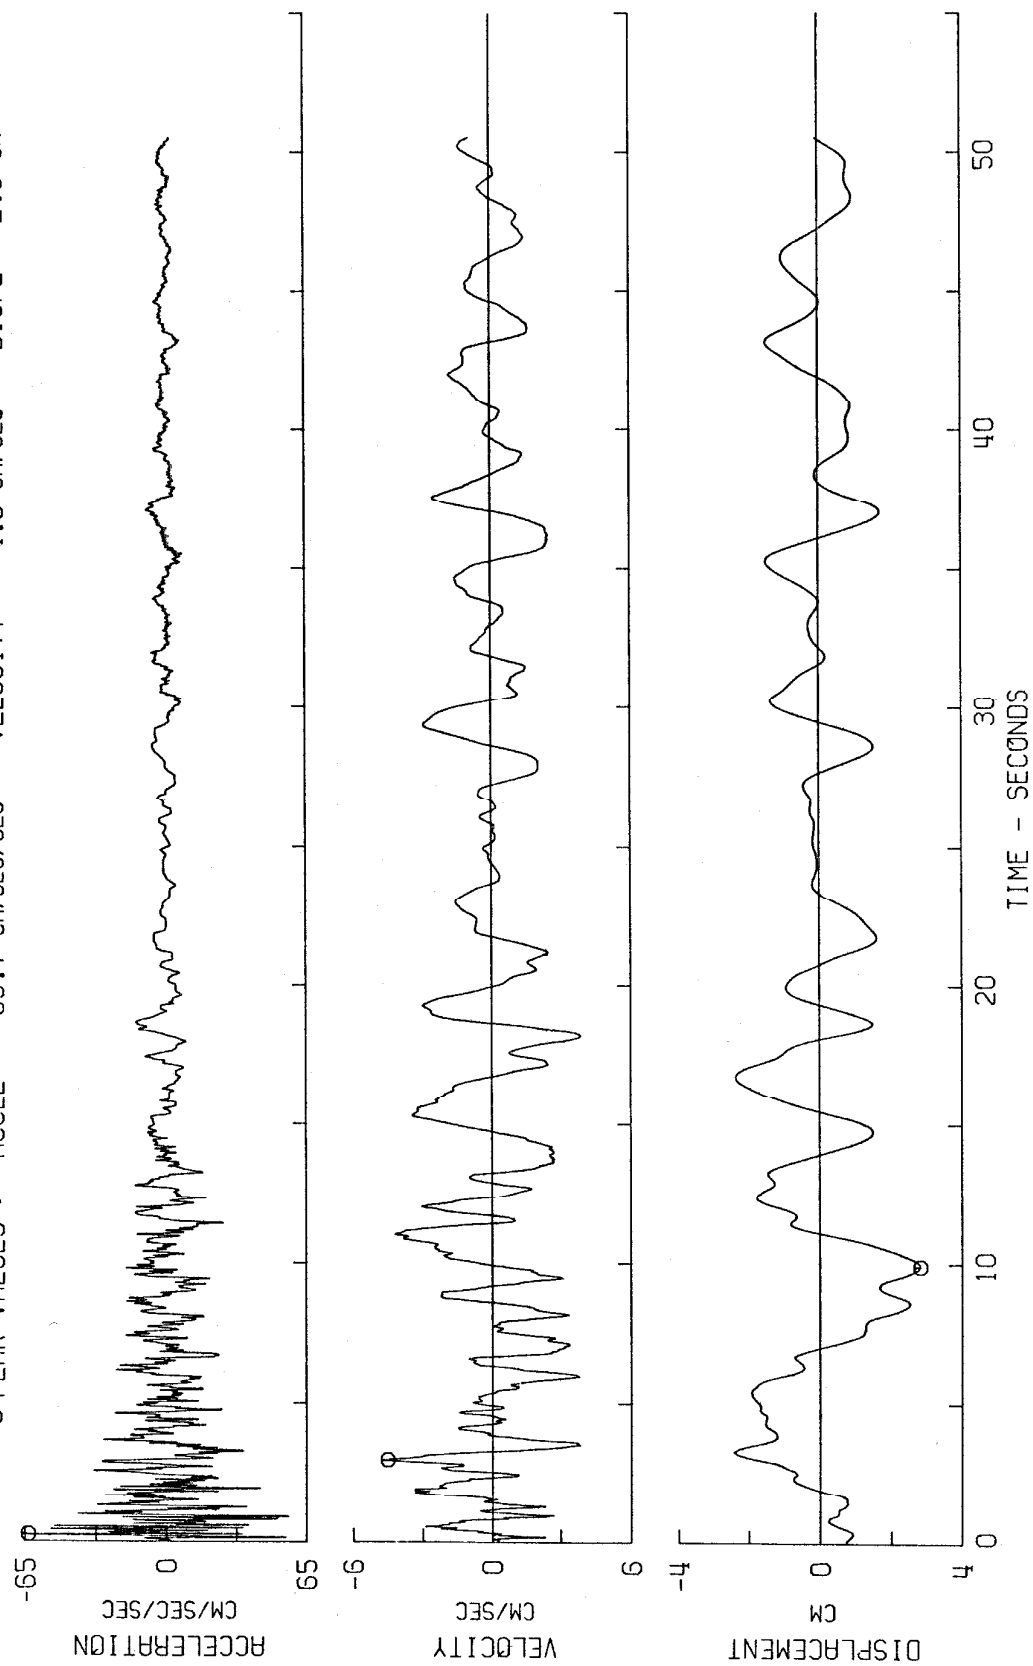
SAN FERNANDO EARTHQUAKE FEB 9, 1971 - 0600 PST  
 11E081 71.062.0 SANTA FELICIA DAM, CAL., OUTLET WORKS COMP DOWN  
 PEAK VALUES: ACCEL = -63.7 CM/SEC/SEC VELOCITY = -4.5 CM/SEC DISPL = 2.8 CM

Figure 10. Santa Felicia Dam Outlet Works Accelerogram, Component Vertical.

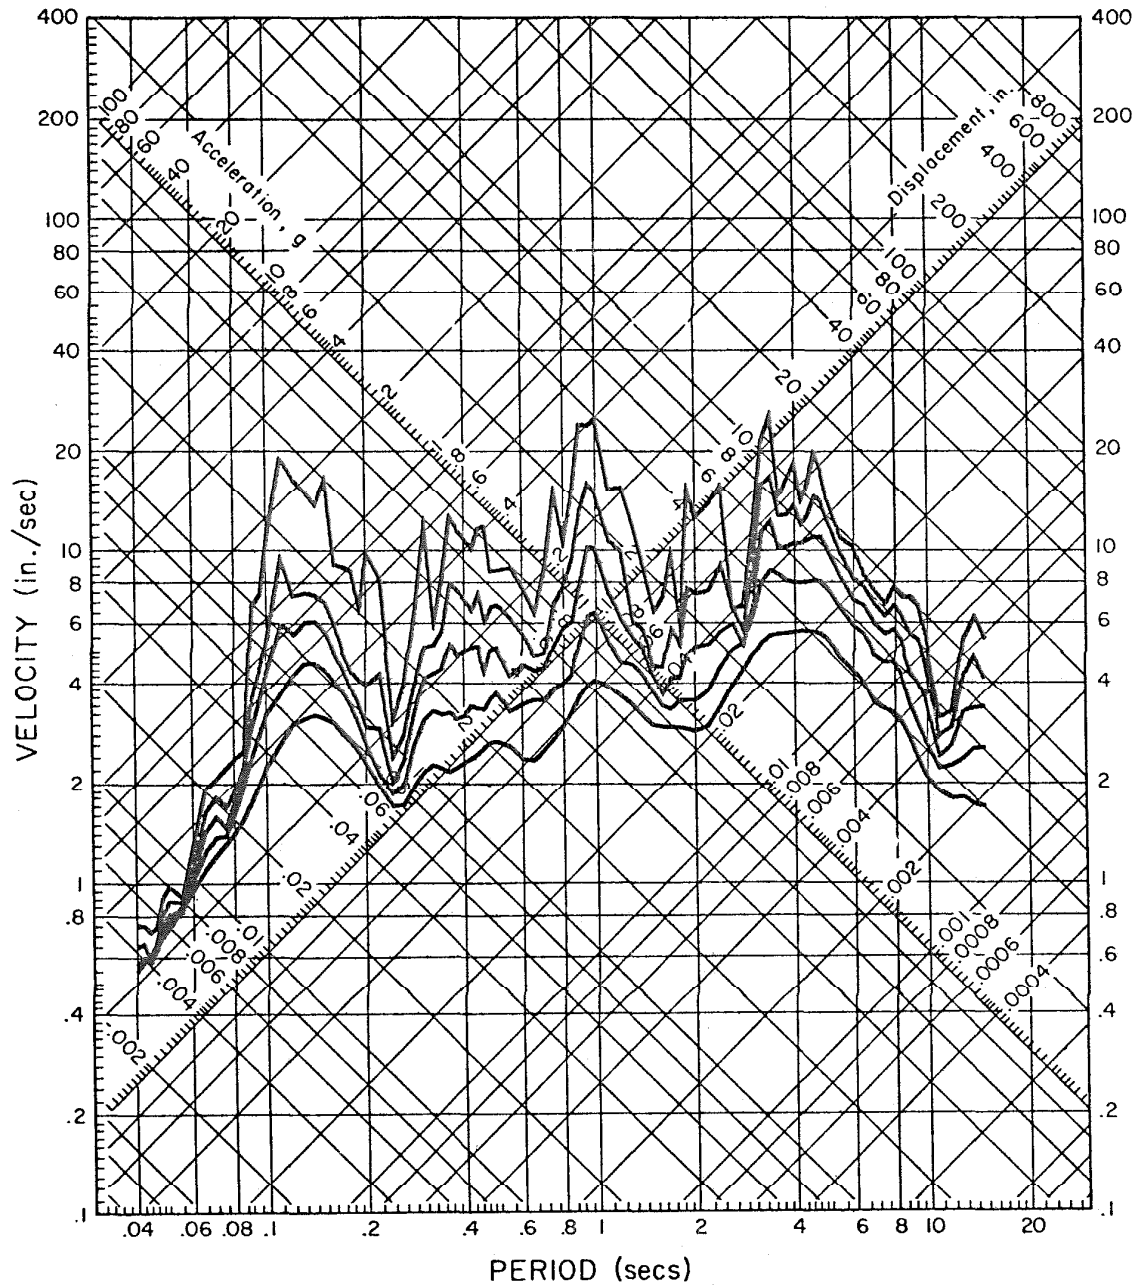
IIIE081 71.062.0 SANTA FELICIA DAM, CAL., OUTLET WORKS COMP S08E

DAMPING VALUES ARE 0, 2, 5, 10 AND 20 PERCENT OF CRITICAL

Figure 11. Response Spectrum Santa Felicia Dam Outlet Works-S08E  
(From Calif. Inst. Tech. Data Reports)

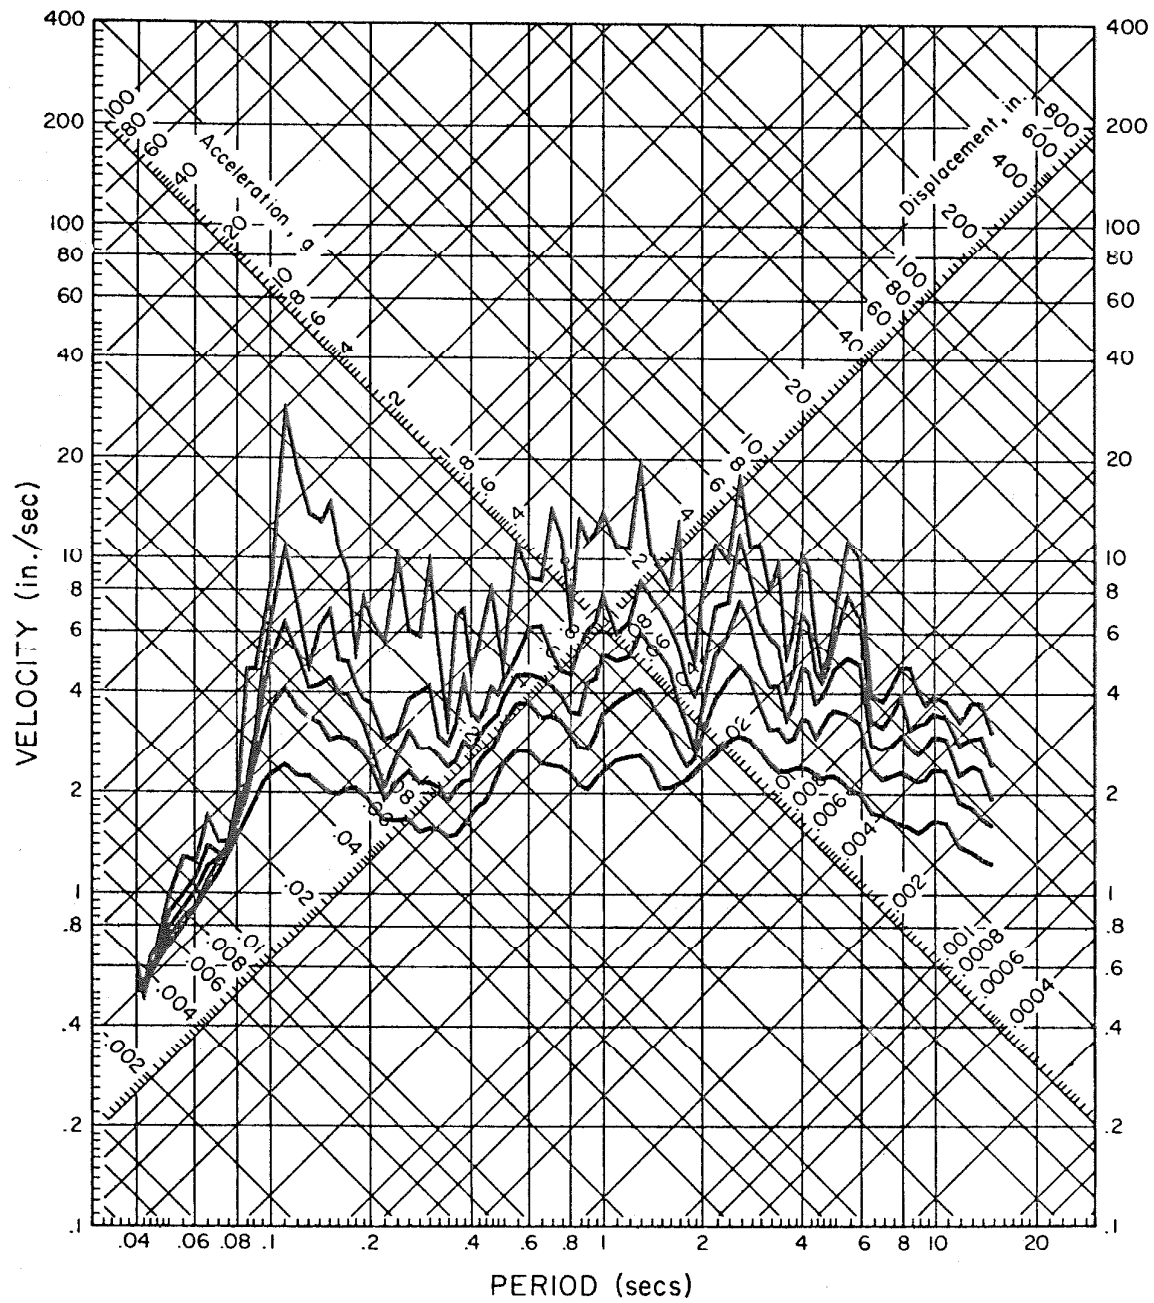
IIIE081 71.062.0 SANTA FELICIA DAM, CAL., OUTLET WORKS COMP S82W

DAMPING VALUES ARE 0, 2, 5, 10 AND 20 PERCENT OF CRITICAL

Figure 12. Response Spectrum Santa Felicia Dam Outlet Works-S82W  
(From Calif. Inst. Tech. Data Reports)

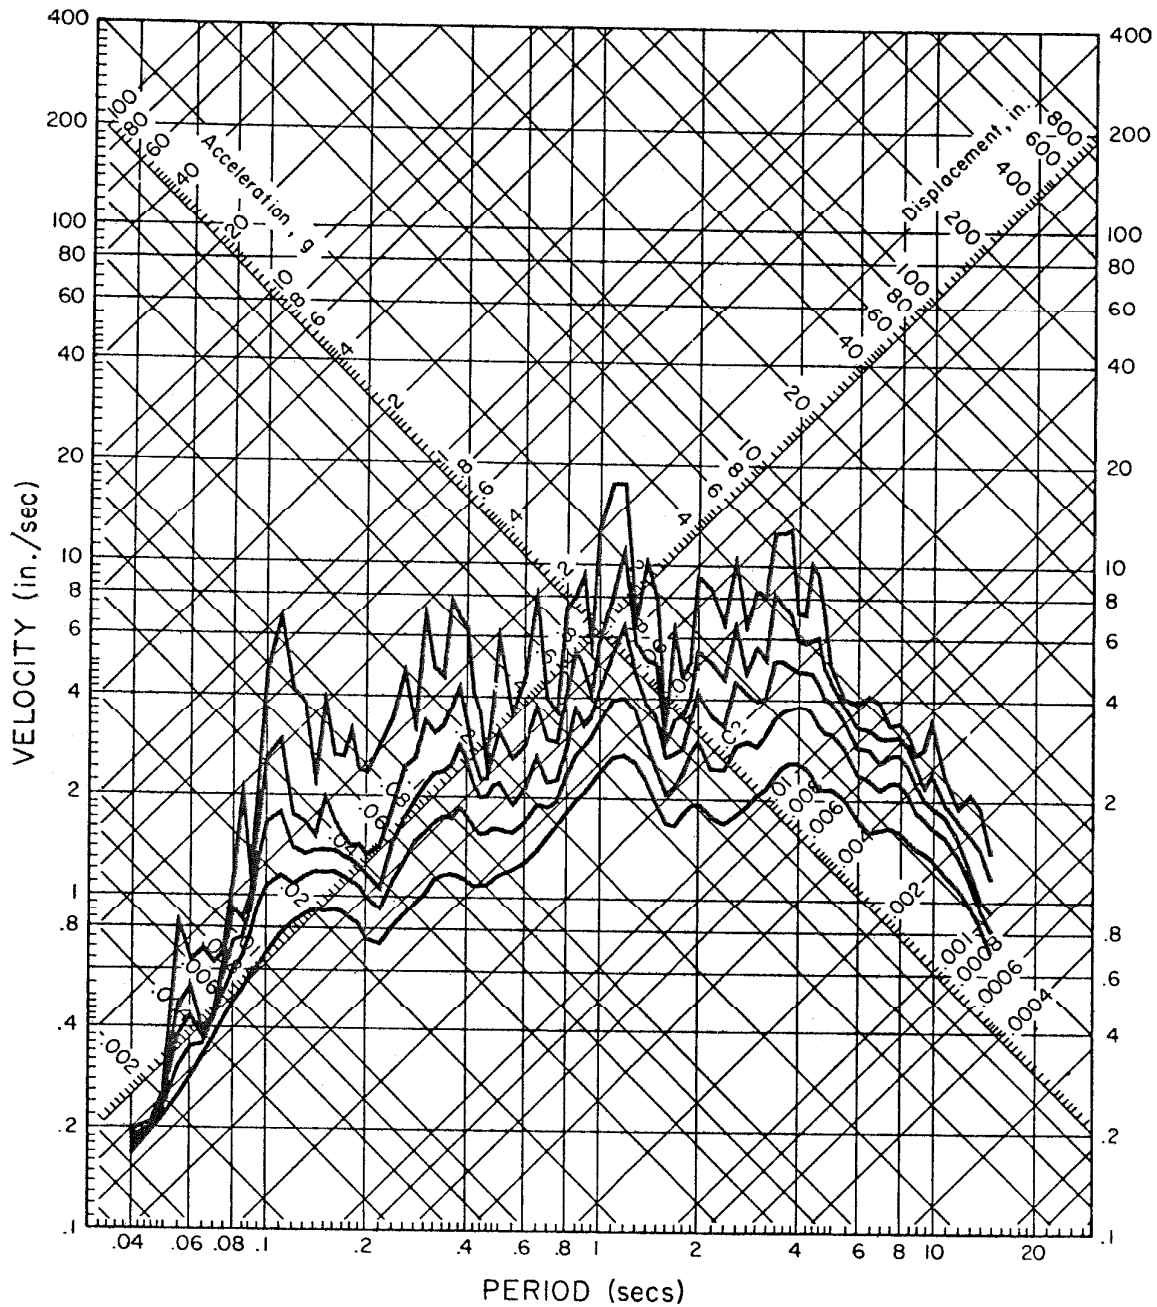
IIIE081 71.062.0 SANTA FELICIA DAM. CAL.. OUTLET WORKS COMP DOWN

DAMPING VALUES ARE 0, 2, 5, 10 AND 20 PERCENT OF CRITICAL

Figure 13. Response Spectrum Santa Felicia Dam Outlet Works-vertical.  
(From Calif. Inst. Tech. Data Reports)
