# EARTHQUAKE RECORDINGS ON OR NEAR DAMS

P. Morrison, R. Maley, G. Brady, R. Porcella

USCOLD

November 1977

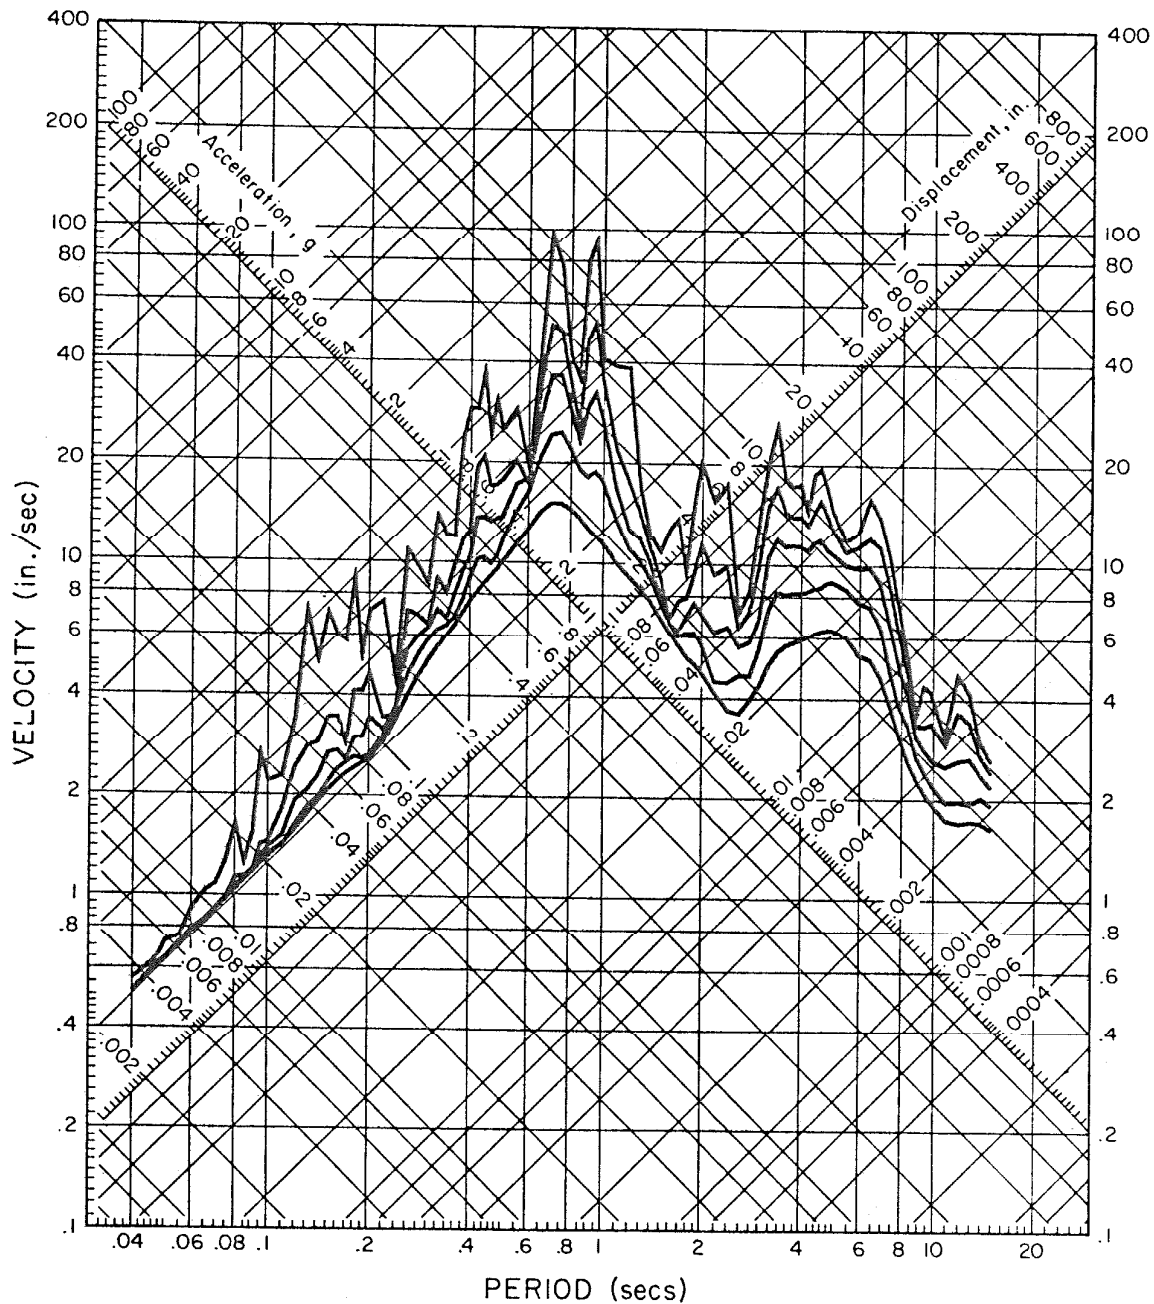
IIIE082 71.063.0 SANTA FELICIA DAM, CAL., CREST COMP S15E

DAMPING VALUES ARE 0, 2, 5, 10 AND 20 PERCENT OF CRITICAL

Figure 14. Response Spectrum Santa Felicia Dam Crest-S15E.  
(From Calif. Inst. Tech. Data Reports)

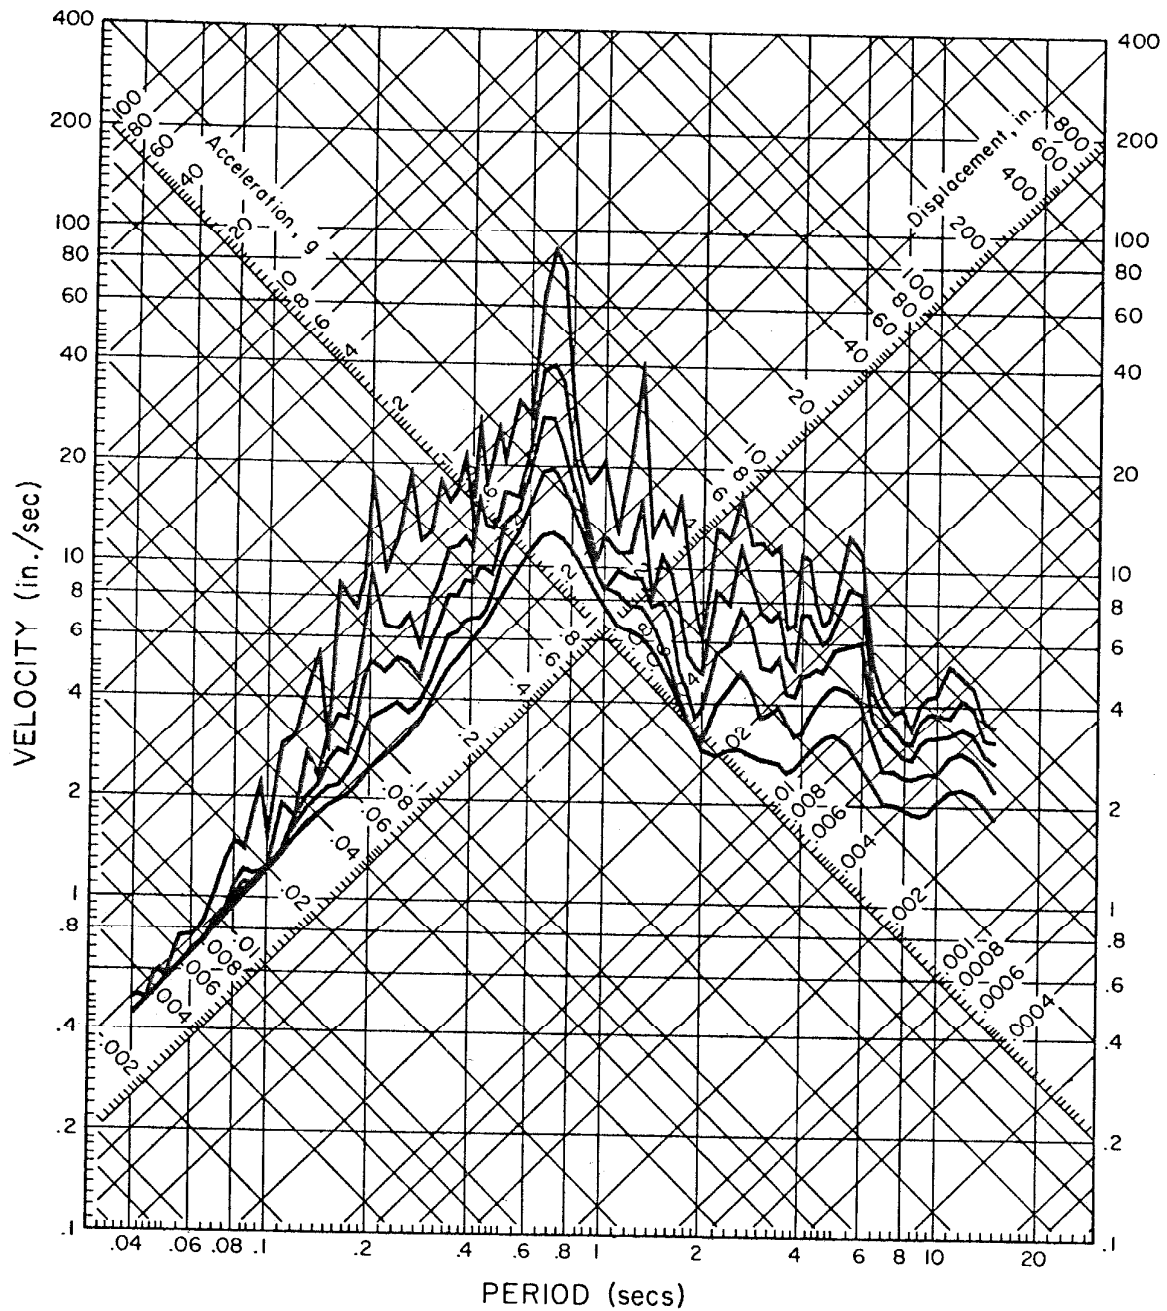
IIIE082 71.063.0 SANTA FELICIA DAM, CAL., CREST COMP S75W

DAMPING VALUES ARE 0, 2, 5, 10 AND 20 PERCENT OF CRITICAL

Figure 15. Response Spectrum Santa Felicia Dam Crest-S75W.  
(from Calif. Inst. Tech. Data Reports)

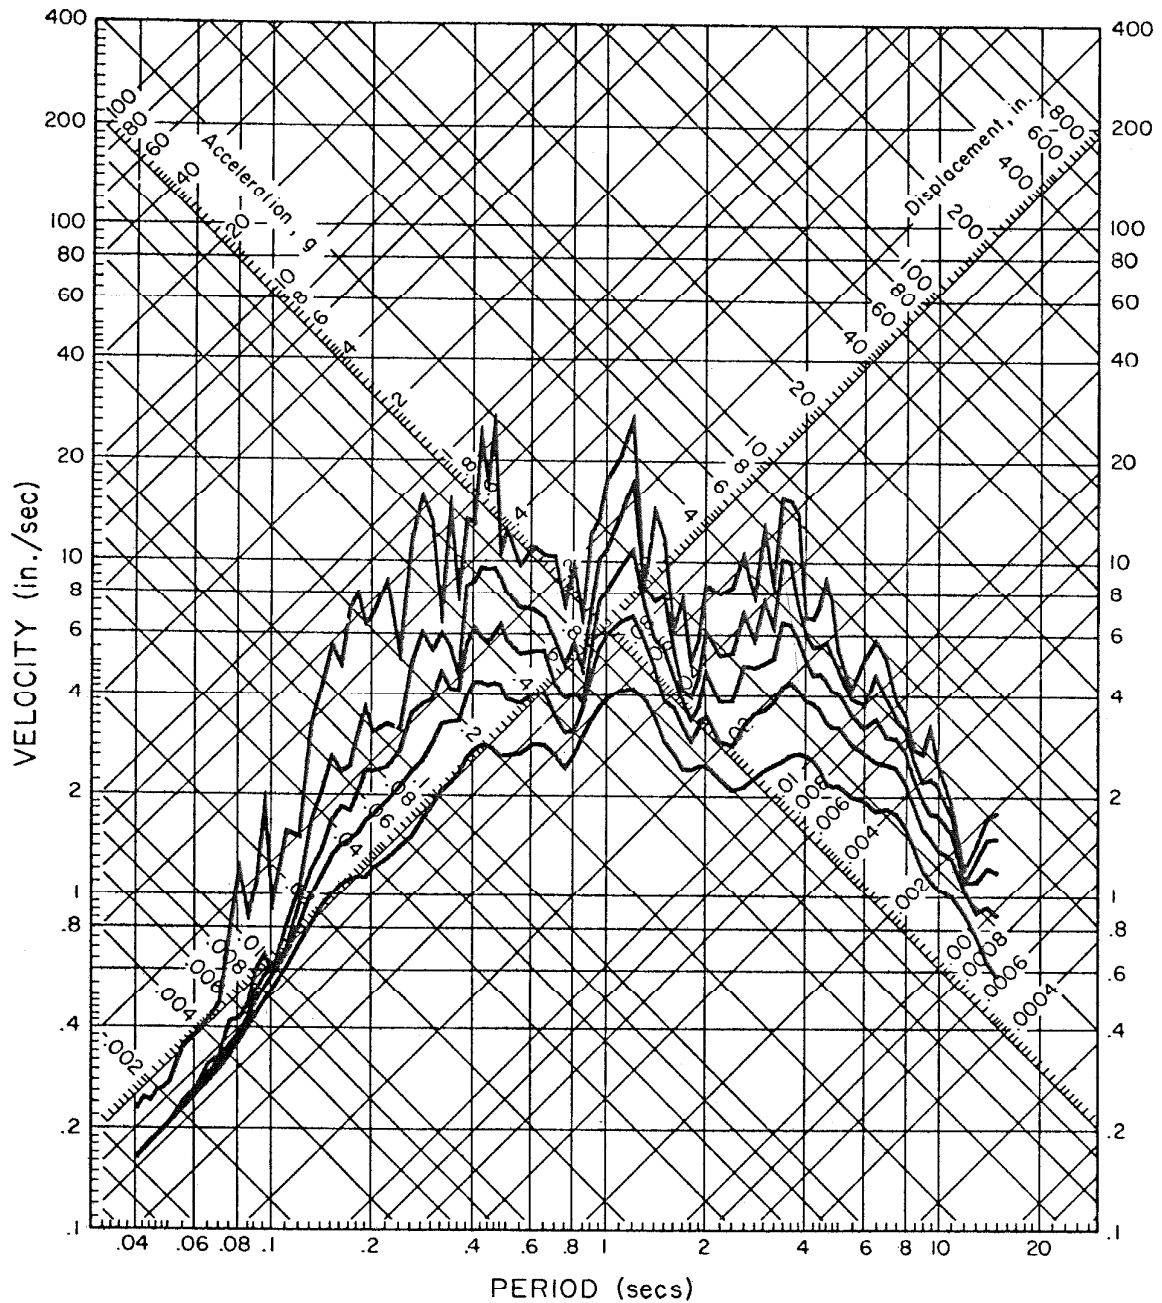
IIIE082 71.063.0 SANTA FELICIA DAM, CAL., CREST COMP DOWN

DAMPING VALUES ARE 0, 2, 5, 10 AND 20 PERCENT OF CRITICAL

Figure 16. Response Spectrum Santa Felicia Dam Crest-Vertical.  
(From Calif. Inst. Tech. Data Reports)

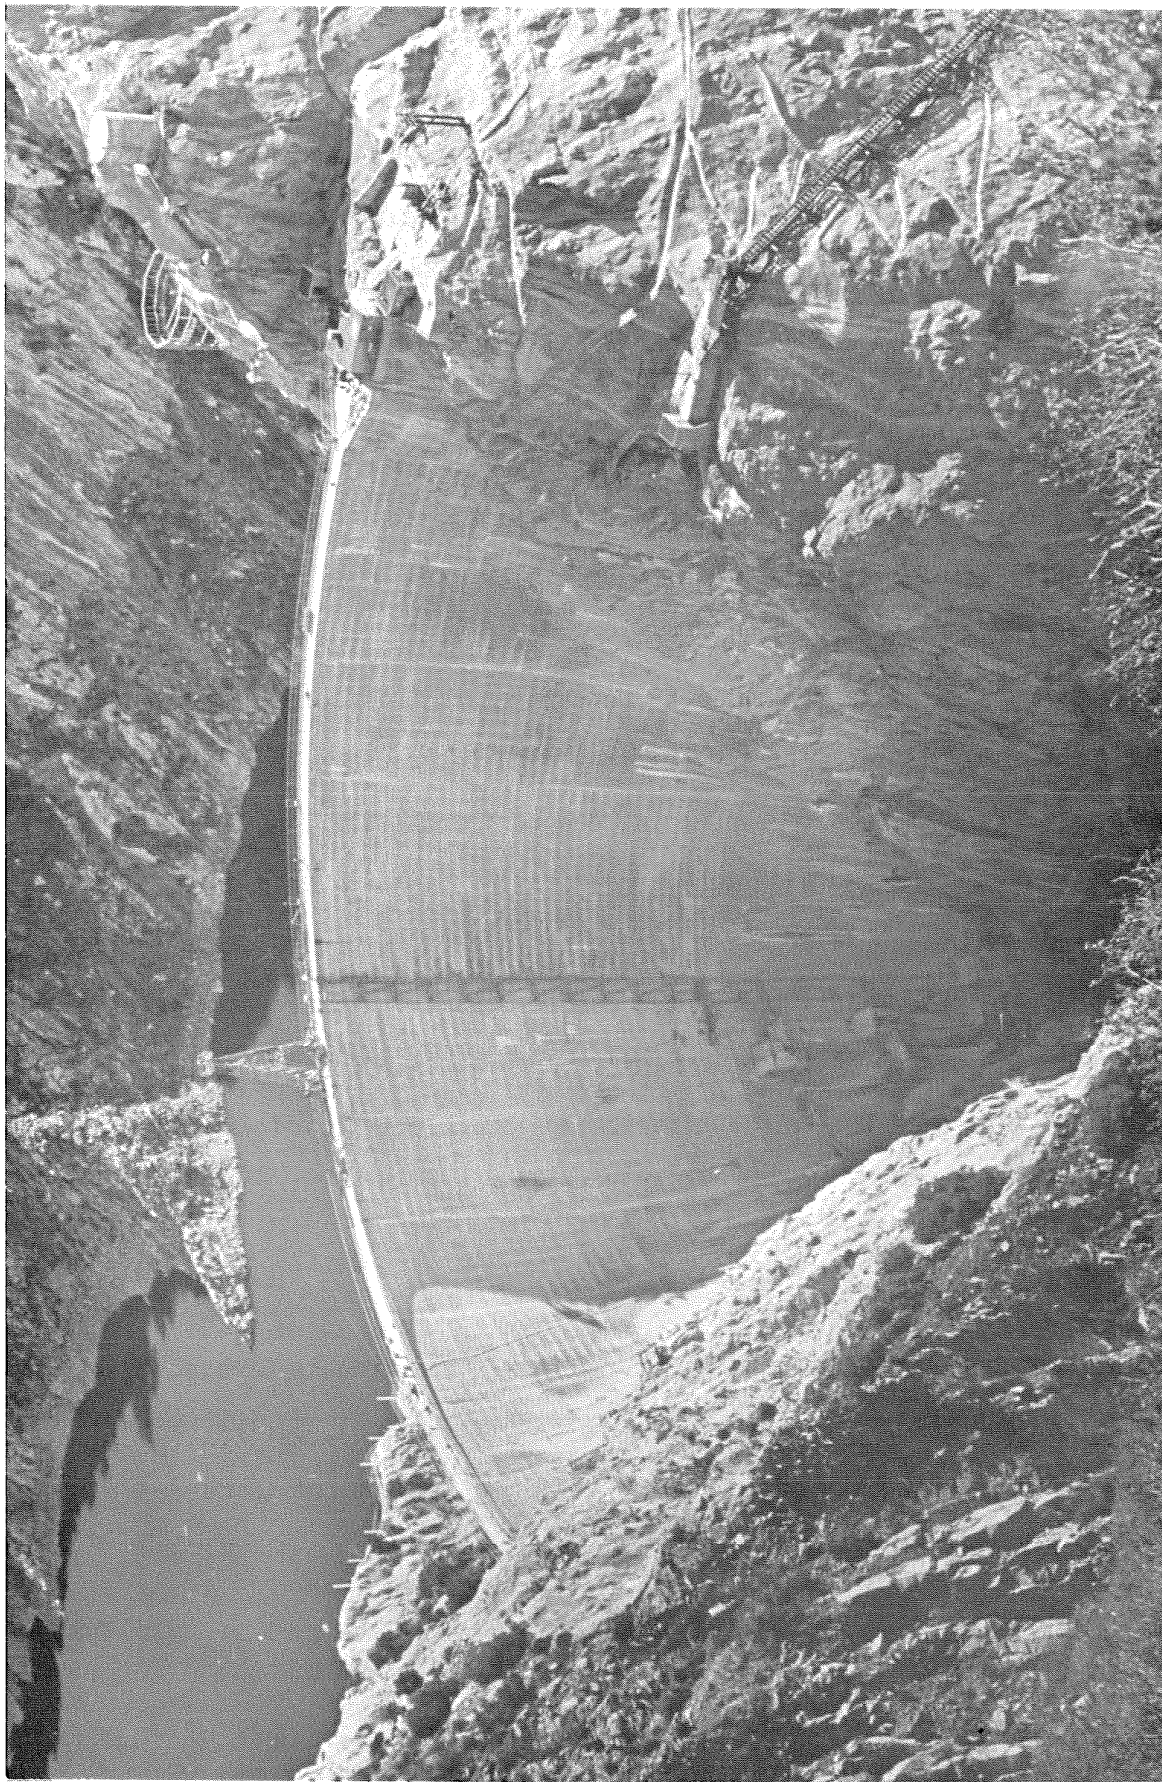
Figure 1. Photograph of Pacoima Dam. The accelerograph was installed in a small metal hut a few meters below the large white water tank shown in upper right of photo.

(Figures 1, 2 and 3). The crest width is 3 m at its narrowest point. The maximum reservoir capacity is  $1.23 \times 10^7 \text{ m}^3$  (10,000 acre-feet) at the upper spillway. The facility has dual spillways consisting of two tunnels at different elevations in the left abutment that join near a common exit. It is reported that the occurrence of the 1925 Santa Barbara earthquake caused the engineers to reconsider the design of the dam for earthquake resistance.

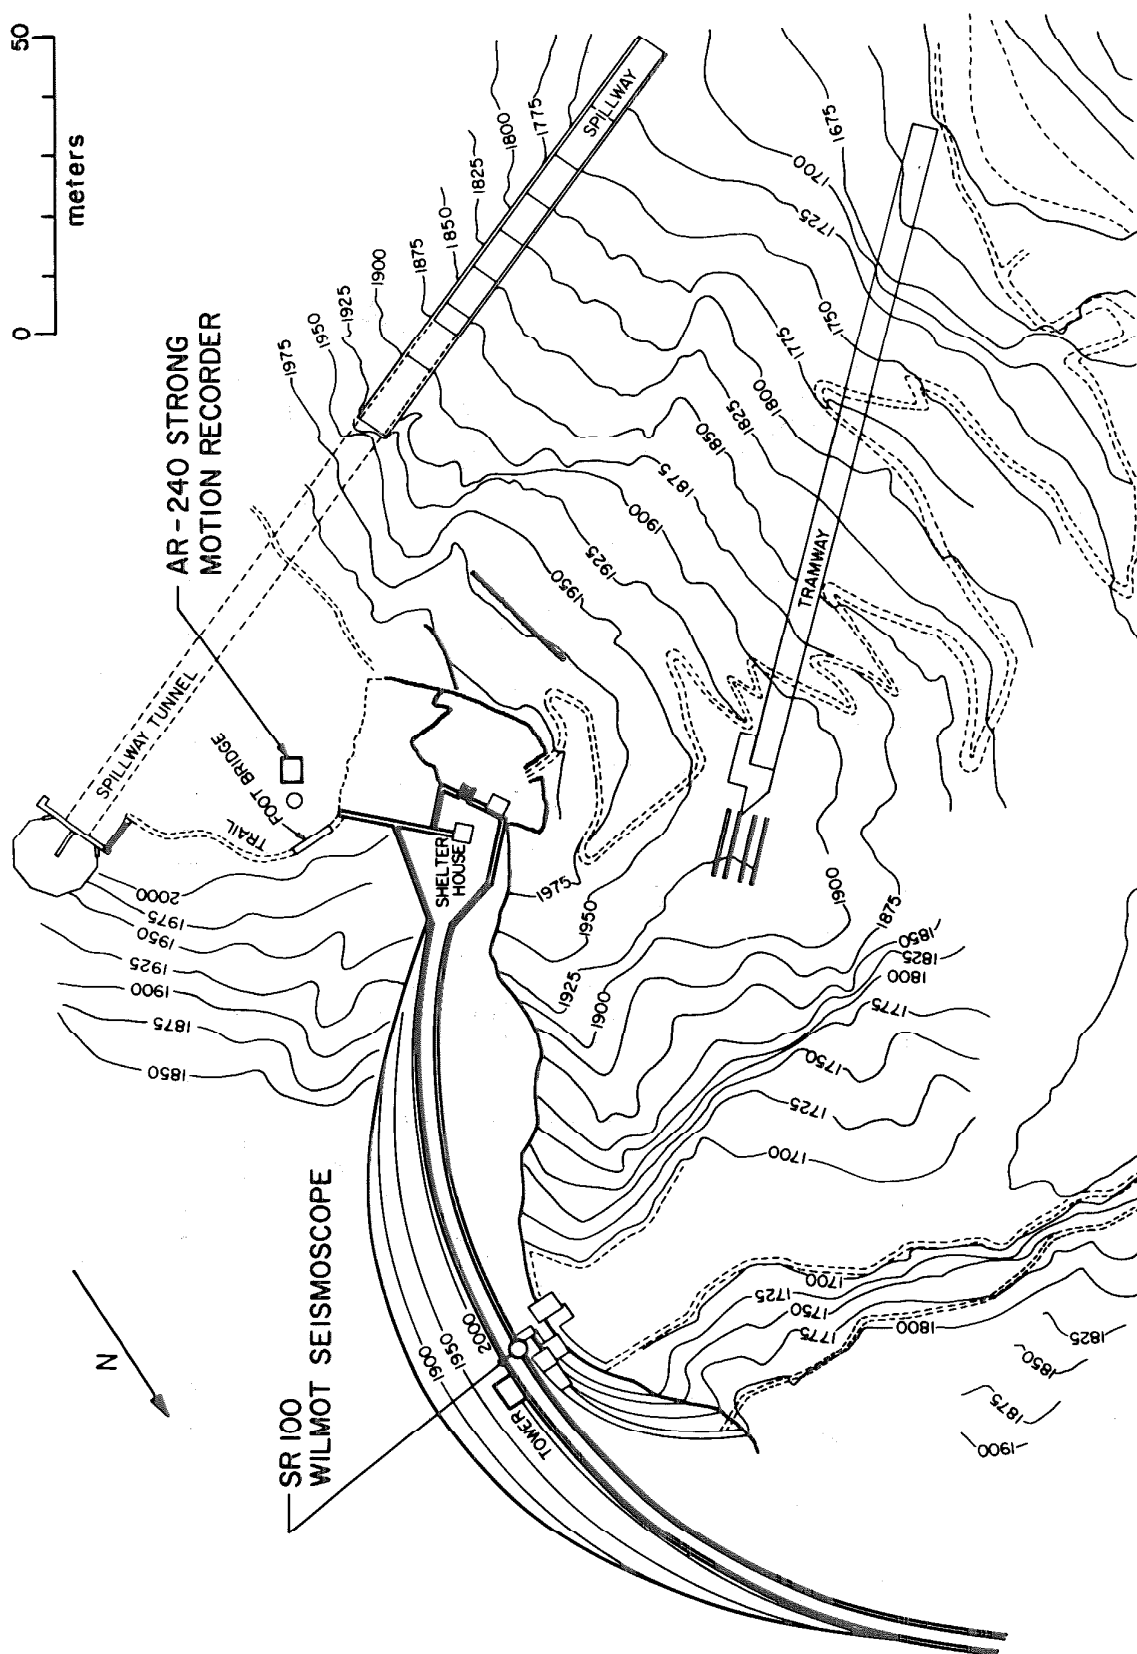
FIGURE 2. Location of strong-motion instruments at Pacoima Dam (Trifunac and Hudson, 1971).

In 1965 a Teledyne AR-240 accelerograph was installed in a small steel building on a sharp ridge of the left abutment approximately 15 m above crest level of the dam (Figure 2). A Wilmot seismoscope was also installed on the downstream parapet near the center of the crest. During the 1971 San Fernando earthquake cracks in the rock beneath the accelerograph station were enlarged and some displacement and shifting occurred causing the instrument housing to tilt slightly. Consequently, the horizontal starting pendulum in the accelerograph produced a continuous electrical contact; this depleted the supply of recording paper while recording some additional 30 aftershocks (reference 5, Introduction). Corrected accelerograms and integrated velocity and displacement curves of the main San Fernando shock are shown in Figures 4, 5, and 6 (reference 15, Introduction). An incomplete record was obtained from the seismoscope when the recording plate was thrown off the instrument at the beginning of the earthquake.

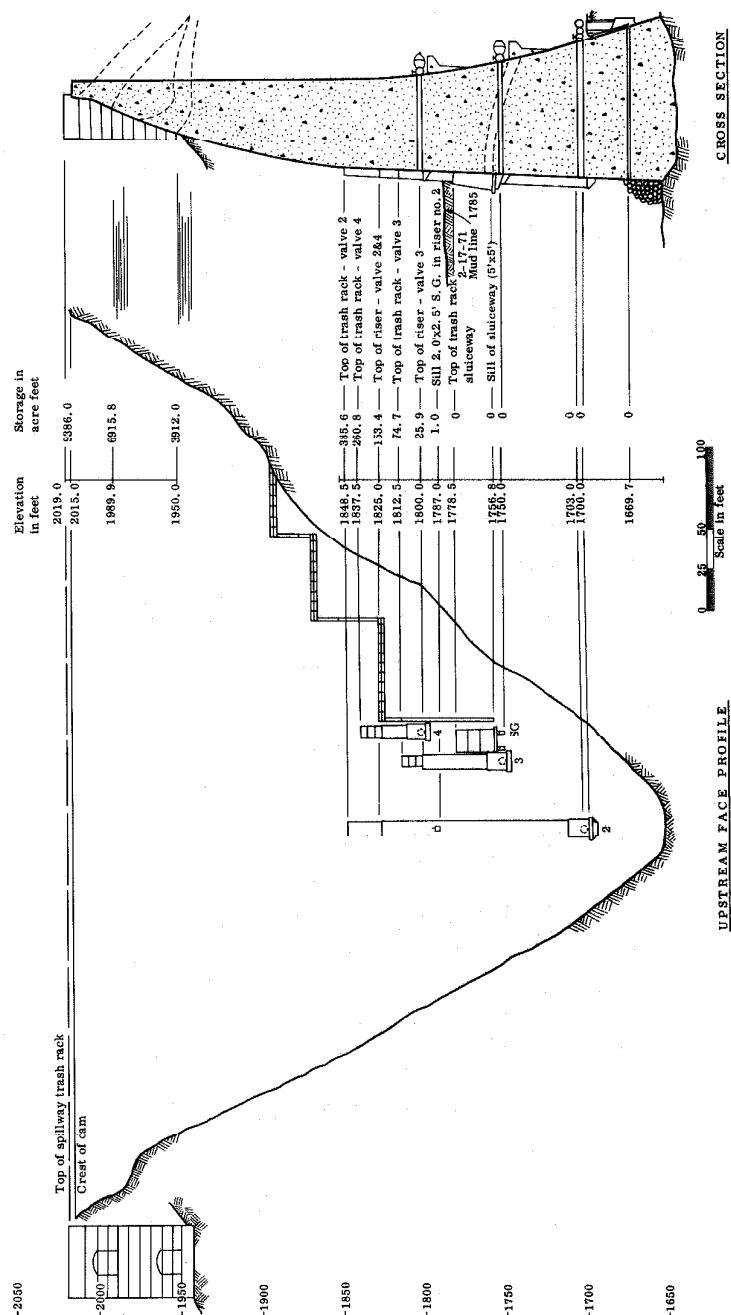
FIGURE 3. Pacoima Dam profile and section (Phillips and others, 1971).

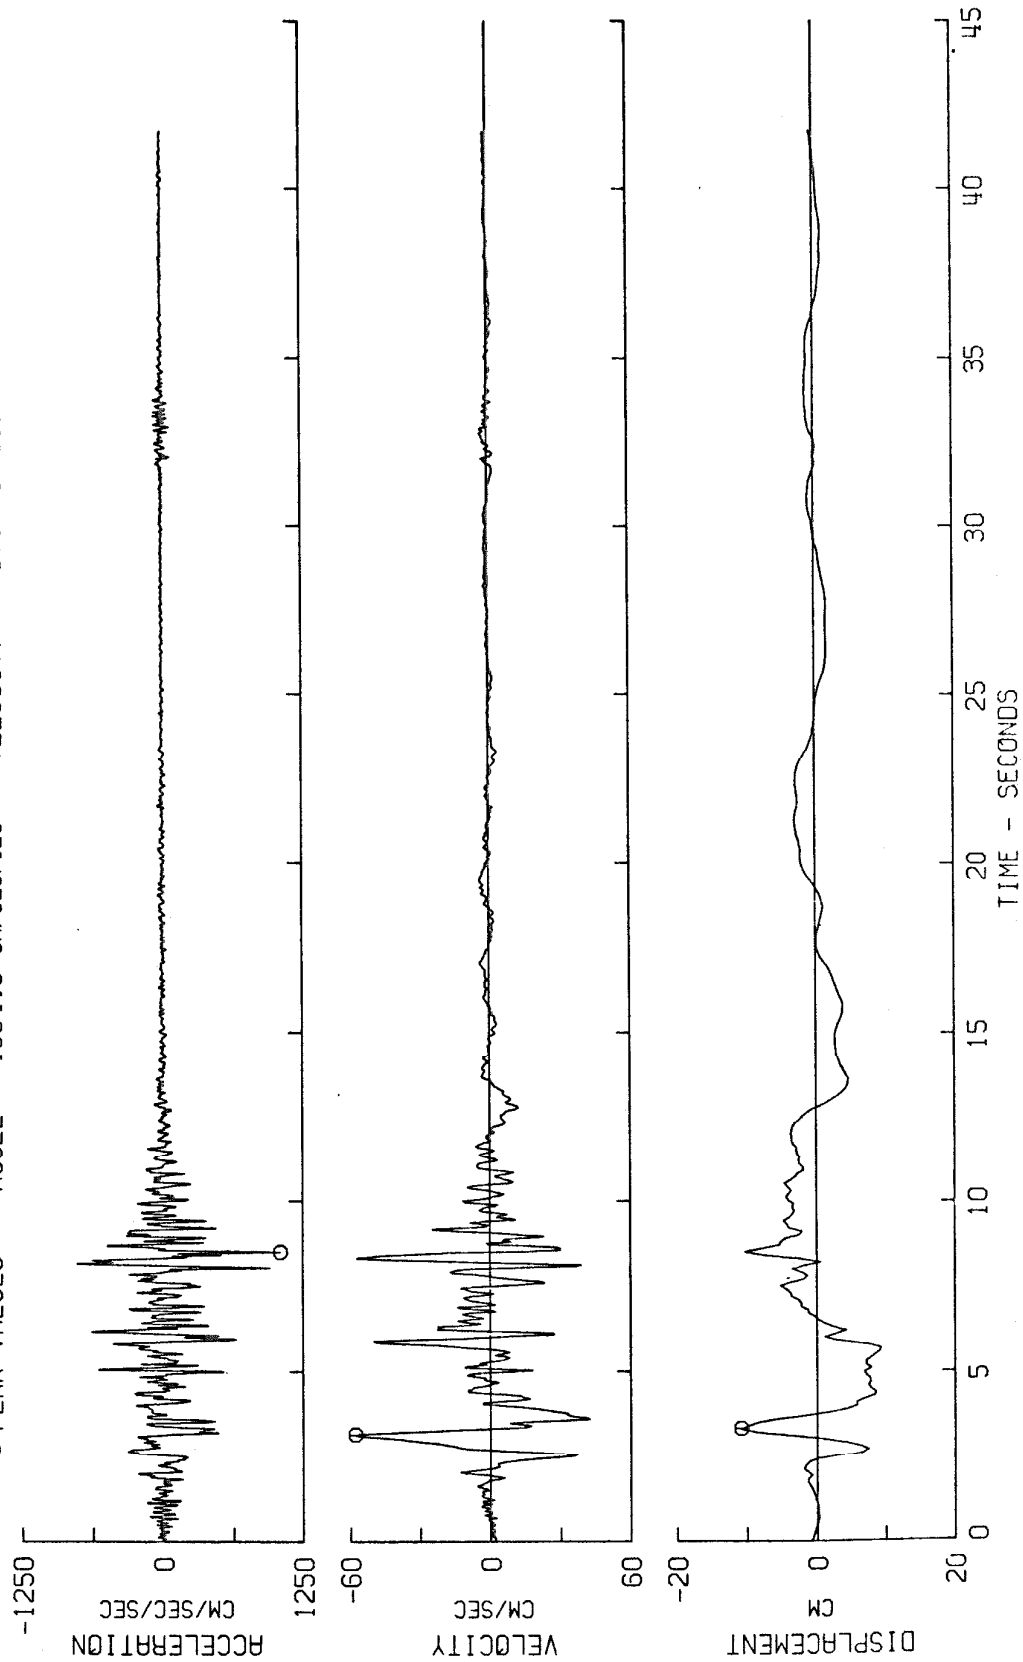
SAN FERNANDO EARTHQUAKE FEB 9, 1971 - 0600 PST  
 IIC041 71.001.0 PACOIMA DAM, CAL. COMP N76W  
 PEAK VALUES : ACCEL = 1054.9 CM/SEC/SEC VELOCITY = -57.7 CM/SEC DISPL = -10.8 CM

Figure 4. Pacoima Dam accelerogram, component N76W.

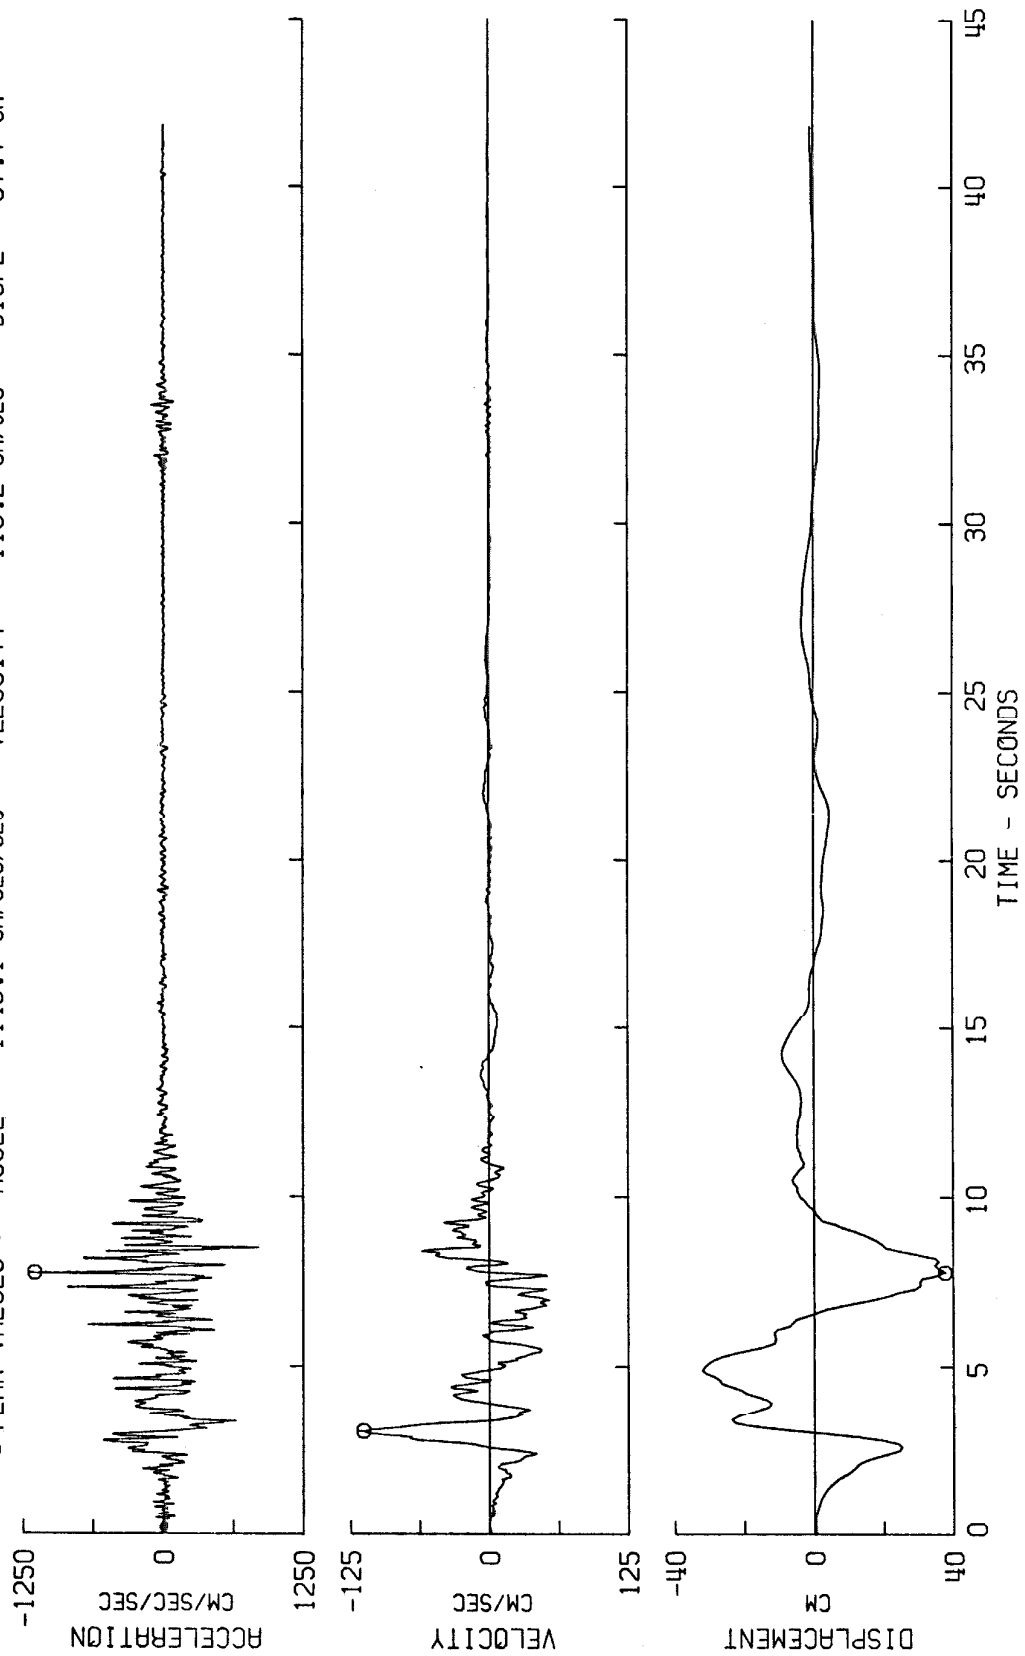
SAN FERNANDO EARTHQUAKE FEB 9, 1971 - 0600 PST  
 IIC041 71.001.0 PACOIMA DAM, CAL. COMP S14W  
 ○ PEAK VALUES : ACCEL = -1148.1 CM/SEC/SEC VELOCITY = -113.2 CM/SEC DISPL = 37.7 CM

Figure 5. Pacoima Dam accelerogram, component S14W.

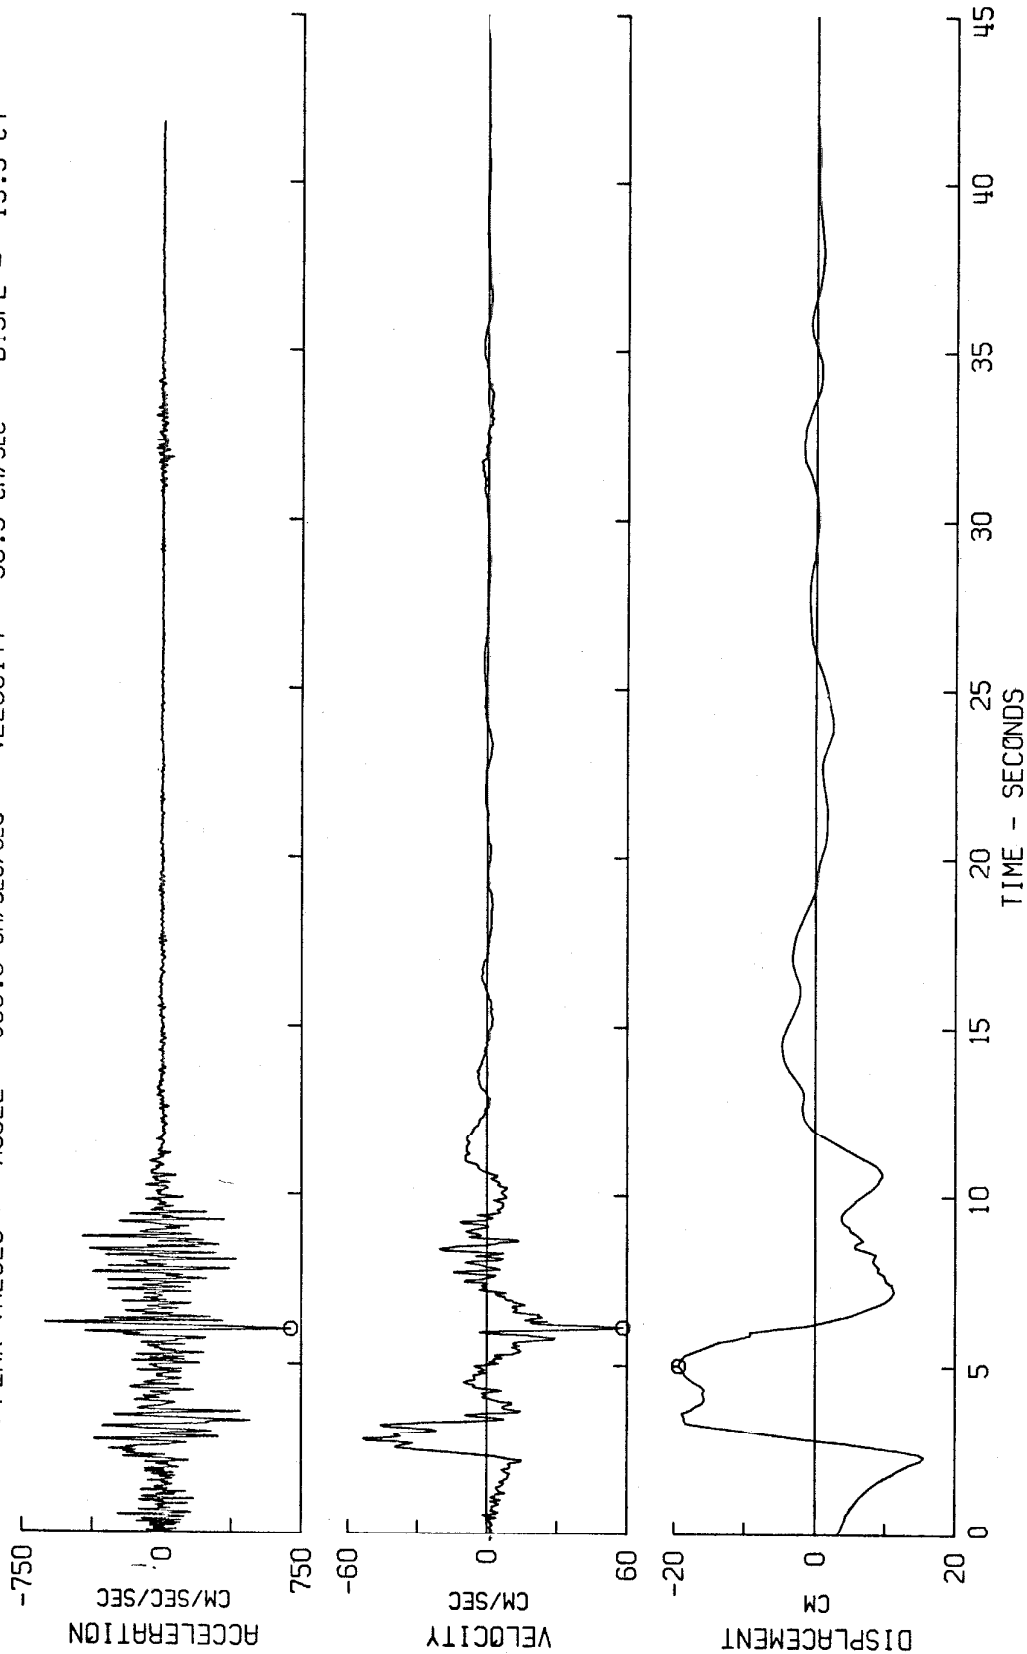
SAN FERNANDO EARTHQUAKE FEB 9, 1971 - 0600 PST  
 IIC041 71.001.0 PACOIMA DAM, CAL. COMP DOWN  
 PEAK VALUES : ACCEL = 696.0 CM/SEC/SEC VELOCITY = 58.3 CM/SEC DISPL = -19.3 CM

Figure 6. Pacoima Dam accelerogram, component vertical.

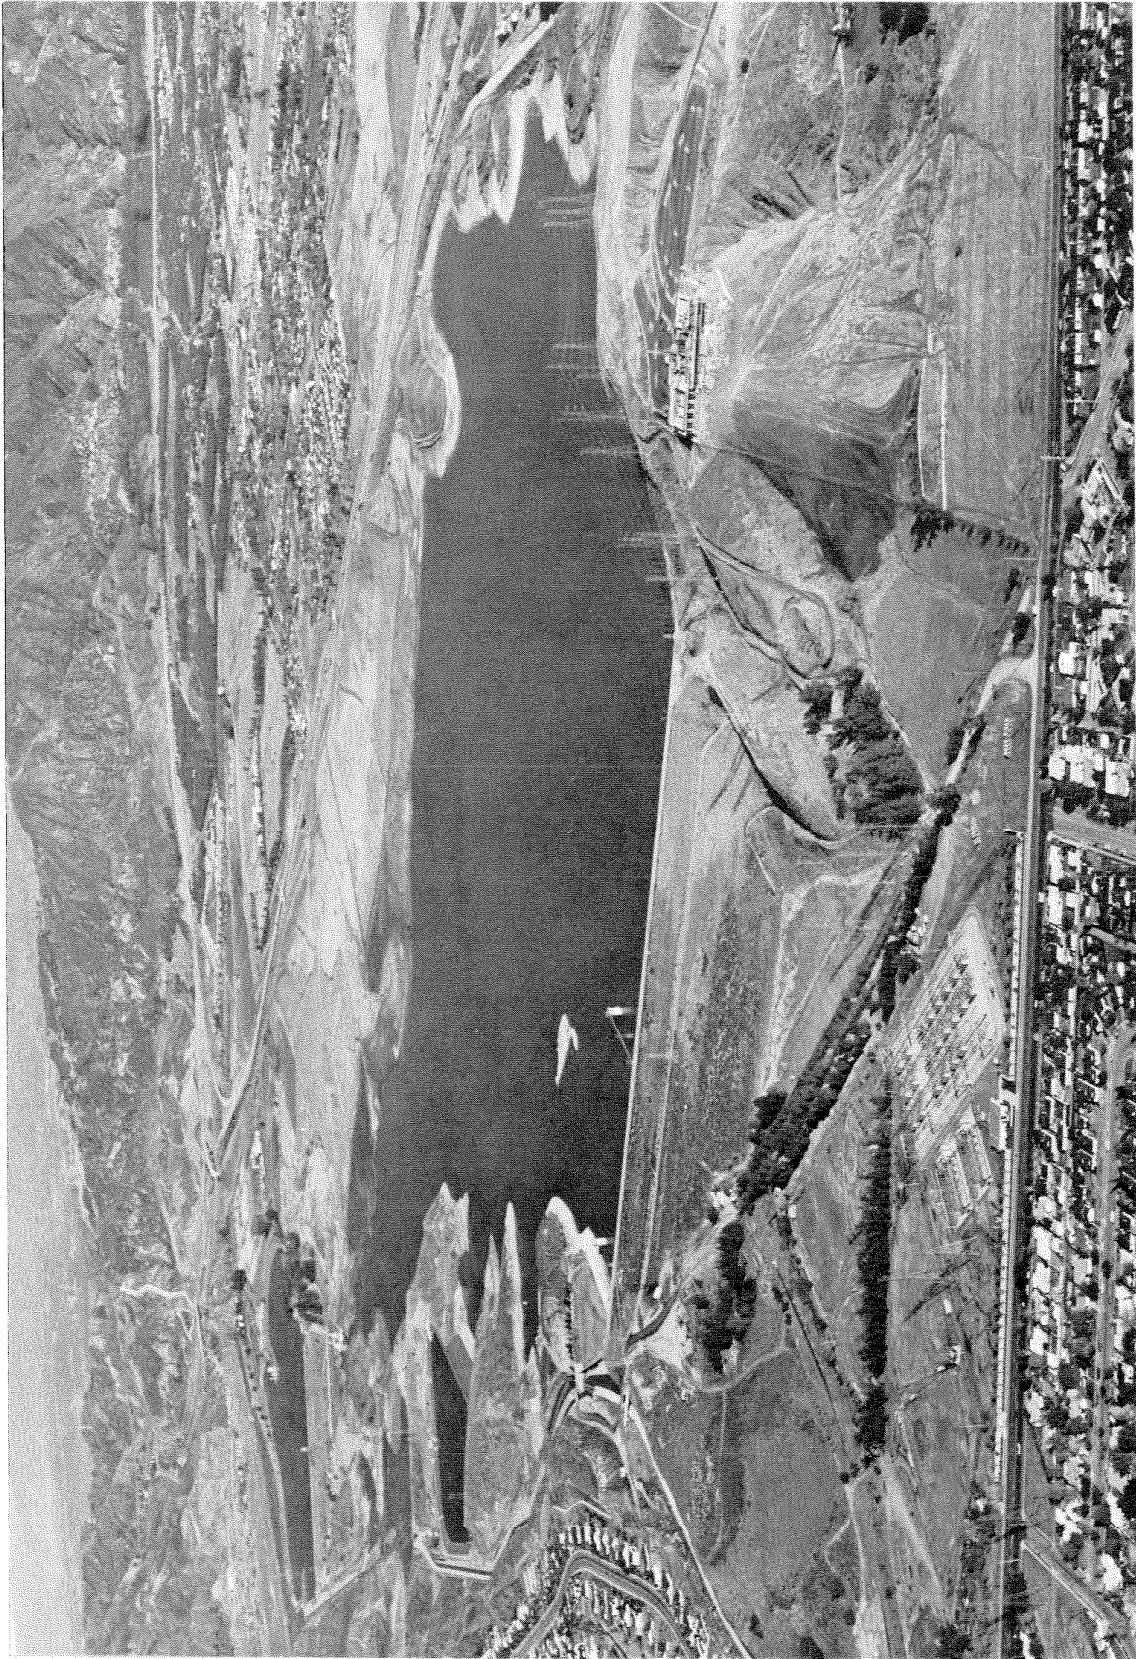
FIGURE 1. Lower San Fernando Dam. The abutment seismoscope is located on the right near the transmission towers.  
(LADWP photograph taken before the earthquake.)

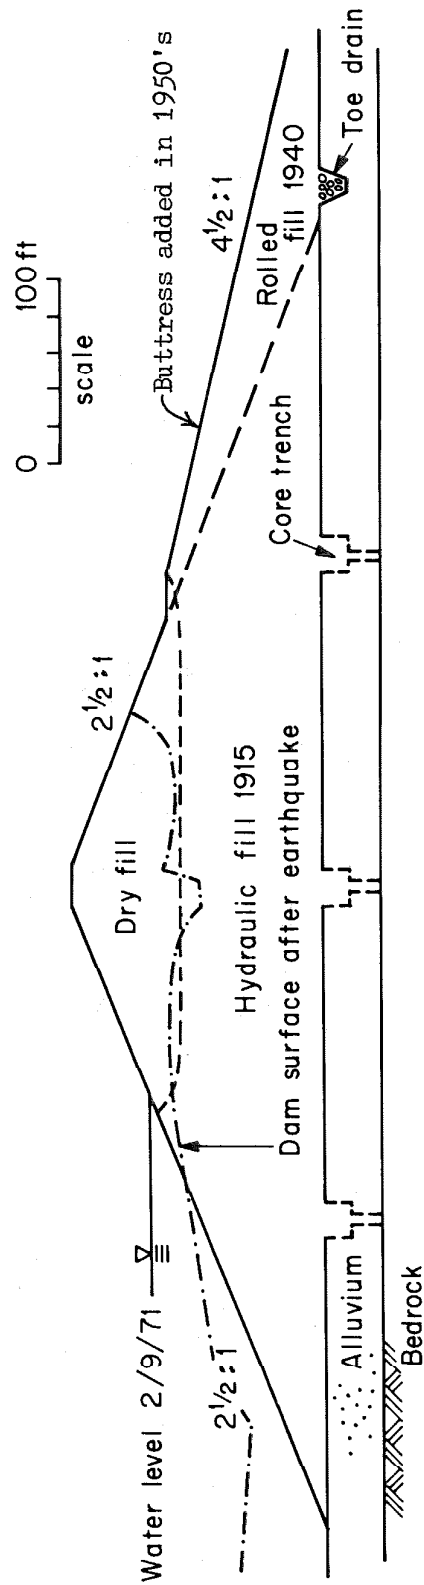
FIGURE 2. Cross-section of Lower San Fernando Dam.

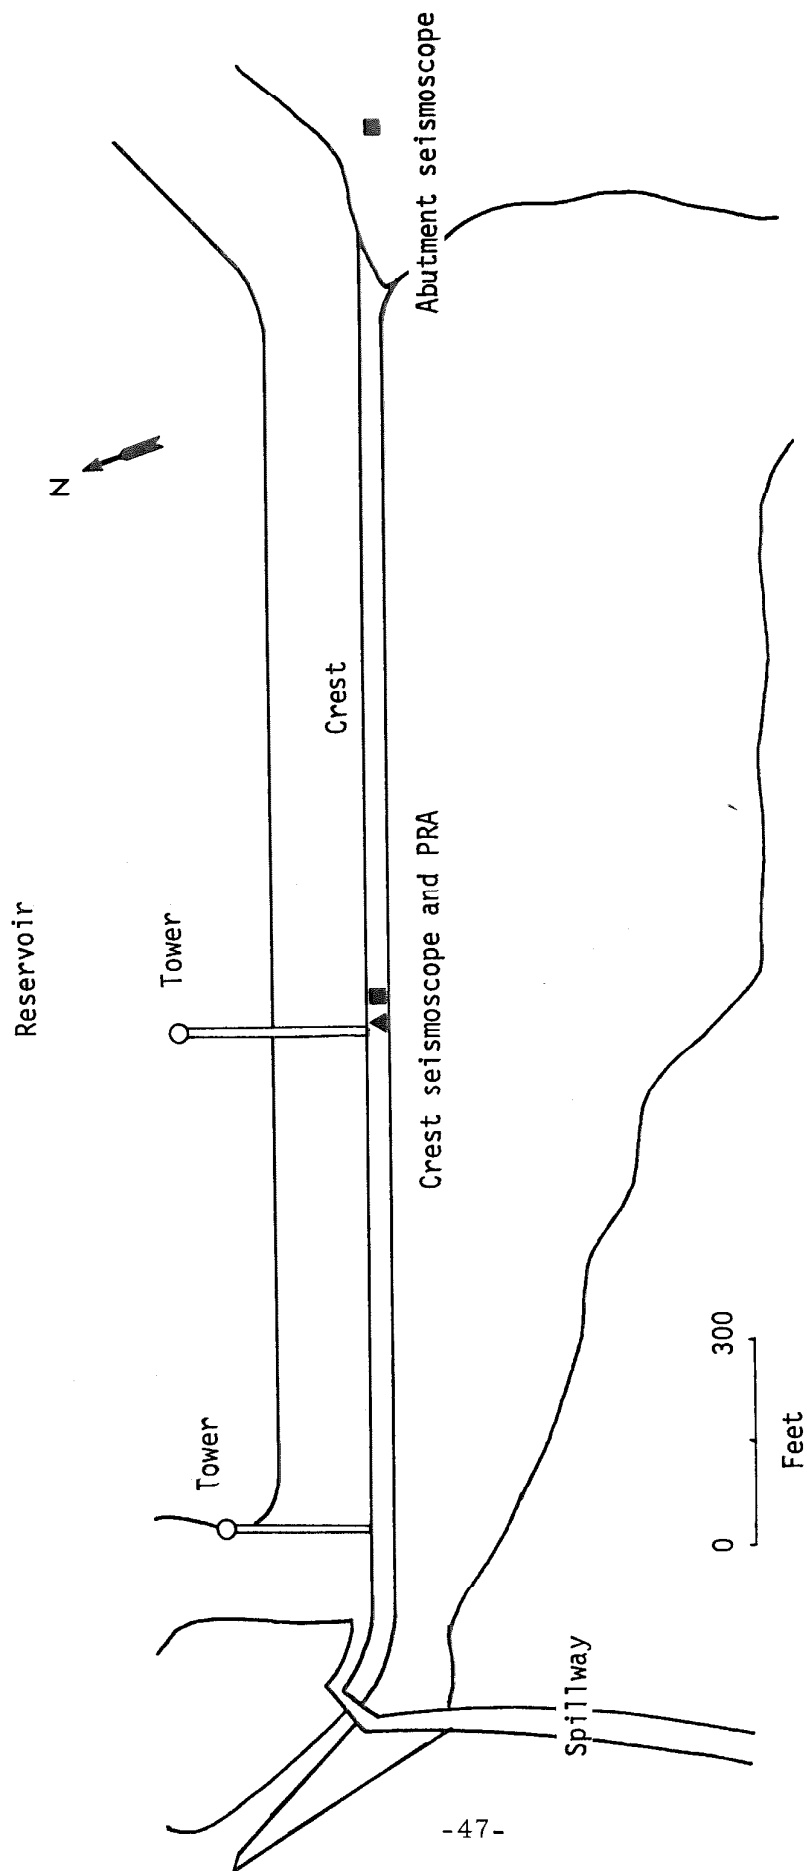
FIGURE 3. Plan view of Lower San Fernando Dam showing the locations of the seismoscopes and the PRA.

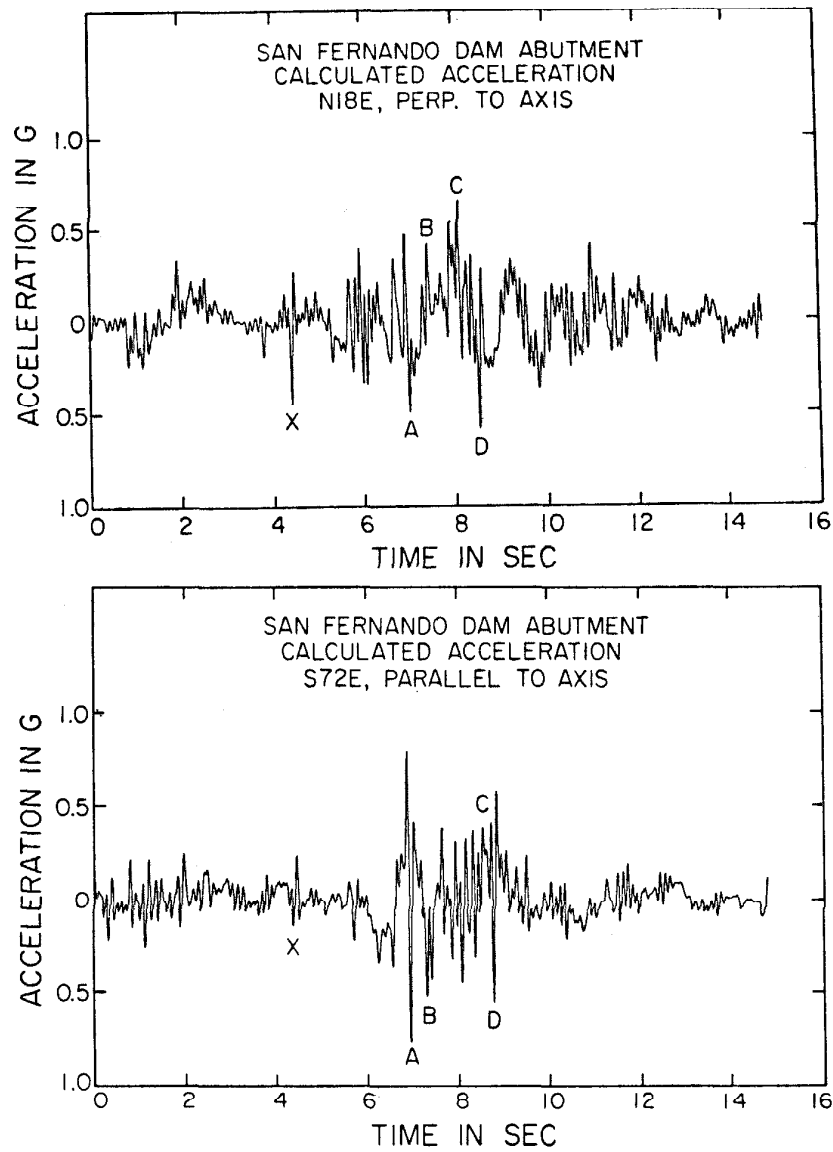
Figure 4. Horizontal acceleration-time history as computed from the abutment seismoscope record (Scott, 1971)

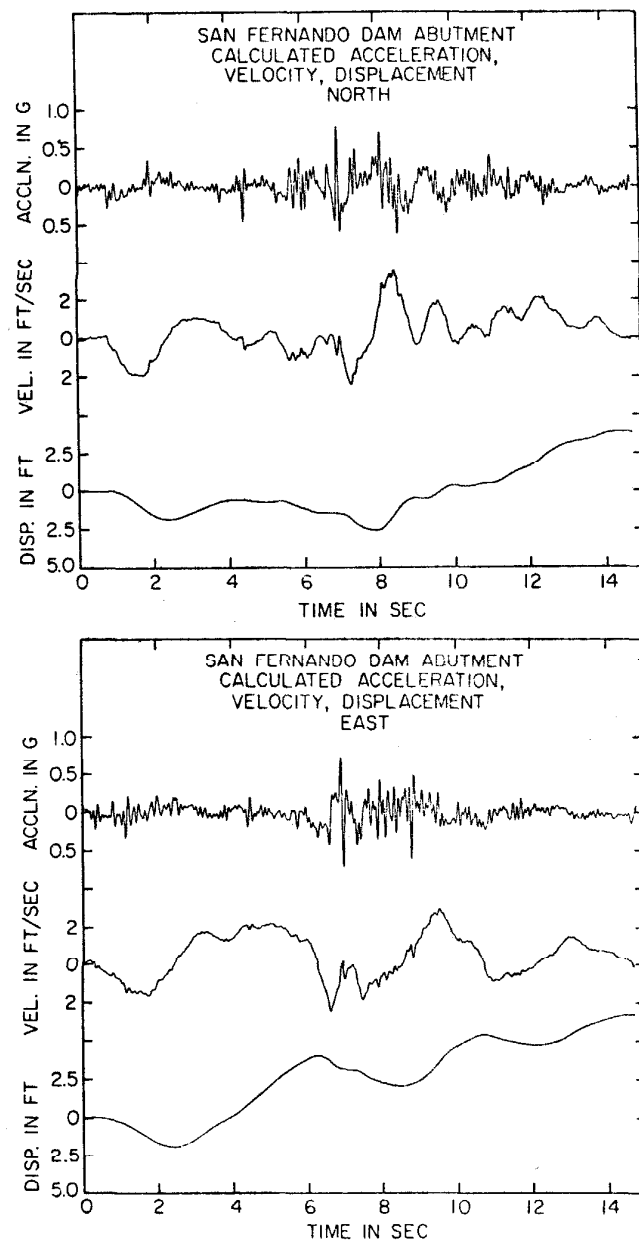
Figure 5. Calculated acceleration, velocity and displacement curves.  
(Scott, 1971)

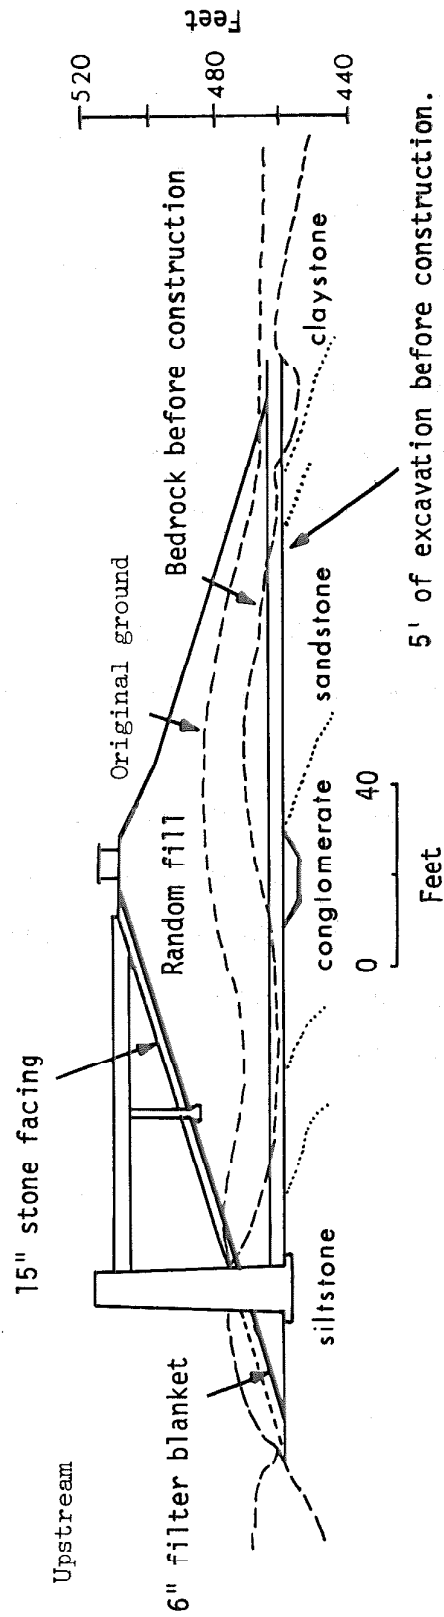
Figure 1. Cross-section of Carbon Canyon Dam.
