# EARTHQUAKE RECORDINGS ON OR NEAR DAMS

P. Morrison, R. Maley, G. Brady, R. Porcella

USCOLD

November 1977

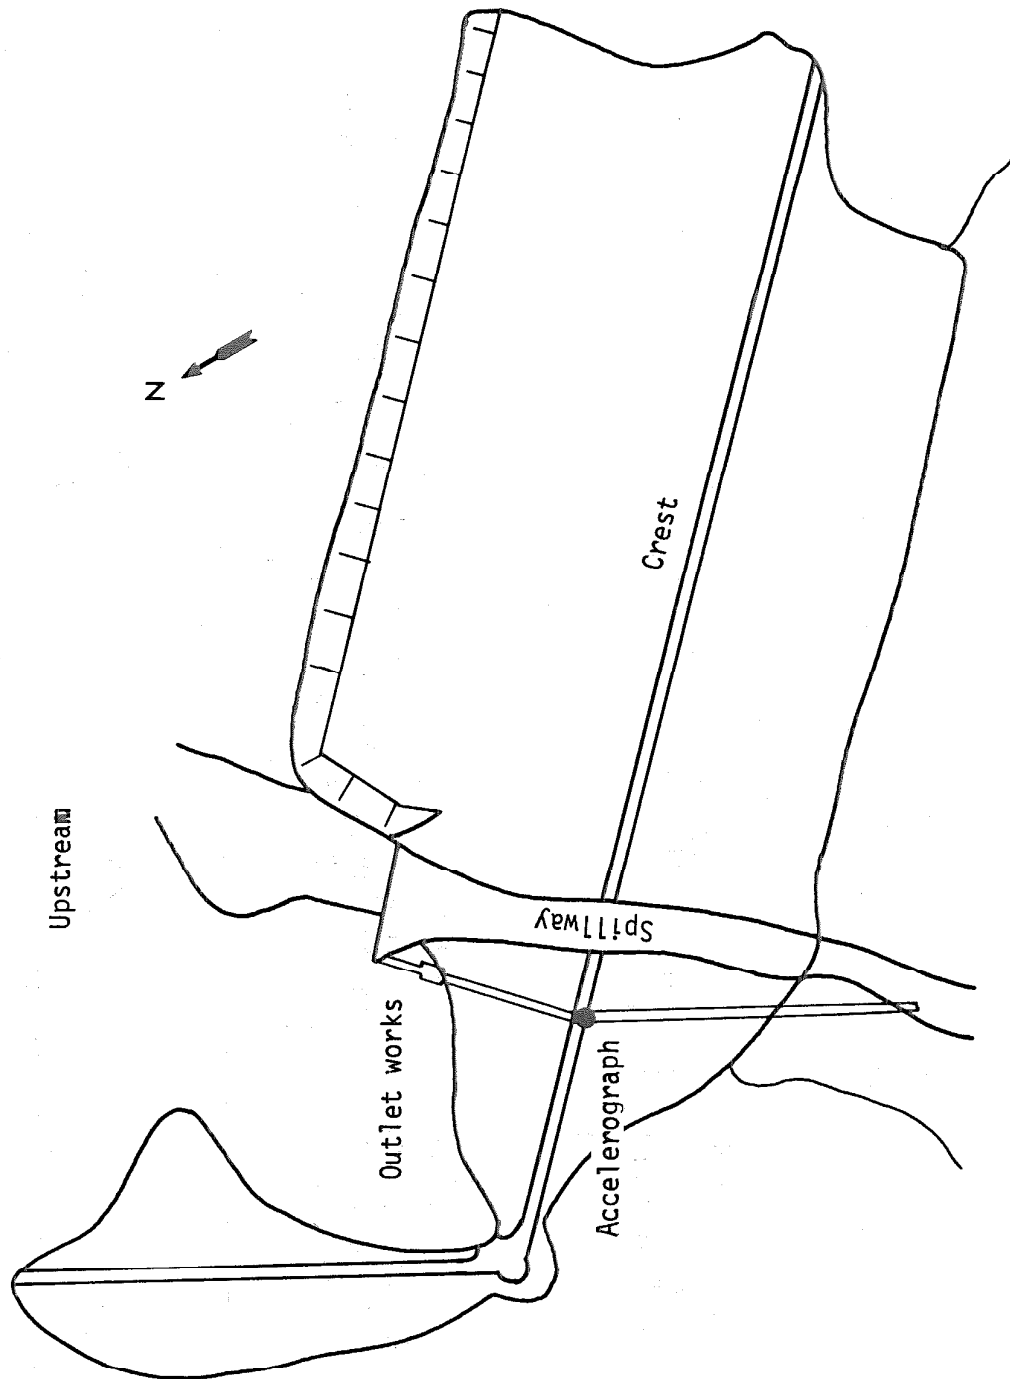
Figure 2. Location of the accelerometer on Carbon Canyon Dam.

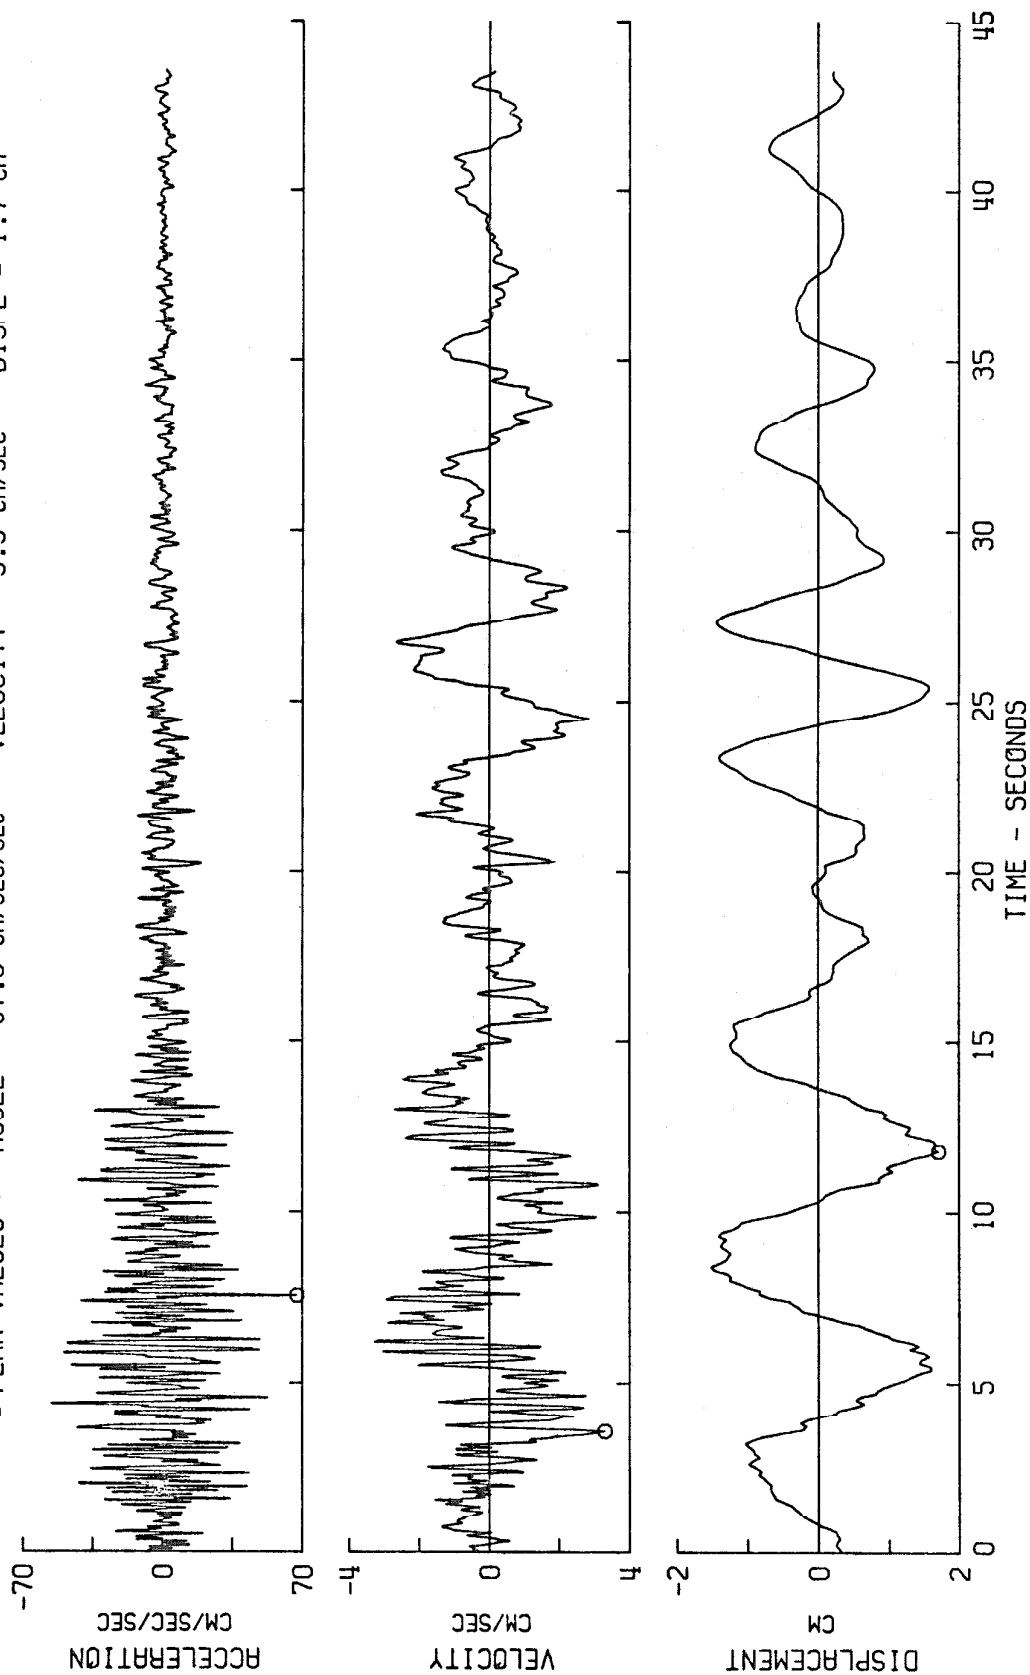
IIN185 71.066.0 CARBON CANYON DAM, CAL. COMP S50E

PEAK VALUES : ACCEL = 67.3 CM/SEC/SEC VELOCITY = 3.3 CM/SEC DISPL = 1.7 CM

Figure 3. Carbon Canyon Dam accelerogram, component S50E

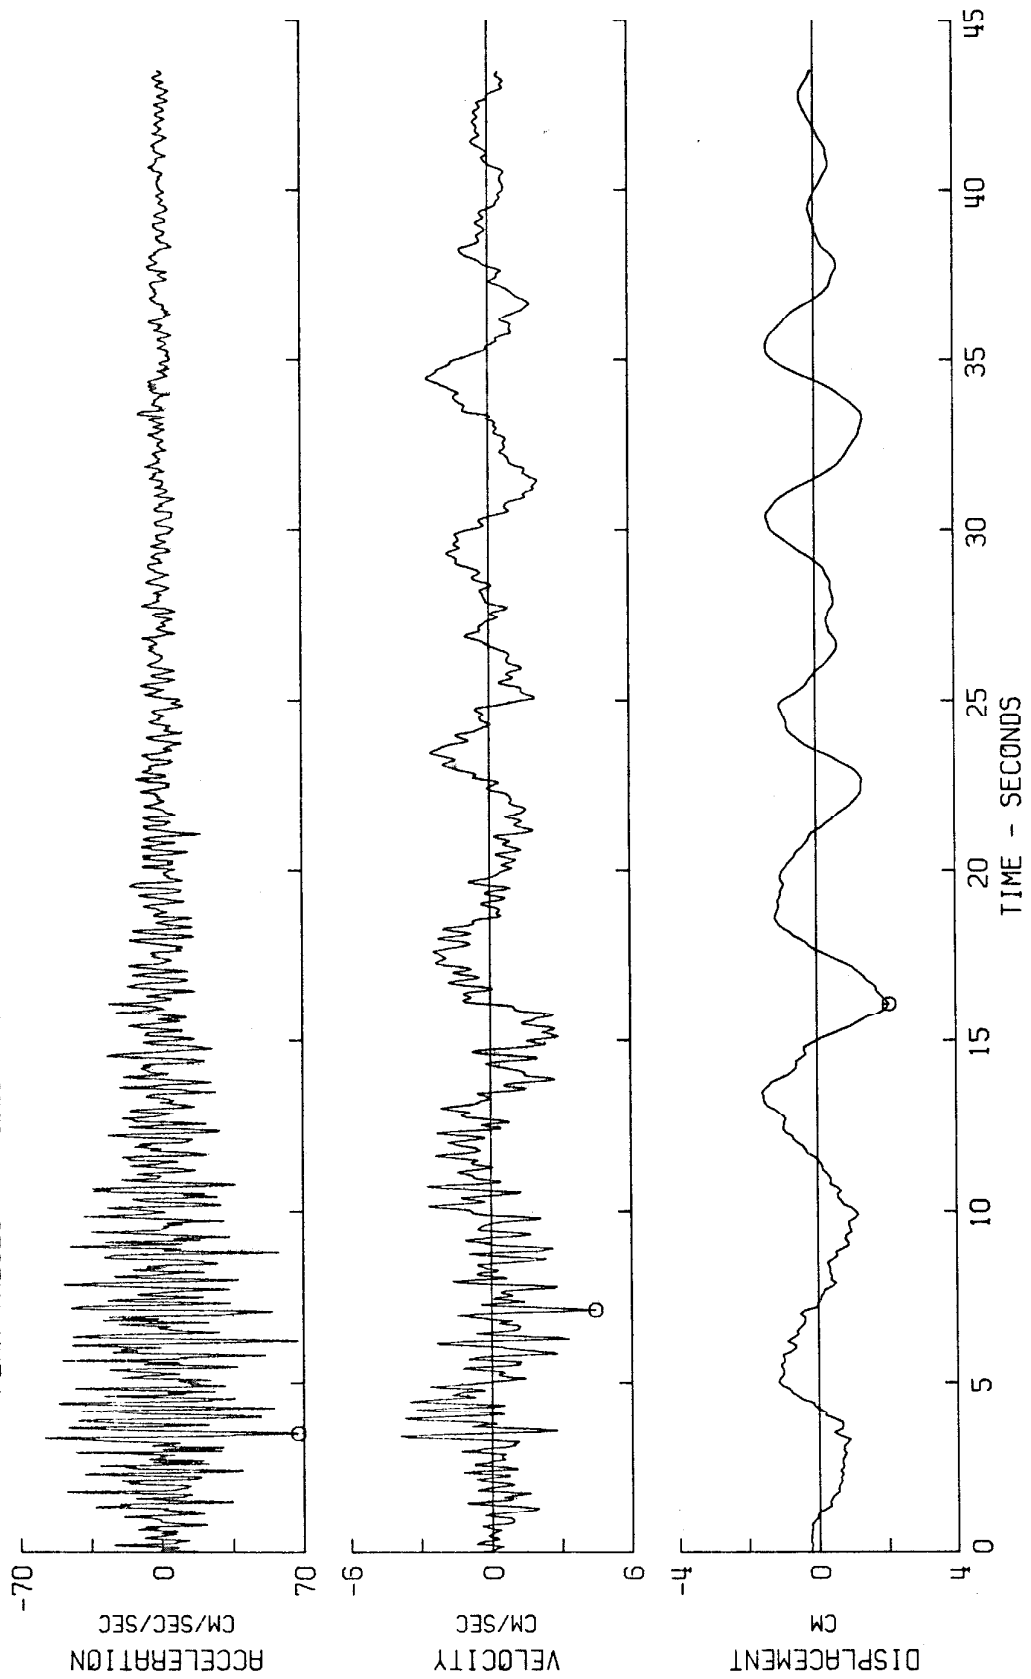
IIN185 71.066.0 CARBON CANYON DAM, CAL. COMP S40W

o PEAK VALUES : ACCEL = 67.3 CM/SEC/SEC VELOCITY = 4.5 CM/SEC DISPL = 2.1 CM

Figure 4. Carbon Canyon Dam accelerogram, component S40W

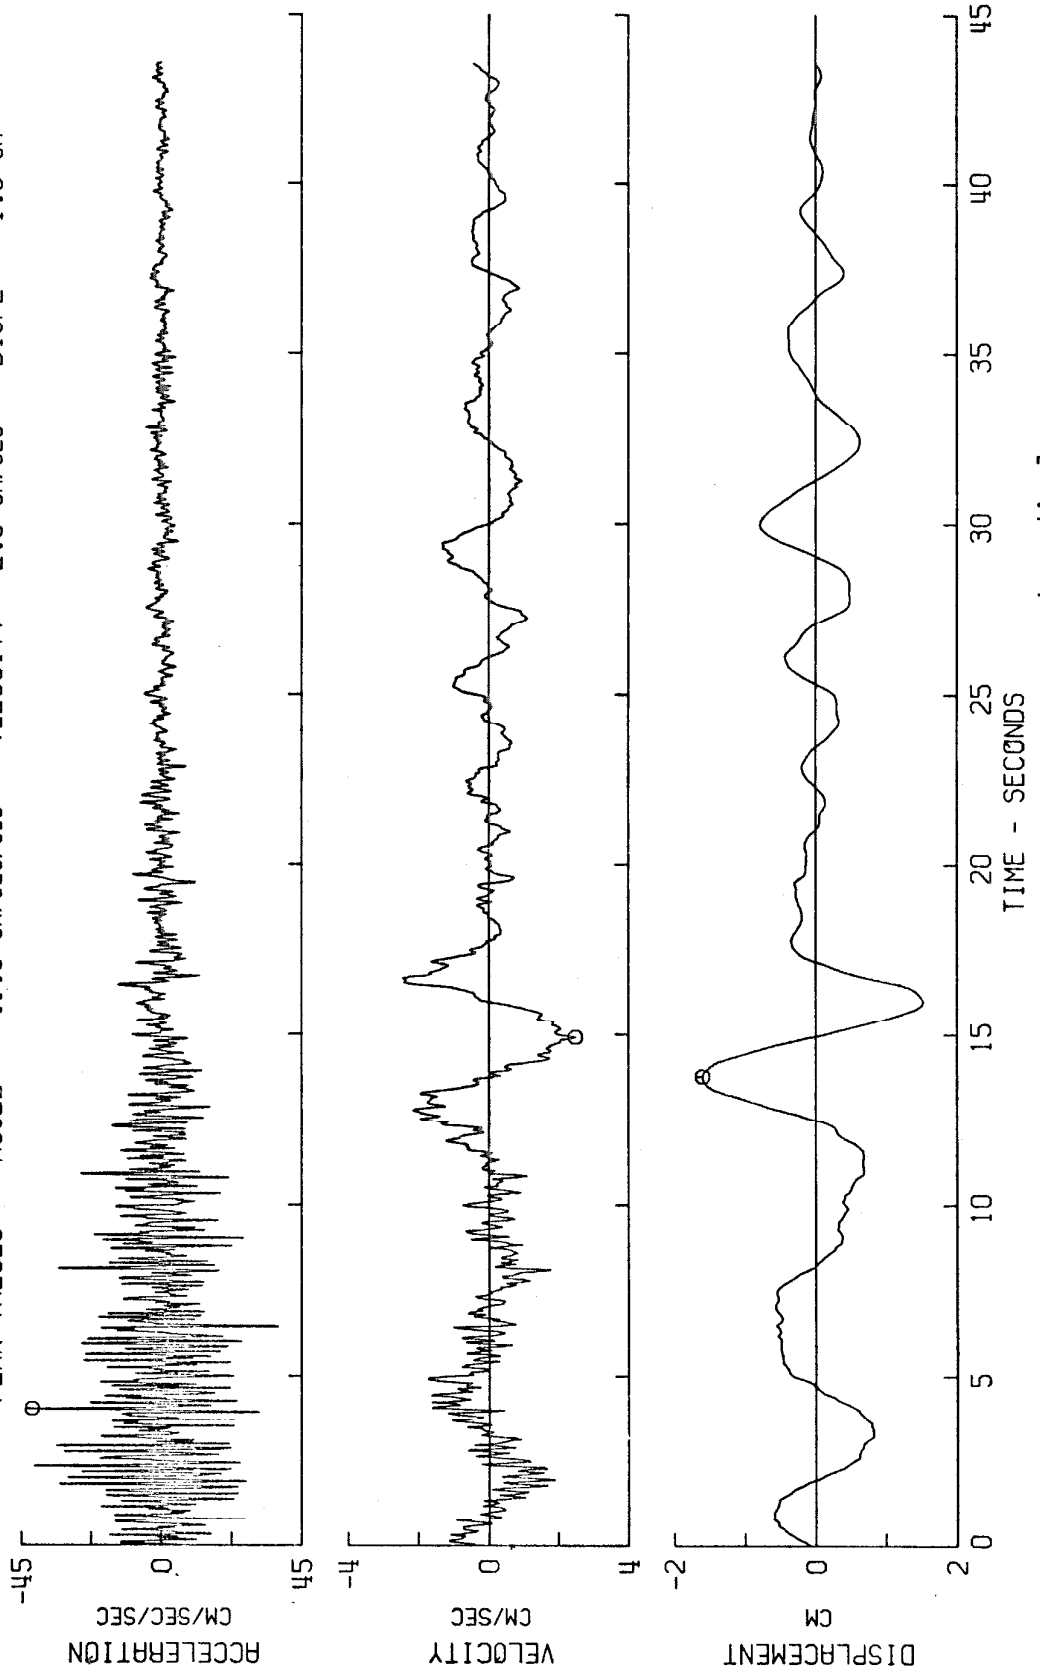
II1185 71.066.0 CARBON CANYON DAM, CAL. COMP DOWN

PEAK VALUES : ACCEL = -41.5 CM/SEC/SEC VELOCITY = 2.5 CM/SEC DISPL = -1.6 CM

Figure 5. Carbon Canyon Dam accelerometer, component vertical.

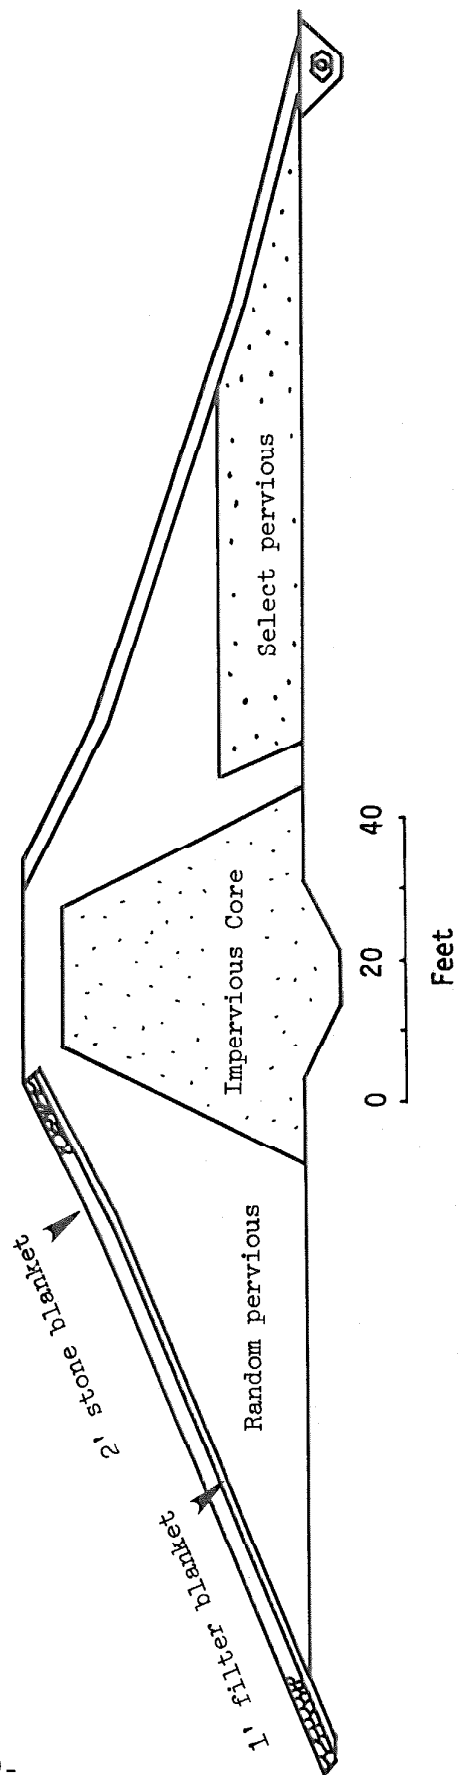
FIGURE 1. Whittier Narrows Dam.

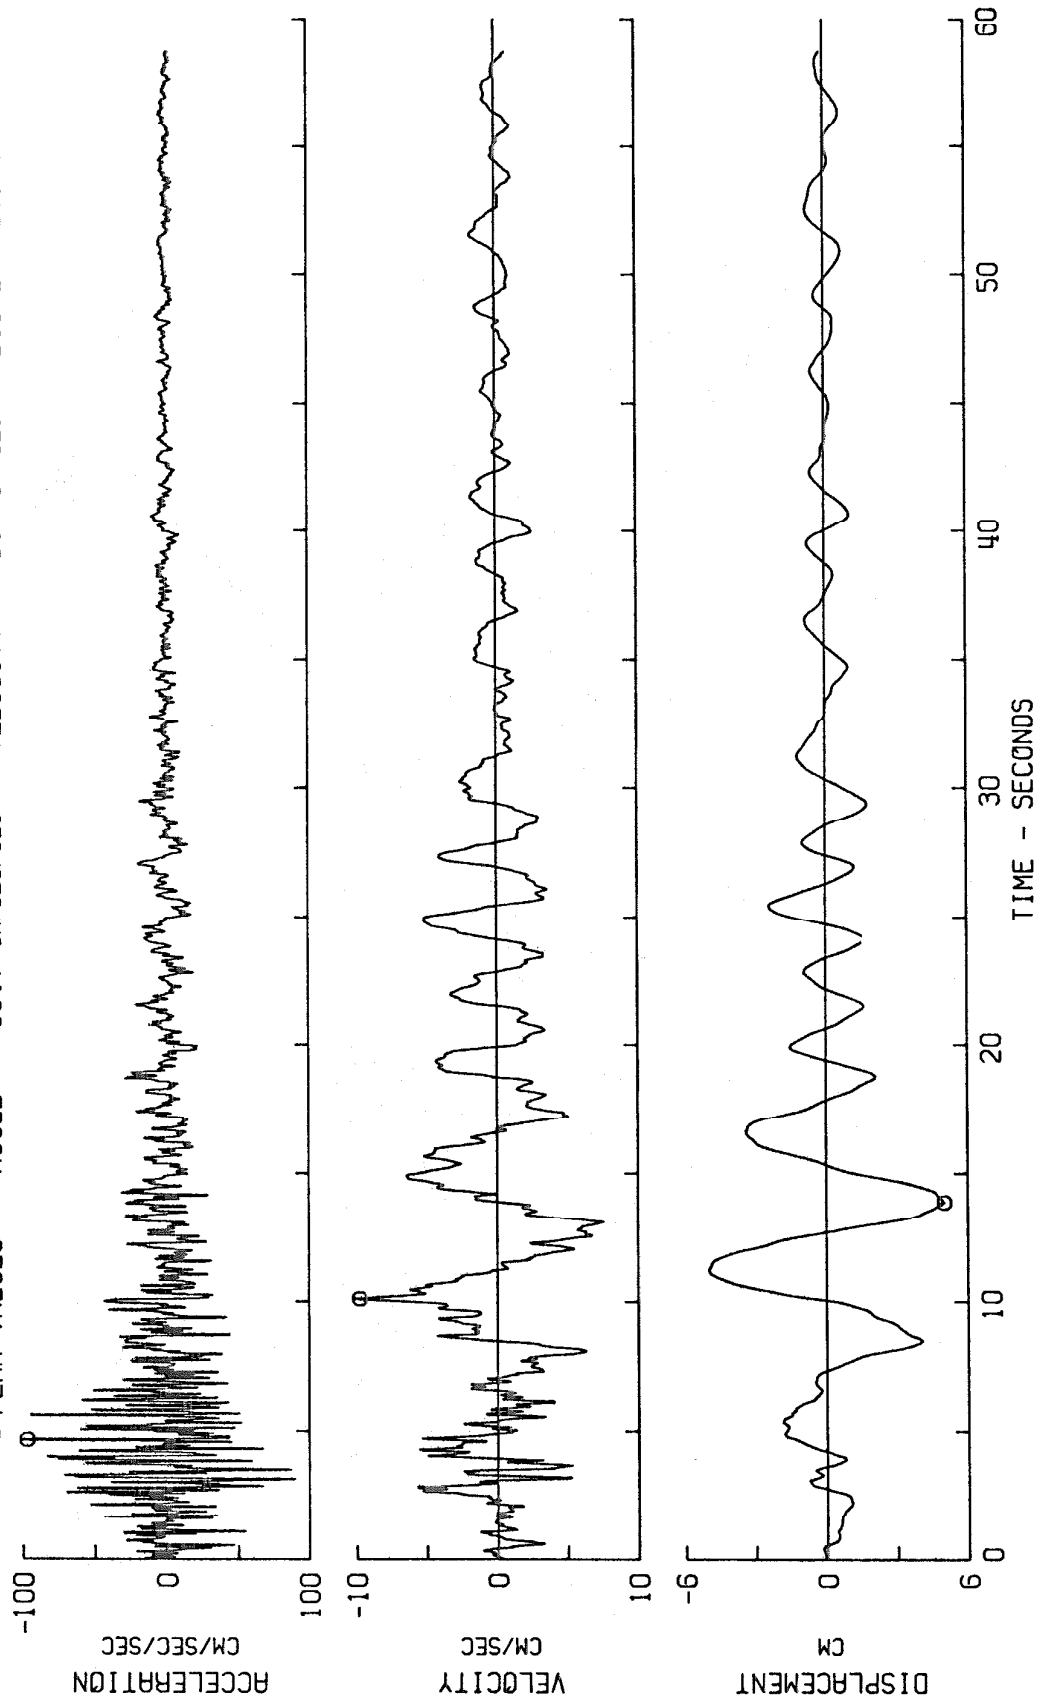
SAN FERNANDO EARTHQUAKE FEB 9, 1971 - 0600 PST  
 IIN186 71.067.0 WHITTIER NARROWS DAM, CAL. COMP S53W

○ PEAK VALUES : ACCEL = -96.7 CM/SEC/SEC VELOCITY = -9.7 CM/SEC DISPL = 5.0 CM

Figure 4. Whittier Narrows Dam Accelerogram, Component S53W.

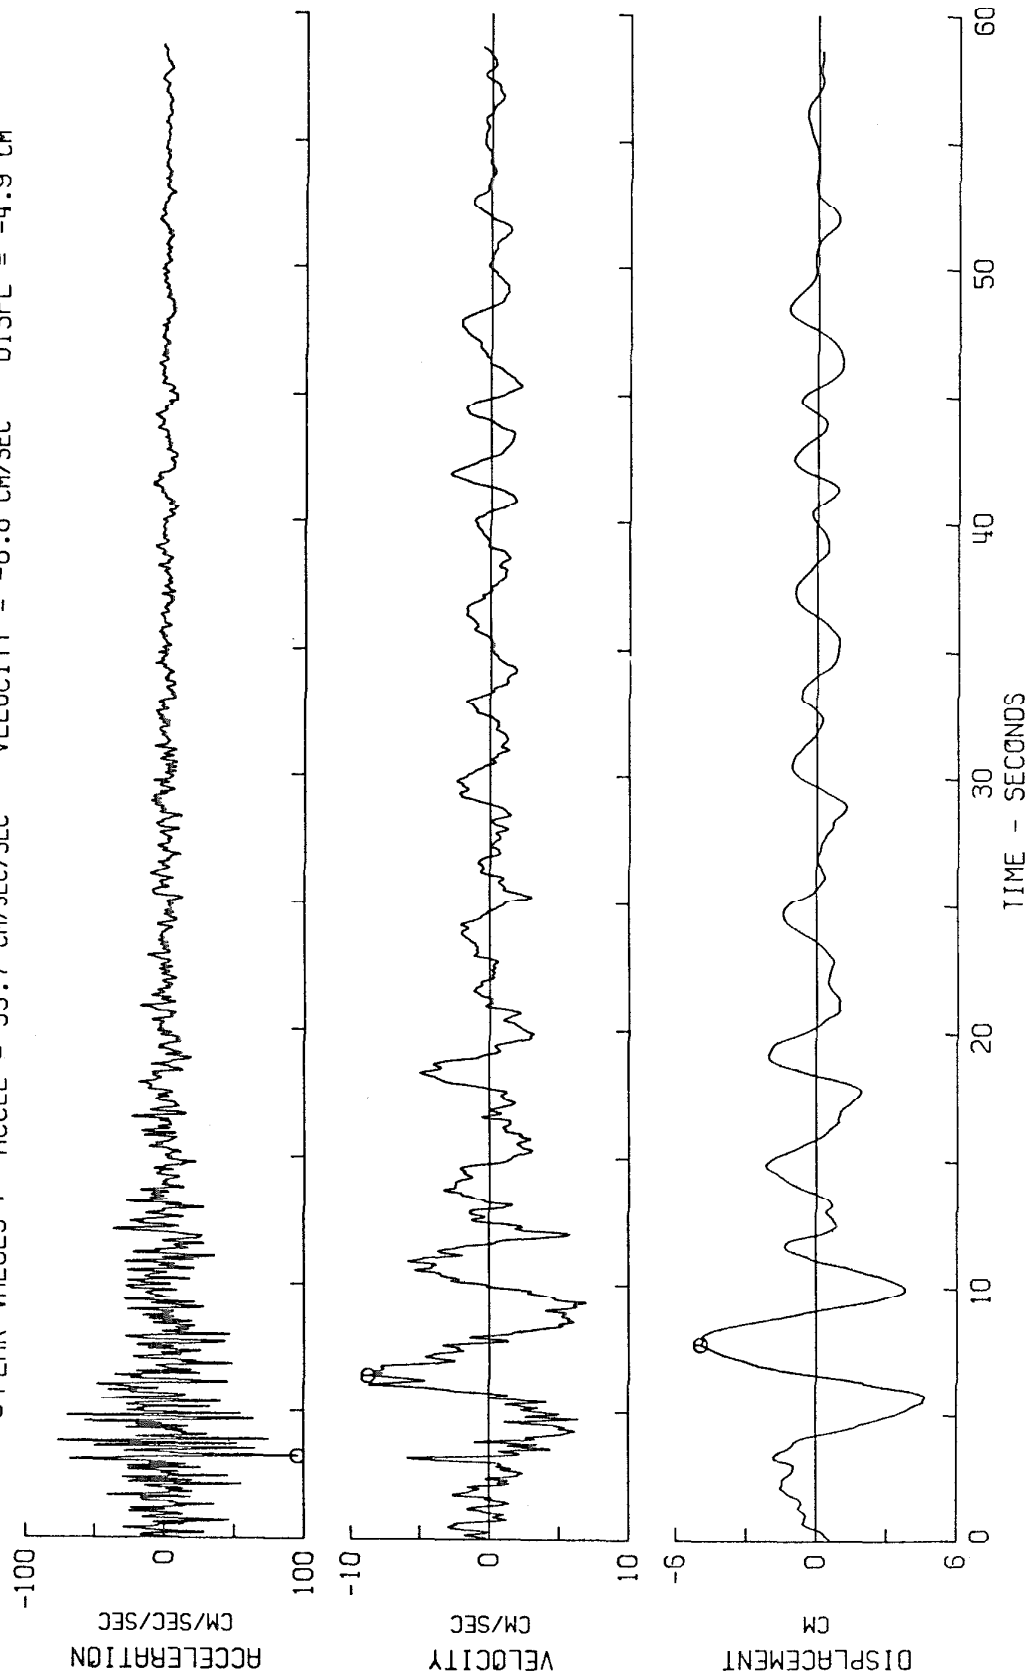
SAN FERNANDO EARTHQUAKE FEB 9, 1971 - 0600 PST  
 IIN186 71.067.0 WHITTIER NARROWS DAM, CAL. COMP S37E

⊙ PEAK VALUES : ACCEL = 95.7 CM/SEC/SEC VELOCITY = -8.8 CM/SEC DISPL = -4.9 CM

Figure 5. Whittier Narrows Dam Accelerogram, Component S37E.

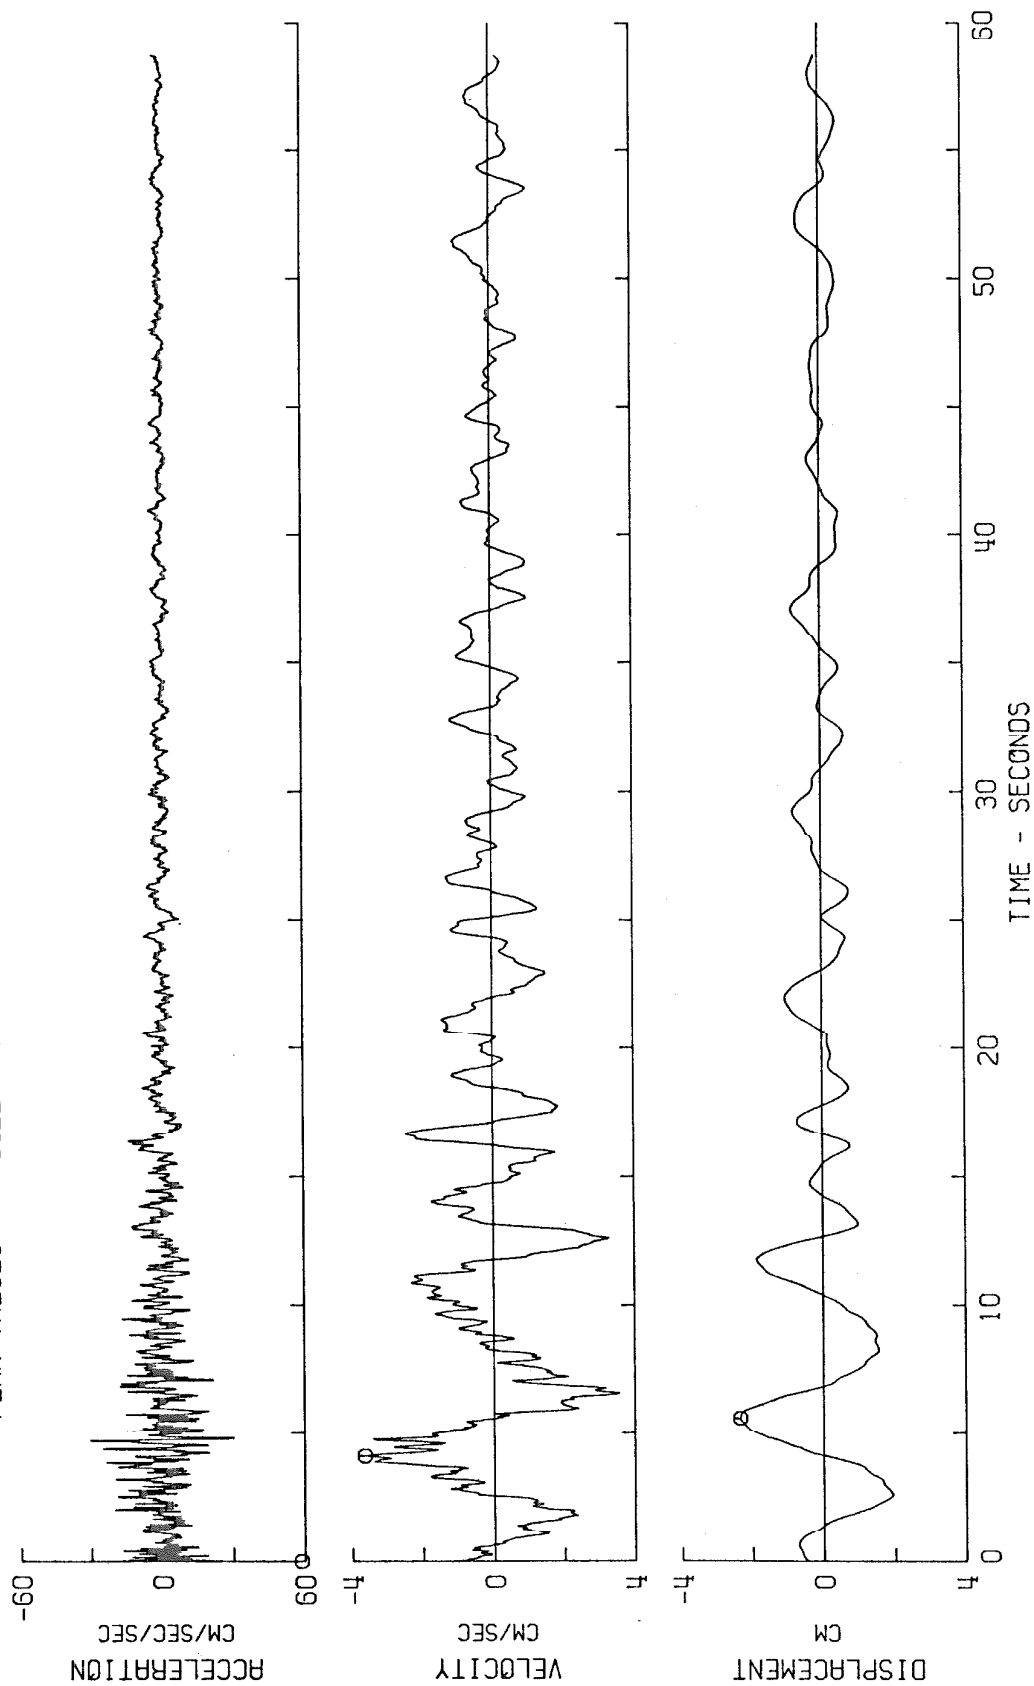
SAN FERNANDO EARTHQUAKE FEB 9, 1971 - 0600 PST  
 IIN186 71.067.0 WHITTIER NARROWS DAM, CAL. COMP DOWN  
 PEAK VALUES : ACCEL = 58.6 CM/SEC/SEC VELOCITY = -3.6 CM/SEC DISPL = -2.3 CM

Figure 6. Whittier Narrows Dam Accelerogram, Component Vertical

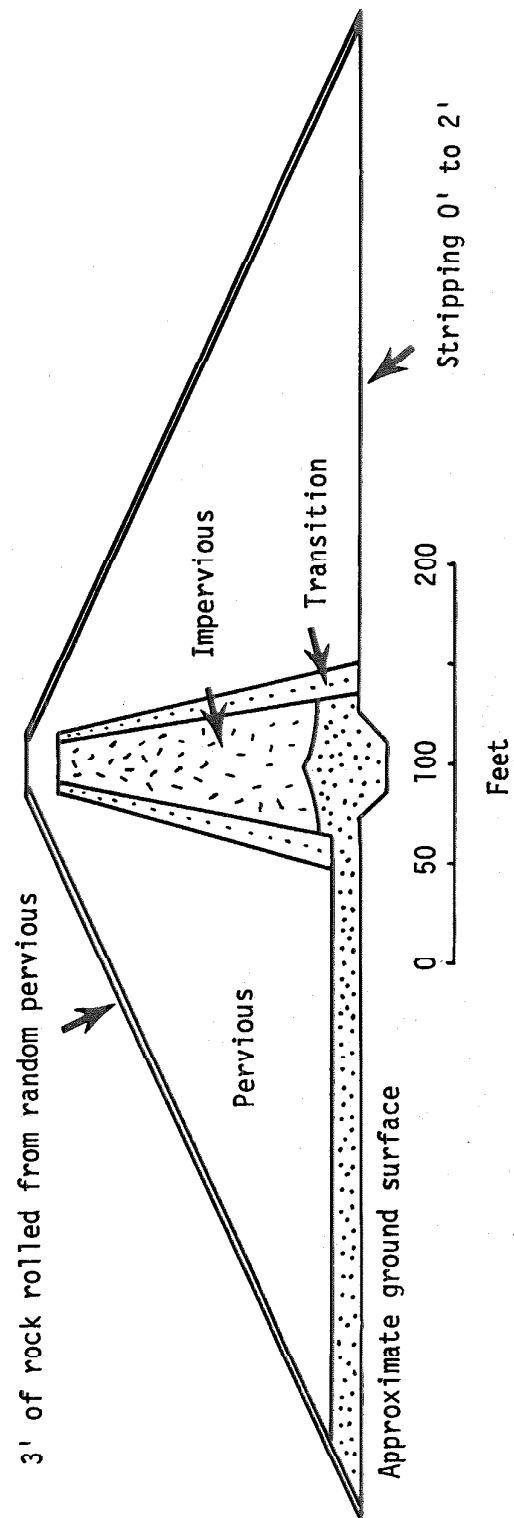
FIGURE 2. Typical section of San Antonio Dam.

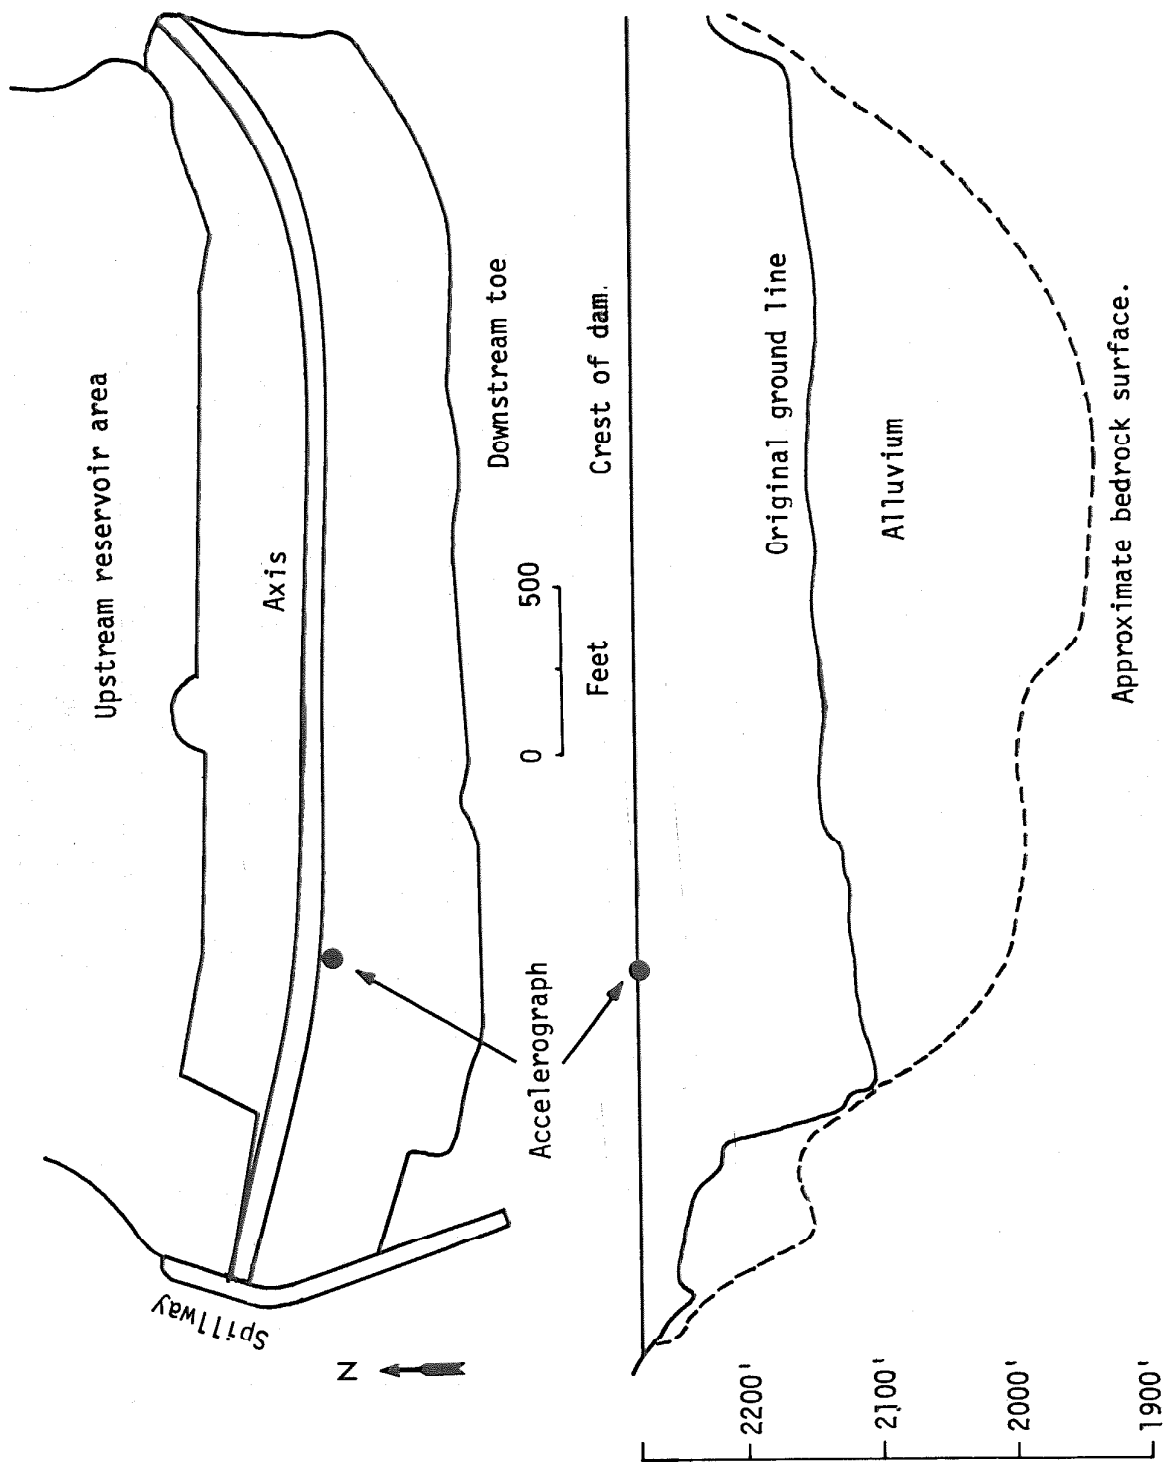
FIGURE 3. Location of accelerograph shown on the plan view and exploration profile of San Antonio Dam.

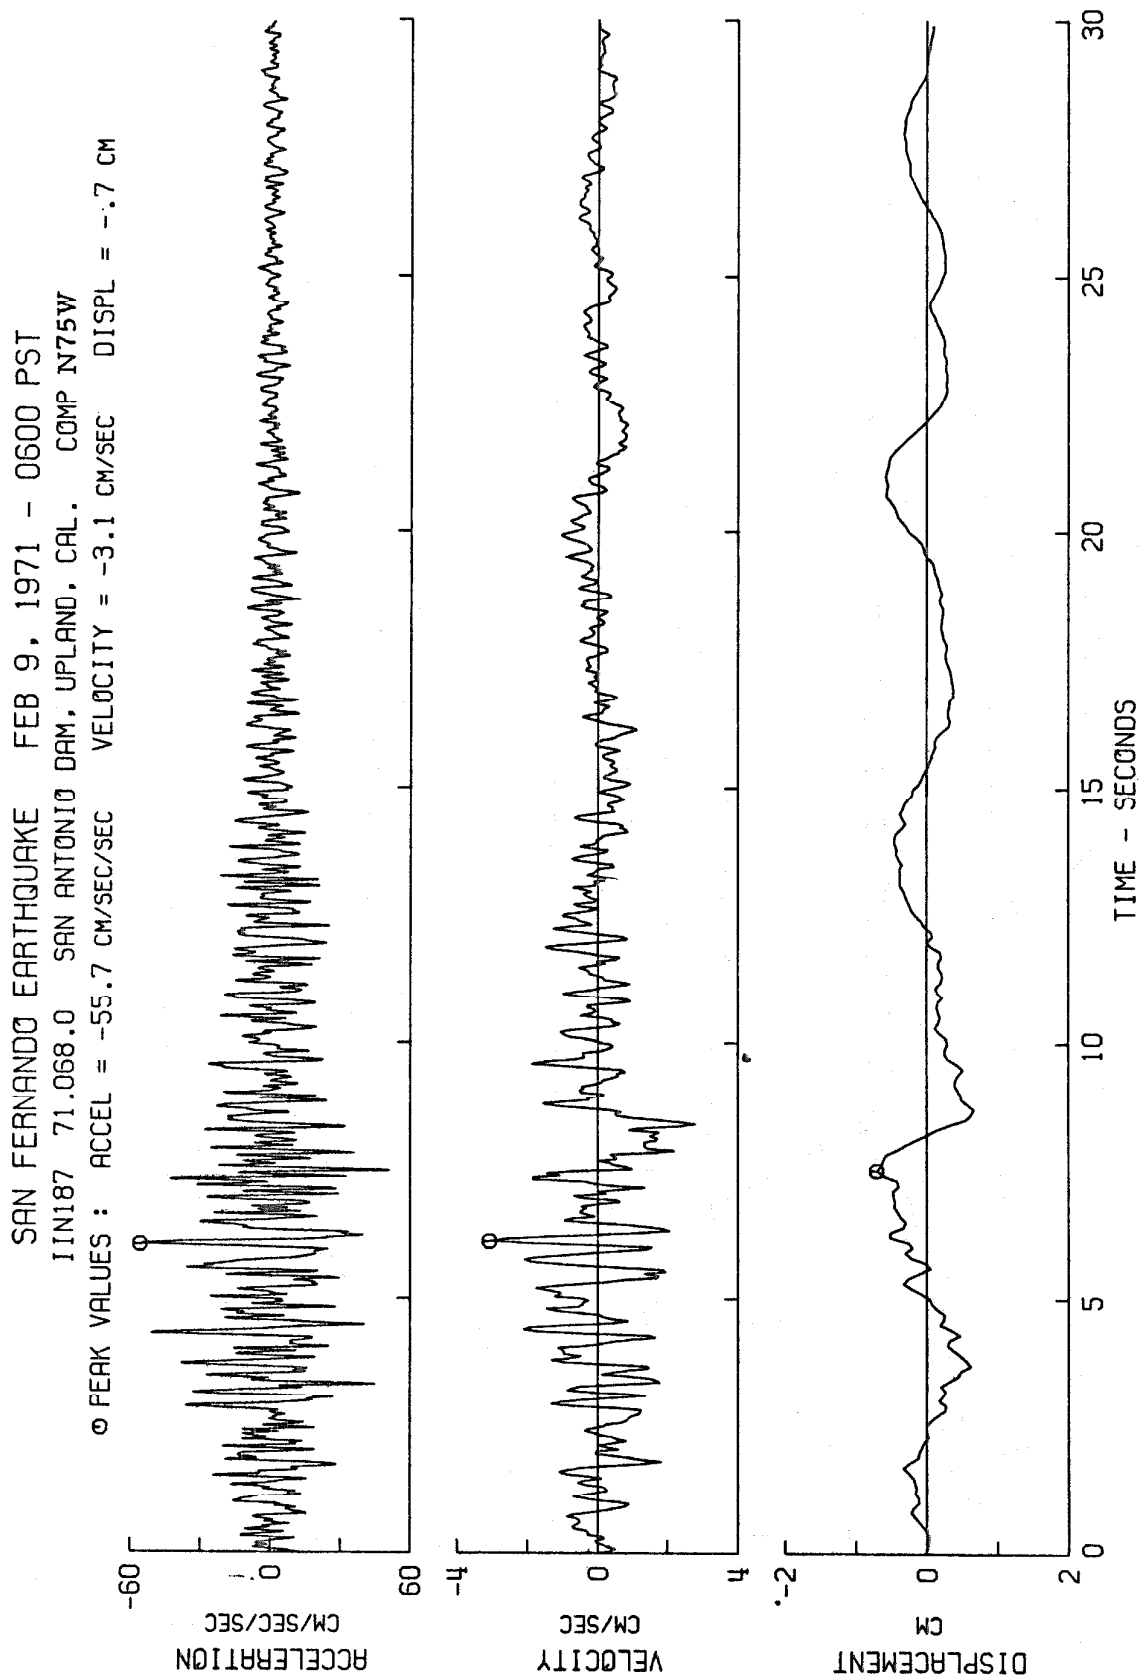
Figure 4. San Antonio Dam acceleration, component N75W

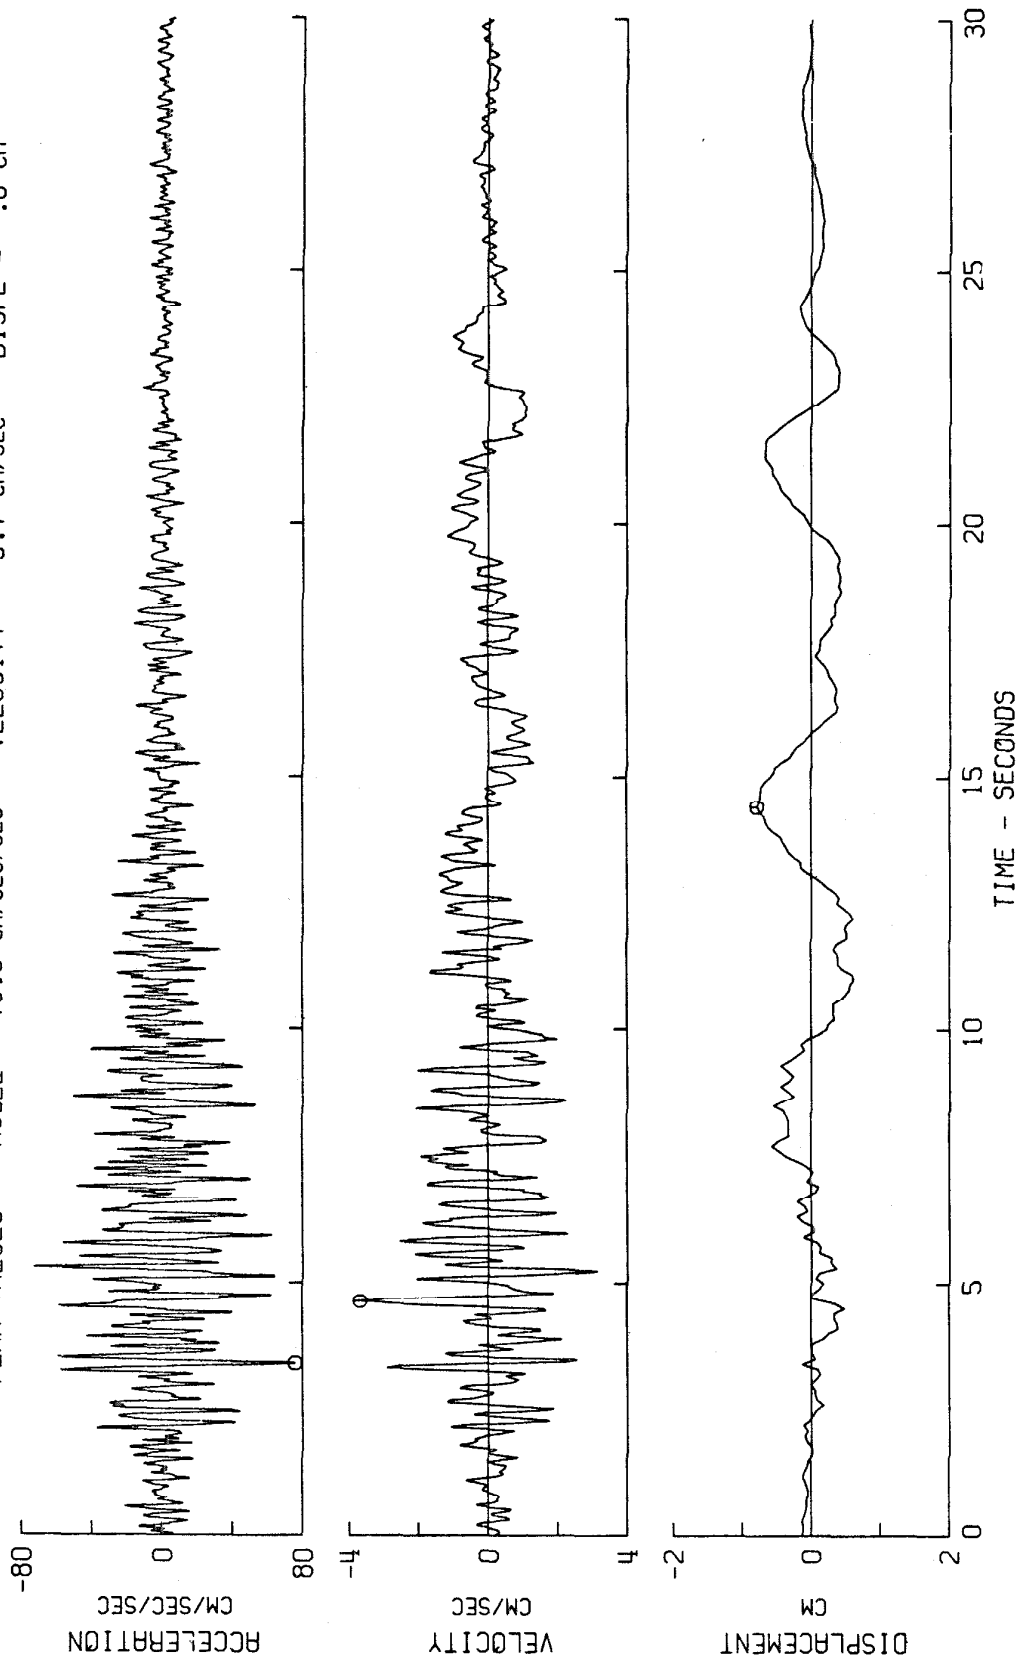
FIGURE 5.

SAN FERNANDO EARTHQUAKE FEB 9, 1971 - 0600 PST  
 IIN187 71.068.0 SAN ANTONIO DAM, UPLAND, CAL. COMP N15E

◊ PEAK VALUES : ACCEL = 75.9 CM/SEC/SEC VELOCITY = -3.7 CM/SEC DISPL = -.8 CM

Figure 5. San Antonio Dam accelerometer, component N15E

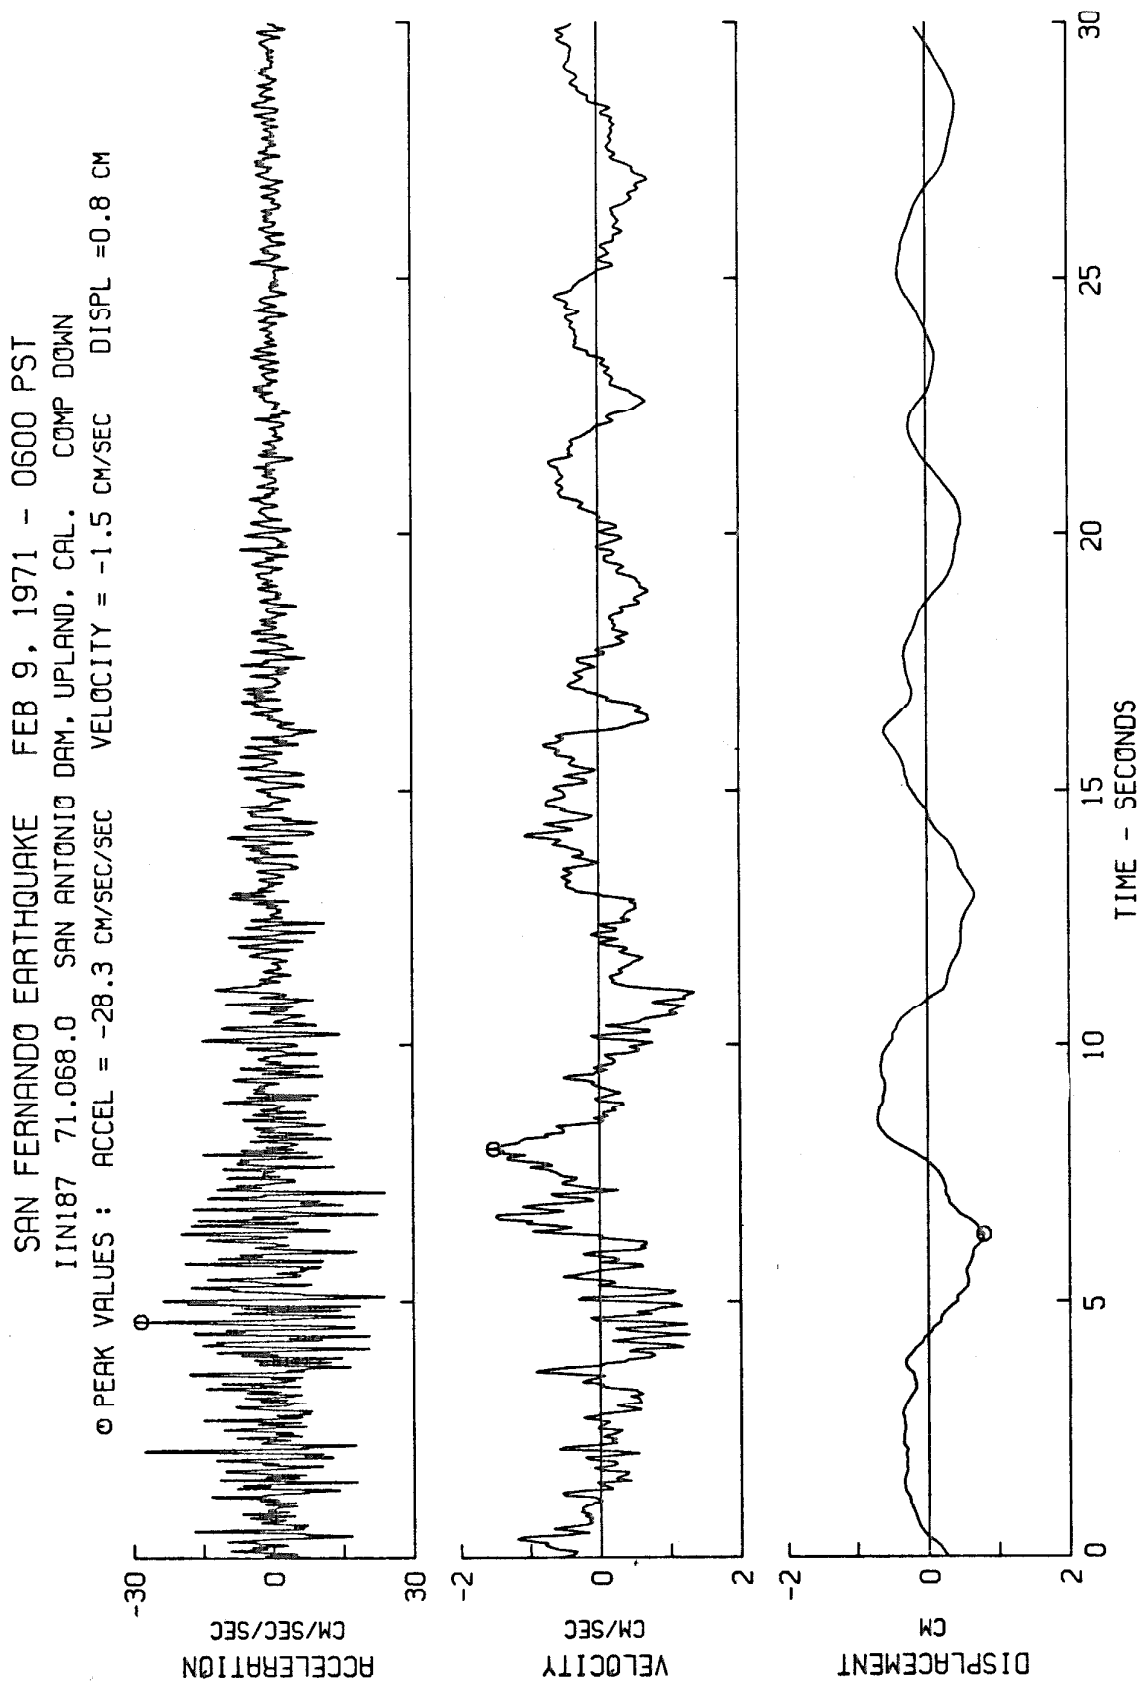
FIGURE 6.

Figure 6. San Antonio Dam accelerometer, component vertical

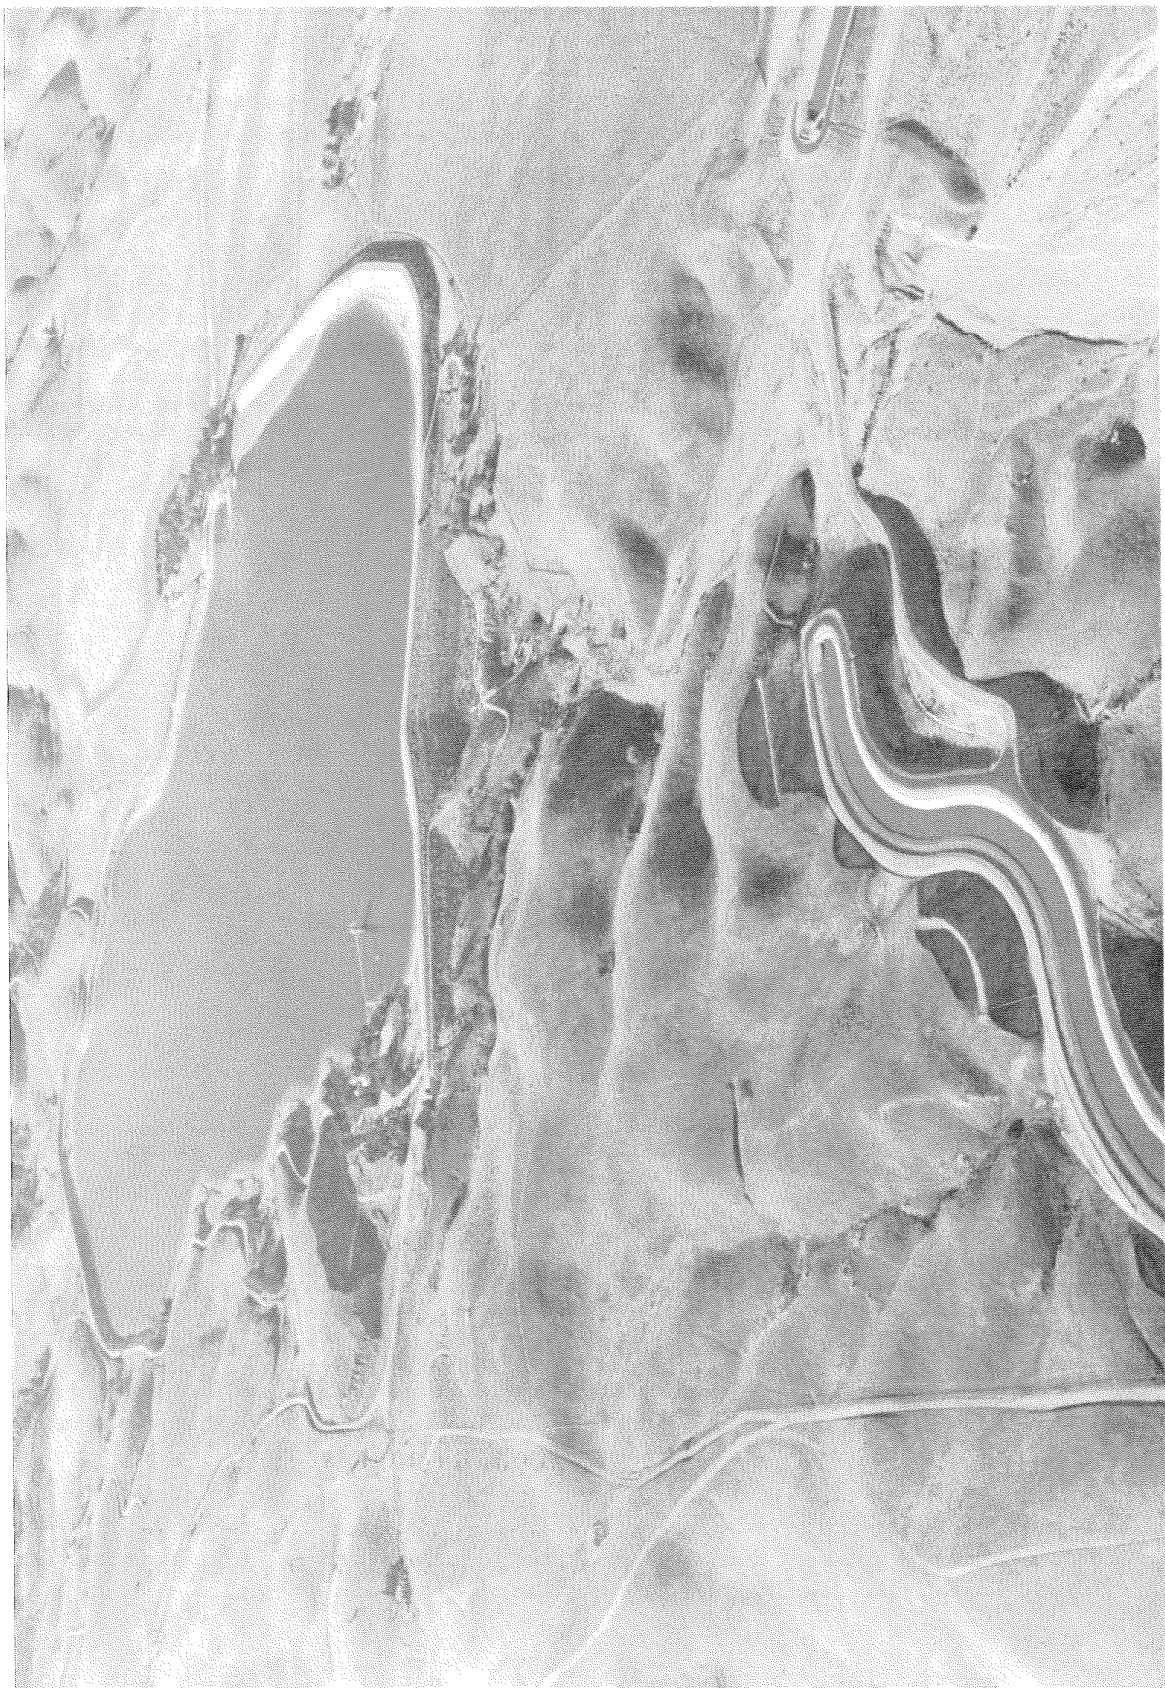
FIGURE 1. Fairmont Dam. The accelerograph is located on the right abutment near the road.
