# EARTHQUAKE RECORDINGS ON OR NEAR DAMS

P. Morrison, R. Maley, G. Brady, R. Porcella

USCOLD

November 1977

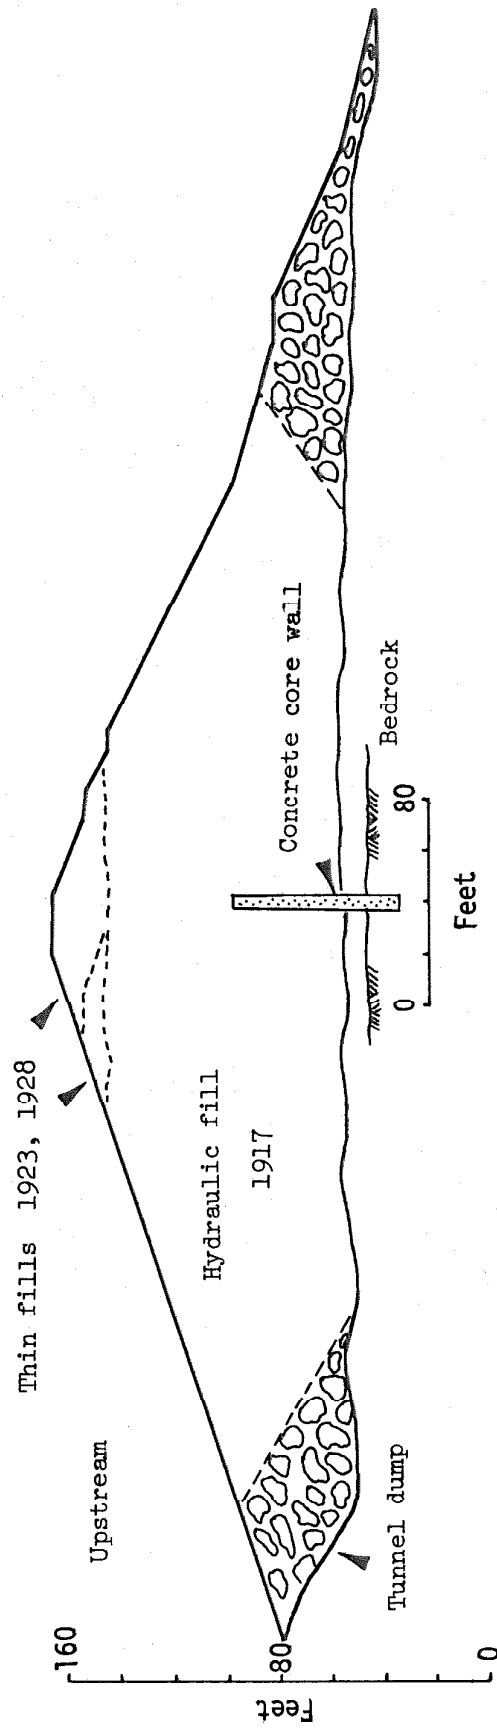
FIGURE 2. Typical Fairmont Dam Section.

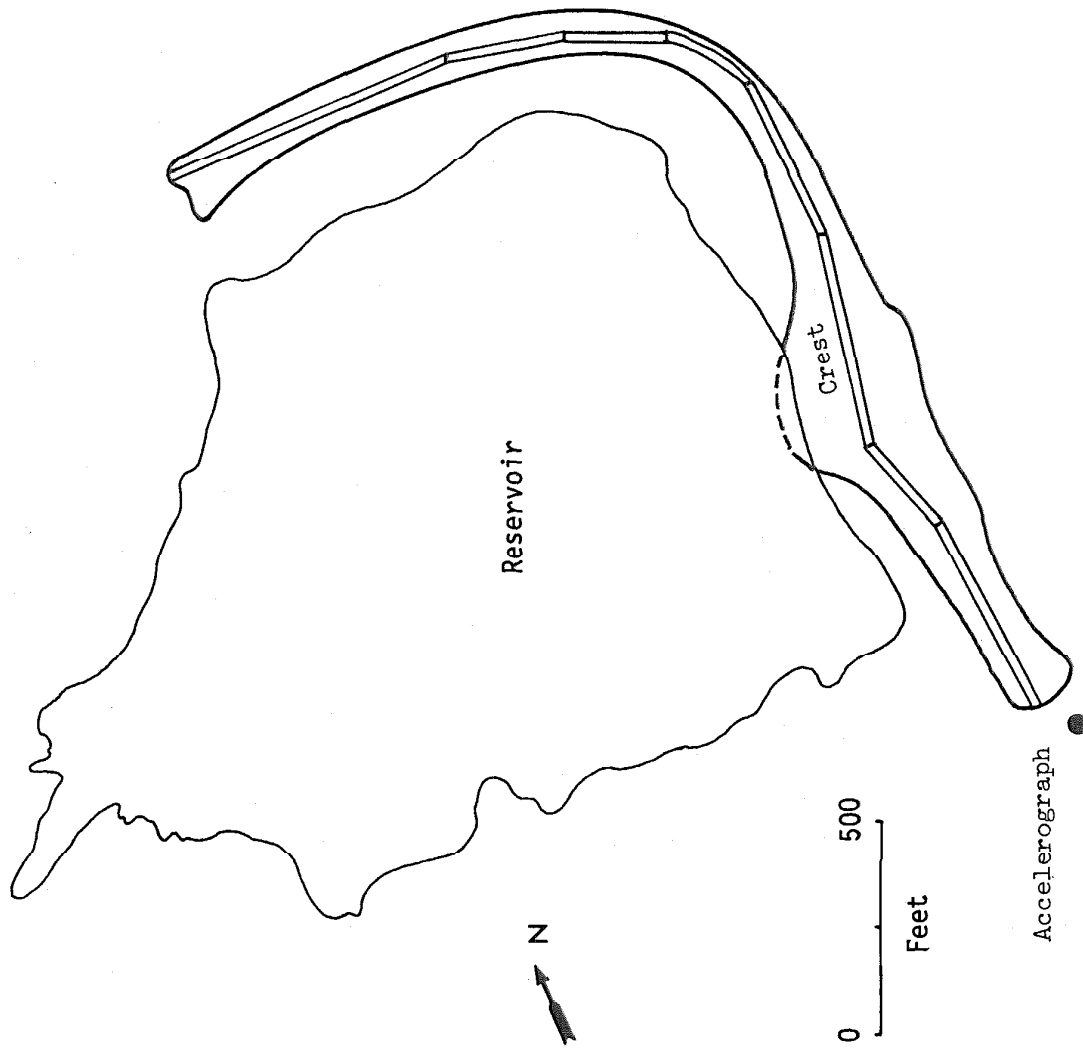
Figure 3. Plan view of Fairmont Dam showing the location of the accelerometer on the abutment.

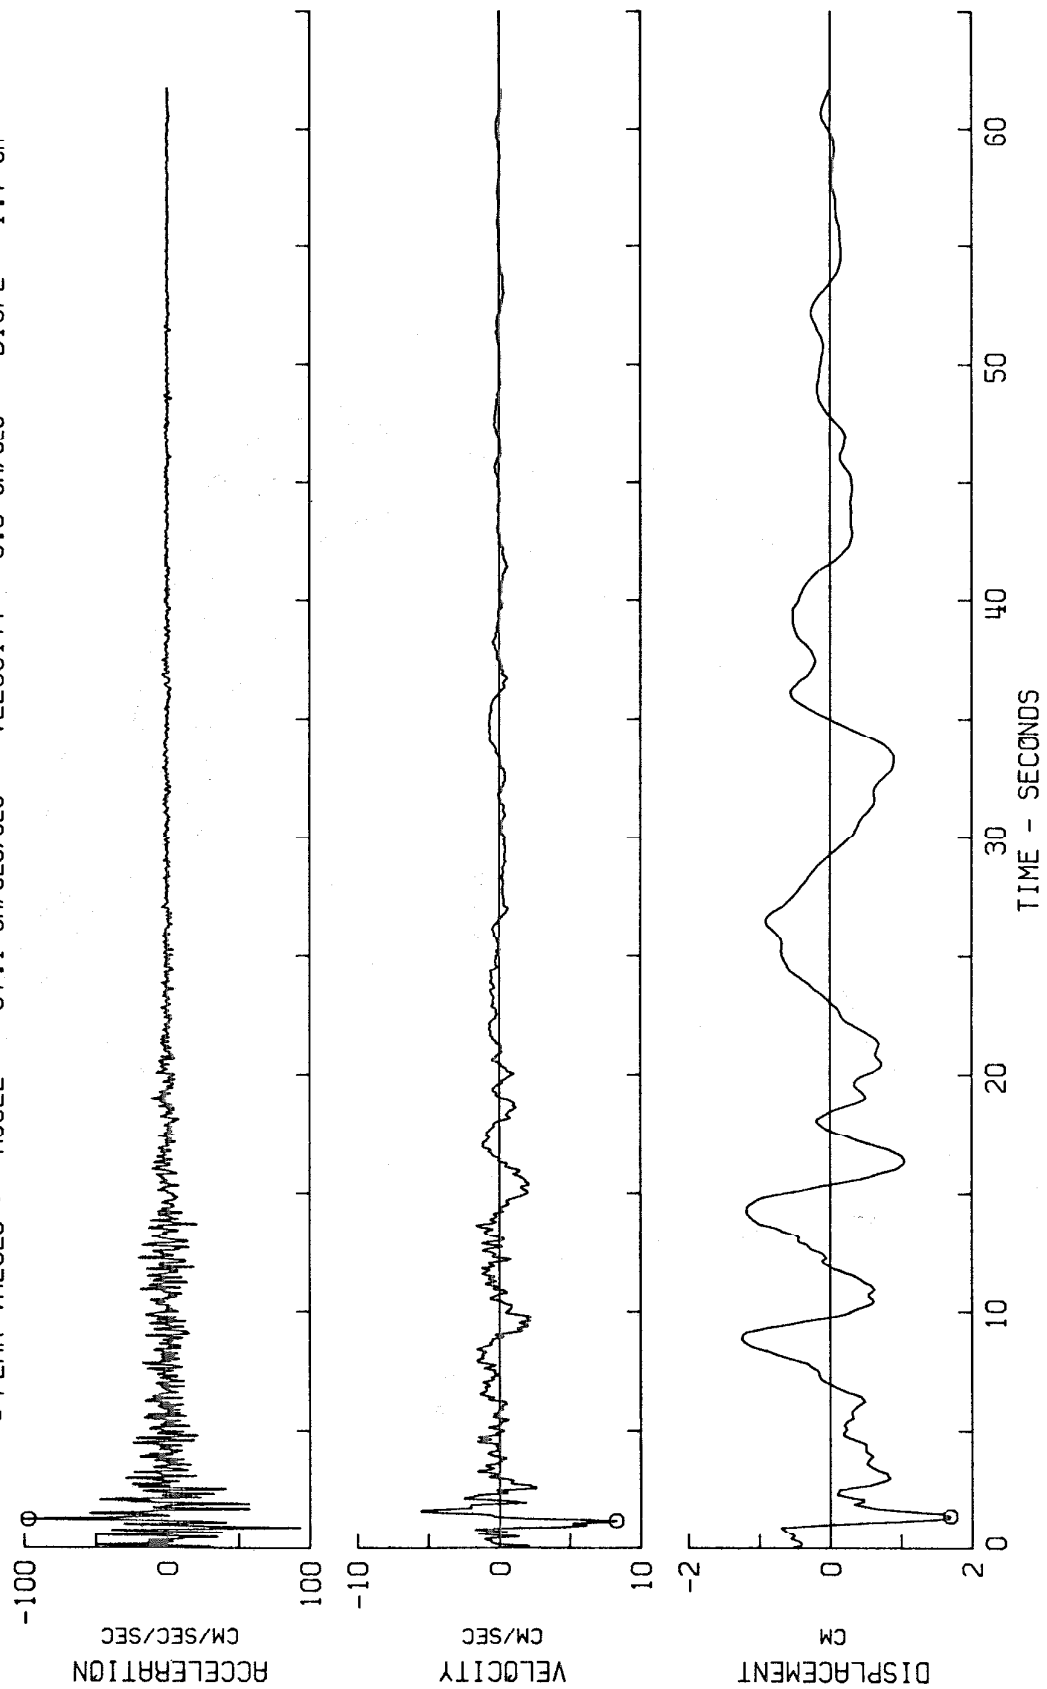
SAN FERNANDO EARTHQUAKE FEB 9, 1971 - 0600 PST  
 110207 71.175.0 RESERVOIR, FAIRMONT RESERVOIR, CAL. COMP N34W  
 ○ PEAK VALUES : ACCEL = -97.1 CM/SEC/SEC VELOCITY = 8.3 CM/SEC DISPL = 1.7 CM

Figure 4. Fairmont Reservoir Accelerogram, Component N34W.

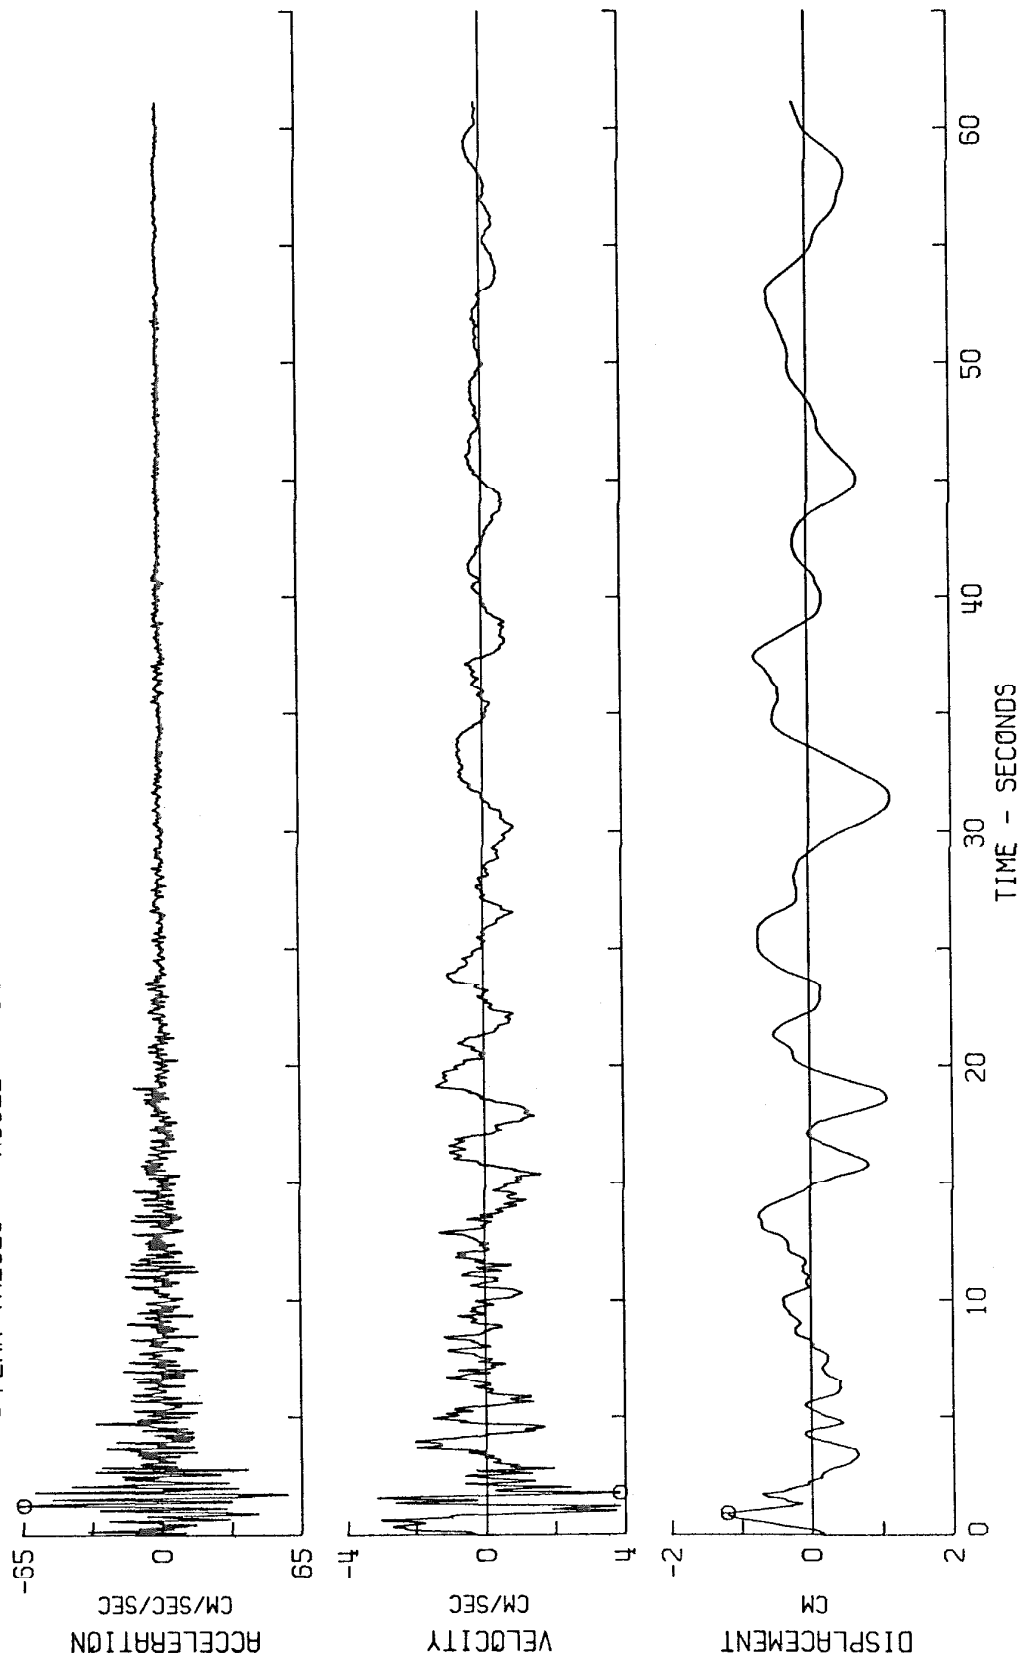
SAN FERNANDO EARTHQUAKE FEB 9, 1971 - 0600 PST  
 110207 71.175.0 RESERVOIR, FAIRMONT RESERVOIR, CAL. COMP N56E  
 ○ PEAK VALUES : ACCEL = -64.7 CM/SEC/SEC VELOCITY = 3.8 CM/SEC DISPL = -1.2 CM

Figure 5. Fairmont Reservoir Accelerogram, Component N56E.

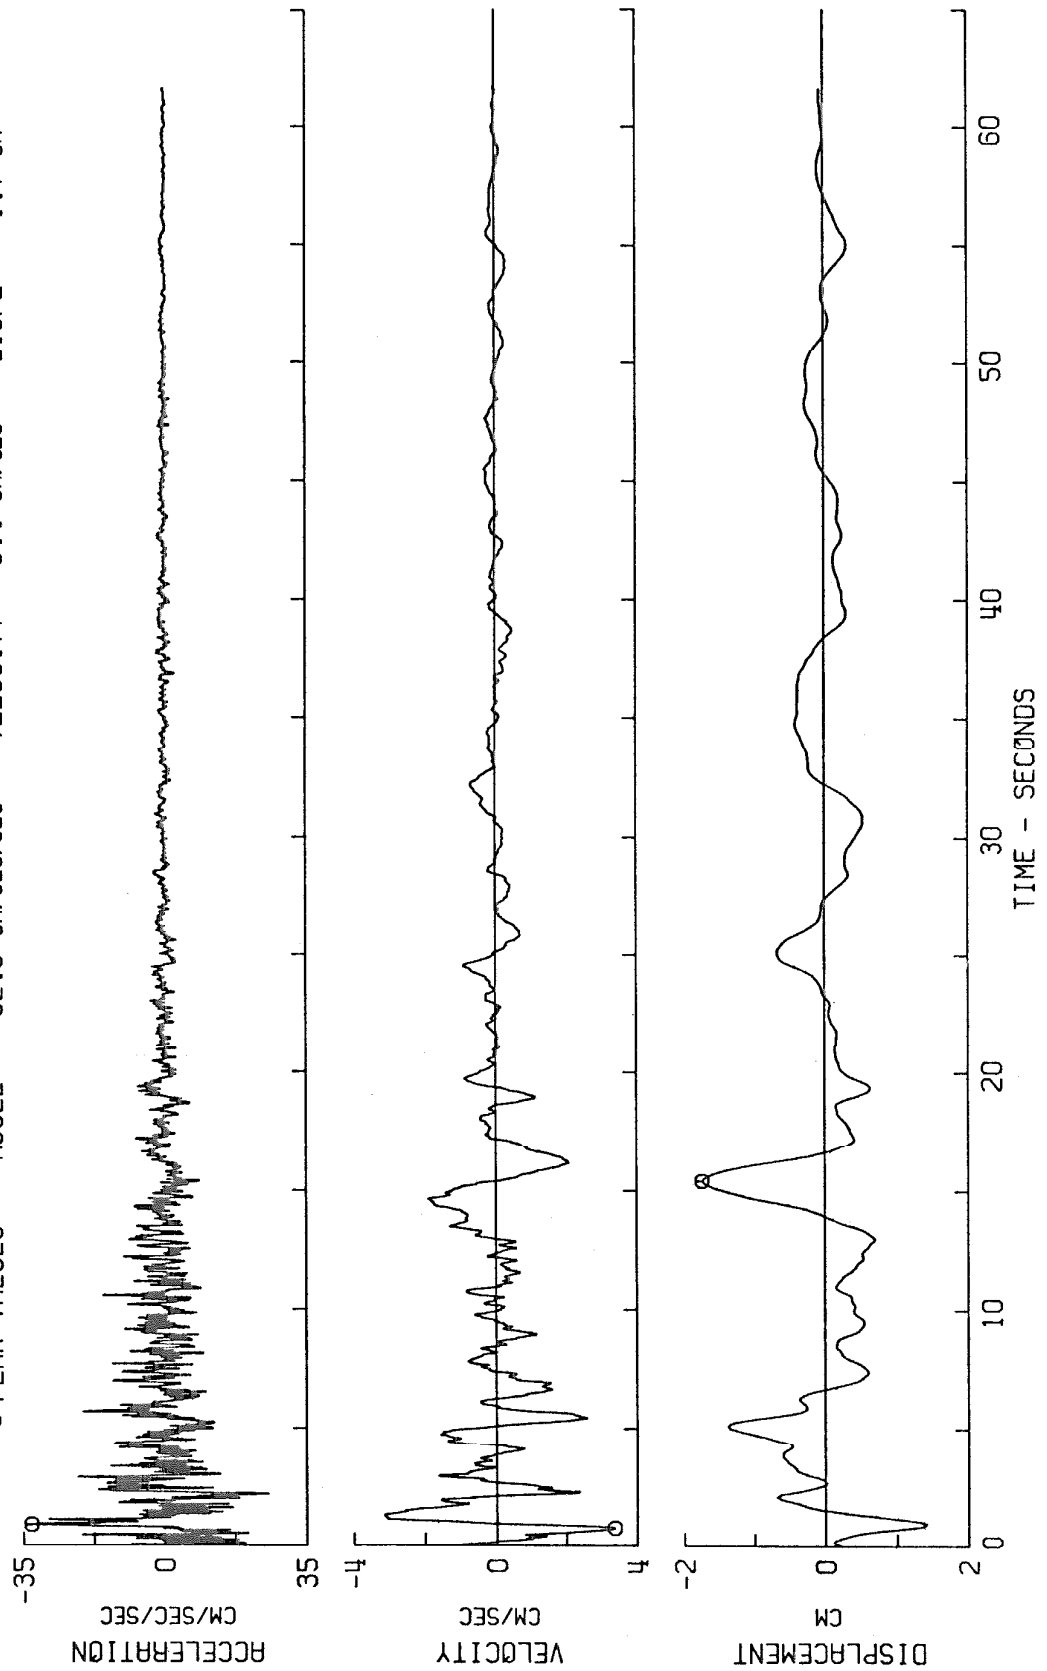
SAN FERNANDO EARTHQUAKE FEB 9, 1971 - 0500 PST  
 110207 71.175.0 RESERVOIR, FAIRMONT RESERVOIR, CAL. COMP UP  
 ○ PEAK VALUES : ACCEL = -32.9 CM/SEC/SEC VELOCITY = 3.4 CM/SEC DISPL = -1.7 CM

Figure 6. Fairmont Reservoir Accelerogram, Component Vertical.

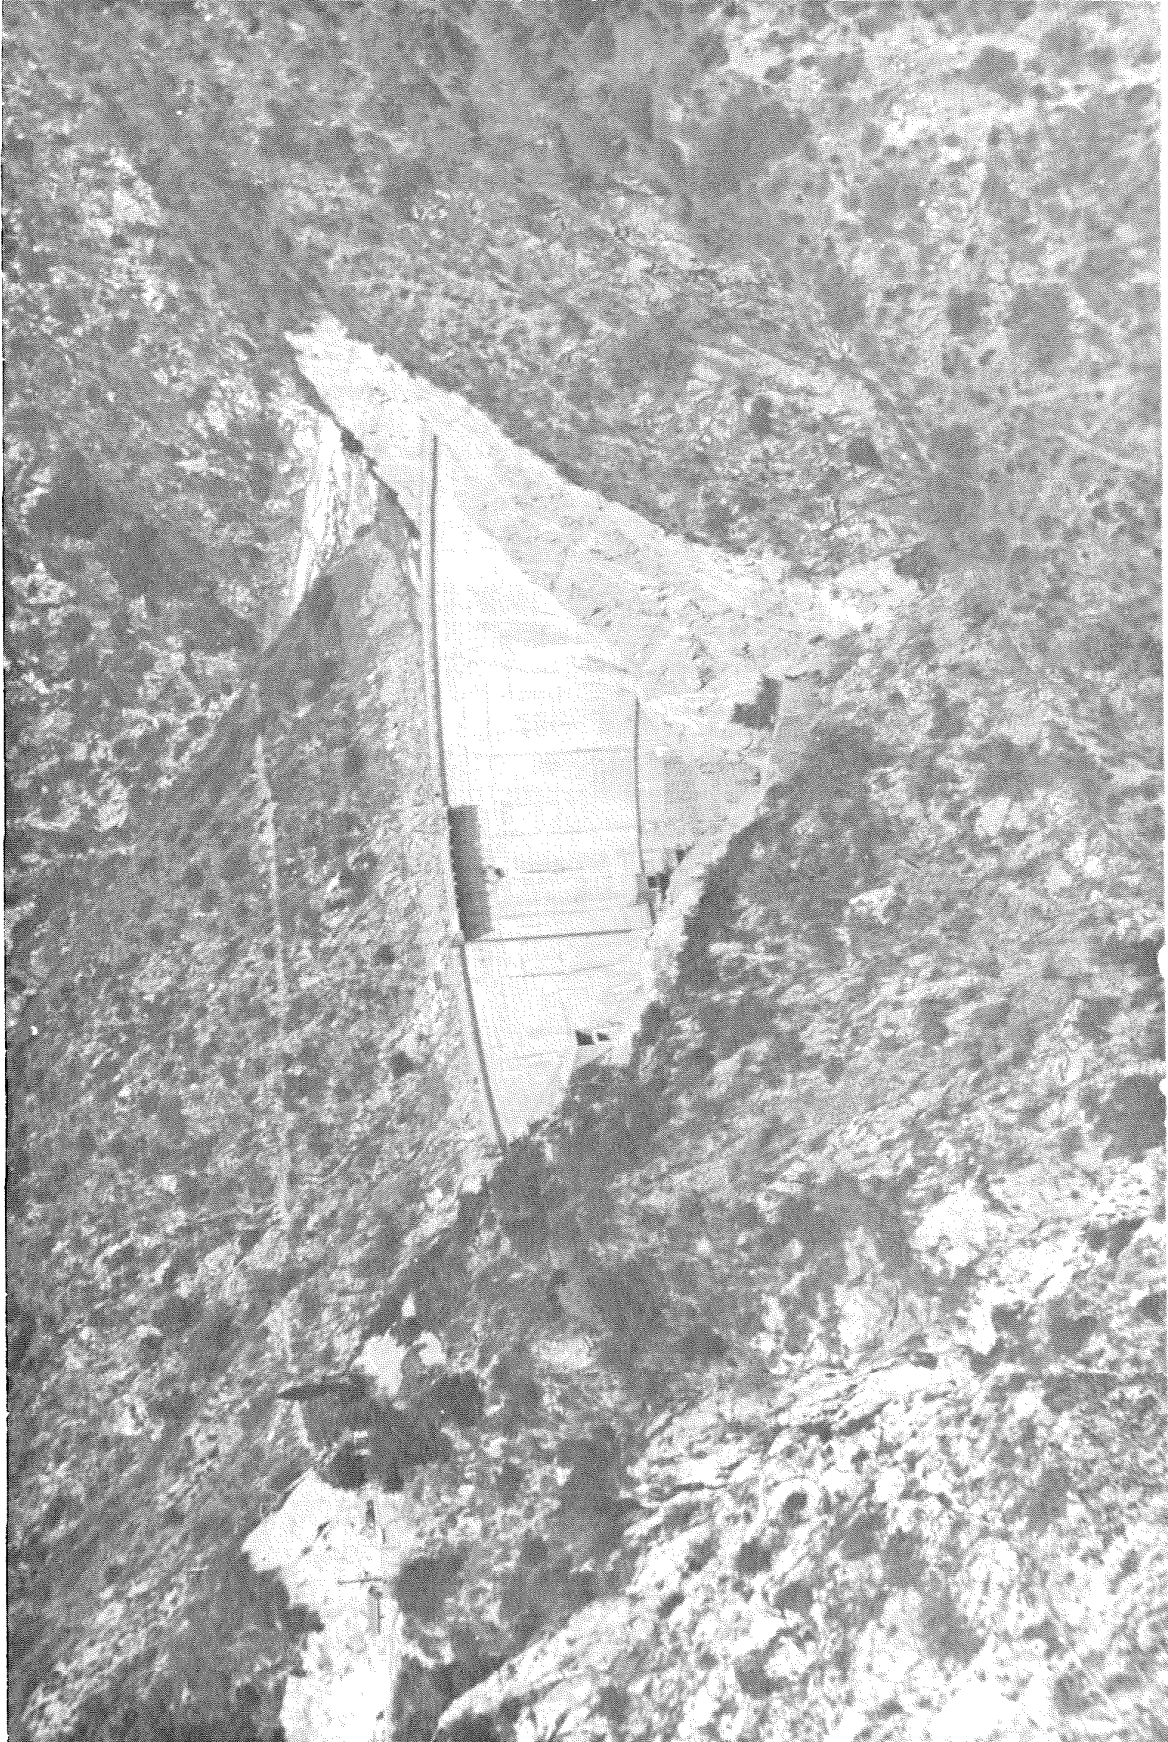
FIGURE 1. Santa Anita Dam. The accelerograph is located on the right abutment between the crest level and the upper road.

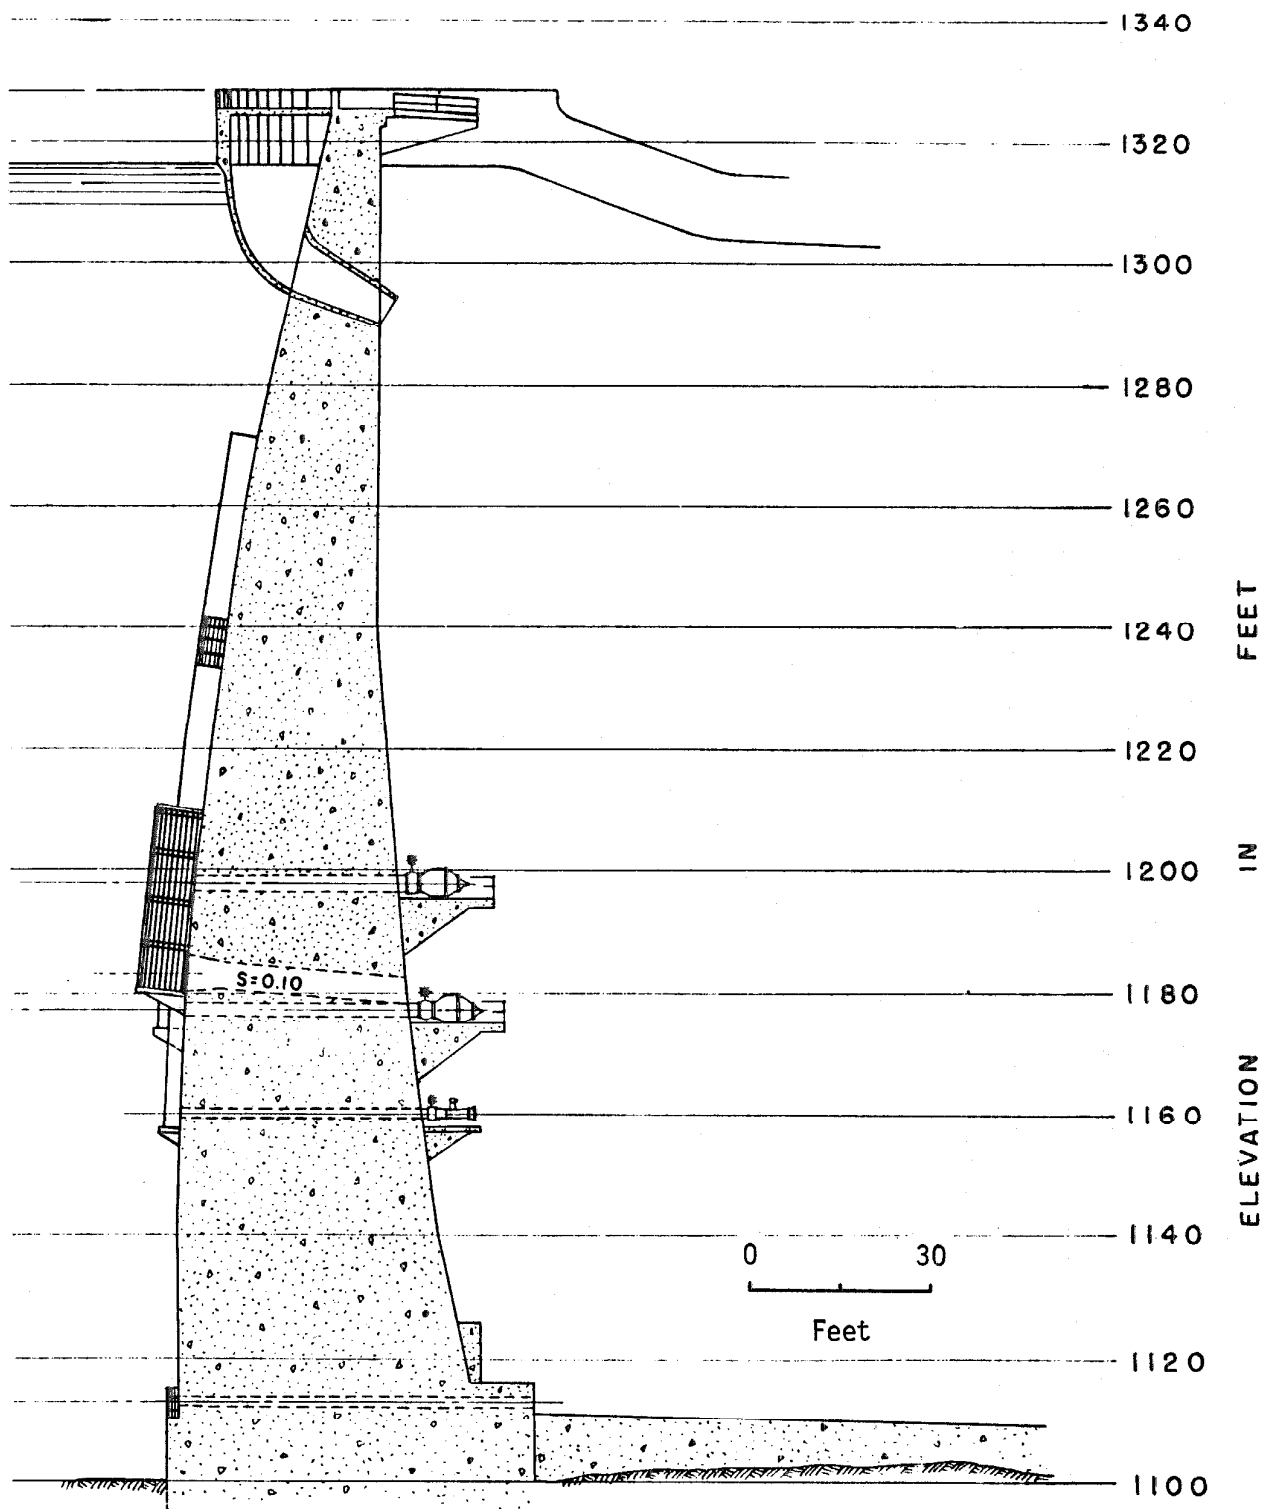
FIGURE 2. Cross-section of Santa Anita Dam.

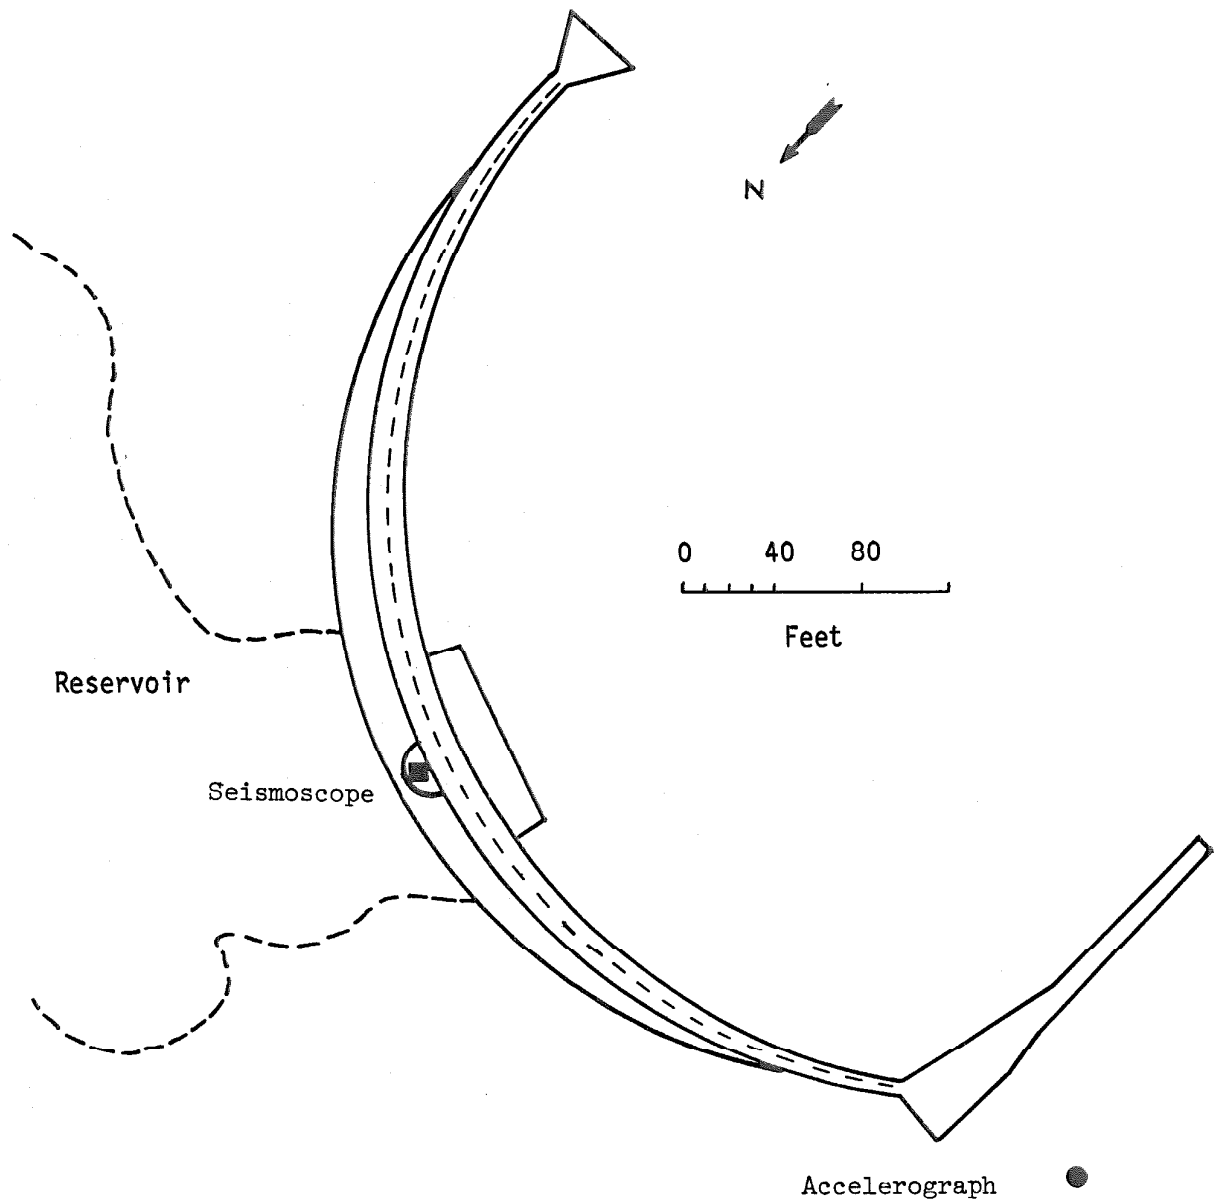
FIGURE 3. Plan view of Santa Anita Dam showing the locations of the accelerometer and seismoscope.

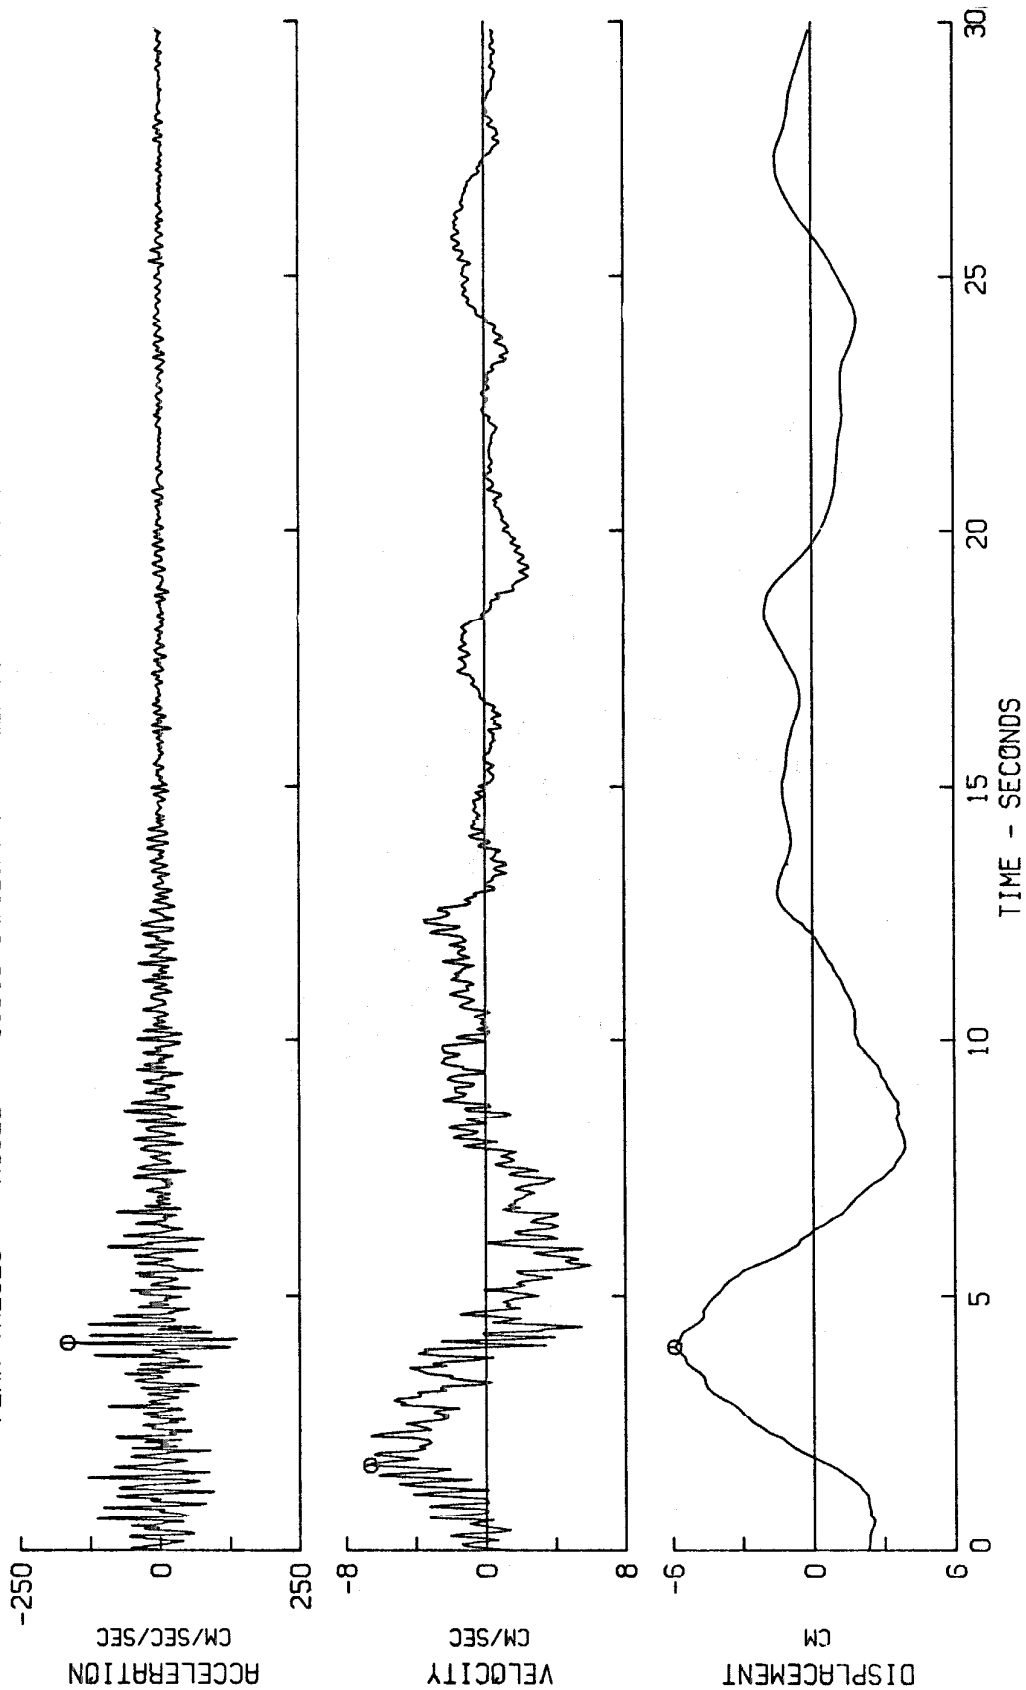
Figure 4

IIP221 71.150.0 SANTA ANITA RESERVOIR, ARCADIA, CAL. COMP N87W

PEAK VALUES : ACCEL = -165.8 CM/SEC/SEC VELOCITY = -6.6 CM/SEC DISPL = -5.9 CM

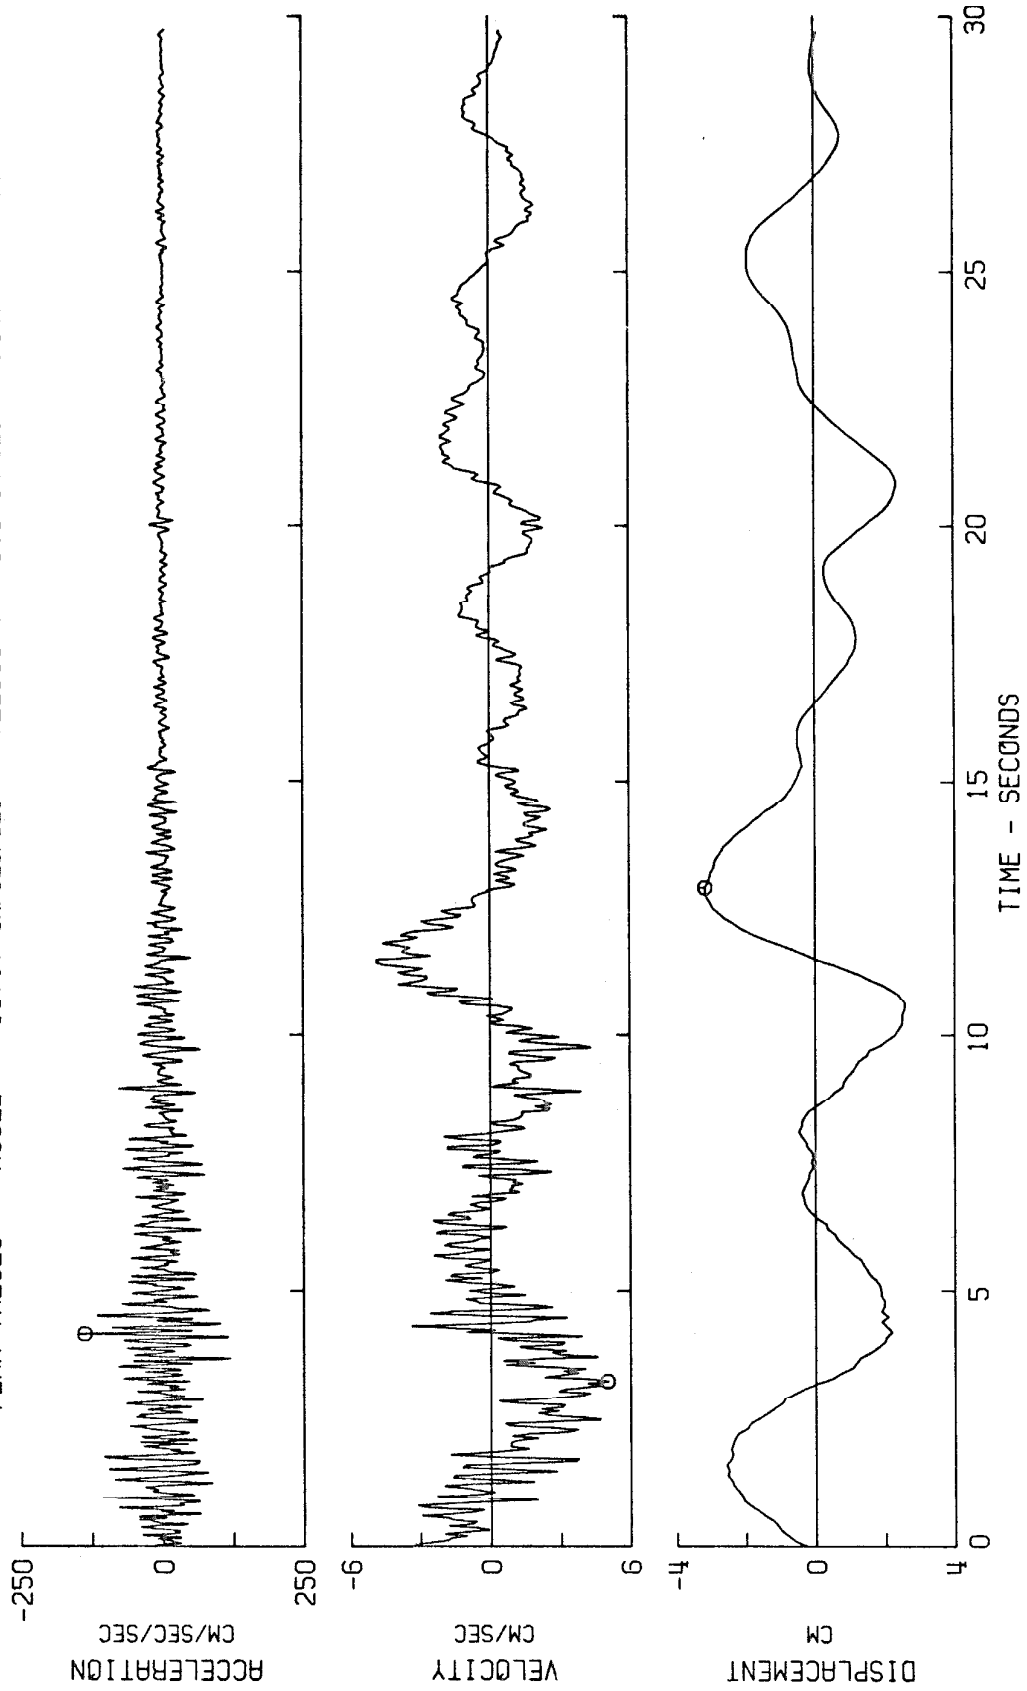
FIGURE 5.

SAN FERNANDO EARTHQUAKE FEB 9, 1971 - 0600 PST  
 IIP221 71.150.0 SANTA ANITA RESERVOIR, ARCADIA, CAL. COMP NO3E

PEAK VALUES : ACCEL = -137.7 CM/SEC/SEC VELOCITY = 5.0 CM/SEC DISPL = -3.1 CM

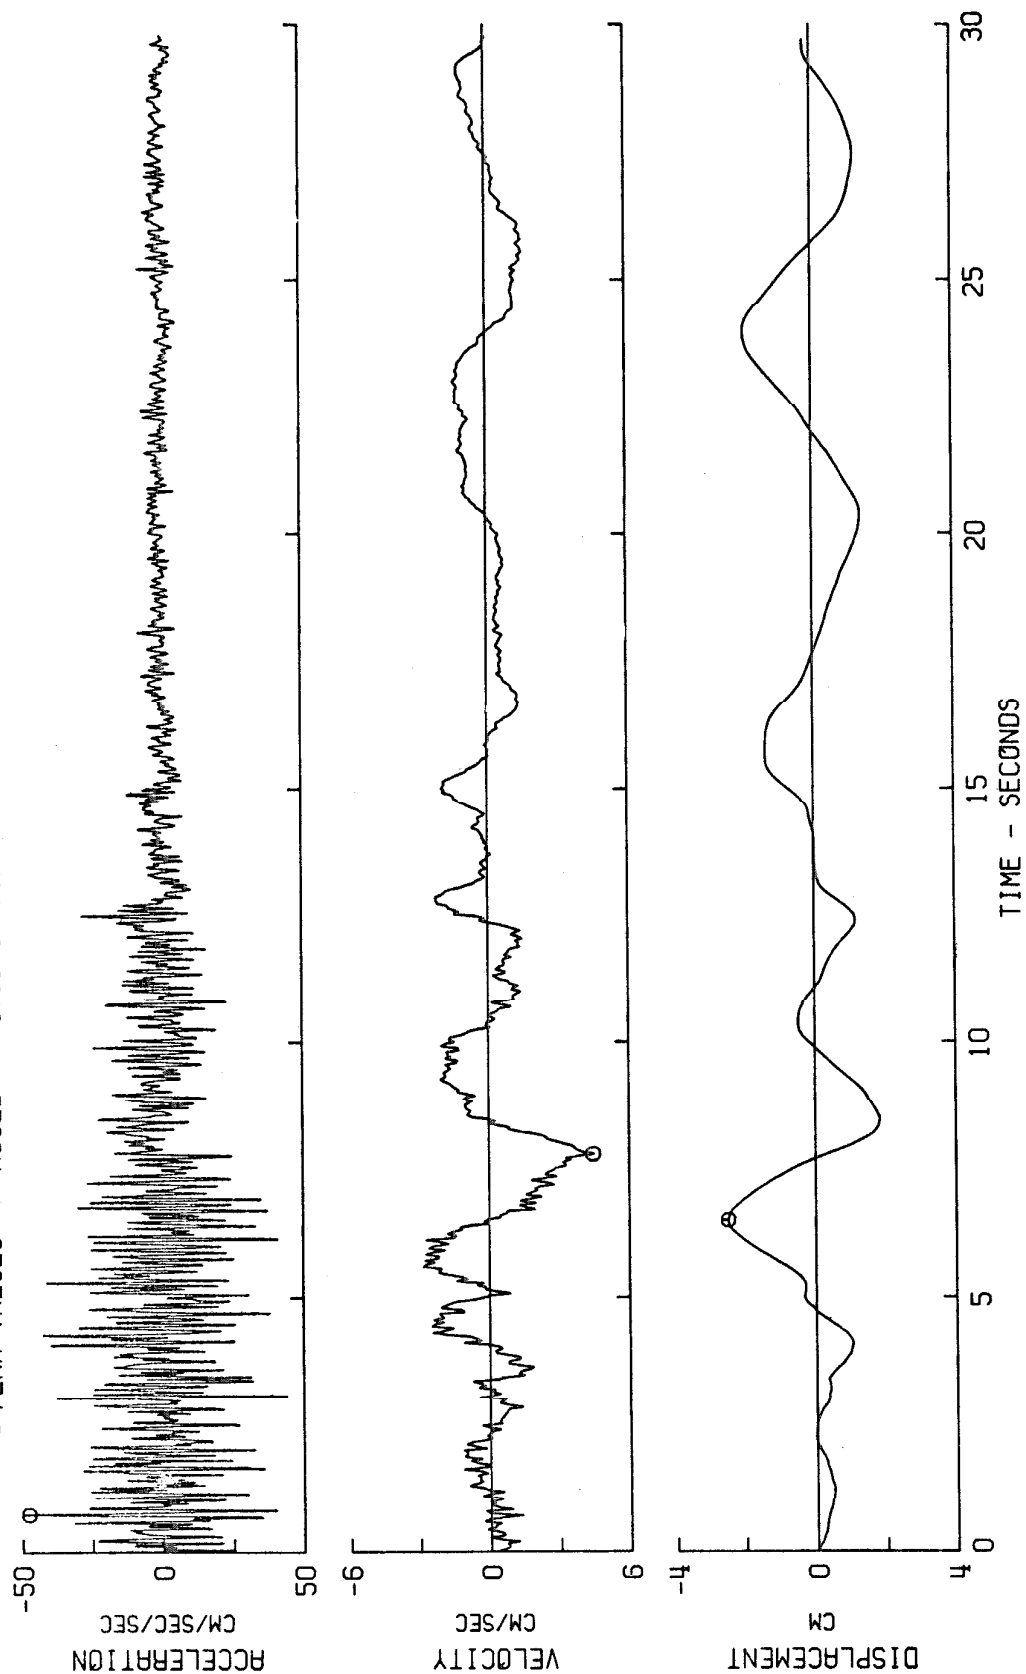
FIGURE 6.

SAN FERNANDO EARTHQUAKE FEB 9, 1971 - 0600 PST  
 IIP221 71.150.0 SANTA ANITA RESERVOIR, ARCADIA, CAL. COMP DOWN

⊙ PEAK VALUES : ACCEL = -47.6 CM/SEC/SEC VELOCITY = 4.5 CM/SEC DISPL = -2.5 CM

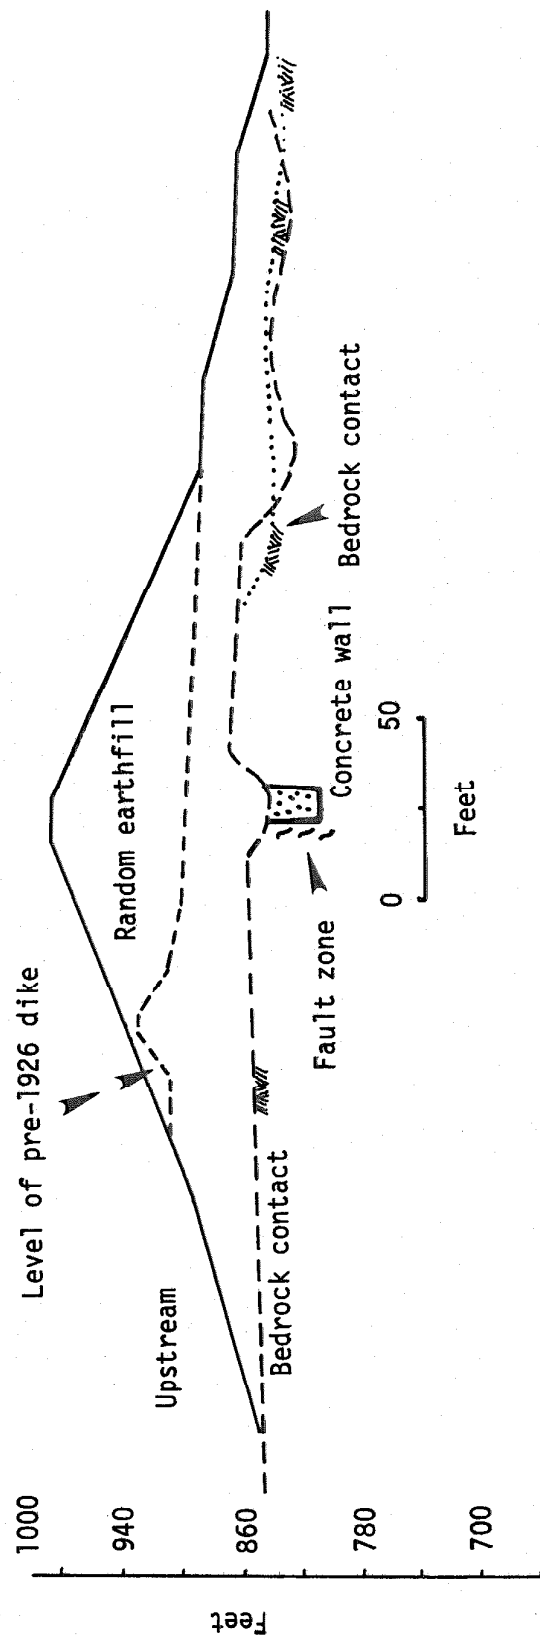
FIGURE 2. Maximum cross-section of Puddingstone Dam.

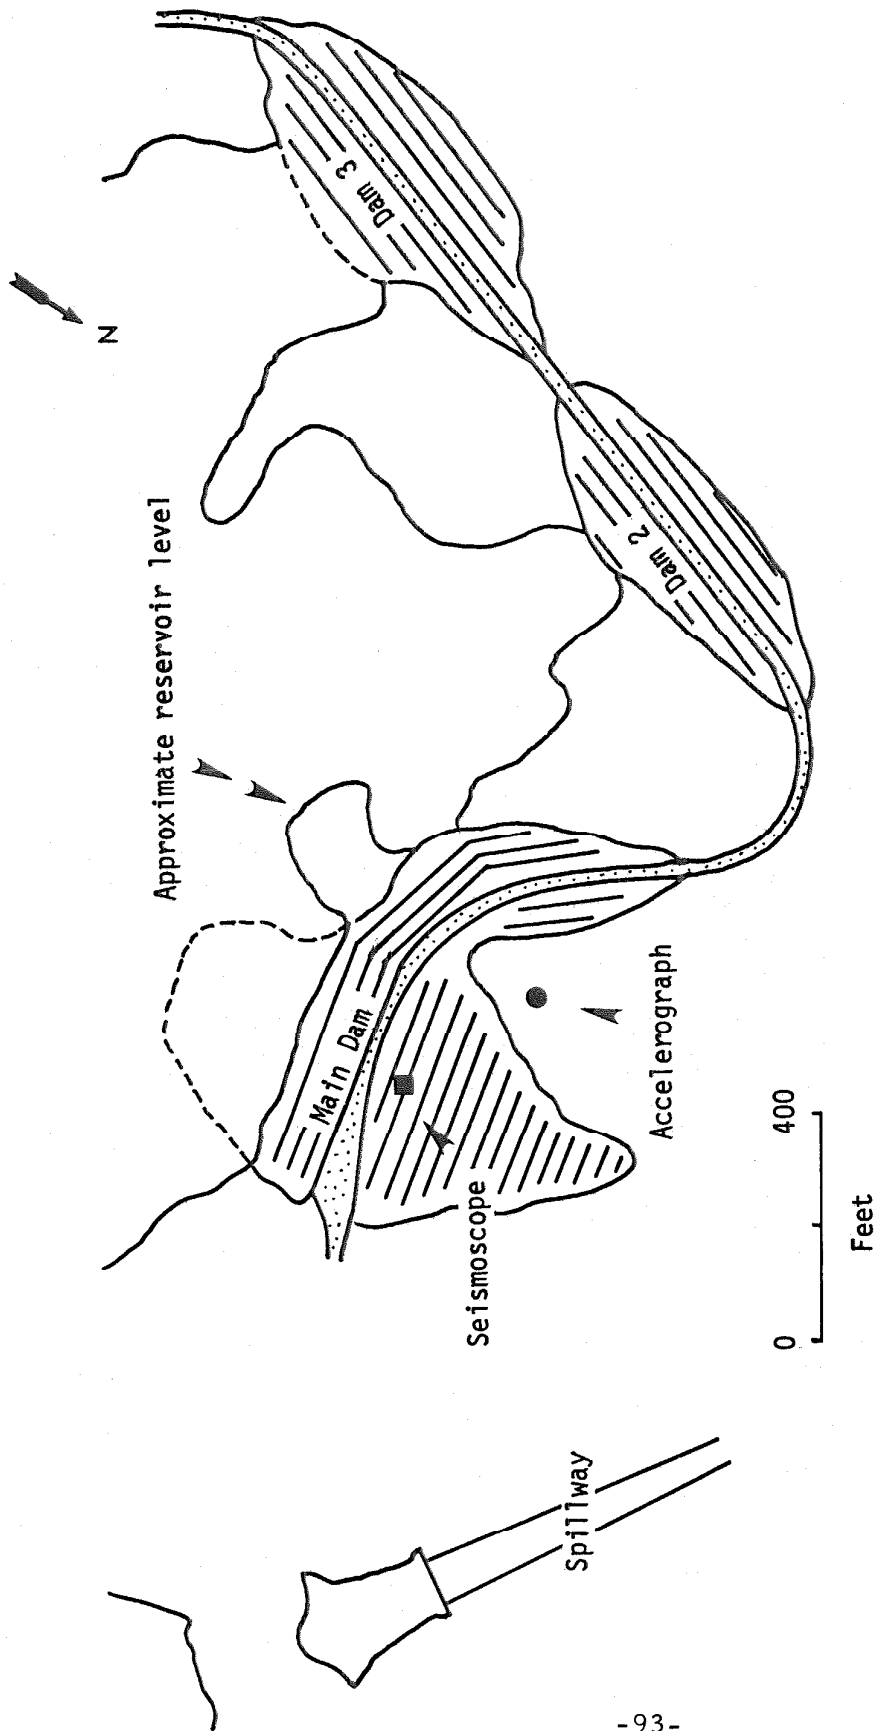
FIGURE 3. Plan view of Puddingstone Dam showing the accelerograph and seismoscope locations.

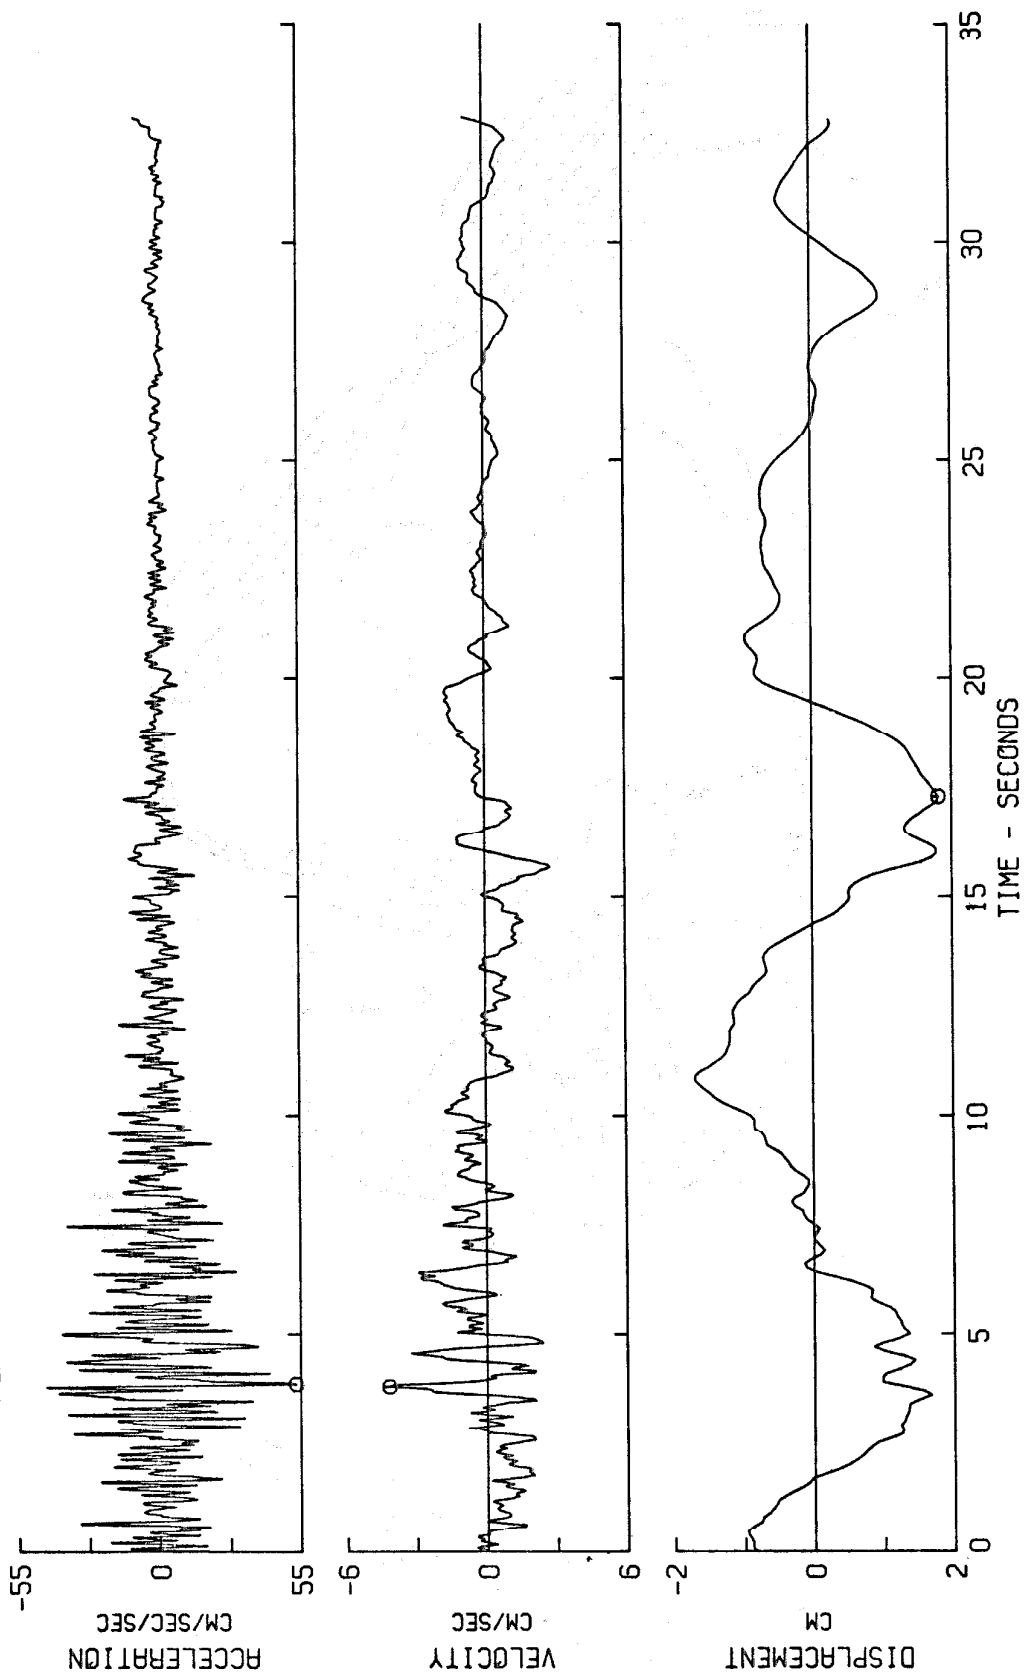
FIGURE 4.

IIP223 71.153.0 PUDDINGSTONE RESERVOIR, SAN DIMAS, CAL. COMP N35W

○ PEAK VALUES : ACCEL = 53.3 CM/SEC/SEC VELOCITY = -4.2 CM/SEC DISPL = 1.8 CM
