# EARTHQUAKE RECORDINGS ON OR NEAR DAMS

P. Morrison, R. Maley, G. Brady, R. Porcella

USCOLD

November 1977

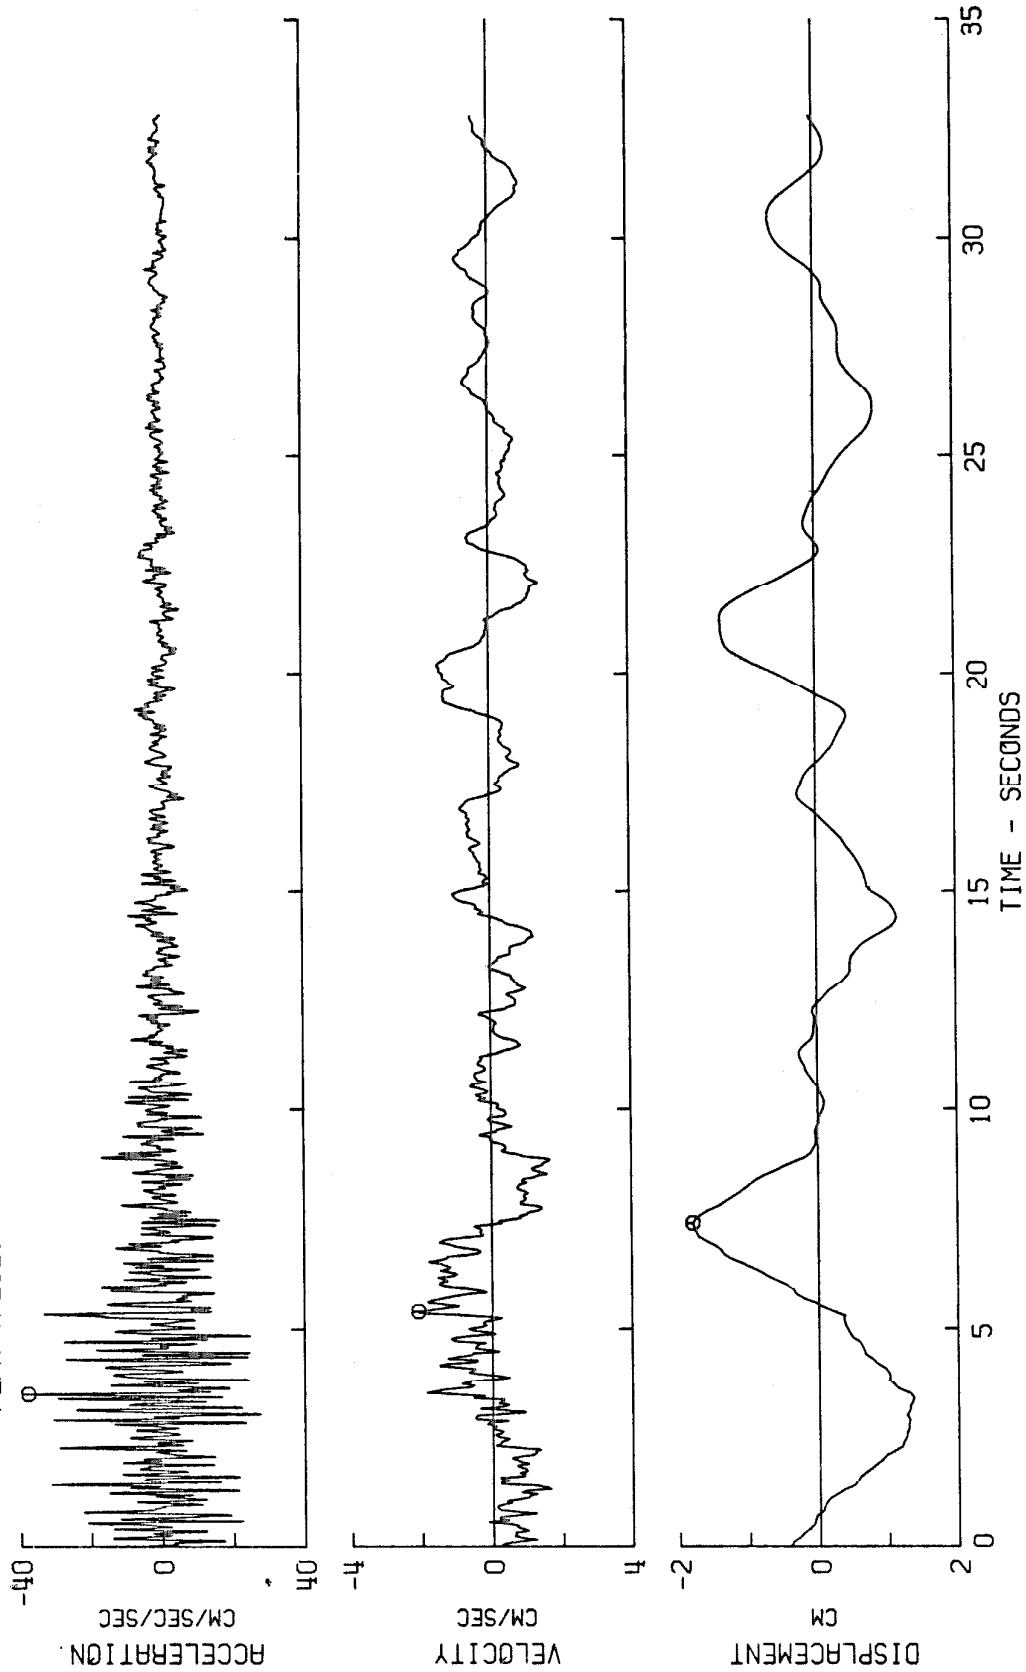
FIGURE 6.

SAN FERNANDO EARTHQUAKE FEB 9, 1971 - 0600 PST  
 IIP223 71.153.0 PUDDINGSTONE RESERVOIR, SAN DIMAS, CAL. COMP DOWN  
 ○ PEAK VALUES : ACCEL = -37.8 CM/SEC/SEC VELOCITY = -2.1 CM/SEC DISPL = -1.8 CM

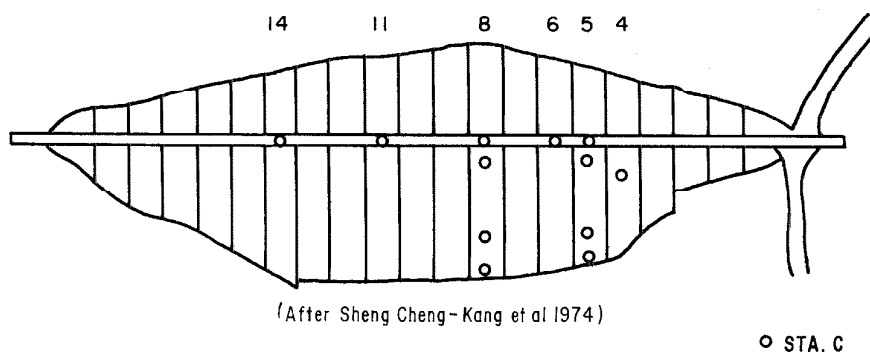
FIGURE 2  
LOCATION OF STRONG-MOTION SEISMOGRAPH STATIONS

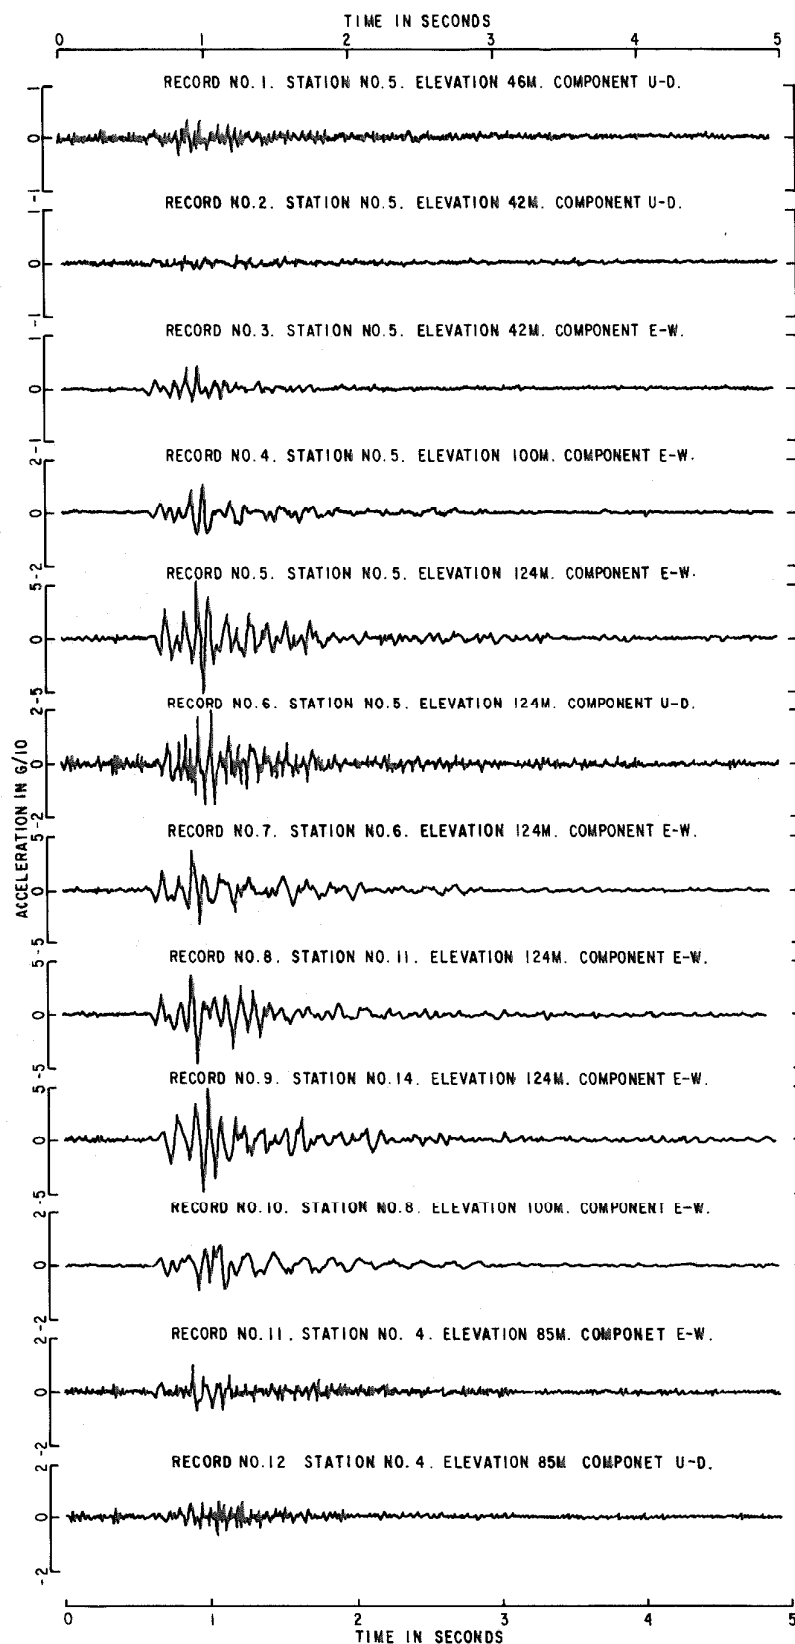
**FIGURE 3. REPLOT OF THE STRONG-MOTION TRACES AFTER DIGITIZATION**  
 THE LEFT-HAND SCALE GIVES THE ACCELERATION AS A FRACTION OF GRAVITY. THE RECORDING SITE CORRESPONDING TO EACH TRACE CAN BE DETERMINED FROM THE STATION NUMBER AND FIGURE 1 AND TABLE 1. THE TIME SCALE IS AS SHOWN

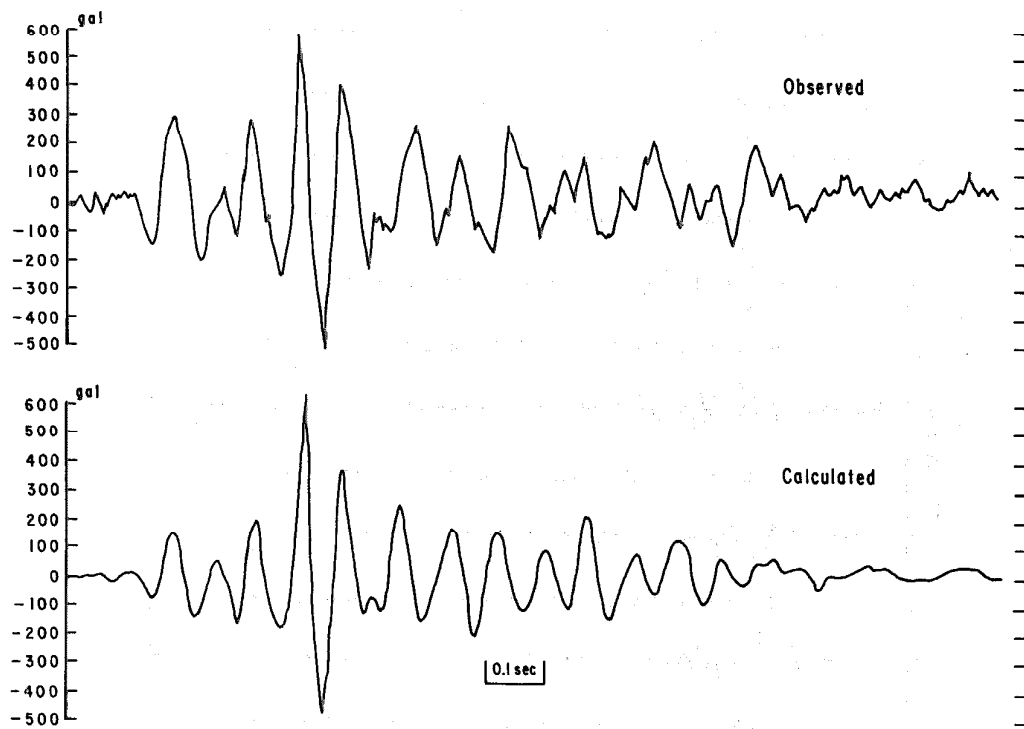
FIGURE 4  
OBSERVED AND CALCULATED ACCELEROGRAM AT ELEV. 124 m. OF PIER NO. 5 (E-W)

The finite-element analysis method was applied to the record from Pier 5. Assuming the pier to be in a state of plane-stress and neglecting the dynamic water pressure, the dam response to the simultaneous input of the horizontal and vertical ground motion (at the foundation of the dam) of Earthquake 22 was computed. Good agreement was obtained between computed and observed results (Figure 4).

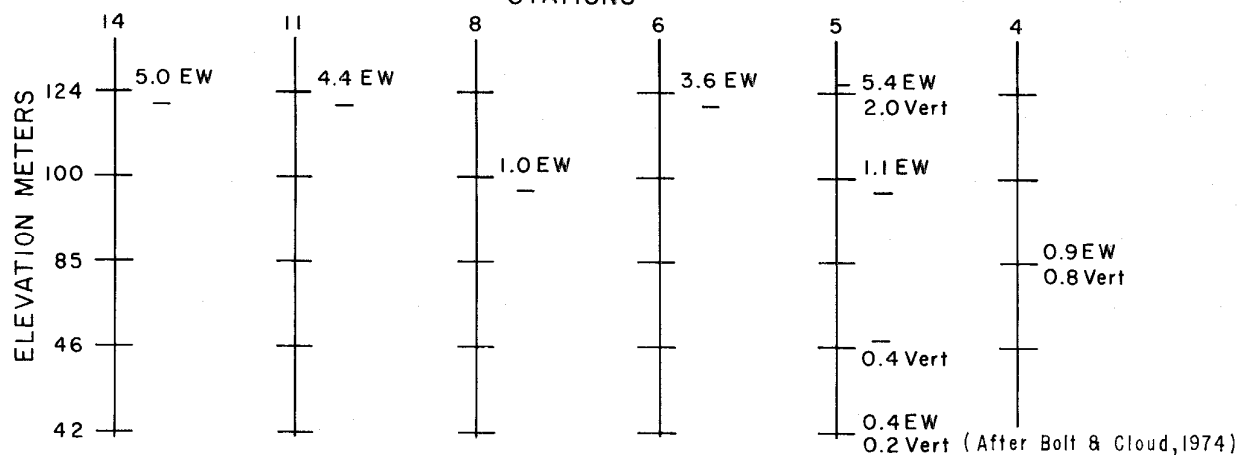
TABLE 2  
MAXIMUM RECORDED ACCELERATION IN g/10  
STATIONS

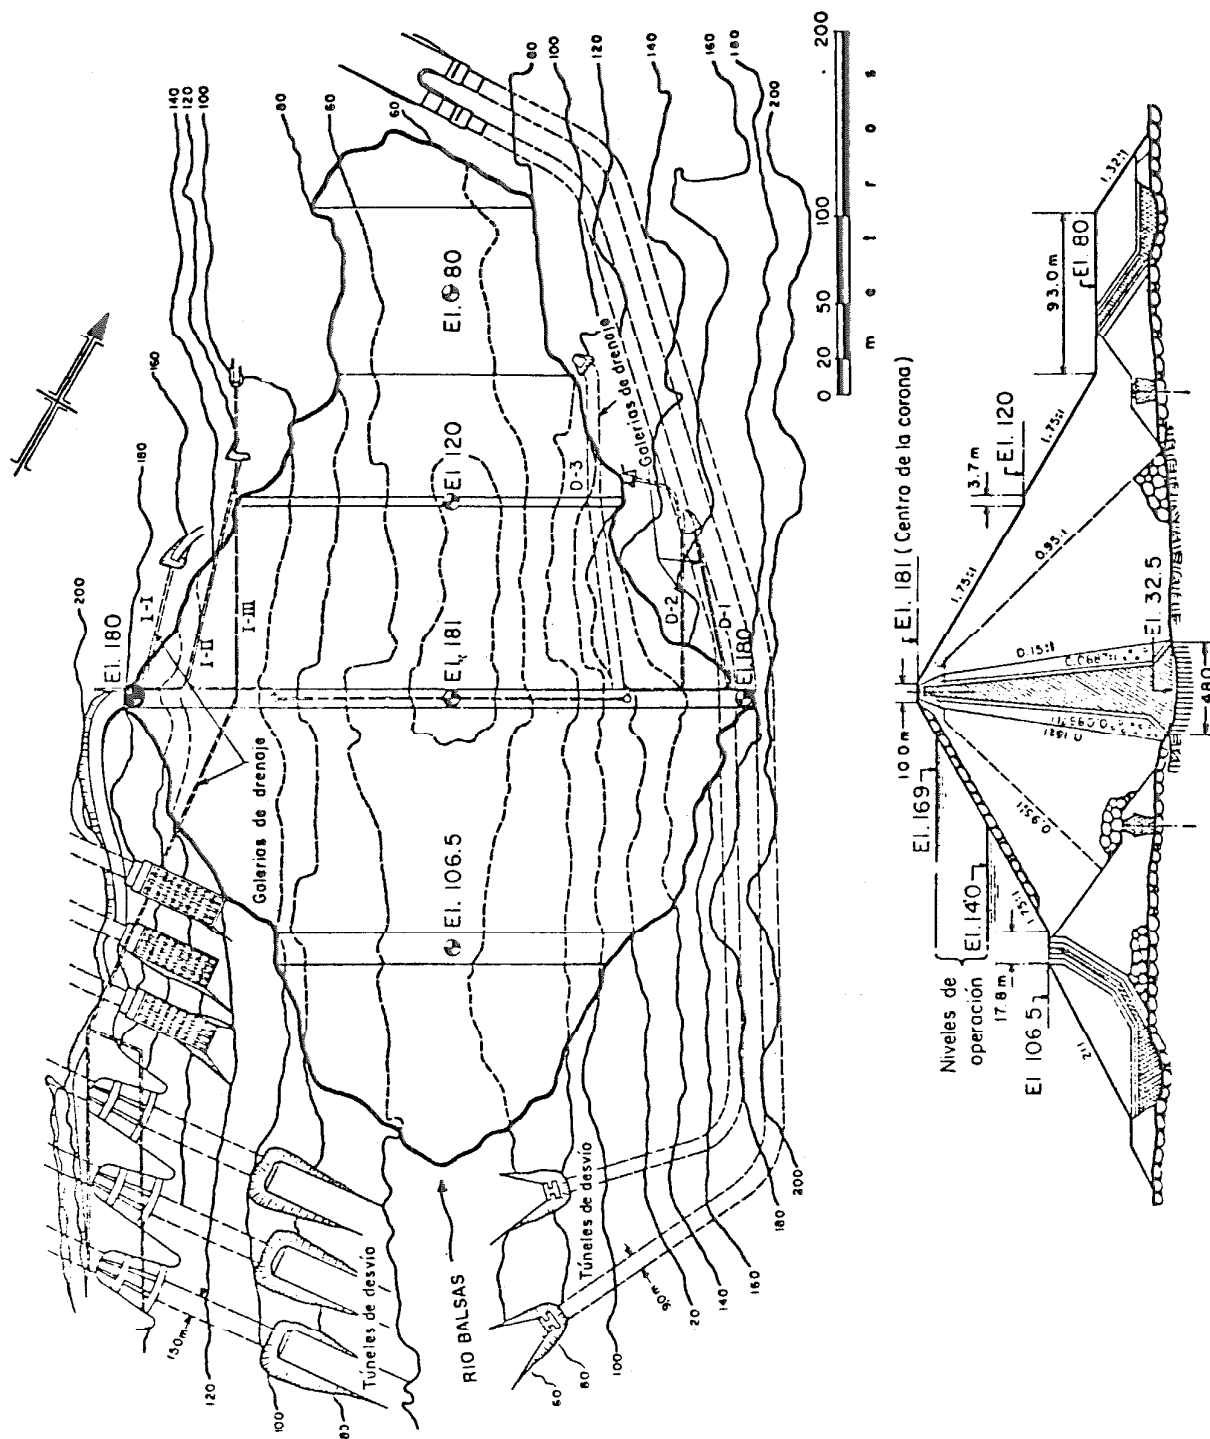
FIGURE 2. El Infiernillo Dam plan and cross section.

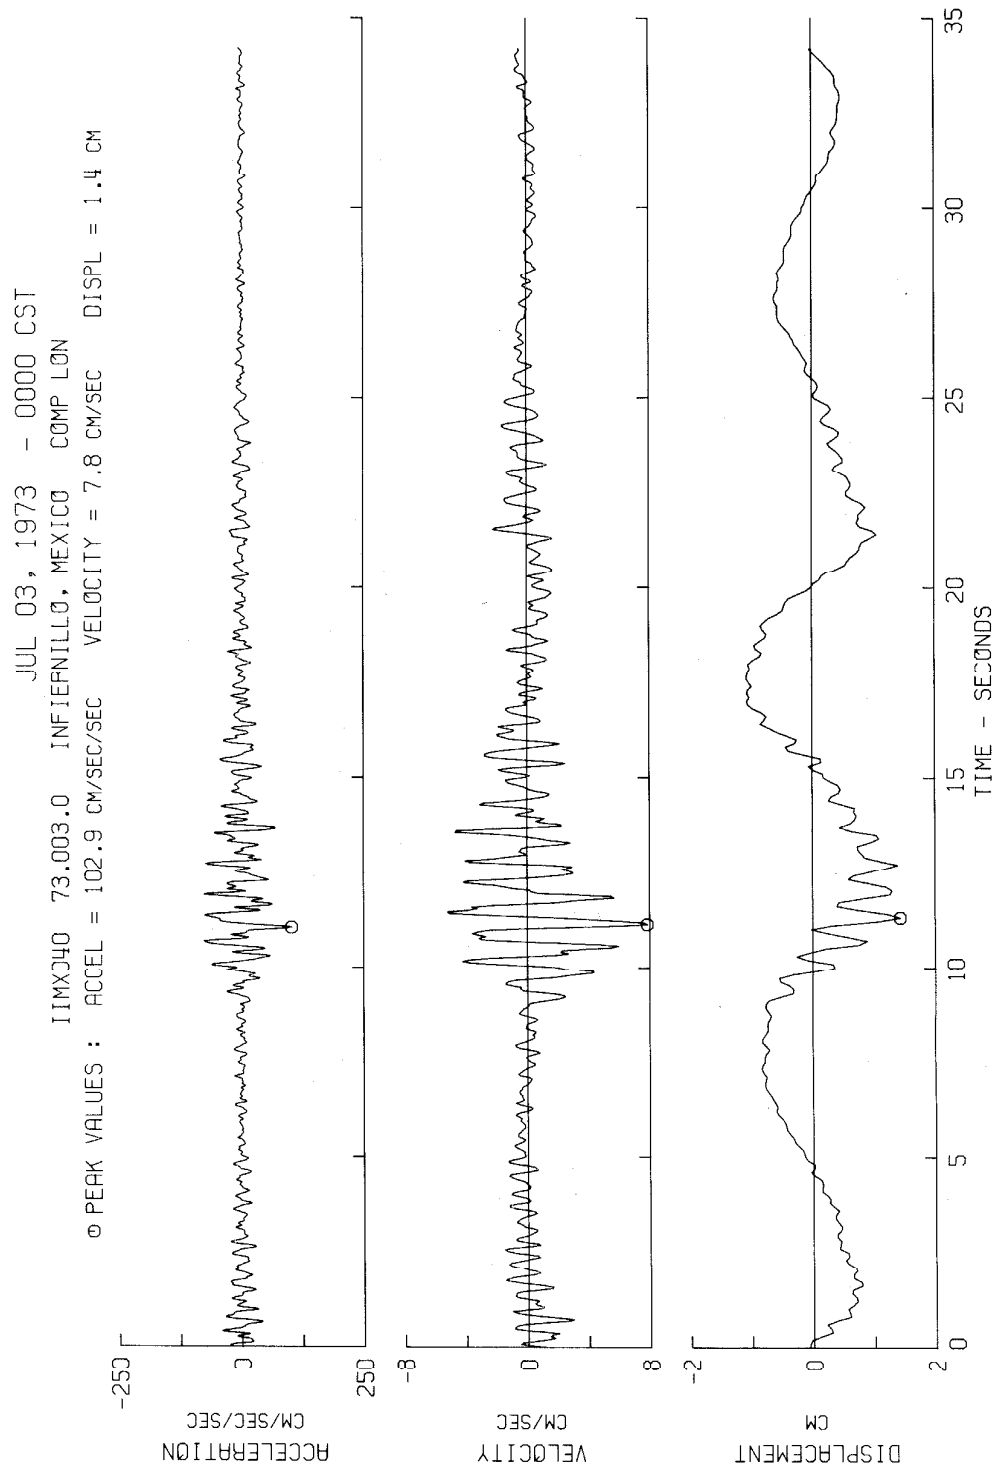
Figure 3. Motion on crest of Infiernillo Dam, longitudinal component. A period of .66 sec is visible on the record. The earthquake had a magnitude of approximately 6.0 with hypo-center approximately 60 km from the dam.

The earthquake of July 3, 1973 provided one record from the crest accelerograph. Figures 3, 4 and 5 show the recorded crest acceleration and the computed velocity and displacement. The original recorded data were digitized and processed according to the standard California Institute of Technology program. Figures 6, 7 and 8 show the corresponding response spectra. It is seen that the longitudinal component of motion shows a strong periodicity at 0.65 seconds period, and the motion is more intense than in the transverse direction. (We are indebted to the Instituto de Ingenieria of the National University of Mexico for the digitized data.)

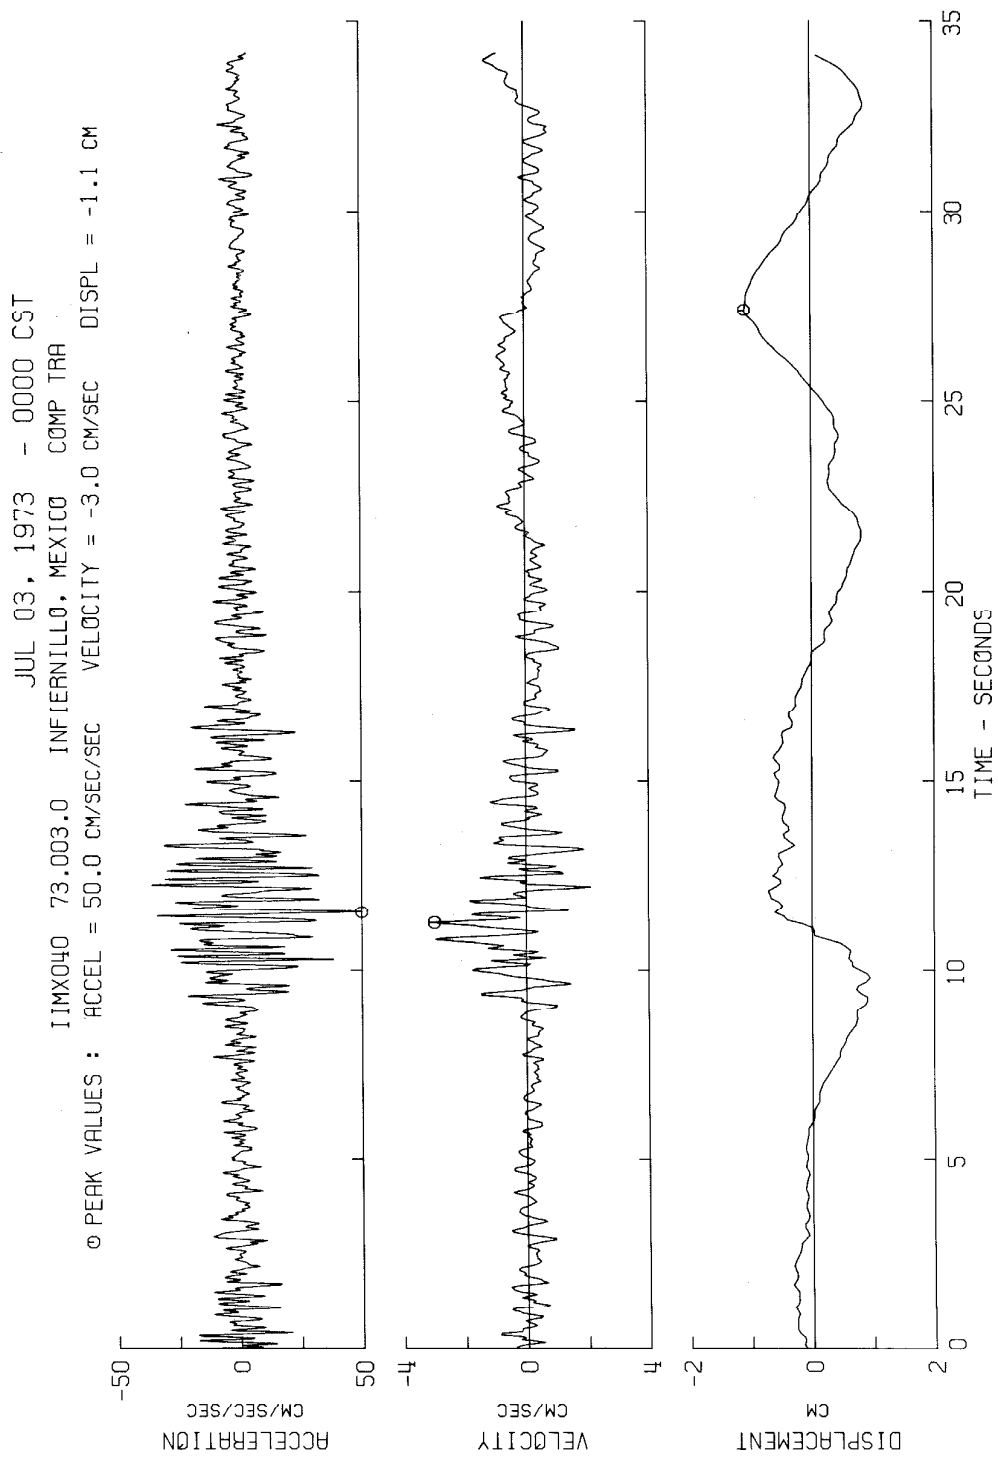
Figure 4. Transverse component of motion on the crest of Infiernillo Dam.

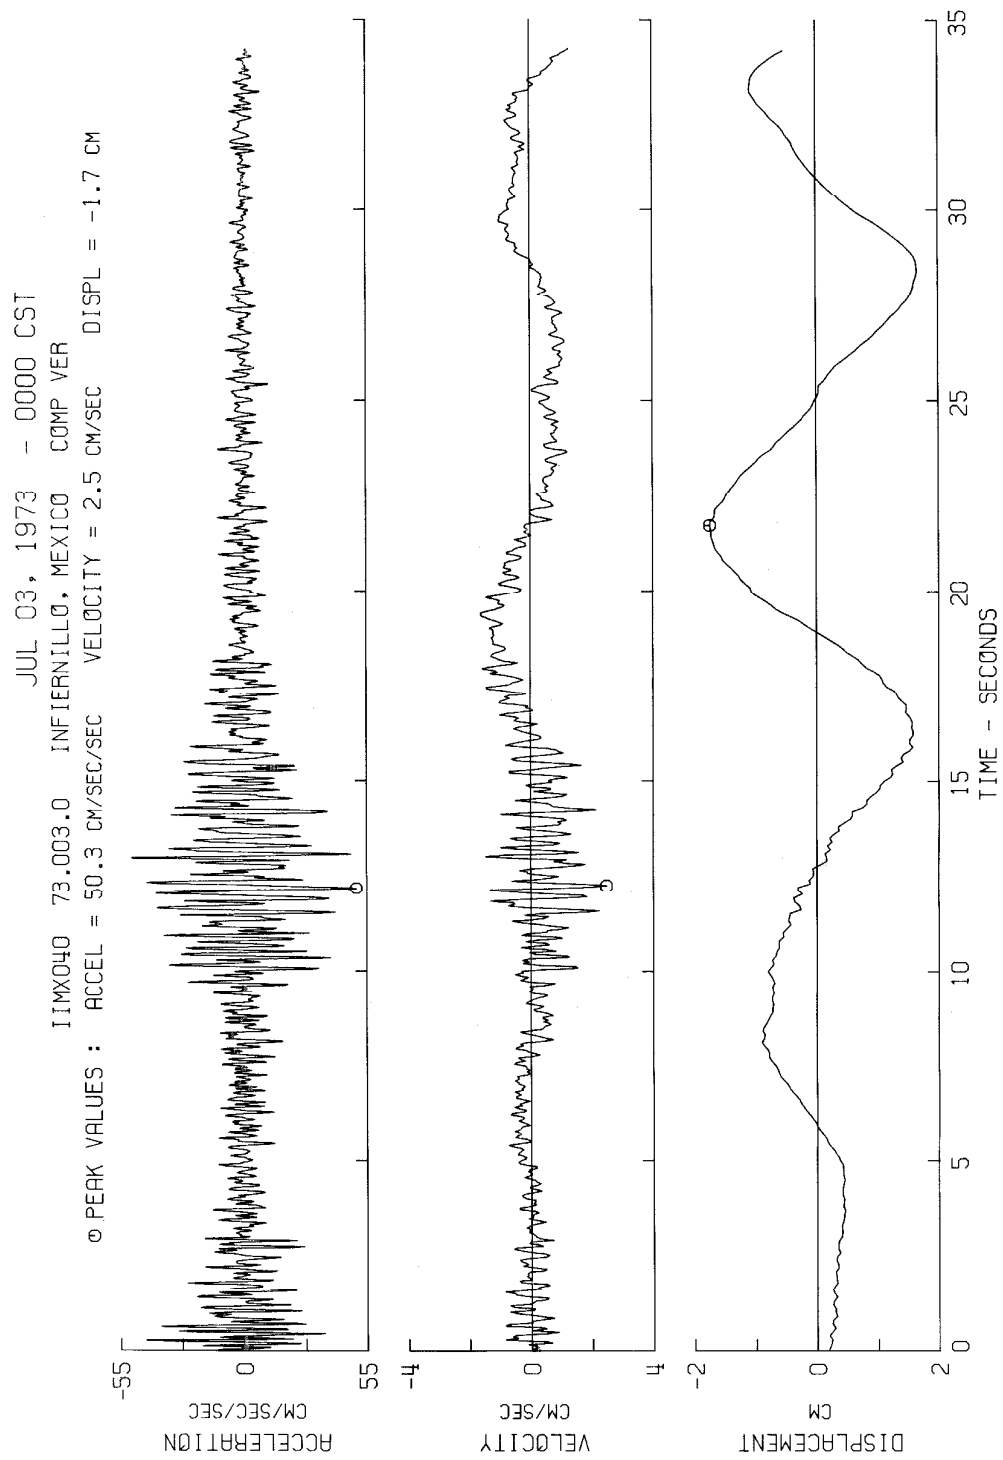
Figure 5. Vertical component of motion on Infiernillo Dam.

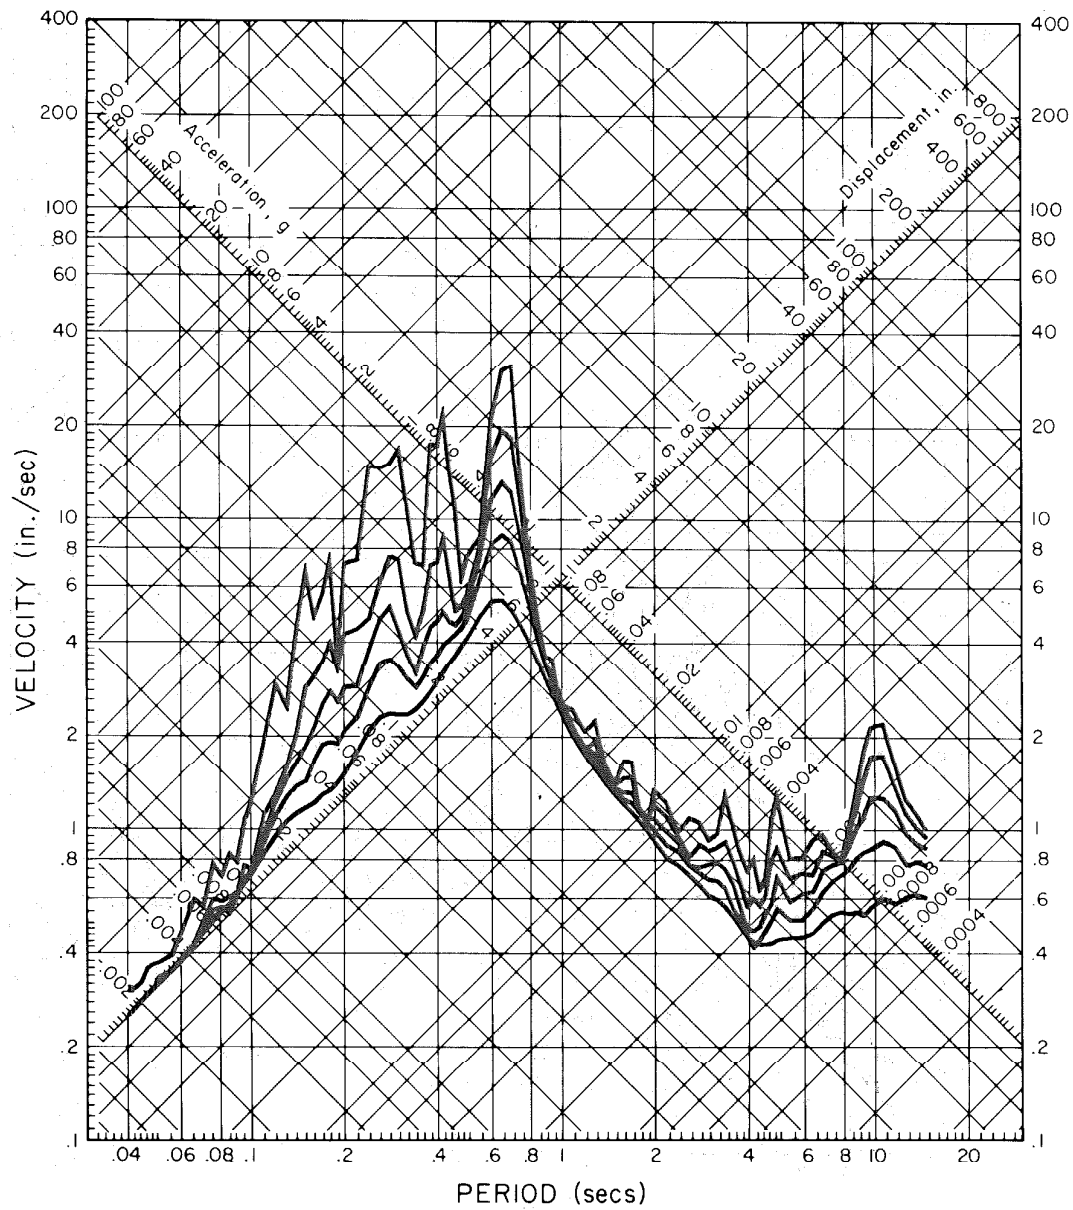
JUL 03, 1973 - 0000 CST

IIIMX040 73.003.0 INFIERNILLO, MEXICO COMP LOW

DAMPING VALUES ARE 0, 2, 5, 10 AND 20 PERCENT OF CRITICAL

Figure 6. Response spectrum for longitudinal component of motion on Infiernillo Dam.

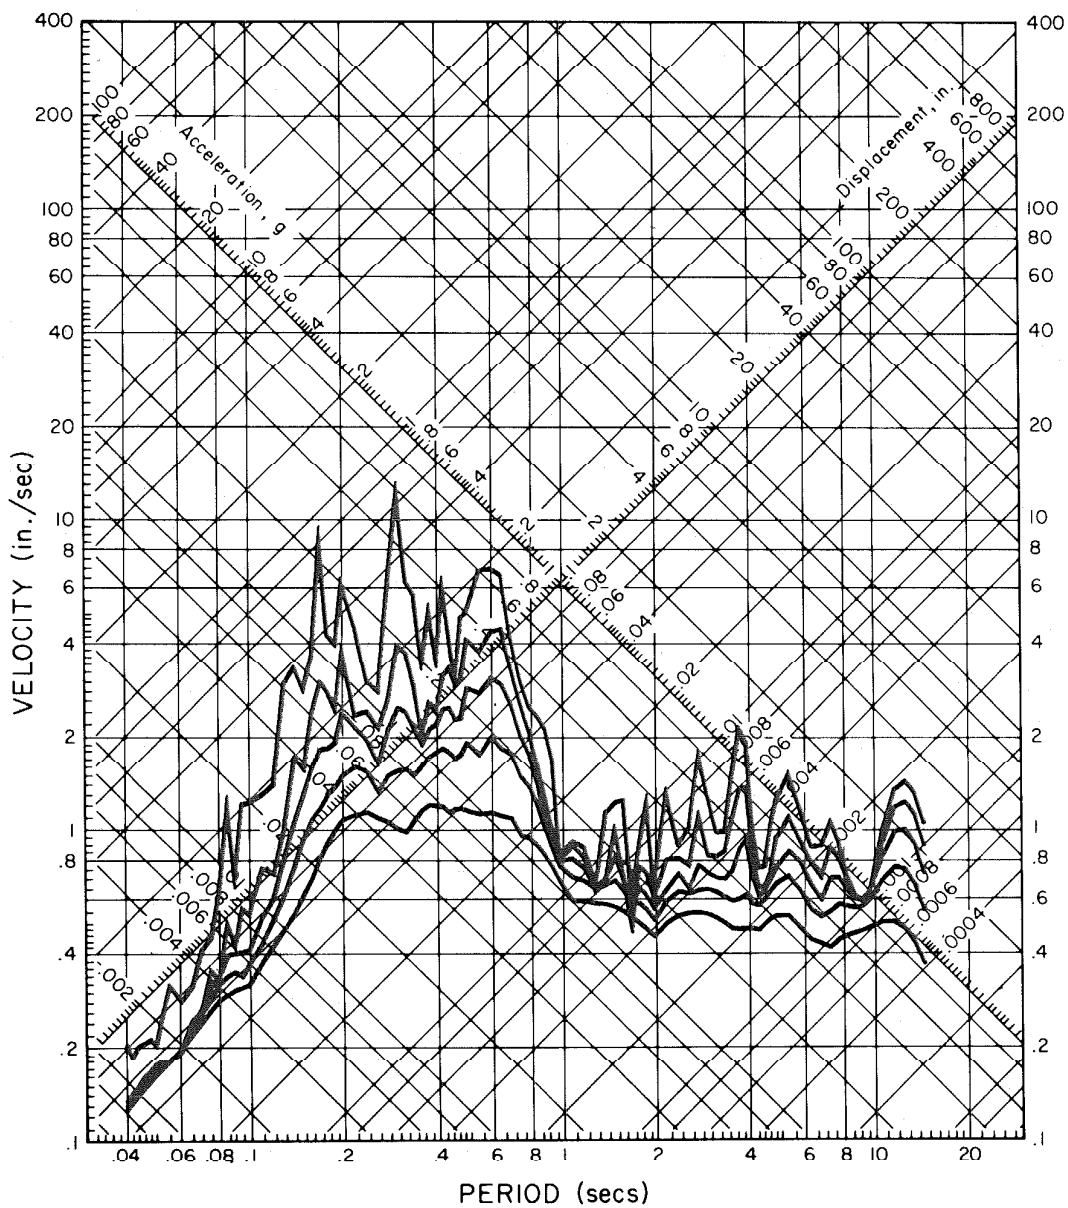
111MX040 73.003.0 INFIERNILLO, MEXICO COMP TRA

DAMPING VALUES ARE 0, 2, 5, 10 AND 20 PERCENT OF CRITICAL

Figure 7. Response spectrum for transverse component of motion on crest of Infiernillo Dam.

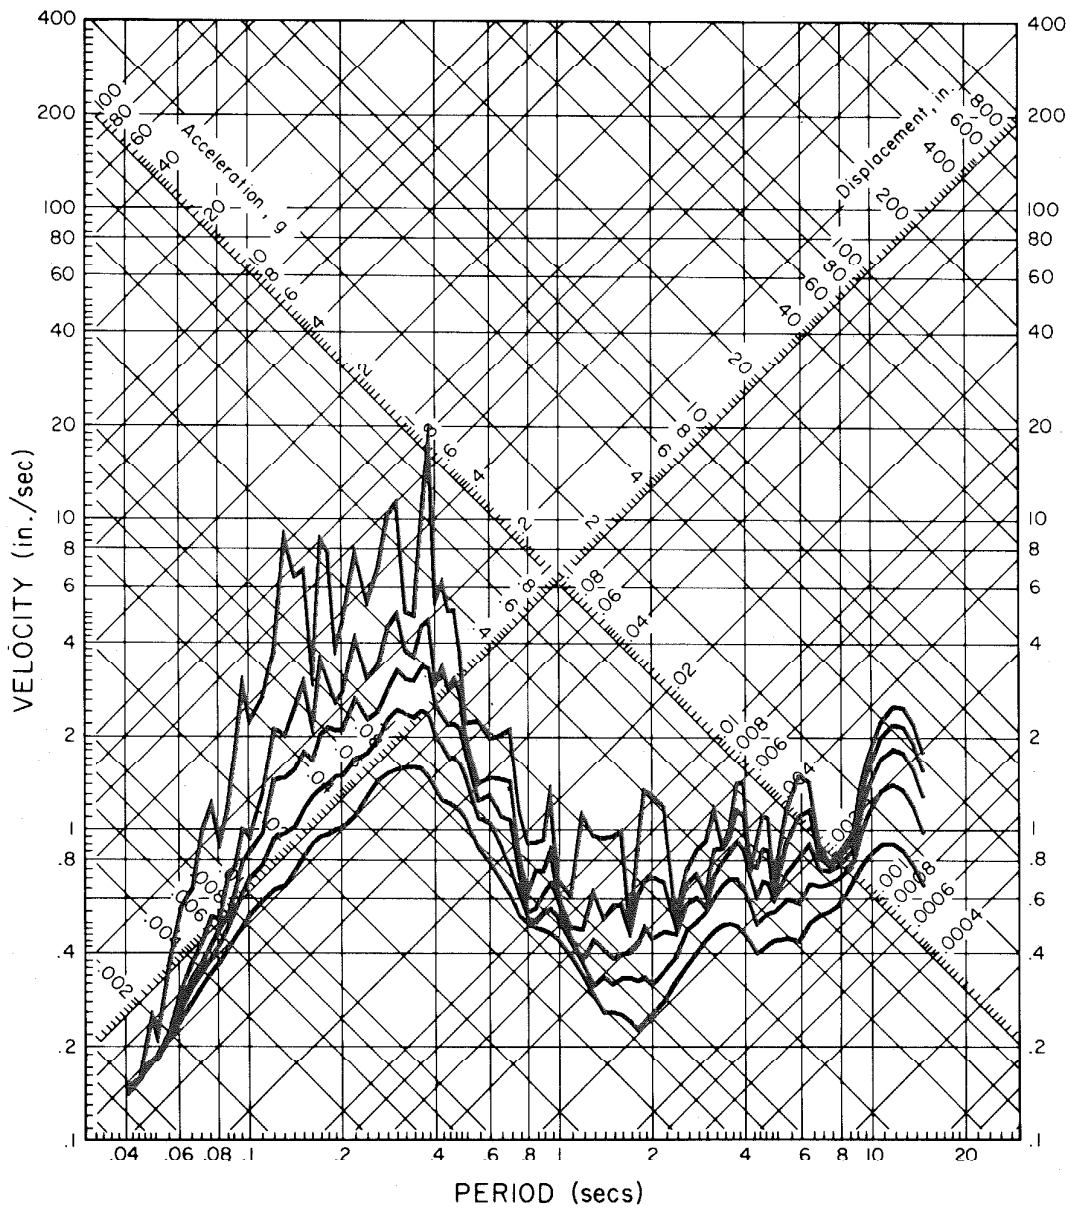
IIIMX040 73.003.0 INFIERNILLO, MEXICO COMP VER

DAMPING VALUES ARE 0, 2, 5, 10 AND 20 PERCENT OF CRITICAL

Figure 8. Response spectrum for vertical component of motion on crest of Infiernillo Dam.

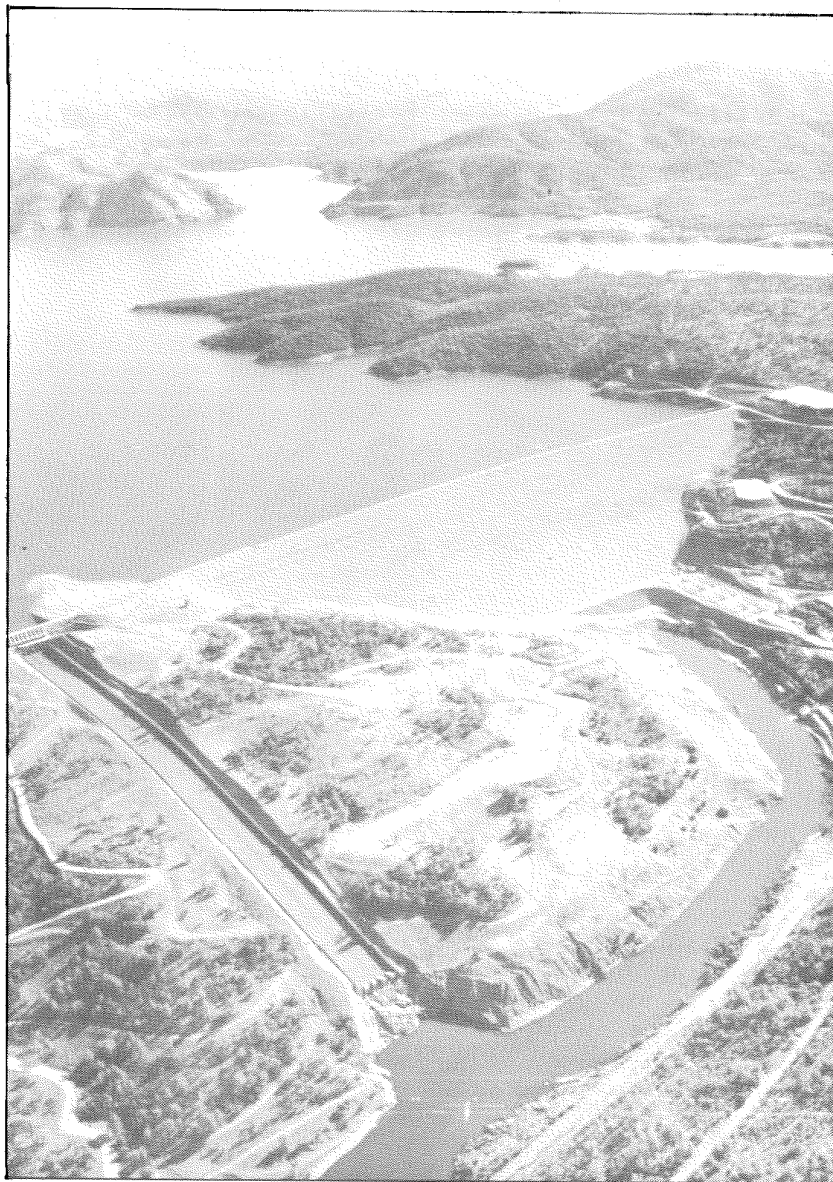
Figure 1. Oroville Dam and Spillway.

Oroville Dam, 39.53°N, 121.48°W, (Figure 1) is the keystone of the California State Water Project. The reservoir (Lake Oroville) is the source of water transported down the 644 km long California Aqueduct to Southern California. Dam construction was completed in mid-1968. On August 1, 1975 an earthquake ( $M_L=5.7$ ) occurred within 12 km of the dam, resulting in no significant damage to the dam.

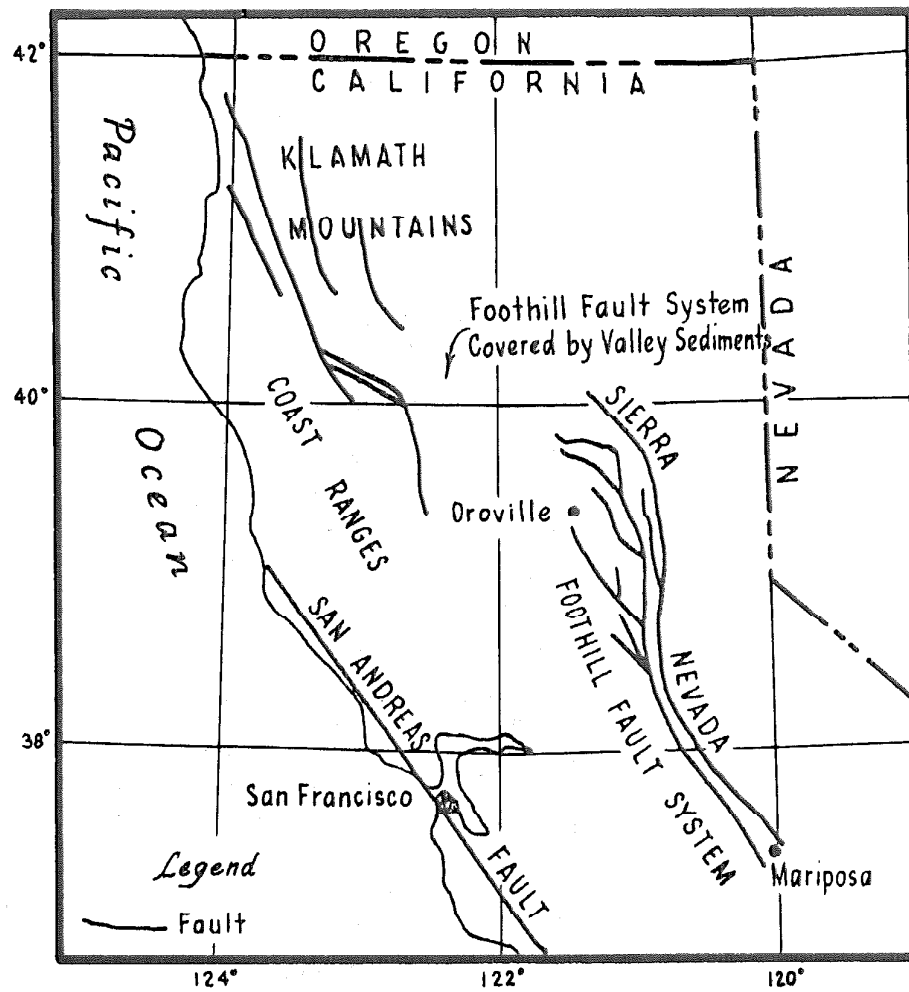
Figure 2. Foothill Fault System (After L.D. Clark)

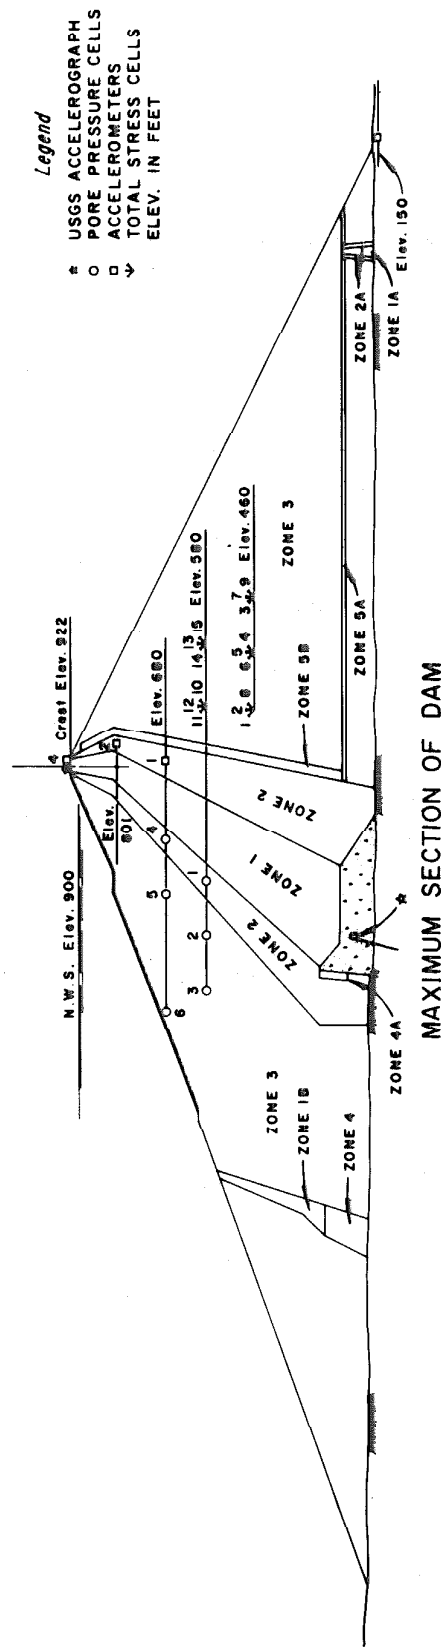
FIGURE 3

ZONE	MATERIAL
1	IMPERVIOUS CORE
1A	IMPERVIOUS SEEPAGE MEASUREMENT BARRIER
1B	IMPERVIOUS UPSTREAM CORE ABOVE ELEVATION 290
2	TRANSITION
2A	TRANSITION SEEPAGE MEASUREMENT BARRIER
3	PERVIOUS SHELL
3A	IMPERVIOUS UPSTREAM CORE ABOVE ELEVATION 290
4	IMPERVIOUS AT UPSTREAM FACE OF CORE BLOCK PARAPET
4A	IMPERVIOUS AT UPSTREAM FACE OF CORE BLOCK PARAPET
5A	DRAIN
5B	DRAIN

**OROVILLE DAM**  
**DYNAMIC INSTRUMENTATION**

The August 1 earthquake triggered the crest AR-240 and a Standard Coast & Geodetic Survey accelerograph located at the Oroville seismograph station about a kilometer north of the dam. The core block AR-240 was inoperative. Initial accelerograms from the force-balanced instrumentation were marred by a power-supply failure which left 0.6 sec gaps in the recordings. However, the problem was remedied and later aftershocks were well recorded. The crest AR-240 was replaced about a week after the August 1 main shock with a Kinematics SMA-1 accelerograph.

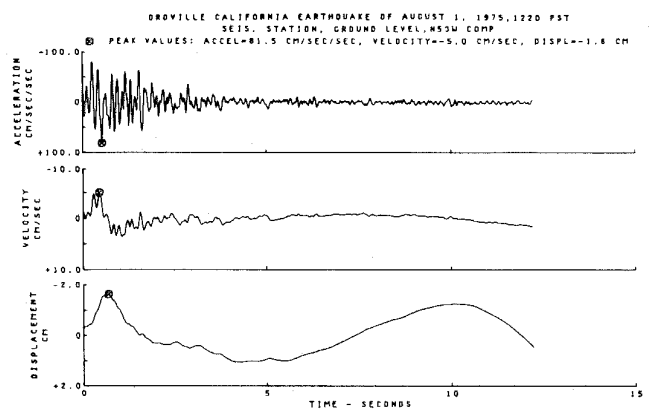
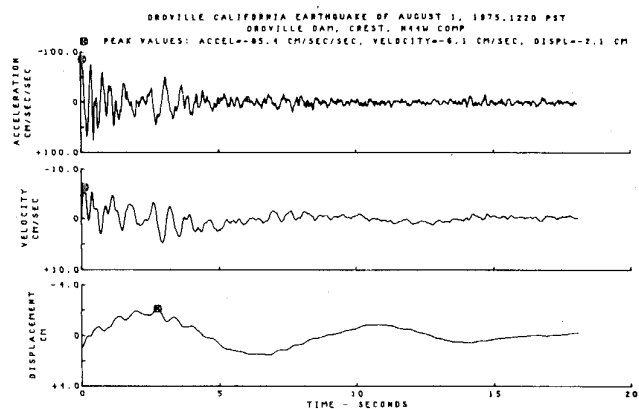
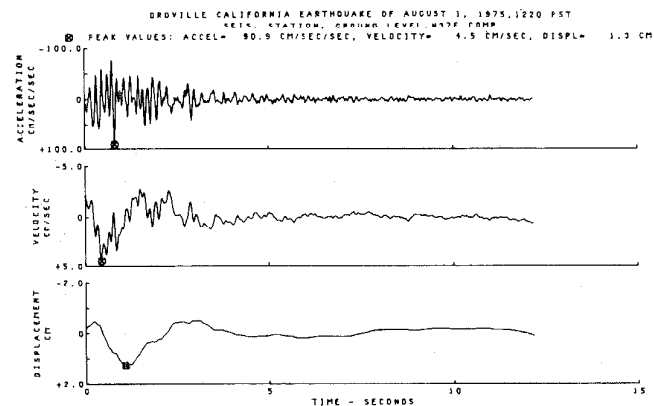
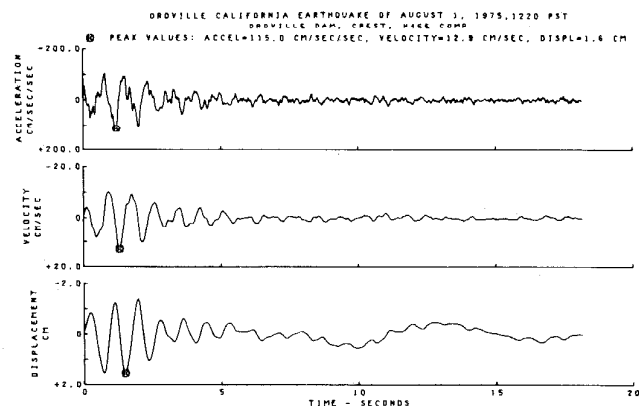
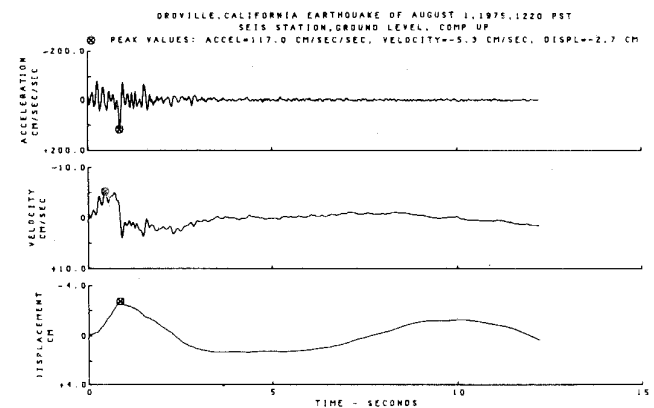
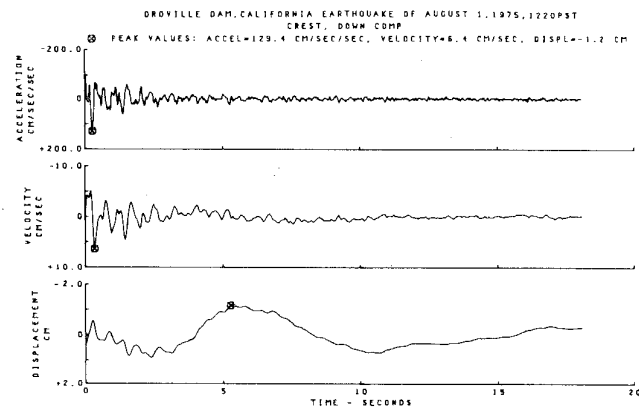
FIGURE 4. ACCELERATION AND COMPUTED VELOCITY AND DISPLACEMENT TRACES FOR THE OROVILLE SEISMOGRAPHIC STATION AND DAM CREST ACCELEROGRAPHS.
