## The Continuing Challenge: Report on the Performance of State Bridges in the Northridge Earthquake

George W. Housner, Hon.M.EERI, and Charles C. Thiel, Jr., M.EERI

Bridges affected by the Northridge earthquake were examined to evaluate the performance of Caltrans bridges, retrofit and peer review programs, and technical procedures. All structures in the region of strong shaking that had been retrofitted since 1989 performed adequately; if the seven bridges that collapsed had been retrofitted, they would be expected to have survived with little damage. The bridges subjected to strong shaking that had been constructed or retrofitted to current Caltrans criteria had, at most, minor damage; all remained in service. The Seismic Advisory Board concluded that the Caltrans seismic design procedures for new bridges and its retrofit procedures for existing hazardous bridges are technically sound. The Board found that the retrofit program is proceeding fairly well, but that the screening methods used to identify hazardous bridges could be improved as could the pace of retrofitting, particularly toll bridges. There were no construction projects underway in the Spring of 1994 for toll bridg

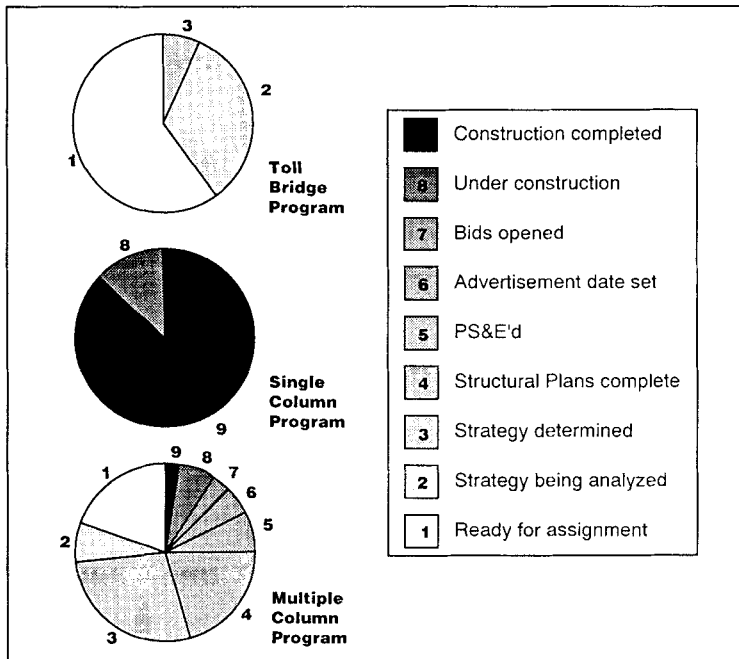
Figure 5-1. The pie charts show the status of the single-column, multiple-column and bridge retrofit programs for state highway bridges. The segment represents the proportion of the structures in the particular category of completion compared to the number of structures affected.

The retrofit program for state highway bridges has been divided into three parts—single-column, multiple-column, and toll-bridge programs—with a total estimated cost of \$2,420 million (Table 5-3). All projects are in progress with the indicated percentages for structures with construction complete, and under construction. Figure 5-1 graphically illustrates the proportion of structures impacted in each of the nine project categories from *Ready For Assignment* to *Construction Completed*.

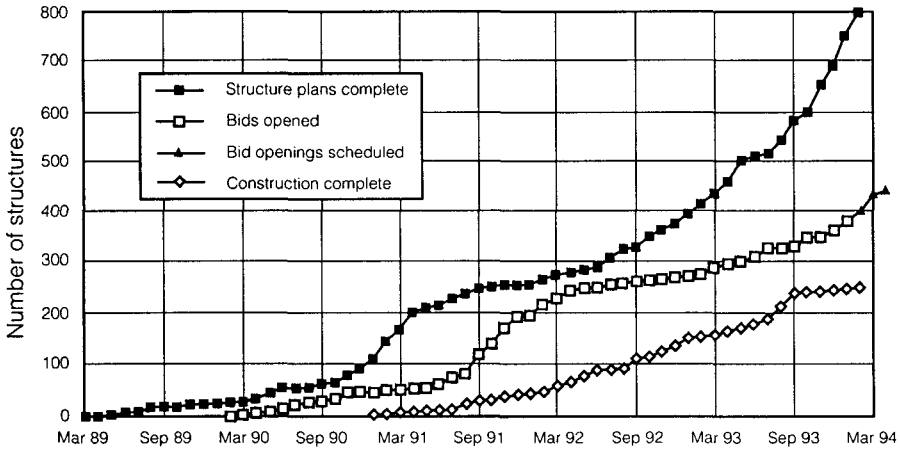
Figure 5-2. The total numbers of seismic safety retrofit projects for state highway bridges in different stages of completion since March 1989. Note that the program accelerated substantially following the Loma Prieta earthquake on October 7, 1989.

A total of 2,537 state bridges remain in the current retrofit program based on the screening procedure discussed above. Further screening and preliminary structural evaluation have resulted in identification of about 2,000 state bridges that require detailing evaluation and retrofit. As indicated in Figure 5-2, retrofit plans have been completed for approximately 800 bridges, bids have been opened for 400, and retrofit has been completed on about 250.

Figure 5-2 graphically emphasizes the remaining vulnerability of the state highway system. In particular, it should be noted that retrofit plans have not yet been completed for any of the 11 toll bridges in California. Most of these bridges, such as the San Francisco Bay Bridge, are vital to the economic welfare of the area they serve.
