**STRONG-MOTION INSTRUMENTAL DATA ON THE  
SAN FERNANDO EARTHQUAKE OF FEB. 9, 1971**

D. E. HUDSON, EDITOR

September, 1971

STRONG-MOTION INSTRUMENTAL DATA ON THE  
SAN FERNANDO EARTHQUAKE OF FEBRUARY 9, 1971

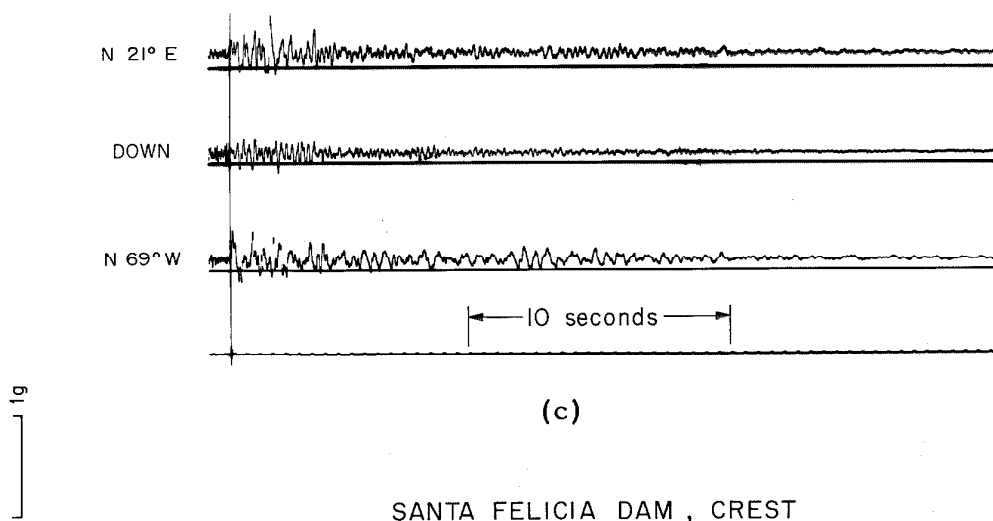
CASTAIC, OLD RIDGE ROUTE

SANTA FELICIA DAM, CREST

Figure 6 AR-240 Accelerograph records from special sites.

above the stream bed. Figure 6 shows the accelerograph record from the crest station where the maximum acceleration was slightly greater than 0.2 g, approximately the same as that measured at the outlet structure below the dam. The relatively long period waves recorded at the crest, 0.6 to 0.9 second, caused the adjacent seismoscope with a natural period of 0.75 second to go off scale, while at the outlet structure the dominant period was near 0.1 second, and consequently comparatively small amplitudes were recorded on the seismoscope at that site (see Chapter 3 of this report by Morrill). The difference in frequencies is attributed to the longer period response of the earthfill dam contrasted to that of a small concrete structure with an integral 30 foot stilling well imbedded in a sandstone and shale complex.

Sample Accelerograms. Examples of sets of three building accelerograms obtained with AR-240 accelerographs on 12 in. wide paper may be seen in Figures 4 and 5 of Chapter 1 by Maley and Cloud. Examples of AR-240 records of ground sites are shown in Figure 6 of Chapter 1. Typical building records obtained on 70 mm. film with the SMA-1 accelerograph are shown in Figure 7, and on 35 mm. film with the MO-2 accelerograph in Figure 8, Chapter 1. A ground station record from an SMA-1 accelerograph is included as Figure 1 of the present chapter.

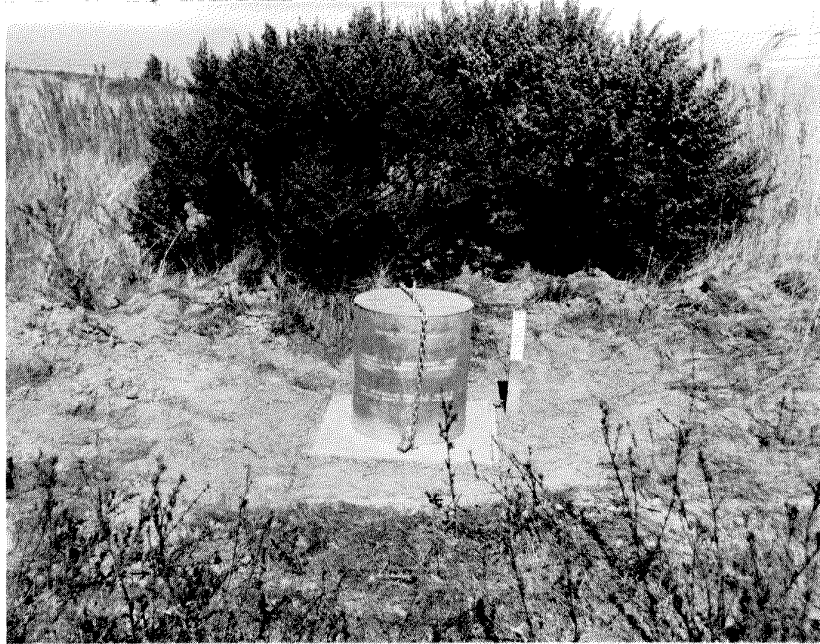
Figure 2. Typical seismoscope field installation, showing concrete base and external protective cover.

The instrument is shown in Figure 1. Seismoscopes are usually installed under "free-field" conditions. A typical installation is shown in Figure 2. There are two types or manufactures of seismoscopes now in use, the Wilmot and the Sprengnether. Characteristics of each are given in Table I. In the tabulations for this report the particular type may be recognized by the serial number.

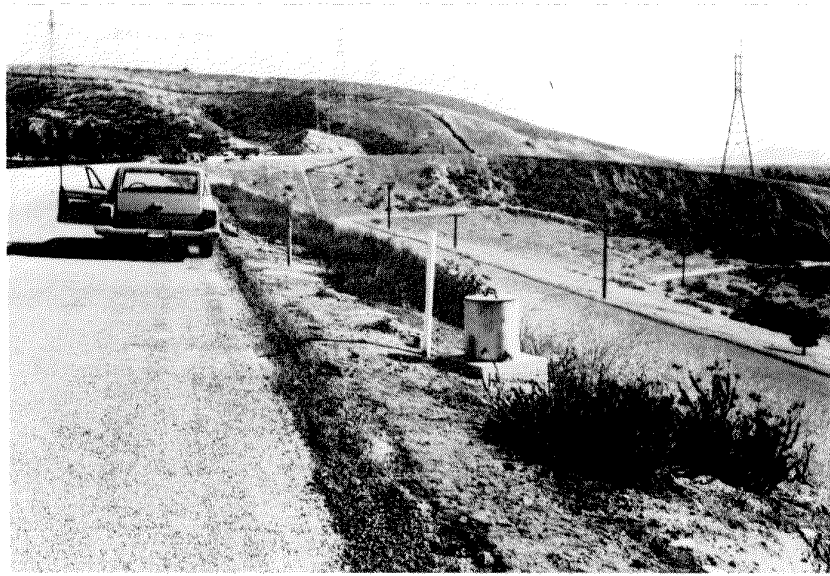
Figure 7(a). Seismoscope Site 256 at crest of Lower San Fernando Dam before earthquake.
